Report No.
SSRP-16/12

**Evaluation of Durability and Wear Characteristics of
Viscous Fluid Dampers for Seismic Bridge Retrofits
with Significant & Sustained Traffic Loadings**

Santiago Creek Damper Tests

May 2017

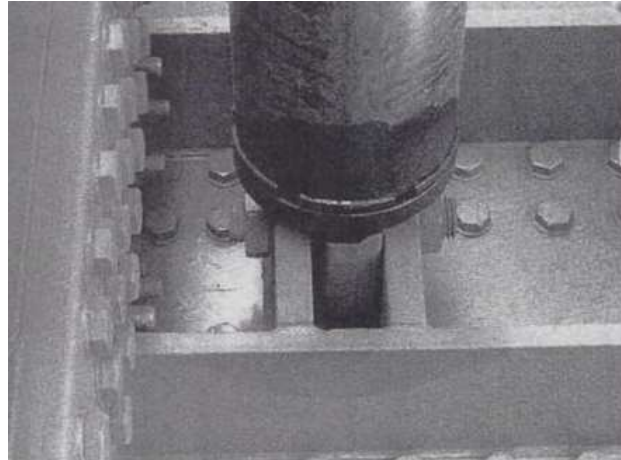
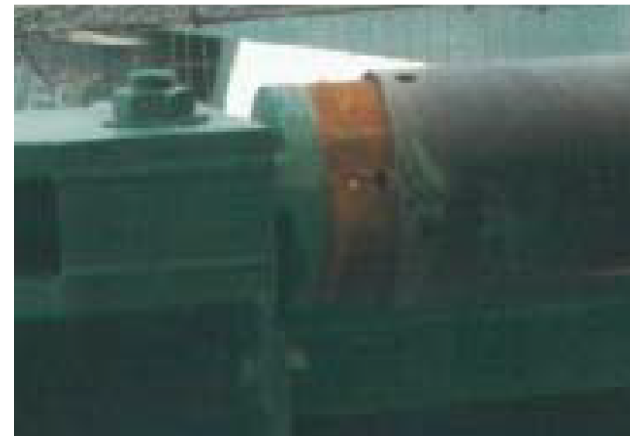
Figure 1. Evidence of fluid leaking in 200K ip dampers installed on Vincent Thomas bridge. a) Leakage at midsection of bottom dampers tower – deck connection, b) Leakage at clevis at the tower connection, c) Sheared bolts on the damper protective covers at the truss connection and sliding of the cover away from the clevis connection. VTB provided the first detailed examination of the in-service problem of leaking dampers.

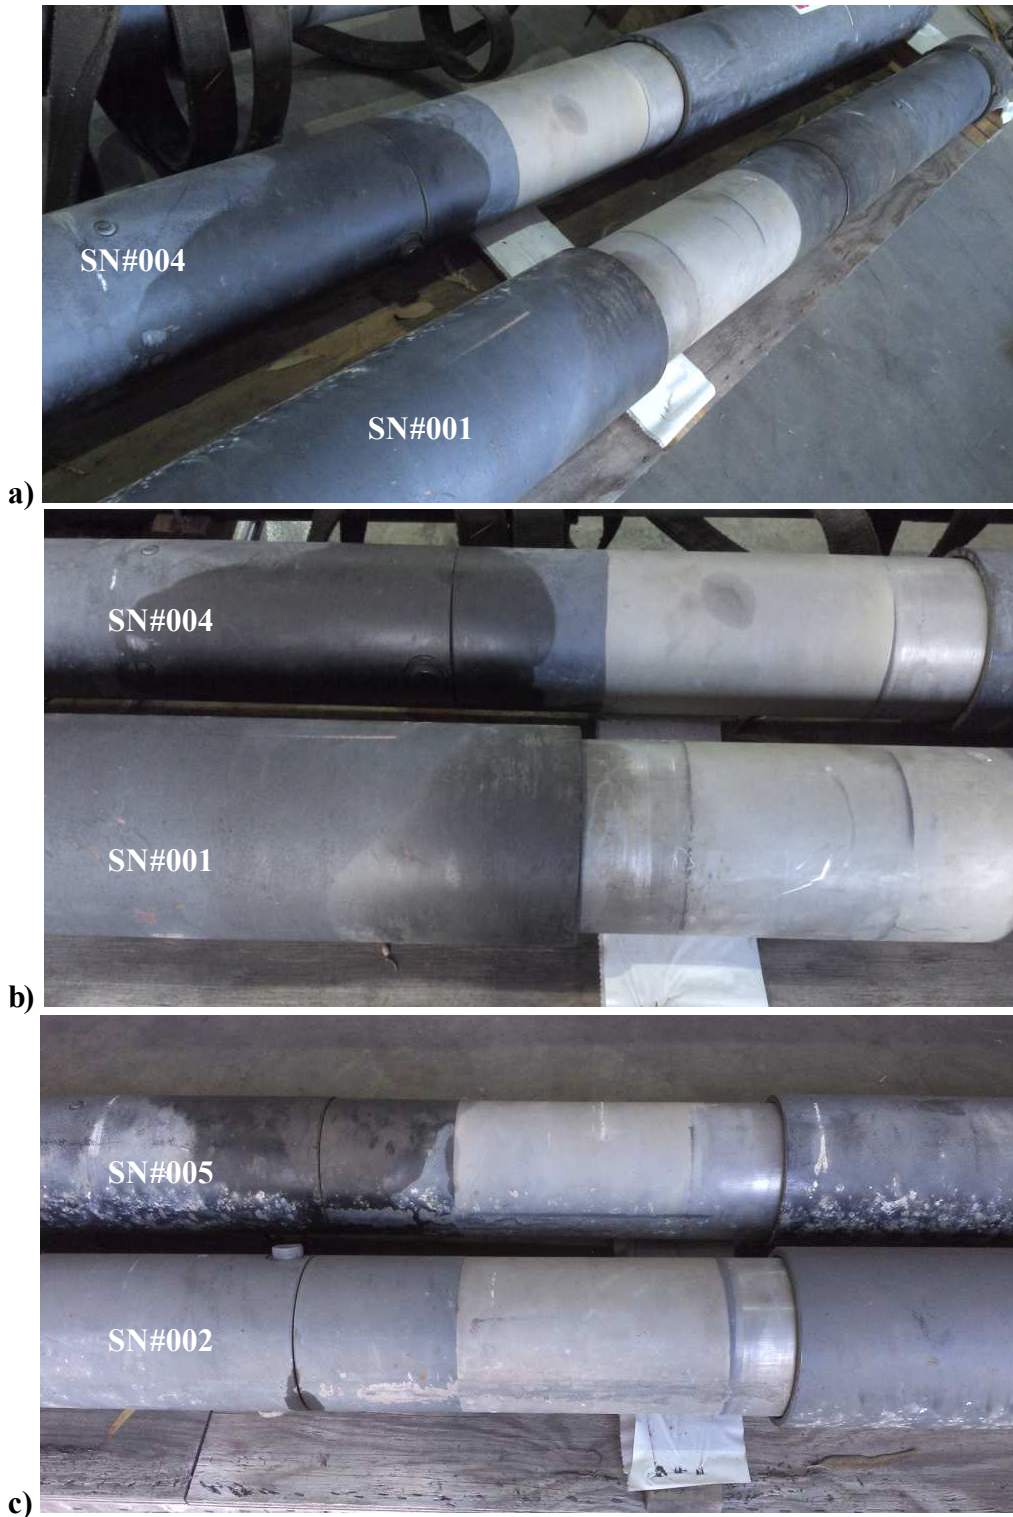
A visual examination suggested that all dampers were in some distress and fluid leaks observed at different locations as noted in Table 1. Leakage at the threaded connection (**E**) was a common occurrence for all six dampers. Damper SN#001 and SN#006 showed additional weepage at the sleeve cover (**C**) and damper SN#005, SN#006 also exhibit fluid leak stains at the clevis tang locations (**G, H**).

Figure 4 shows close-up view of the leakage in several dampers. In Figure 4(a),(b) SN#004 is leaking at the threaded connection (E) only while SN#001 also shows weepage at the sleeve cover (C). Looking back to the construction detail, traces of fluid leak at (C) most likely originate from the front bearing failure. Figure 4(c) shows wide disparities in observed leakage in different dampers. Another comparison is shown in Figure 5 for SN#002 and SN#005 where the former looks relatively clean, figure 5(a), and the latter appears to be leaking profusely, figure 5(a), (b). SN#005 condition was to be poor on account of the large stain at the threaded connection (E) with additional leak stains at the clevis/ tang – perhaps indicative of leakage at the rear bearing or the reservoir chamber, Figure 5(c).

Any weepage observed on the sleeve cover, and at the tangs is taken to be direct evidence of bearing damage – as the only viable leak path originates from the bearings. Leakage at the threaded connection is somewhat deceptive as the leak path does not traverse any seals, bearings and could stem from construction defects. *We note that thread sealants are employed during the assembly process and these may become embrittled and crack under repeated service loading.*

Figure 4: Inspection of as-received Enidine dampers recovered from Santiago Creek. a) Leakage at the thread in SN#004 and leakage at thread and seepage at sleeve cover in SN#001, b) Close up view of leaks in (a); c) Varying degrees of thread leakage in SN#002 and SN#005. No seepage observed in either damper SN#002, SN#005 sleeve covers.

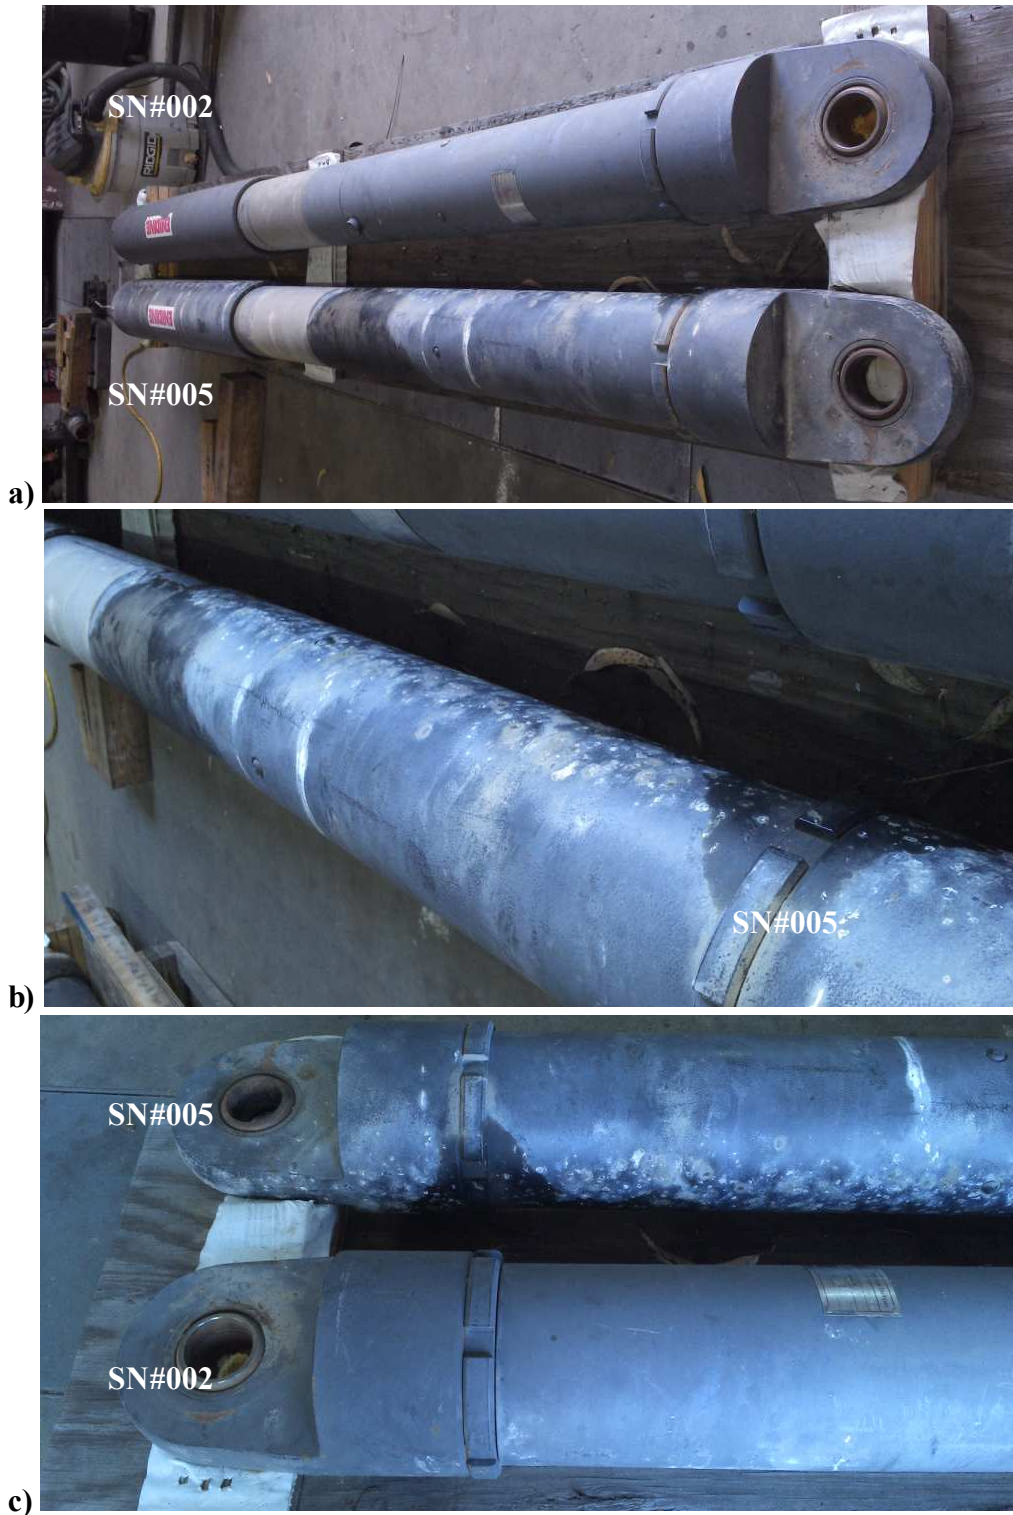
Figure 5: Comparative visual examination of dampers SN#002, SN#005. a) Damper 002 (top) is reasonably clean but 004 (bottom) shows profuse leakage at threaded joint and at clevis/tang connection. b) close-up of leakage at tang connection, c) comparison of 002 and 005 tang.

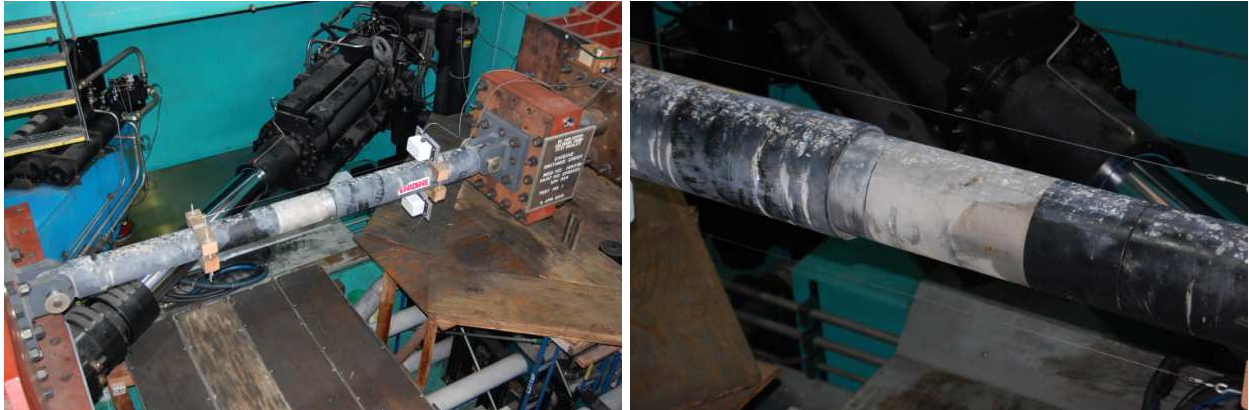
Figure 7. Overview of SN#004 as mounted for testing and leaking at the threaded connection.

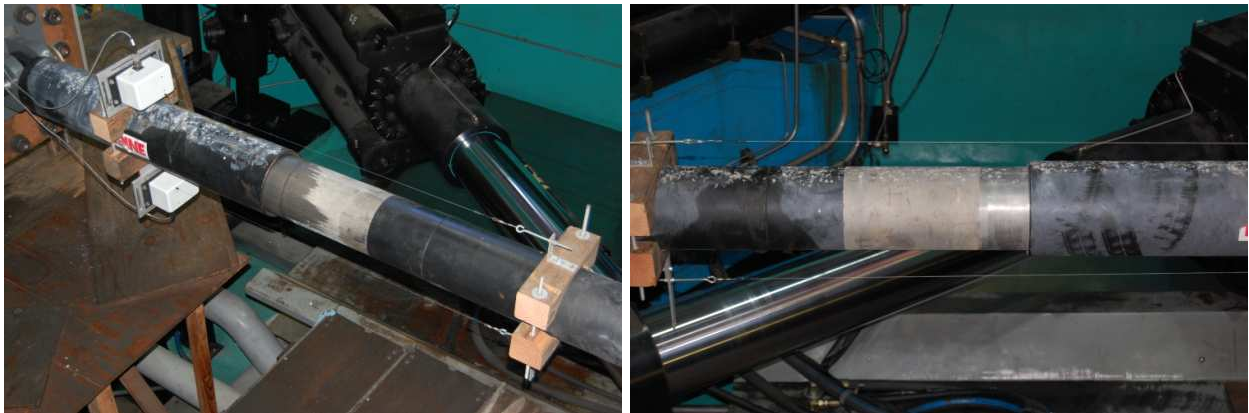
Figure 8 a) SN#006 leaking at the sleeve cover, b) SN#001 leaking at the threaded connection

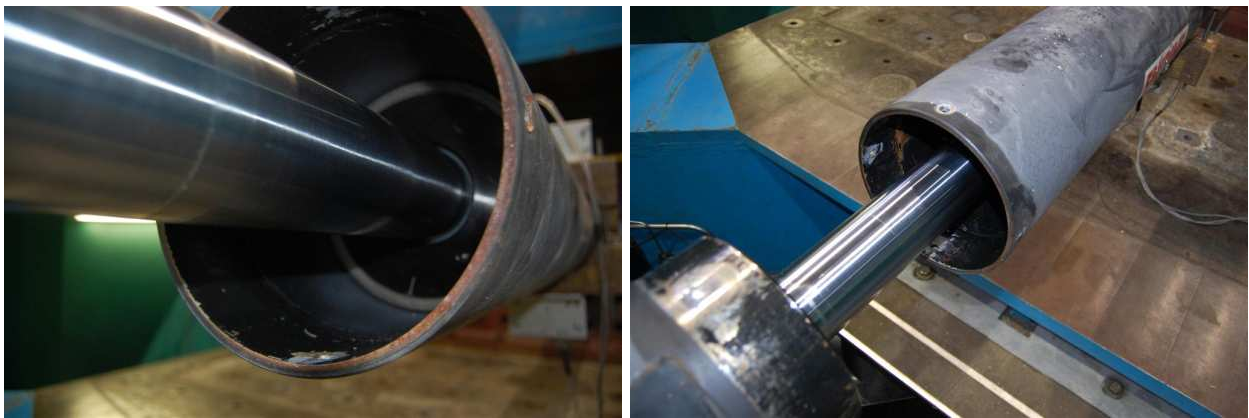
Figure 14. (a) inside view of the dry sleeve cover and clean front bearing for SN#003 damper, (b) inside view of the oily sleeve cover for SN#006 damper indicating mild leakage at front bearing.
