<p>16. ABSTRACT</p> <p>The Type 732SW bridge rail is an updated version of the Type 26 bridge rail and was tested for compliance to the Manual for Assessing Safety Hardware (MASH 09) as a part of this research project.</p> <p>The 732SW is a taller, stronger version of the Type 26 with a sidewalk. It is comprised of a sidewalk, vertical concrete wall, and steel handrail for pedestrians. The barrier tested was about 24 m (79 ft) long and was constructed at the Caltrans Dynamic Test Facility in West Sacramento, California.</p> <p>Three crash tests were conducted under MASH 09: Test 3-11 (the 2270P pickup at TL-3), Test 3-10 (the 1100C small car at TL-3), and Test 2-10 (the 1100C small car at TL-2) because Test 3-10 resulted in a ridedown acceleration that was outside of the MASH 09 limits. The results of Tests 3-11 and 2-10 were within the limits of the MASH 09 guidelines.</p> <p>The Type 732SW bridge rail is recommended for approval on California highways requiring TL-2 bridge rails with pedestrian traffic. Since it is symmetric, the Type 732SW is also recommended in locations where a reverse hit is possible.</p>

**COMPLIANCE CRASH TESTING OF
THE TYPE 732SW BRIDGE RAIL**

DEPARTMENT

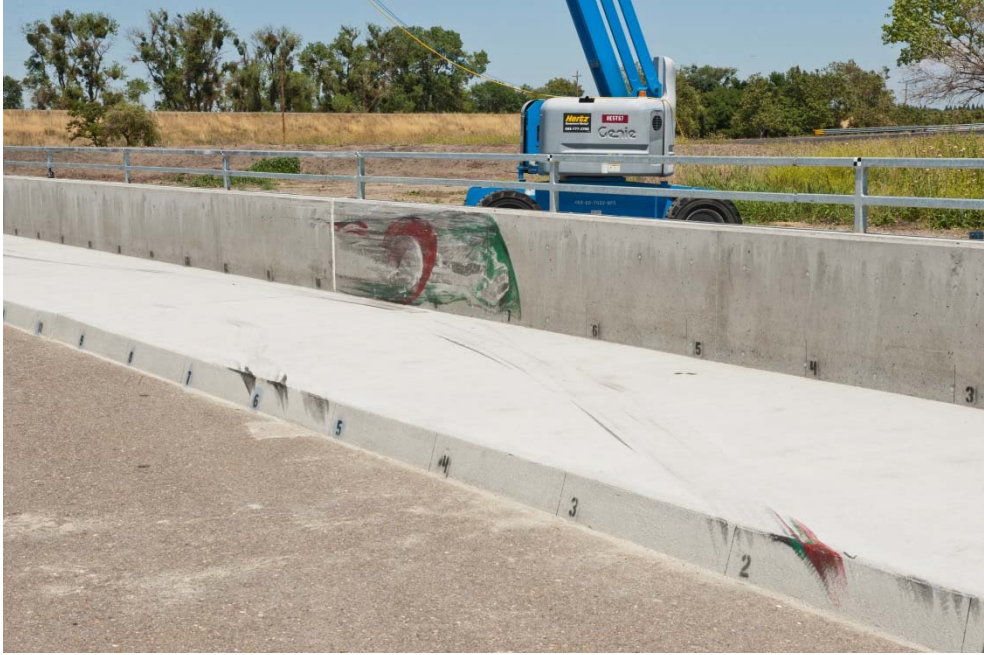
There was only minimal permanent damage to the barrier during Test 130MASH3P13-01. There was only very minor scraping of the concrete barrier face and scraping of the steel handrail. There was no structural damage to warrant immediate repair. There was no permanent deflection in the concrete curb or steel rail. As the vehicle impacted the barrier, the dynamic deflection in the steel rail was 1 inch (25 mm), as measured from the overhead camera.

Figure 3-2 – Type 732SW Barrier after Test 130MASH3P13-01

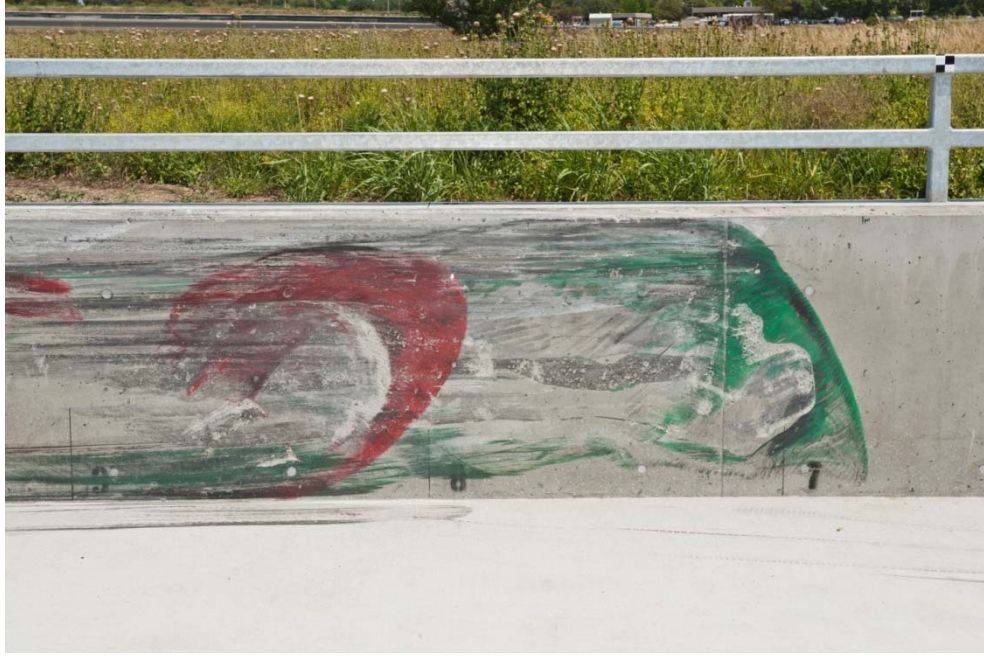
Figure 3-3 – Close-up of 732SW Barrier after Test 130MASH3P13-01

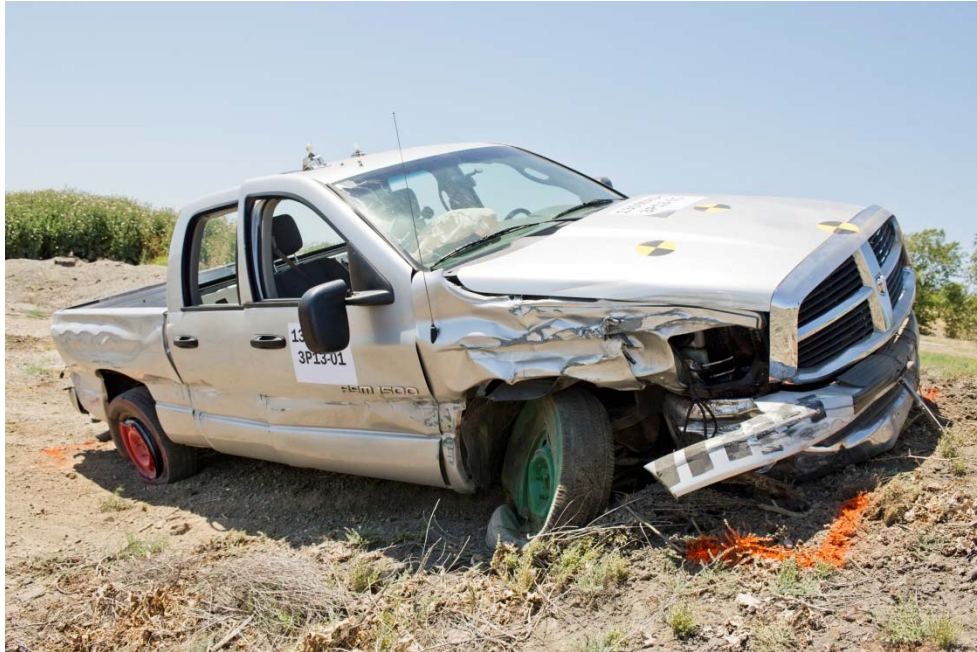
The right front tire ruptured upon impact with the sidewalk. The right front corner of the vehicle was severely damaged in the impact with the barrier face. The right front fender, hood, bumper, headlamp area, grille, and suspension components were all affected. The passenger side doorframe was deformed outward but the doors remained latched. The left front and right rear tires were also ruptured. The top of the vertical concrete wall caused denting along the entire length of the passenger side as the vehicle continued to contact the barrier after the initial impact. The right front tire was pushed rearward and slightly into the passenger side foot well area. The maximum amount of passenger compartment deformation was 54 mm (2.1 in), which occurred in the floorboard and is below maximum MASH 09 limits. All other occupant compartment deformations were below MASH 09 limits for that area of the vehicle. The passenger side of the windshield cracked but did not separate or enter the occupant compartment.

Figure 3-7 – Right front corner of test vehicle after Test 130MASH3P13-01

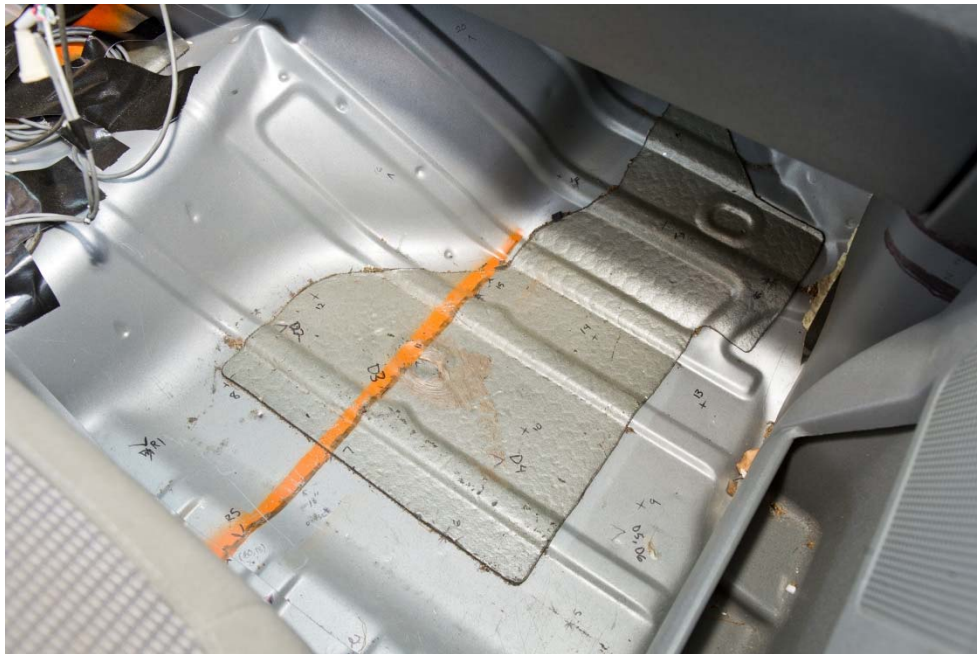
Figure 3-8 – Floorboard deformation of test vehicle after Test 130MASH3P13-01

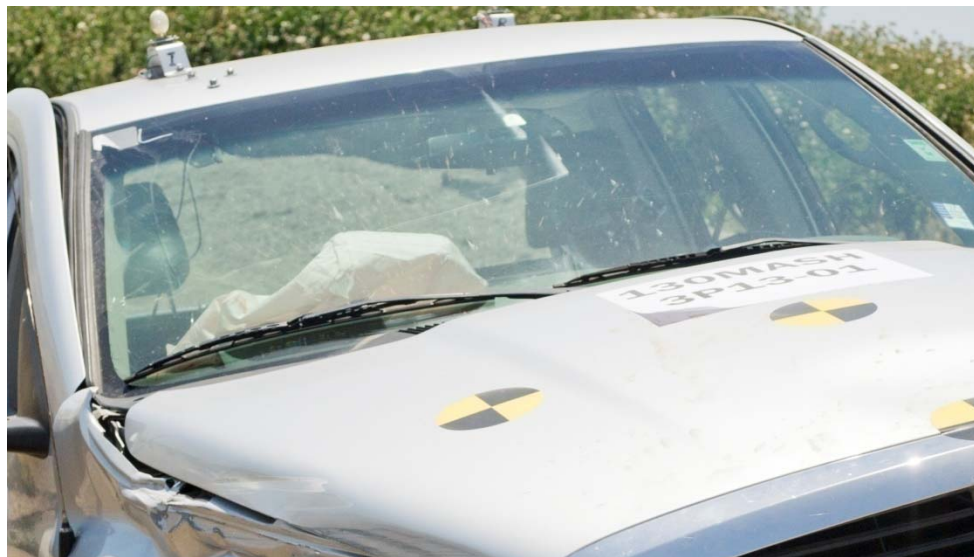
Figure 3-10 – Vehicle windshield after Test 130MASH3P13-01

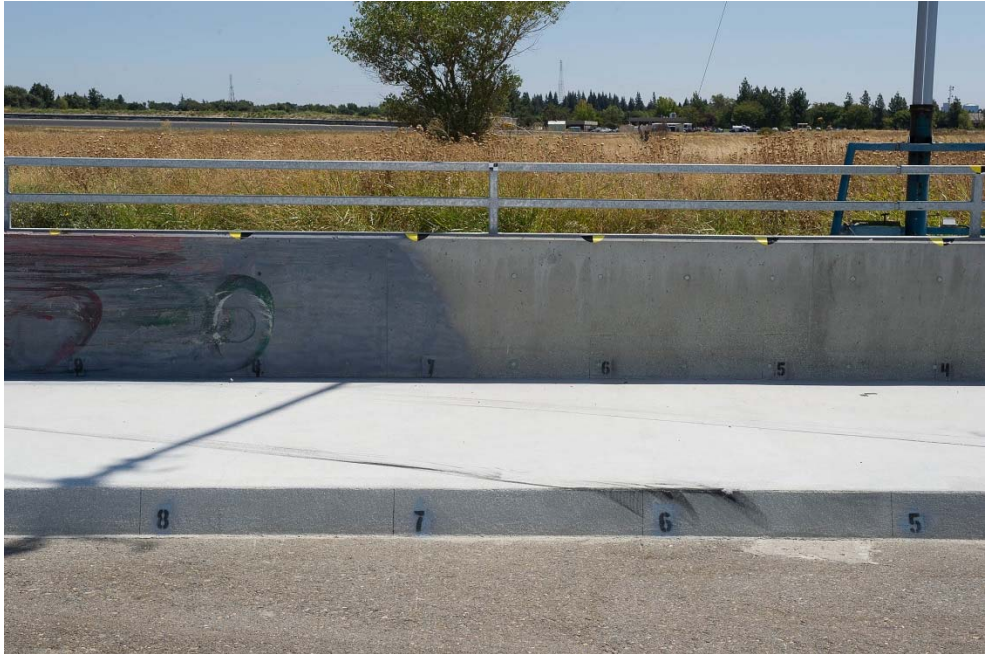
There was essentially no permanent damage to the barrier during 130MASH3C13-02. The barrier scraped paint off the vehicle along the length of contact. There was a negligible amount of scraping and gouging of the concrete face. Although the vehicle hood snagged slightly on the barrier post, there was no damage to the post. There would be no need for repair by maintenance crews.

Figure 3-13 – Type 732SW bridge rail face after 130MASH3C13-02

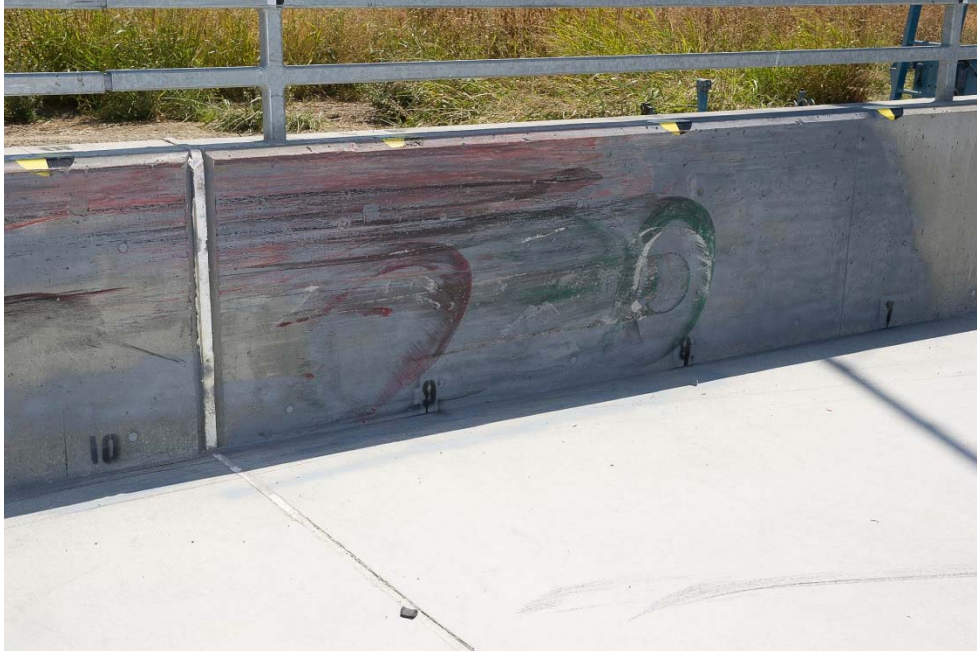
Figure 3-14 – Barrier face scraping after 130MASH3C13-02

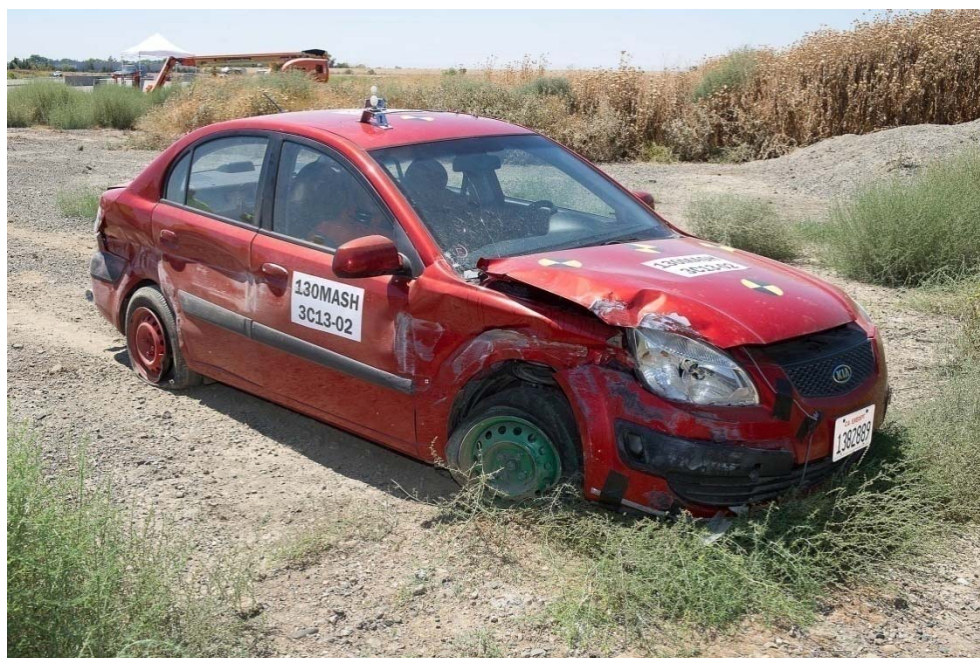
The front right wheel absorbed most of the impact with the barrier curb and face. The rim was bent during impact with the curb causing the tire to deflate. The wheel well of the test vehicle sustained most of the damage. Additional damage also occurred to the side of the vehicle as it scraped the barrier when redirected. Since the front right wheel took most of the impact, there was no distinguishable damage to the floorboard (see Figure 3-20). The right front corner of the vehicle was moderately damaged. The right front bumper and right fender were pushed rearward. The entire right side of the vehicle was moderately damaged. All four tires deflated during the impact. The maximum passenger compartment deformation was 1.7 inches at the floor pan near the center of the vehicle.

Figure 3-18 – Front right corner of test vehicle after 130MASH3C13-02

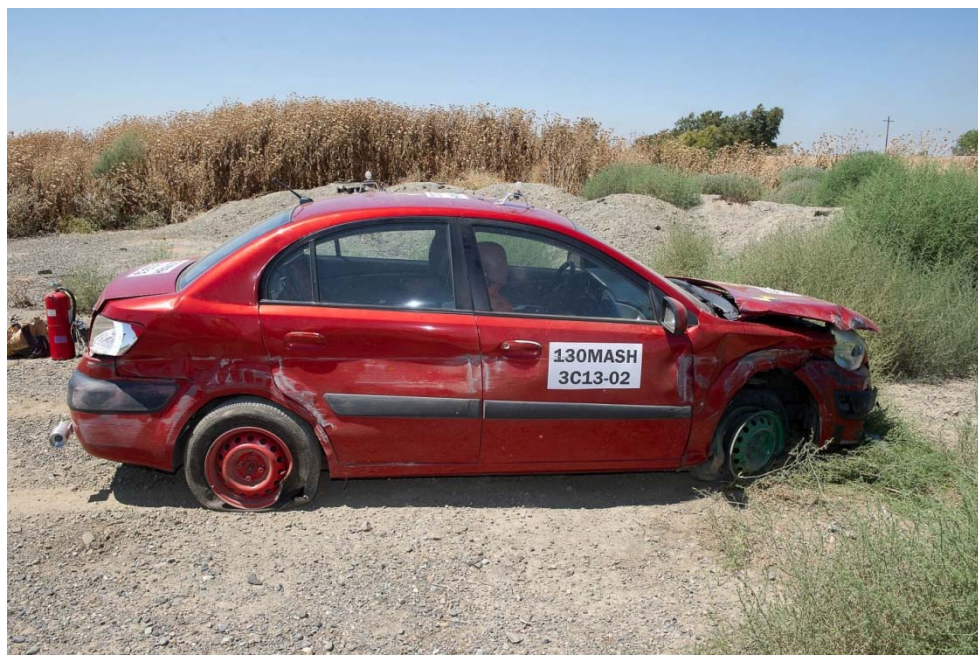
Figure 3-19 – Right side of test vehicle after 130MASH3C13-02

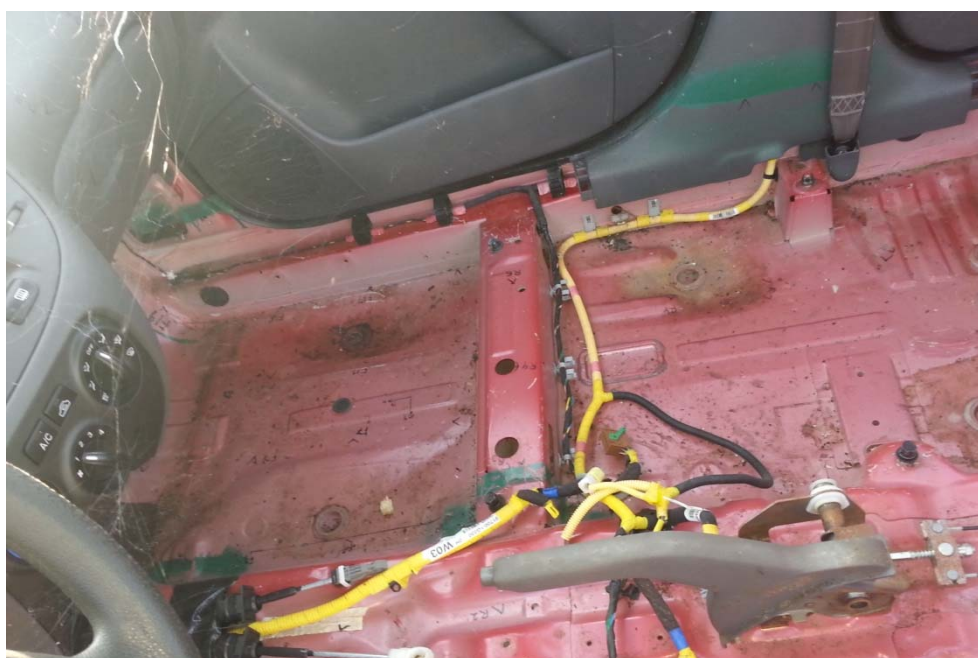
Figure 3-20 – Interior Floor Board of test vehicle after 130MASH3C13-02

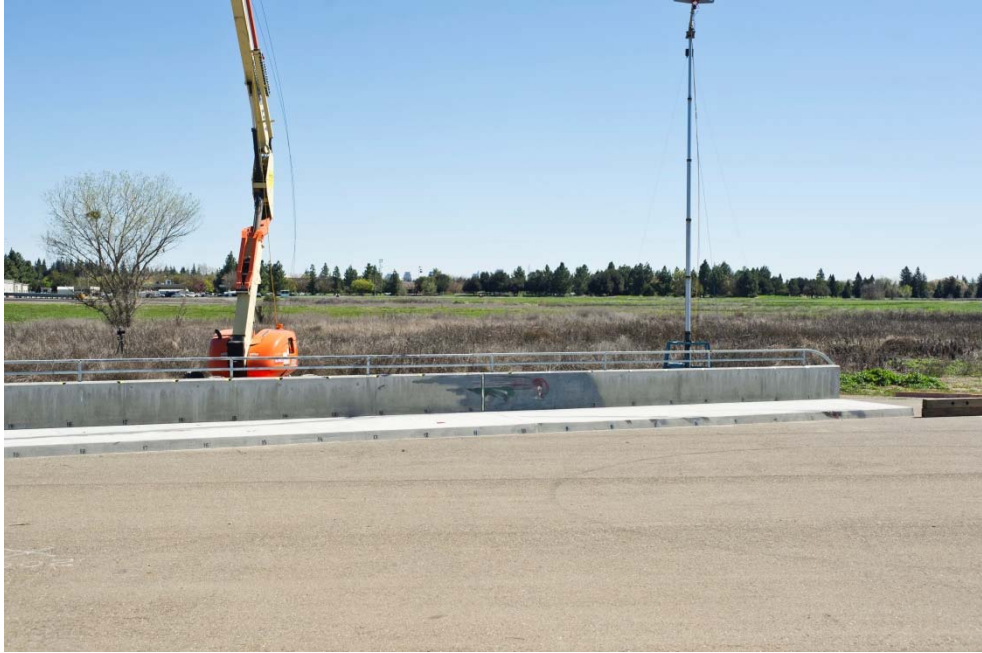
There was essentially no permanent damage to the barrier during 110MASH2C14-01. The only damage was a negligible amount of scraping and gouging of the concrete face. Damage to the barrier was considered cosmetic and would not have required field repairs.

Figure 3-24 – Type 732SW bridge rail face after Test 110MASH2C14-01

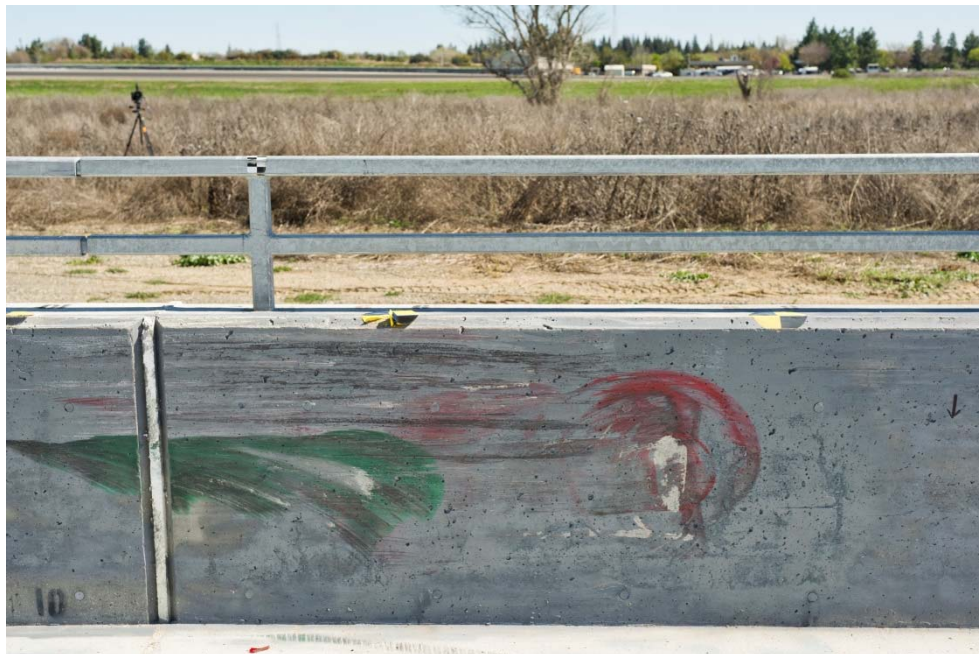
Figure 3-25 – 732SW Barrier face scraping after Test 110MASH2C14-01

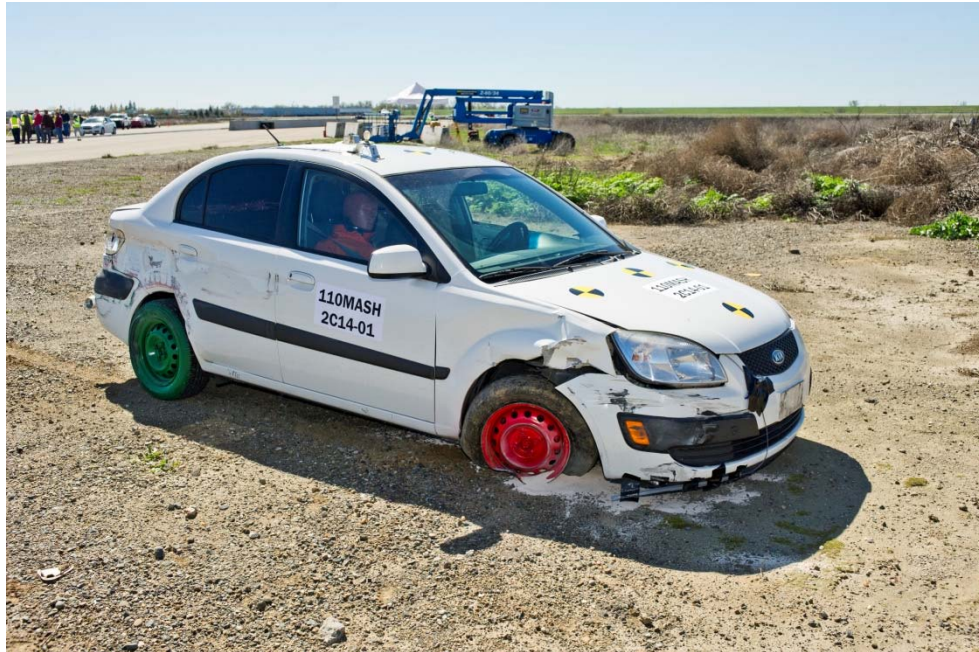
The front right wheel absorbed most of the impact. The rim was bent during impact causing the tire to deflate. The wheel well of the test vehicle sustained most of the damage. Additional damage also occurred to the side of the vehicle as it scraped the barrier when redirected. Since the front right wheel took most of the impact, there was no distinguishable damage to the floorboard (see Figure 3-31). The right front corner of the vehicle was moderately damaged. The right front bumper and right fender were pushed rearward. The right side of the vehicle at the front and rear was moderately damaged. The two front tires deflated during the impact. The maximum passenger compartment deformation was 0.6 inches at the floor pan near the passenger door.

Figure 3-29 – Front right corner of test vehicle after Test 110MASH2C14-01

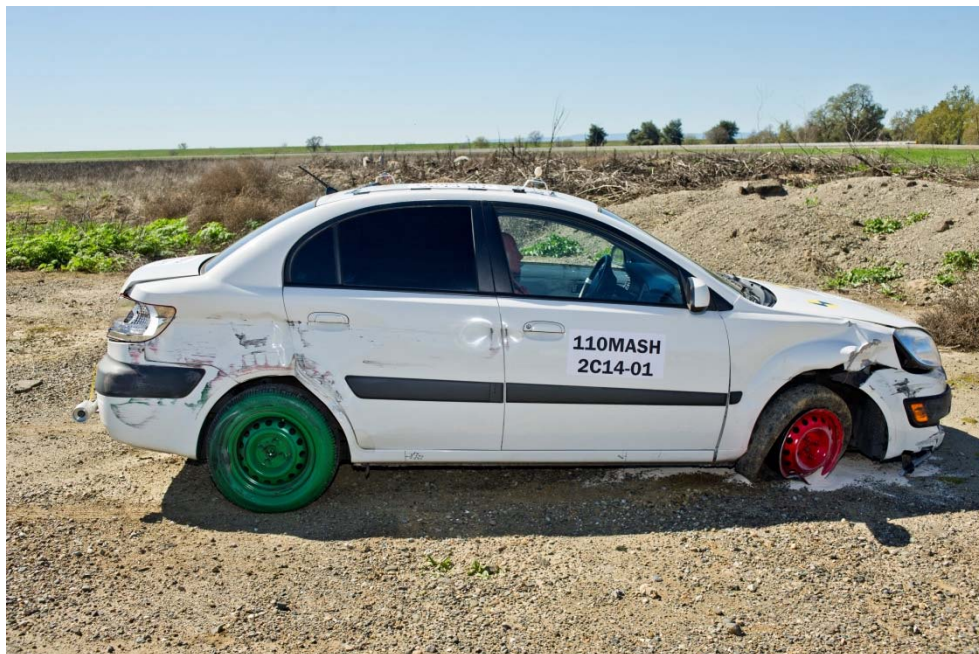
Figure 3-30 – Right side of test vehicle after Test 110MASH2C14-01

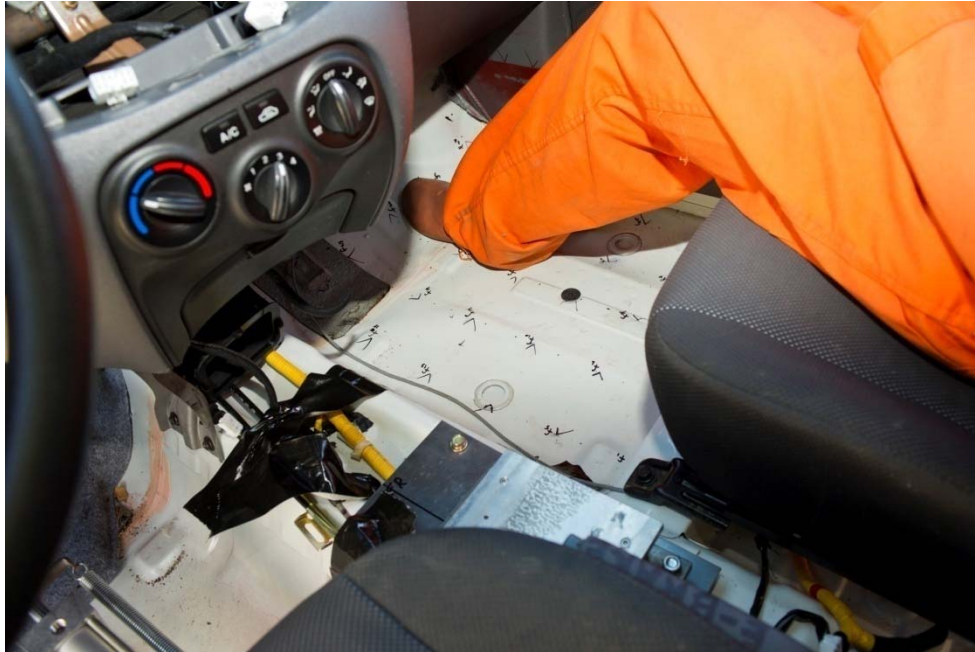
Figure 3-31 – Floor Board of test vehicle after Test 110MASH2C14-01
