1. REPORT NO. FHWA/CA10-0644	2. GOVERNMENT ACCESSION NO.	3. RECIPIENT'S CATALOG NO.	
4. TITLE AND SUBTITLE INVESTIGATION OF THE CRASHWORTHINESS OF BARRIER MOUNTED HARDWARE: BARRIER MOUNTED SIGN AND SIGNPOST		5. REPORT DATE June 2011

INVESTIGATION OF THE CRASHWORTHINESS OF BARRIER MOUNTED HARDWARE: BARRIER MOUNTED SIGN AND SIGNPOST

STATE OF CALIFORNIA
DEPARTMENT OF TRANSPORTATION
DIVISION OF RESEARCH AND INNOVATION
OFFICE OF SAFETY INNOVATION AND COOPERATIVE RESEARCH

June 2011

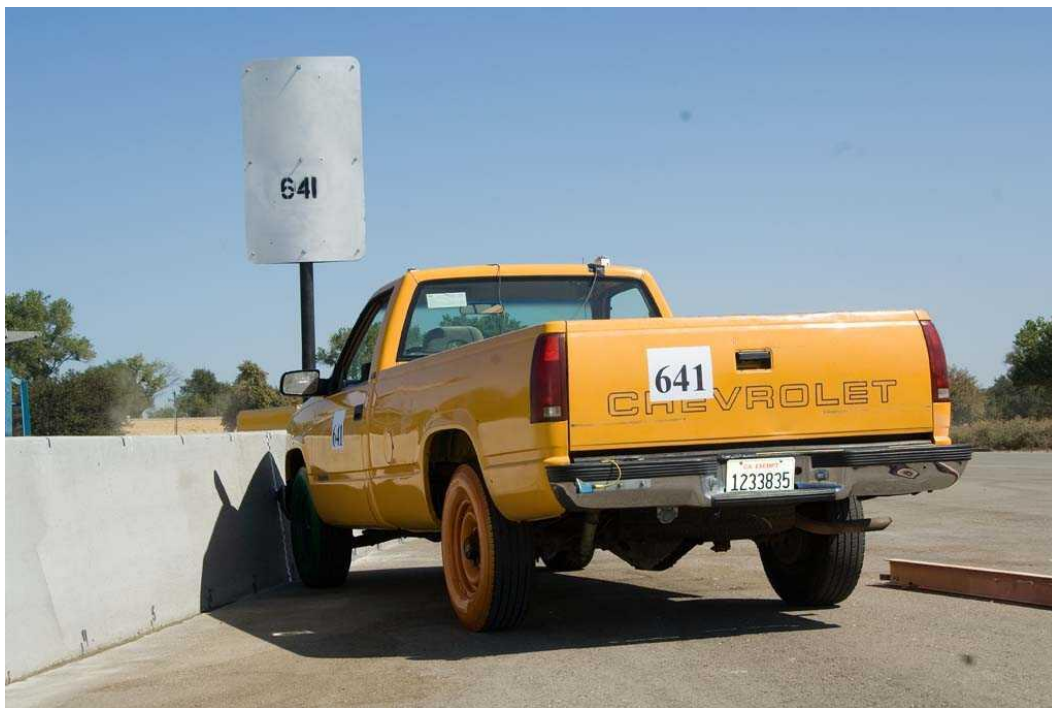
Figure 2-3 Downstream View of the Barrier and Vehicle SS641

There was only cosmetic damage to the barrier. The signpost saddle was pushed 19 mm (0.75 in) downstream and the two bolts were also bent slightly downstream. The sign pole had a dynamic deflection of 10.6° and a static deflection of 3.4° leaning downstream of impact.

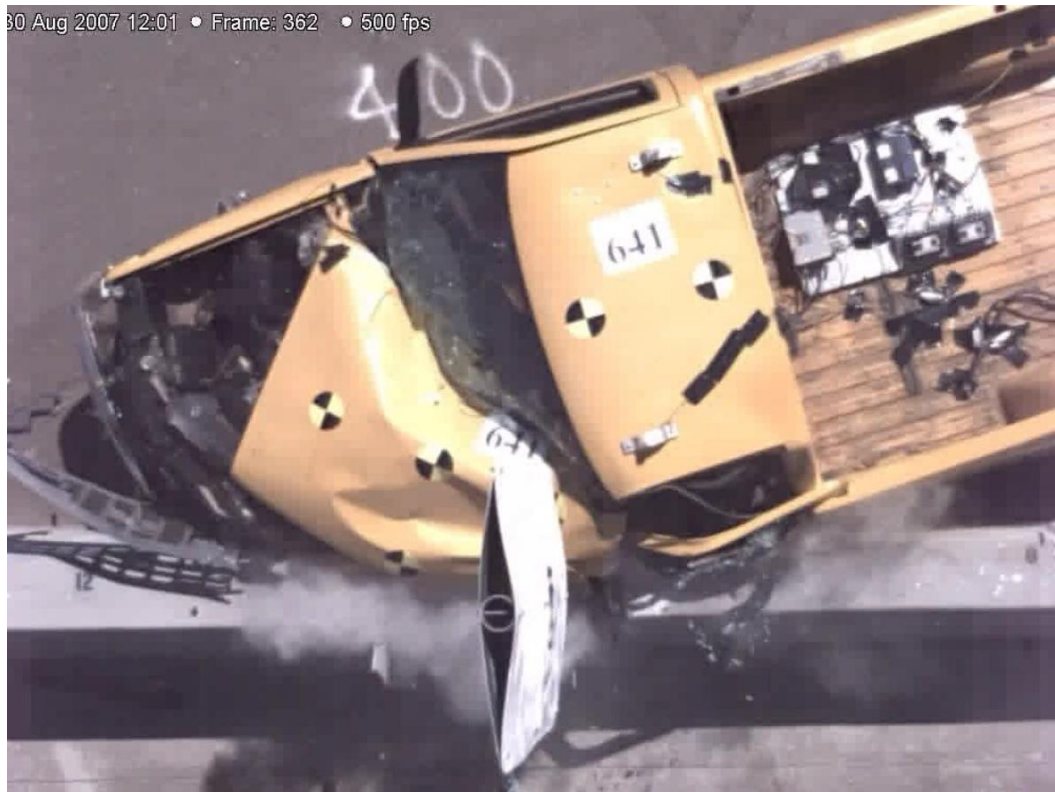
Figure 2-7 Vehicle Impacting Signpost and Barrier

The driver's side front quarter of the vehicle sustained significant damage in the initial impact with the barrier. The amount of damage increased as the hood impacted the signpost. The front left wheel was pushed backward 340 mm (13.4 in) from its initial location. The hood penetrated the windshield by 250 mm (9.8 in) measured from the bottom center of the windshield to the resting place of the hood. The vehicle's battery had been thrown out of the engine compartment but was still held in place by the negative terminal cable. The top of the driver side door had buckled outward from the vehicle's frame. The jagged slice down the side of the vehicle caused by the signpost bolts is due to the sustained contact with the barrier. Inspection of the occupant compartment revealed that the dashboard was pushed back 202 mm (8.0 in) toward the driver. The driver side had a peak loss of 98 mm (4.0 in) measured between the bottom of the dashboard and the floorboard.

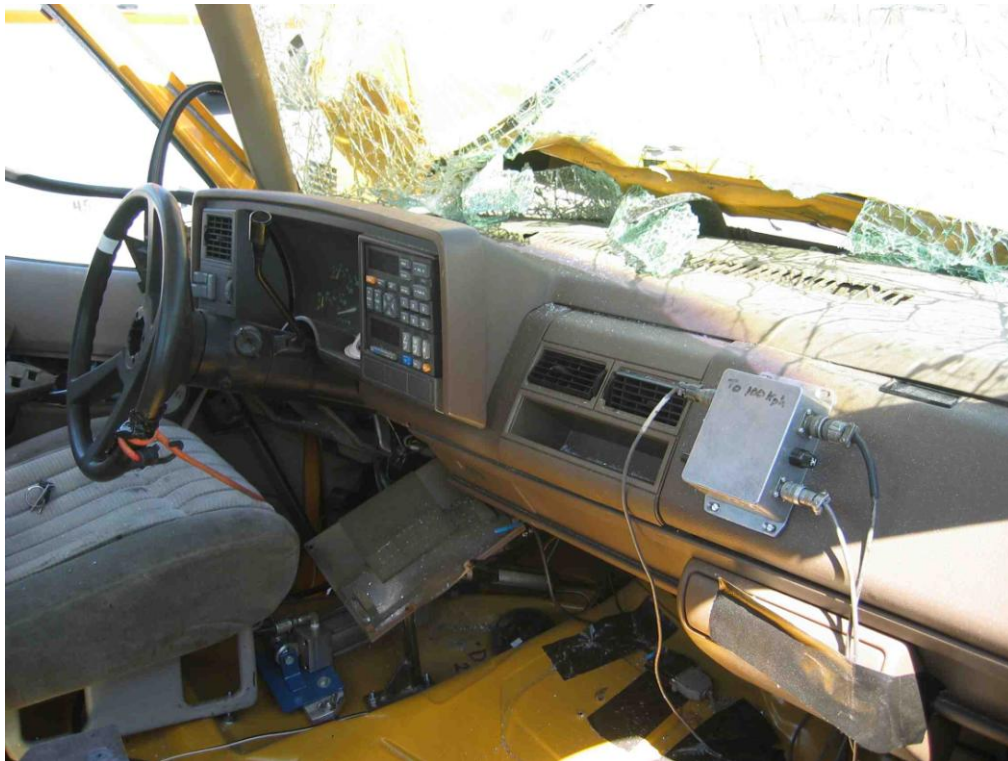
Figure 2-12 Vehicle After Test Internal (1)

The occupant risk for this test is unacceptable. The hood penetrated the windshield by 250 mm (10 in) and would have showered the occupants with glass. The front grill broke off and would have been a hazard to opposing traffic. The battery was almost thrown from the vehicle and was only restrained by the negative terminal wire. There was excessive deformation on the driver side of the occupant compartment. Table 2-2 has a summary of the occupant risk. (Due to problems with the data acquisition system, there was no usable information to find the occupant impact velocities or ridedown accelerations.)
