**COMPLIANCE CRASH TESTING OF A STEEL VERSION
OF THE TYPE 732 BRIDGE RAIL**

DEPARTMENT OF TRANSPORTATION
ENGINEERING SERVICE CENTER
MATERIALS ENGINEERING AND TESTING SERVICES

January, 2002

1. REPORT NO. FHWA/CA/TL-2001/41	2. GOVERNMENT ACCESSION NO.	3. RECIPIENT'S CATALOG NO.	
4. TITLE AND SUBTITLE COMPLIANCE CRASH TESTING OF A STEEL VERSION OF THE TYPE 732 BRIDGE RAIL		5. REPORT DATE January, 2002

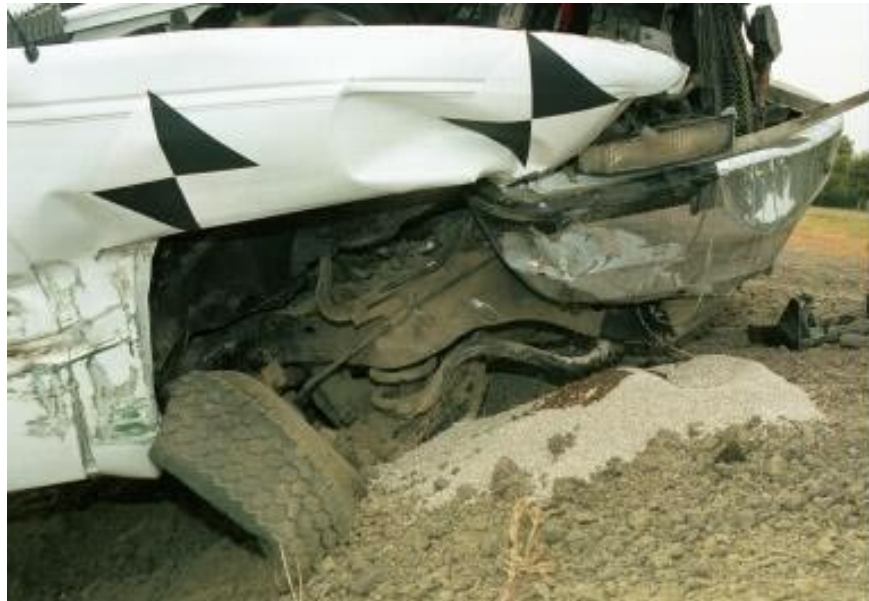
Figure 2-9 Right front corner of test vehicle after Test 571

The right front corner of the vehicle was moderately damaged in the initial impact with the barrier. The right front fender, hood, bumper, headlamp area, grille, and suspension components were all affected. The passenger side doorframe was deformed outward but the door remained latched. The right front tire was also ruptured. Some minor damage along the right side of the vehicle and to the right rear quarter occurred as the vehicle continued to contact the barrier after the initial impact. The vehicle became briefly airborne, with the left rear corner reaching a maximum height of 900 mm. As the vehicle came back into contact with the ground it was in a nose-down pitch and right roll attitude which placed a majority of the landing force on the already damaged right front suspension components. This additional force caused the right front tire to push rearward and slightly into the passenger side footwell area. The maximum amount of passenger compartment deformation, 127 mm, occurred in the floorboard. This was within the accepted limit of 150 mm.¹

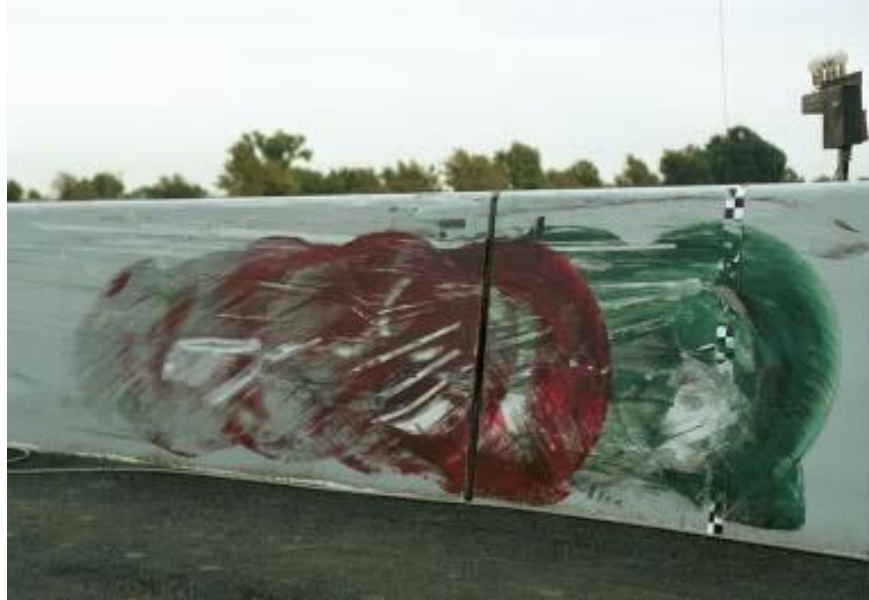
Figure 2-10 Type 732S barrier face after Test 571

There was essentially no permanent damage to the barrier during Test 571. The vehicle did scrape the paint off the barrier along the length of contact and the vehicle lug nuts created some minor gouges, which were no more than 5 mm deep. These gouges could be ground and filled on-site by maintenance crews without removing any barrier segments.

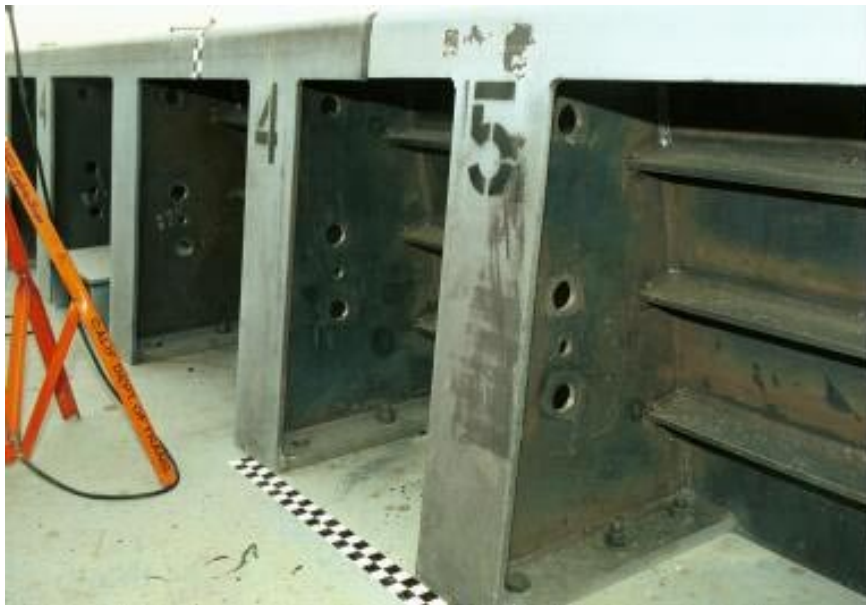
Figure 2-11 Type 732S barrier backside after Test 571

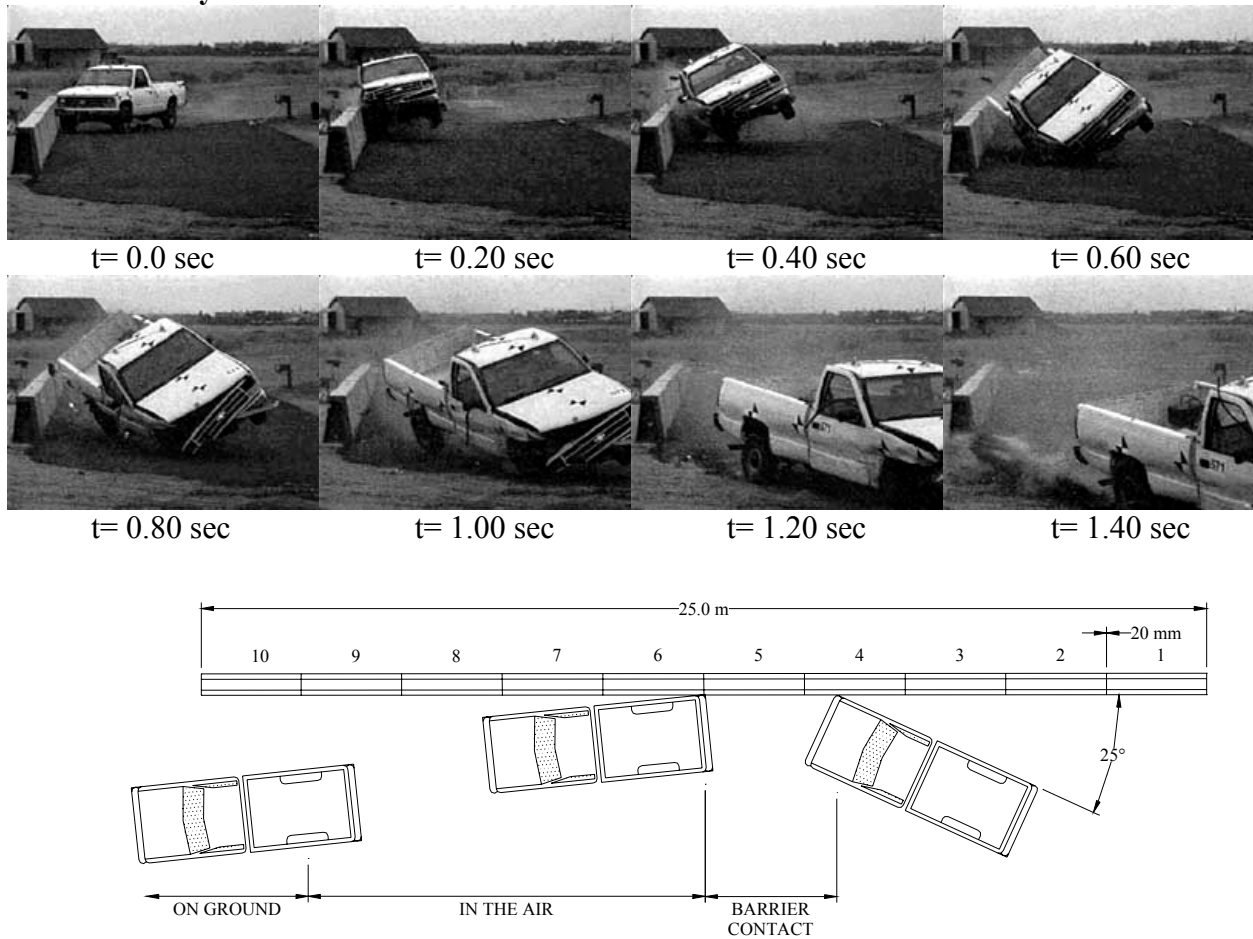
Figure 2-12 Impact sequence and diagram for Test 571

Barrier Damage: Only superficial marring and less than 4 mm of permanent lateral deflection.

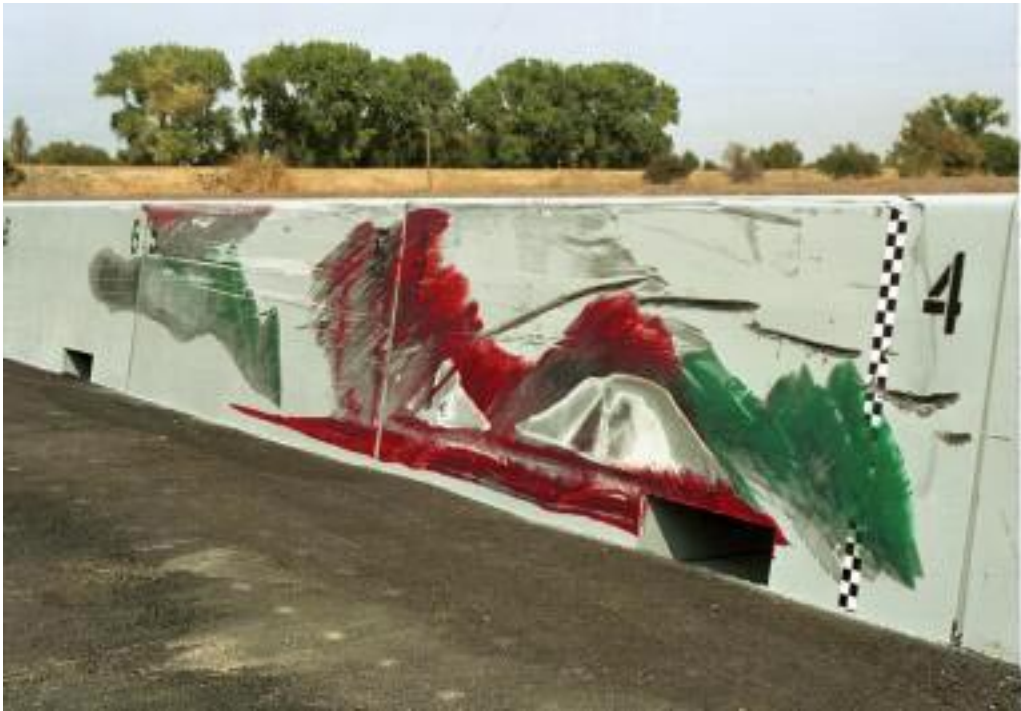
Figure 2-18 Type 732S barrier face after Test 572

As in Test 571, there was essentially no permanent damage to the barrier during Test 572. The vehicle did scrape the paint off the barrier along the length of contact and the vehicle lug nuts created some minor gouges, which were no more than 7 mm deep. These gouges could be ground and filled on-site by maintenance crews without removing any barrier segments.

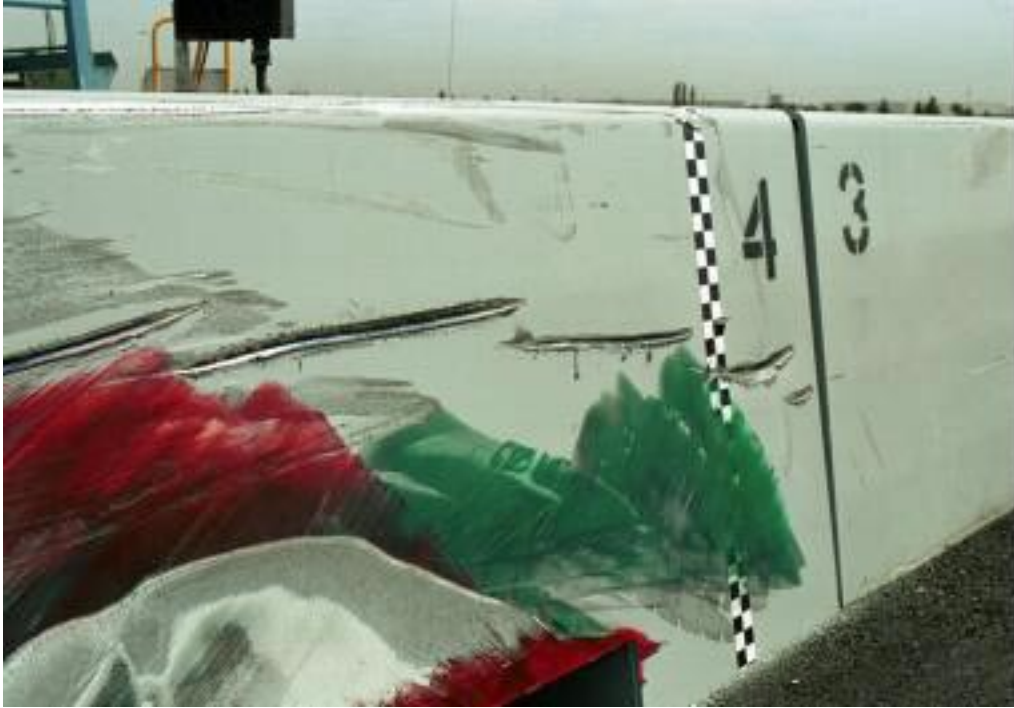
Figure 2-19 Barrier face gouges from vehicle lug nuts after Test 572
