Creosoted Piling Investigation for the San Francisco-Oakland Bay Bridge: A Twenty-Five Year Study

CREOSOTED PILING INVESTIGATION
FOR THE
SAN FRANCISCO-OAKLAND BAY BRIDGE
A Twenty-Five Year Study

CREOSOTED PILING INVESTIGATION
SAN FRANCISCO - OAKLAND BAY BRIDGE

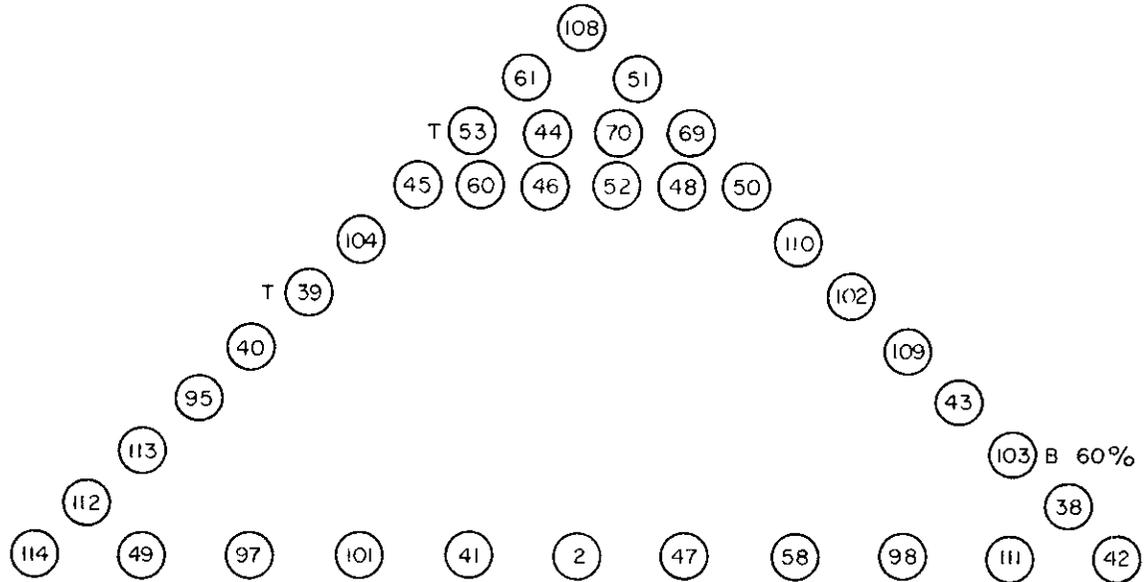
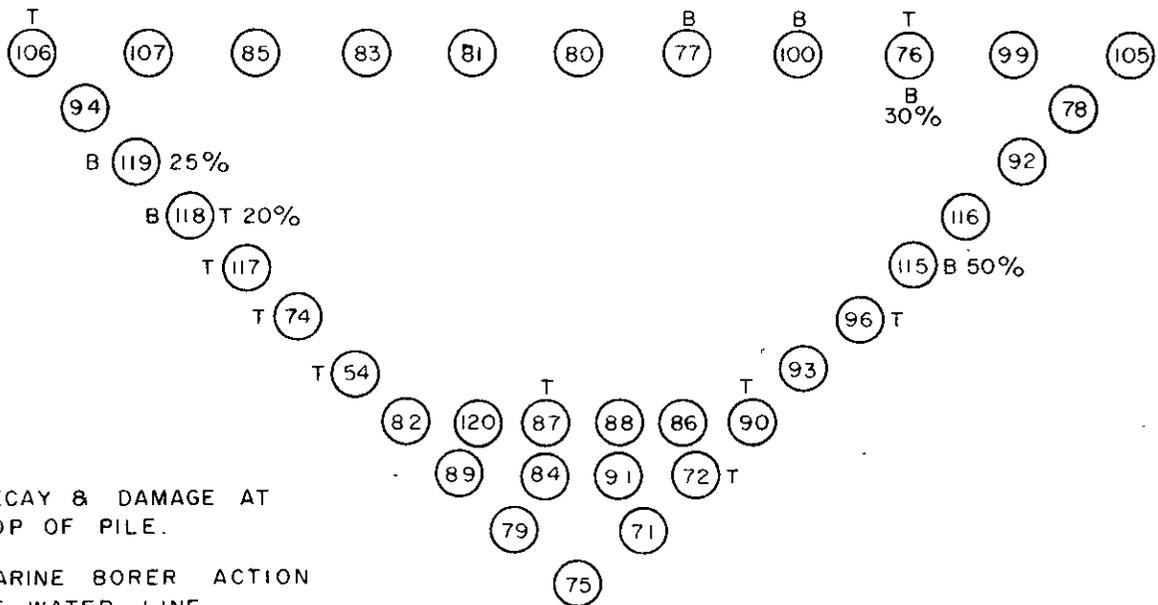
NUMBERING ON PILES OF FENDER OF
PIER E-4

The 1945 examination showed marine borer attack in pile 103, pier E-4 (Exhibit 1), and that similar attack was evident in some of the fender timbers. A few bracing blocks were deteriorated.

The attached piling charts indicate those pilings which show marine borer or other damage. The percentage values indicate the approximate cross sectional content of core wood deteriorated.

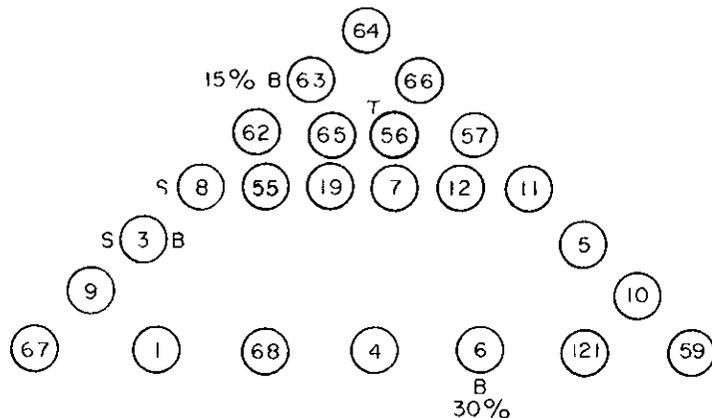
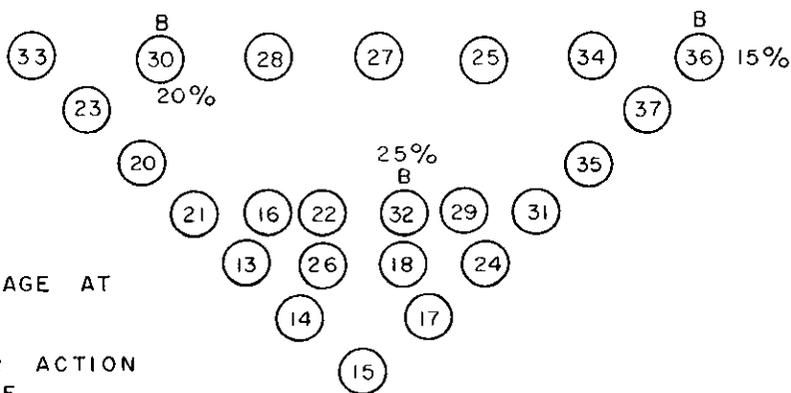
NUMBERING ON PILES OF FENDER OF
PIER E-5

The 1954 investigation showed pile 103 badly deteriorated. Diagonal bracing blocks showed additional marine borer attack. Fender E-5 (Exhibit 2) indicated ship damage, and the bases of the fenders also showed increased deterioration.

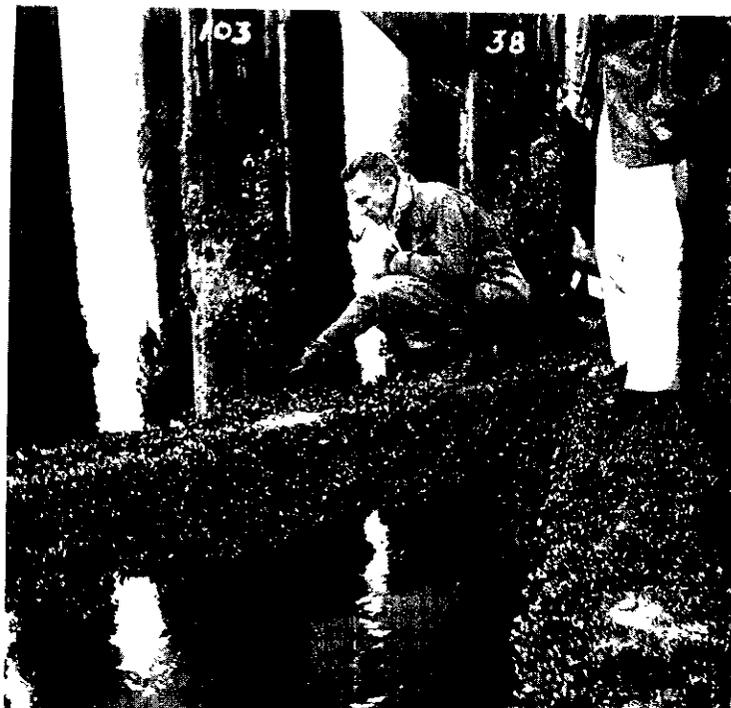
Pile 103, which first showed marine borer damage in 1945, was from the wet or green piling stock. The increment borer report shows a minimum penetration depth of $3/4$ inch of creosote in this pile. The factors which contributed to the attack by the marine borers could have been due to some surface defect or damage at the water line associated with the minimum depth of penetration for the creosote, or since the piling is bolted to horizontal bracing in the tidal zone a slight spreading of the bolt hole opening could have exposed untreated wood. The net result is that the untreated core wood of this pile has been completely eaten out from the bracing level downward some 42" or more in depth. The cross sectional loss of core area is estimated at 60%.

Pile 103, North End Pier E-4.
Inspector holding pick handle in
cavity caused by marine borers.

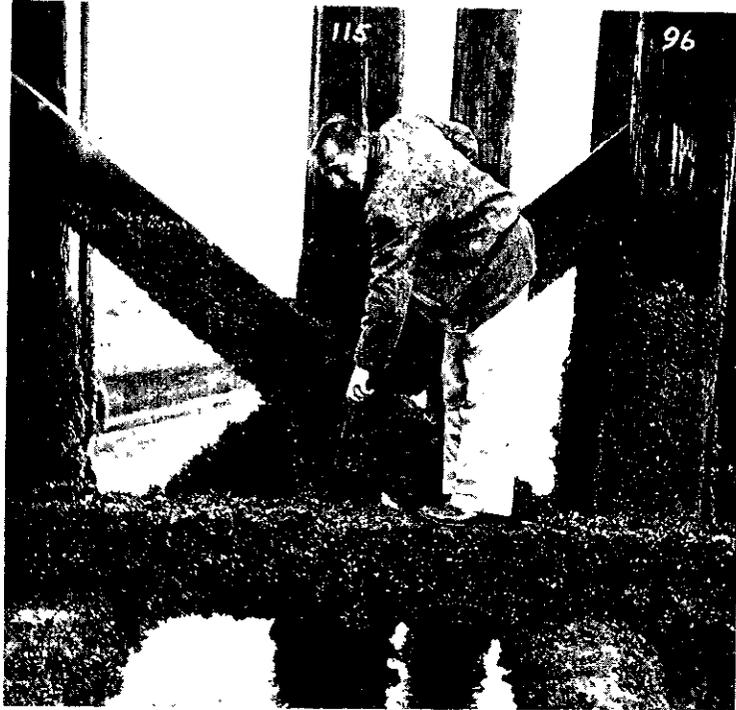
Inspector indicates opening in Pile 115. South End of Pier E-4.

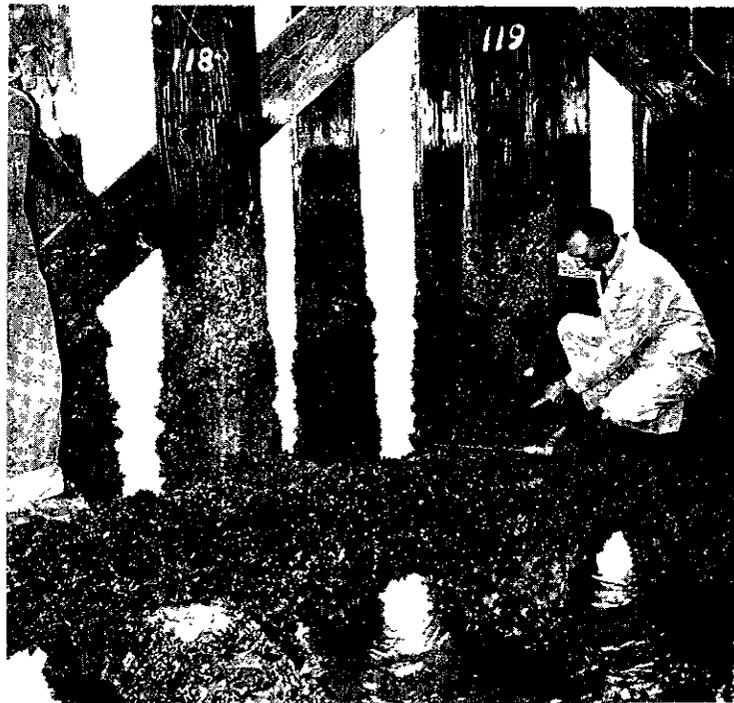
Inspector indicates opening in Pile 119. Number 118 also had a small opening.

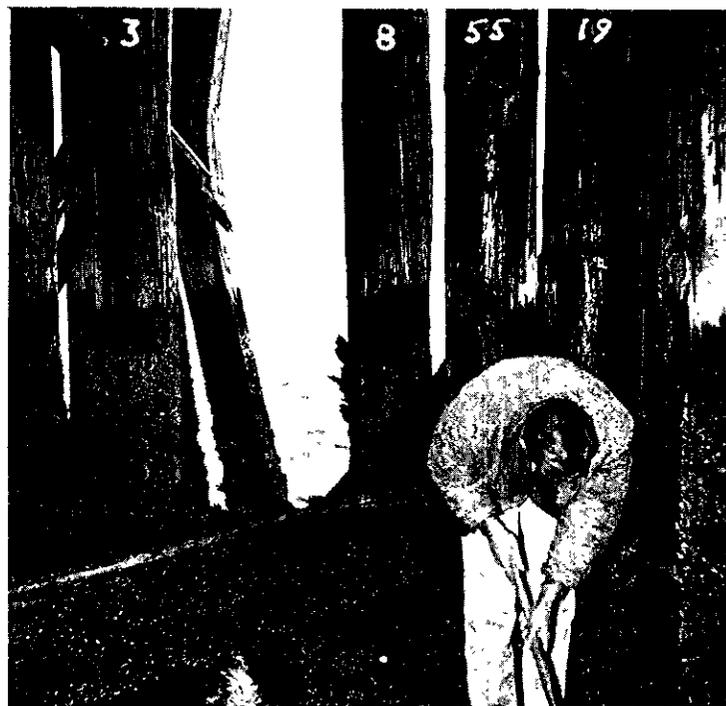
Damage by ship or barge collision was also noted. In one instance, as photographed, the piles had been bruised and partially split. The untreated core wood was showing some evidence of attack where the tie bolts had opened up the piling at the time of impact.

Piles 3 and 8 damaged by ship.
Pier E-5 North End.

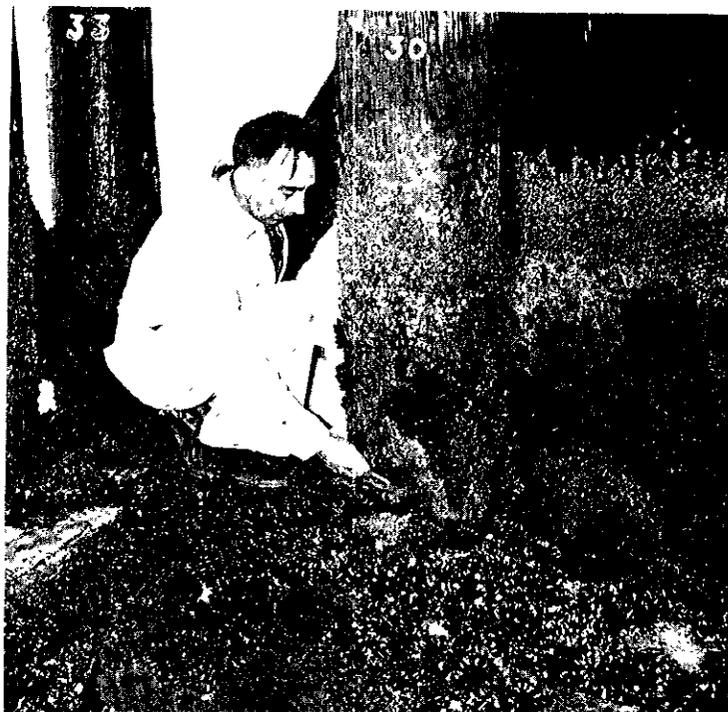
Opening in Pile 30.
Pier E-5, South End.

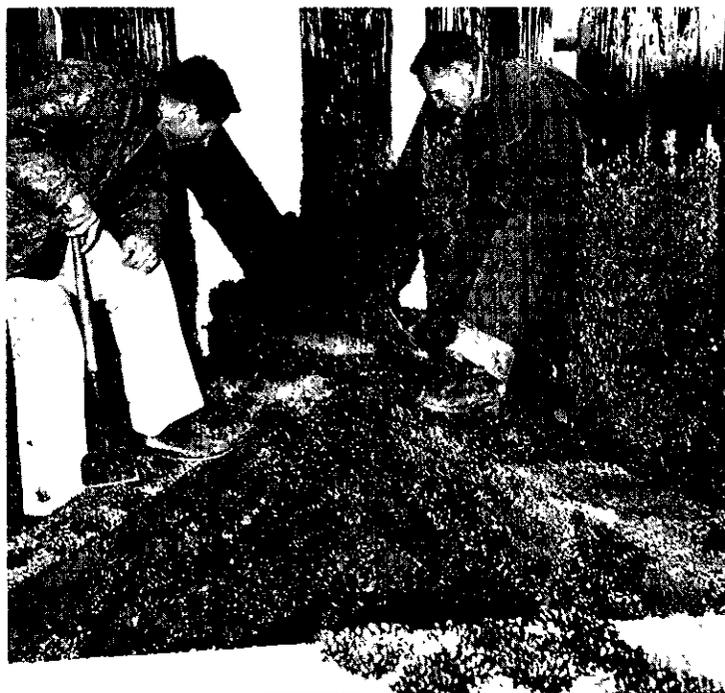
A small opening was found in Pile 36
at East apex of Pier E-5, South End.
