BRIDGE INSPECTION REPORT

Other Inspection

BRIDGE NO.:
10 0136

STRUCTURE NAME:
ALBION RIVER

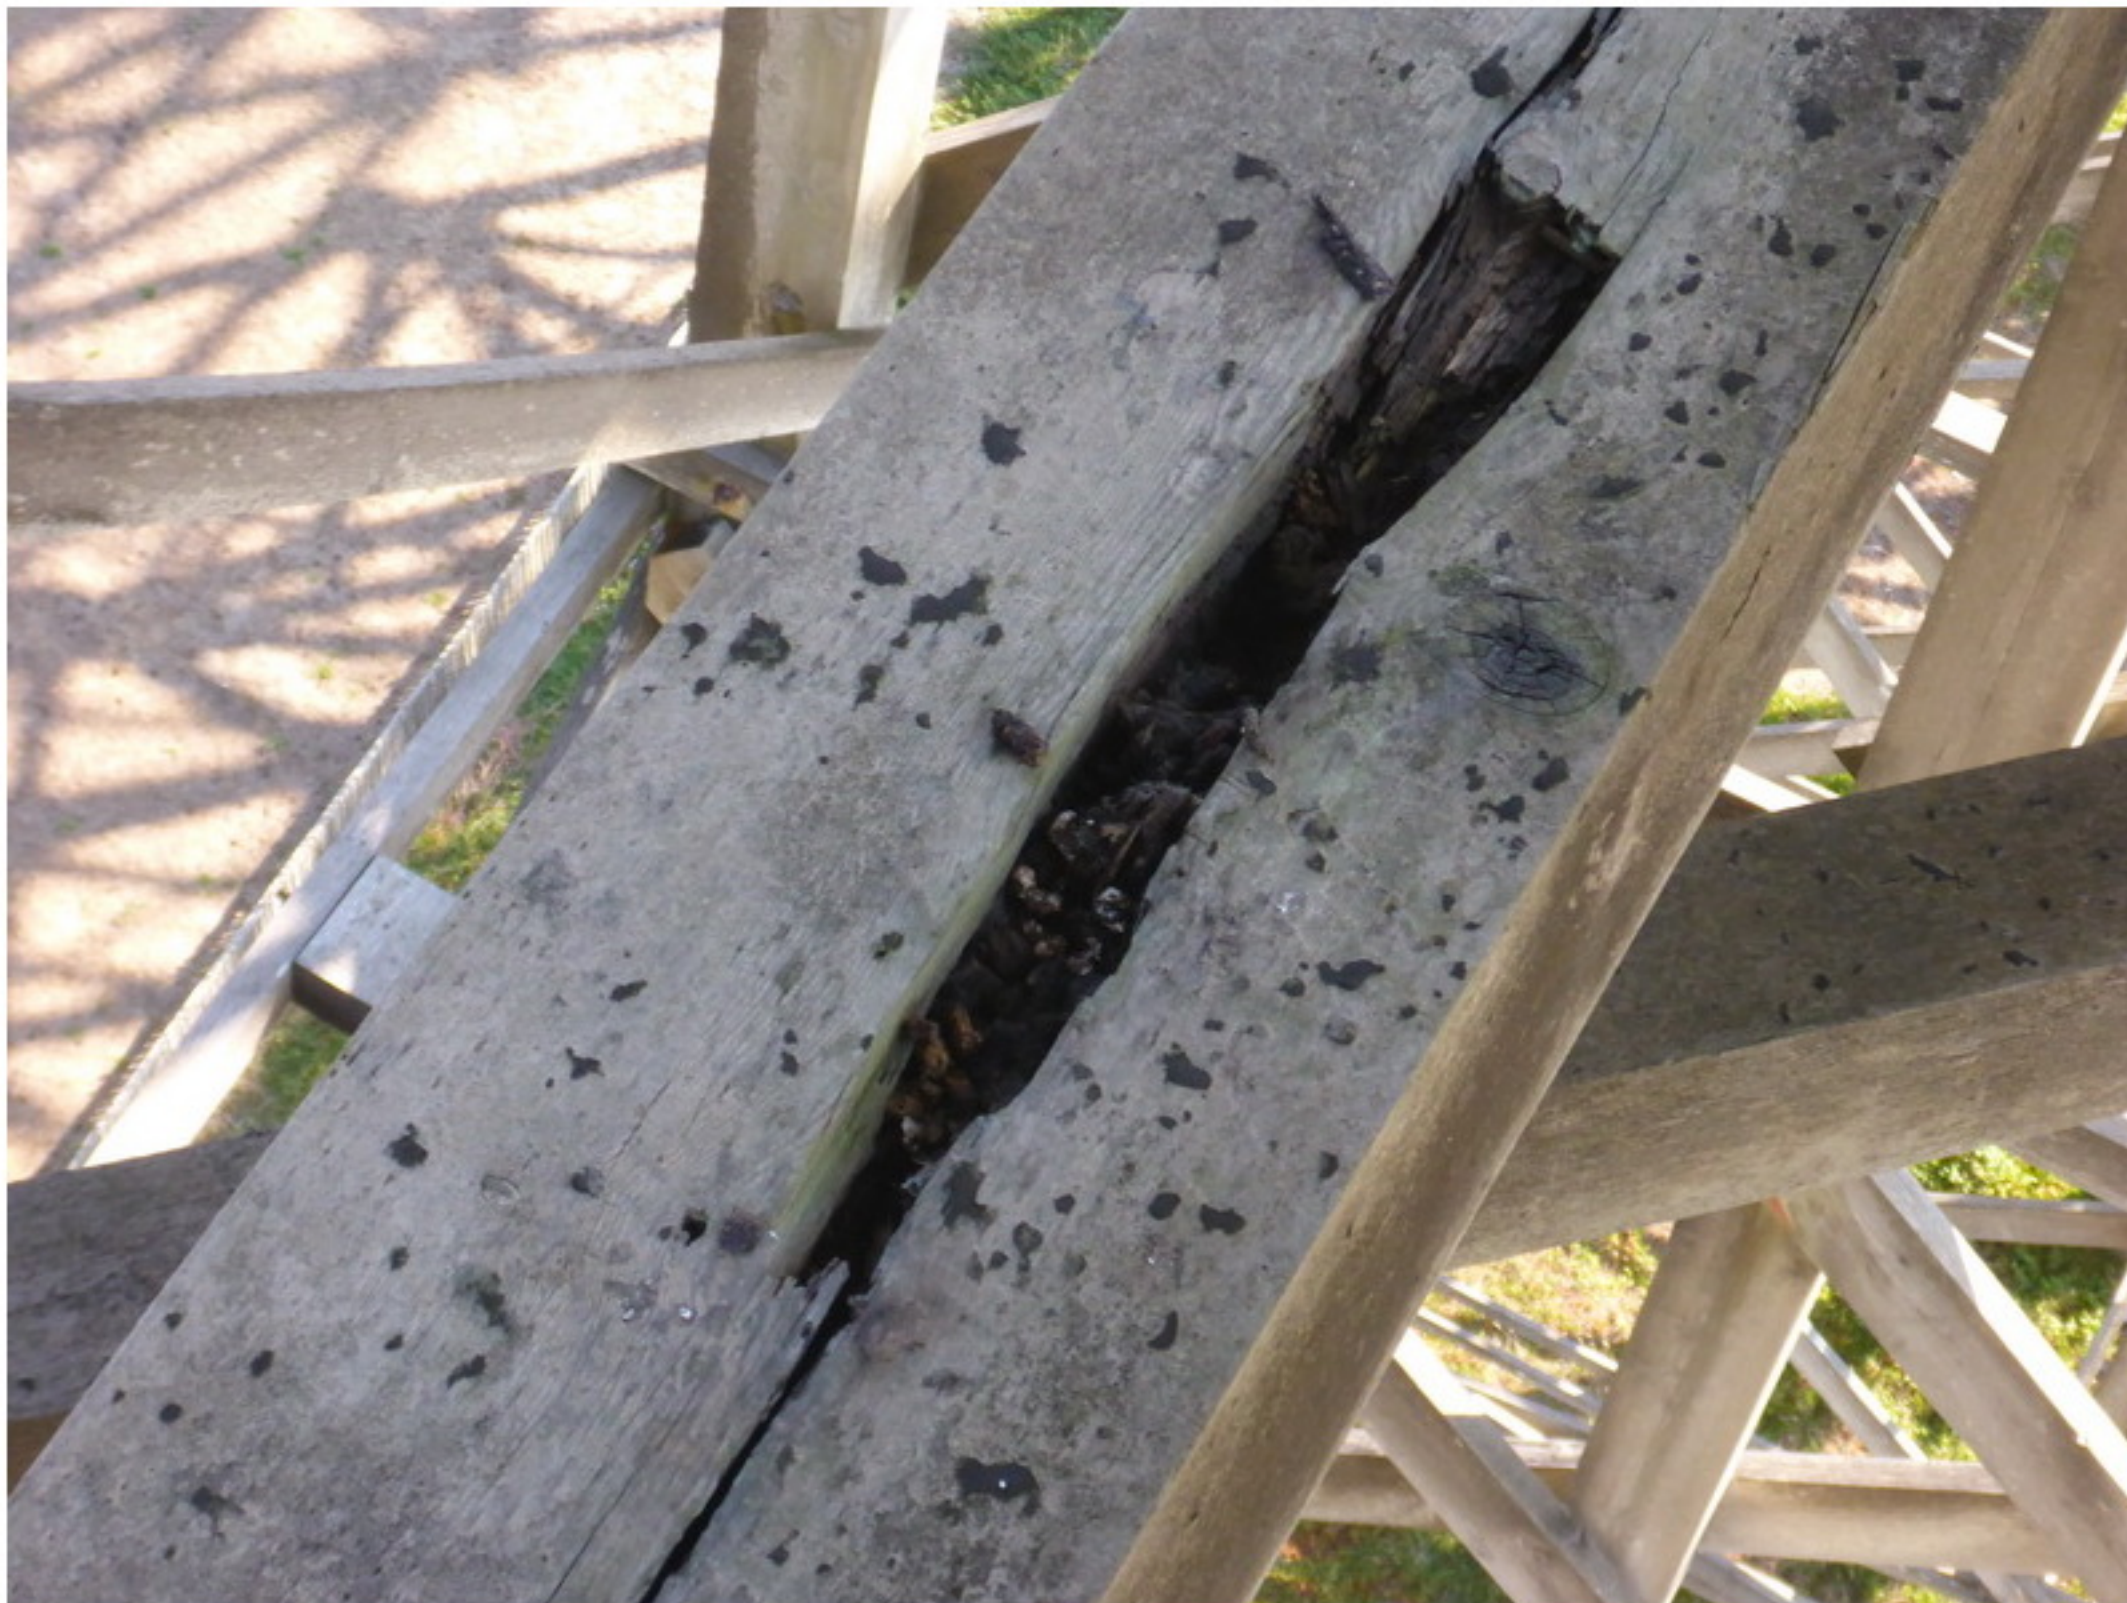
Photo No. 4

An area of decay was found at the top left horizontal between Bent 15 and Bent 16.

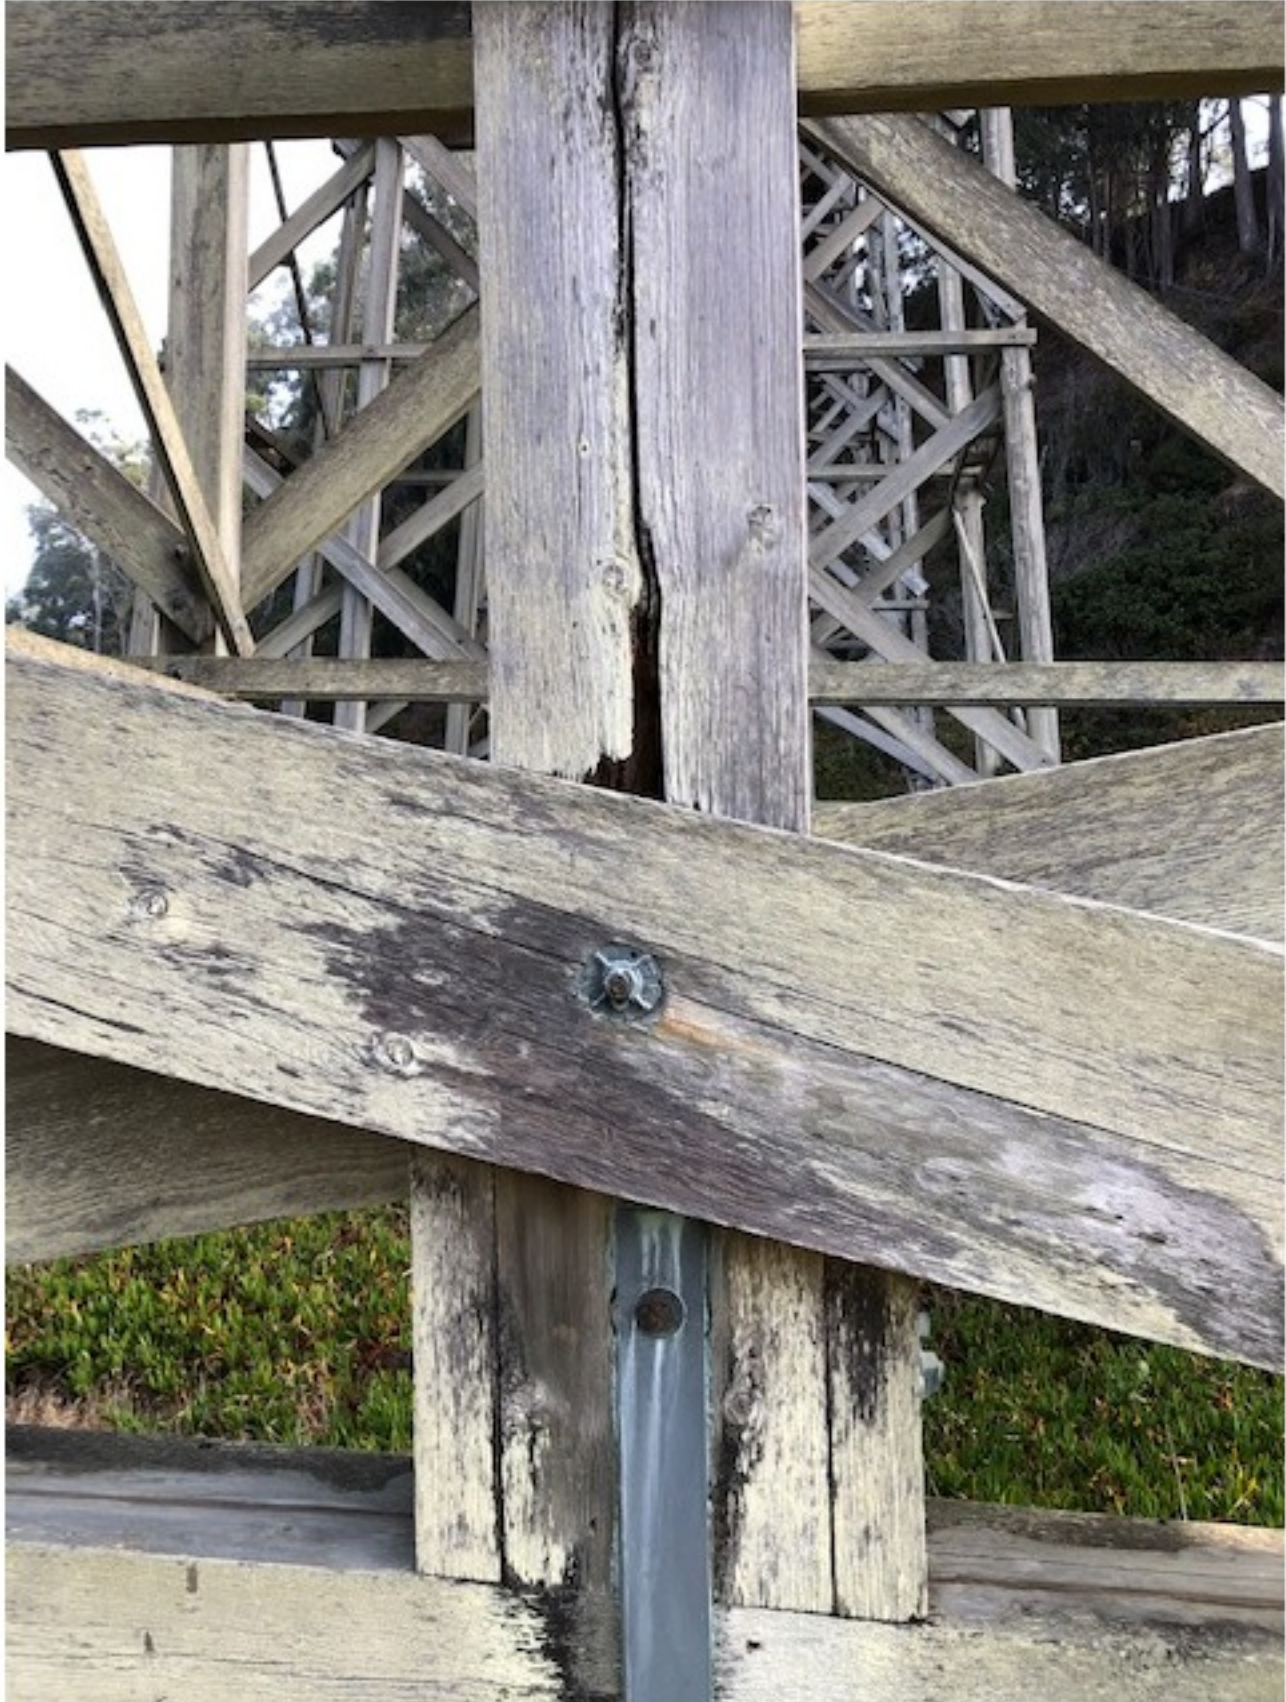
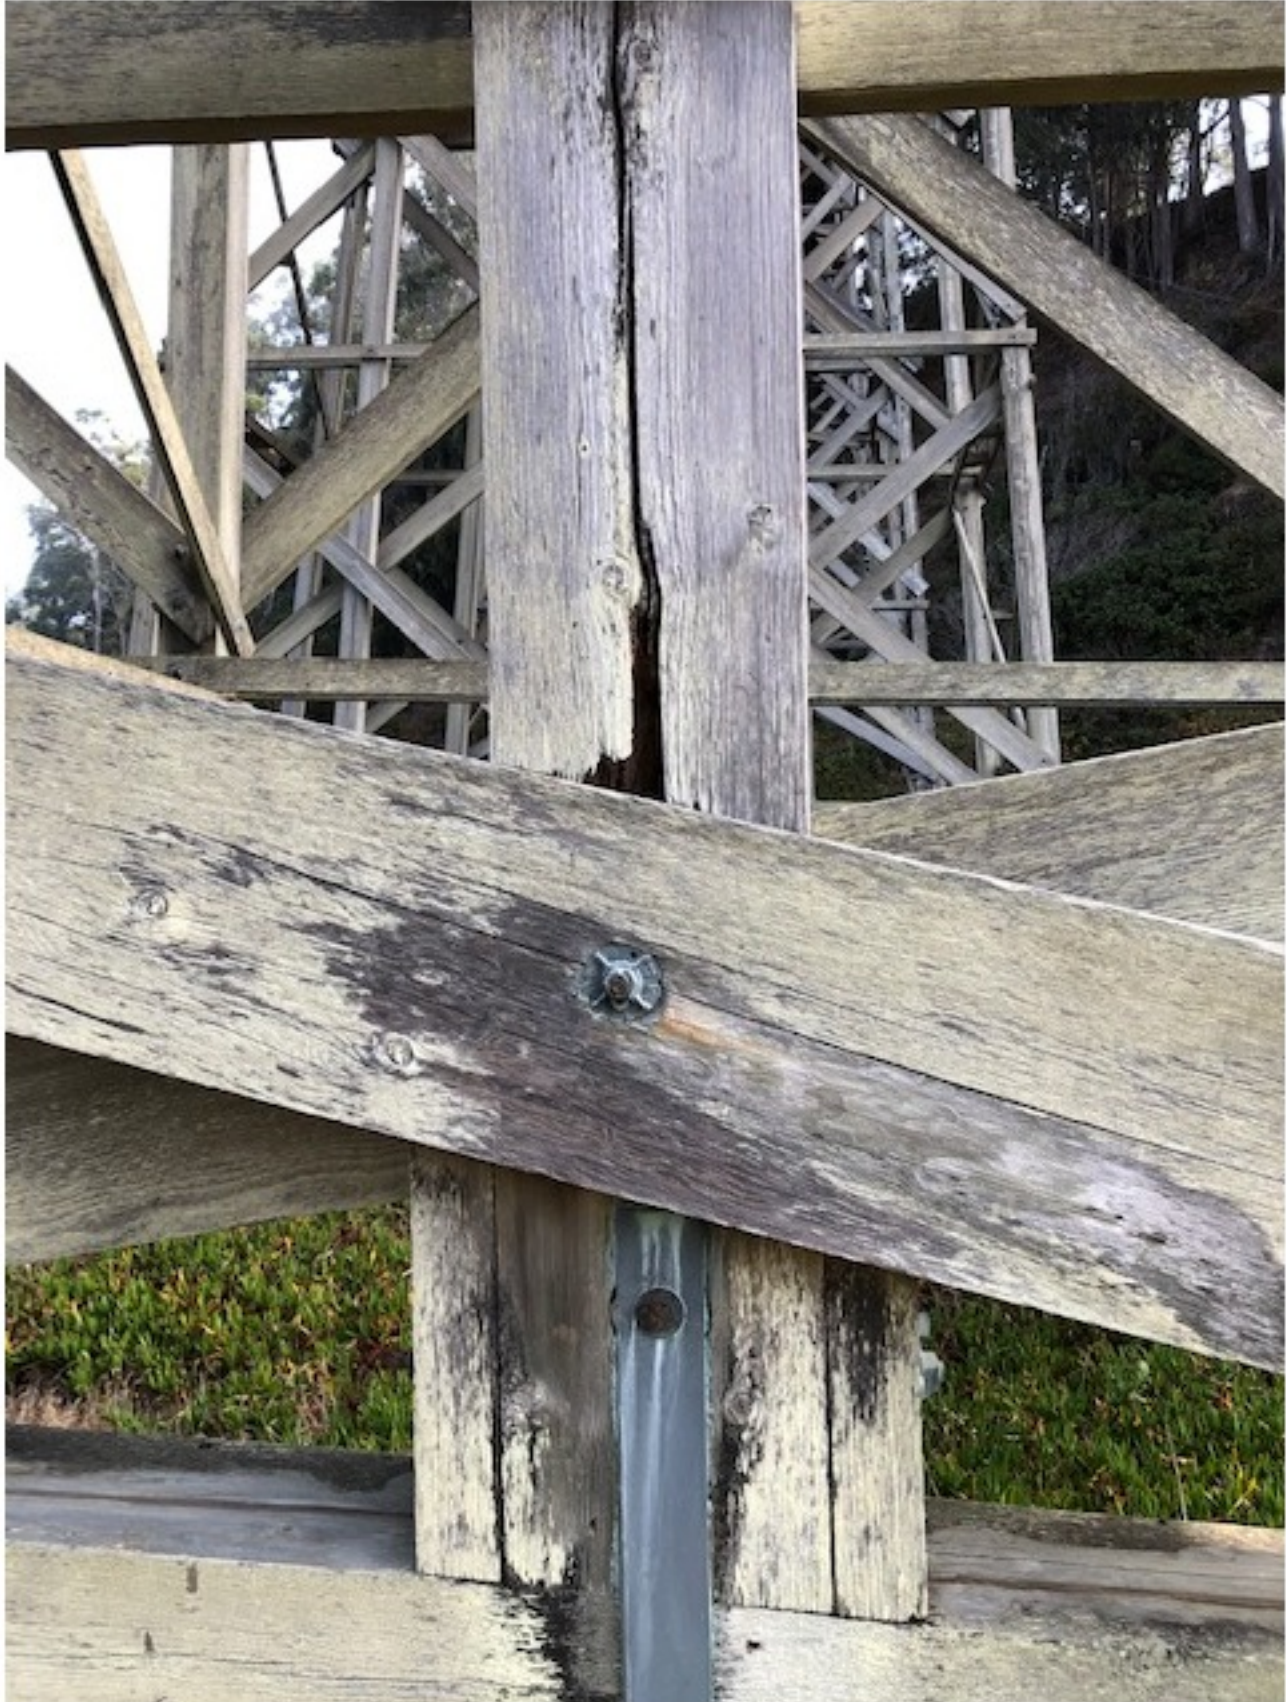
Photo No. 12

A work request (#9990) has also been submitted to SMI Ratings Branch to evaluate the affect of the apparent insect infestation on the load bearing capacity of timber Column 4 at Bent 23. The extent of the infestation is documented under the respective parent element. Preliminary calculations indicate that the damage due to the insect infestation is not an immediate threat to the safe load capacity of the structure, however, the Load Ratings Branch will perform an in-depth review of the safe load capacity including the timber substructure elements.

Column 4 at Bent 23 has a void and rot due to termite infestation.

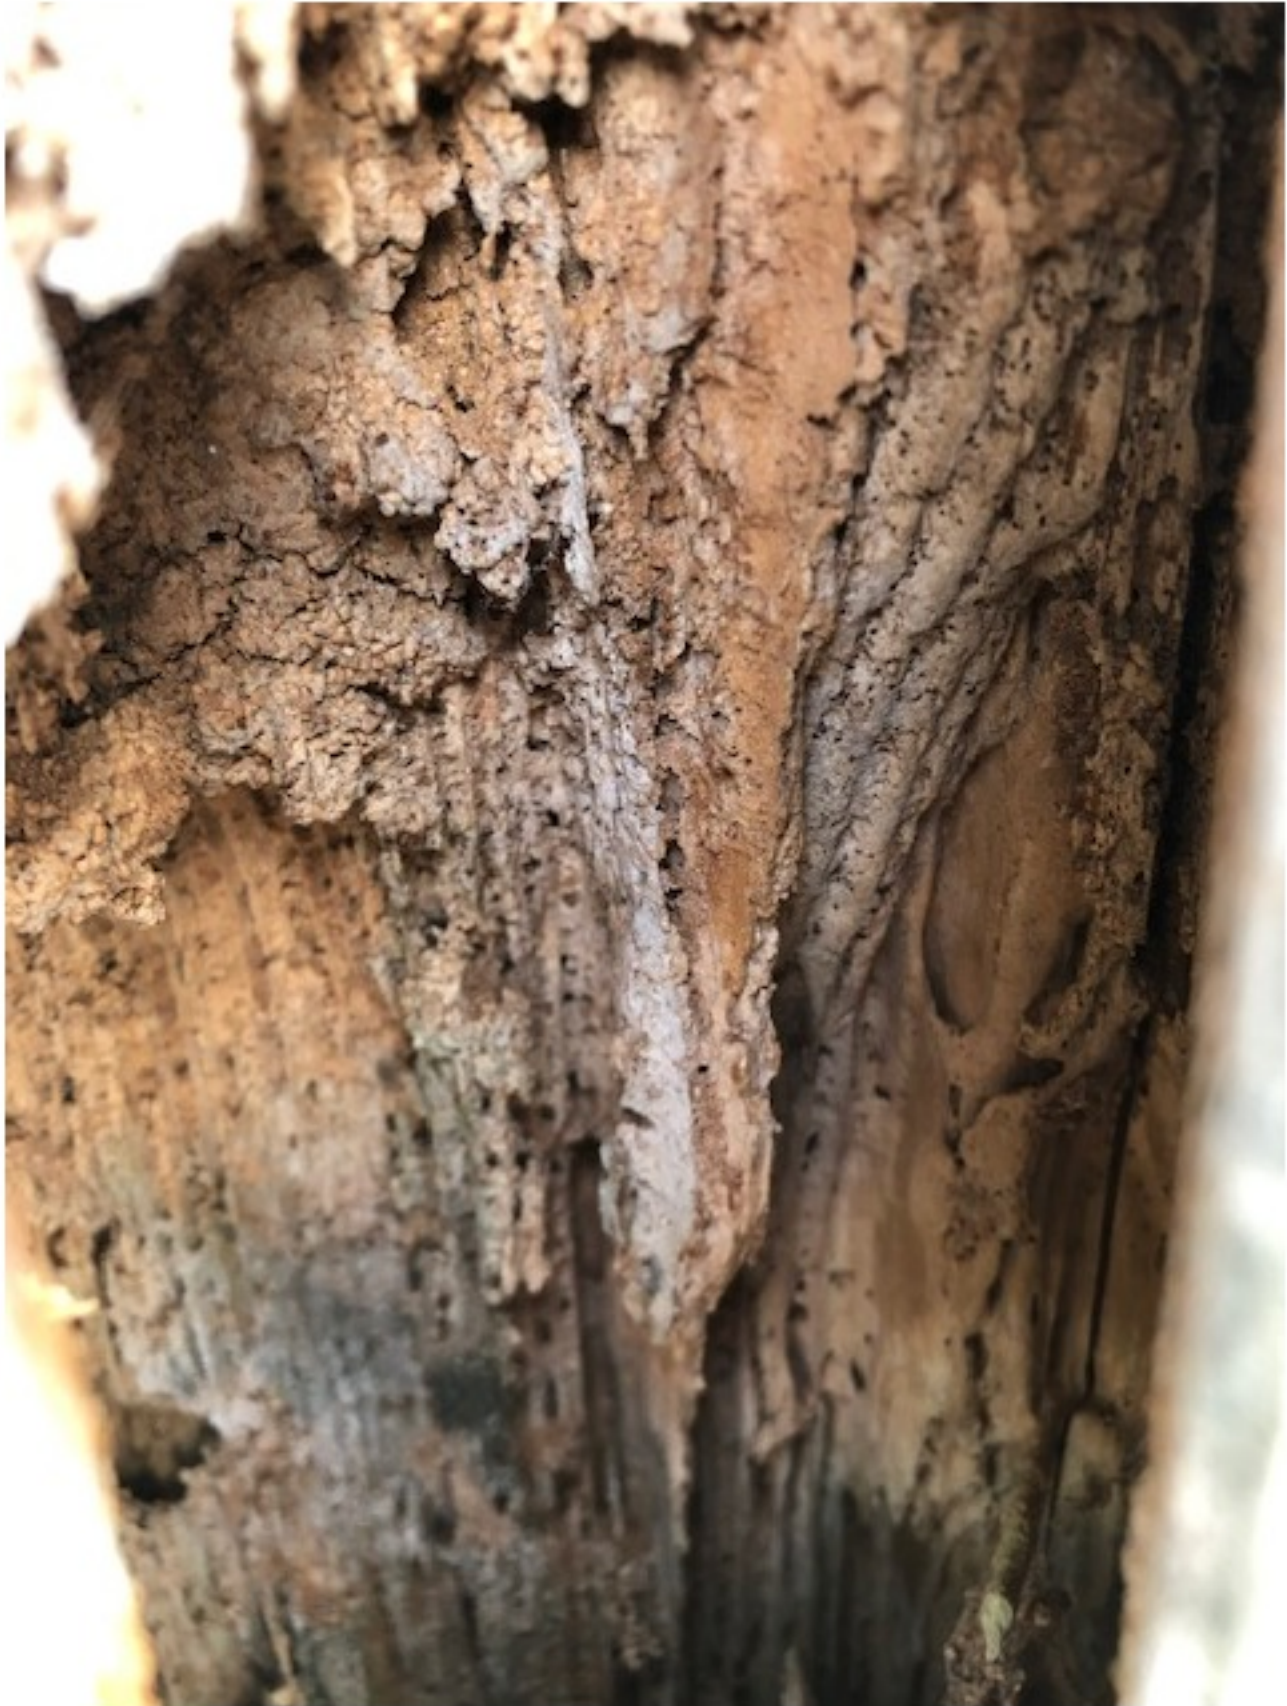
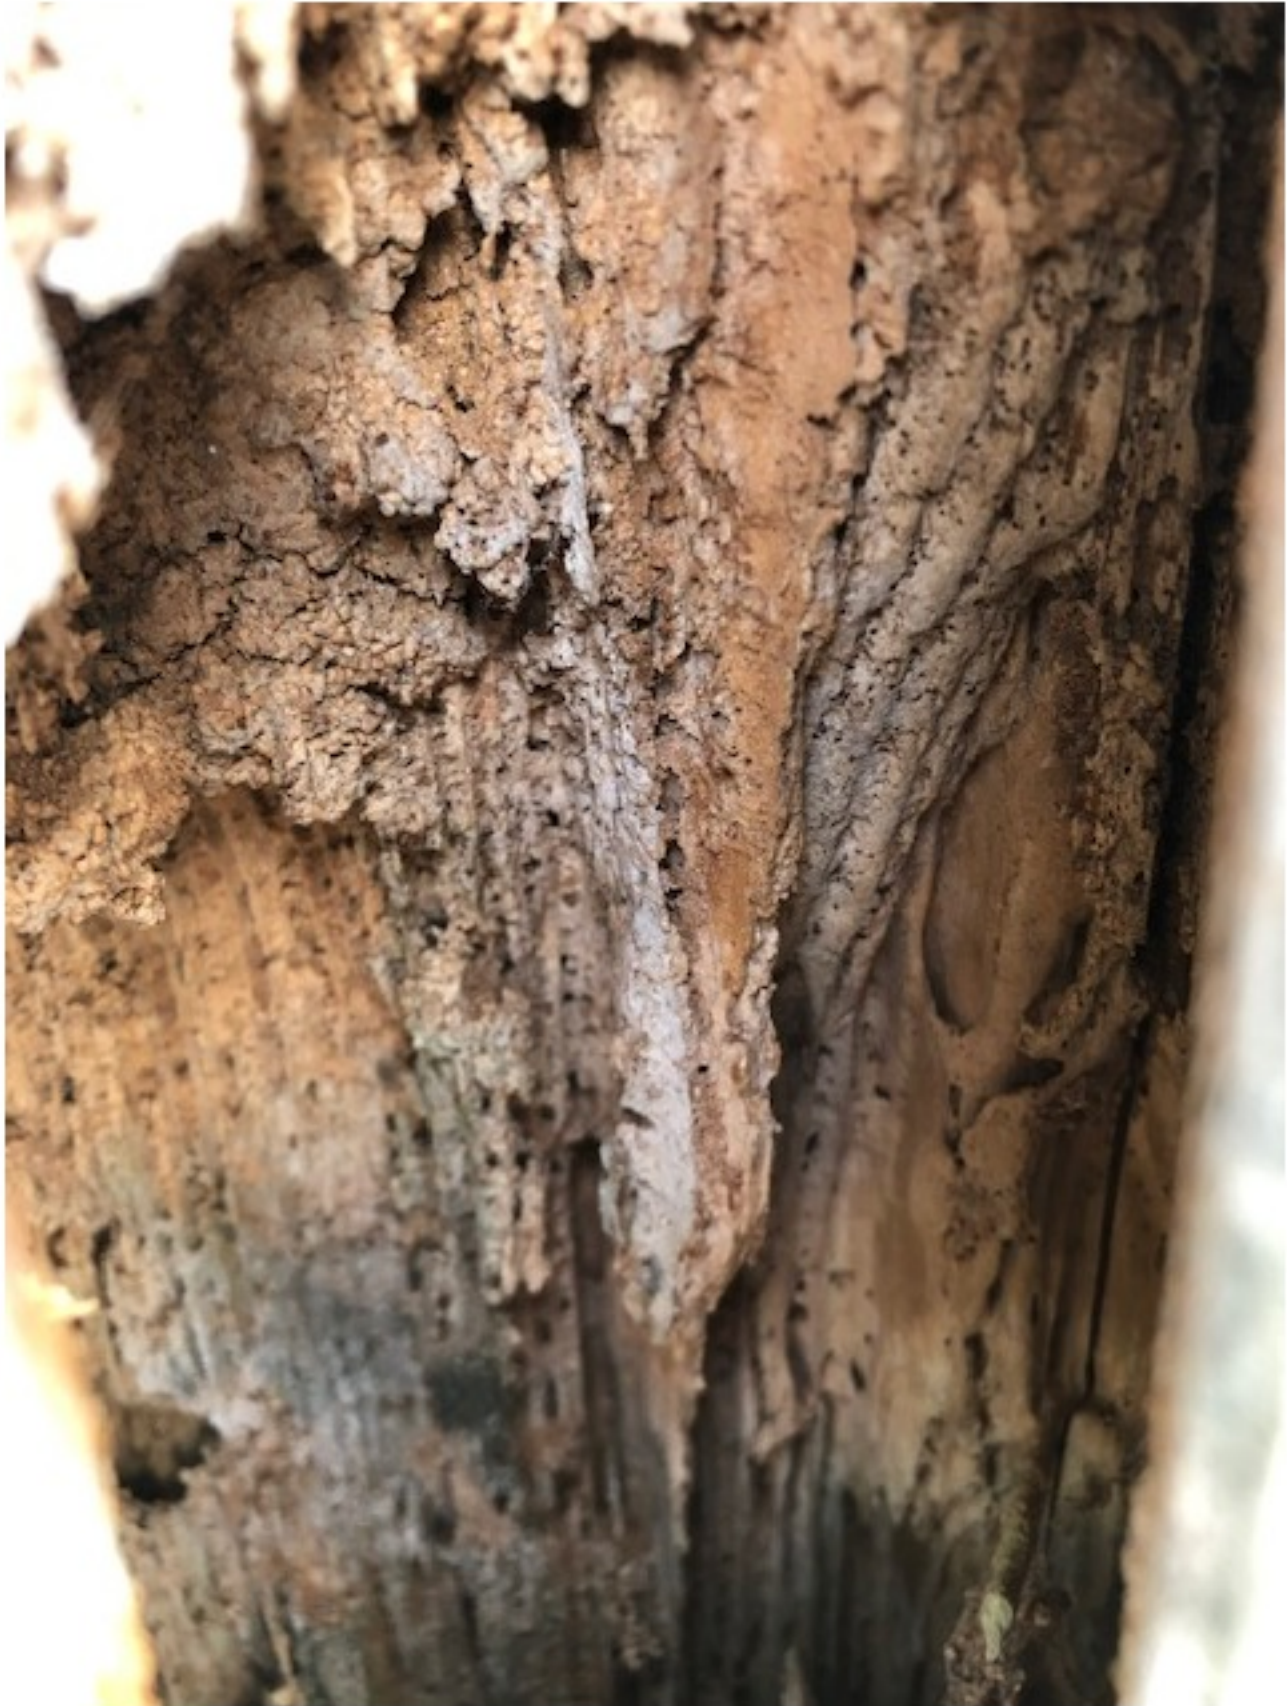
Photo No. 13
Core rot due to termites in Column 4 at Bent 23.

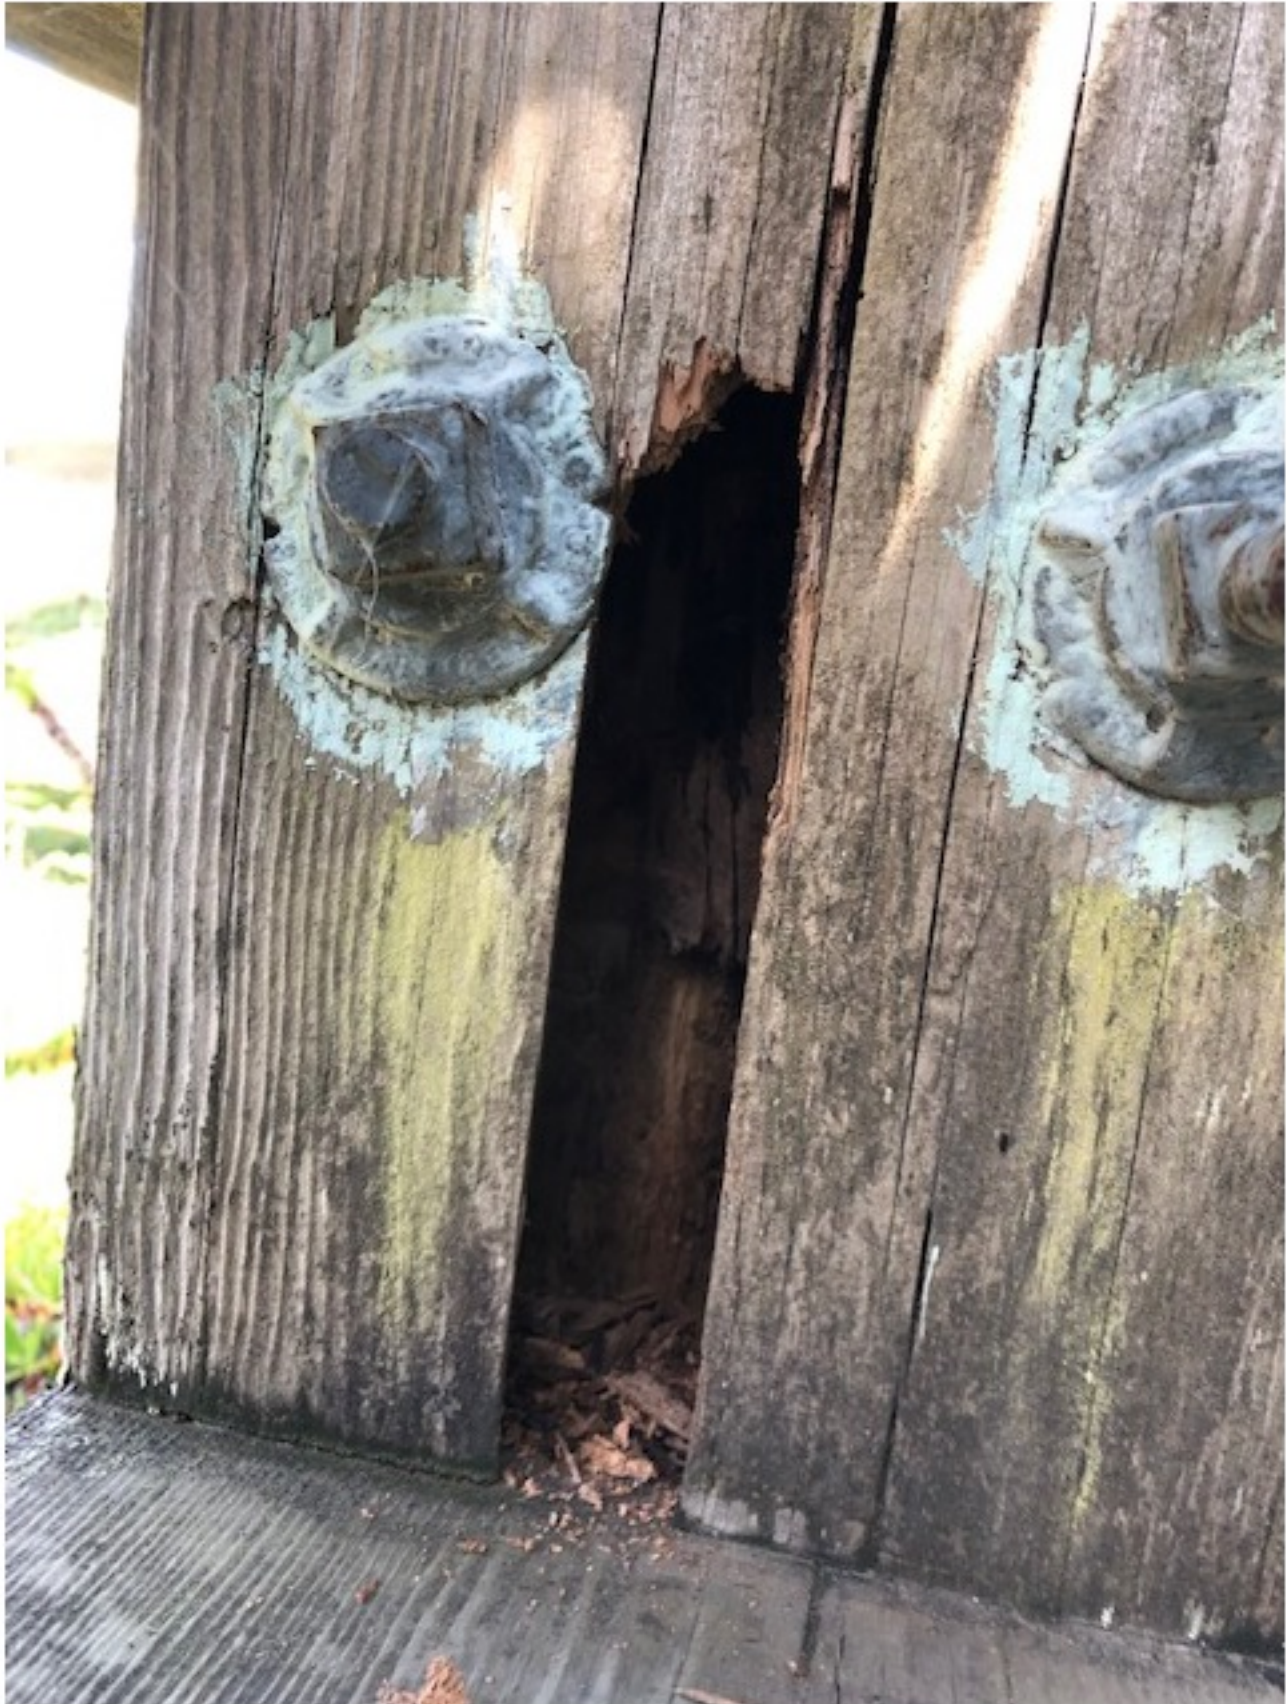
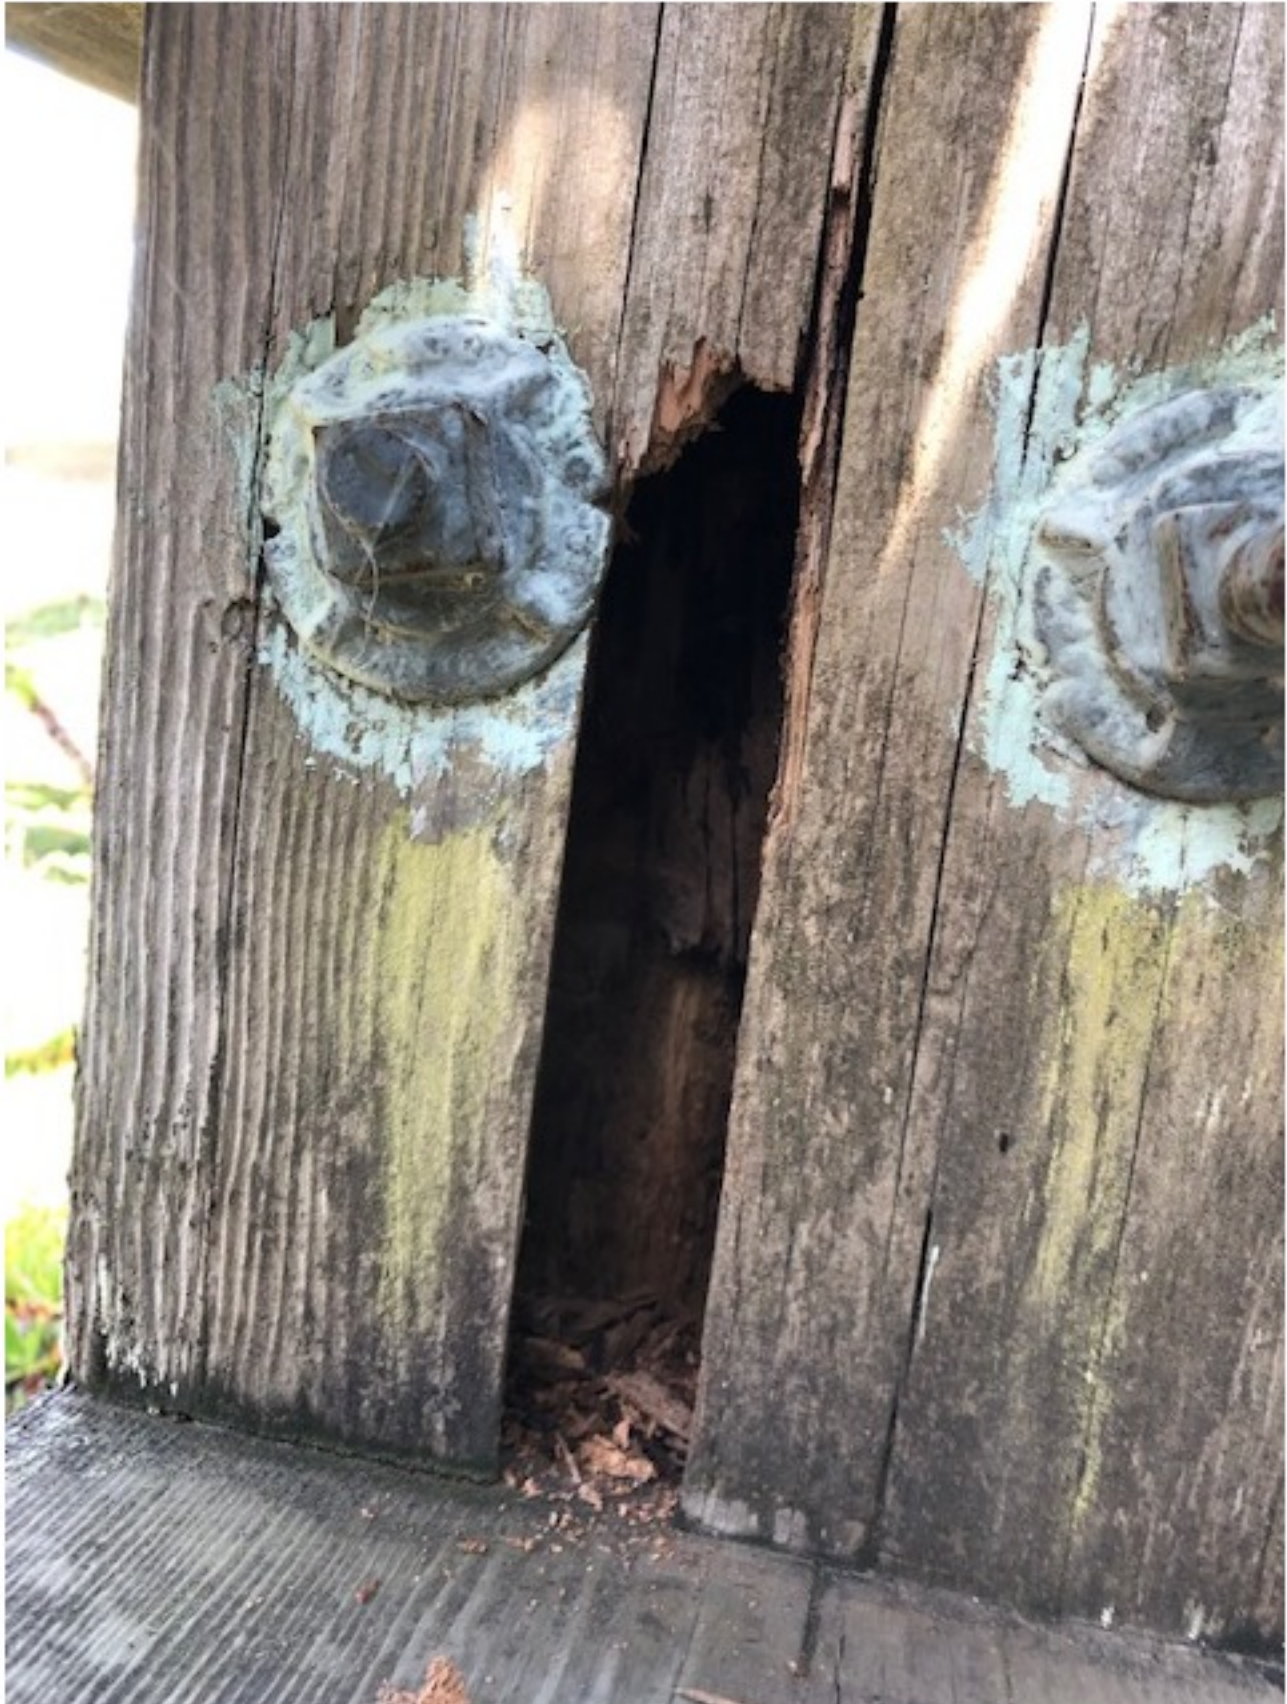
Photo No. 14

The east scab at Column 2 of Bent 24 has a void and rot due to termite infestation.

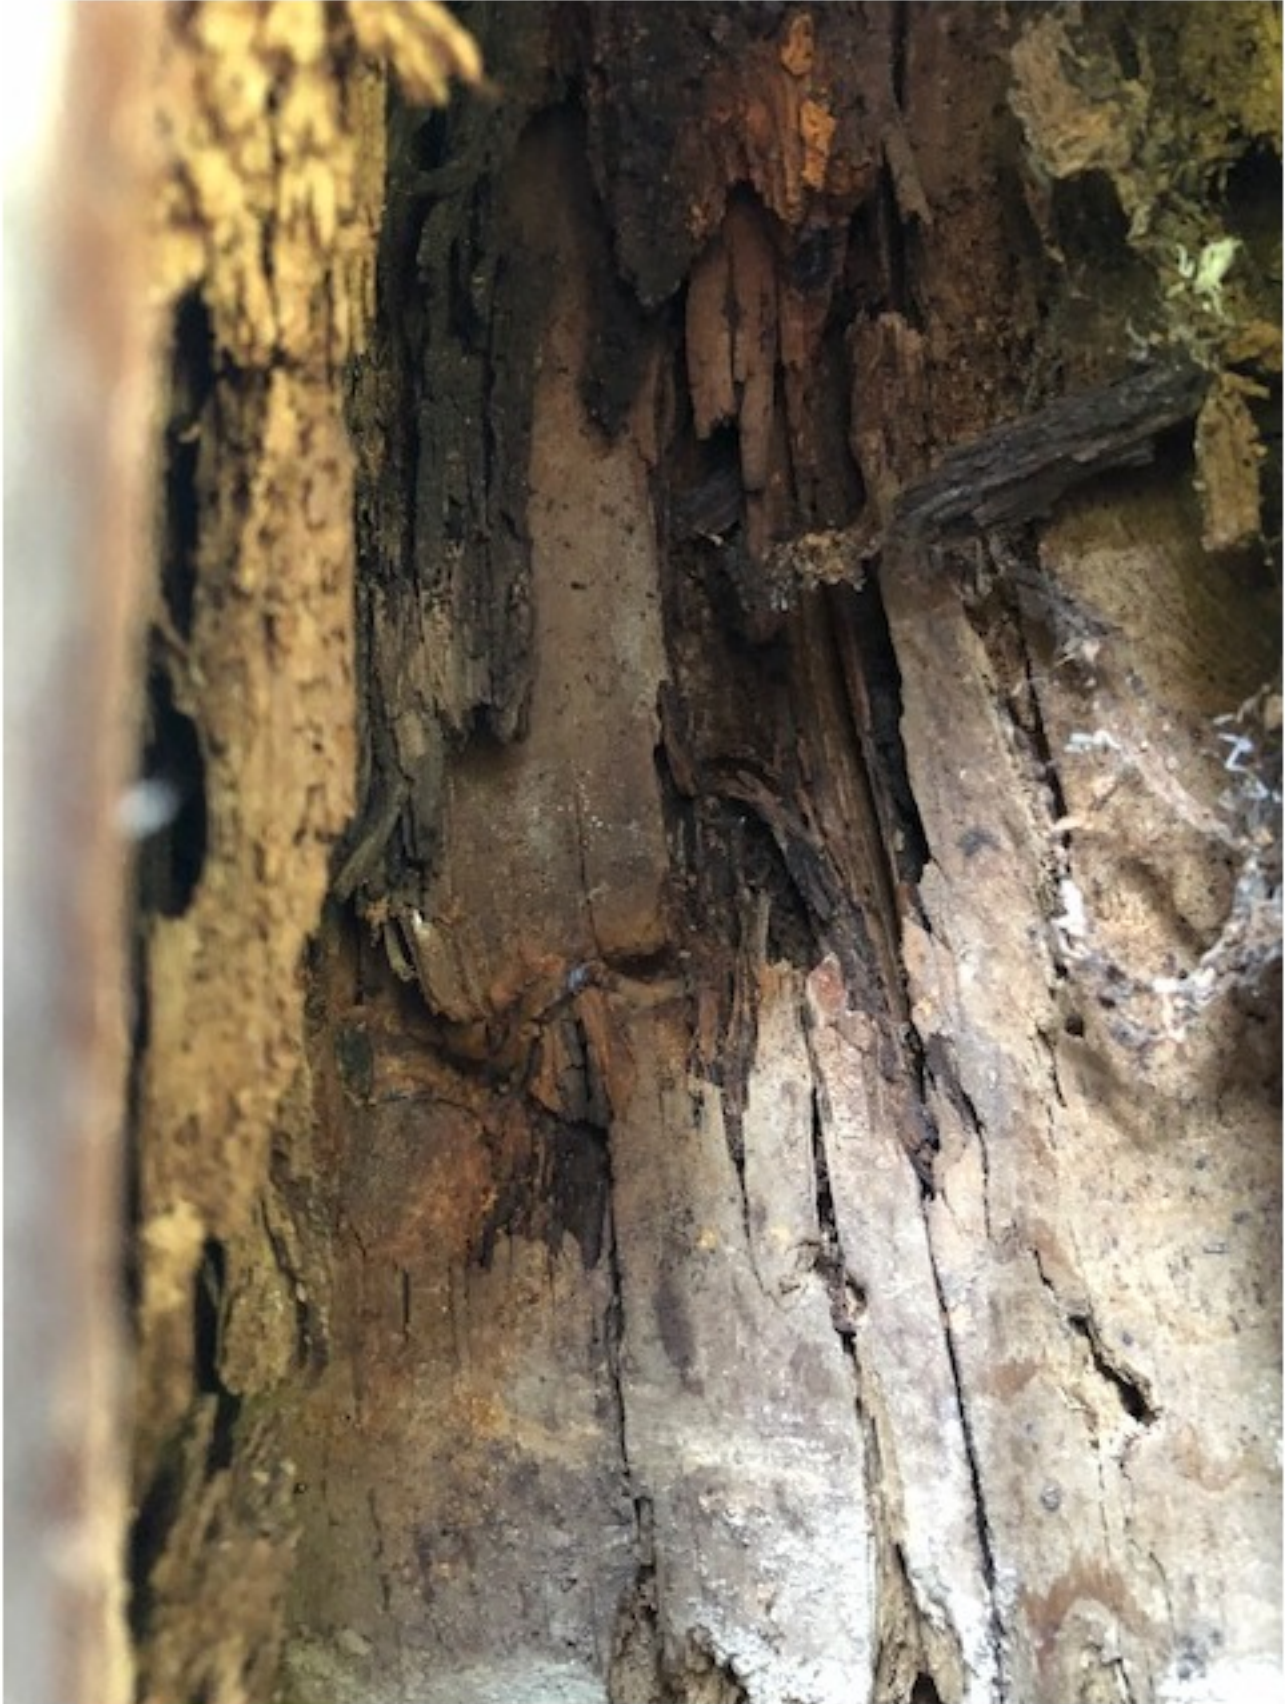
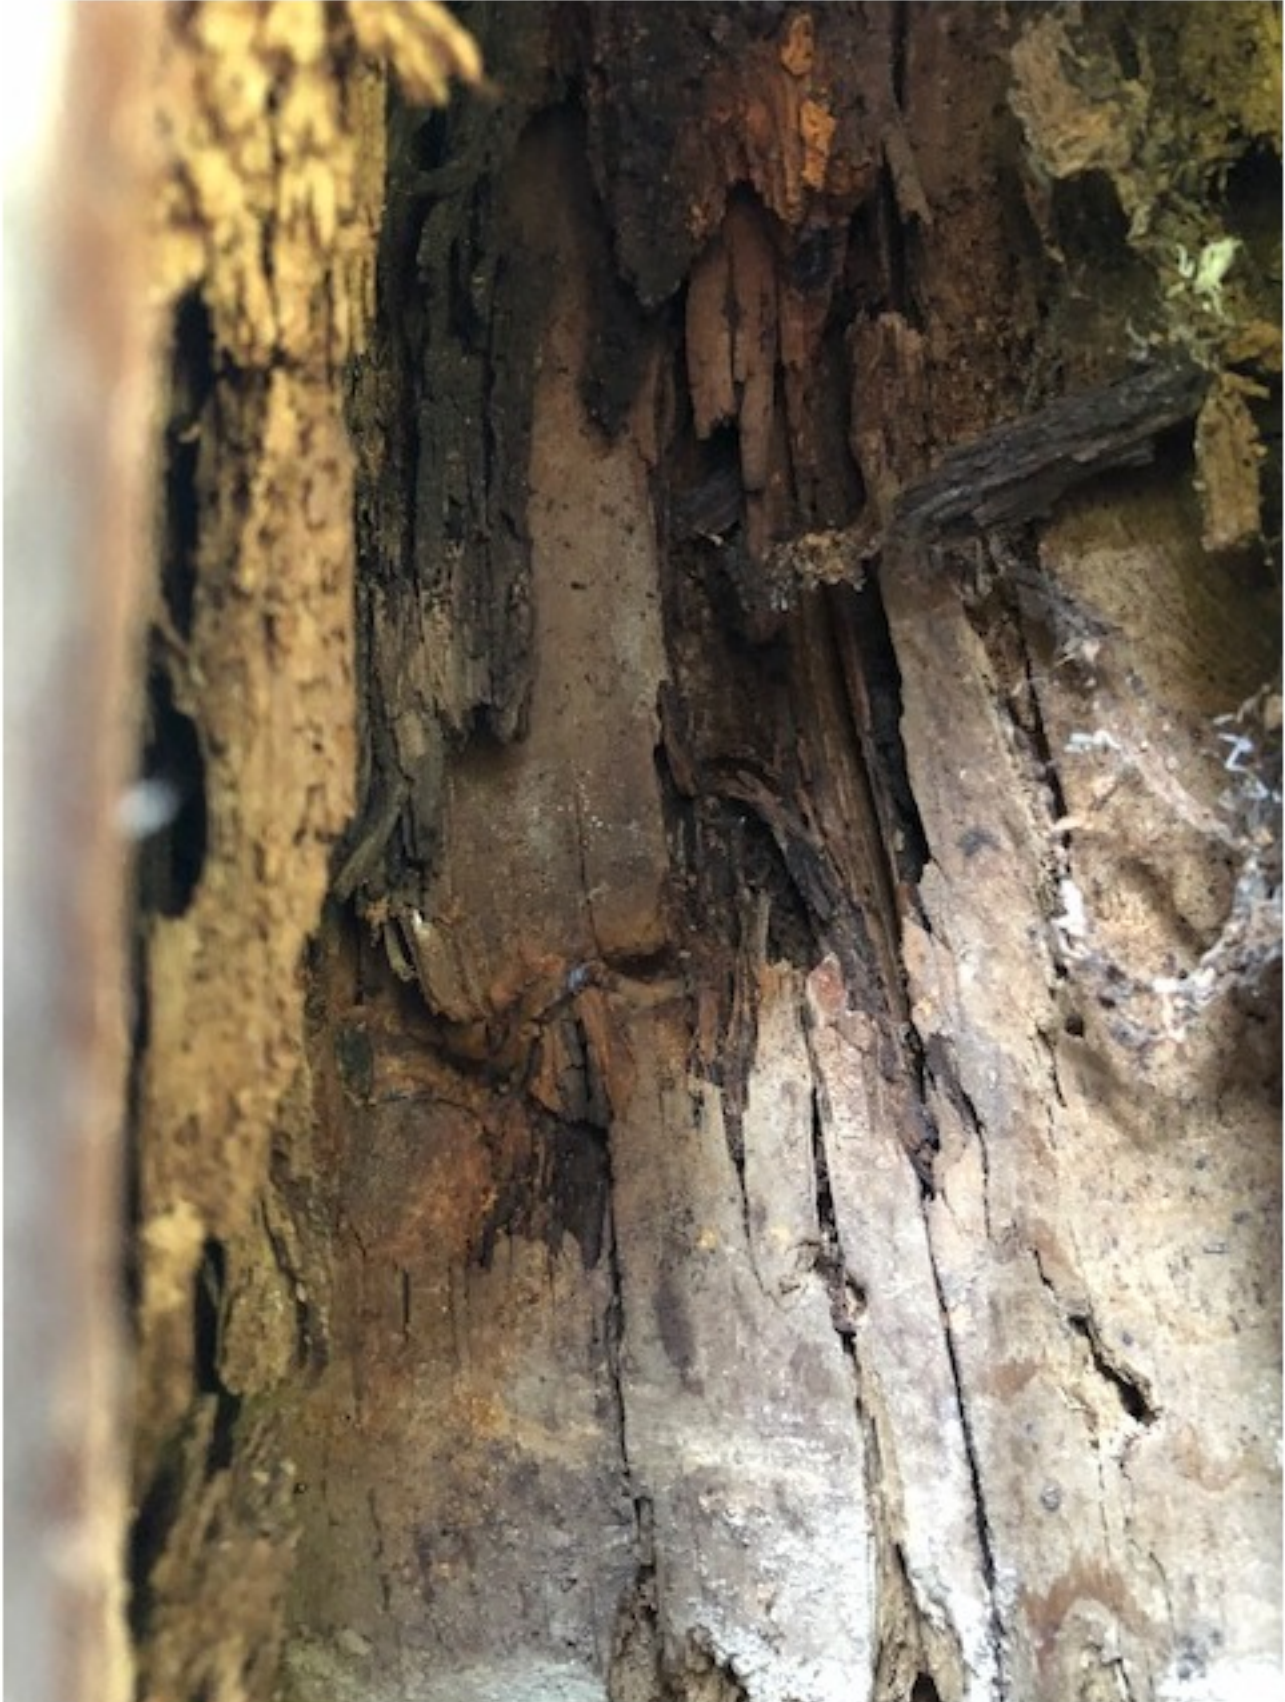
Photo No. 15

Core rot due to termites in the eastern timber scab at Column 2 of Bent 24.
