BRIDGE INSPECTION REPORT

Other Inspection

BRIDGE NO.:
10 0136

STRUCTURE NAME:
ALBION RIVER

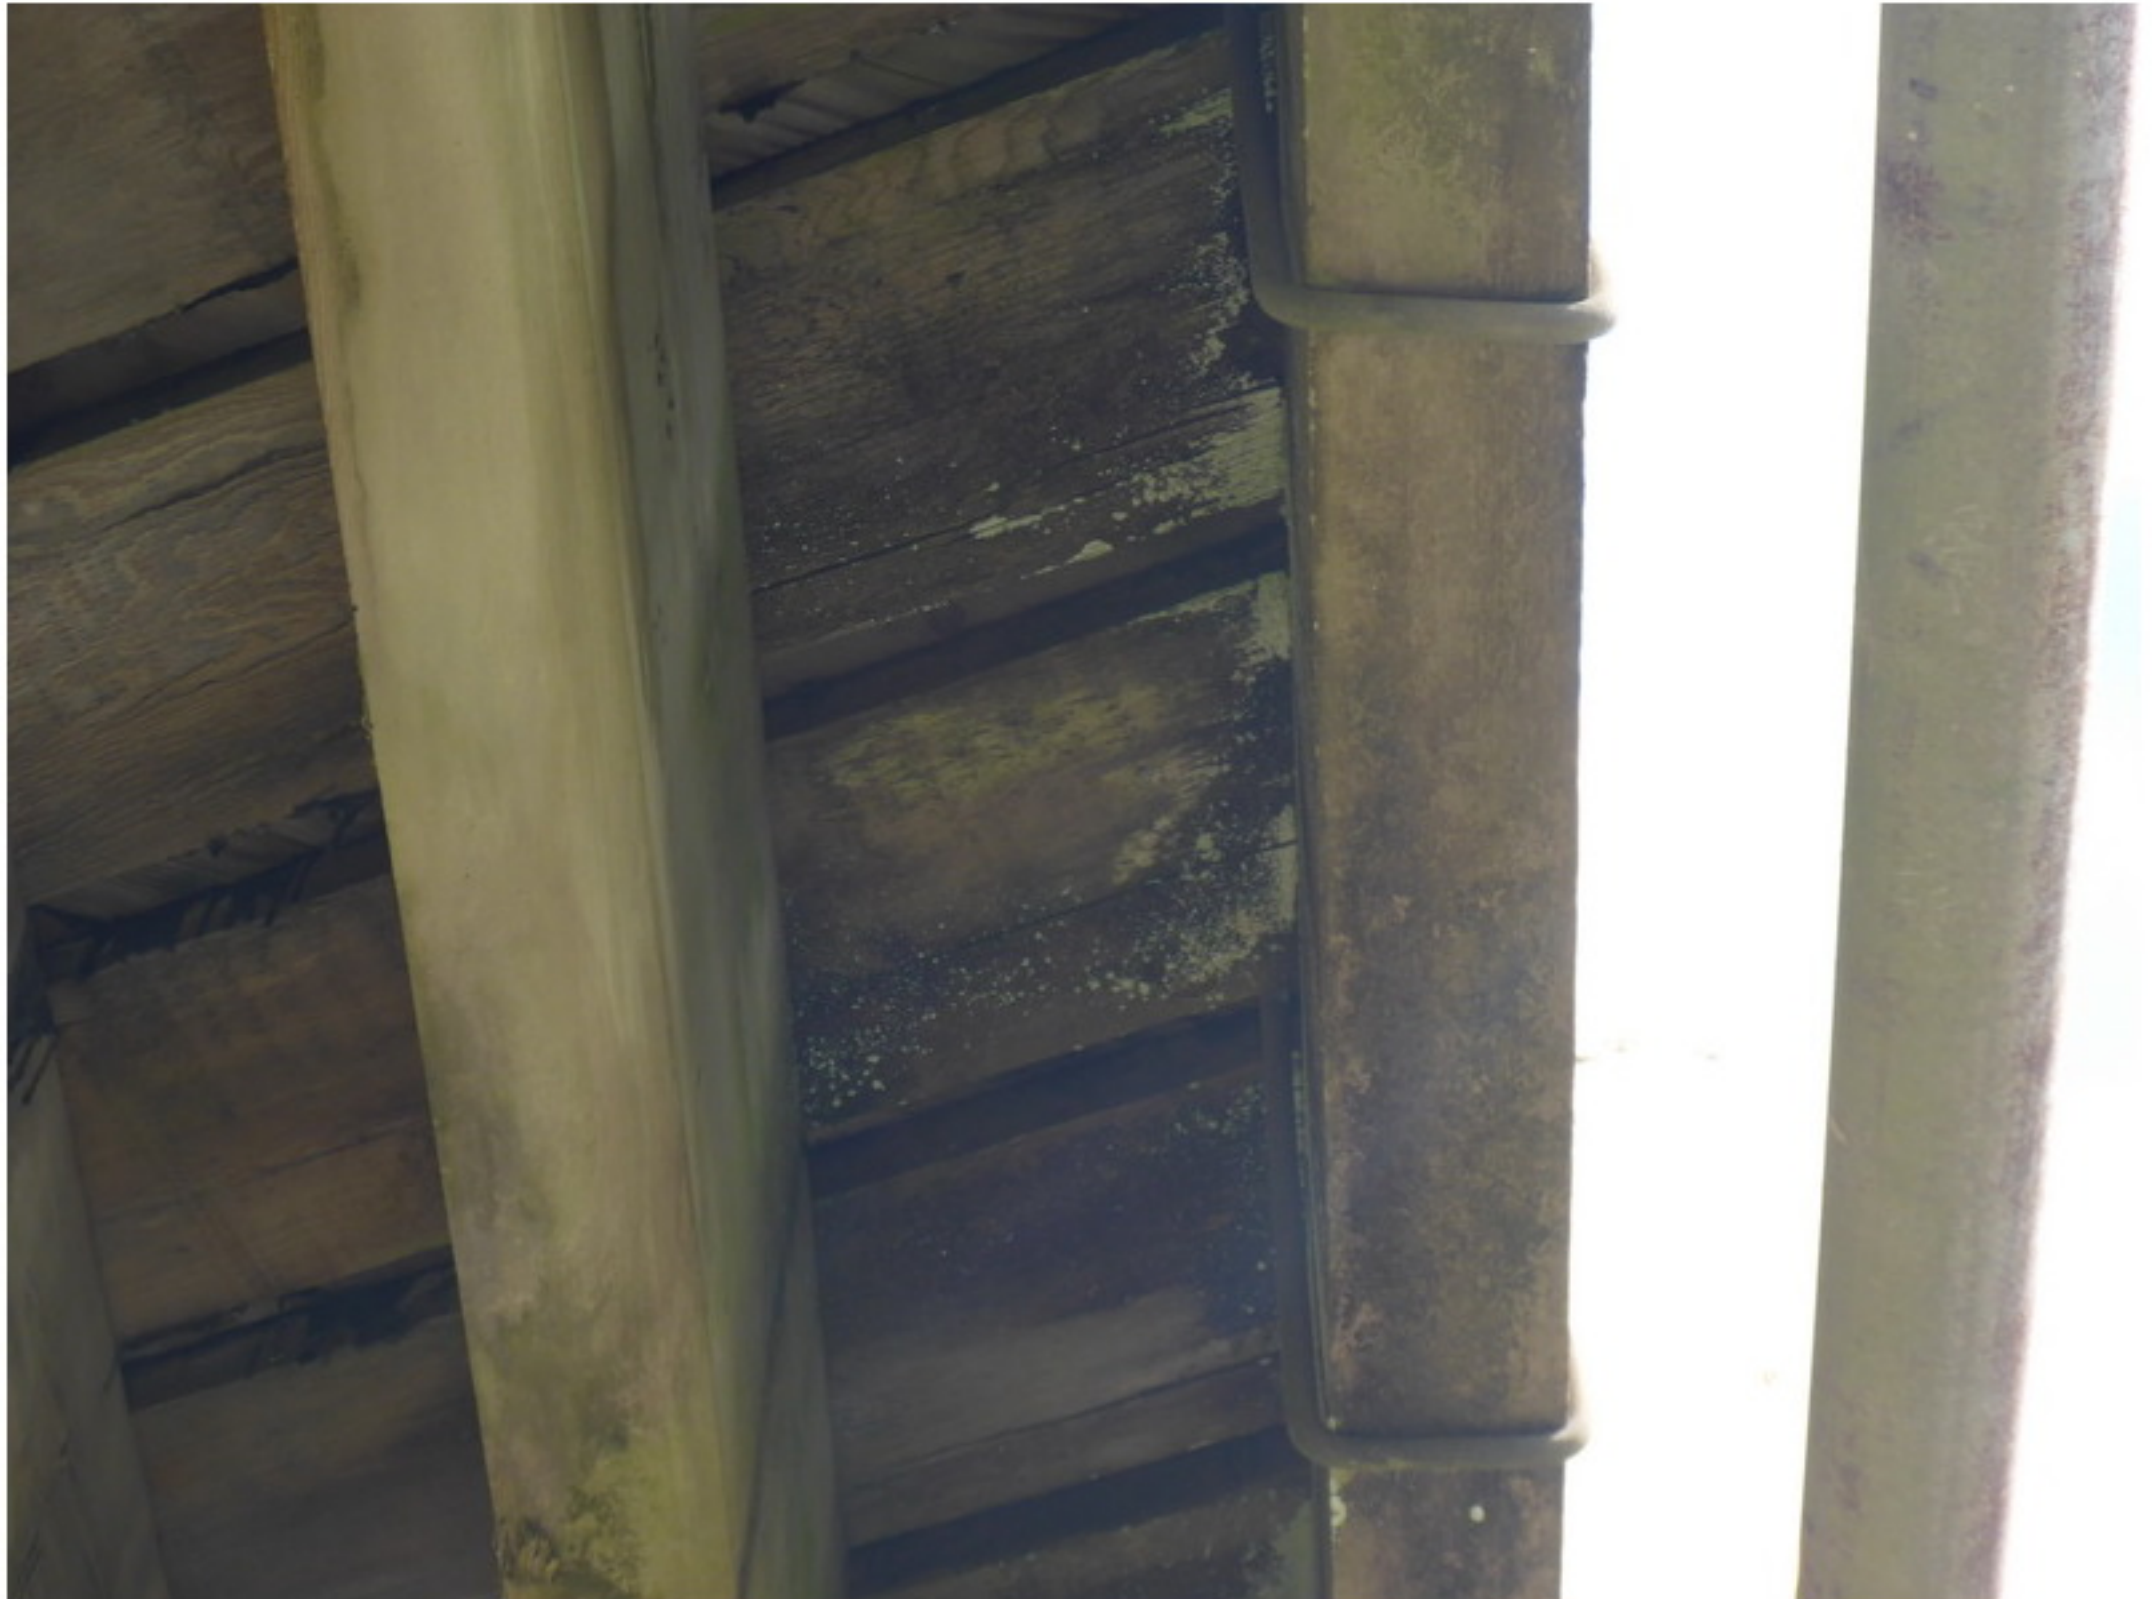
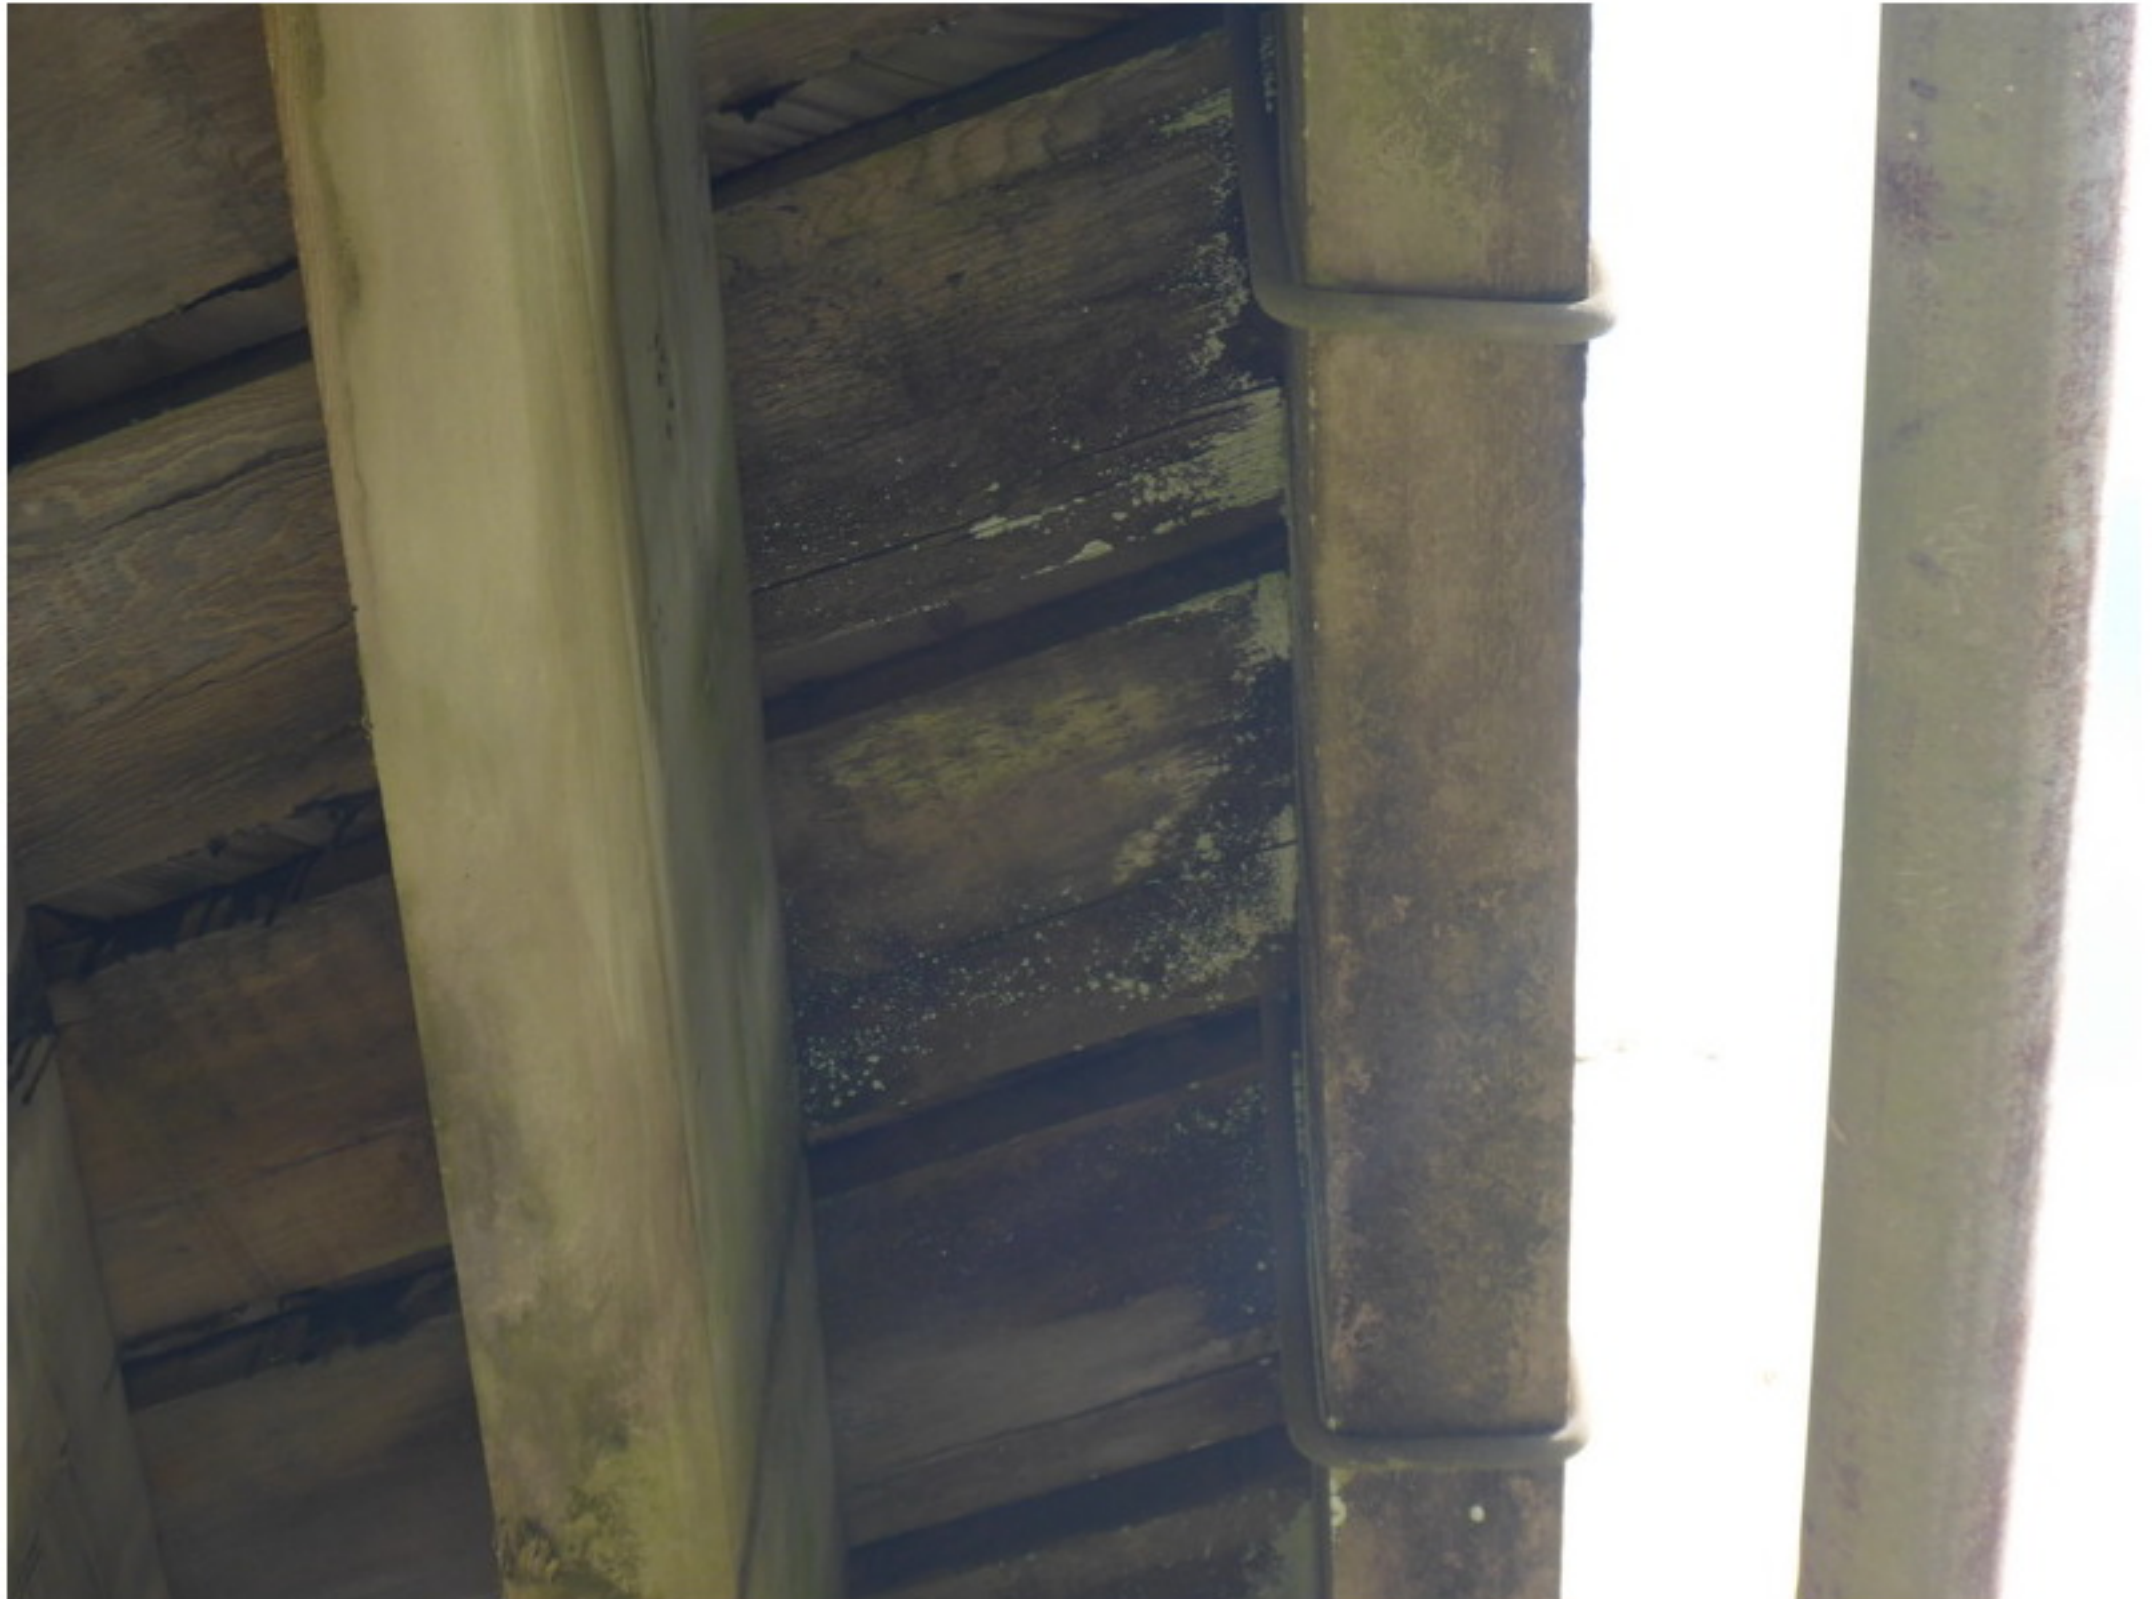
Large areas of rotted and decayed timber deck planks were discovered along the edge of deck on both sides throughout the length of the structure. The rot was typically present in the area beneath the deck drains and extended approximately 18 to 24 inches into the deck on both layers of deck planks (see Photos 9 - 21 from the BIR dated 10/11/2017). The exact amount of decay (linear footage) was not measured but conservatively estimated at 15 to 20% of the total length of the deck.

Photo No. 1
Typical mold and rot located along the edges of the timber deck.

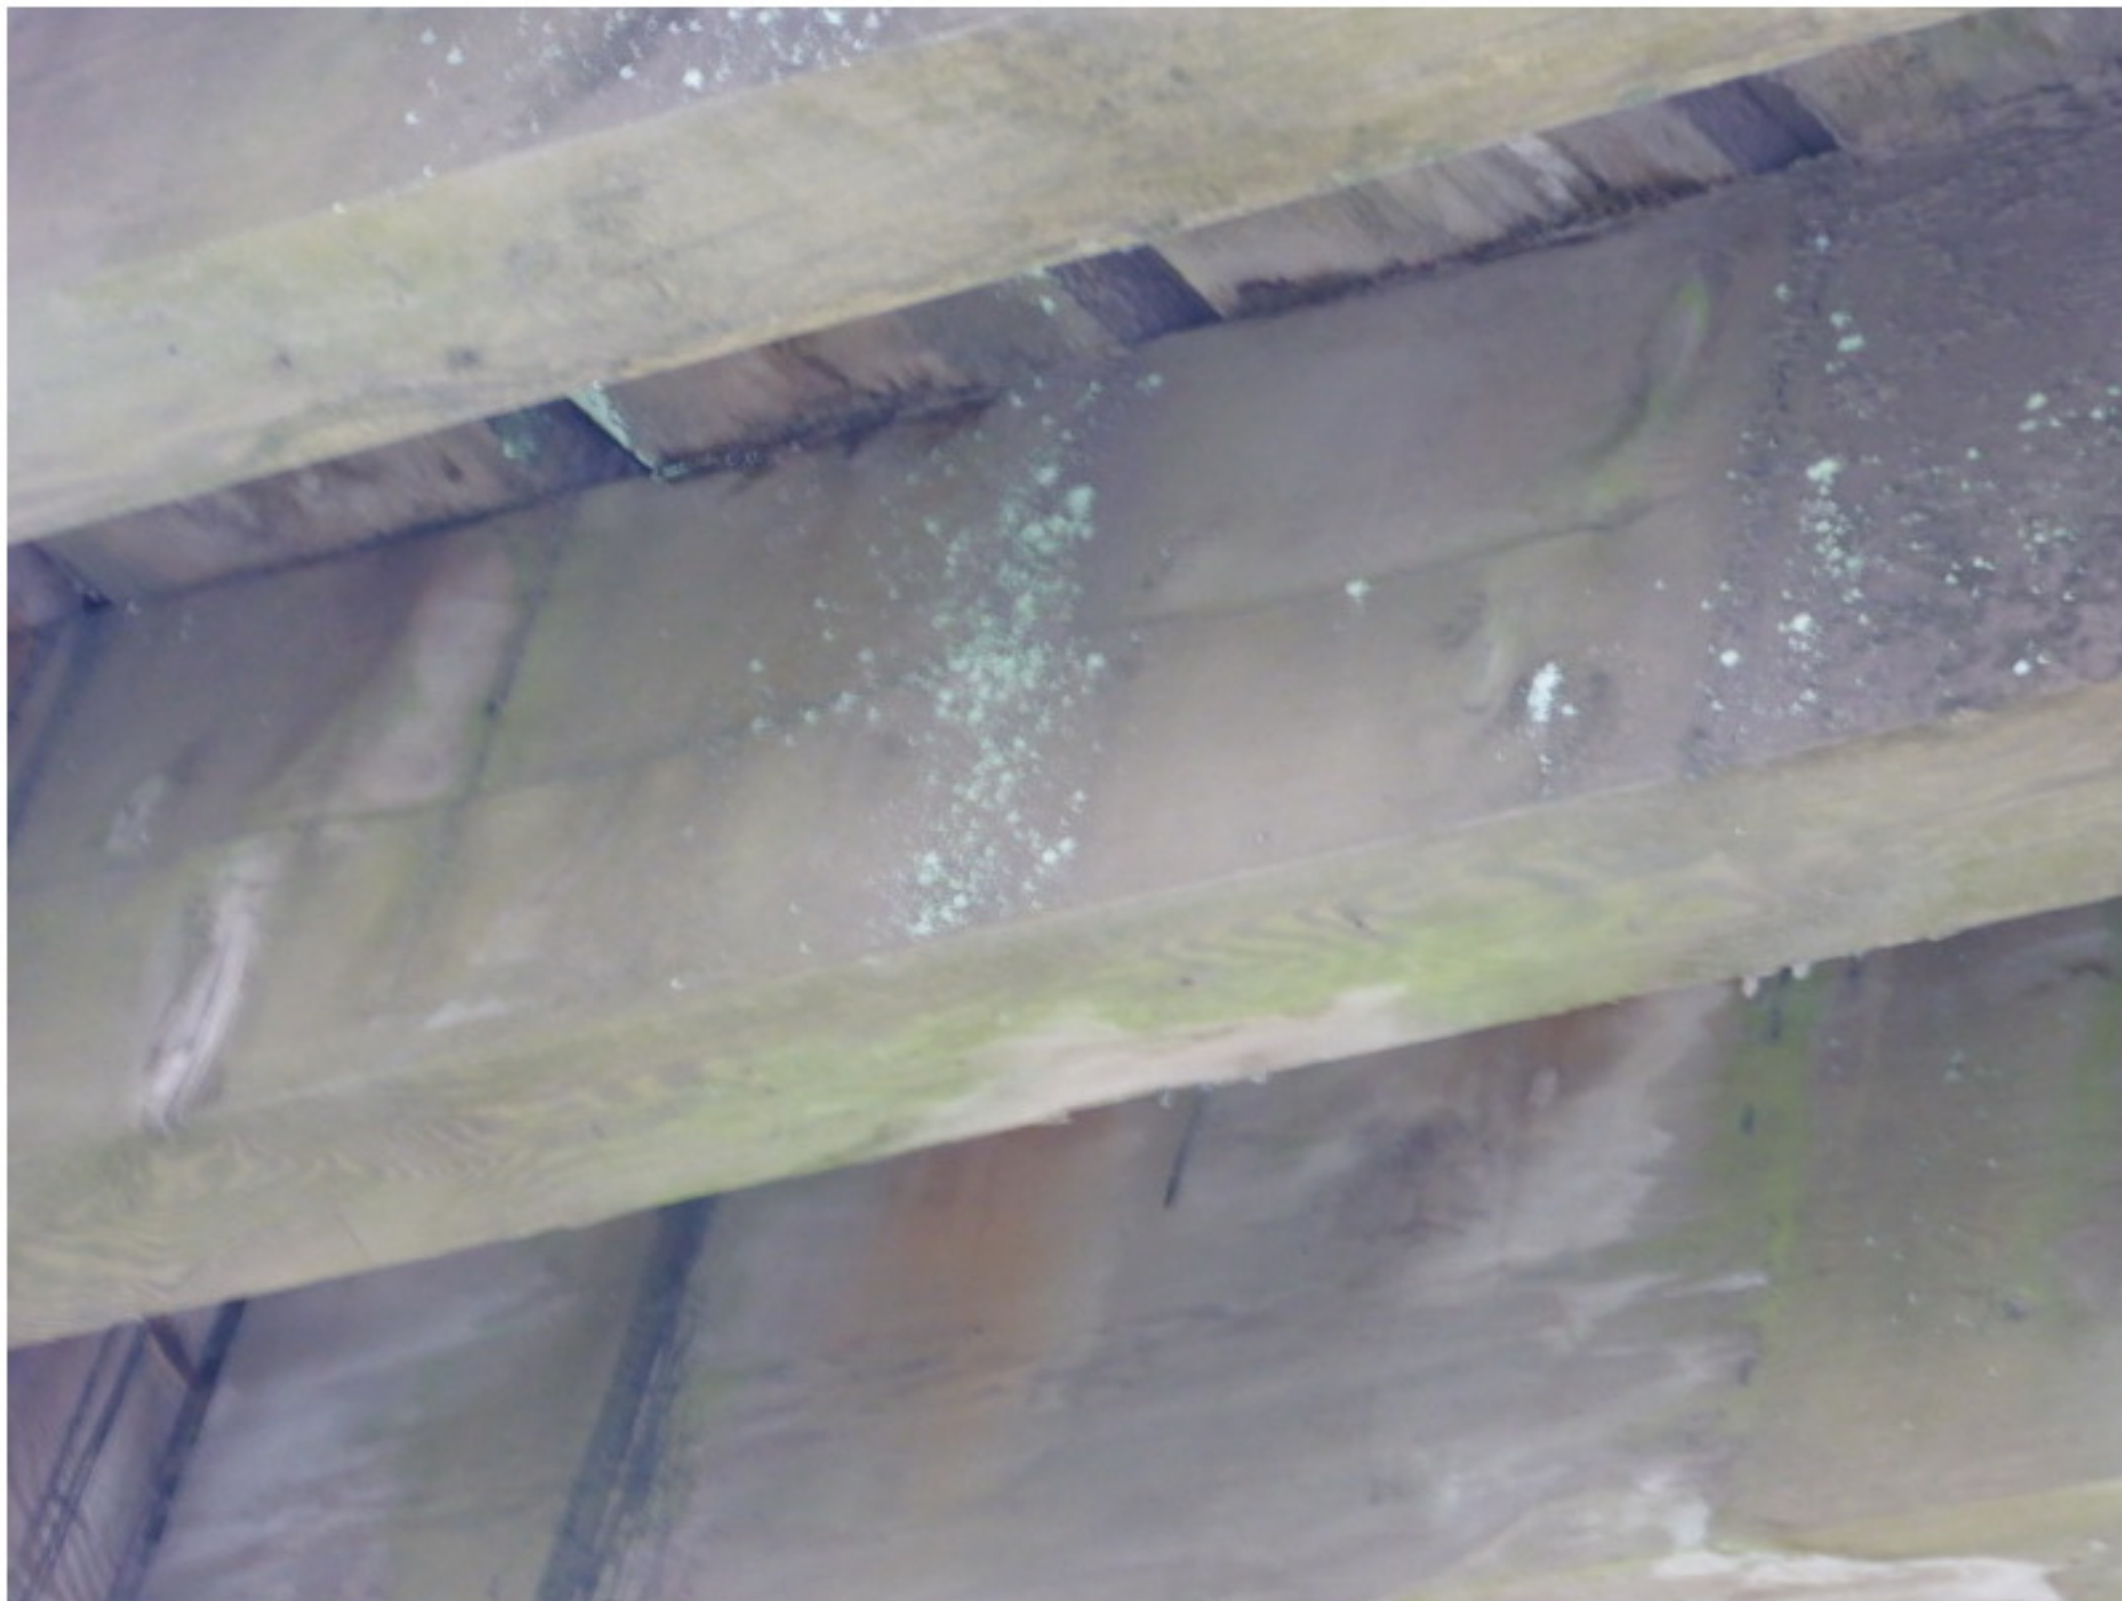
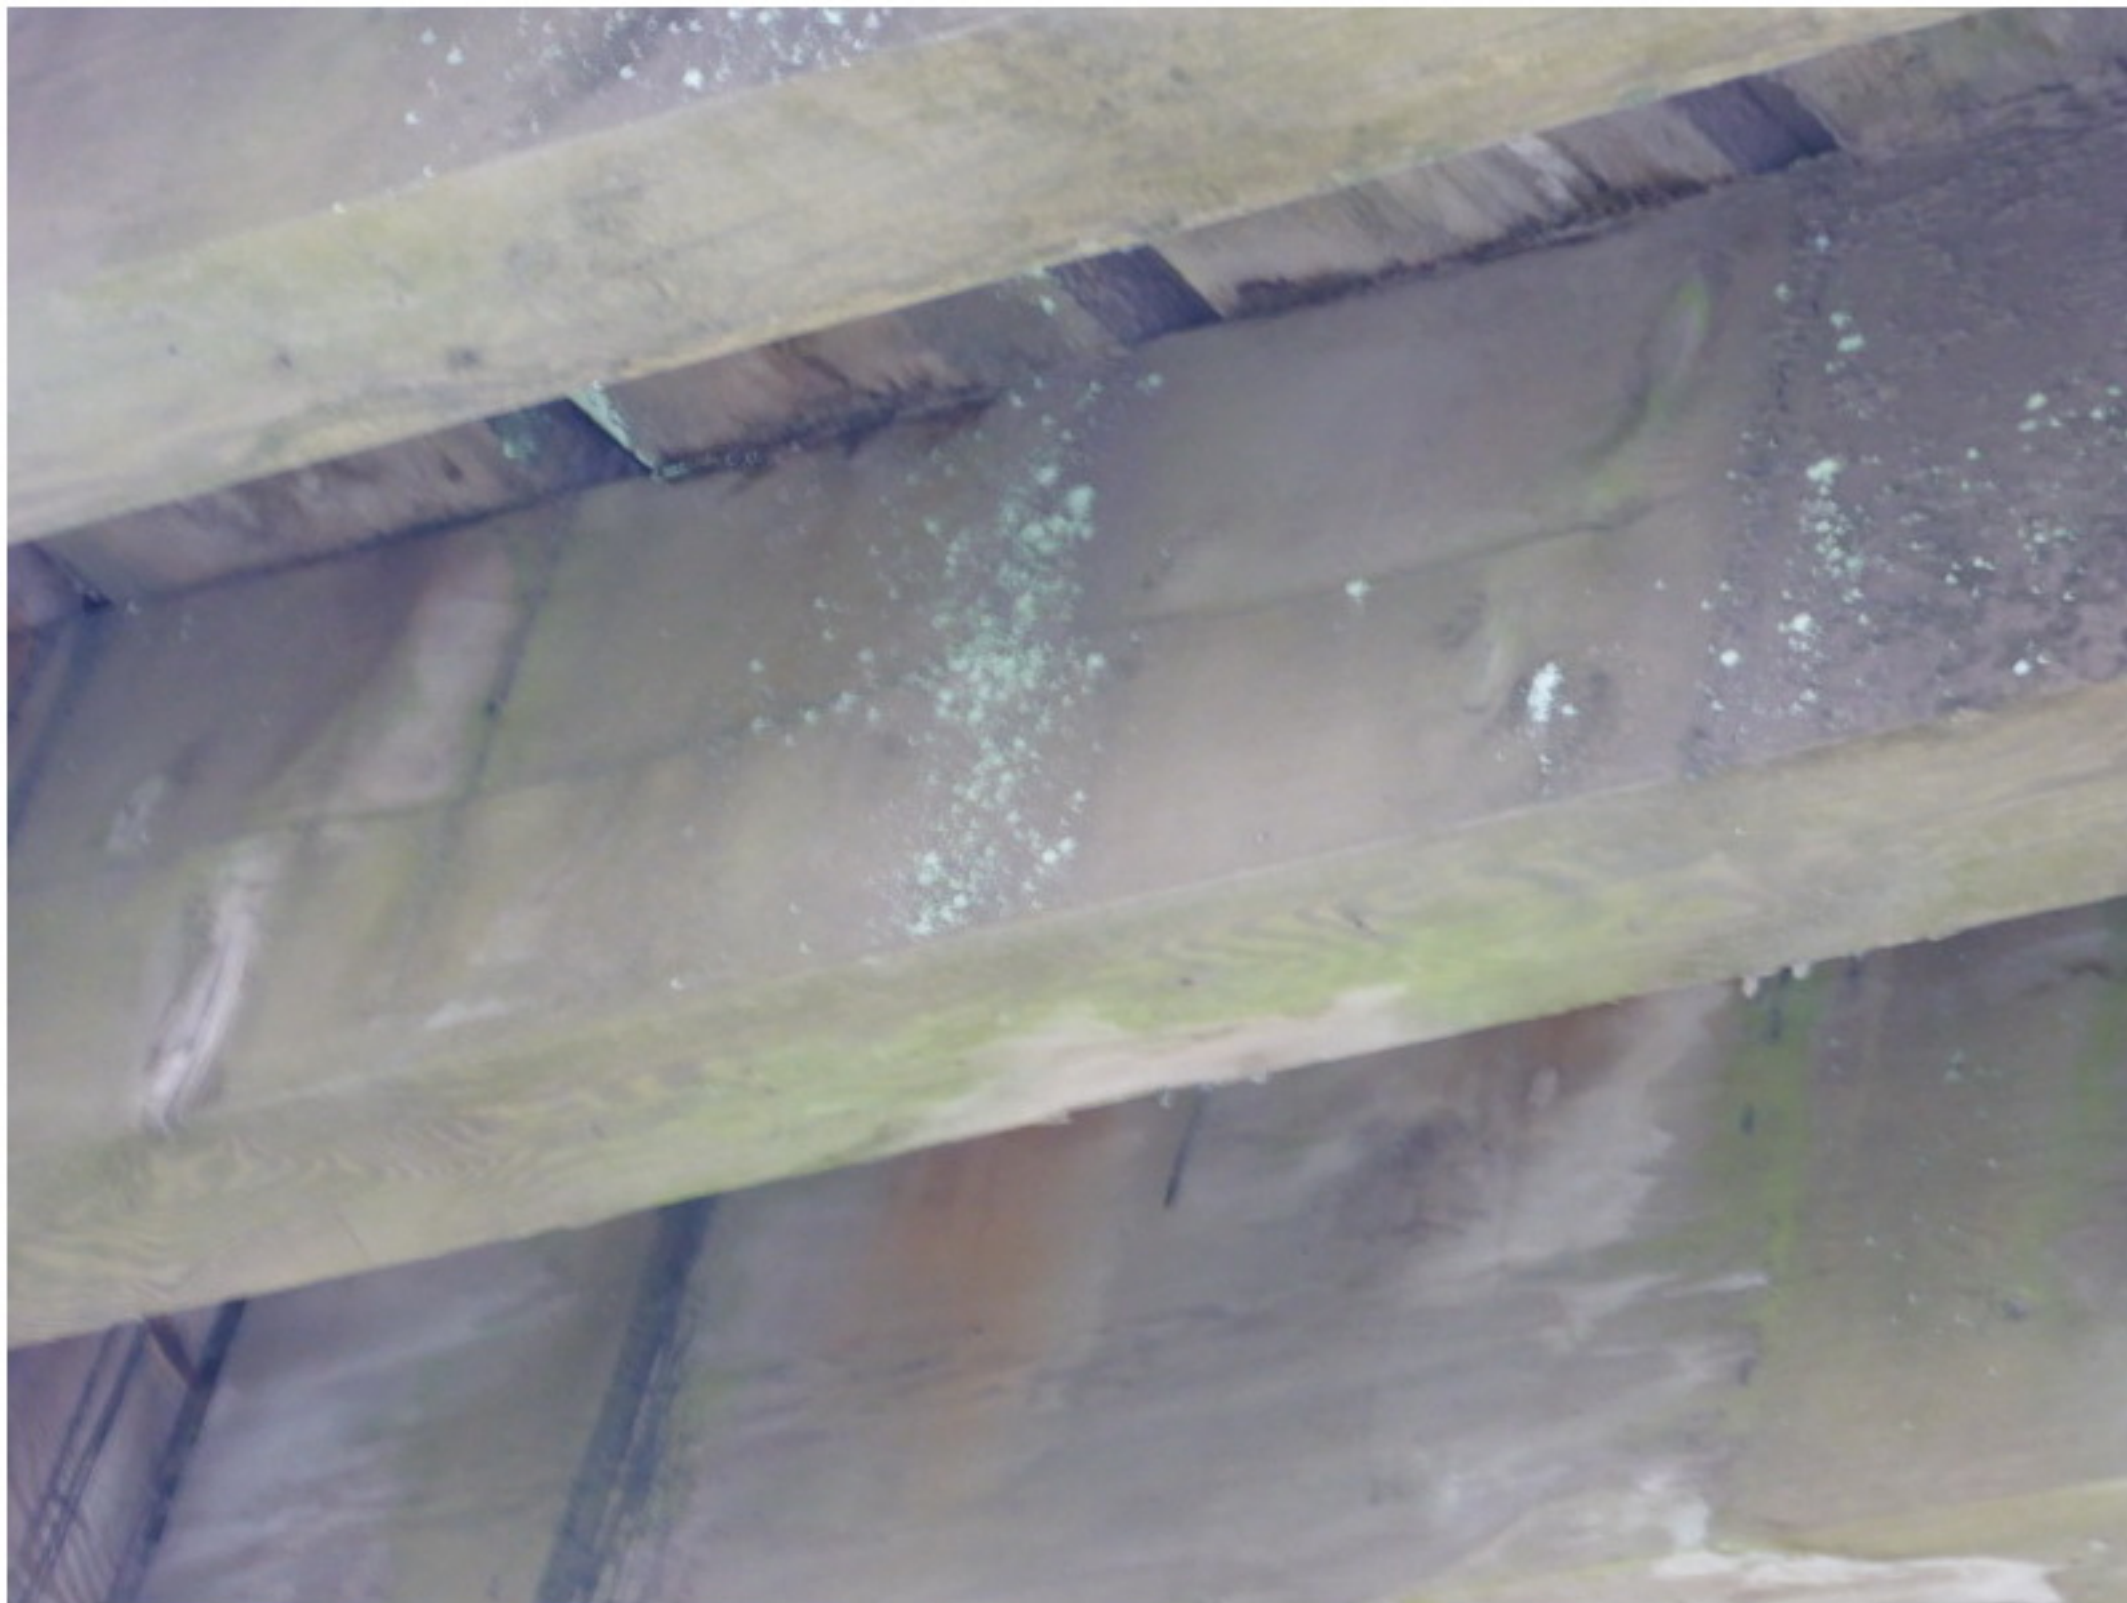
Photo No. 2

Typical horizontal check present in Girder 13 of Span 13.

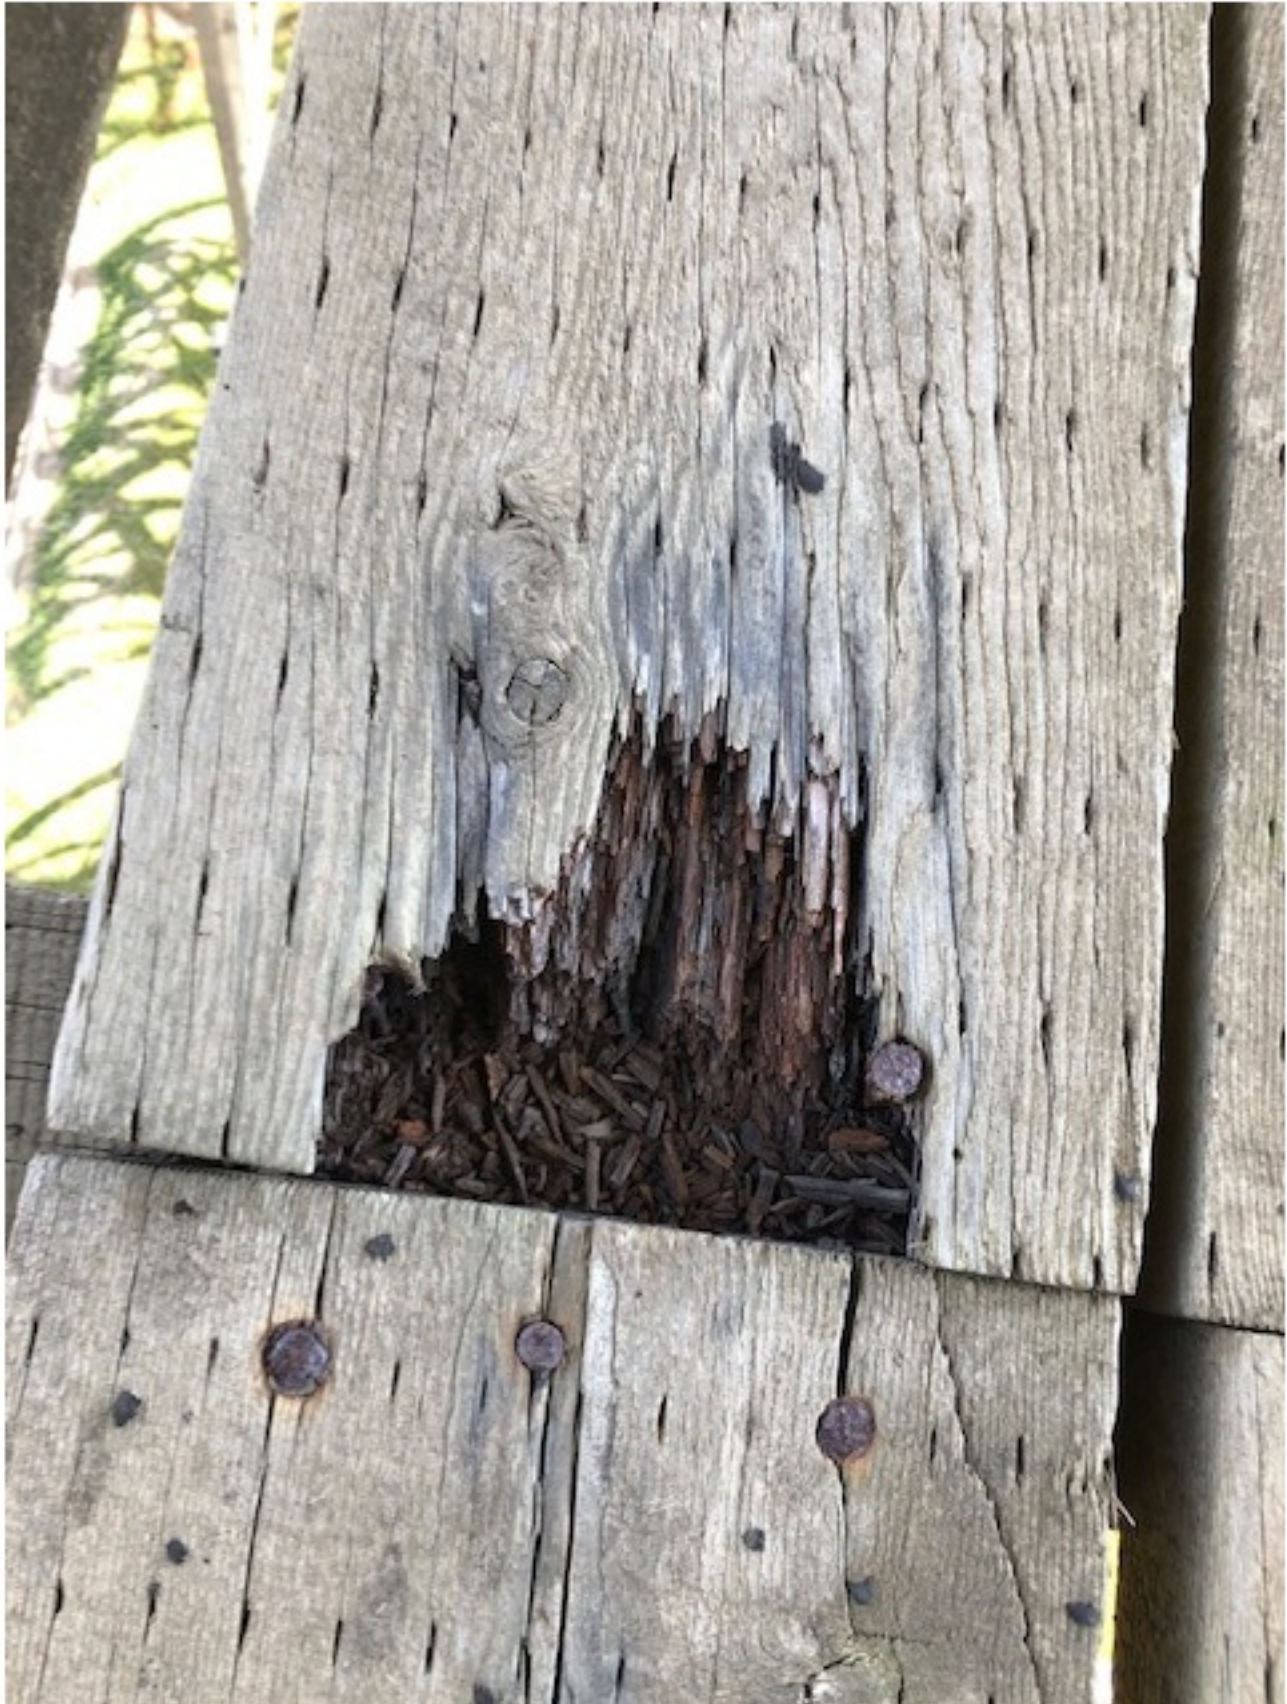
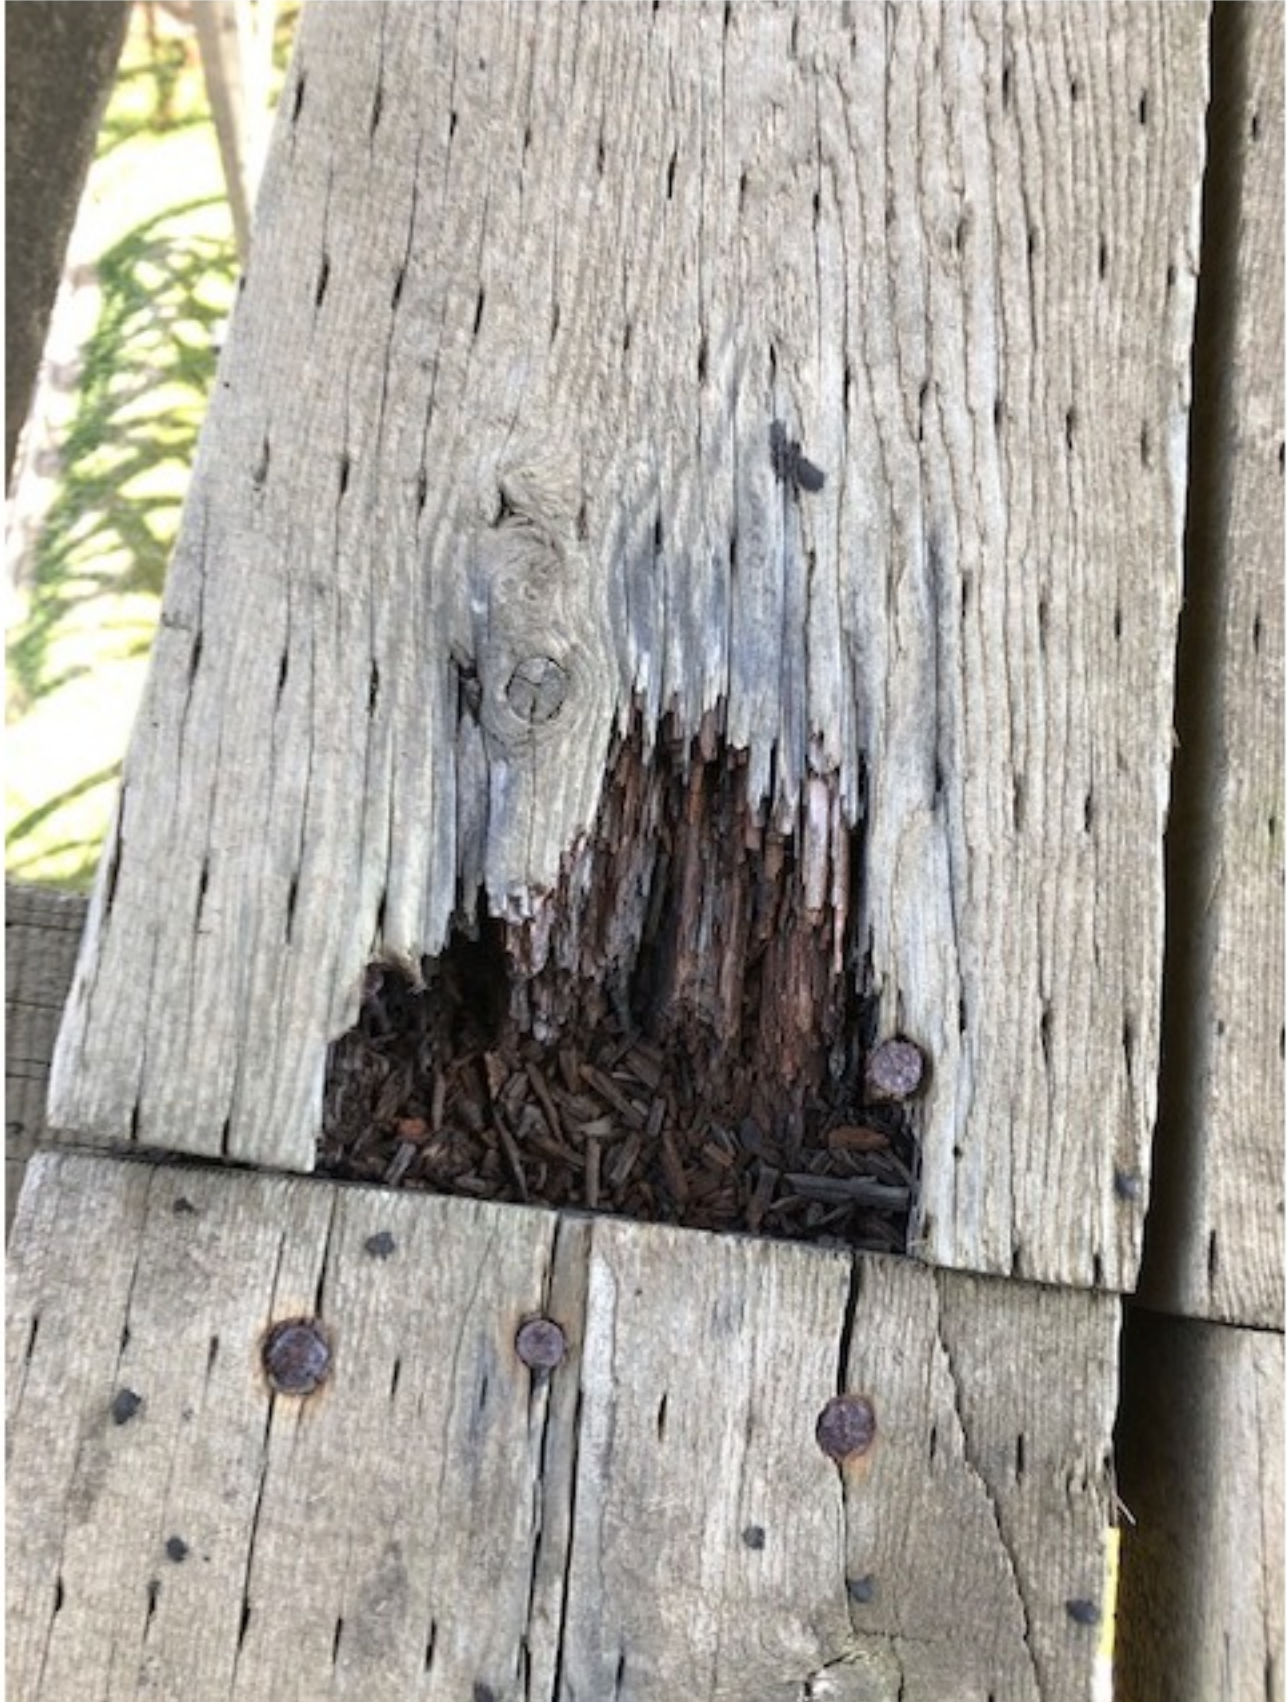
Photo No. 3

The right catwalk member in Span 22 is rotted around the connection points.

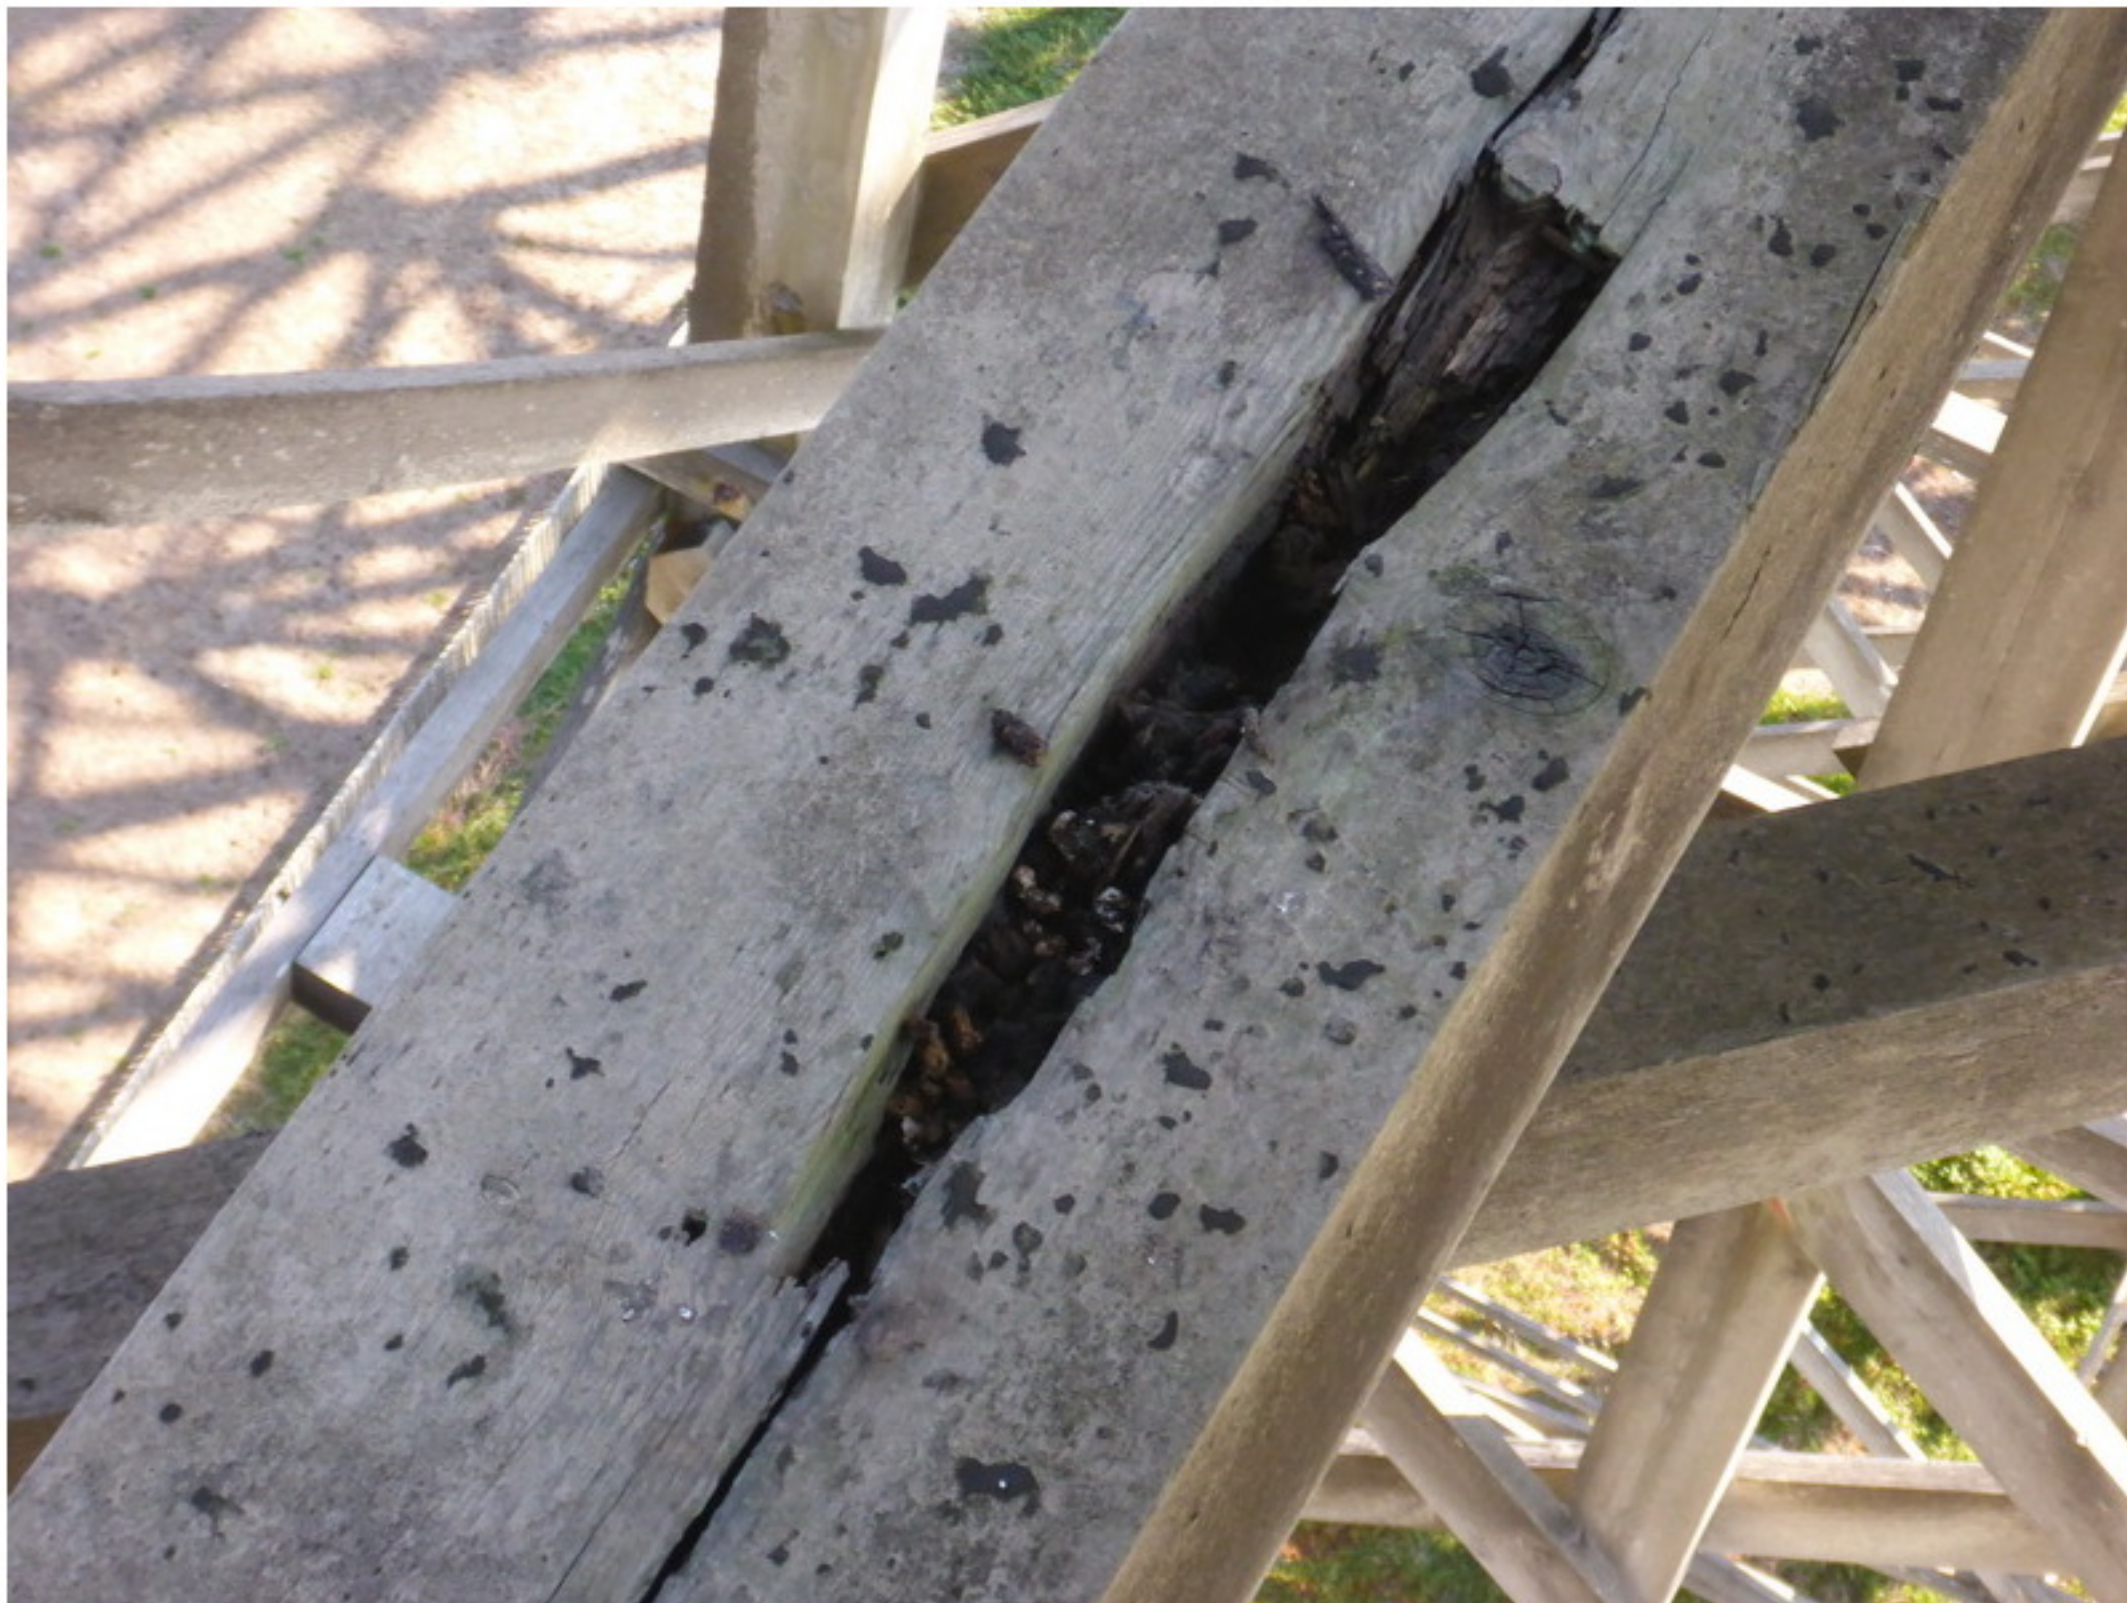
Photo No. 4

An area of decay was found at the top left horizontal between Bent 15 and Bent 16.
