BRIDGE INSPECTION REPORT

Other Inspection

BRIDGE NO.:
10 0136

STRUCTURE NAME:
ALBION RIVER

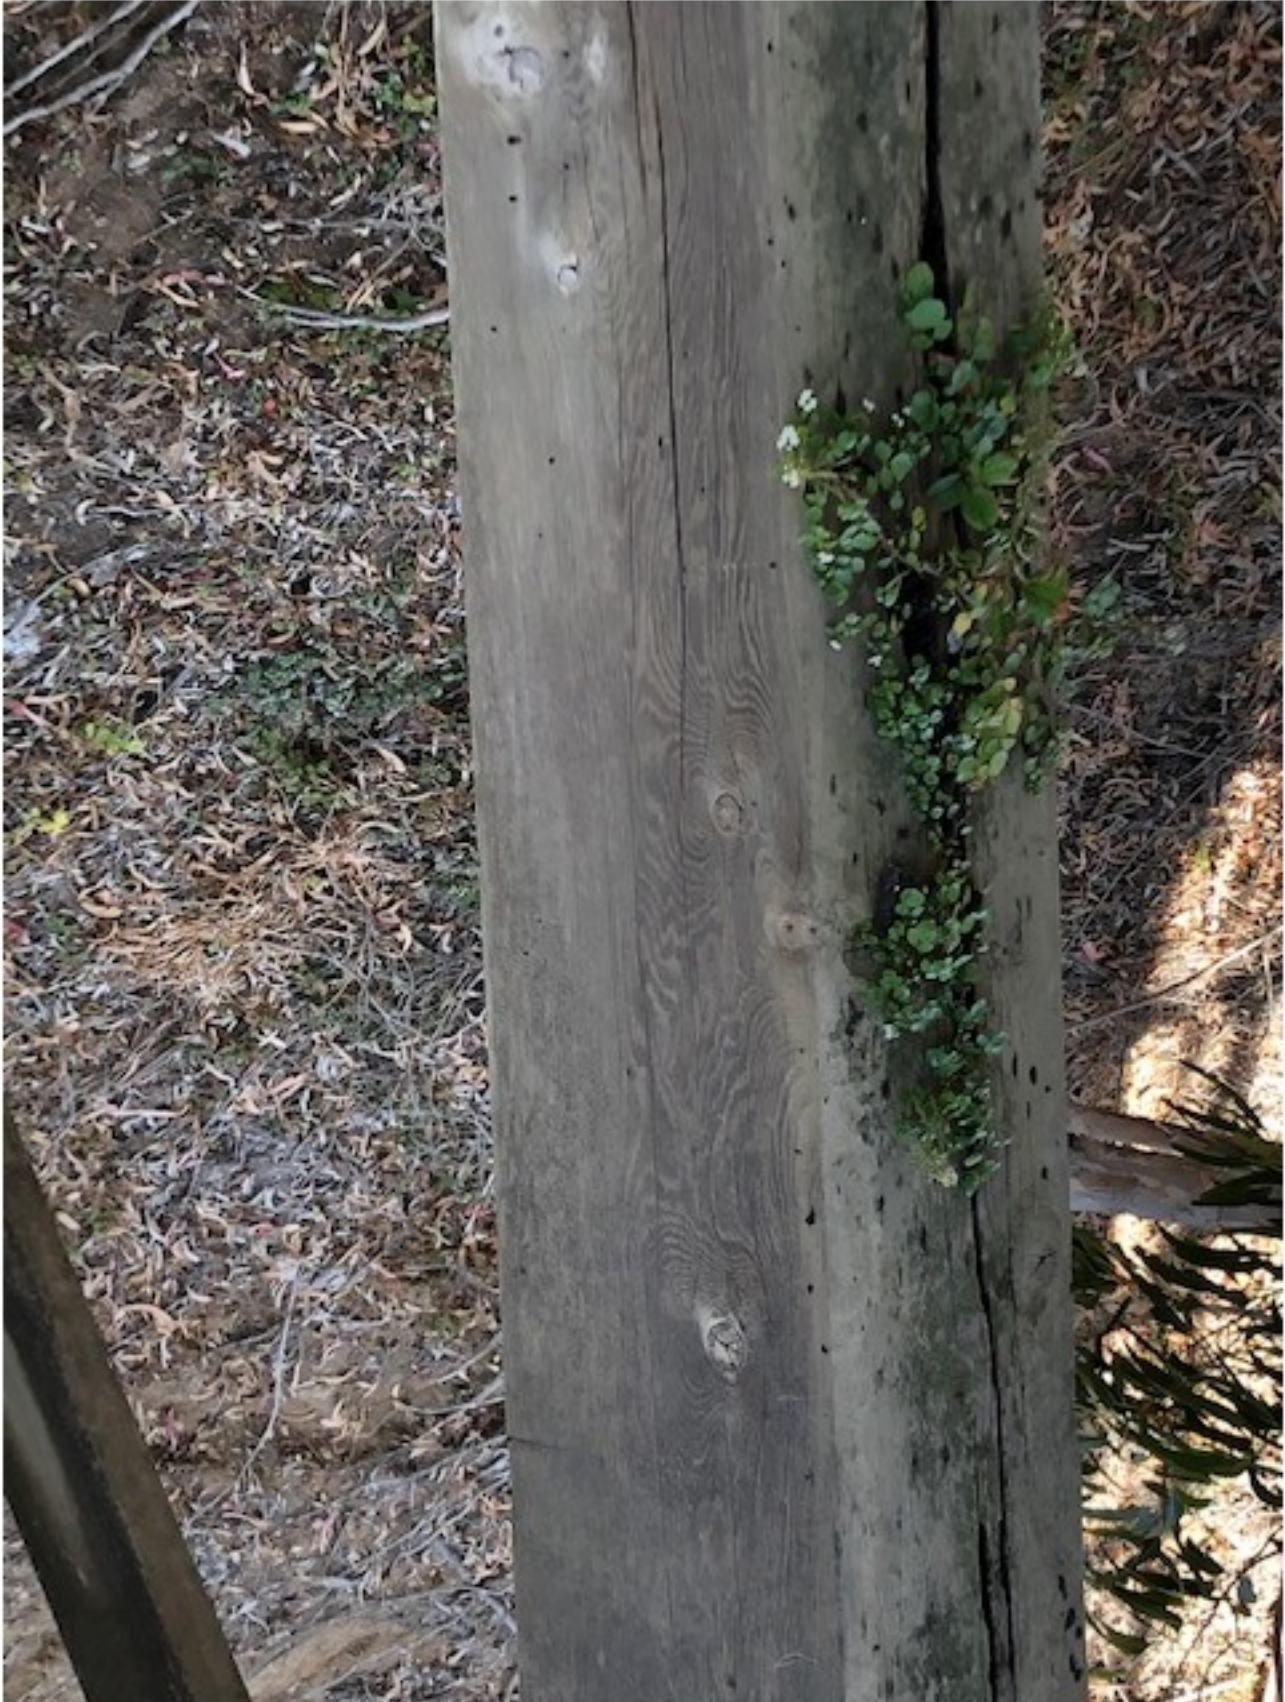
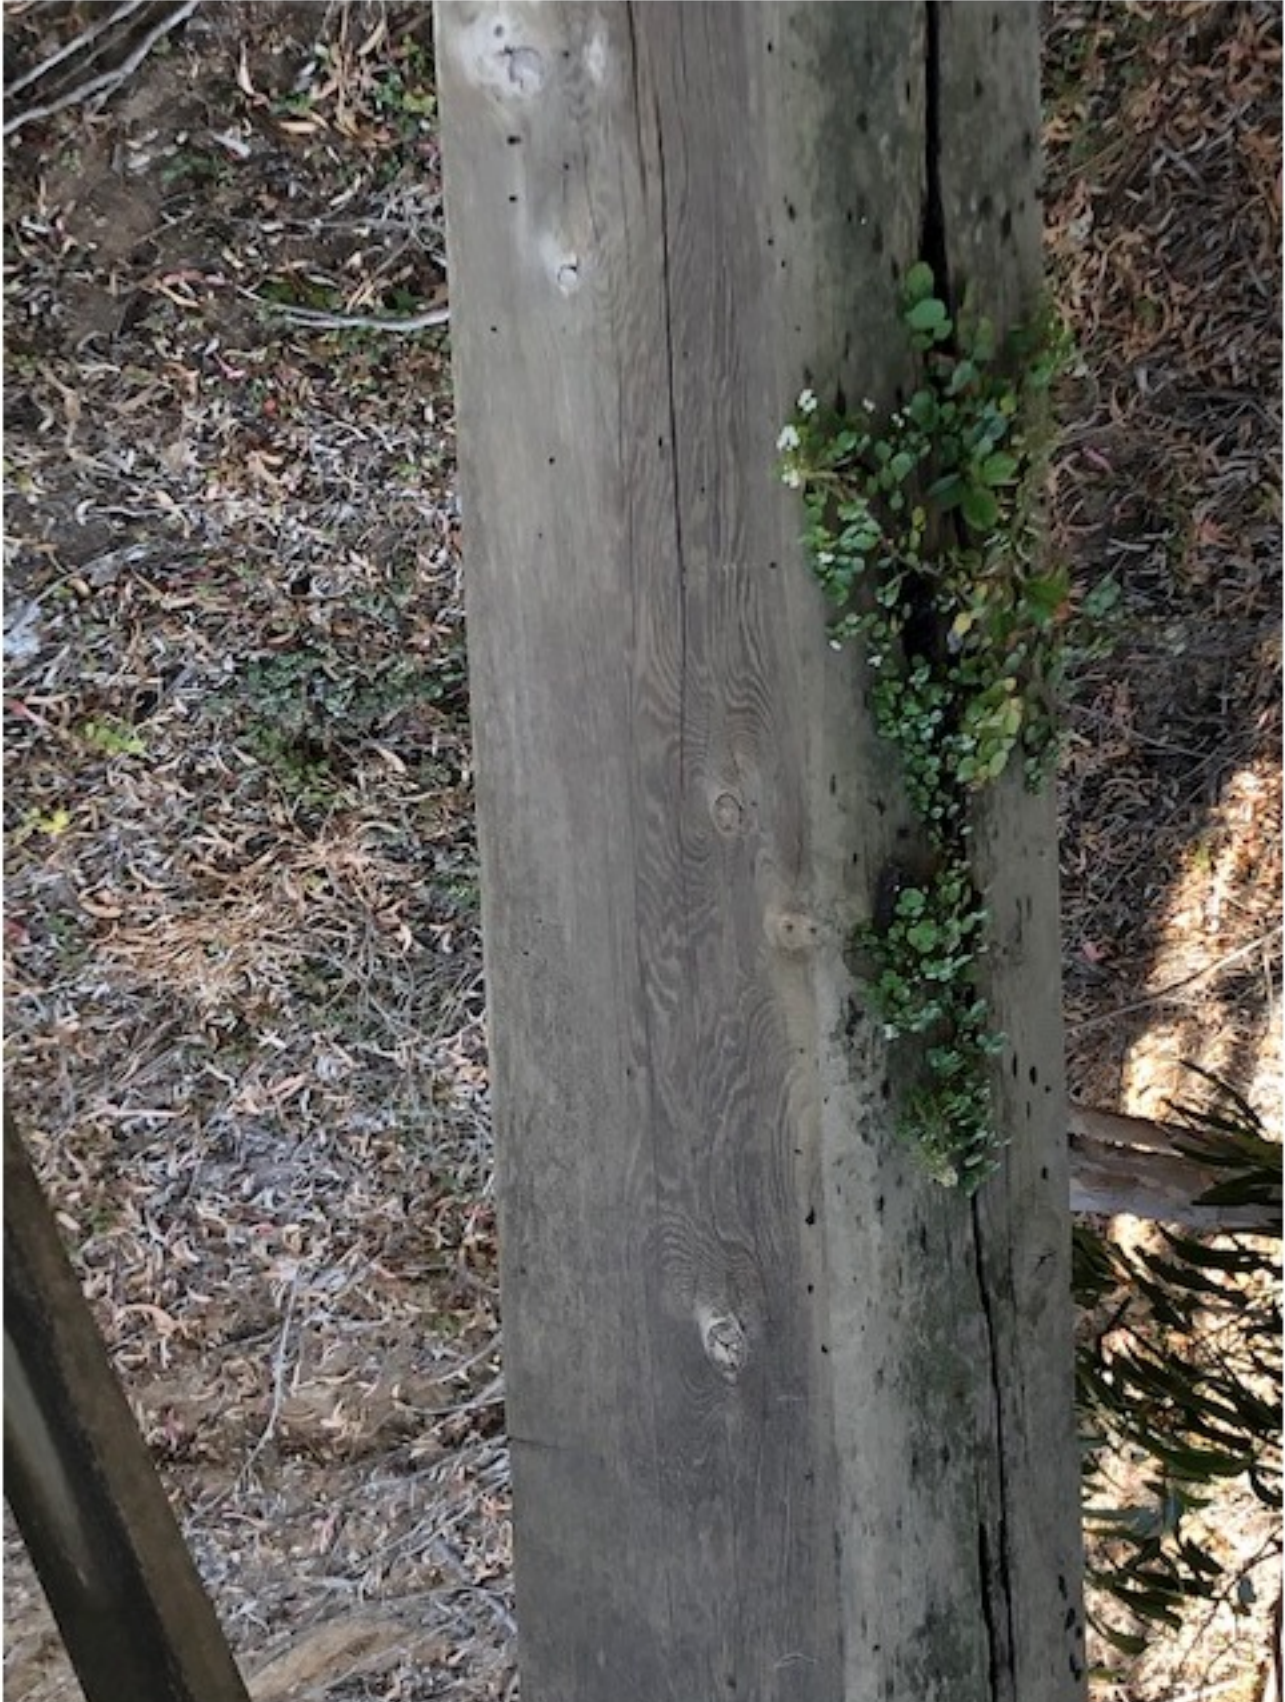
Photo No. 5

An area of decay was found at the top right horizontal between Bent 23 and Bent 246.

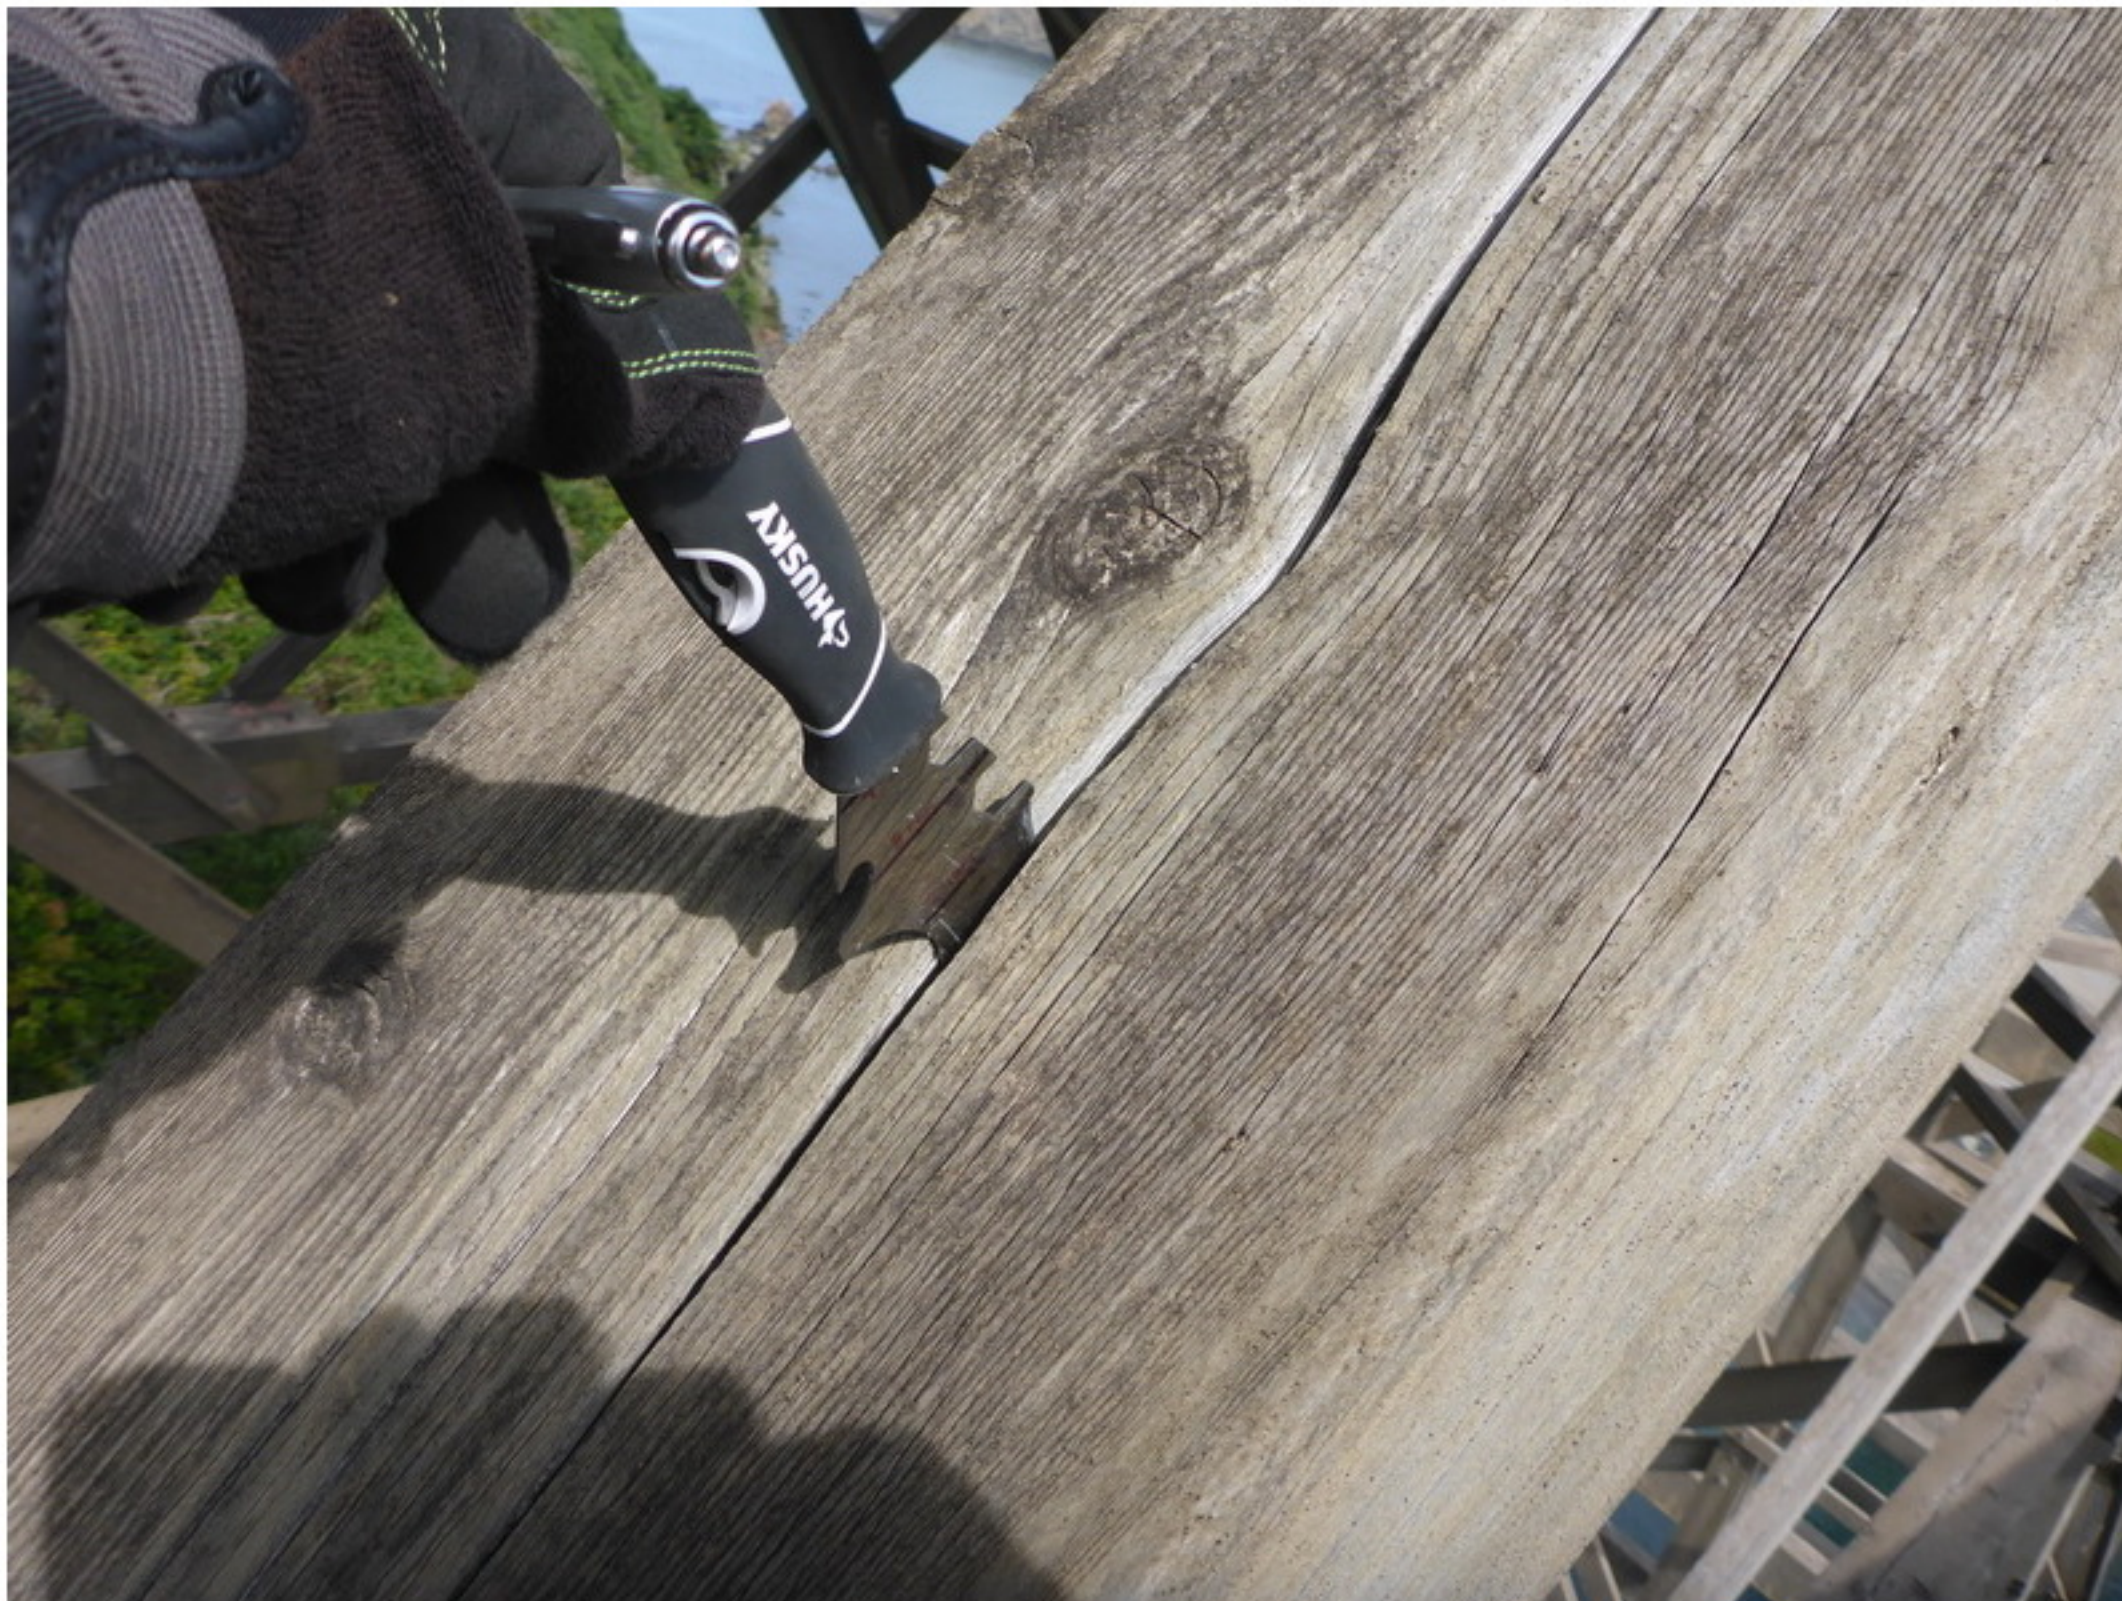
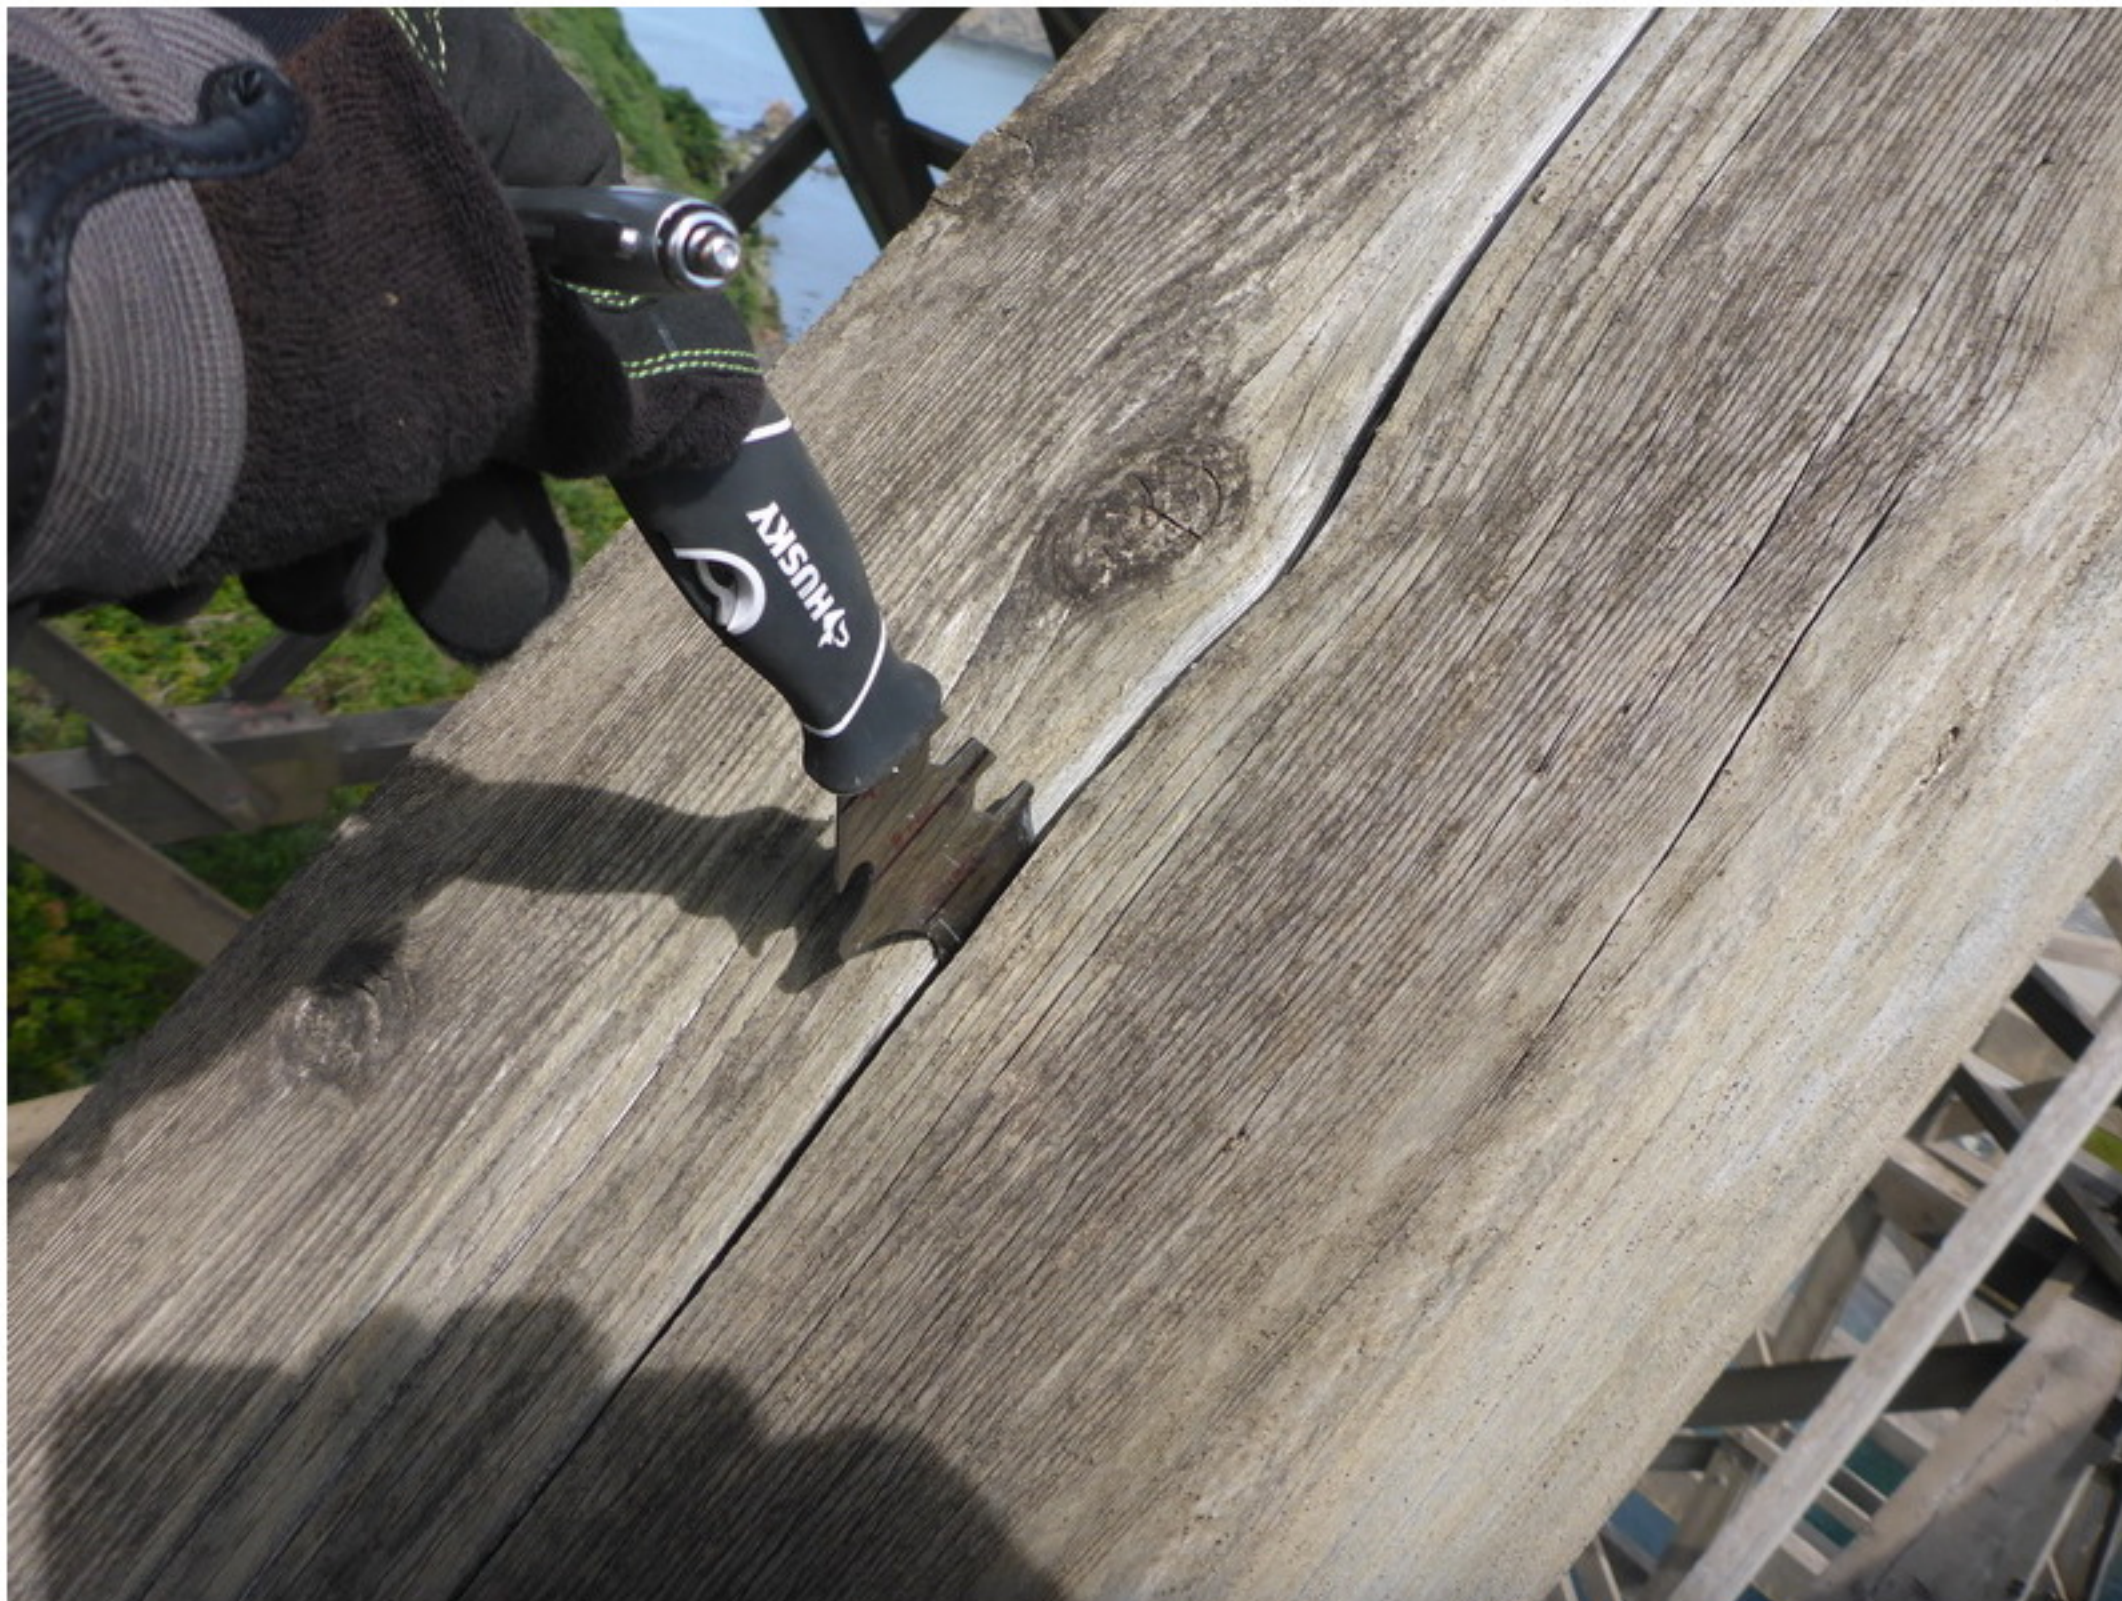
Photo No. 6

Large check along the fourth upper diagonal of the timber truss in Span 8.

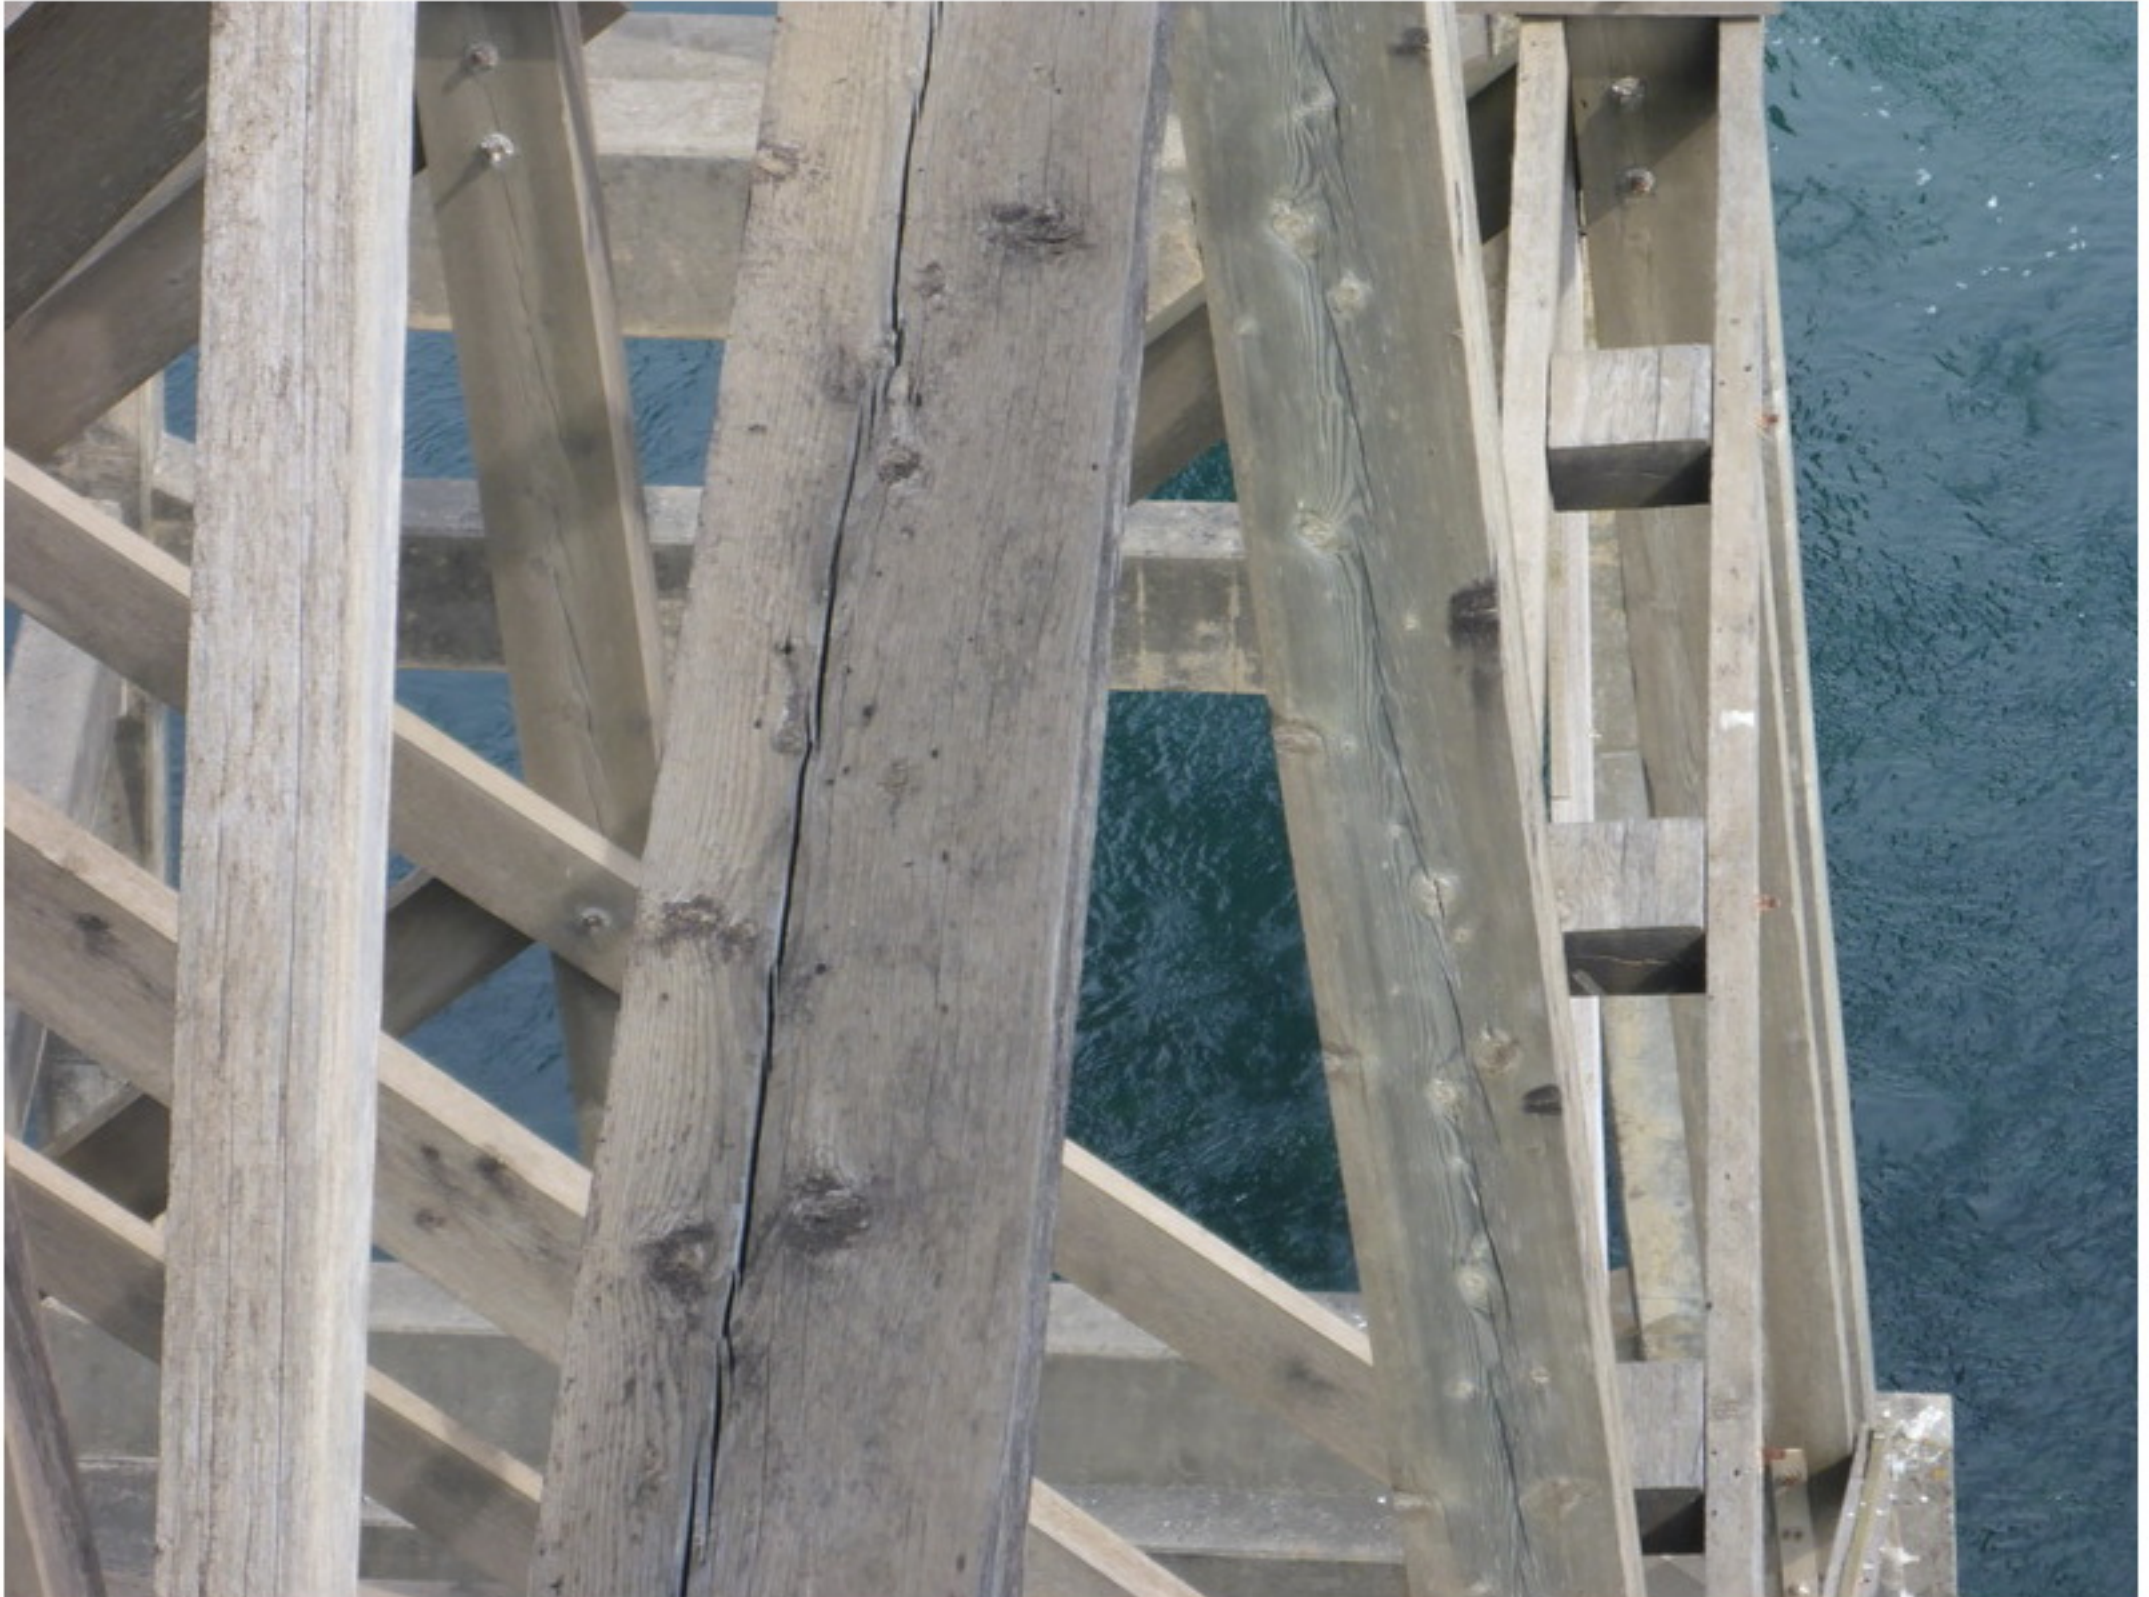
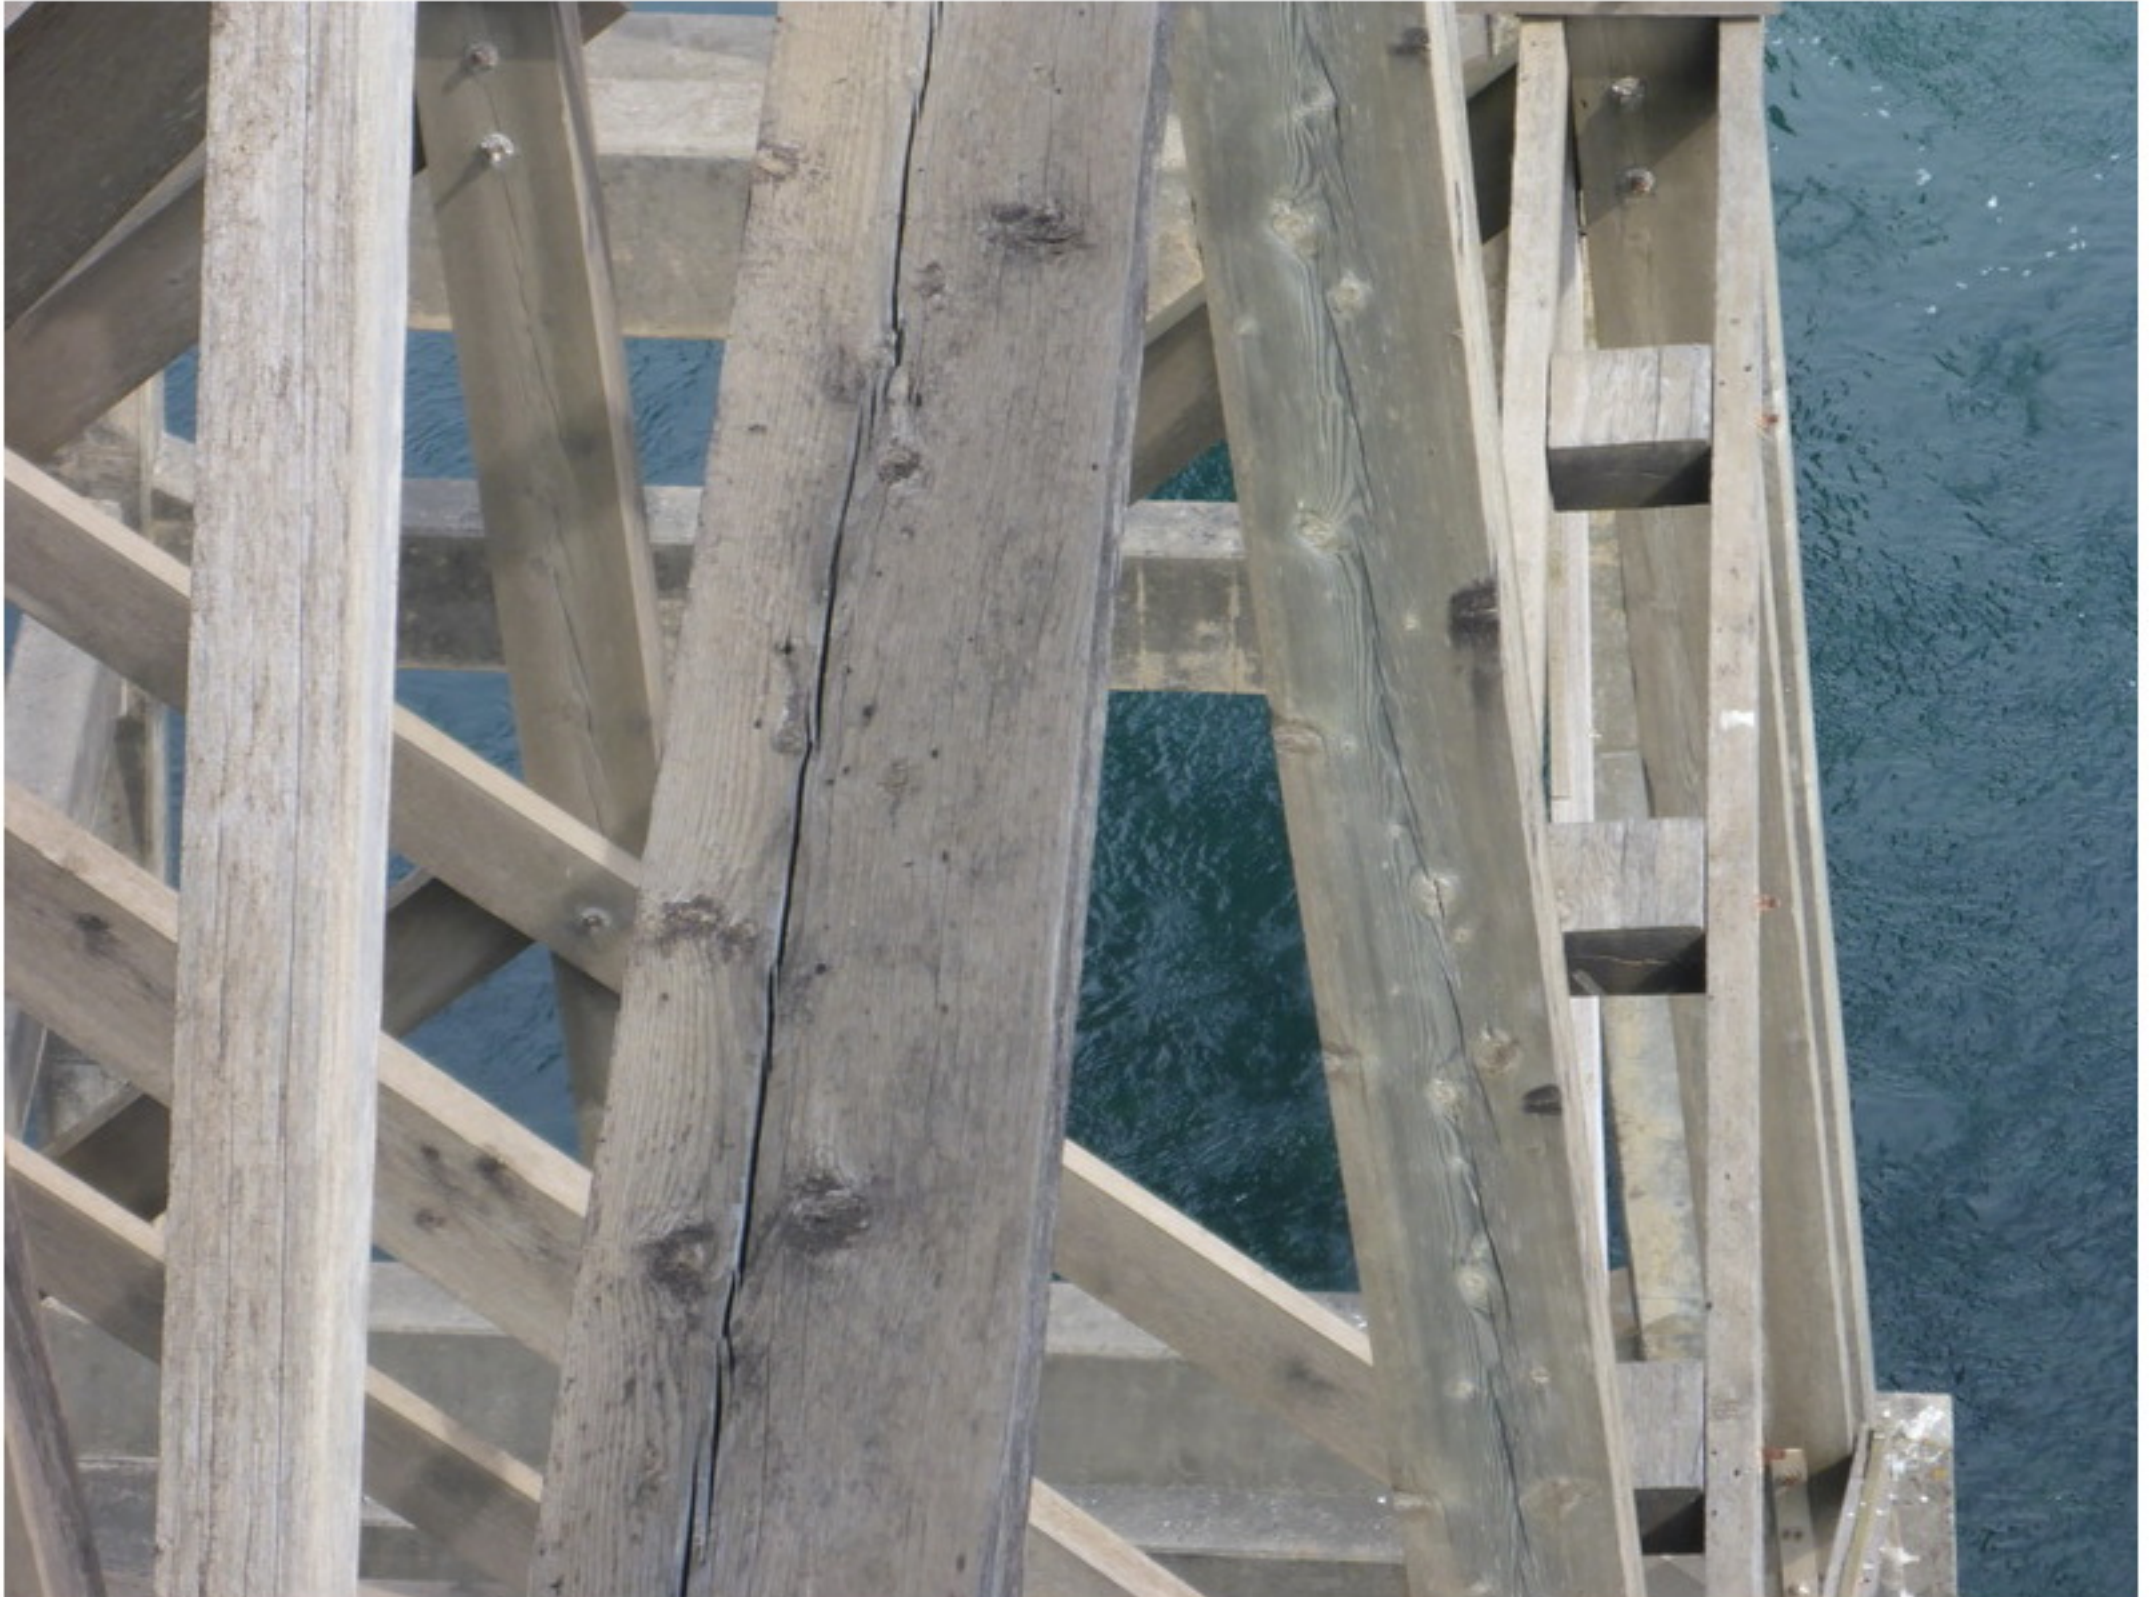
Photo No. 7

Large check present in the fourth horizontal member of Span 8.
