BRIDGE INSPECTION REPORT

Other Inspection

BRIDGE NO.:
10 0136

STRUCTURE NAME:
ALBION RIVER

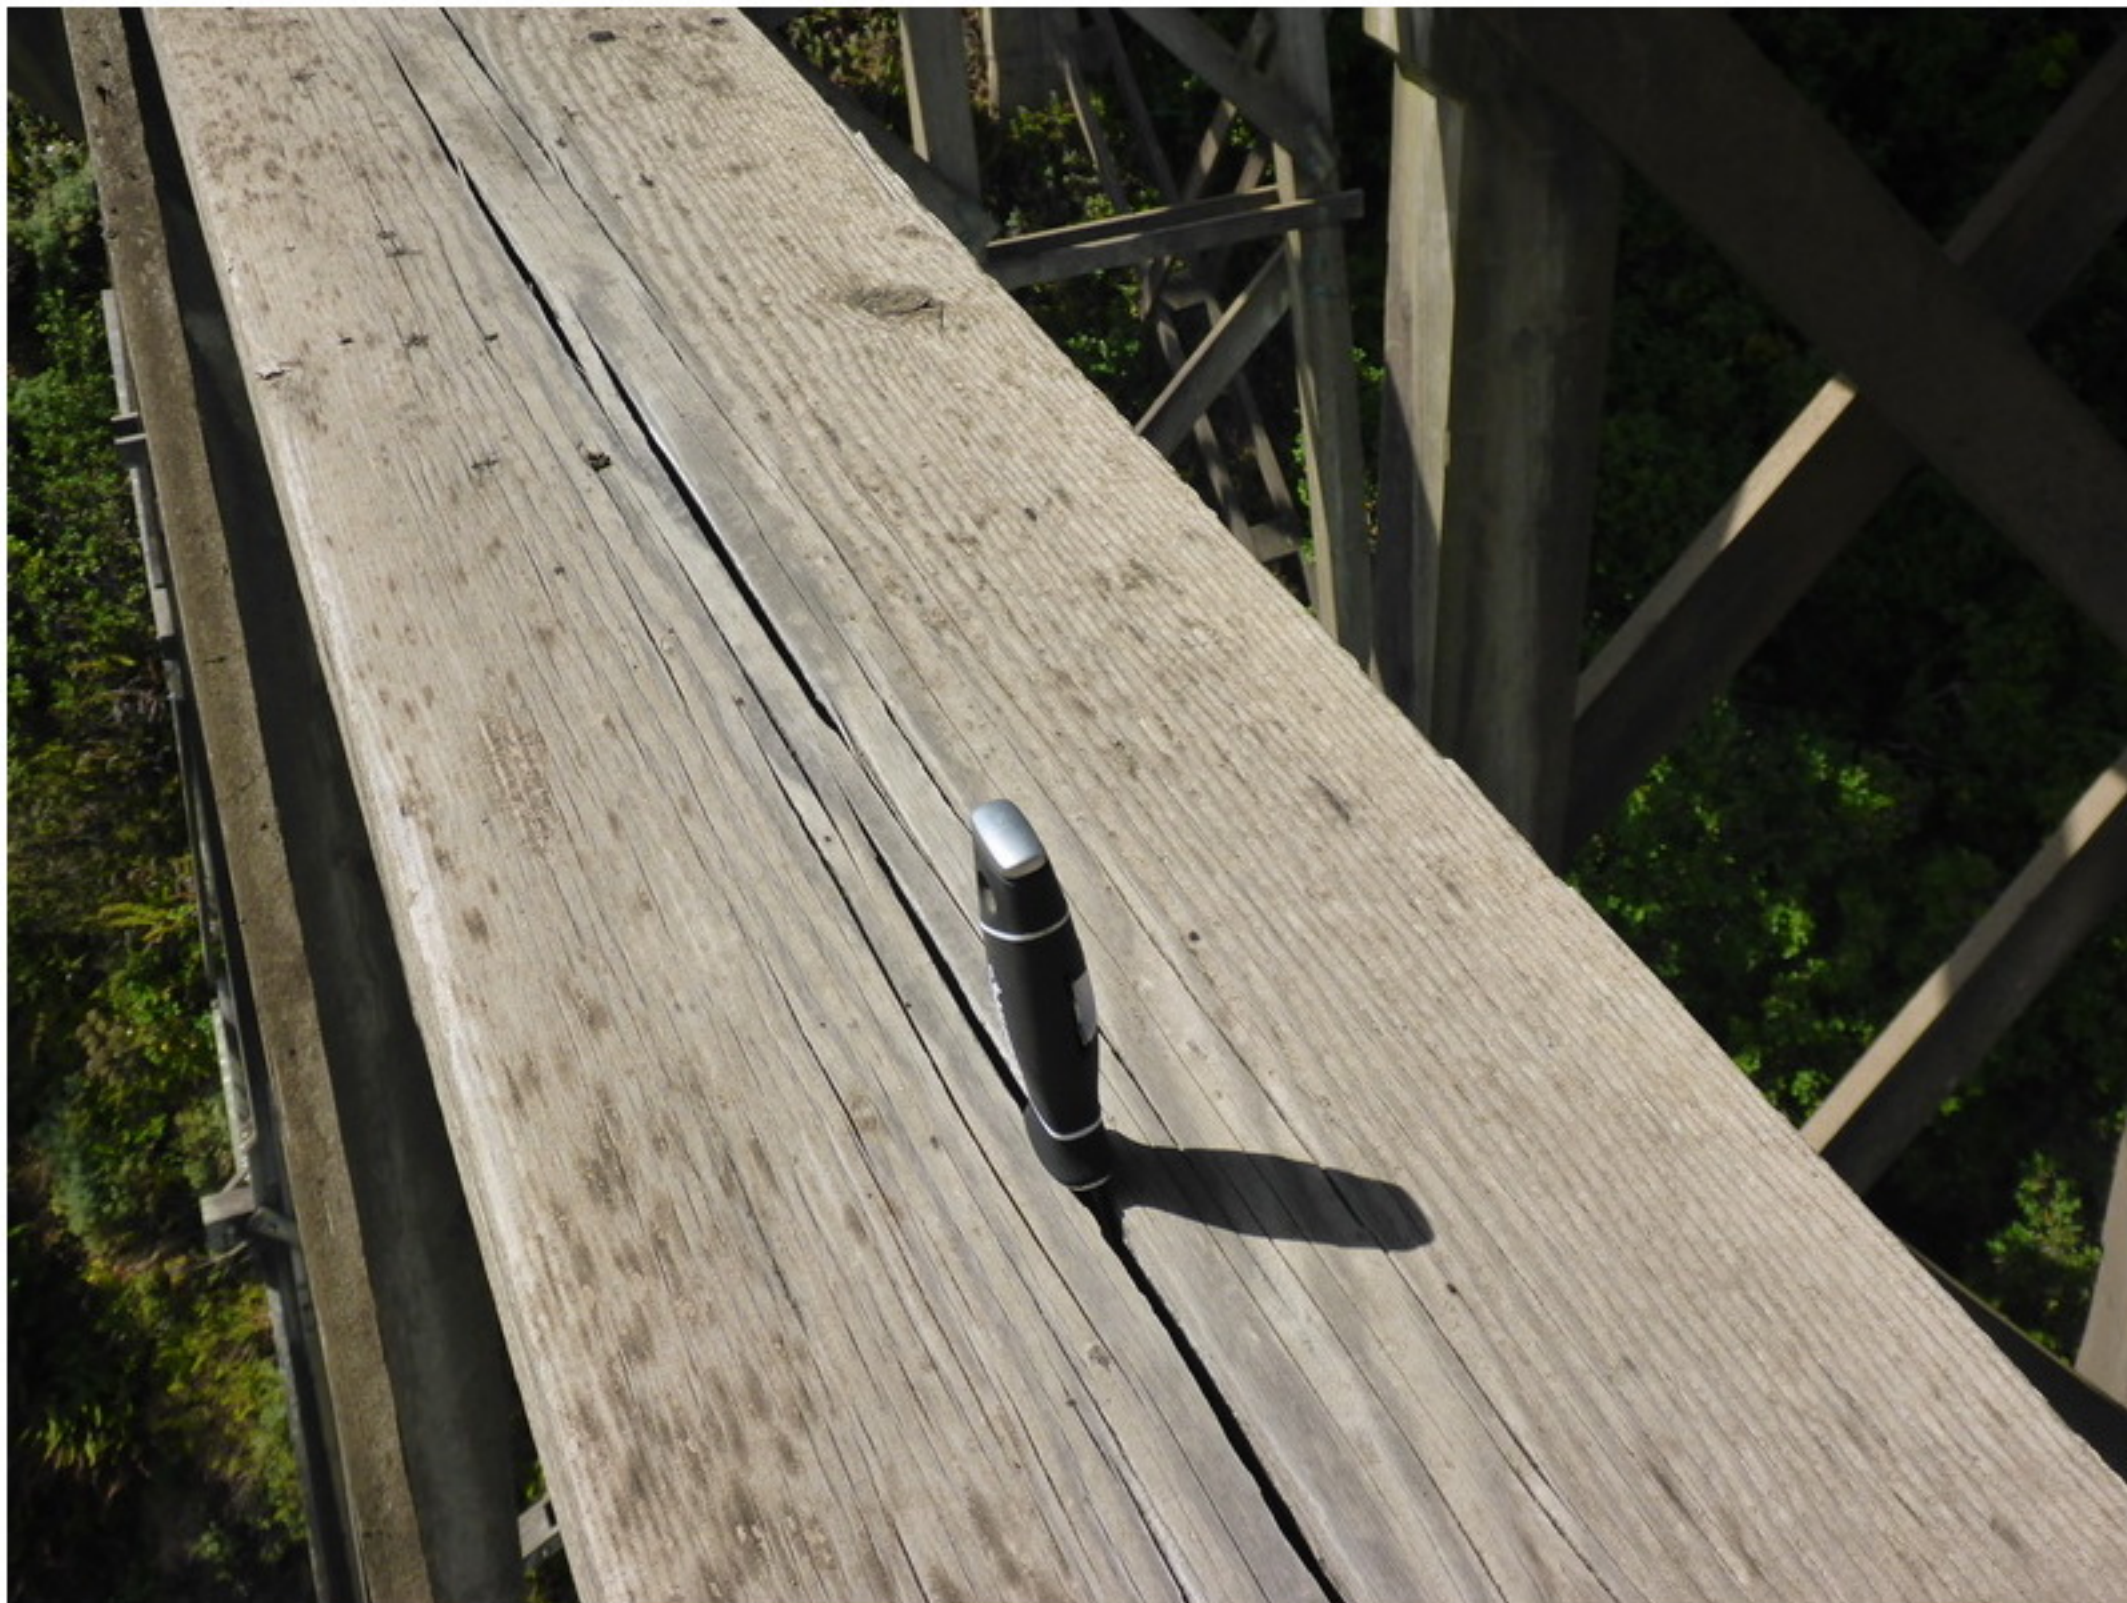
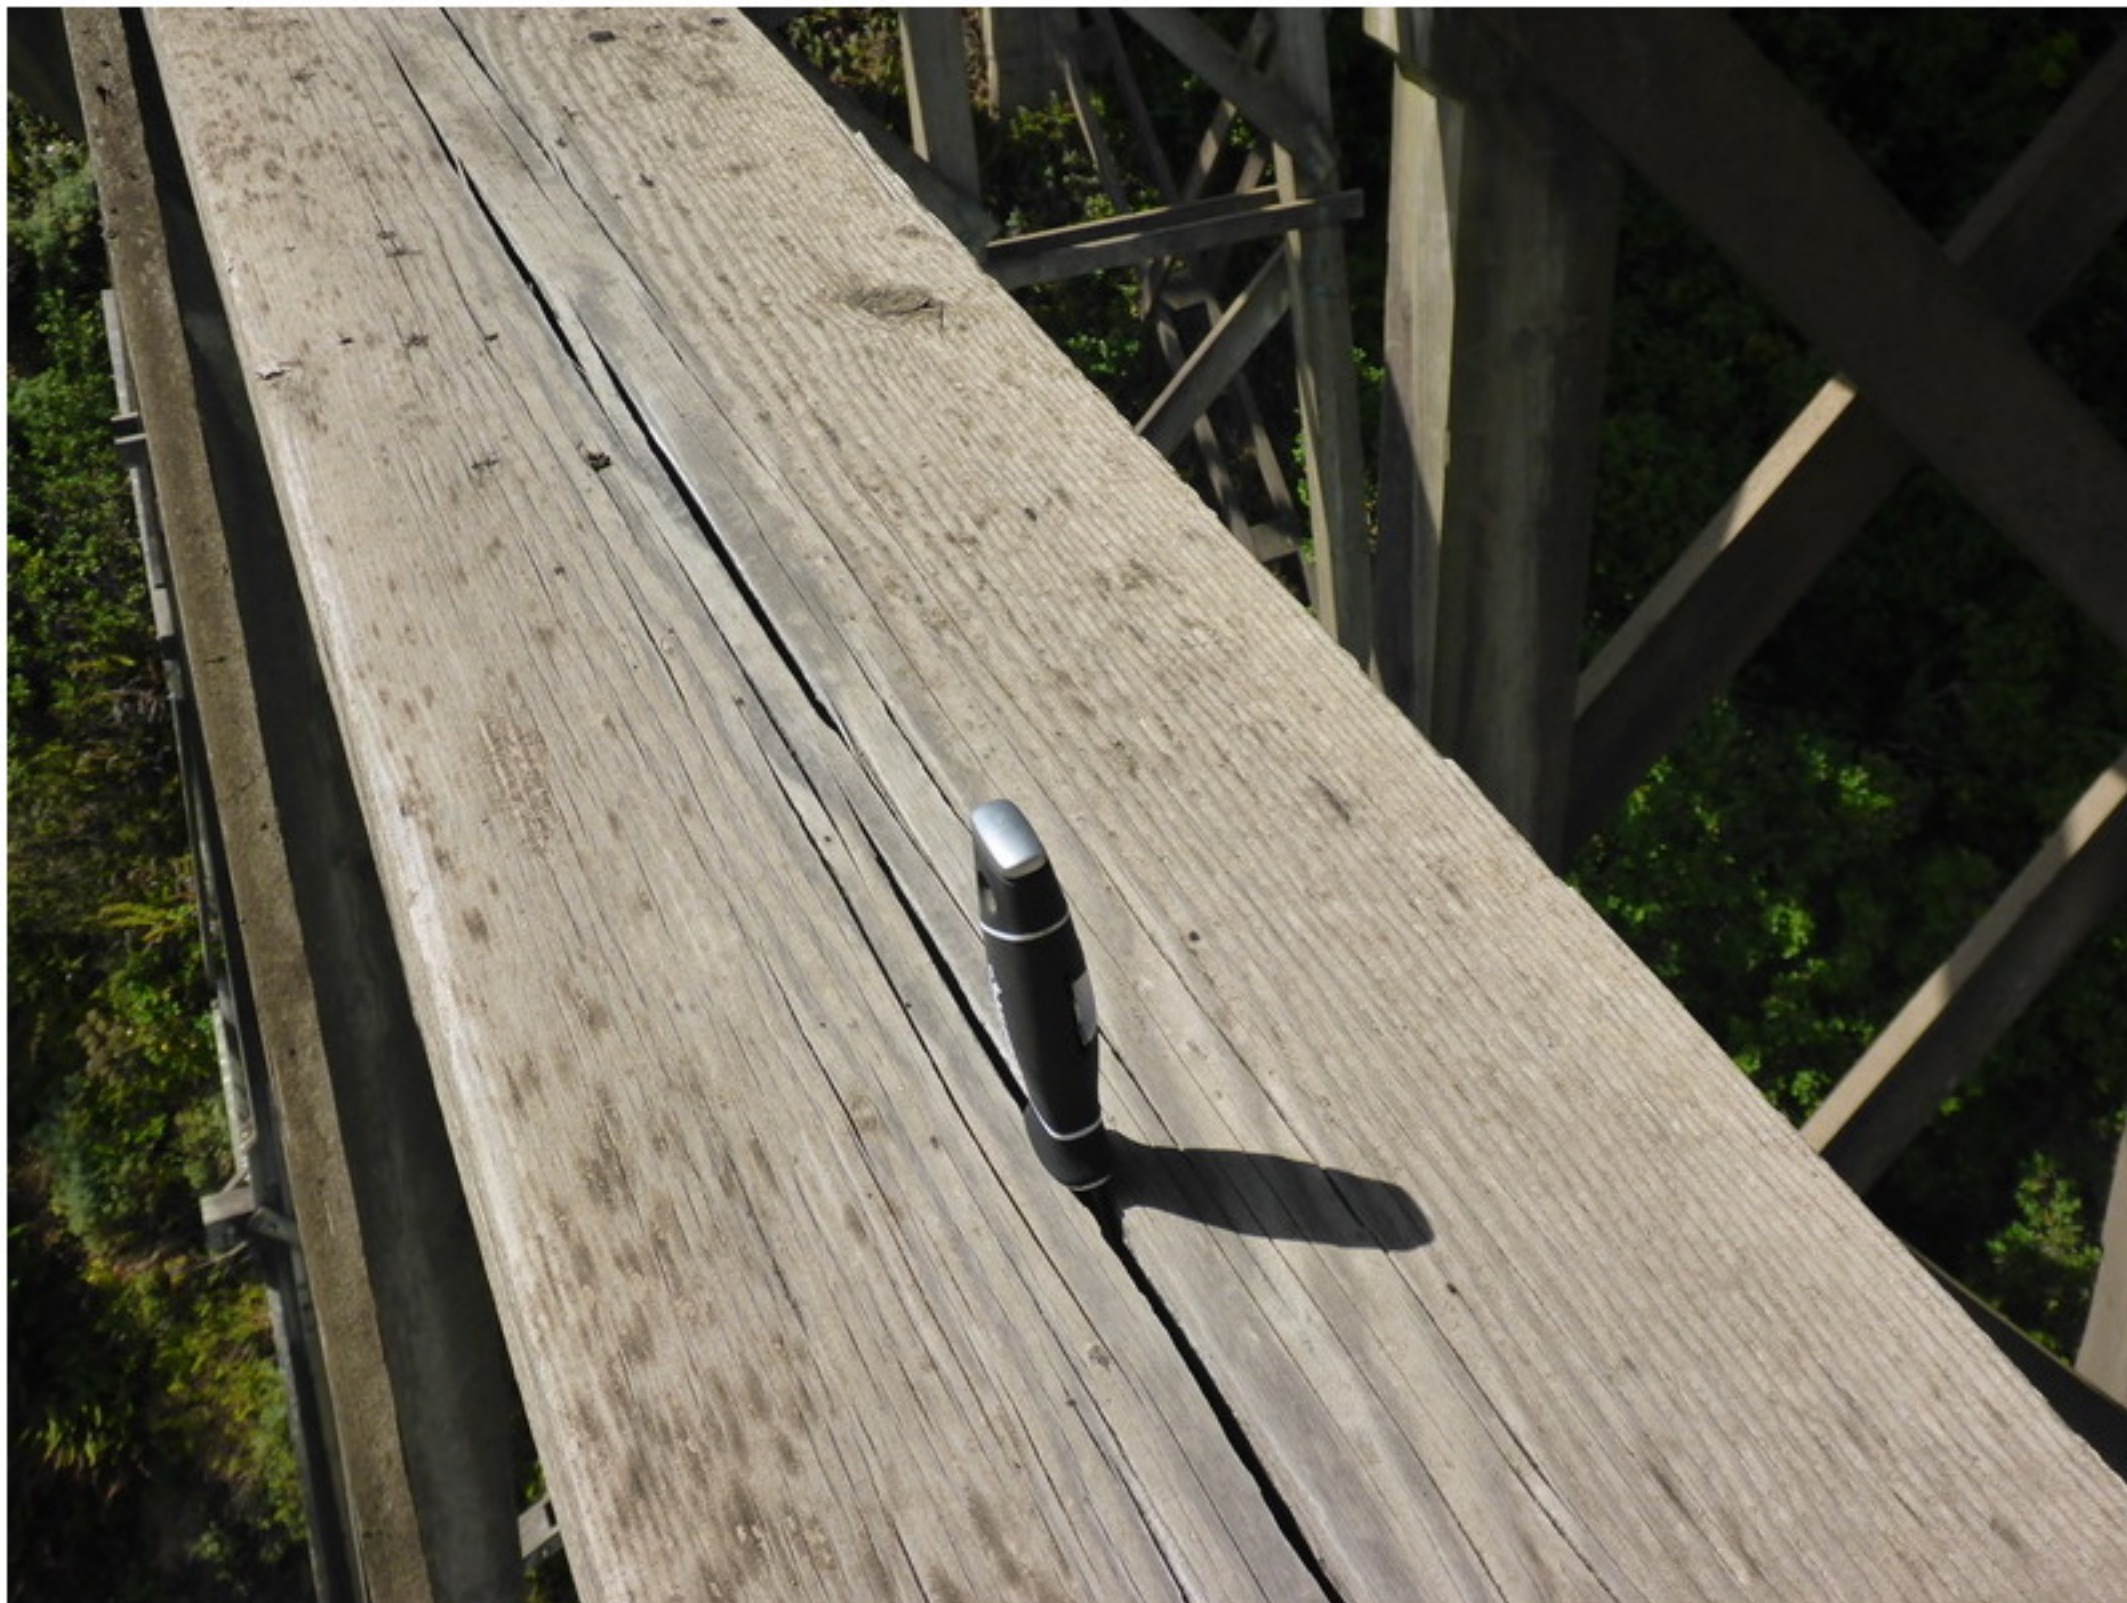
Photo No. 8

Large check along the fourth horizontal of the timber truss in Span 11.

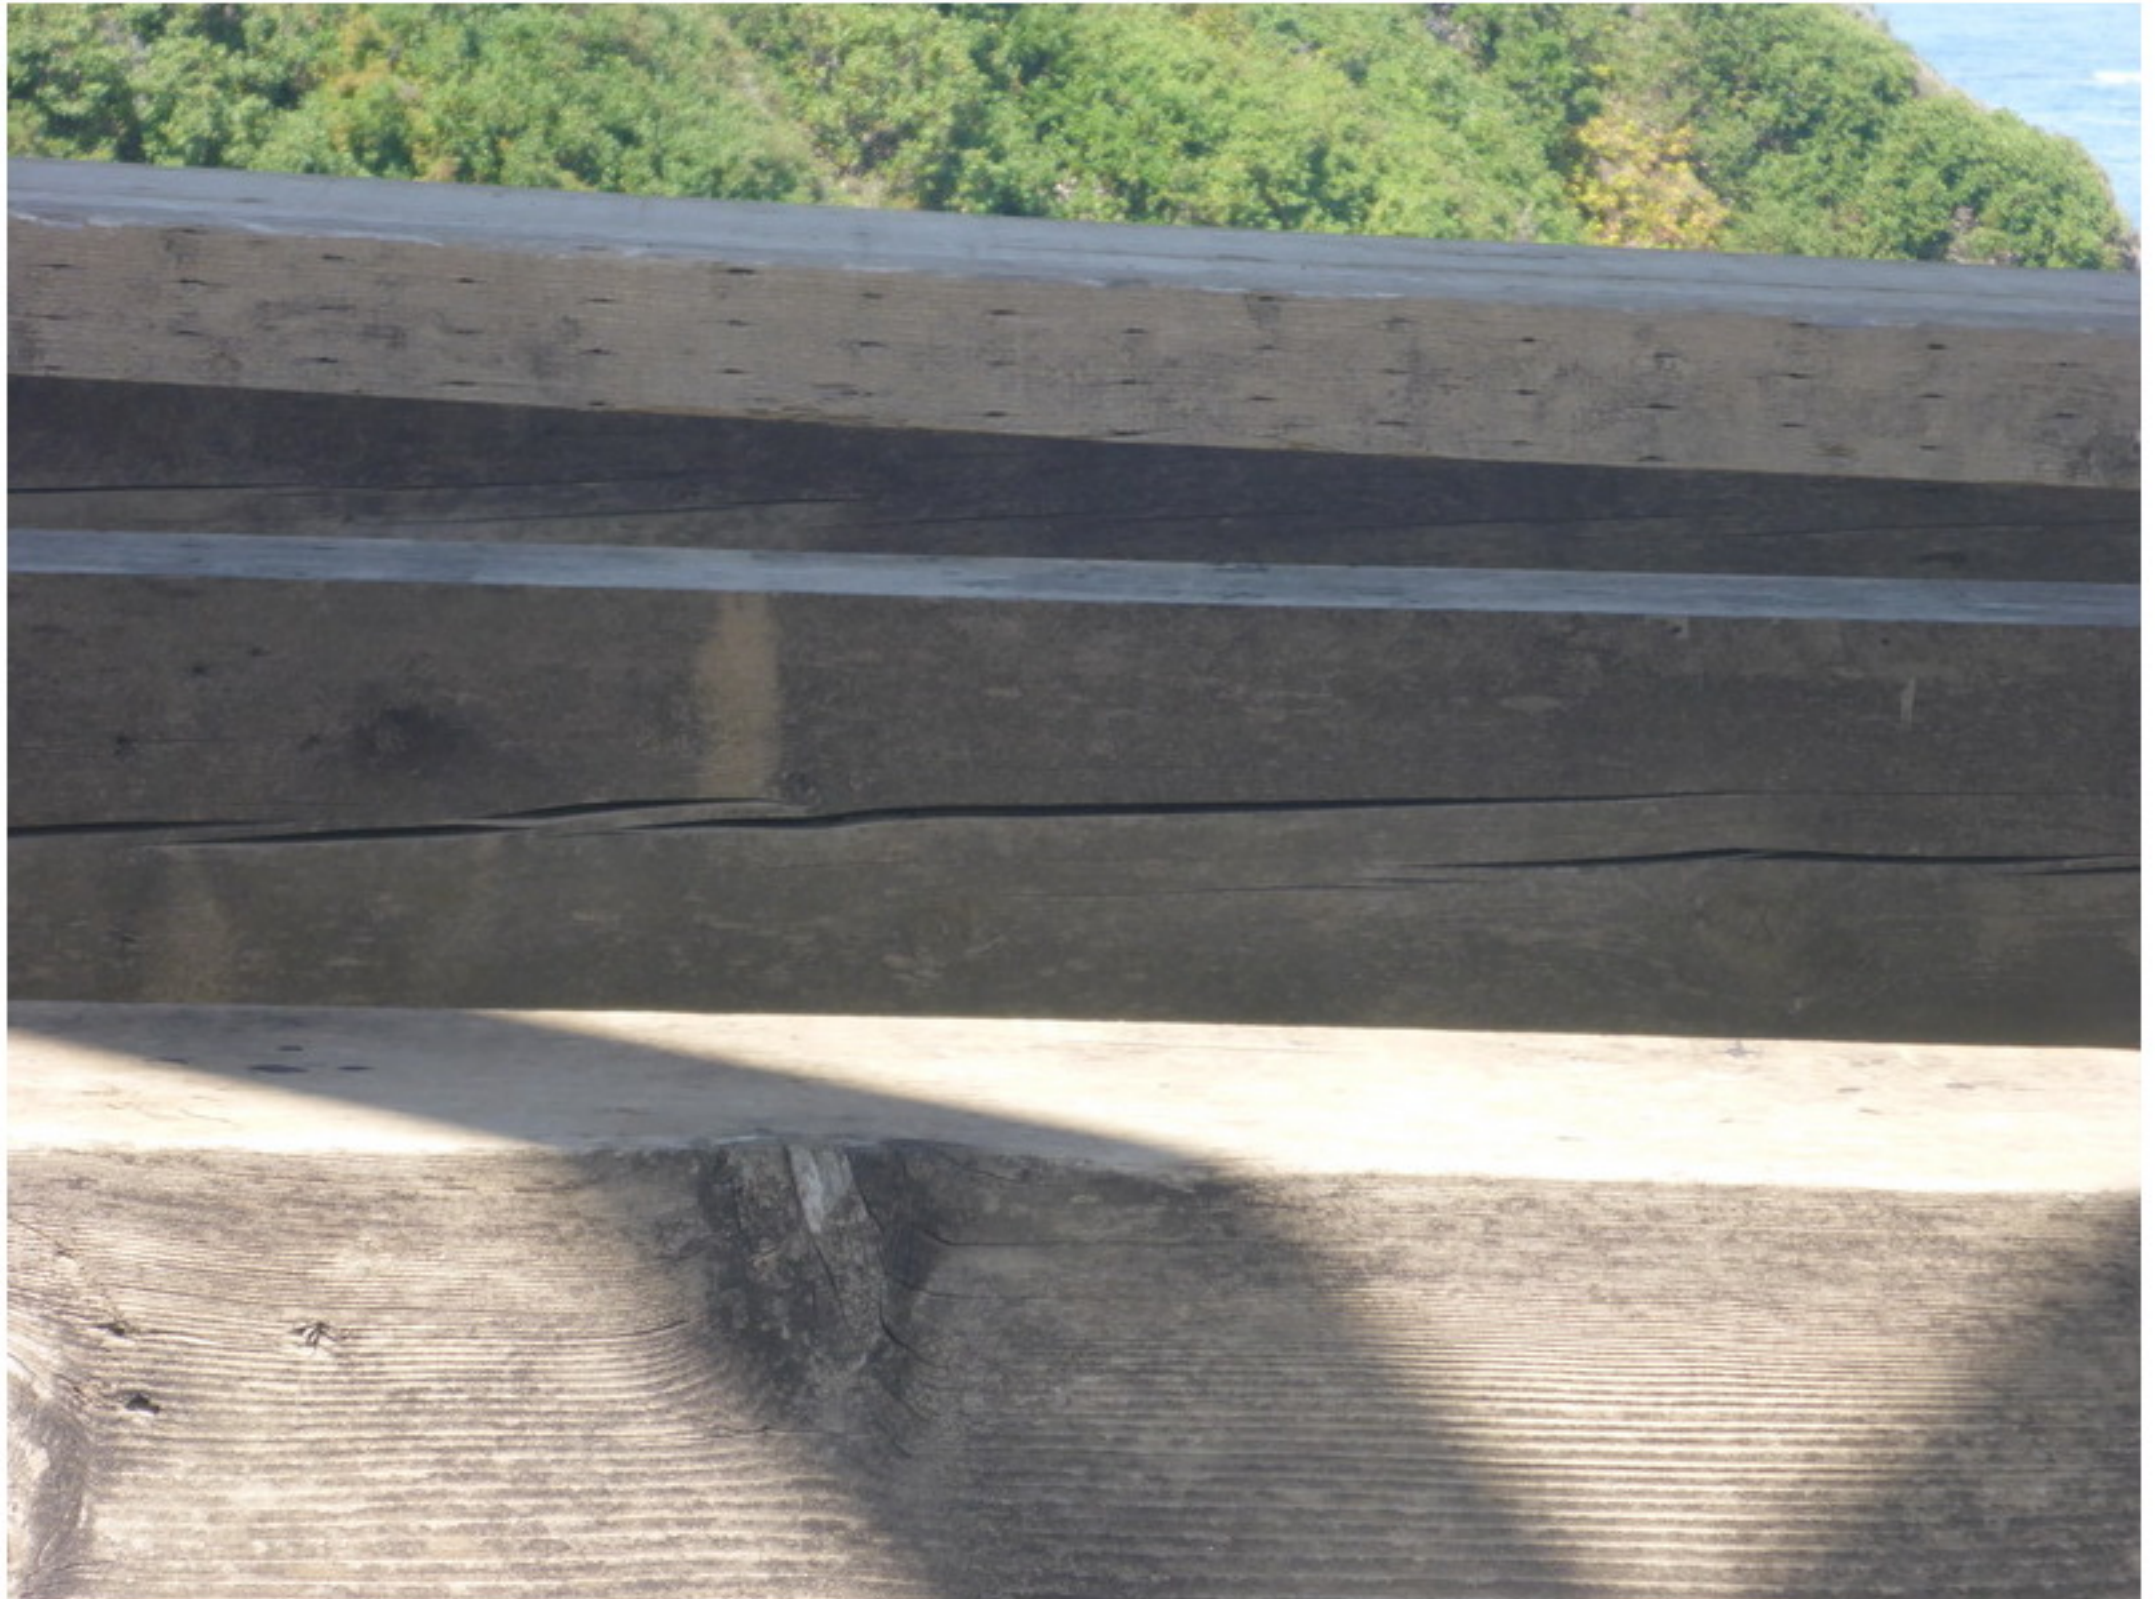
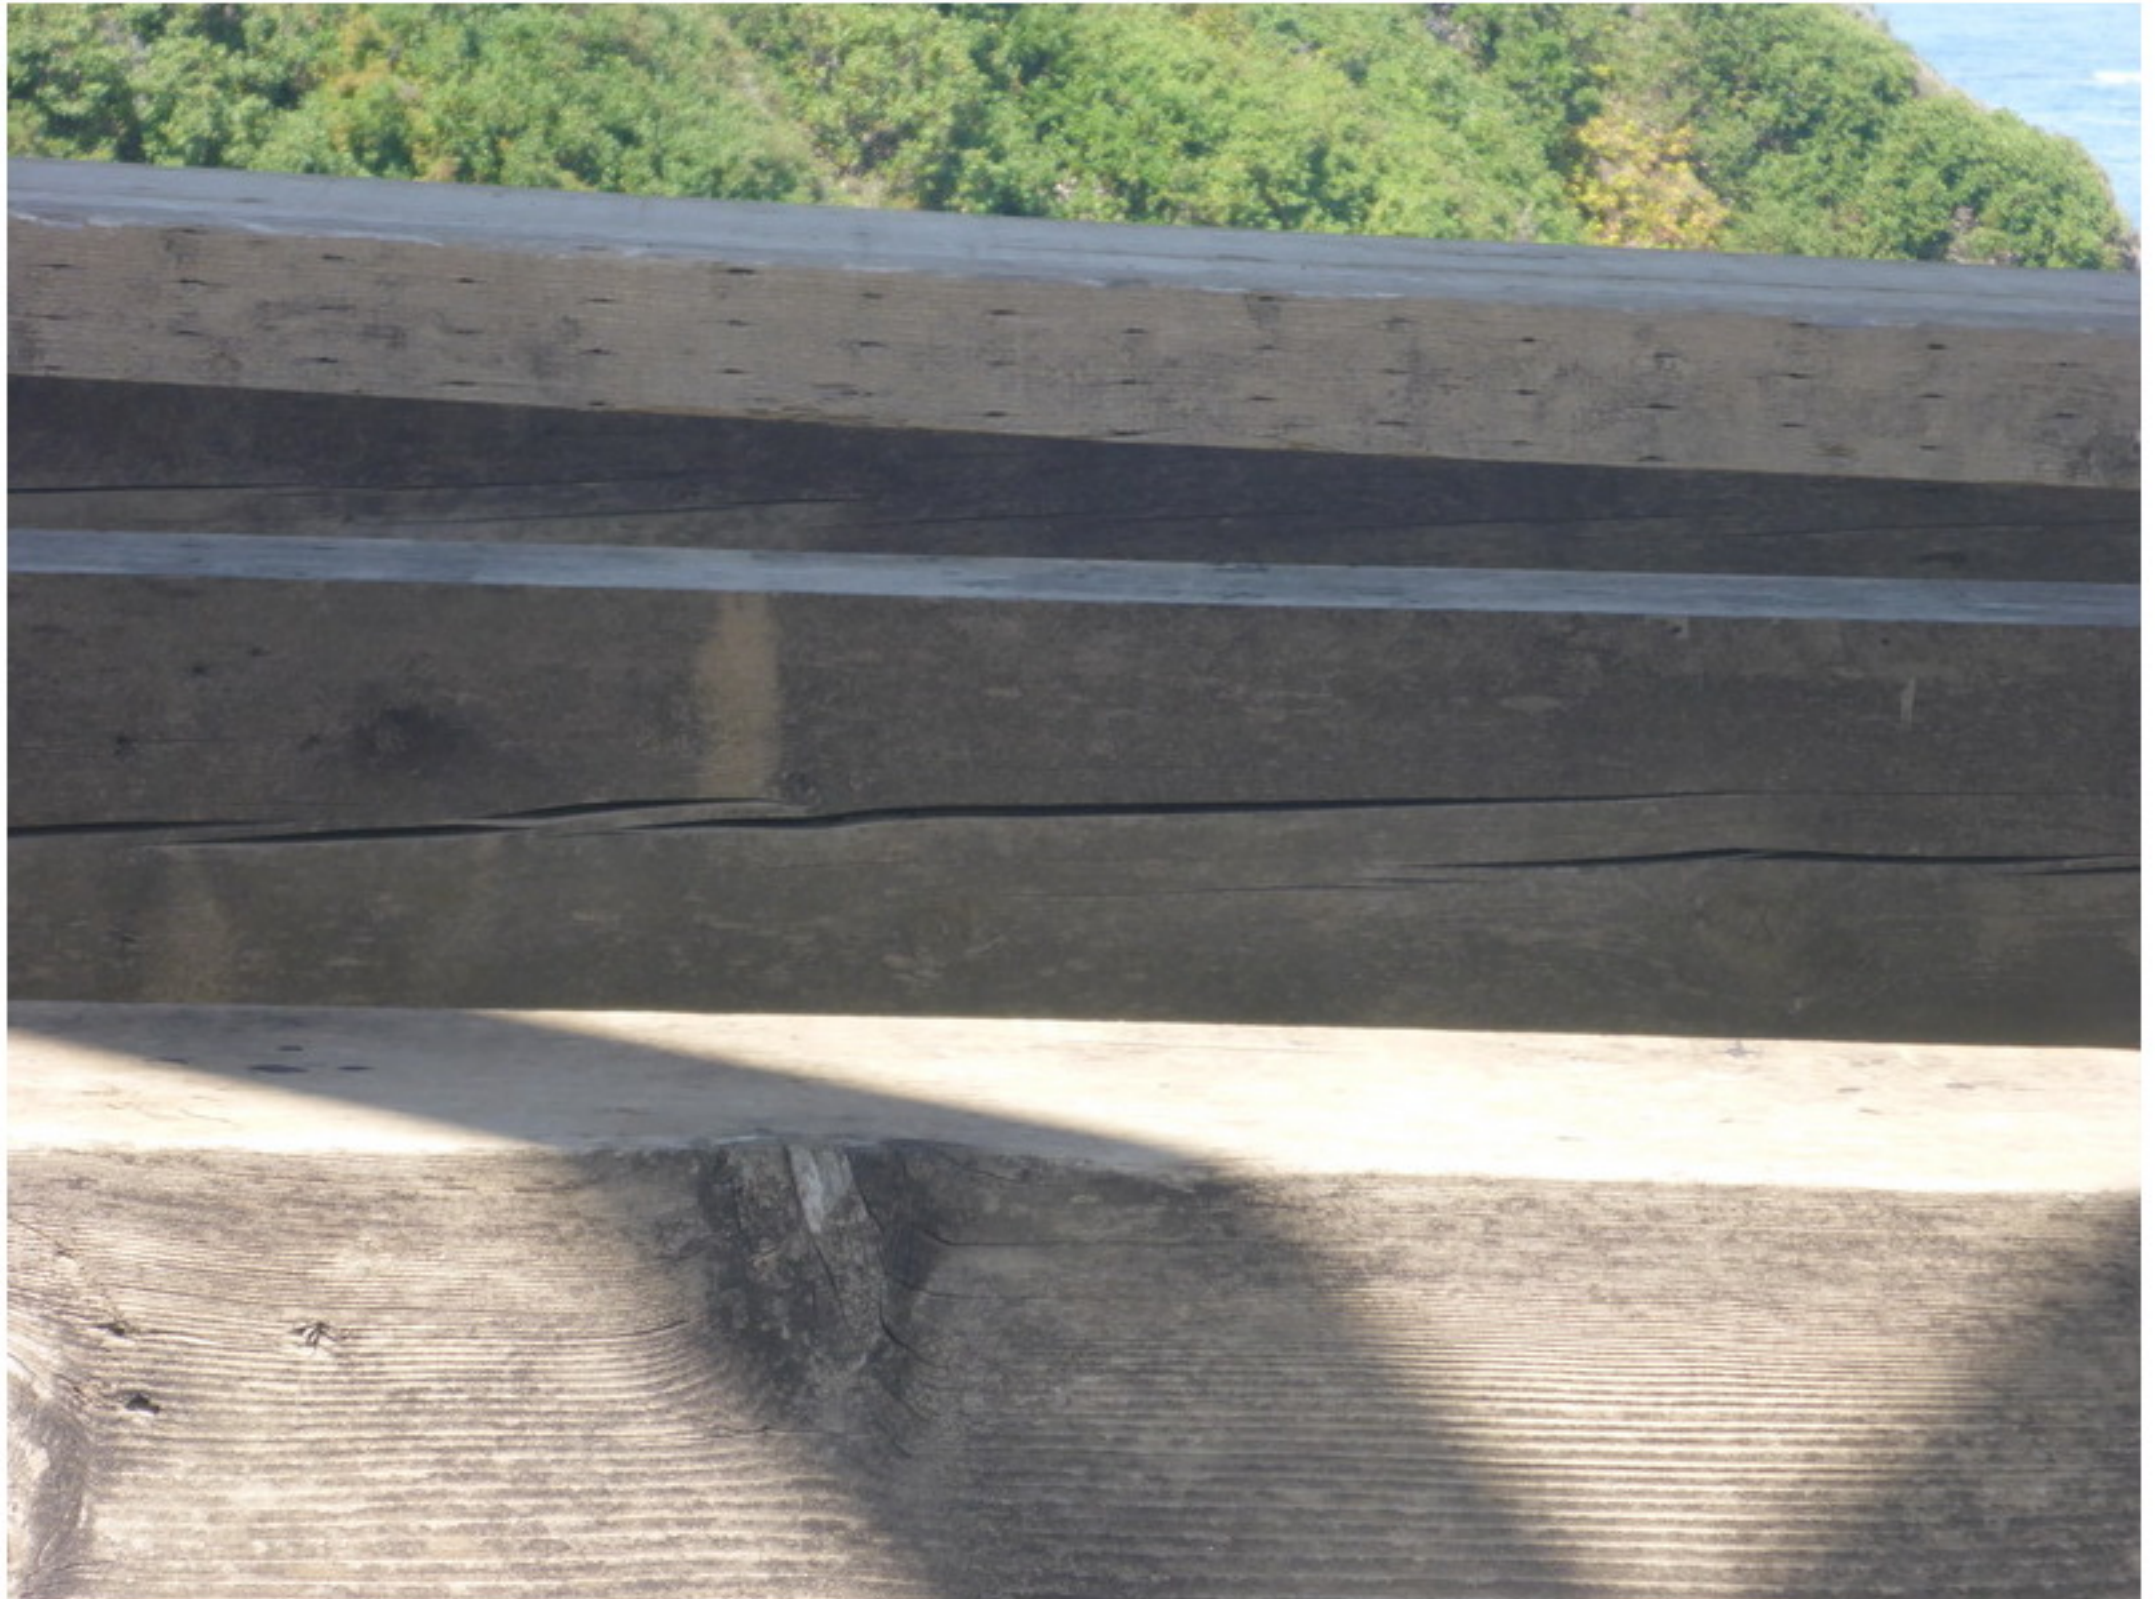
Photo No. 9

Check along the second horizontal of the timber truss in Span 13.

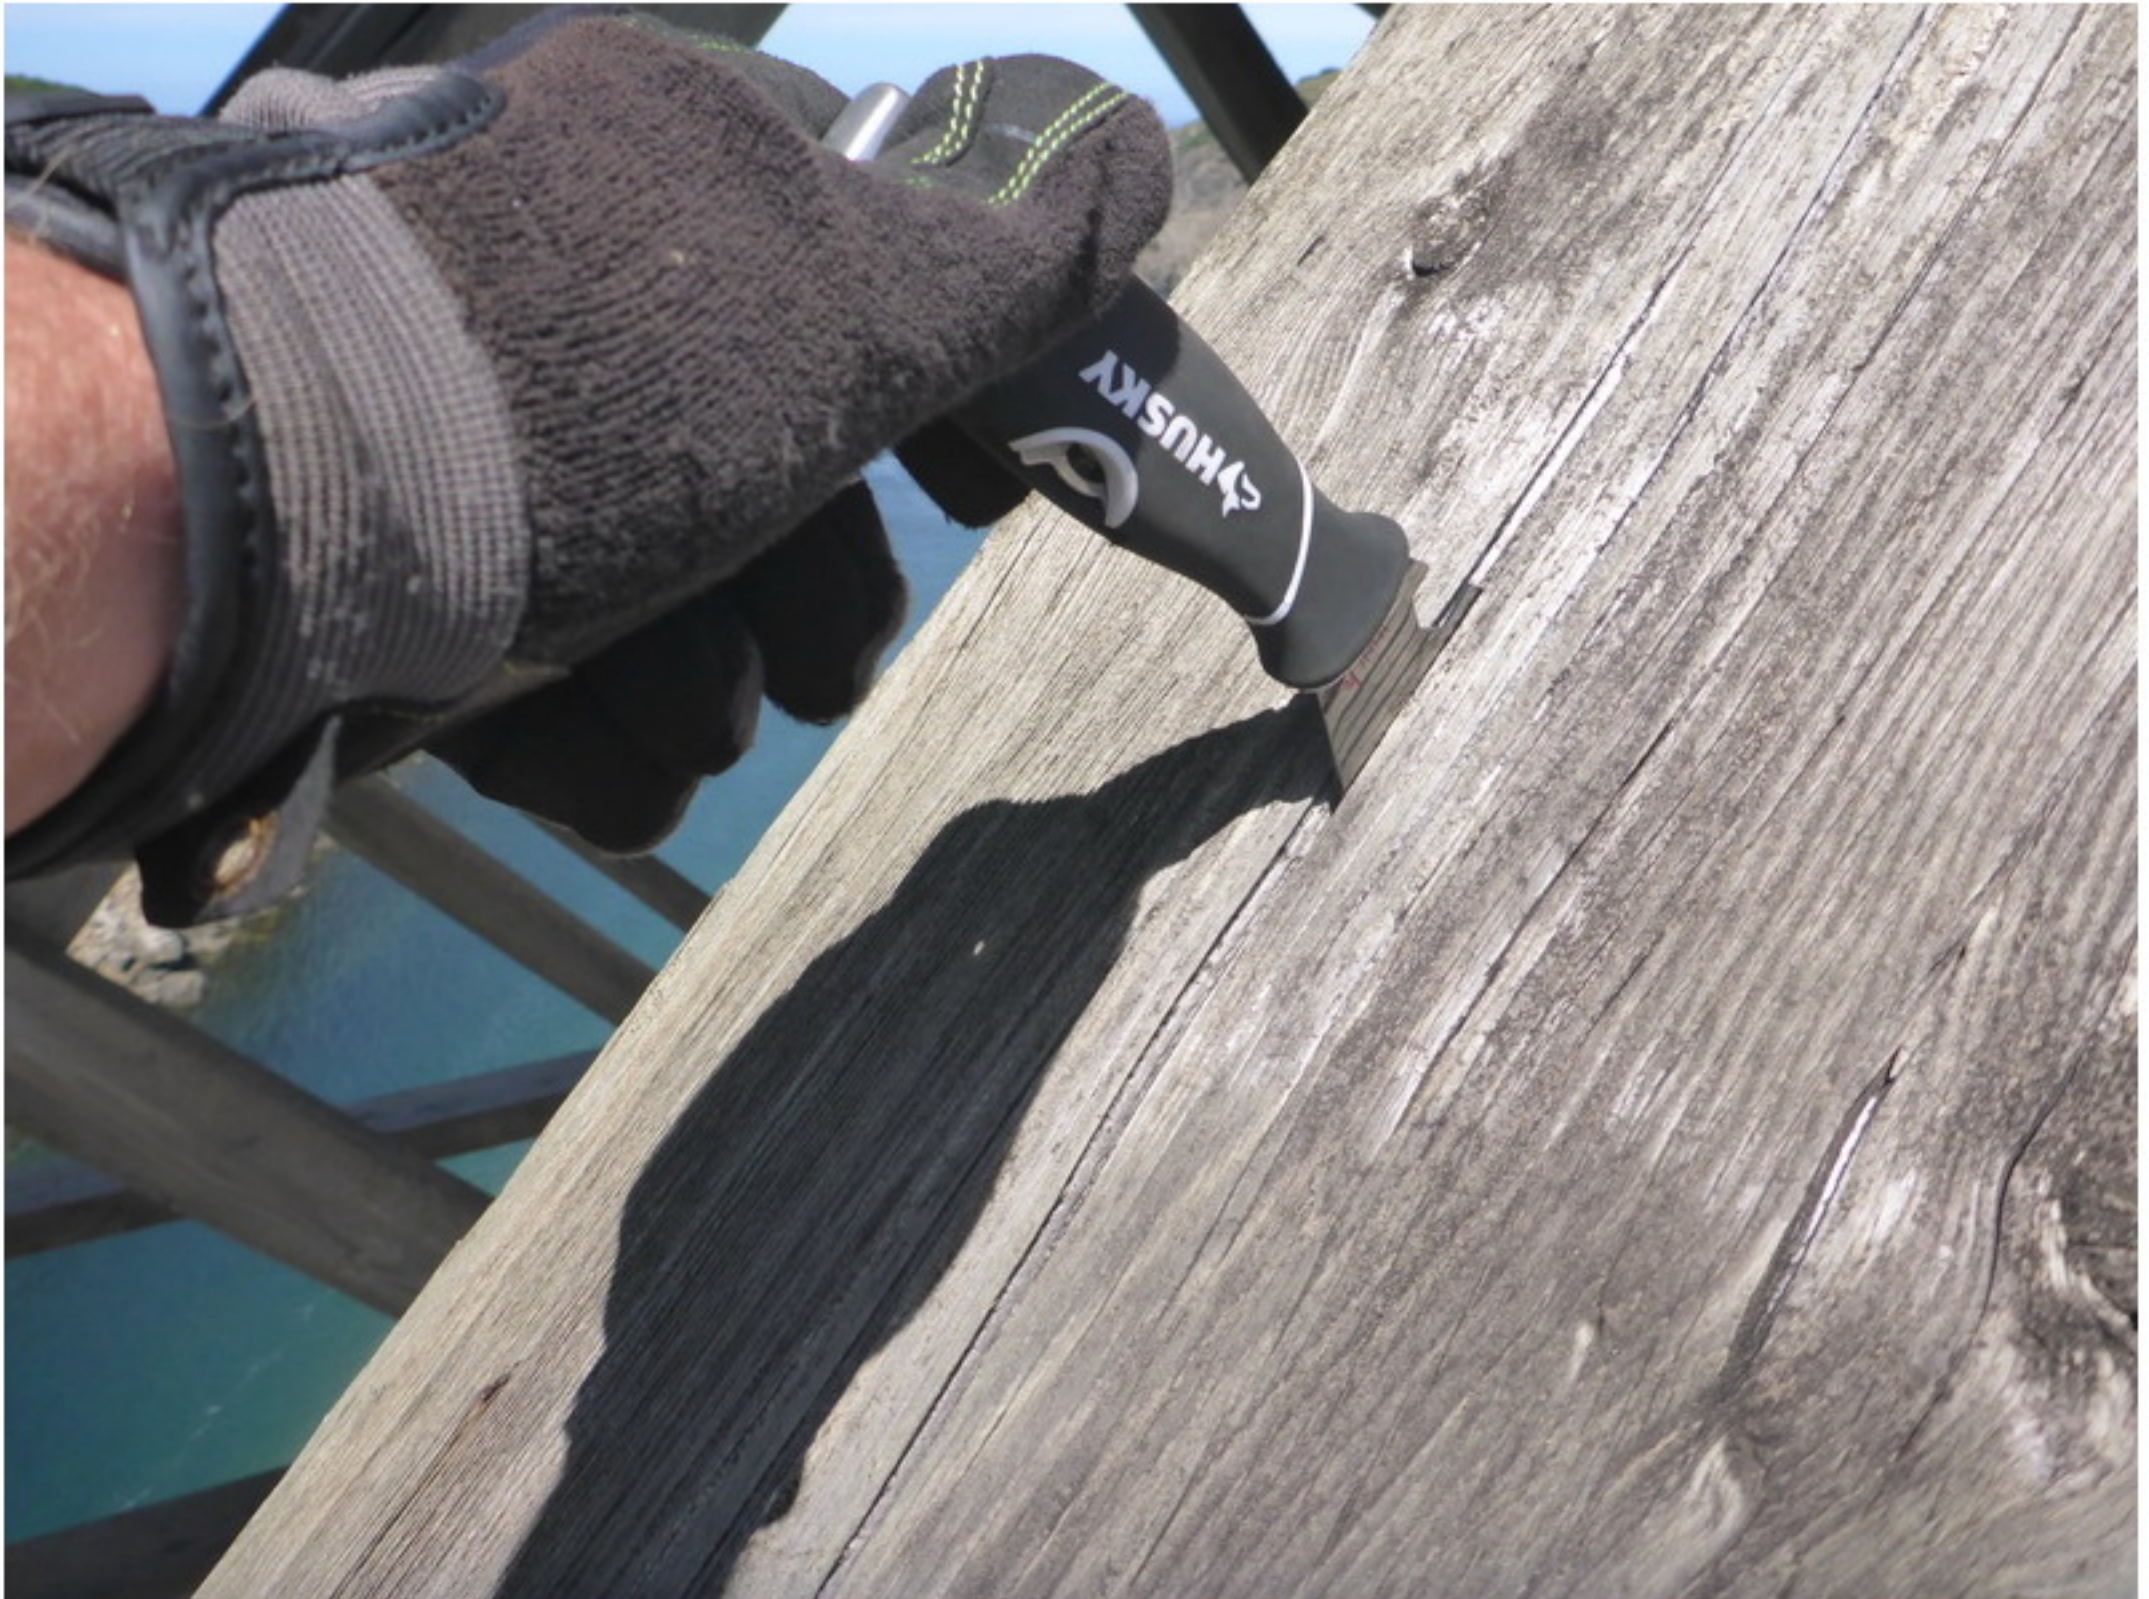
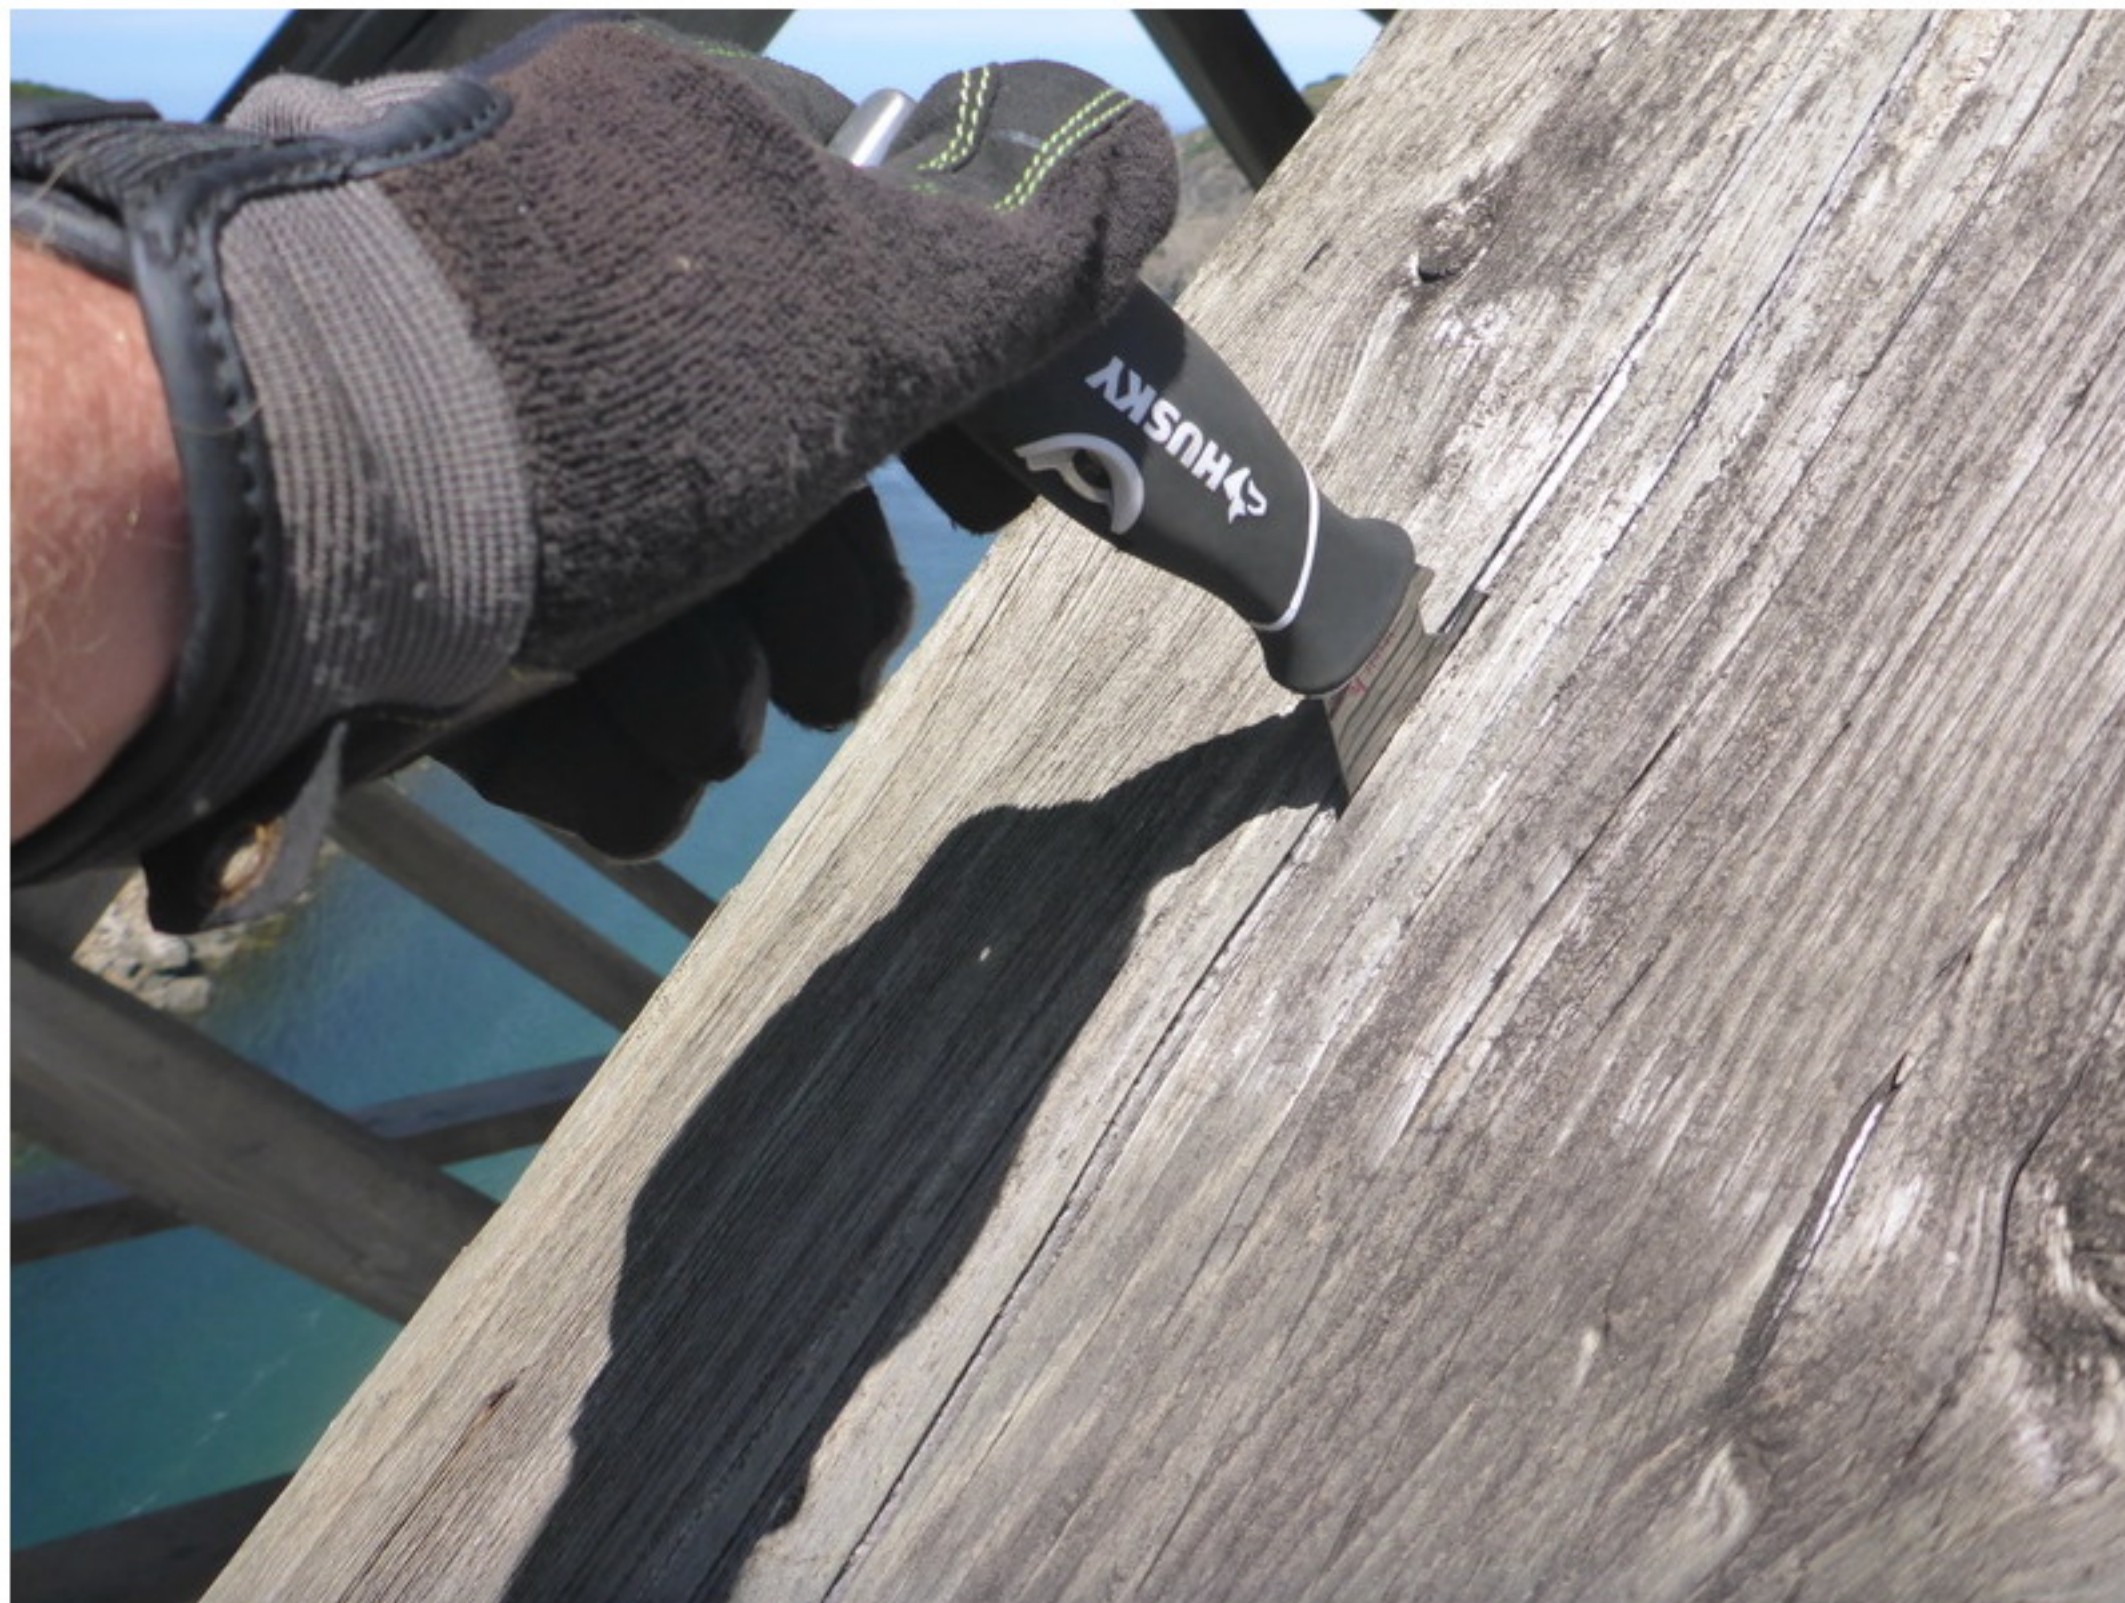
Photo No. 10

Large check along the fourth upper diagonal of the timber truss in Span 14.
