BRIDGE INSPECTION REPORT

Other Inspection

BRIDGE NO.:
10 0136

STRUCTURE NAME:
ALBION RIVER

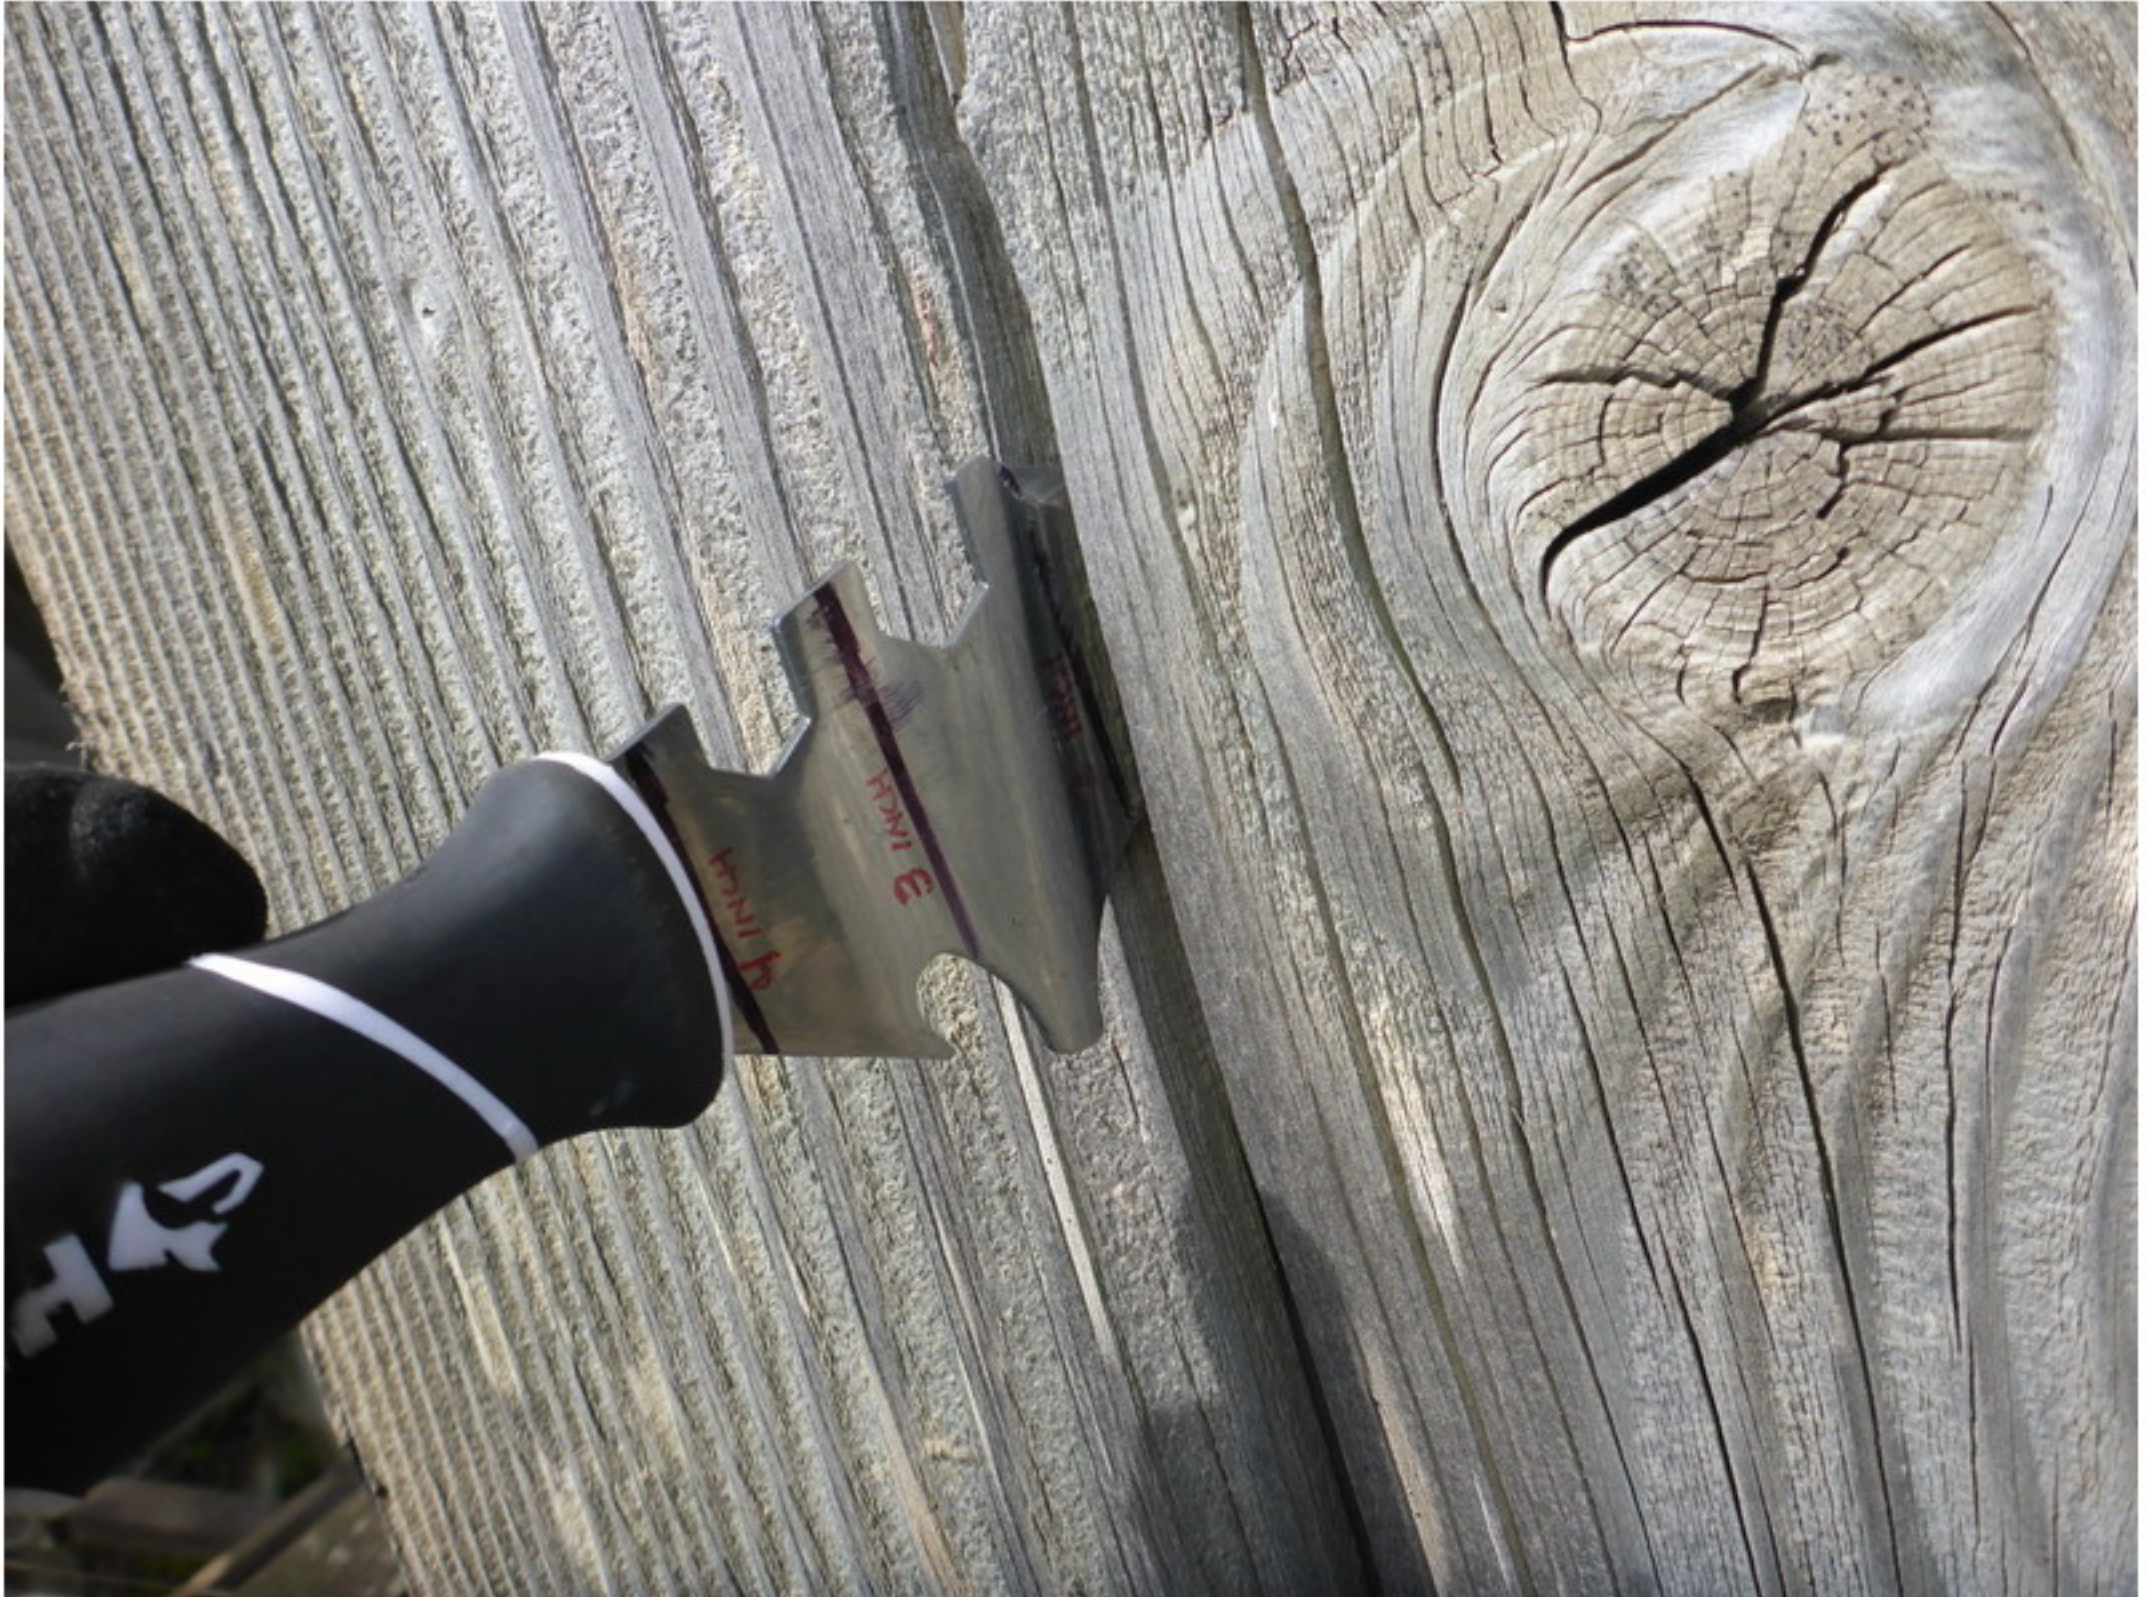
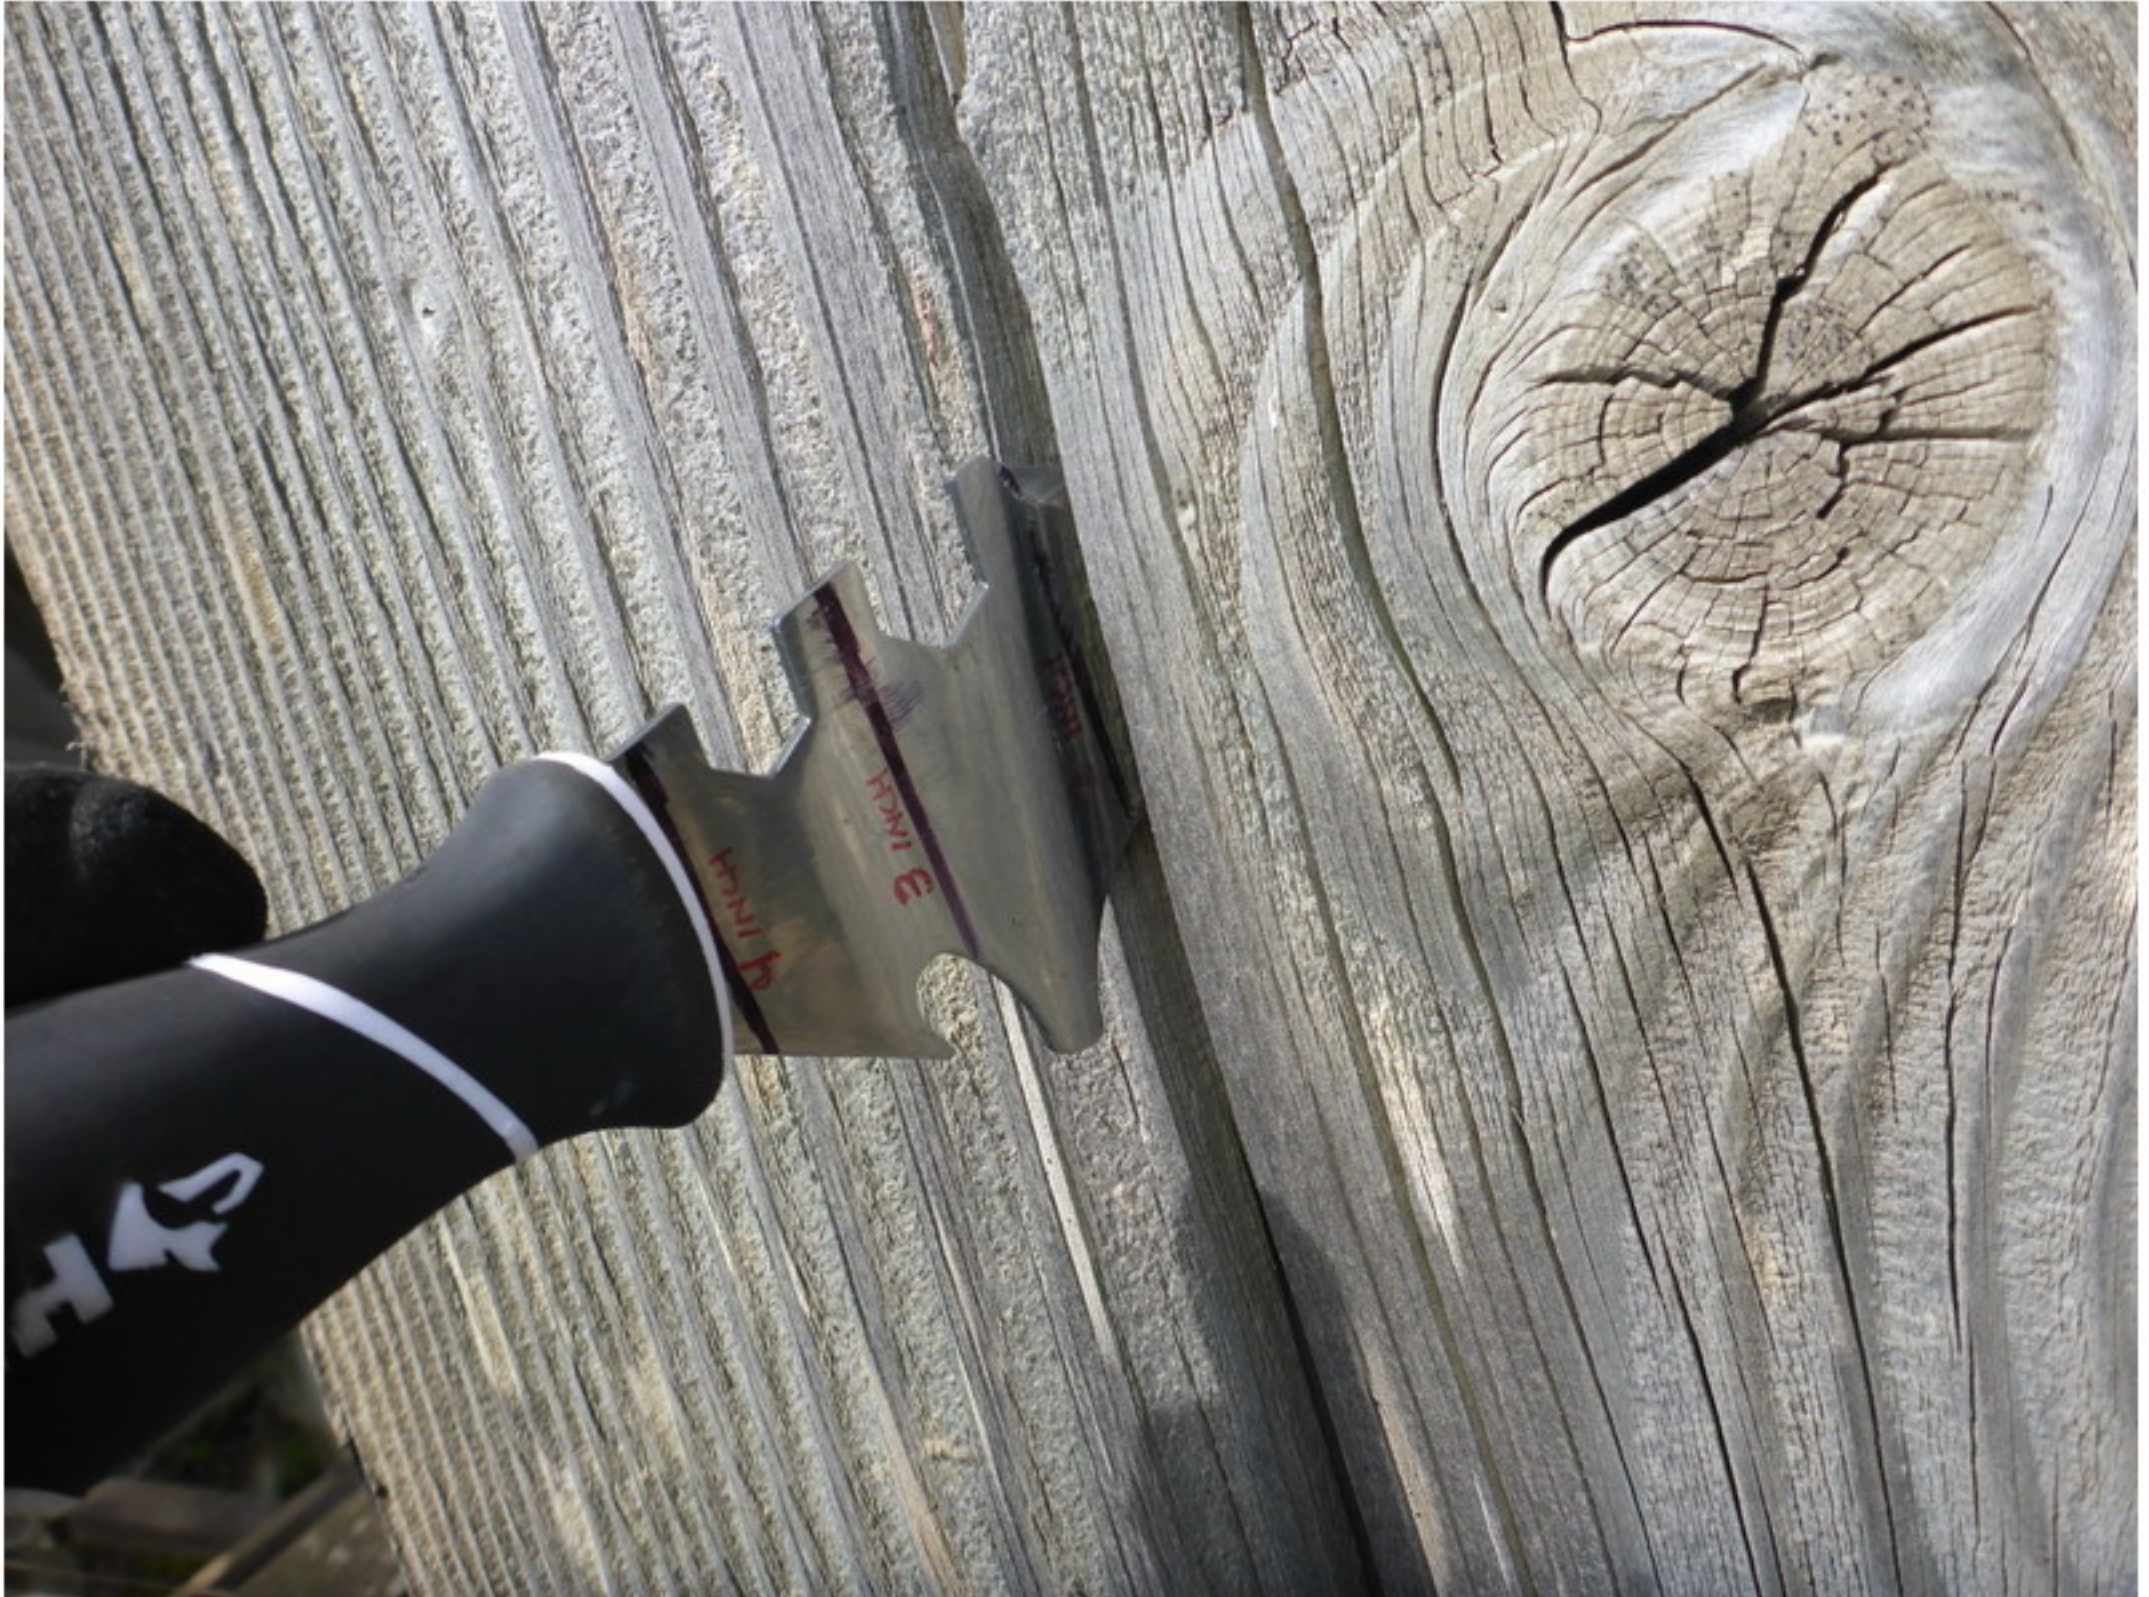
Photo No. 11
Large check along the fourth column of Bent 9.

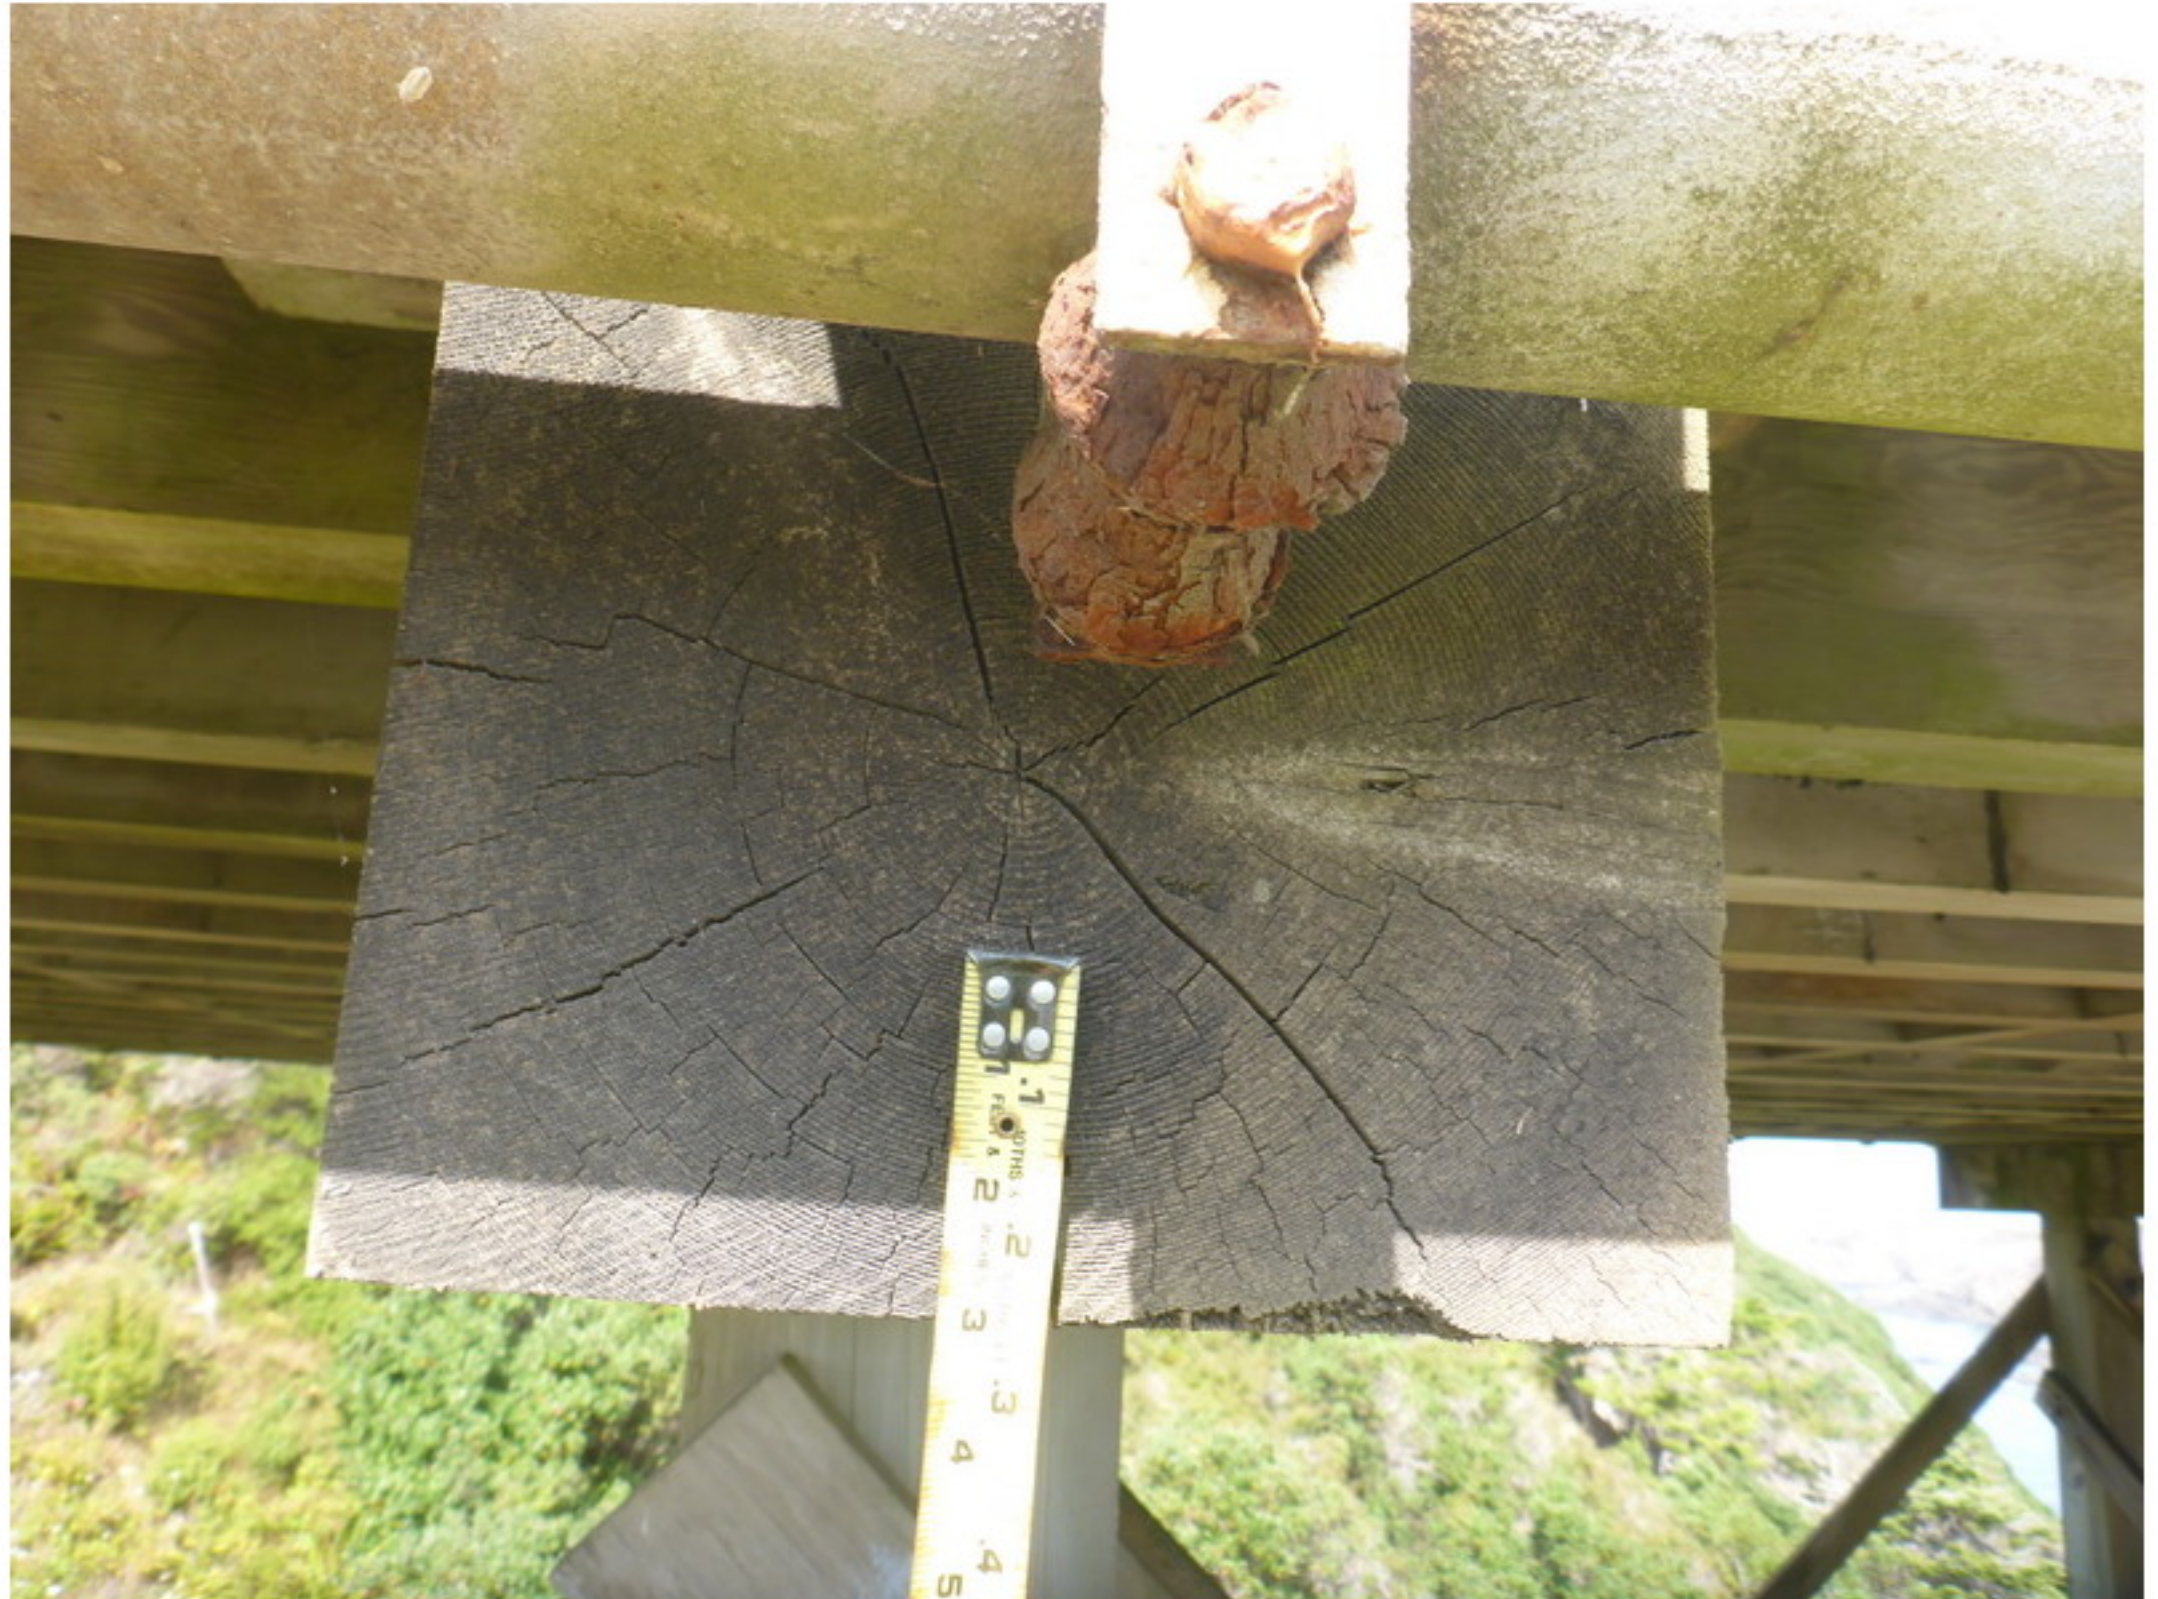
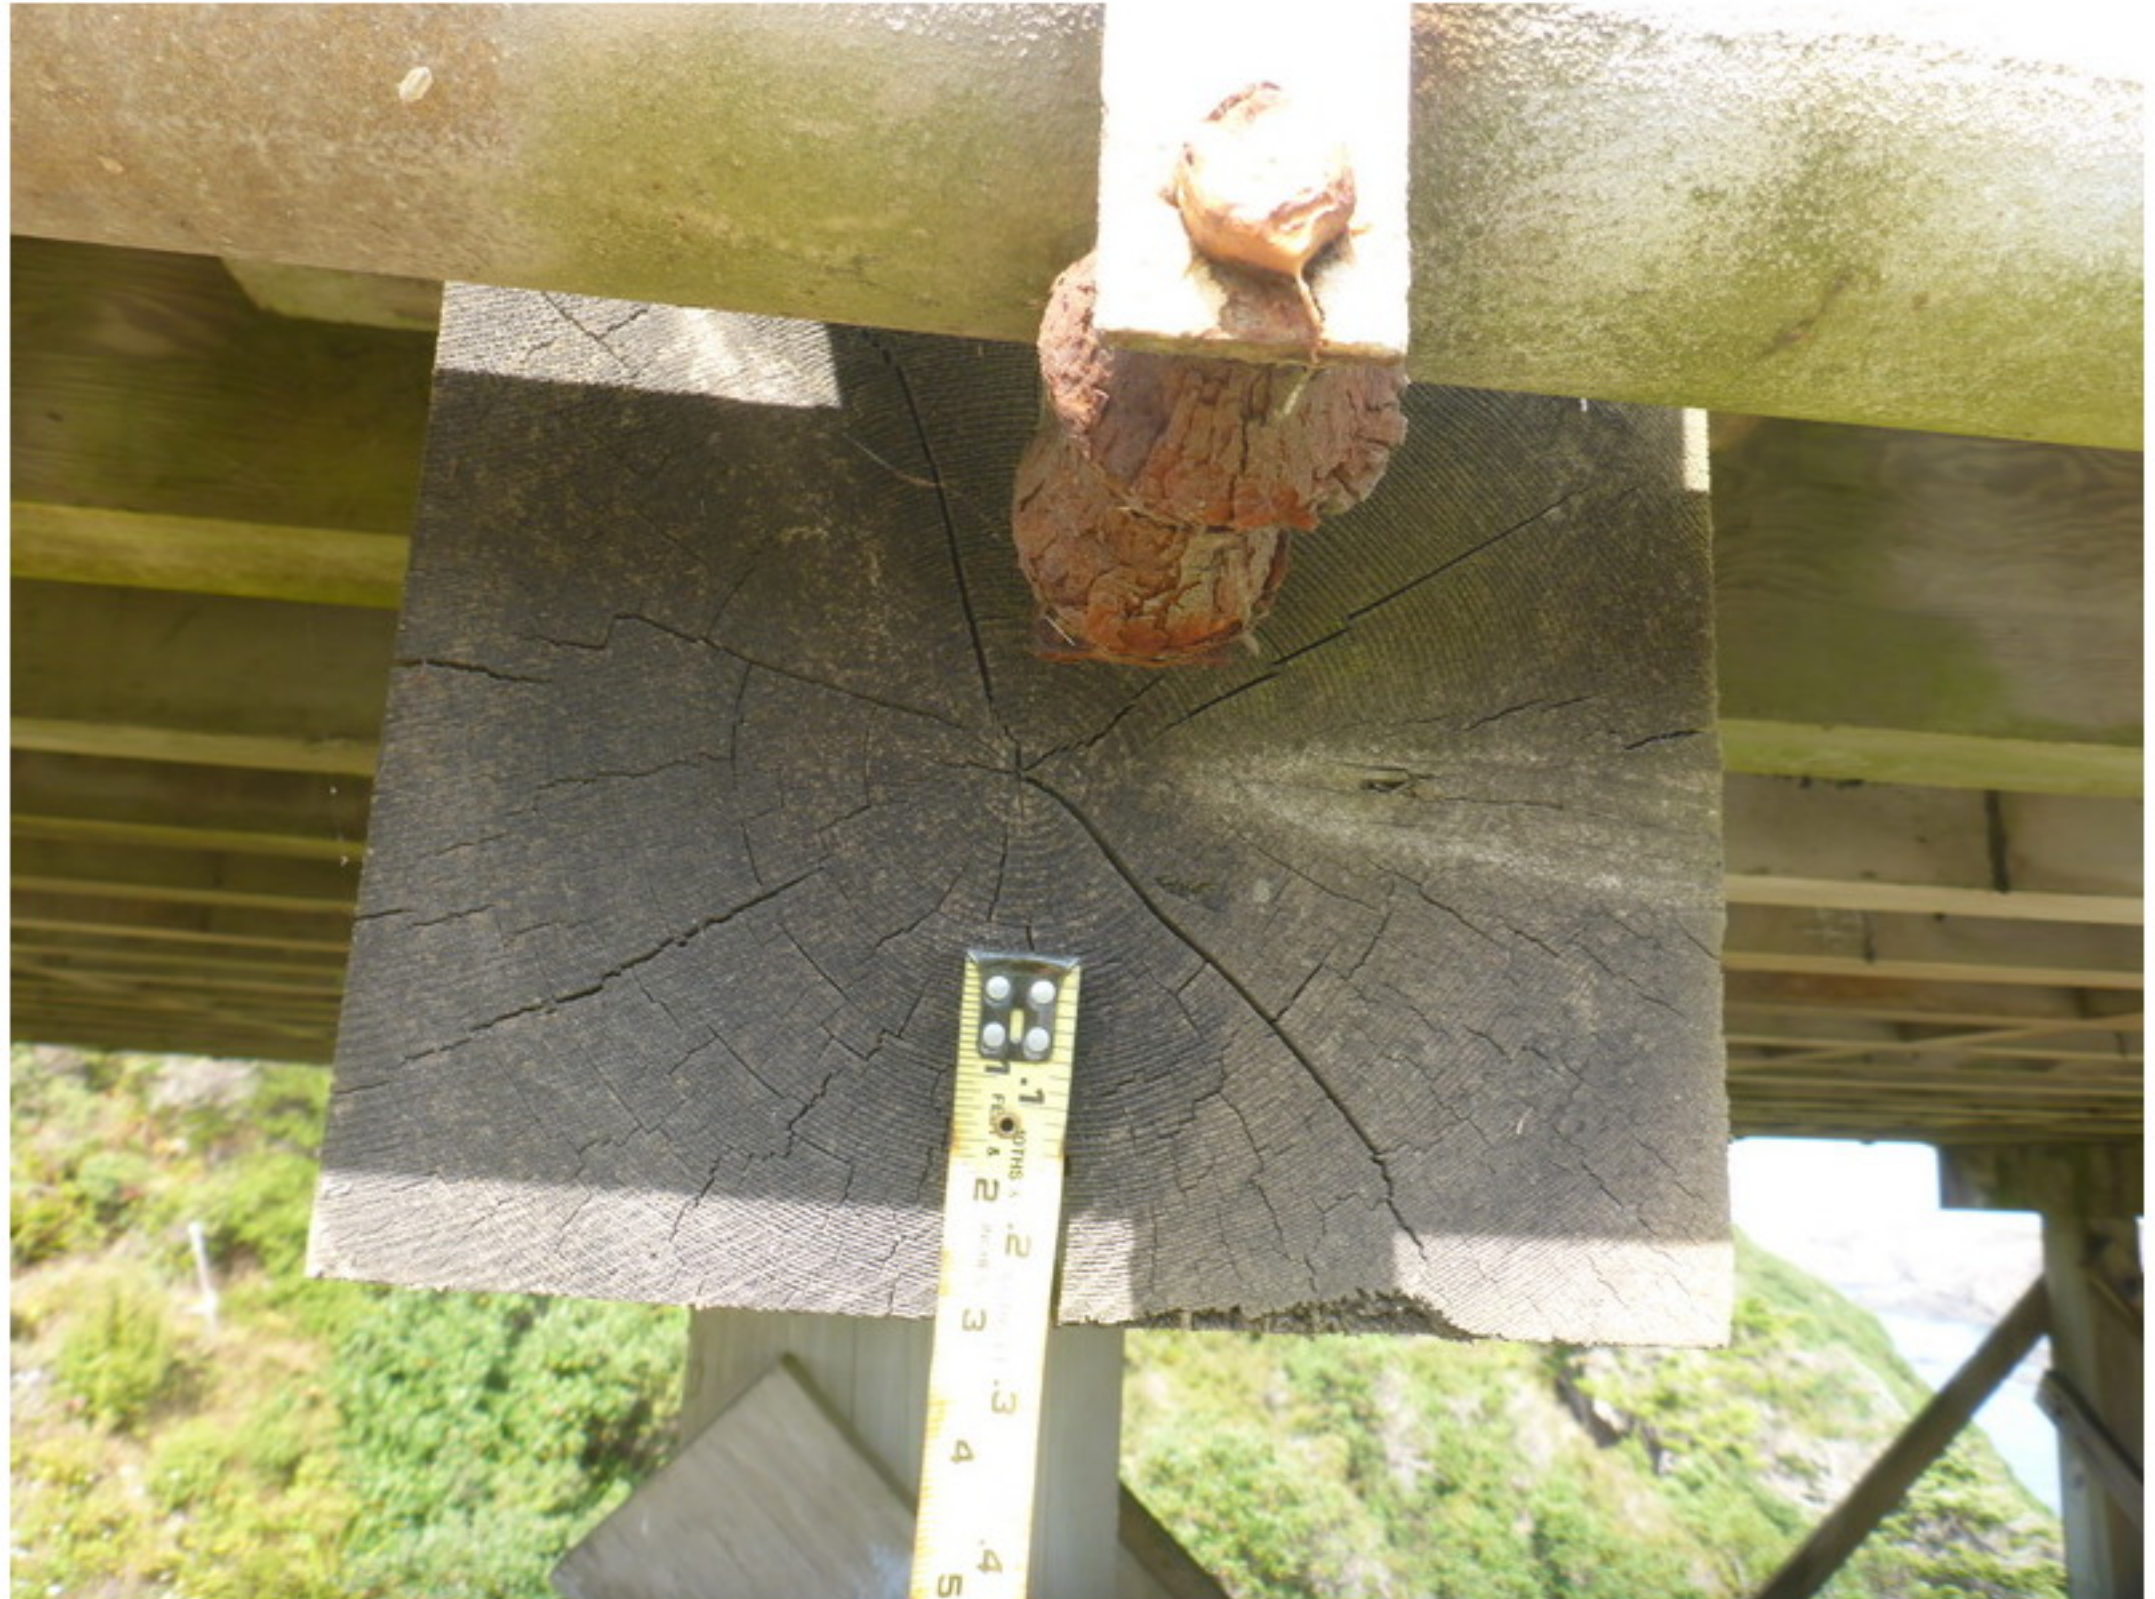
Photo No. 16
Typical checks visible at the end of the bent caps.

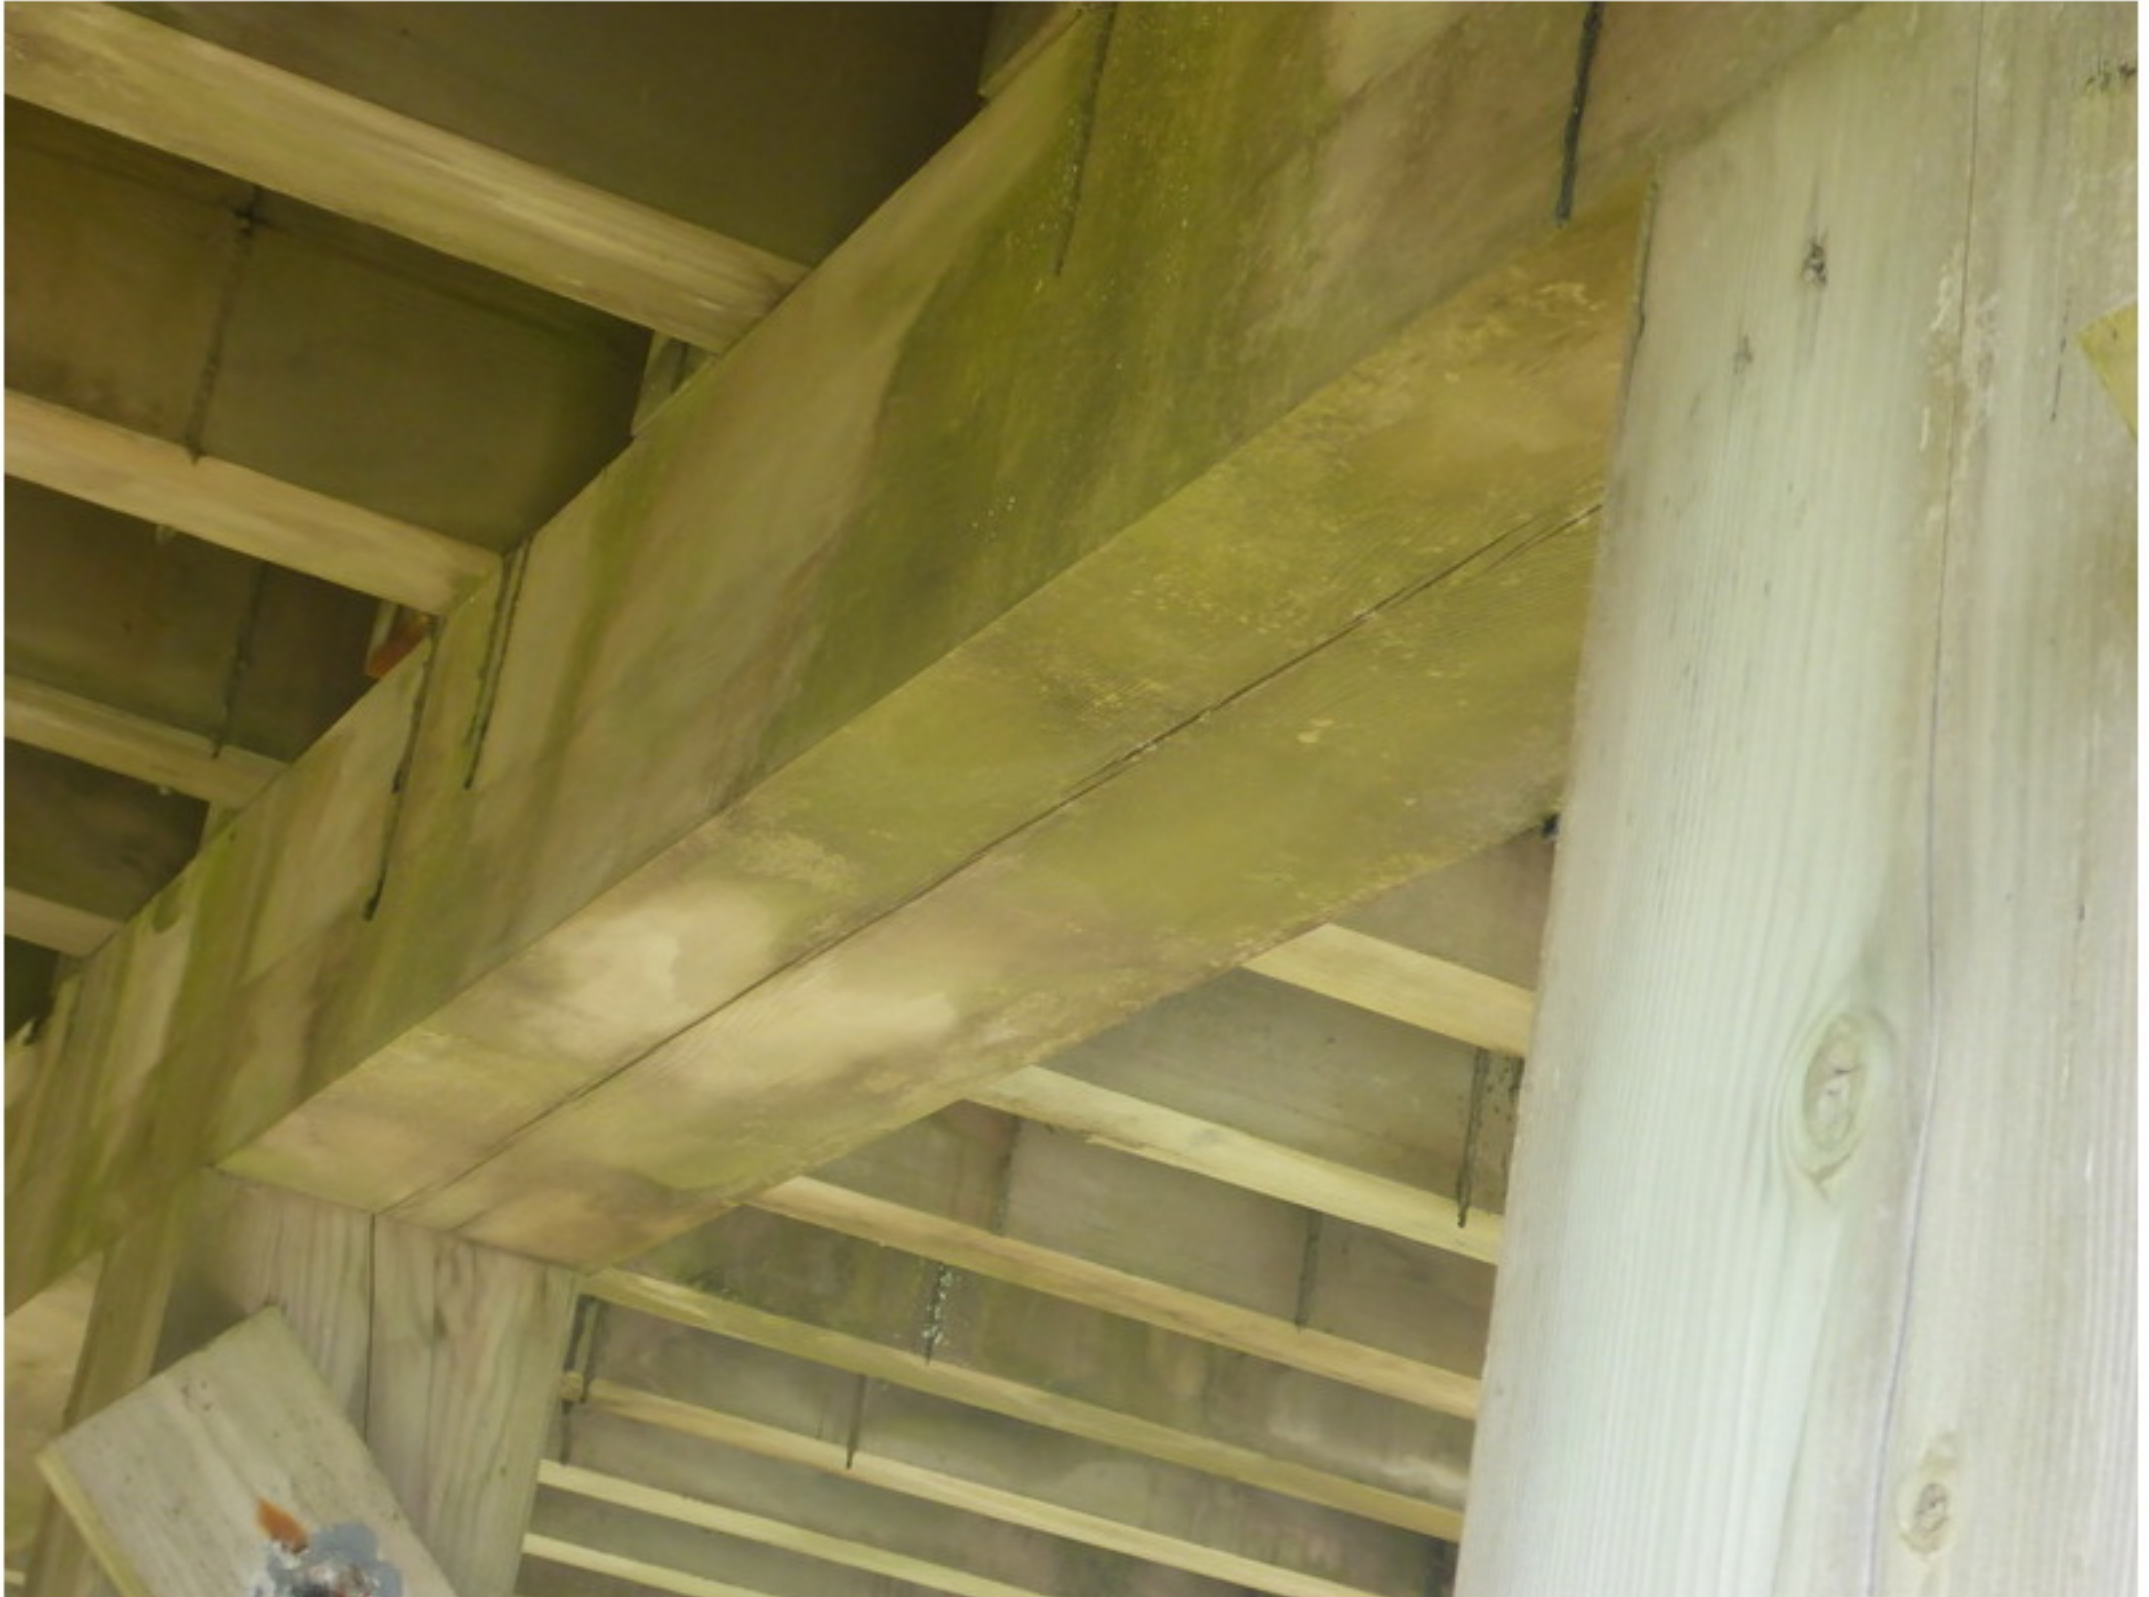
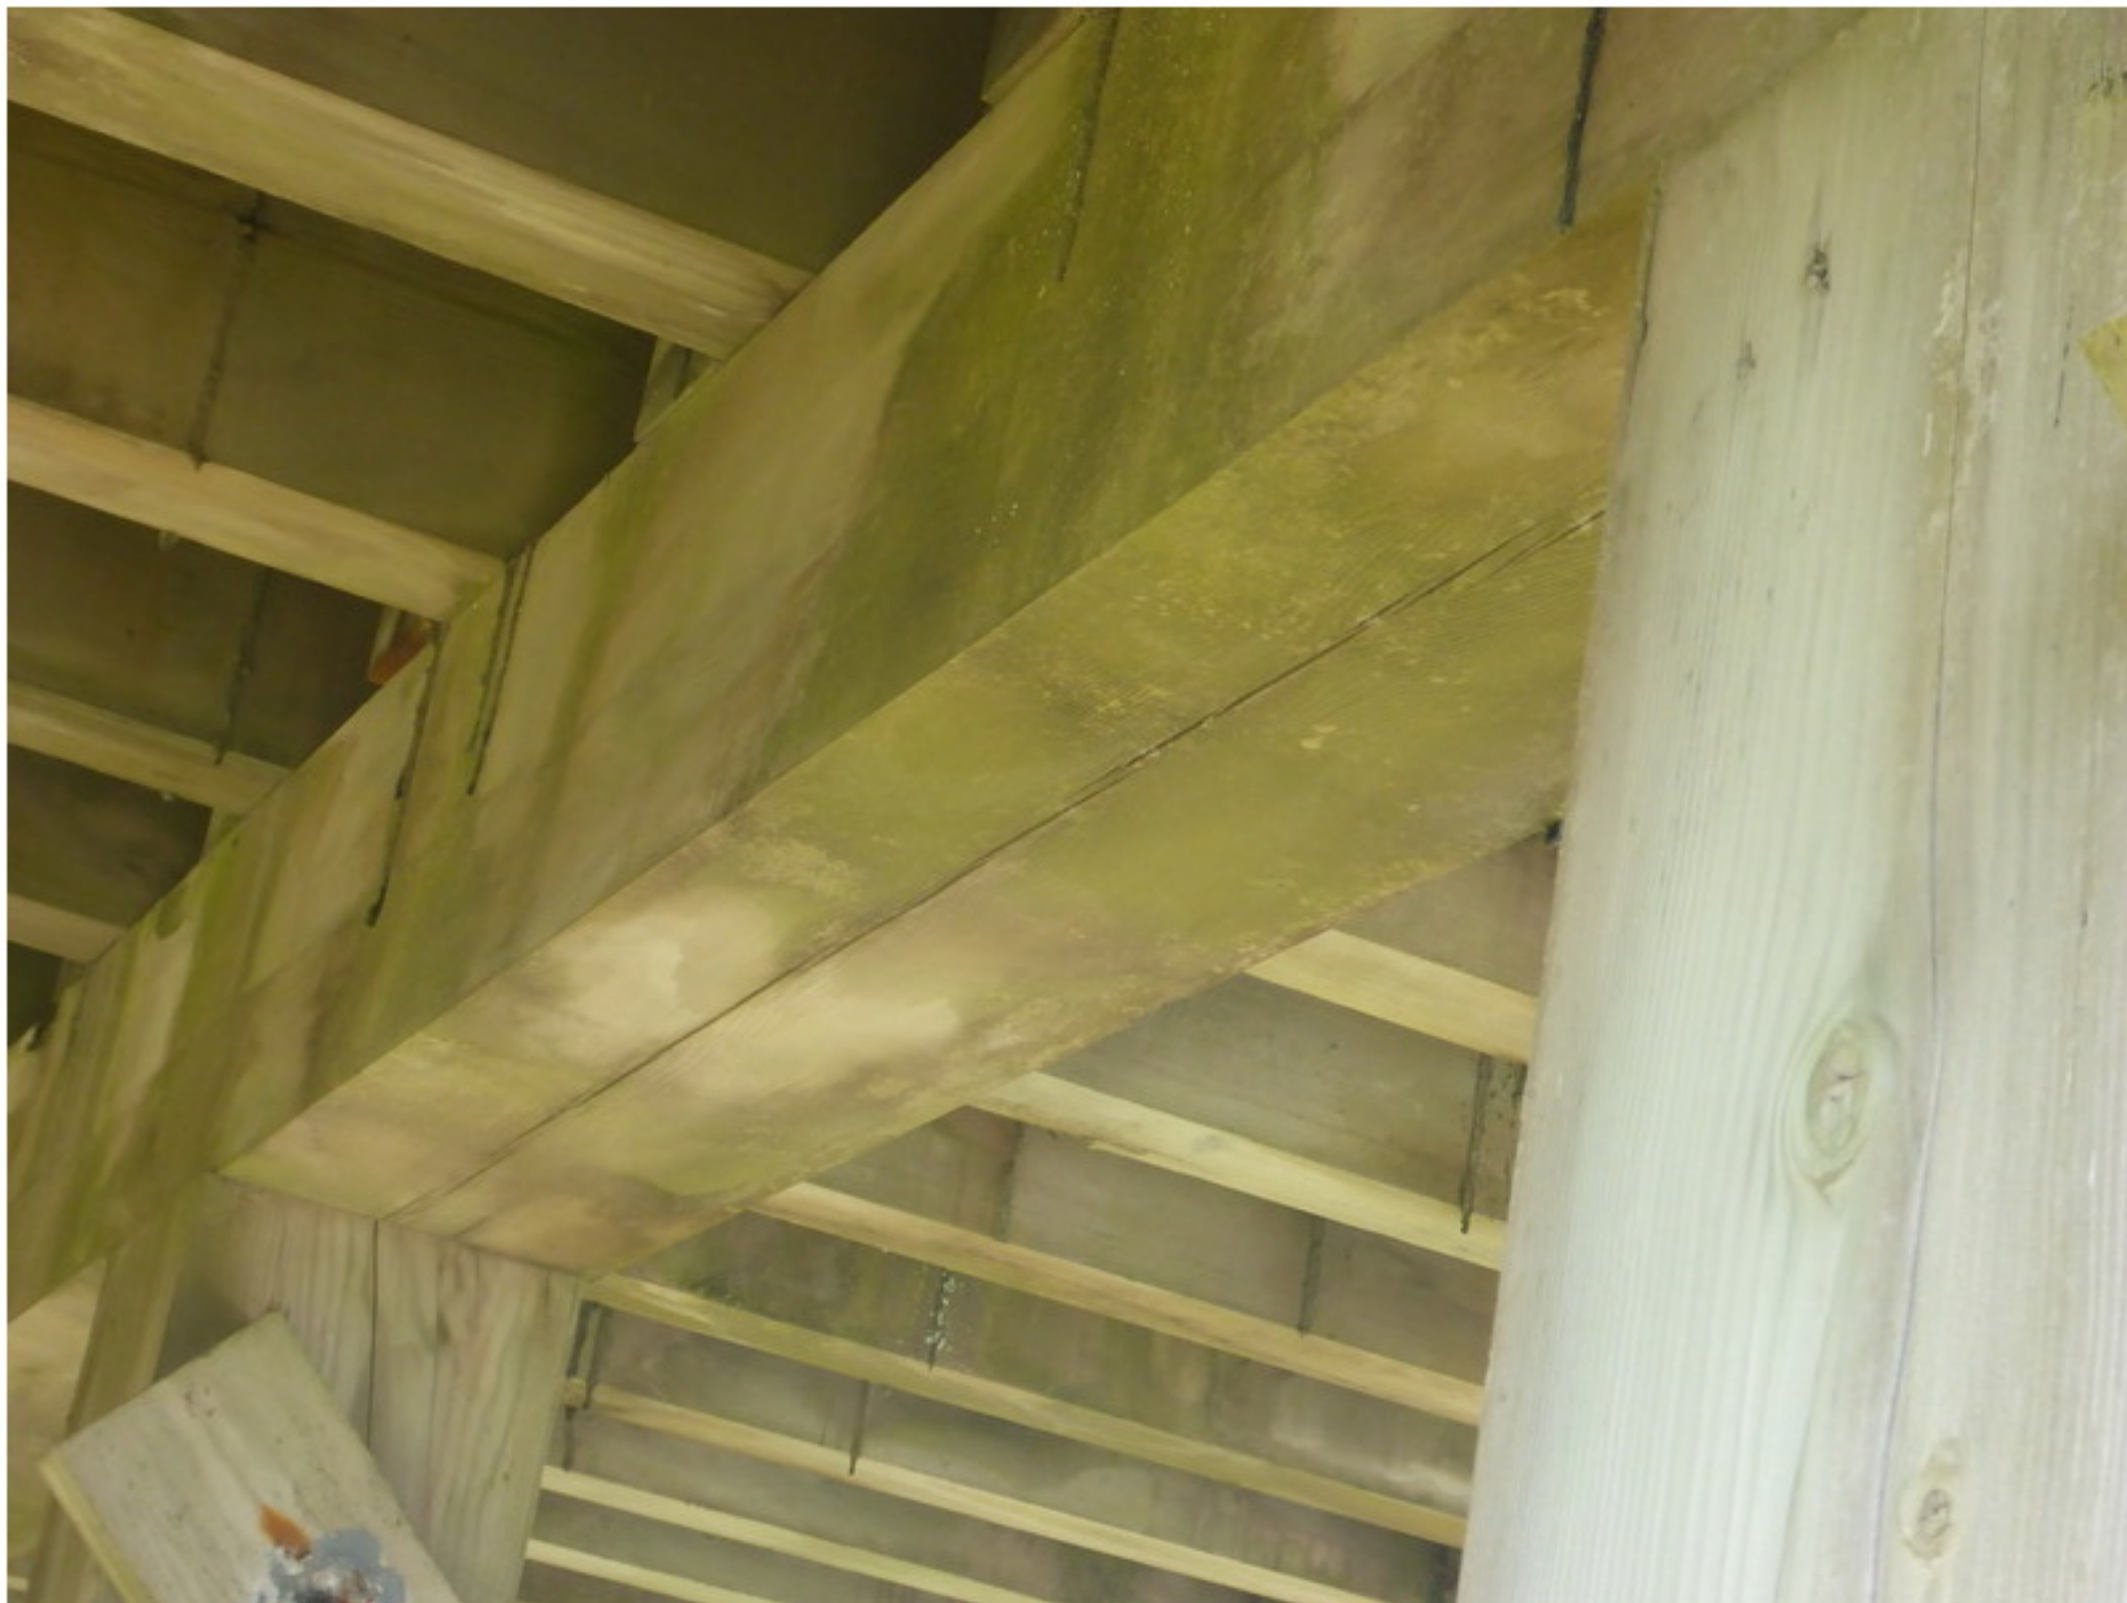
Photo No. 17

Horizontal check present along the bottom of Bent Cap 8.
