| 4. TITLE AND SUBTITLE PPRC11 SPE 4.41.2: Laboratory and Accelerated Pavement Testing (APT) of Gap-Graded Rubberized Mixes (Hot Mix Asphalt and Warm Mix Asphalt) for the Department of Resource Recycling and Recovery (CalRecycle). Subtitle: Warm-Mix Asphalt Study - Field Test Performance Evaluation | | 5. REPORT DATE December 2013 |
| 7. AUTHOR D. Jones | | 6. PERFORMING ORGANIZATION CODE |
| 9. PERFORMING ORGANIZATION NAME AND ADDRESS California Department of Transportation Division of Research, Innovation and Systems Information, MS-83 P.O. Box 942873 Sacramento, CA 94273-0001 | | 8. PERFORMING ORGANIZATION REPORT NO. UCPRC-TM-2013-08 |

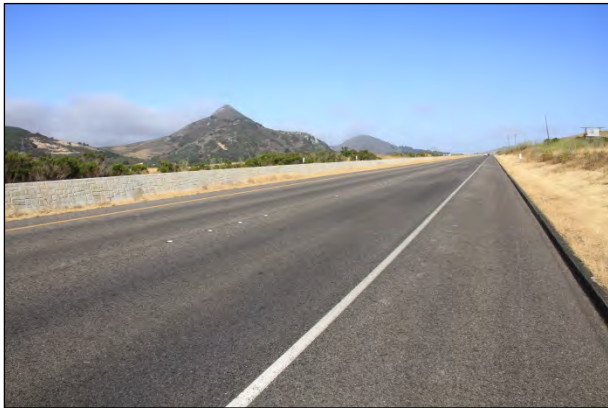
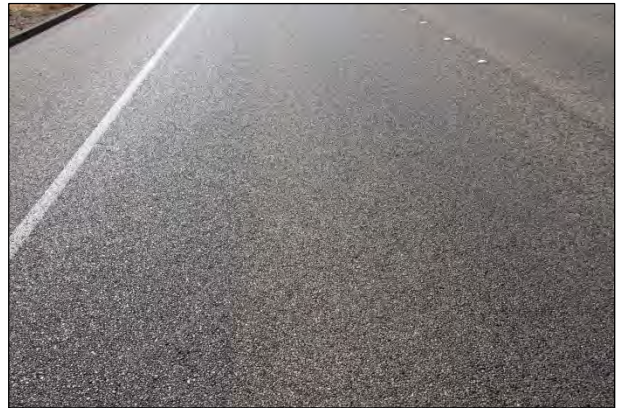
No deterioration compared to the May 2007 baseline measurements was noted on the sections after 60 months of traffic. The track marks were no longer visible on any of the sections.

Figure 3.3: Morro Bay Control, May 2012 (60 months), track marks no longer visible.

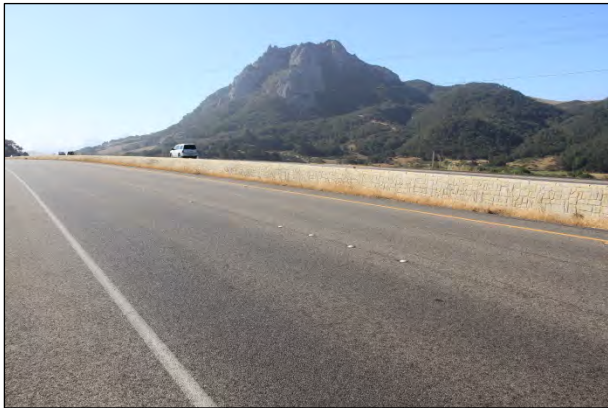
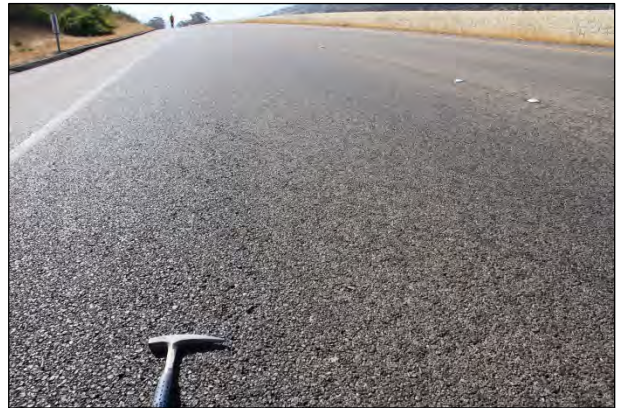
Figure 3.6: Morro Bay Advera, May 2012 (60 months), track marks no longer visible.

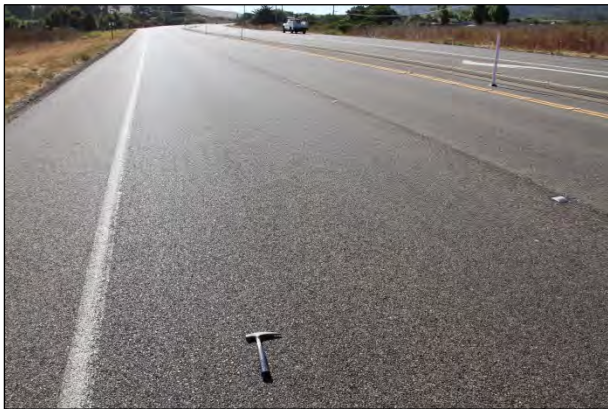
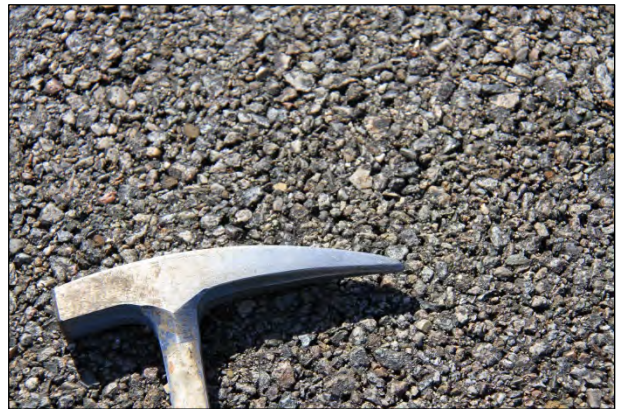
Figure 3.10: Morro Bay Evotherm, May 2012 (60 months), track marks no longer visible.

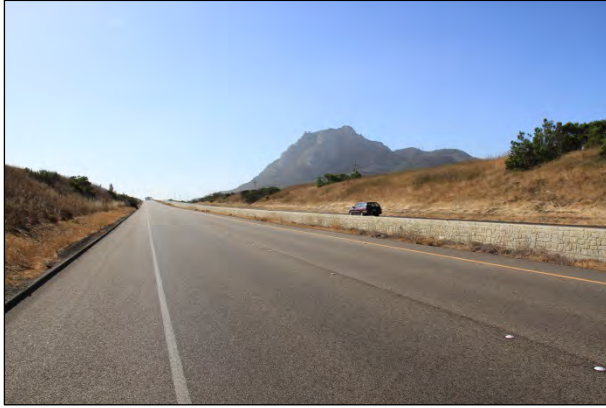
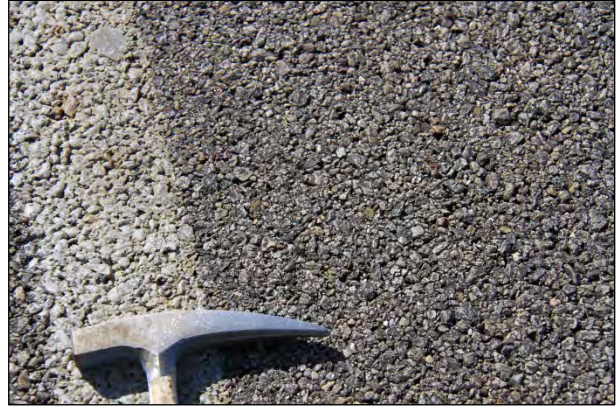
Figure 3.14: Morro Bay Sasobit, May 2012 (60 months), track marks no longer visible.

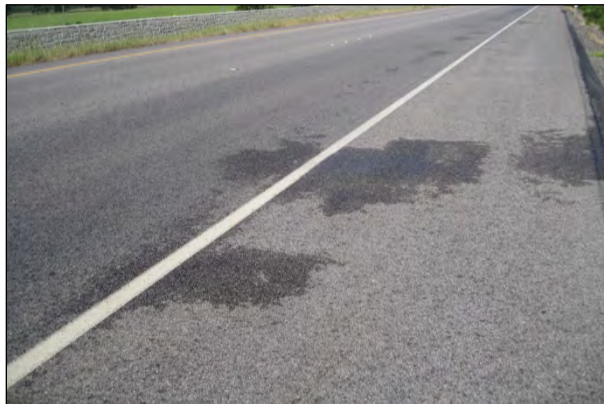
No deterioration compared to the May 2007 baseline measurements was noted on the sections after 73 months of traffic. Although the surface color of all sections was considerably lighter compared to new asphalt, the surface was still in very good condition and only minor stone loss, consistent with the age of the surface, was observed. Permeability through the open-graded friction course also remained effective on all sections (Figure 3.16).

Figure 3.16: Morro Bay Sasobit, June 2013 (73 months), showing effective drainage.

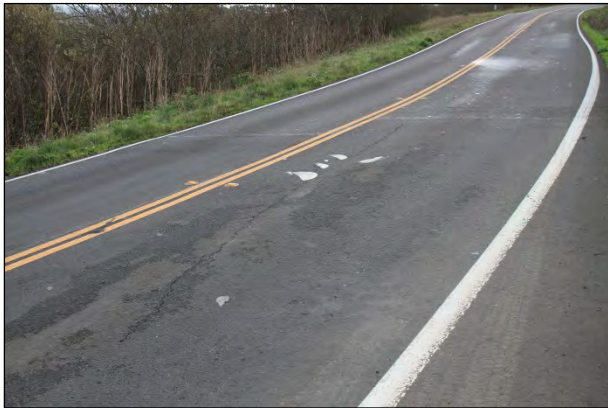
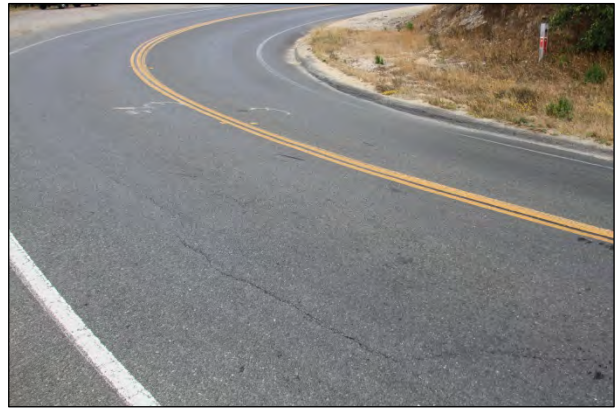
No deterioration compared to the December 2008 baseline measurements was noted on the section after 18 months of traffic. However, some longitudinal cracks were noted on the hill section around postmile 17. This was attributed to slope movement and not to performance of the warm-mix asphalt.

Figure 4.3: Point Arena Evotherm, November 2010, showing longitudinal cracks.

| Parameter | Evotherm | | | | | | | | | | |
|--|---|---|---|---|---|---|---|---|---|---|---|
| ¹ Some longitudinal cracks only on hill/sharp curve between PM15.4 and PM17.0. Cracks were attributed to slope movement, not asphalt performance. | | | | | | | | | | | |

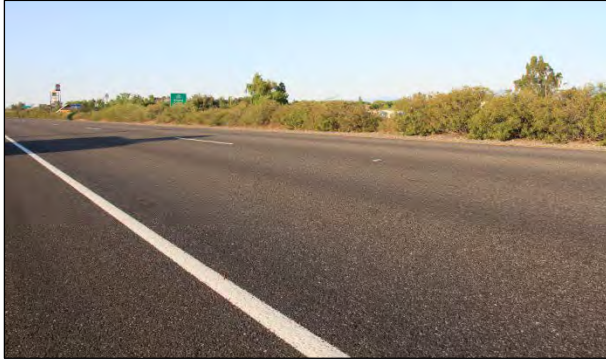
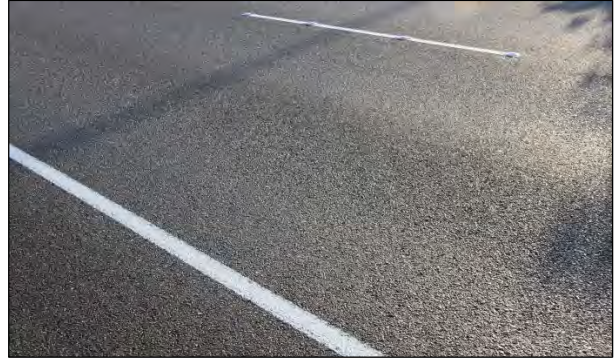
Rut depths of approximately 0.16 in. (4.0 mm) were measured on both the control and Evotherm sections. This indicated that rut performance on the hot- and warm-mix sections was similar after 12 months of trafficking and that binder oxidation rates had probably stabilized. No other deterioration compared to the June 2009 baseline measurements was noted on the sections after 12 months of traffic.

Figure 5.2: Orland Control, June 2011 (24 months). Note ruts in wheelpath.

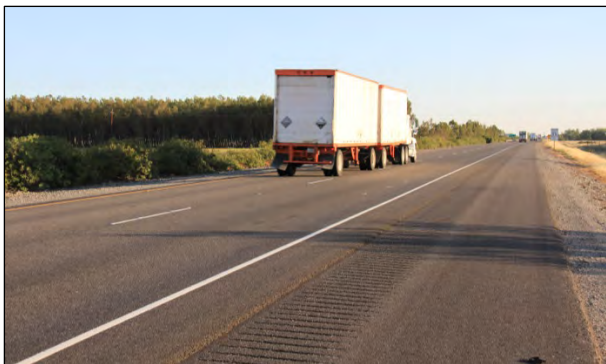
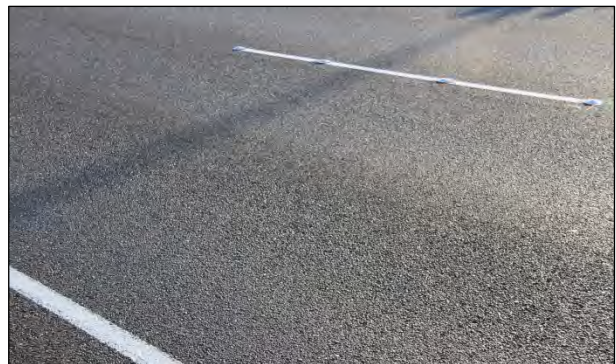
Minor rutting (average between 0.08 in. and 0.1 in. [2.0 mm and 3.0 mm]) was measured in the wheelpaths of the truck lane on the warm-mix section. No rutting was measured on the control section. The difference in rutting performance was attributed to lower oxidation of the binder in the warm-mix and consequent lower stiffness. Similar early rutting on warm-mix test sections was observed during accelerated loading tests conducted earlier in the warm-mix asphalt study (1). No other deterioration compared to the June 2009 baseline measurements was noted.

Figure 5.4: Orland Evotherm, June 2011 (24 months). Note ruts in wheelpath.

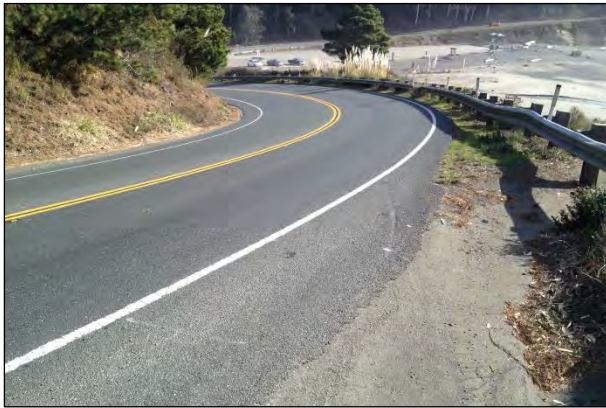
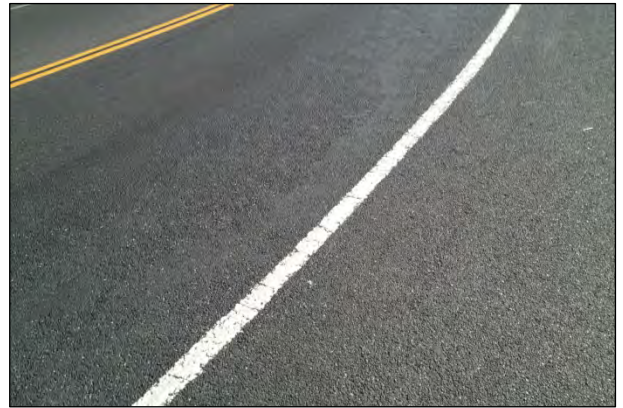
No deterioration compared to the July 2010 baseline measurements was noted on the sections after 30 months of traffic. However, minor raveling was noted on a short section of the outside wheelpath on a sharp bend on the Advera section.

No deterioration compared to the July 2010 baseline measurements was noted on the sections after 42 months of traffic. The raveling observed on the Advera section during the December 2012 visit had not deteriorated.

Figure 7.4: Mendocino Advera, December 2013 (42 months). Note raveling in outside wheel path.

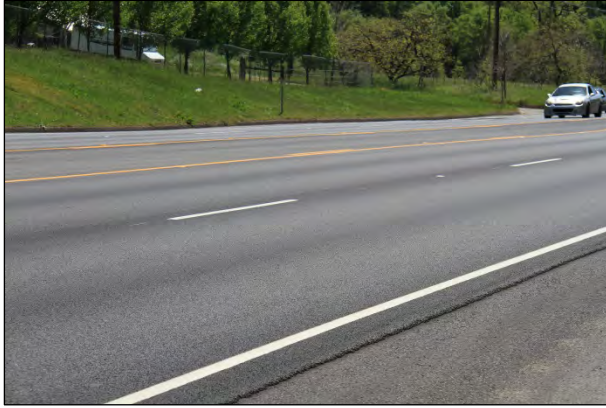
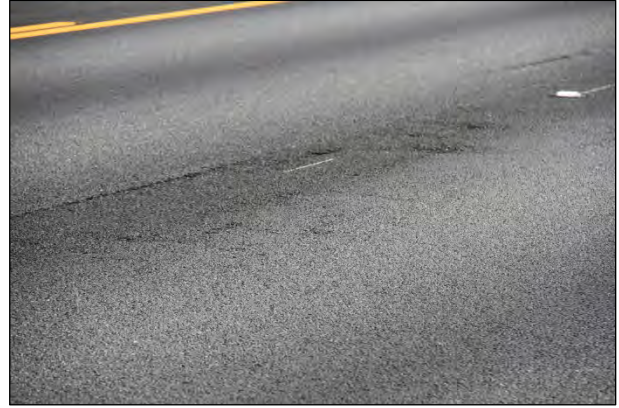
The road surface resembled a typical open-graded friction course and was given an overall rating of “good.” Some localized areas of what appeared to be segregation in the mix were noted. Some open longitudinal joints were also noted. No early stone loss was noted, and no other problems were observed. Water was effectively draining through the friction course and out through the sides of the road.

Figure 8.2: Auburn Evotherm, August 2010 (0 months). Note segregation and open joint.

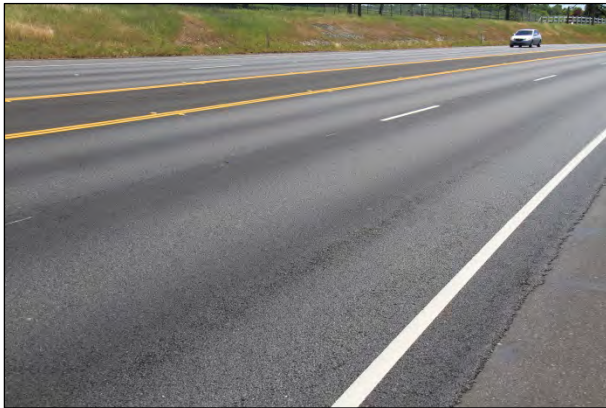
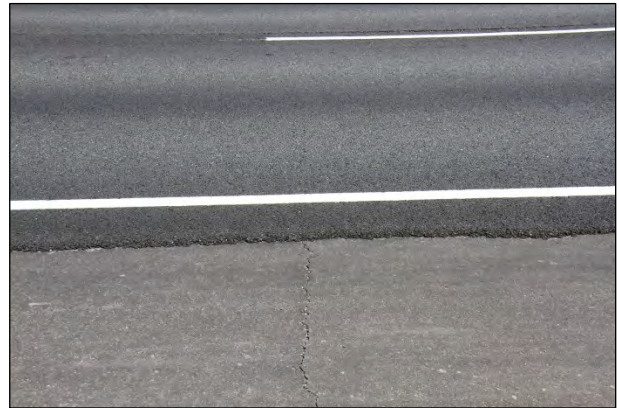
Reflected transverse cracking and some minor raveling in the outside wheelpath of the outside lanes was noted in some areas of the project. Given that no hot-mix control was available for comparison purposes, it was not clear whether these distresses were related to the warm-mix technology, to construction issues, or to other factors. No further deterioration compared to the August 2010 baseline measurements was noted.

Figure 8.3: Auburn Evotherm, July 2012 (24 months). Note deterioration and reflected crack.
