1. REPORT NUMBER CA09-0678	2. GOVERNMENT ASSOCIATION NUMBER	3. RECIPIENT'S CATALOG NUMBER
4. TITLE AND SUBTITLE Pedestrian and Bicycle Safety Evaluation in a SMART Corridor	5. REPORT DATE October 2008

7. AUTHOR David R. Ragland, Terri O' Connor,		6. PERFORMING ORGANIZATION CODE
9. PERFORMING ORGANIZATION NAME AND ADDRESS University of California, Berkeley Traffic Safety Center 2614 Dwight Way Berkeley, CA 94720	8. PERFORMING ORGANIZATION REPORT NO.

David R. Ragland, PhD, MPH, and Terri O'Connor
UC Berkeley Traffic Safety Center (TSC)

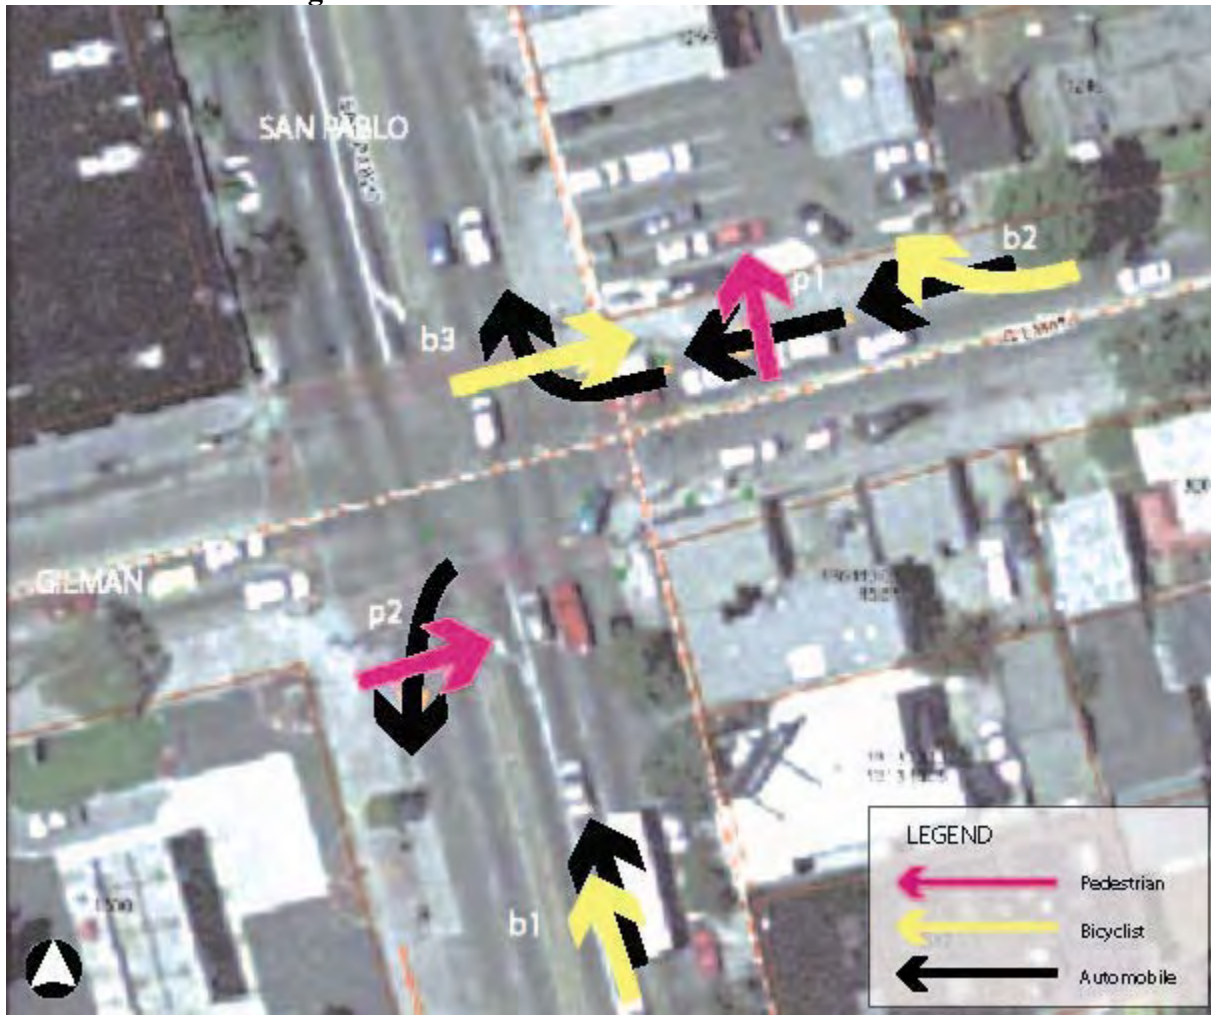
Figure 5.2. San Pablo Avenue and Gilman Street

The intersection is dominated by north-south automobile traffic along San Pablo with a west-to-east squeeze conflict, as a lane drop occurs when Gilman changes from commercial/industrial to residential. A busy shopping center with a regional draw is located to the southwest of the intersection and has entrances on Gilman to the north and San Pablo to the south, which results in traffic backups and conflicts on the sidewalks, driveways, and at a bus stop. A gas station is located on the southwest corner, with entrances and exits located close to the intersection on each side. Gilman also leads to I-80/580 to the west and to and a Target Superstore to the west and north, which draws additional traffic through the intersection. All of this contributes to a very active intersection with vehicles, pedestrians, and bicyclists.

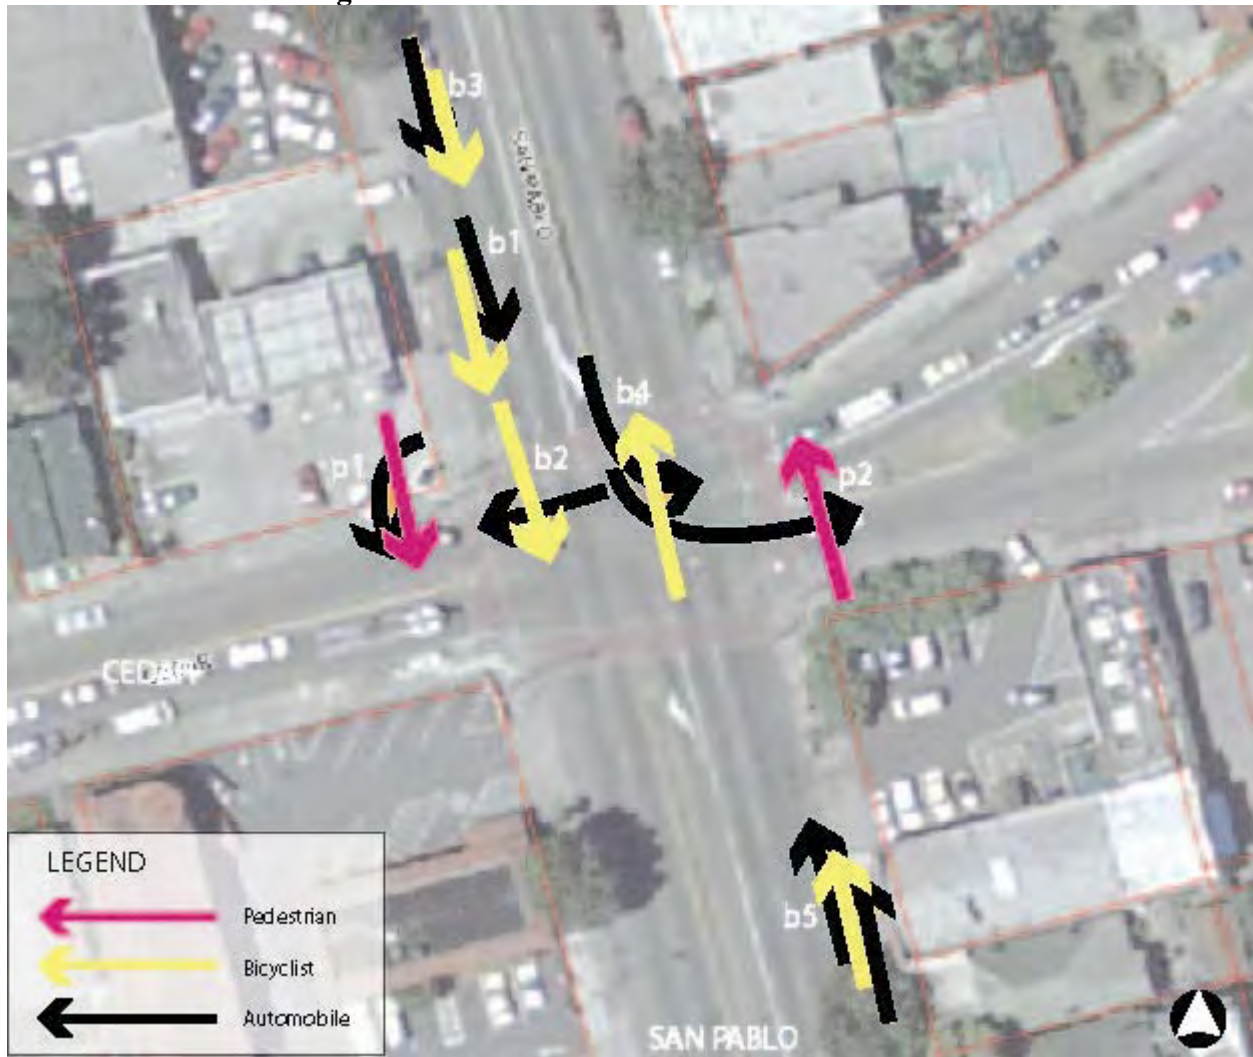
Figure 5.4. San Pablo Avenue and Cedar Street

Collisions between vehicles and five bicyclists, and vehicles and two pedestrians were reported for this intersection between 1998 and 2003. The crash types and previous movements are illustrated in Figure 5.4.

The majority of the crashes appeared to be concentrated in the northwestern quadrant and approach to the intersection. The pedestrian crashes involved a driveway crossing and a left-turning vehicle violation of pedestrian ROW in a crosswalk

The bicyclist crashes involved vehicles entering traffic, bicycles hitting stopped cars, and vehicles cutting-off bicyclists via turning or lane changes.

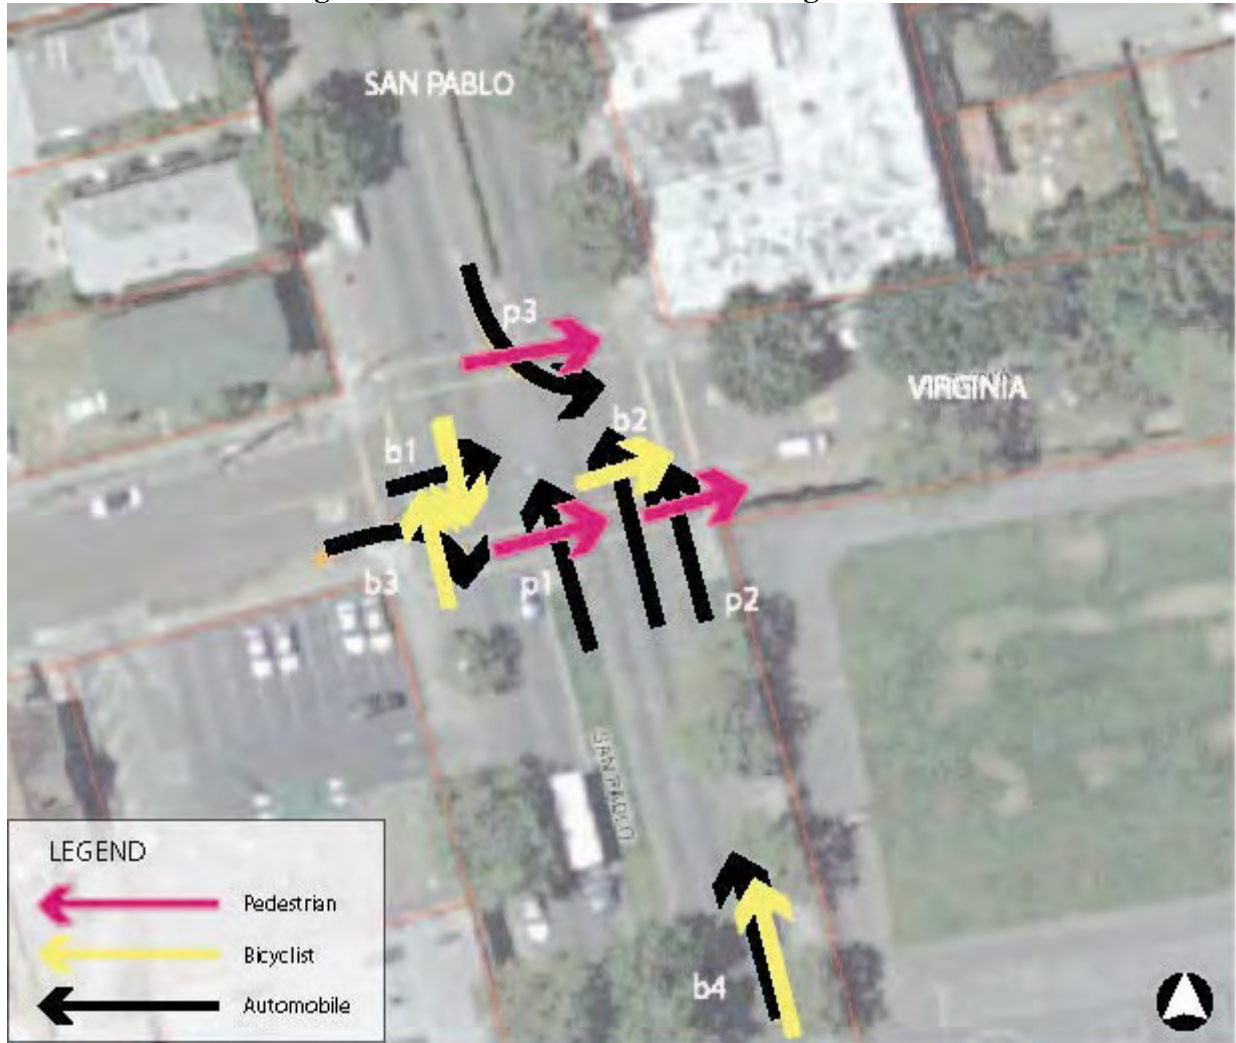
Figure 5.5. San Pablo Avenue and Virginia Street

bicycle crashes involved bicyclists in each direction. One bicyclist was moving against traffic, one hit a stopped vehicle, and the others were riding perpendicular to traffic in the intersection. The crash types and previous movements are illustrated in figure 5.5.

This intersection is characterized by intermittent high-speed traffic with no traffic control on San Pablo Avenue and stop-sign control on both Virginia approaches. Additionally, this is a bicycle boulevard³² crossing with a high level of bicycle traffic.

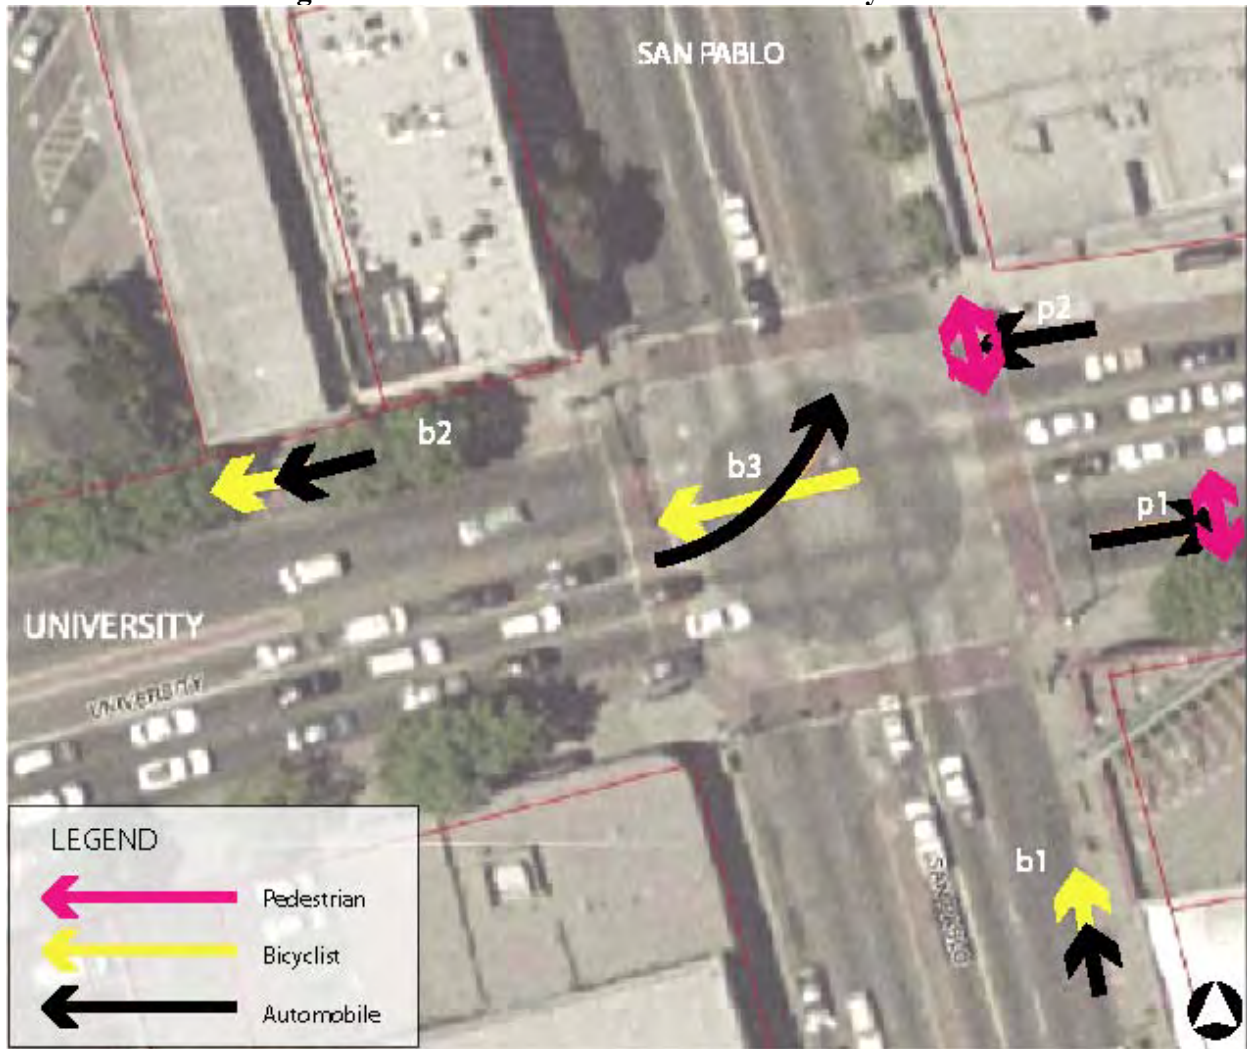
Figure 5.7. San Pablo Avenue and University Avenue

Vehicle collisions with four bicyclists and, and vehicle collisions with four pedestrians were reported at this intersection between 1998 and 2003; however, there was no common pattern among the crashes. Two pedestrian crashes were more than 100 feet from the intersection. The crashes involved pedestrian violations such as jaywalking and walking under the influence. The bicycle crashes involved bicyclists hitting stopped vehicles and bicyclists riding against traffic. The crash types and previous movements for these collisions are illustrated in Figure 5.7.

The intersection at San Pablo and University Avenues is at a confluence of two high capacity arterial roadways with bus stops for multiple bus lines located on each corner. The intersection is characterized both by the highest vehicle and pedestrian volumes for all Berkeley intersections studied. Despite low bicyclist volumes, the rate of vehicle collisions with bicycles was high given their relative exposure. One conclusion might be that the bicyclists who use this intersection are most likely there because it is a destination (there are several shops and restaurants at this intersection); otherwise they would use the nearby bicycle route network, which would allow riders to negotiate an easier, less congested route to their destination.

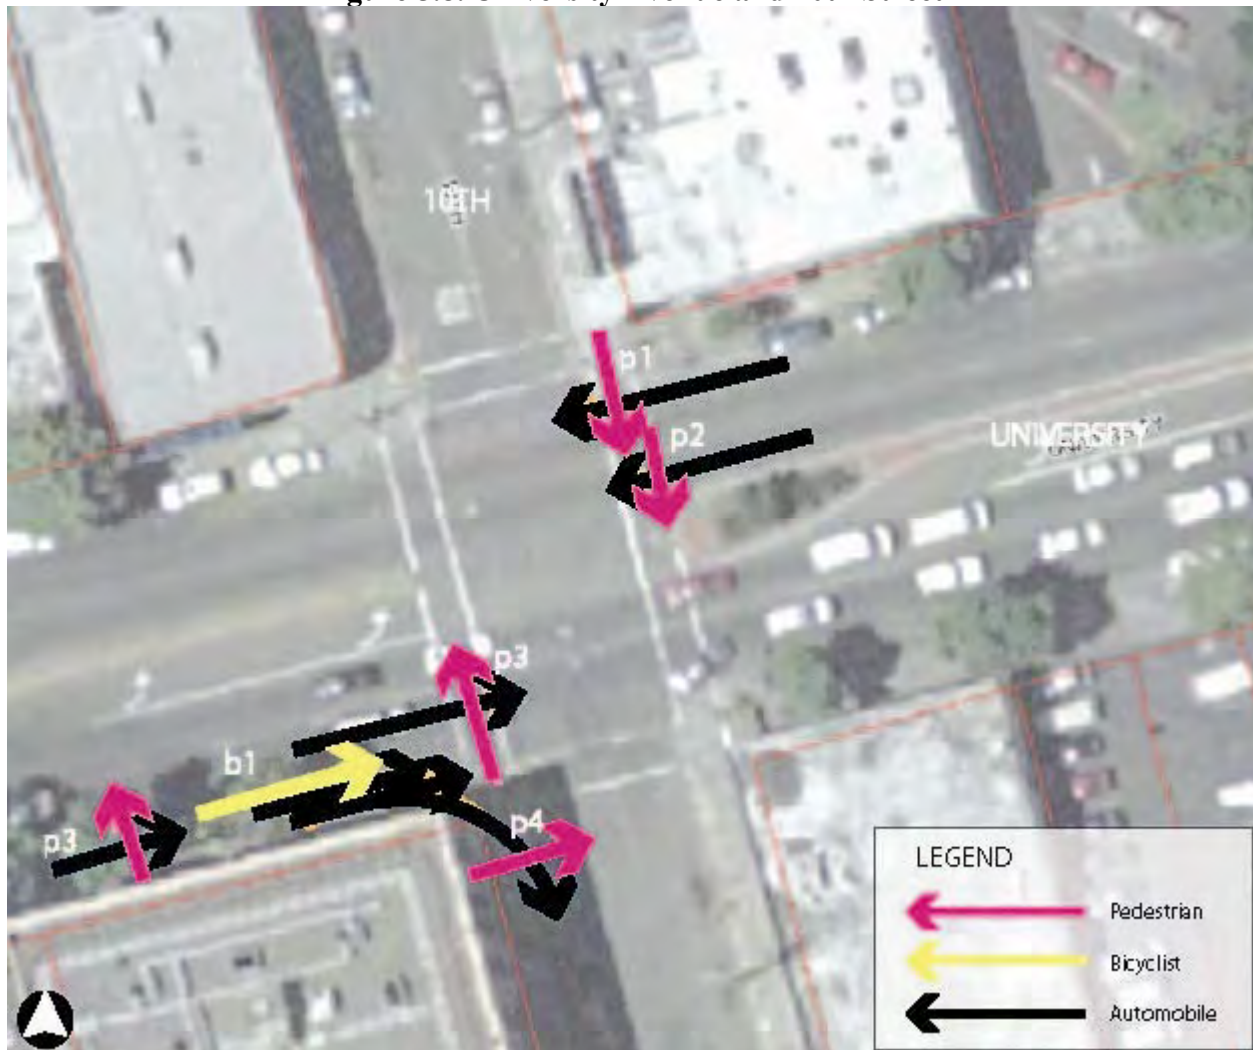
Figure 5.8. University Avenue and 10th Street

There were five pedestrian crashes and one bicycle crash reported to SWITRS for this intersection in the past six years. The crash types and previous movements are illustrated in figure 5.8.

The reported collisions between vehicles and pedestrians or bicyclists at the intersection of University Avenue and 10th Street were concentrated on the southwest and northeast corners and approaches to the intersection. Pedestrian crashes occurred in instances of vehicles moving

straight through the intersection, or approaching the intersection, and turning right. In most cases the vehicle violated the pedestrian right-of-way. The single bicycle crash involved straight moving vehicles approaching the intersection.

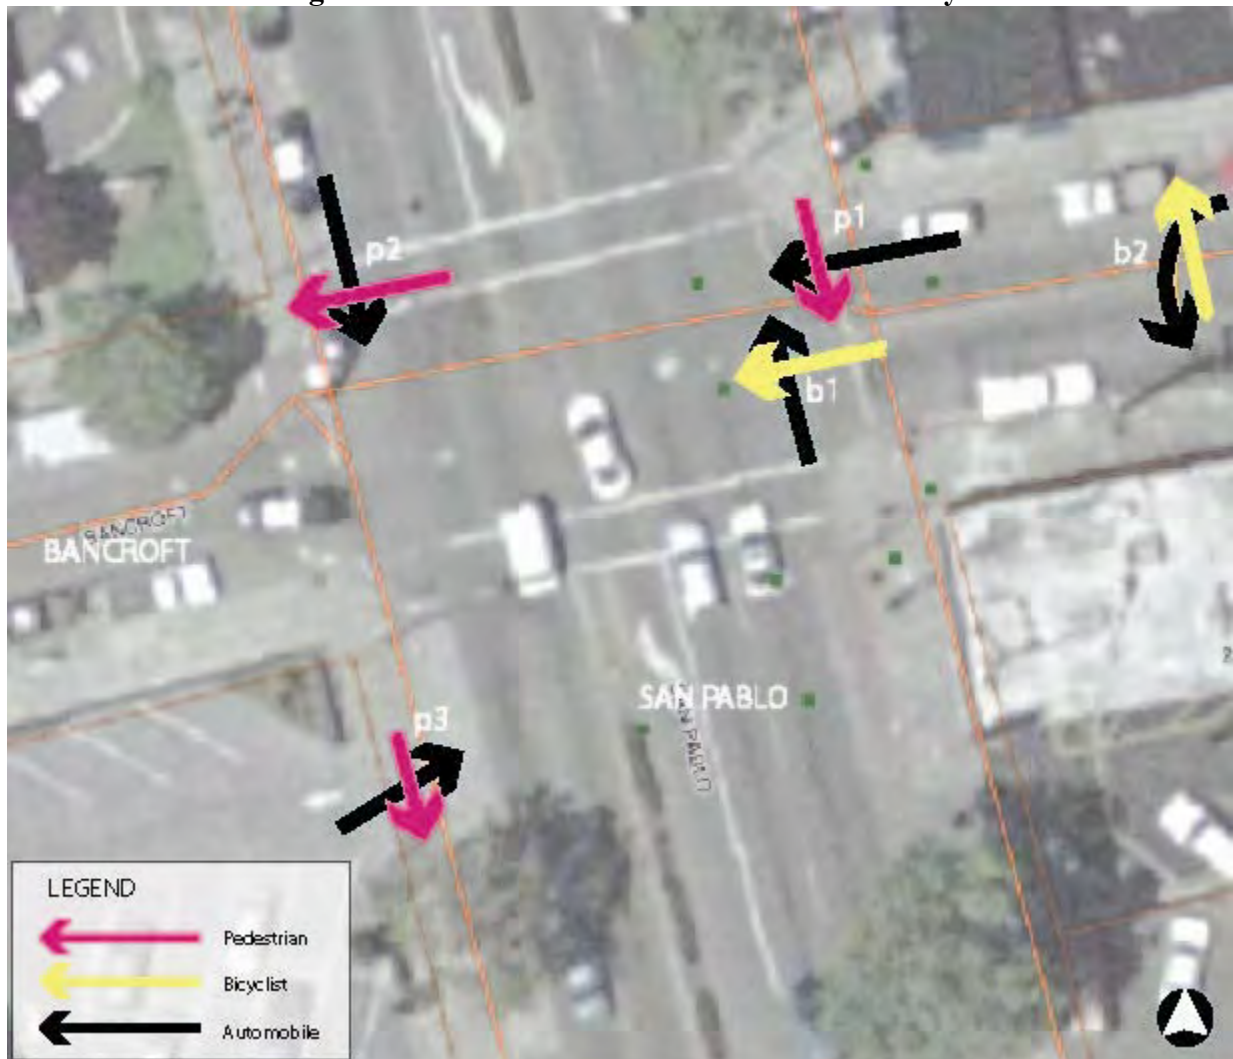
Figure 5.11. San Pablo Avenue and Bancroft Way

The intersection at San Pablo and Bancroft is characterized by high vehicle and bicycle traffic and an absence of traffic signals. The crash history has shown a risk for collisions between vehicles making uncontrolled left-turns onto Bancroft and northbound and southbound pedestrians. The infrastructure poses a risk for conflicts between drivers and pedestrians and bicyclists, with several driveways cutting through the sidewalk close to the intersection.

- Speed trailers: discourages speeding, reduces conflict.
- Pedestrian activated flashing beacons: reduces conflict, increases use of crosswalks, however, could reduce pedestrian awareness.
- Upgraded/extended median (pedestrian refuge island): reduce conflict, reduce number of trapped pedestrians, increase number of pedestrians using crosswalk.

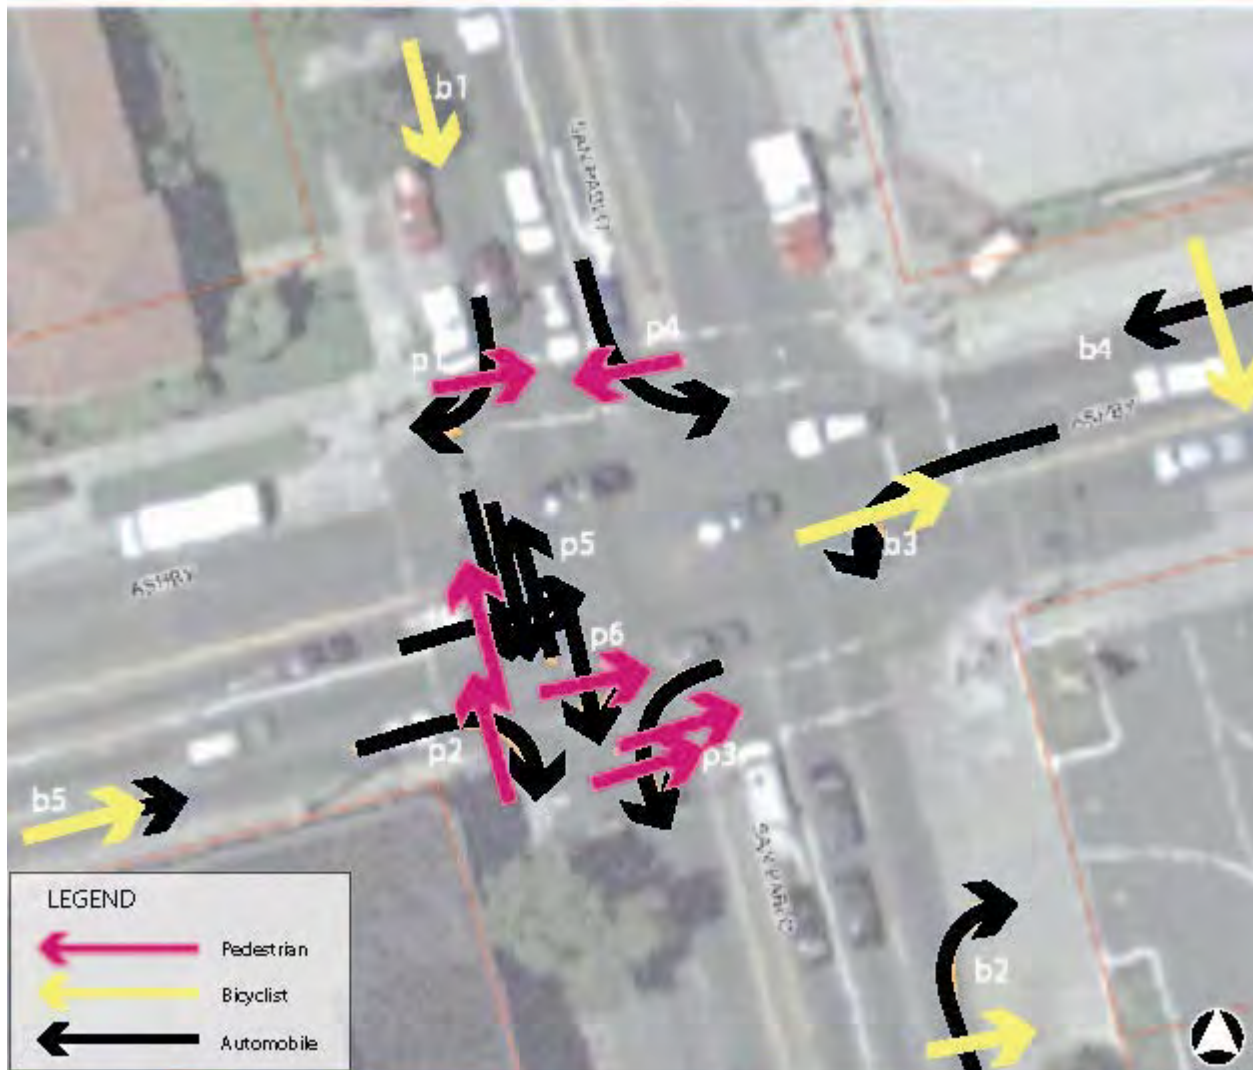
Figure 5.15. San Pablo Avenue and Ashby Avenue

Three of five bicycle crashes occurred outside of the intersection. Two bicyclists were struck while riding on the wrong side of the road against traffic. The bicycle crashes involved right-turning, left-turning, straight-moving and stopped vehicles. Most bicycle crashes involved bicyclist violations. The crash types and previous movements are illustrated in the figure 5.15.

The Ashby intersection was characterized by high speed and high volume vehicle traffic, with 75% of the vehicle flow, 50% of the pedestrians and 200% of the bicycles observed at the intersection of San Pablo and University Avenues. This combination of factors lower volumes of motor vehicles with lower pedestrian volume, generally leads to a higher speed mix due to less congestion. The majority of crashes occurred in the southwest corner of the intersection and typically involved turning vehicles. Similar numbers of pedestrians and bicyclists were involved in collisions with vehicles; however, a significant number of pedestrian crashes involved multiple pedestrians.
