FHWA/CA/ESC-98/06 Part 3

Vehicle Crash Tests of The Type 80 Bridge Rail

March 1999

**VEHICLE CRASH TESTS OF THE
TYPE 80 BRIDGE RAIL**

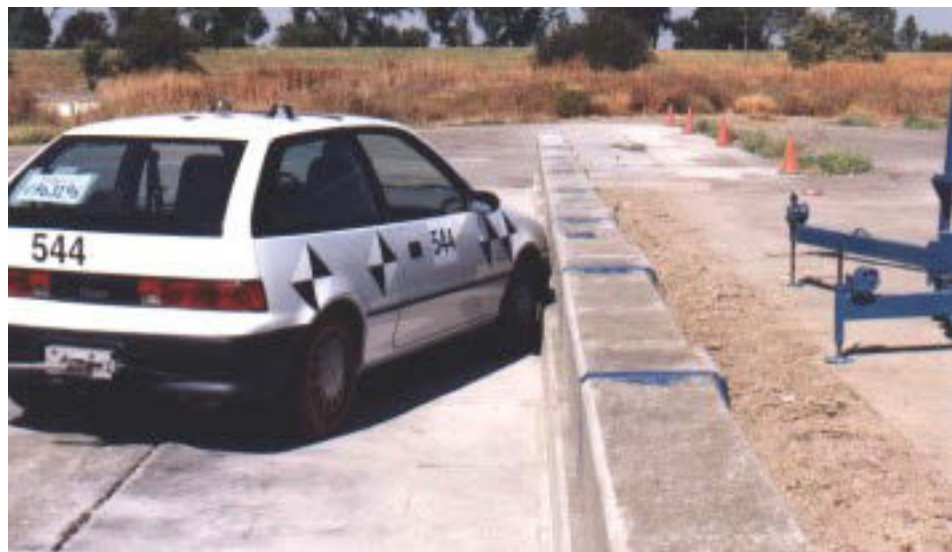
Figure 2-16 Post Impact Side View of Vehicle 544

The right front section of the vehicle sustained crushing of the bumper and frame, damage to the suspension and a flat tire, Figure 2-16 through Figure 2-18. The right side of the vehicle from the front bumper to the rear bumper was scraped during contact with the beam section of the rail. The hood was also crushed on the right side but remained attached at the latch and hinges.

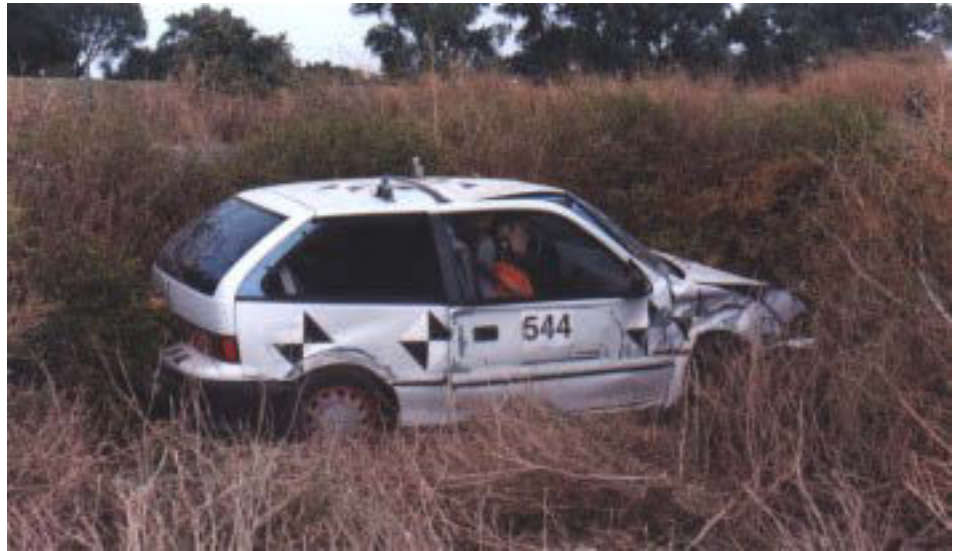
Figure 2-17 Close up of Passenger Side Front Damage, Vehicle 544

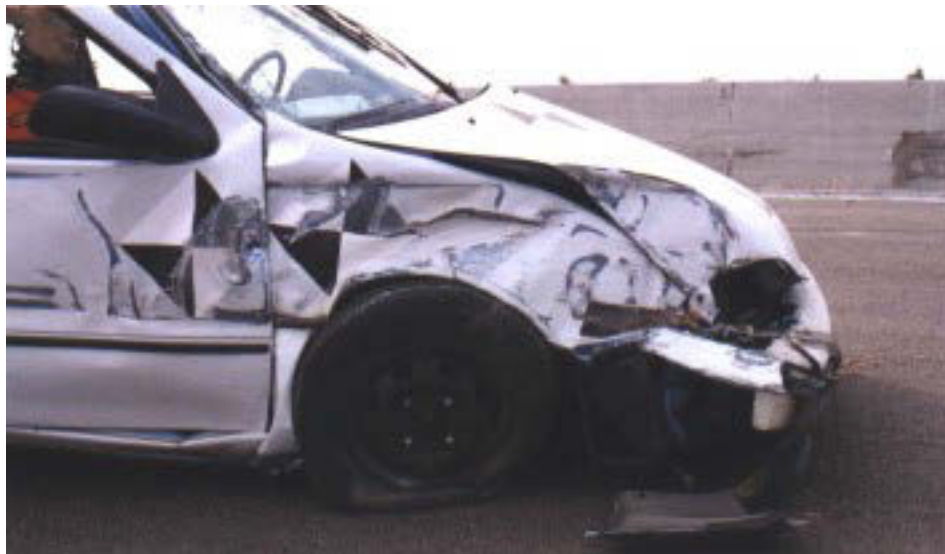
Figure 2-18 Post Impact Front View, Vehicle 544

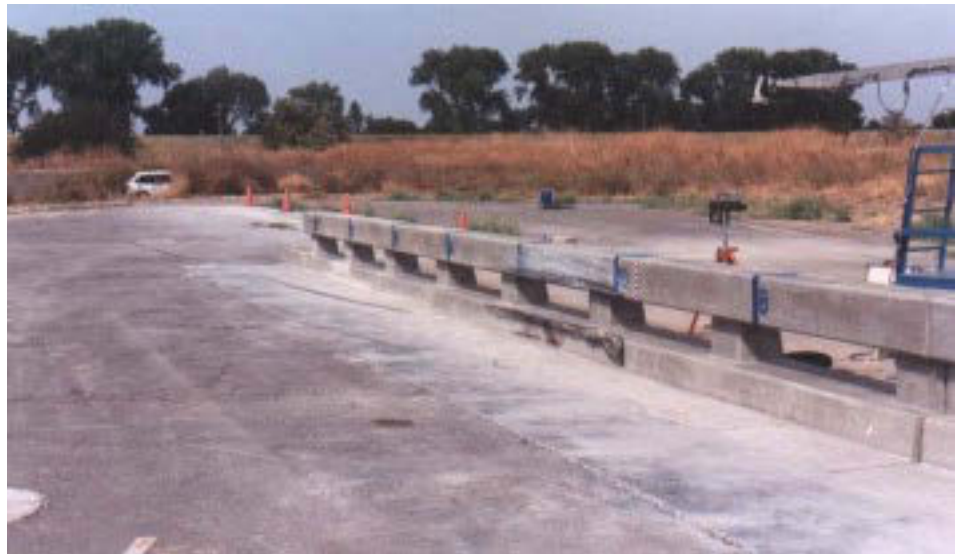
Figure 2-20 Post Impact Bridge Rail Scuff Marks Test 544

Barrier damage was cosmetic only, consisting of scrapes and tire marks. Both of the right side tires left marks on the curb and beam section of the bridge rail. Small amounts of concrete spalled from the face of the barrier where the vehicle's sheet metal and wheels made contact.

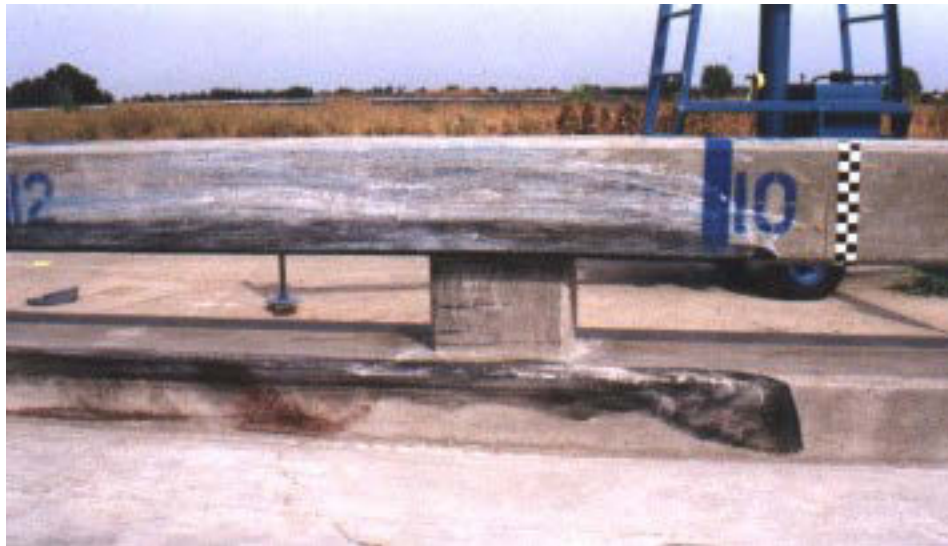
Figure 2-21 Post Impact Bridge Rail Scuff Marks Test 544

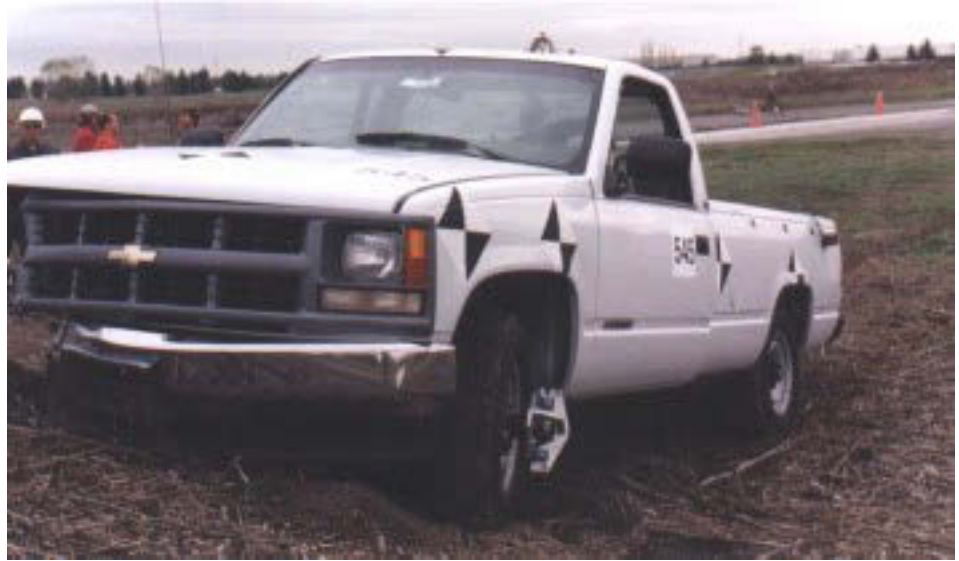
Figure 2-27 Post Impact Side of Test Vehicle 545

The vehicle received damage from the right front corner to the right rear corner, Figure 2-27. The right front and right rear wheel rims were deformed and the tires deflated. The left side wheels and tires were undamaged. The spare tire was forced from its undercarriage storage location and ended up about 15 m from the vehicle resting position.

The initial impact occurred on the right front quarter panel, resulting in substantial buckling and scraping, Figure 2-27. The right side of the bumper was pushed back about 260 mm. As the vehicle continued along the rail the entire right side was deformed where it contacted the bridge rail beam face. As a result, the right door did not operate due to moderate buckling and scraping. The truck bed was also scraped and buckled along the right side and the entire bed shifted to the right 40 mm. The tailgate did not function but the hood and left door were left in good condition and were operable. The roof of the truck did not have any signs of buckling. The windshield was cracked but remained mounted. The left and rear windows were not cracked.

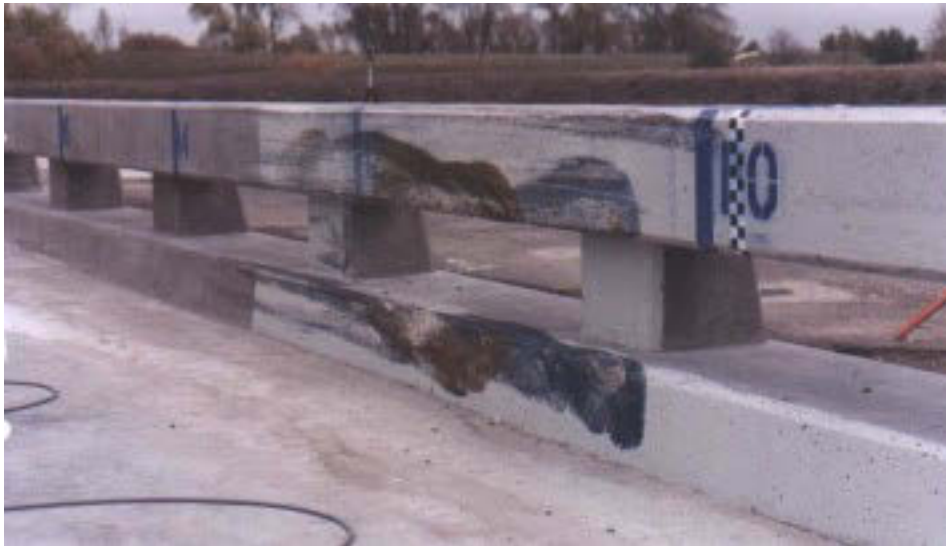
Figure 2-31 Test 545 Impact Area

The barrier received minor scraping and spalling, mainly at the lower edge of the beam section. Other barrier damage was cosmetic only, consisting of scrapes and tire marks. Both of the right side tires left marks along the face of the barrier.

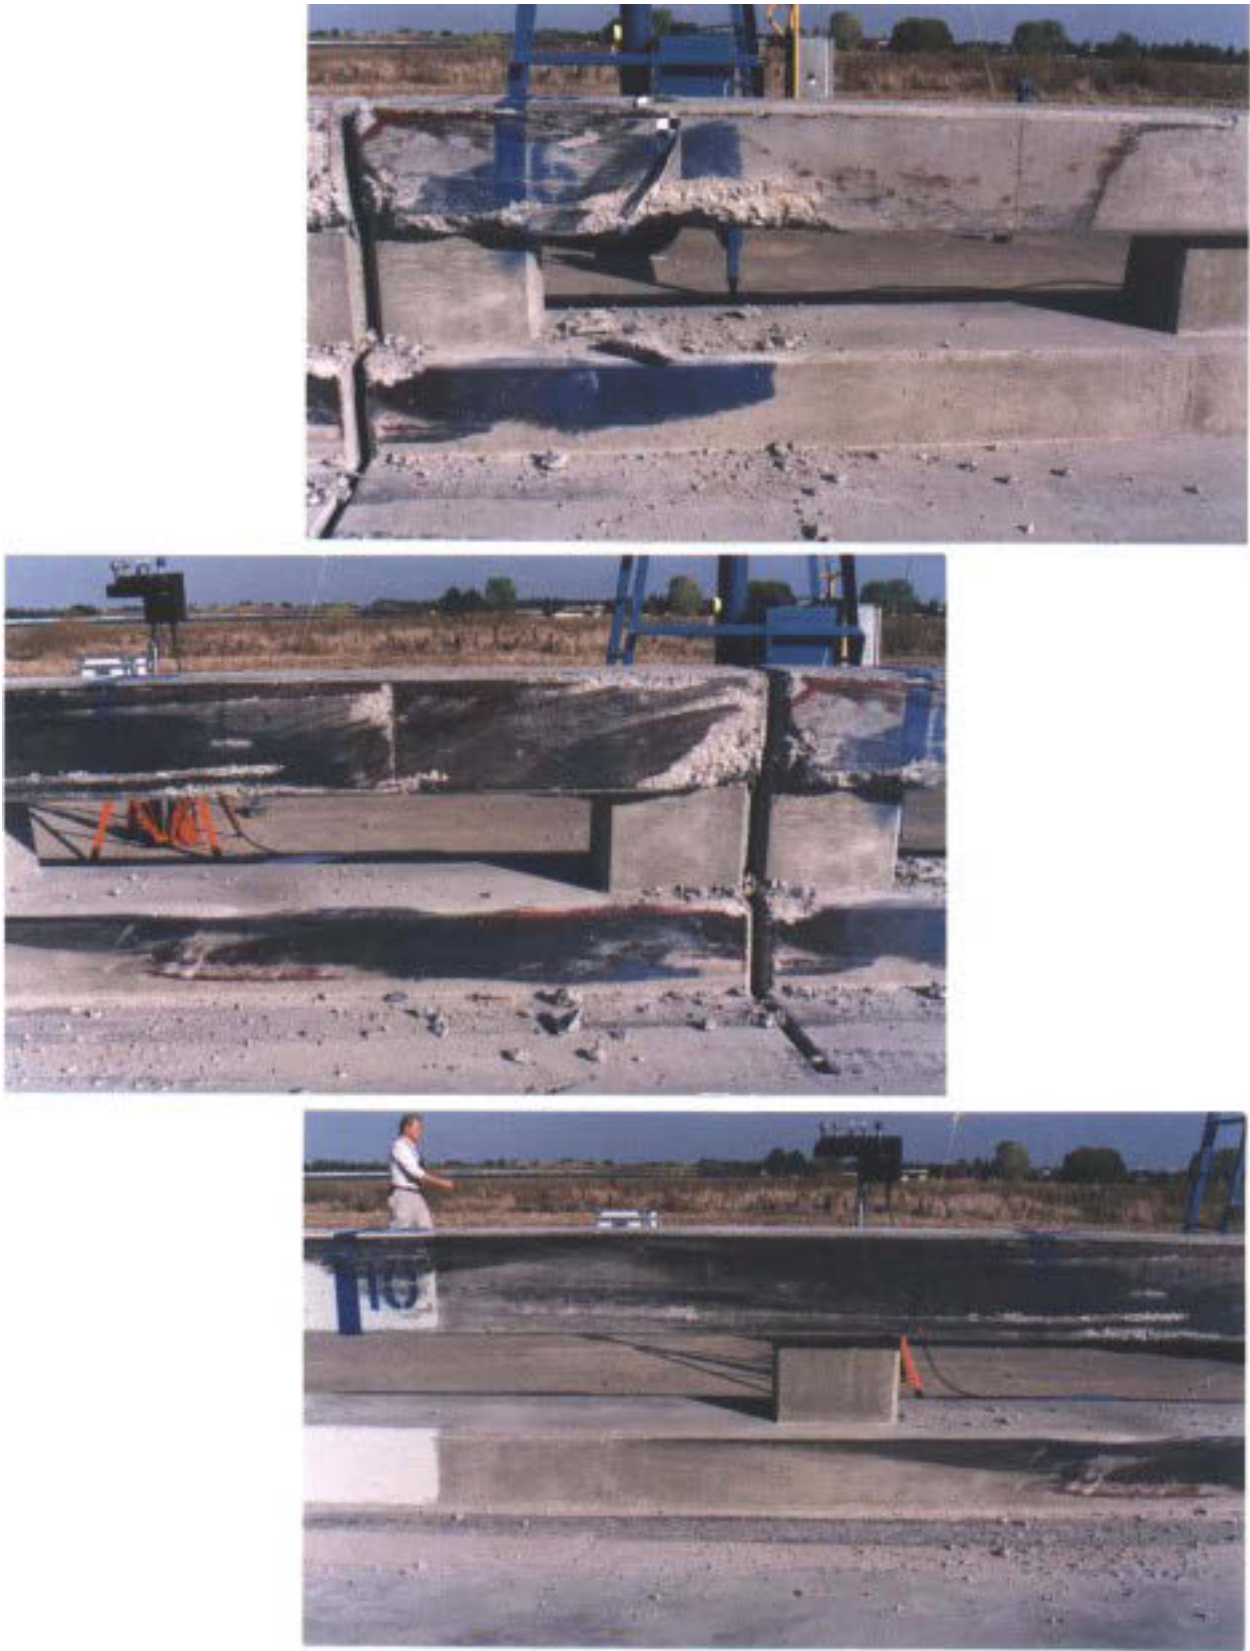
Figure 2-42 Close up of Impact Area

The bridge rail was scraped along the curb and beam section face leaving exposed patches of aggregate and concrete spalls. Most of the spalling occurred 0.75 m upstream of the expansion joint and at the expansion joint, Figure 2-42. The spalls were minor in nature and could be easily repaired. Additional marks were left on the bridge rail from the trucks tires. The right front and rear tires were painted blue and red, respectively.
