VEHICULAR CRASH TESTS OF
THE CALIFORNIA ST-20 BRIDGE RAIL
FINAL REPORT # FHWA/CA/SD/2004/01

July 2004

CALTRANS STUDY # 680323

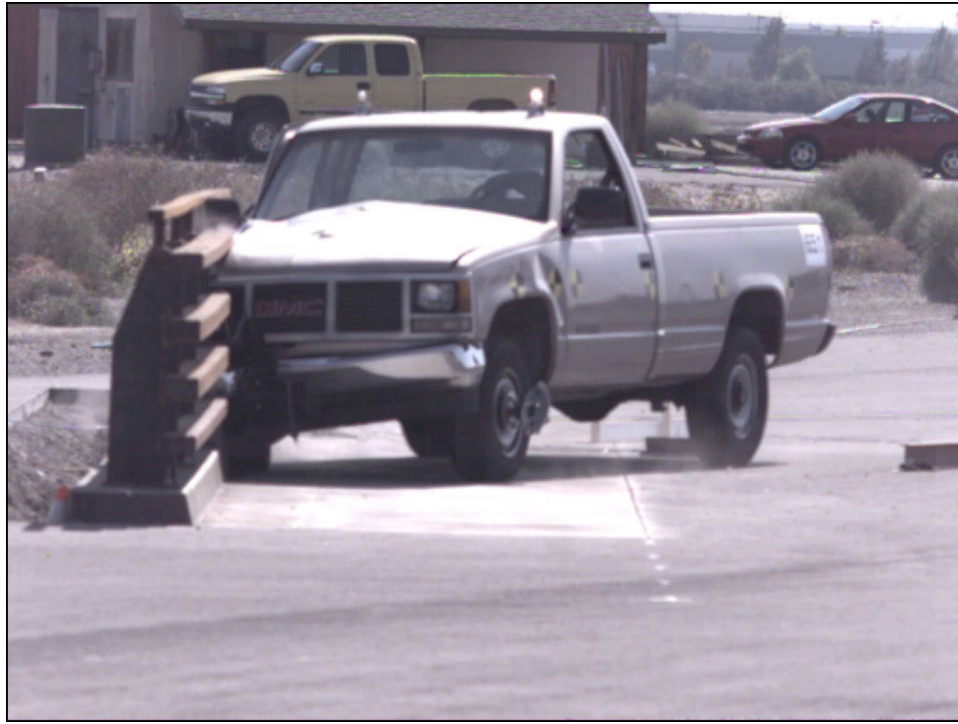
Figure 2-15 - Test 651 Hood Buckling, 66 ms After Impact

penetration. The impact speed and angle were 100.4 km/h and 26 degrees, respectively. At 15 ms past impact the hood and right fender started to buckle. The hood passed between the top two rail elements (excluding the handrailing) (Figure 2-15).

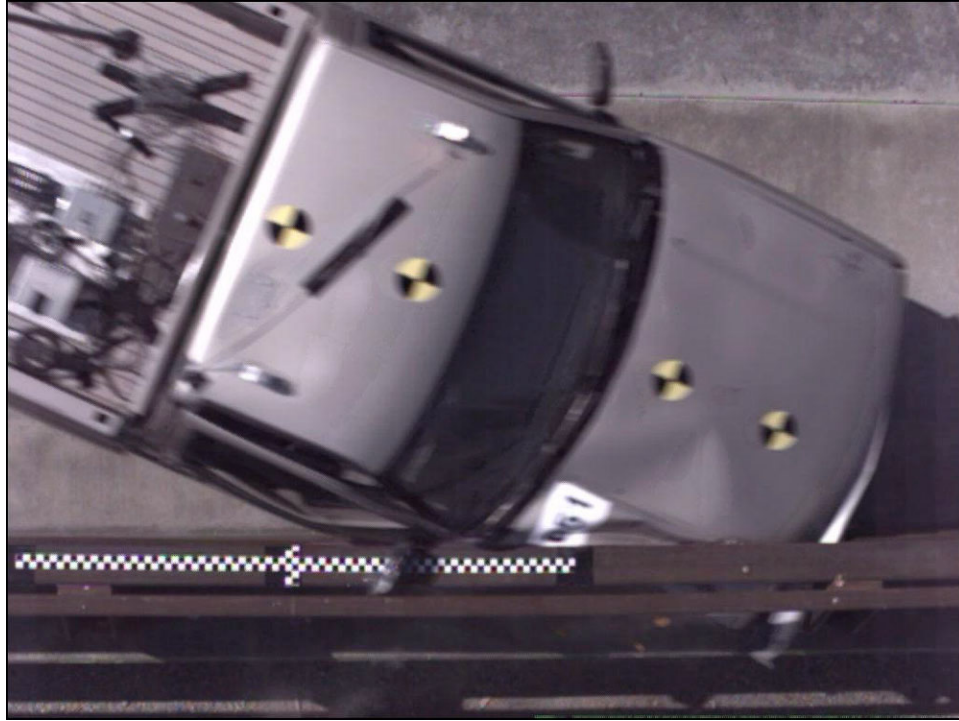
Figure 2-16 - Test 651 Maximum Hood Penetration, 64 ms After Impact

Maximum penetration of the hood occurred 64 ms after initial contact. From the overhead camera angle (see Figure 2-16), the hood penetrated 410 mm past the face of the barrier (or 320 mm past the face of the post). At 70 ms the hood contacted the third post. The leading edge of the hood started to pull away from the bridge rail as the back of the hood started to rotate back toward the windshield. A fold in the hood knocked the windshield wiper blade back, but did not penetrate the windshield. The hood lost contact with the third post 96 ms after impact.

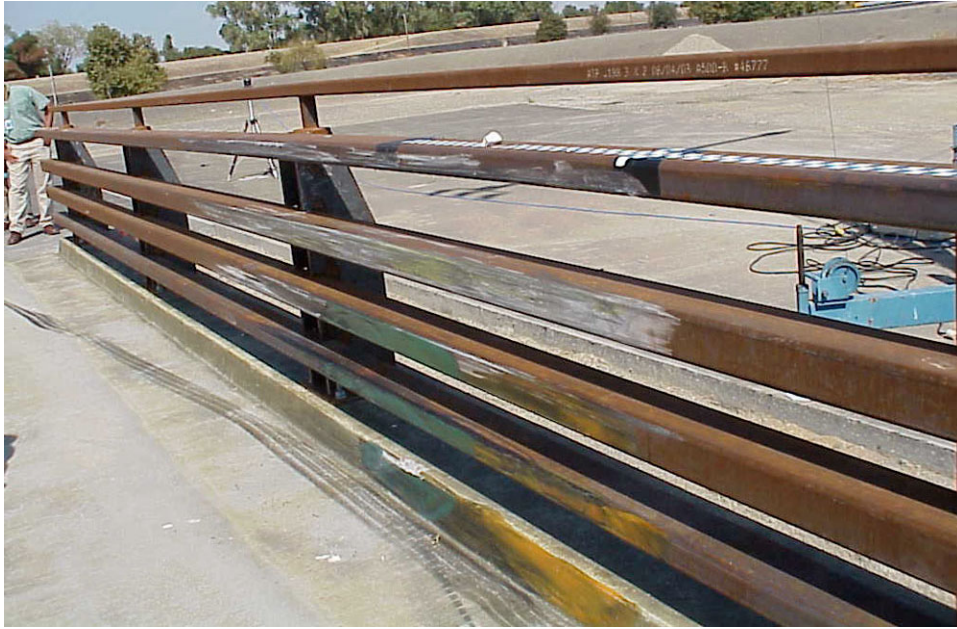
Figure 2-17 - Test 651 Rail Scuffing

Barrier damage was limited to minor spalling of the concrete curb and minor deflection of the rail. Rail deflections were measured mid-span between posts 2 and 3. The maximum dynamic deflection of the top rail of the ST-20 was 25 mm. The maximum permanent deflection of the barrier was 5 mm. Damage to the barrier was considered cosmetic and would not have required field repairs.

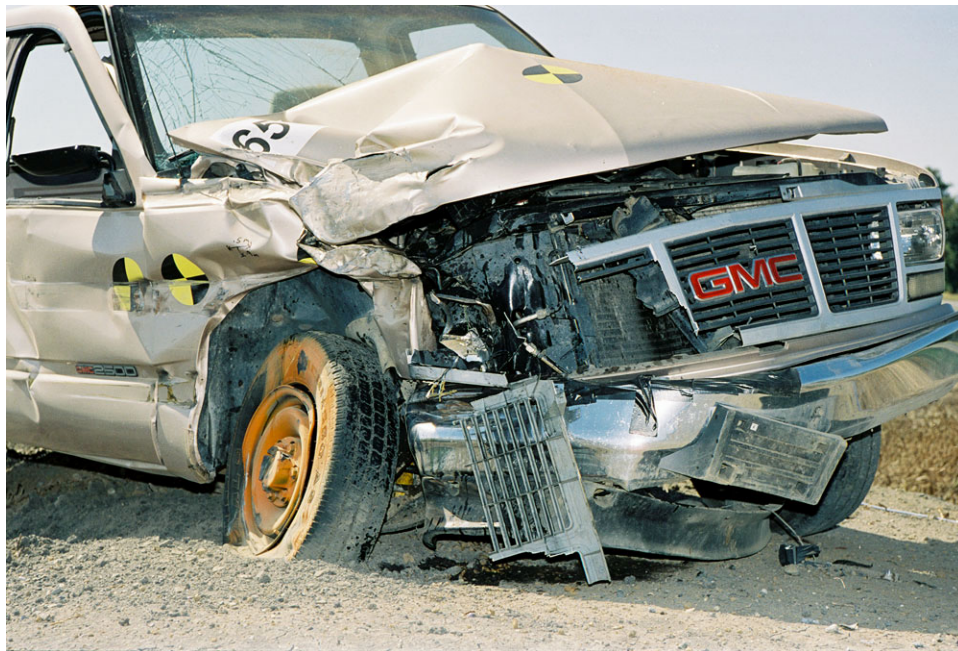
Figure 2-19 - Test 651 Vehicle Damage, Front Right Corner

The grill, bumper and hood sustained damage that indicates vehicle snagging (Figure 2-19). The right quarter of the grill was sheared off. The bumper was folded back. The right quarter of the hood was crumpled and pulled back toward the hinge. The hinge did not fail. The hood did not release from its latch. The front right tire was flat and the rim was damaged. Additionally, the wheel assembly was pushed back into the wheel well, eliminating the ability to steer the vehicle after the initial impact.

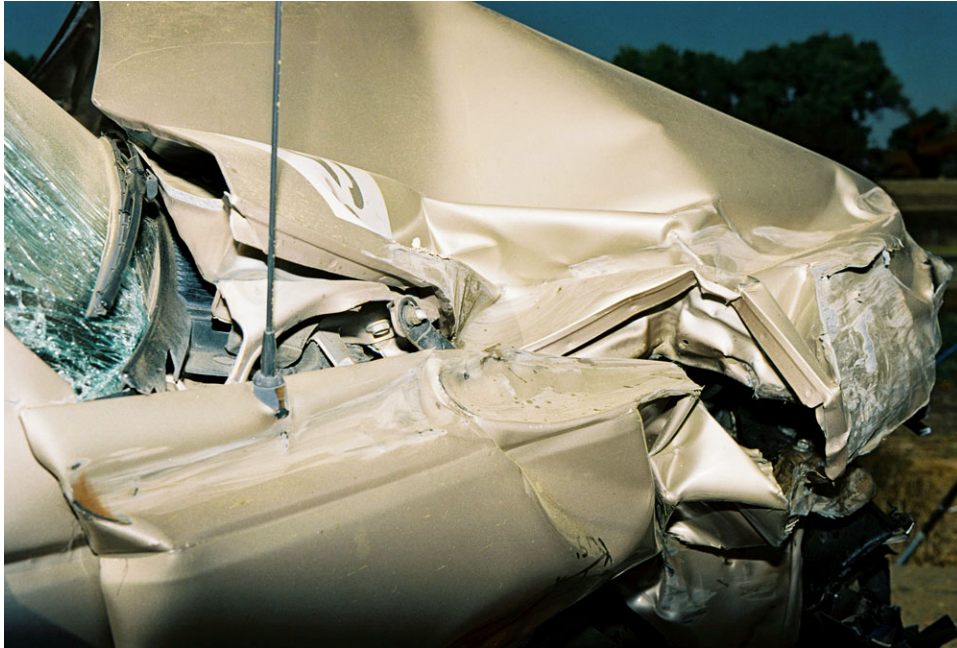
Figure 2-20 - Test 651 Vehicle Damage, Hood and Windshield

The windshield was severely cracked, but not penetrated (Figure 2-20). Cracks indicated that the windshield failed under flexure, instead of direct contact. The windshield wiper was pushed back and up.

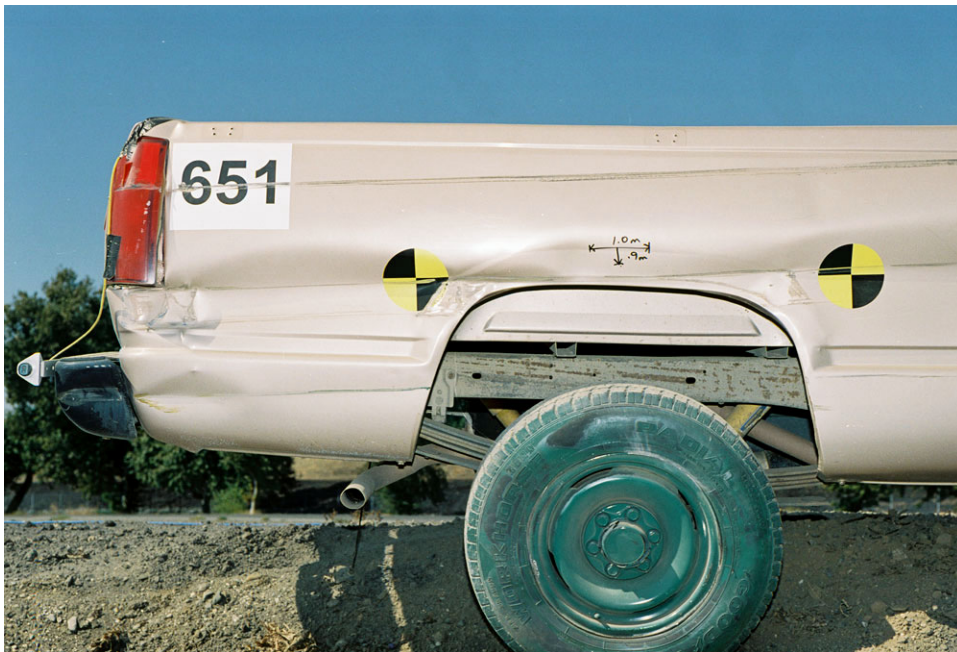
Figure 2-21 - Test 651 Vehicle Damage, Right Side of Truck Bed

The front right corner of the test vehicle sustained most of the damage. Additional damage also occurred to the windshield, the right side door, the side of the truck bed, and the floorboard of the passenger side of the cab.

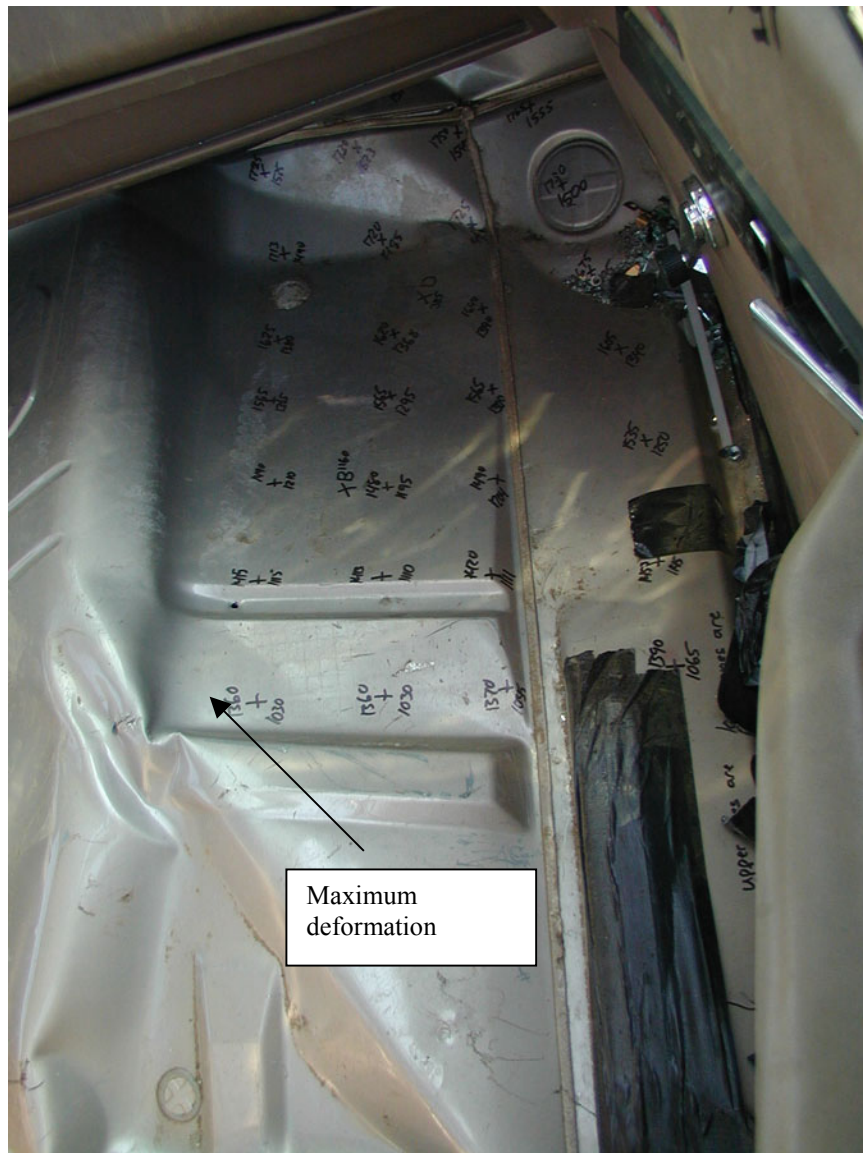
Figure 2-22 - Test 651 Vehicle Damage, Floor Deformation

The floorboard buckled due to the tire being pushed back in the wheel well (Figure 2-22). The maximum floorboard deformation was 25 mm and was located at the rise of the transmission hump midway between the front and rear of the cab.
