An Evaluation of Potential Effects on Old-Growth Redwoods
from Implementation of the Richardson Grove Operational
Improvement Project

August 14, 2015

Dennis Yniguez
Registered Consulting Arborist
Dennis@TreeDecisions.com
510-649-9291

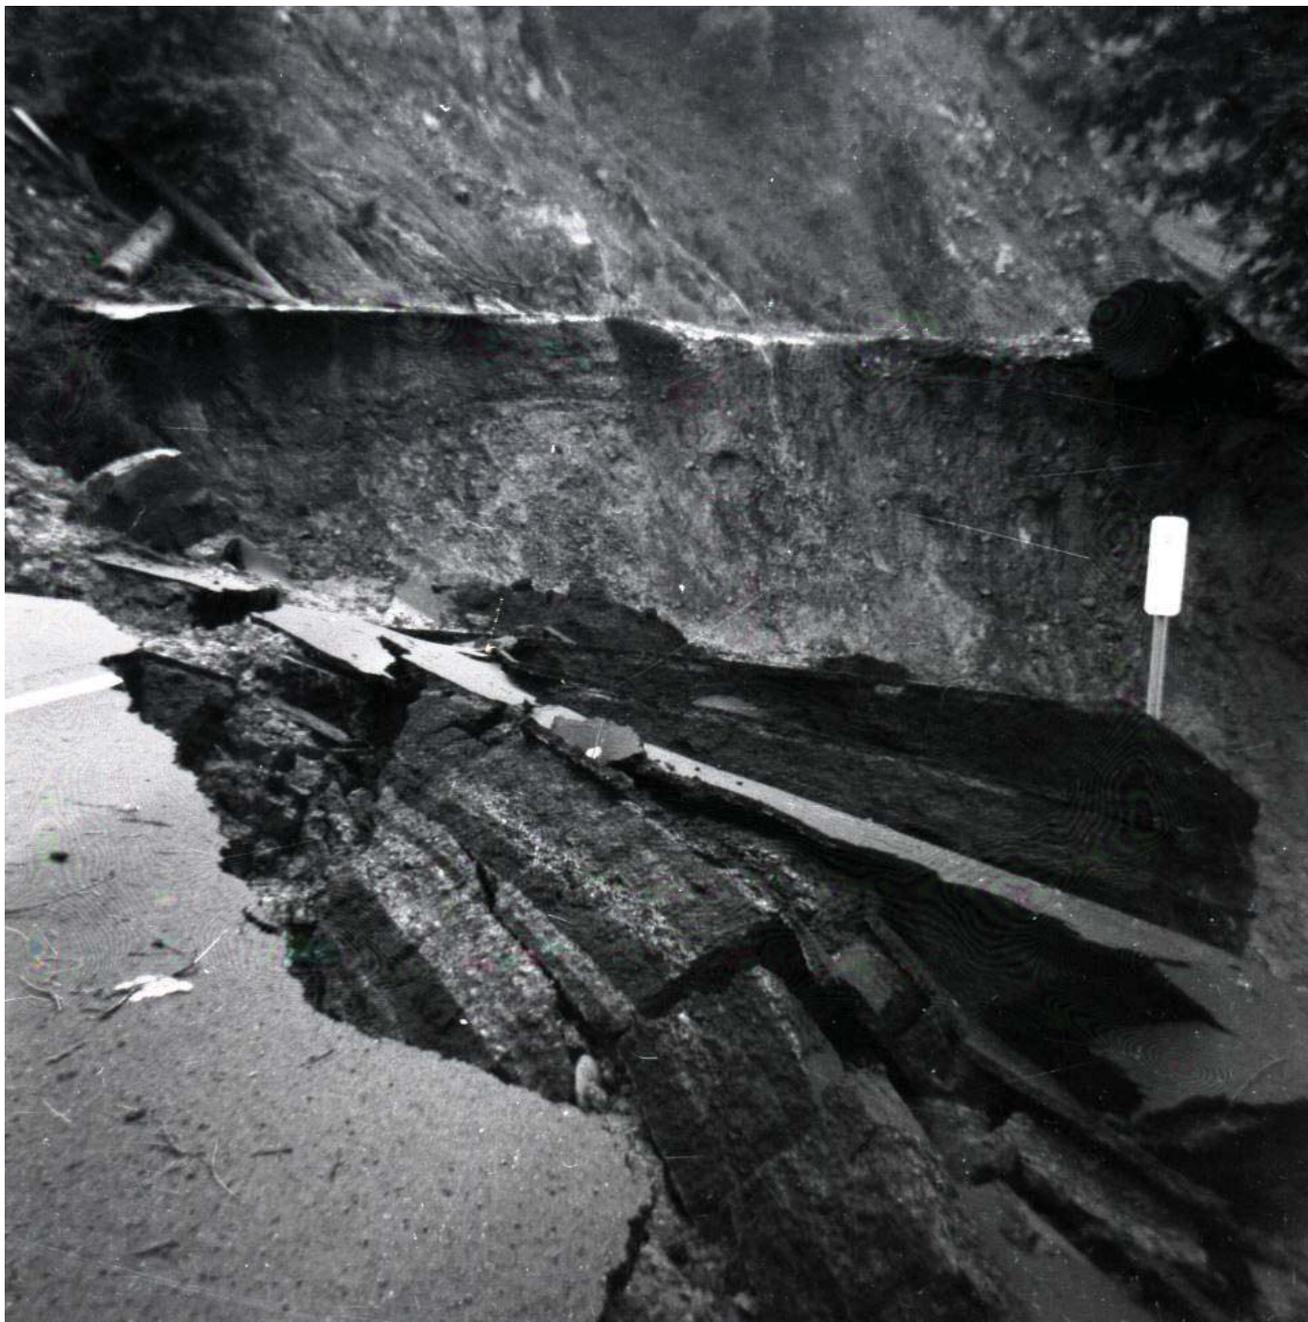
5. **December 1964:** U.S. Highway 101 flood washout in Richardson Grove reveals the depth of road material.
(Courtesy of California State Parks, 2011, Catalog #090-17559)

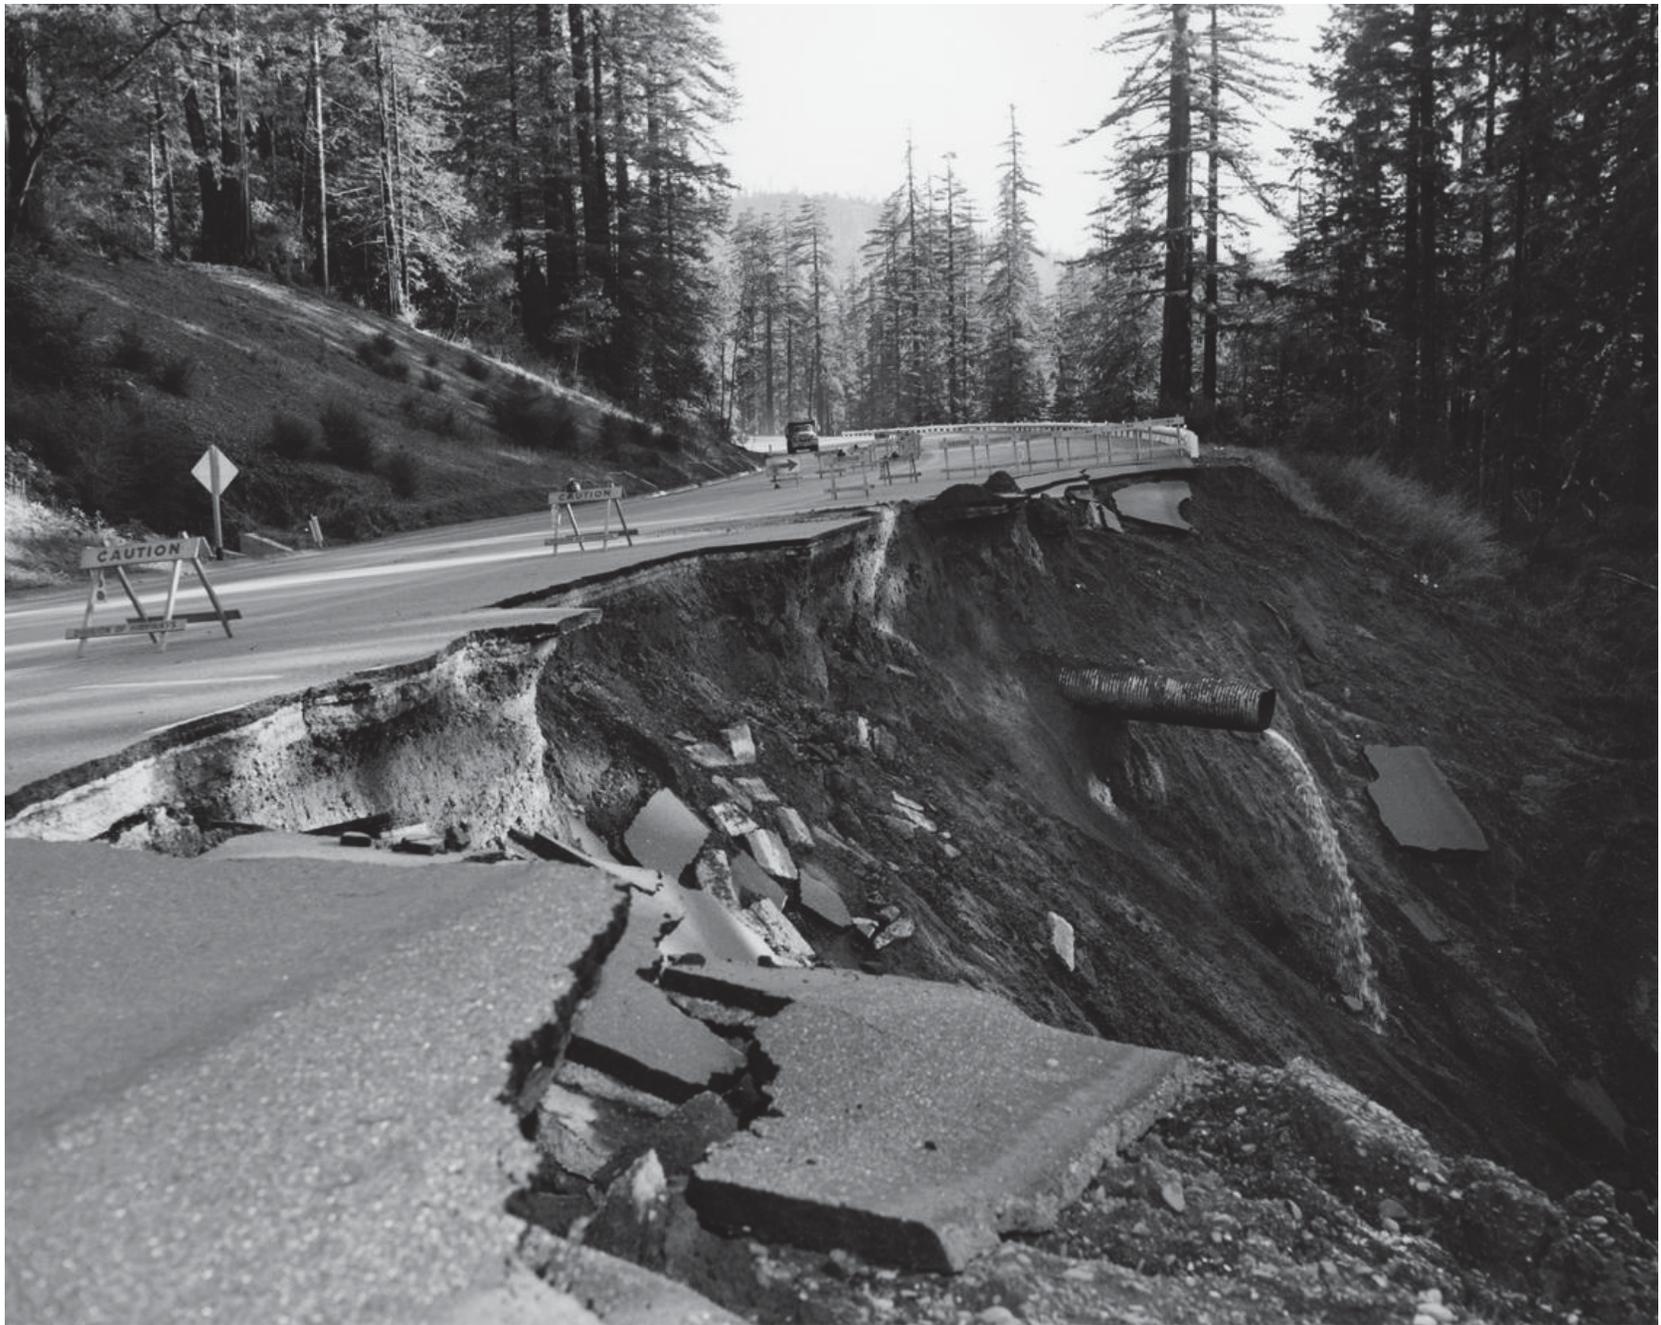
6. **January 1965:** U.S. Highway 101 flood washout near Myers Flat in Humboldt County reveals the depth of road material. (Caltrans Transportation Library and History Center, Sacramento)

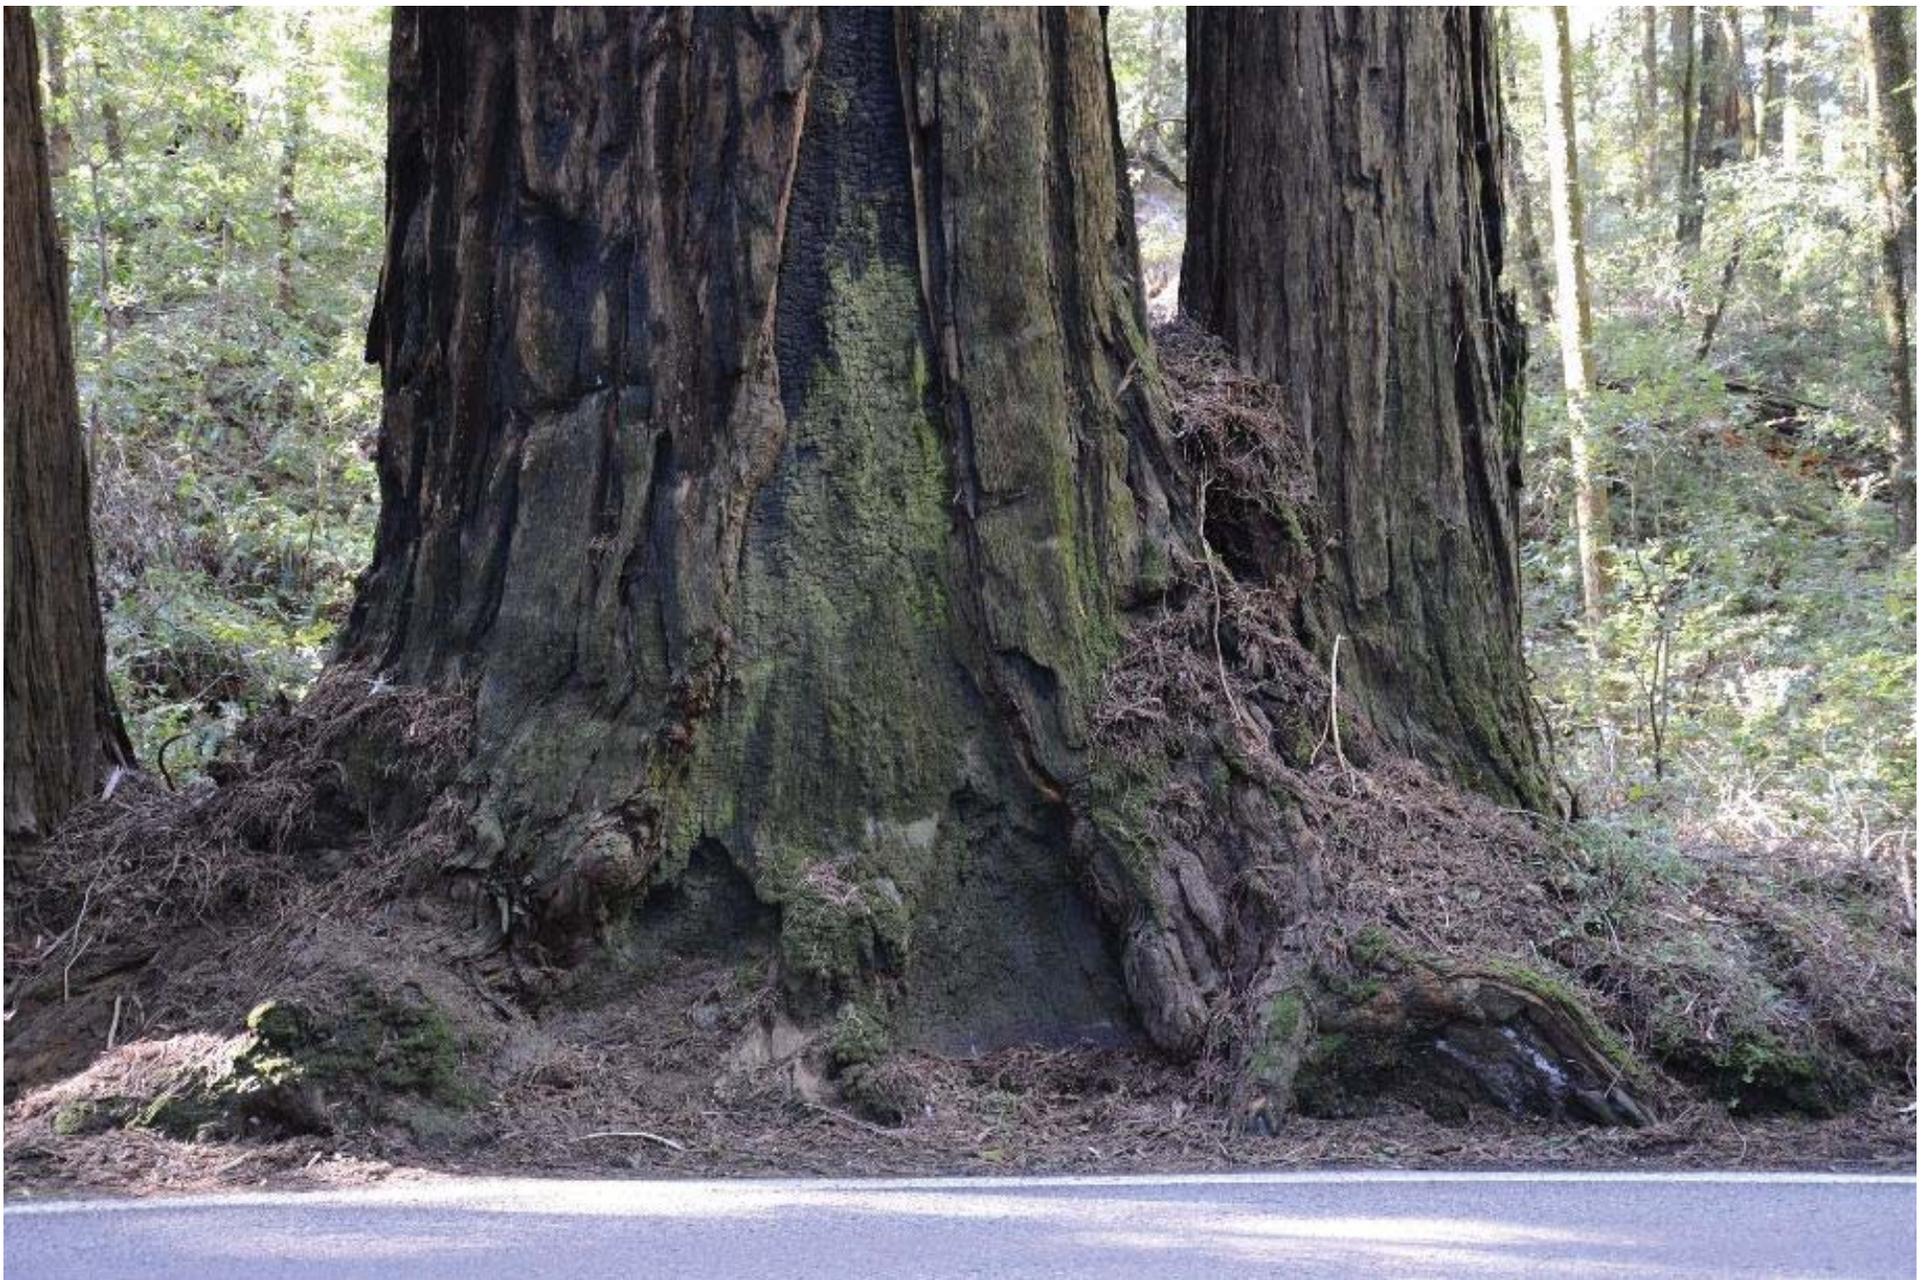
7. **2012:** Tree No. 20 alongside U.S. Highway 101 in Richardson Grove. Very large buttress roots were severed for highway construction, causing the top of the tree to dry out and form a "spike top." No buttress roots of old-growth redwoods would be severed during the Richardson Grove Operational Improvement Project.

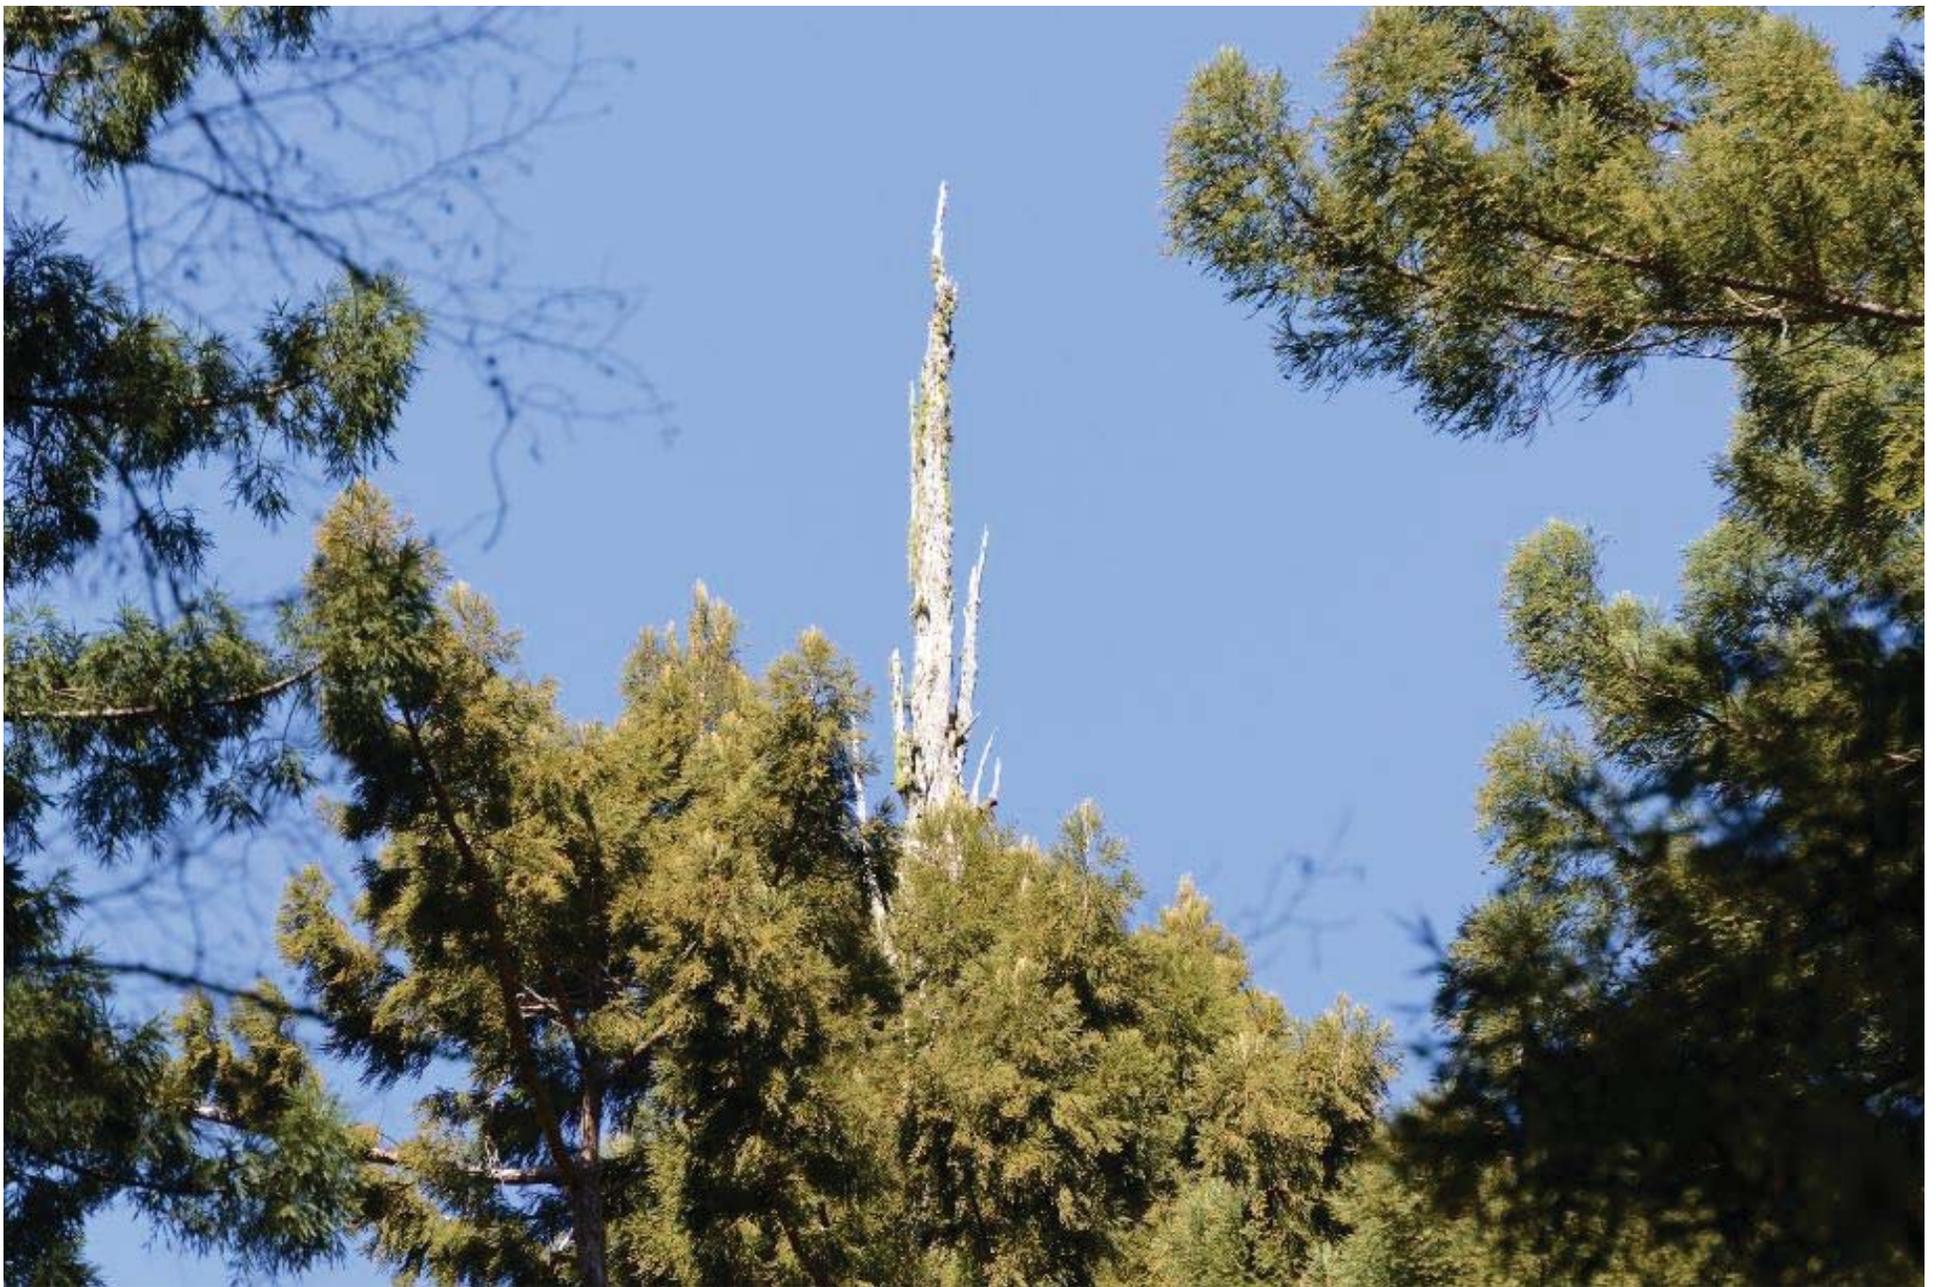
8. **2012:** Top of Tree No. 20, showing a "spike top" most likely caused by severance of major buttress roots several decades ago during highway construction. No buttress roots of old-growth redwoods would be severed during the Richardson Grove Operational Improvement Project.

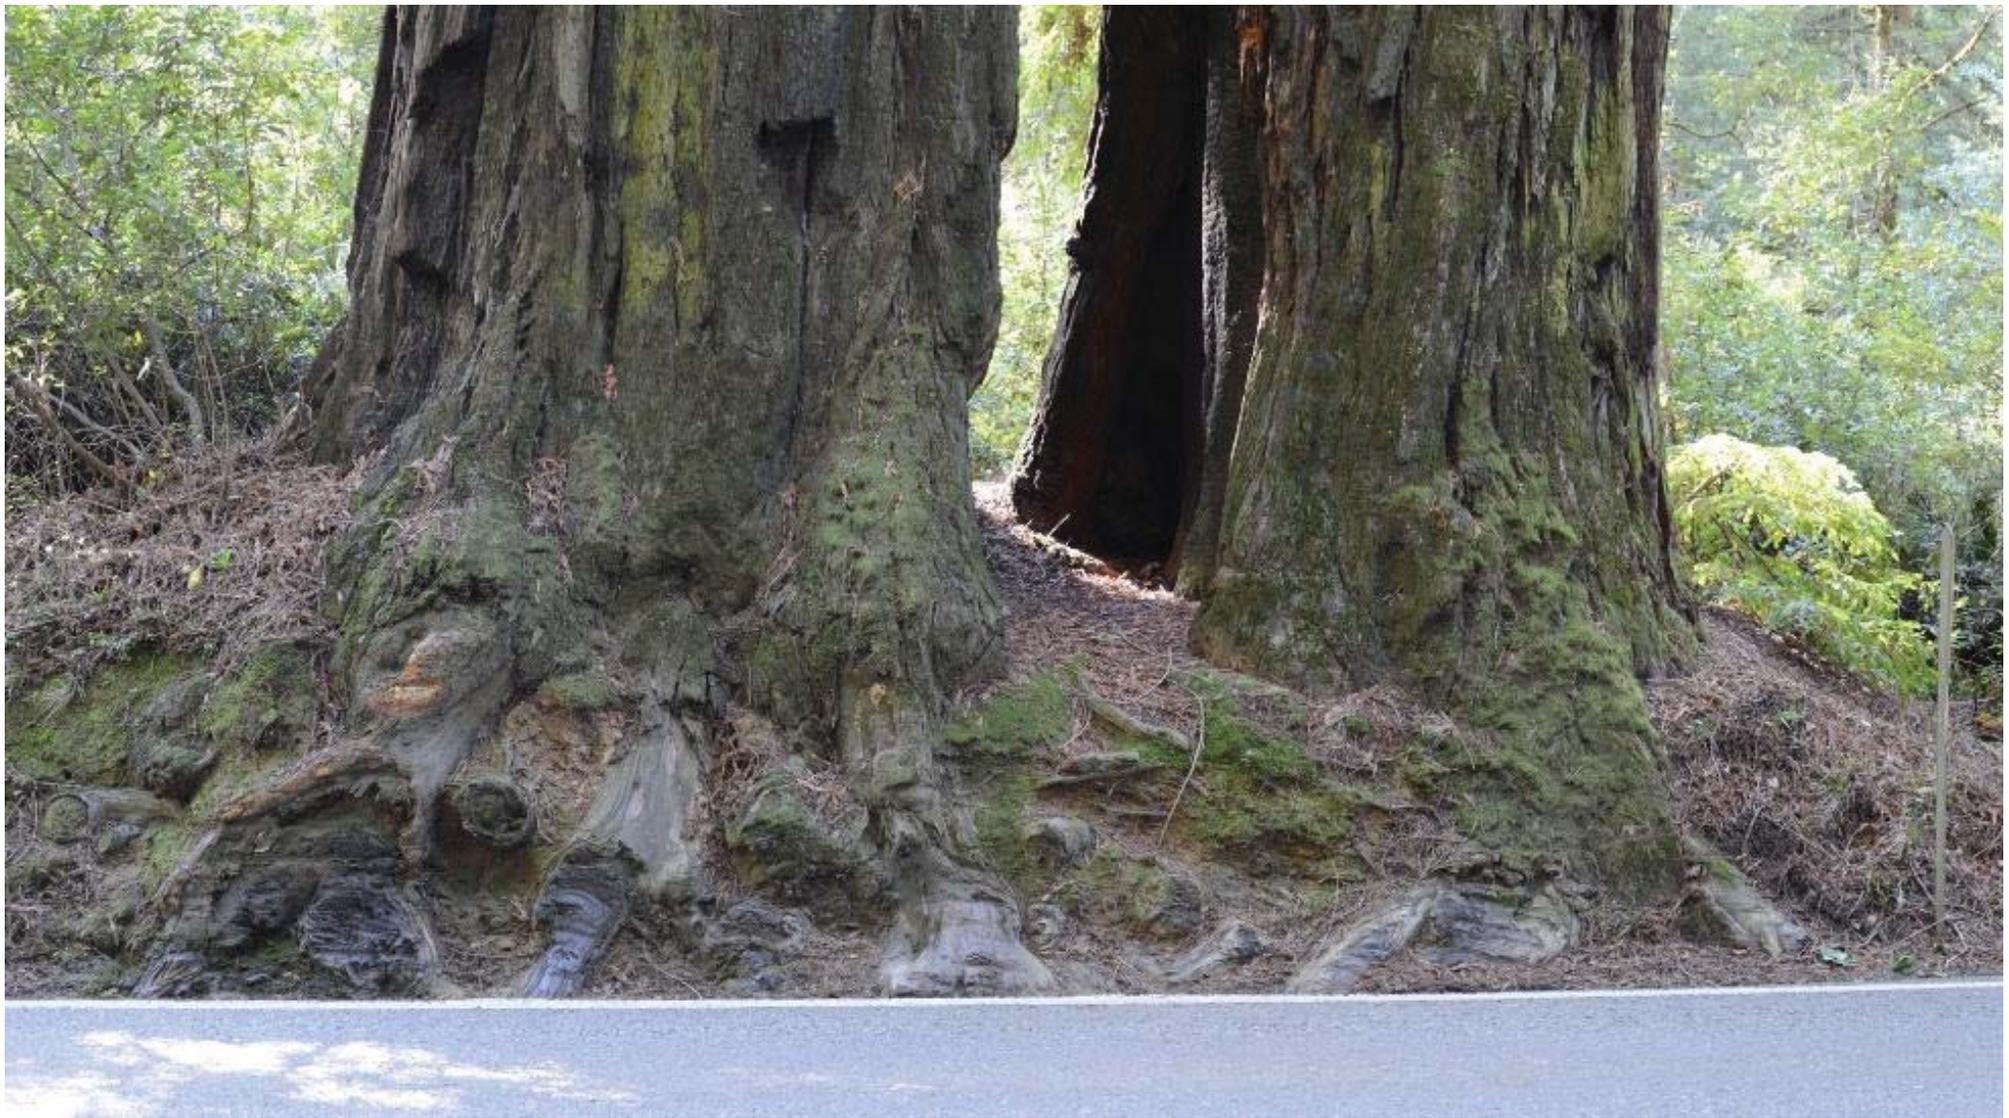
9. **2012:** Trees No. 89 and 90 alongside U.S. Highway 101 in Richardson Grove. Several decades ago, very large buttress roots of these redwoods were severed for highway construction, causing the topmost part of the trees to dry out and form a "spike top." No buttress roots of old-growth redwoods would be severed during the Richardson Grove Operational Improvement Project.

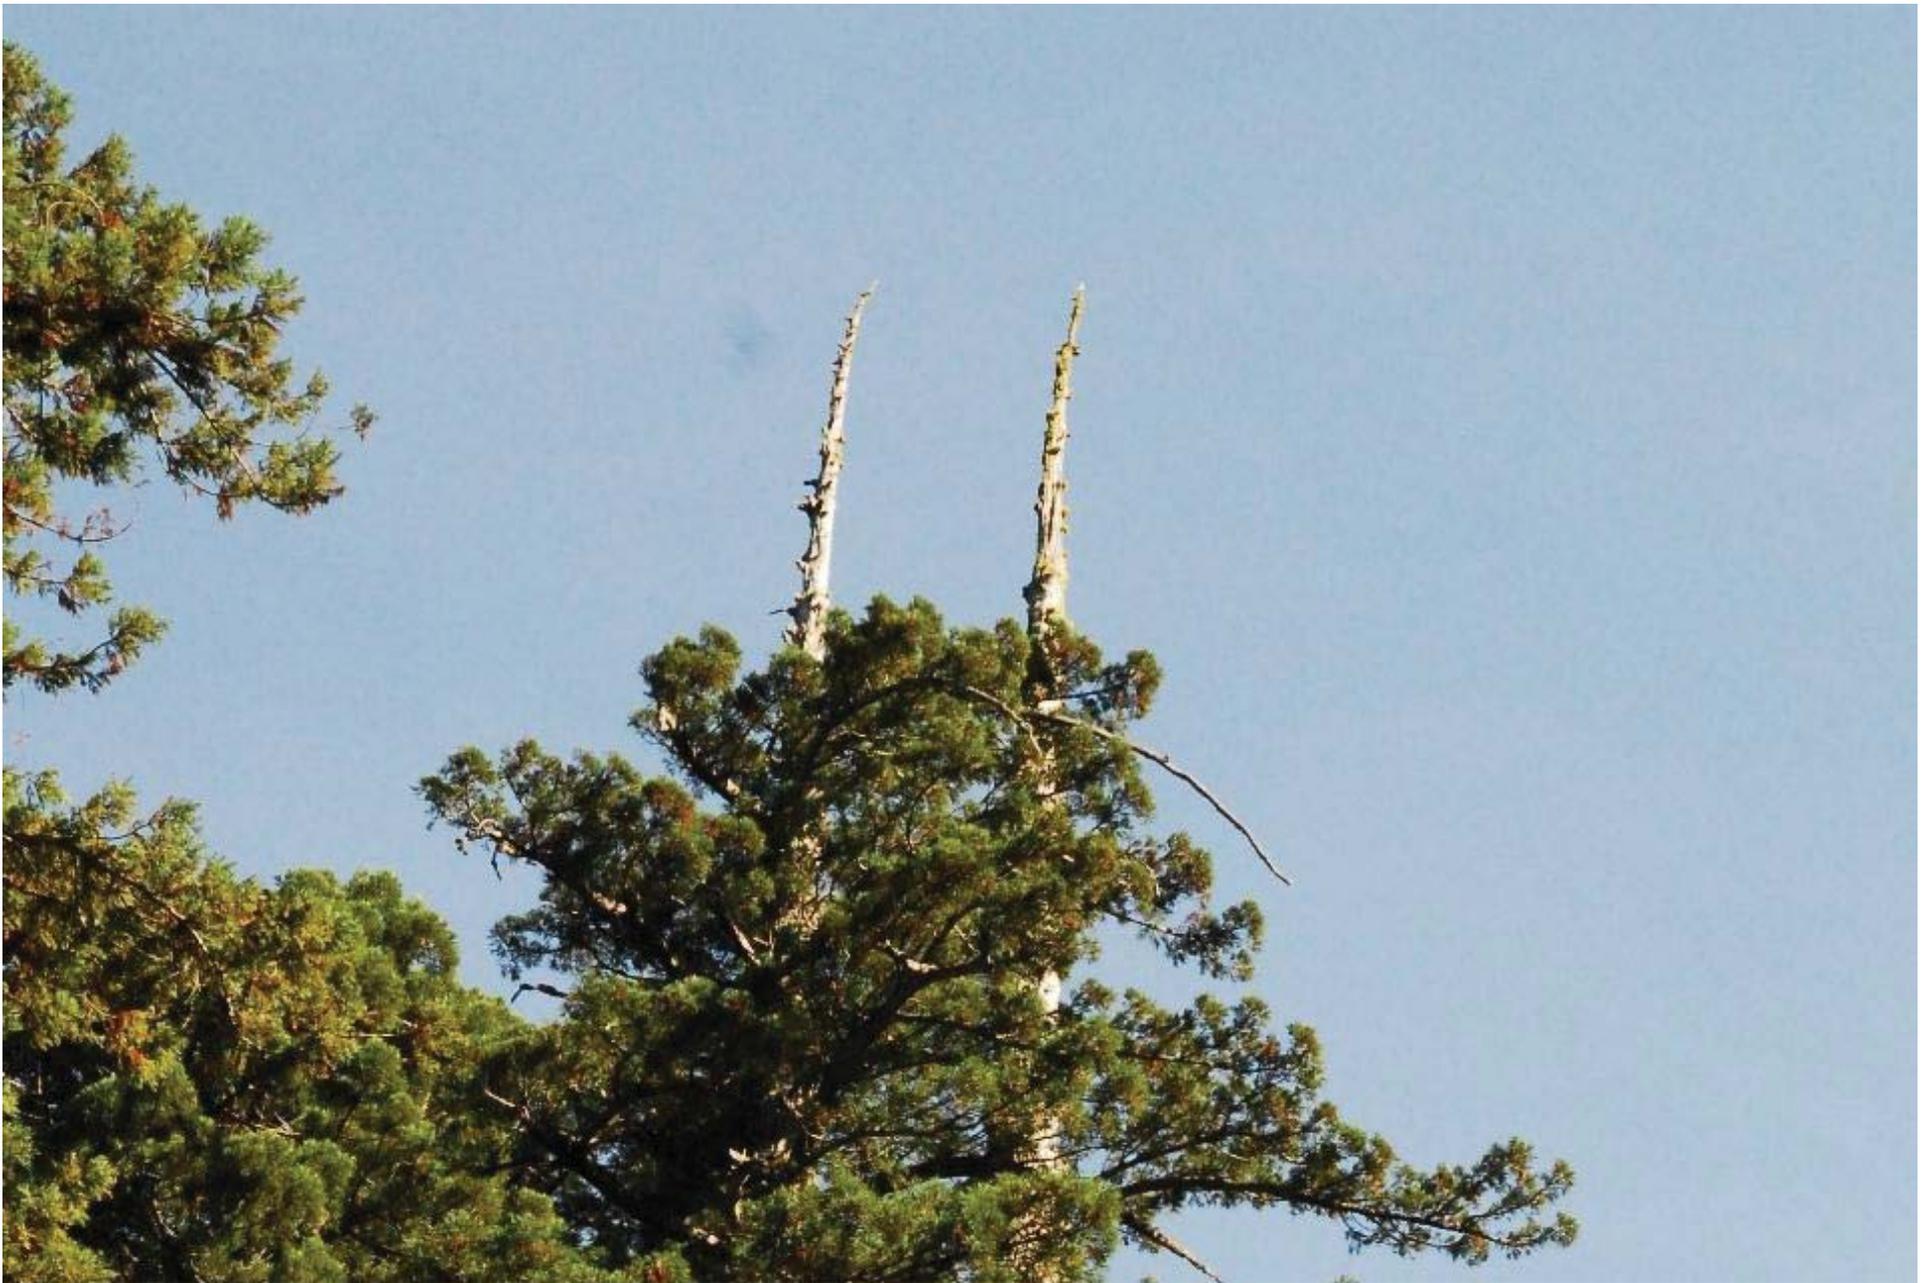
10. **2012:** The tops of Trees No. 89 and 90 showing "spike tops" apparently caused by severance of major buttress roots during highway construction. No buttress roots of old-growth redwoods would be severed during the Richardson Grove Operational Improvement Project.

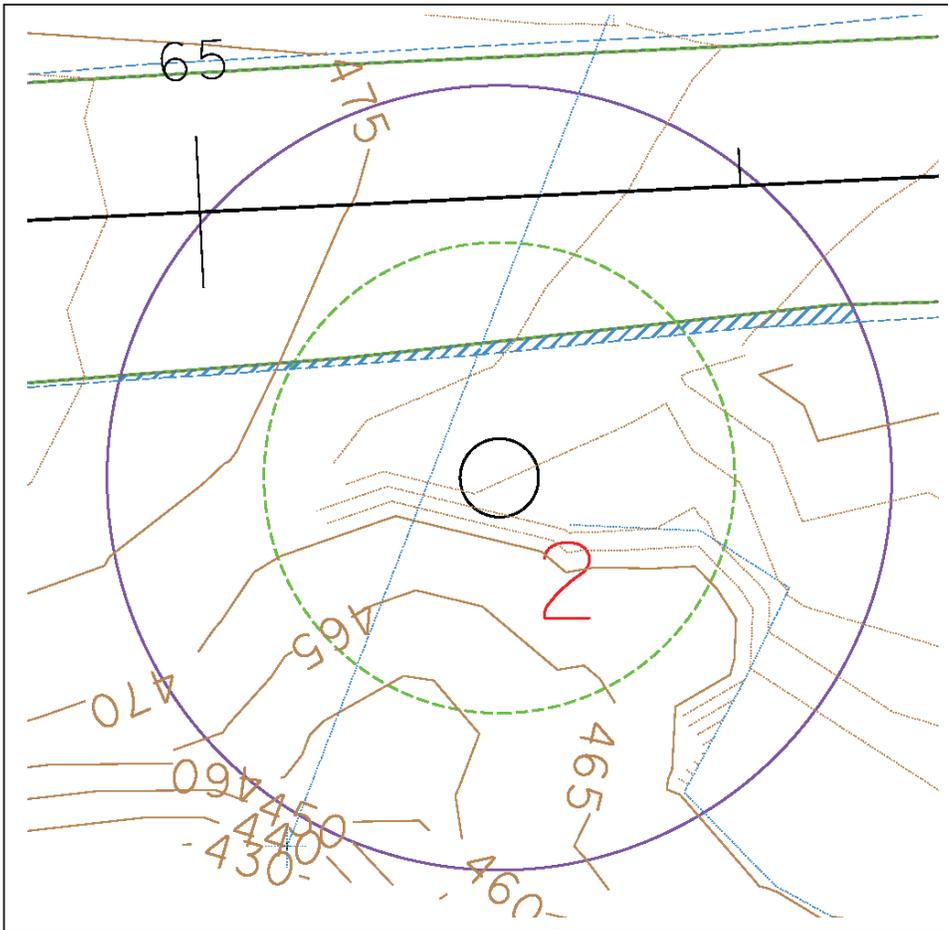
Description: Tree #2, 87 inches DBH (depicted in Attachment A, Sheet 3). Tree base appears to have been struck by a vehicle, and the root flare is not visible.

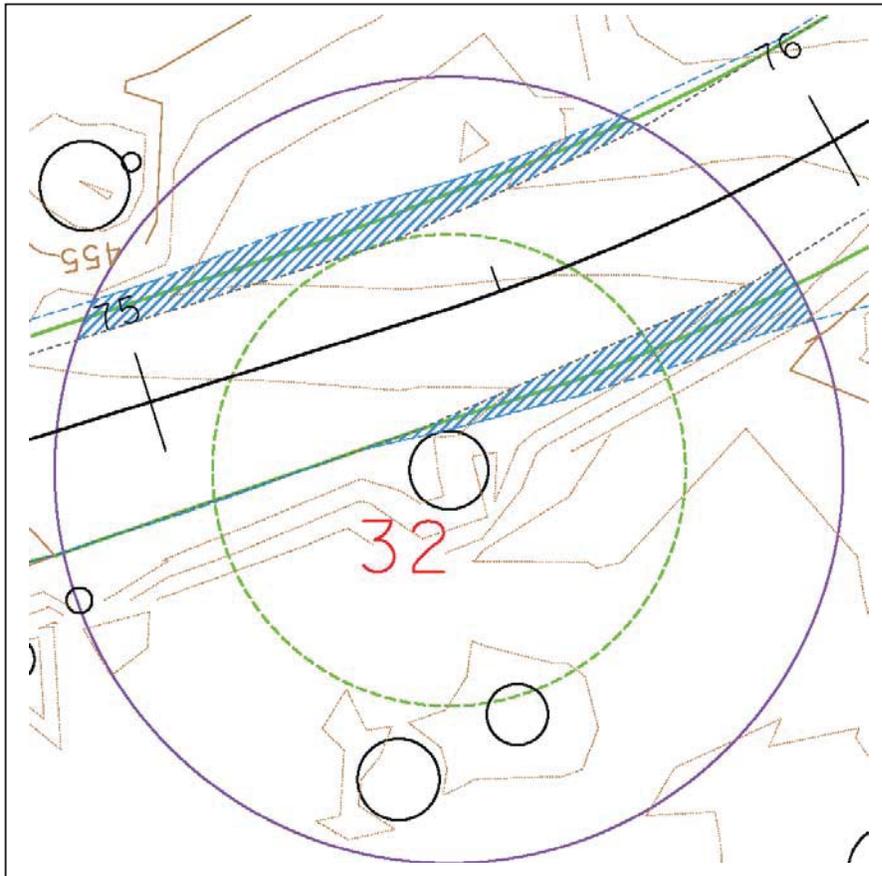
Description: Tree #32, 129 inches DBH (depicted in Attachment A, Sheet 7). Tree has two trunks. The base of tree is at the edge of road; root flare has never been cut.

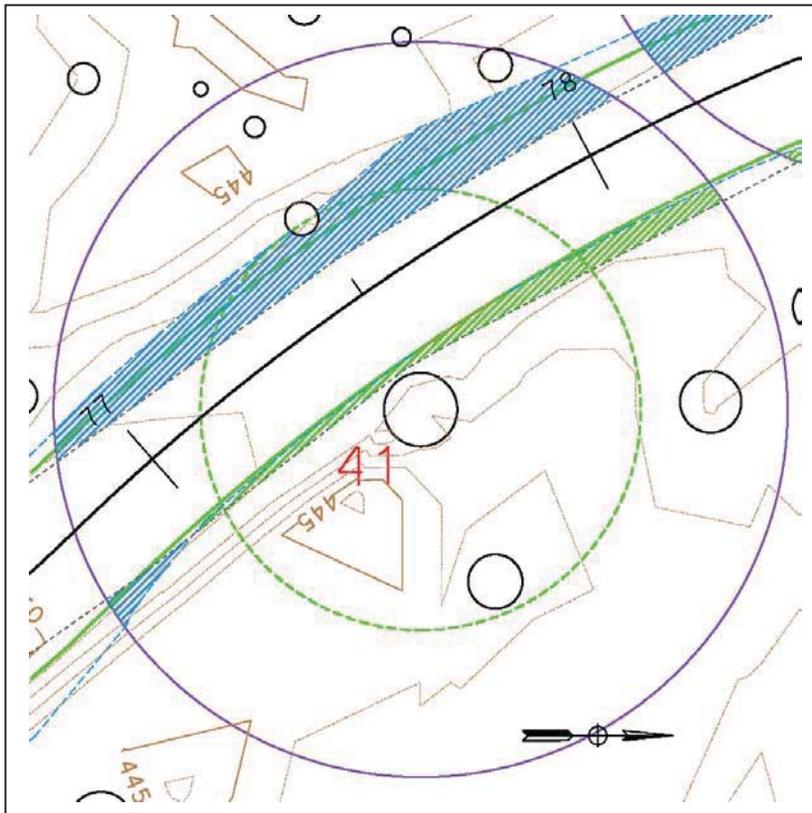
Description: Tree #41, 165 inches DBH (depicted in Attachment A, Sheet 7). Tree is next to road, and base and lower trunk appear to have been struck by a vehicle.

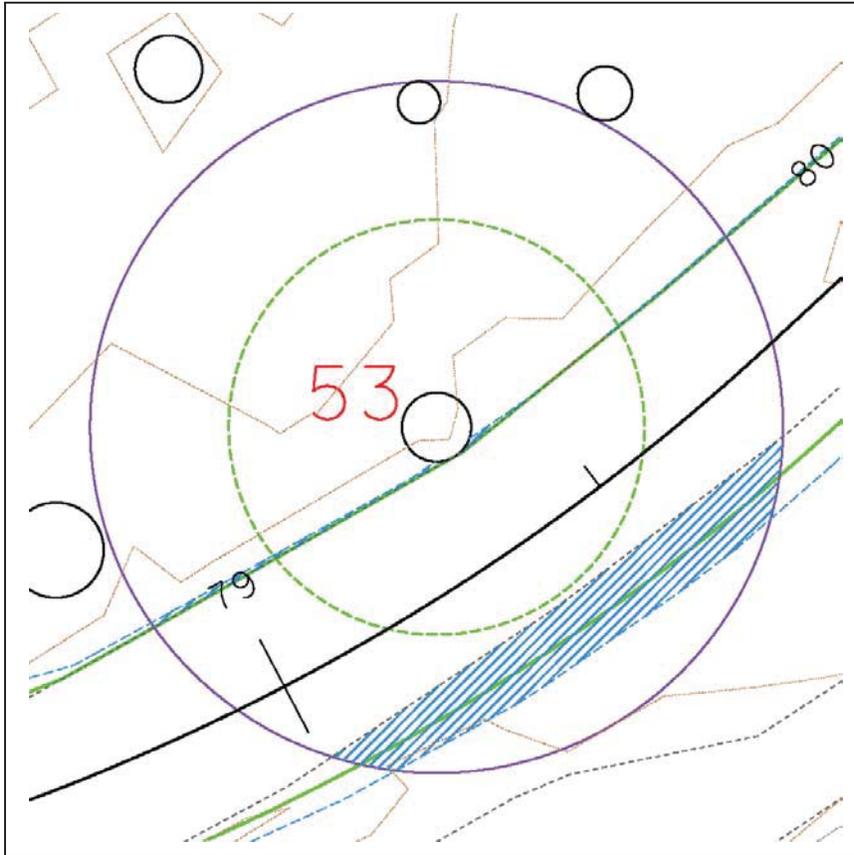
Description: Tree #53, 111 inches DBH (depicted in Attachment A, Sheet 8). Tree appears to have been struck by vehicles; basal flare was apparently cut for road installation, but crown is in very good condition.

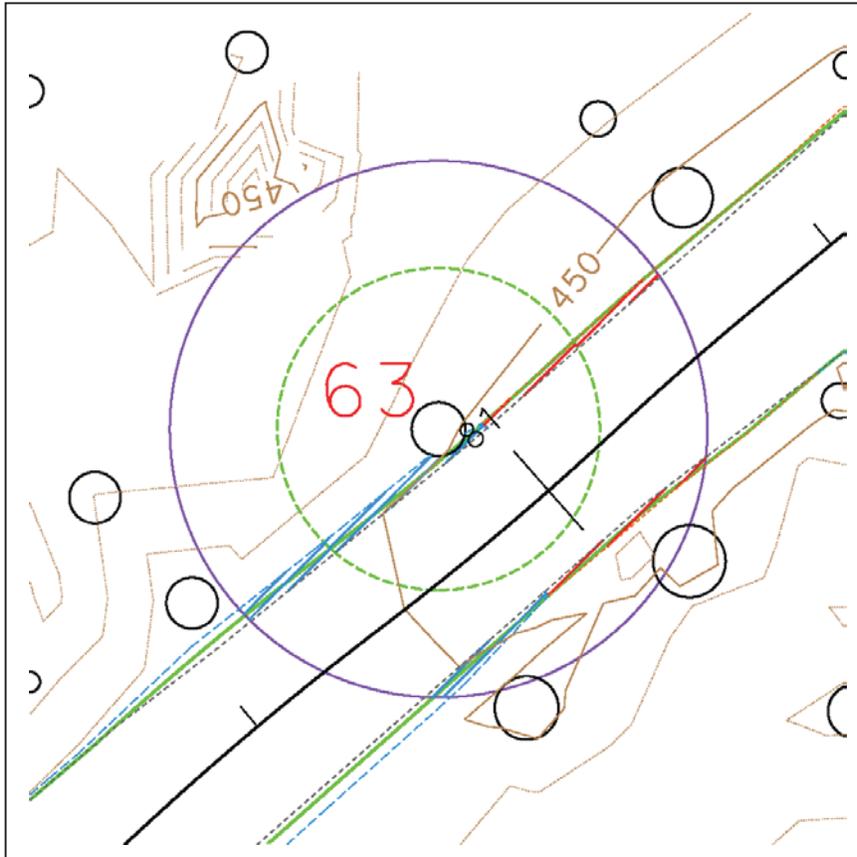
Description: Tree #63, 86 inches DBH (depicted in Attachment A, Sheet 9). Basal flare of tree may have been cut when road was constructed; tree appears to have been struck by vehicles.

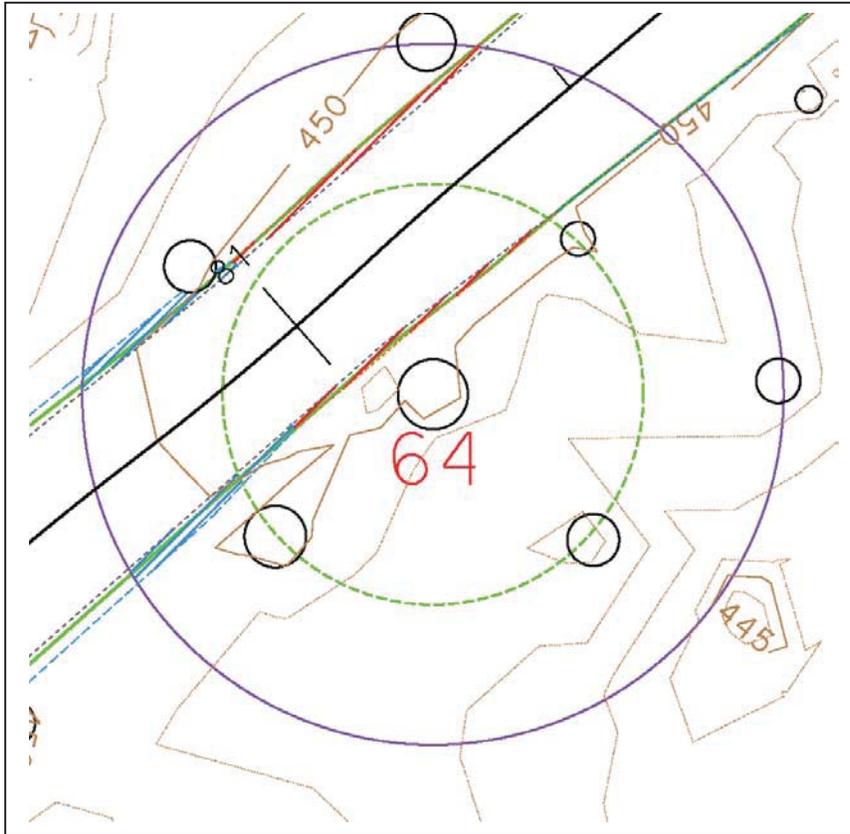
Description: Tree #64, 116 inches DBH (depicted in Attachment A, Sheet 9). Root flare of tree has been cut back at edge of road.

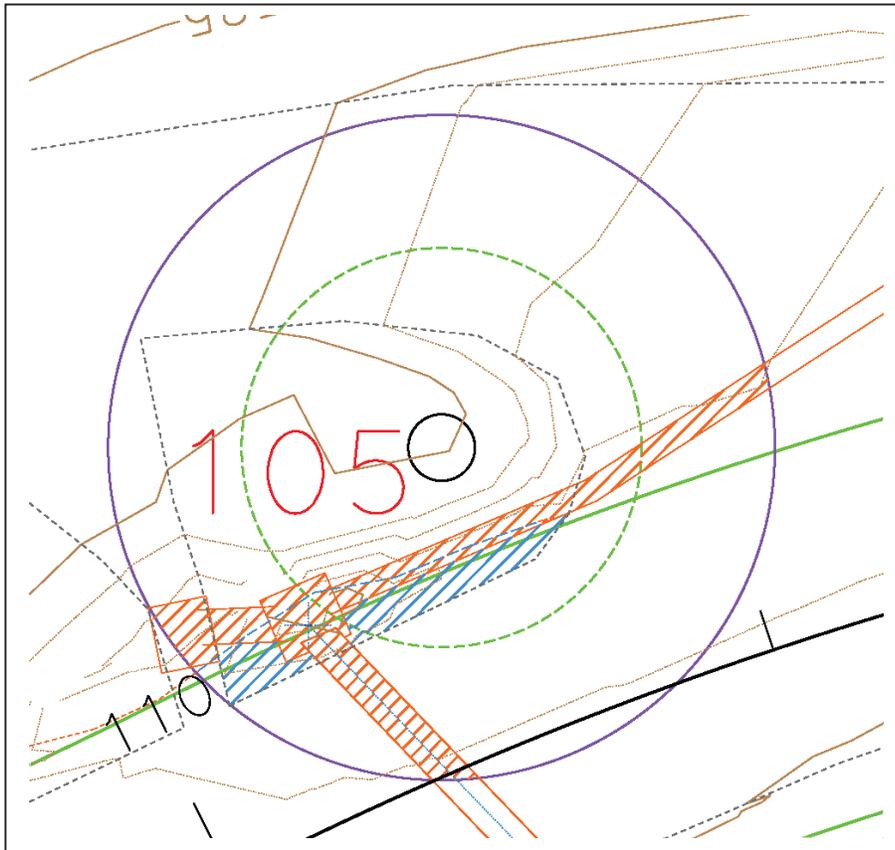
Description: Tree #105, 68 inches DBH (depicted in Attachment A, Sheet 19). Tree is growing outside of the state park on a raised mound of earth that is adjacent to private and public roadways. The buttress flare does not appear to be severed or buried and the crown appears healthy.
