# CALIFORNIA BRIDGE ENGINEERS SEMINAR

Presentation 4 - Innovative Independent Quality Assurance for Fracture-Critical Bridge Members

# Innovative Independent Quality Assurance for Fracture-Critical Bridge Members

Maged Armanuse, Office Chief  
Office of Quality Assurance and Source Inspection  
Division of Engineering Services

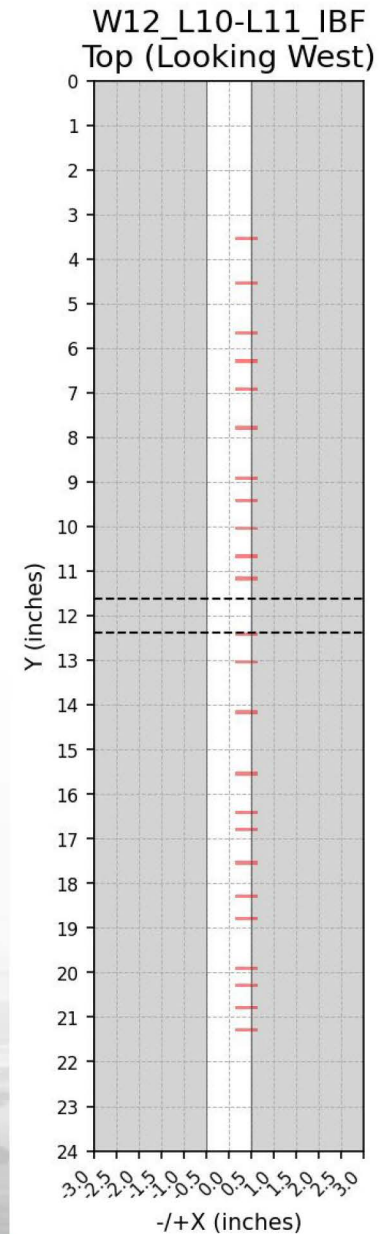
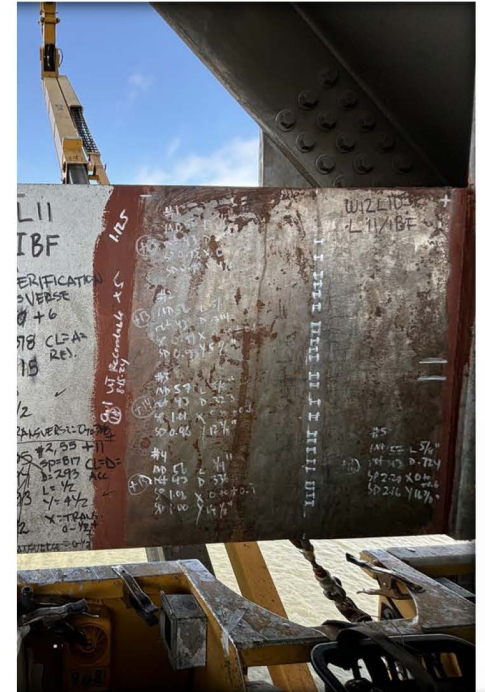
- PAUT and refined weld depictions revealed linear indications within base metal (not weld flaws).
- Confirmed by microscopy and cross-checking with inspection data.
- Documented and separated from weld rejects to avoid unnecessary repairs.
- Findings guided a refined inspection strategy for similar cases.

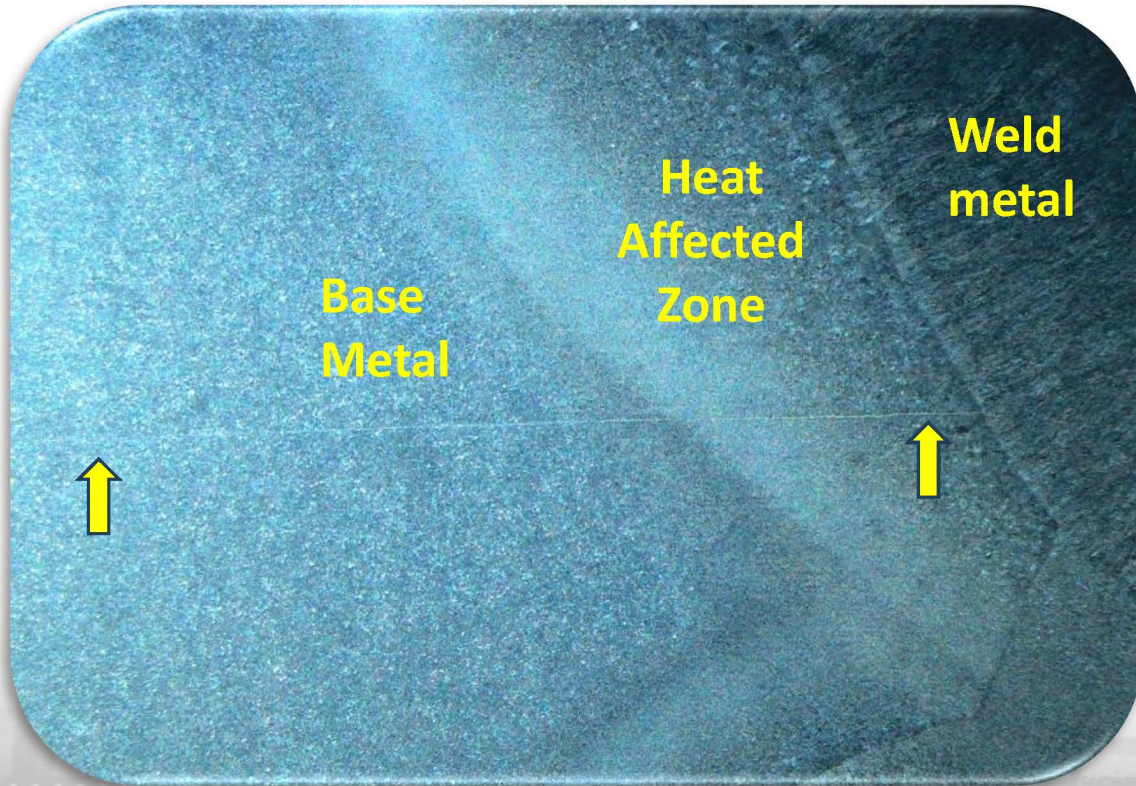
Magnification 1x

## Base metal indications (San Mateo Bridge)

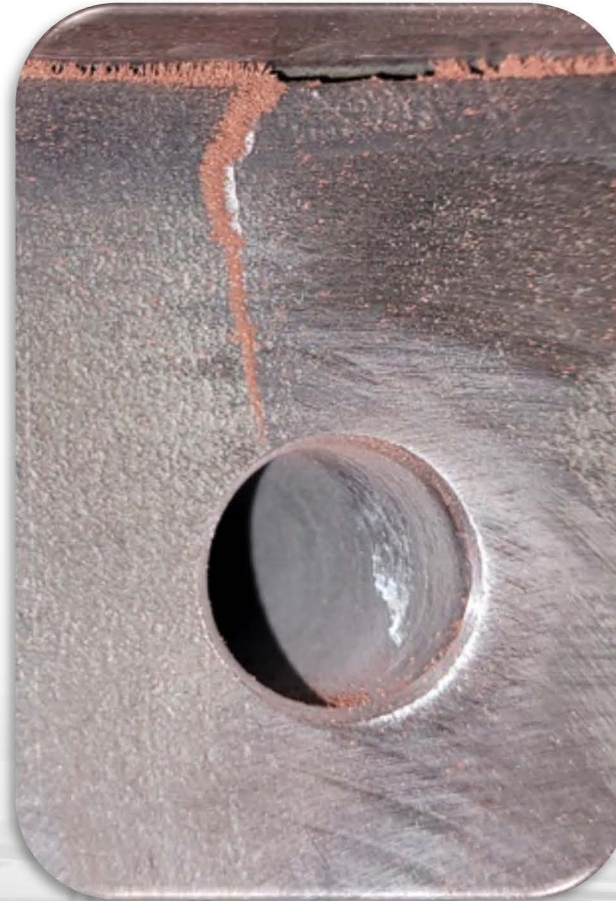
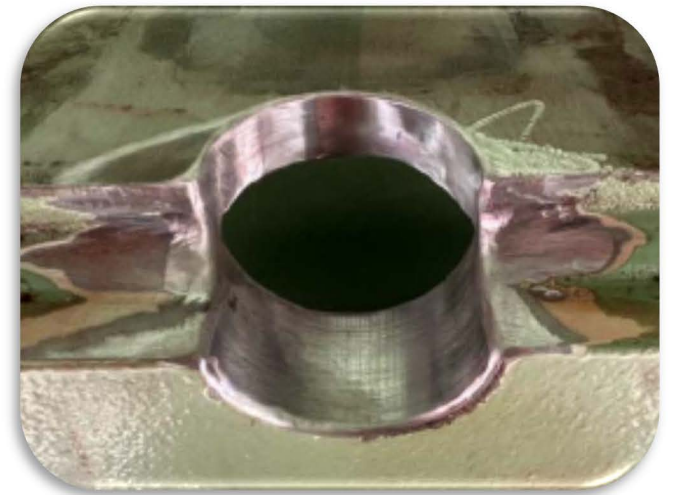
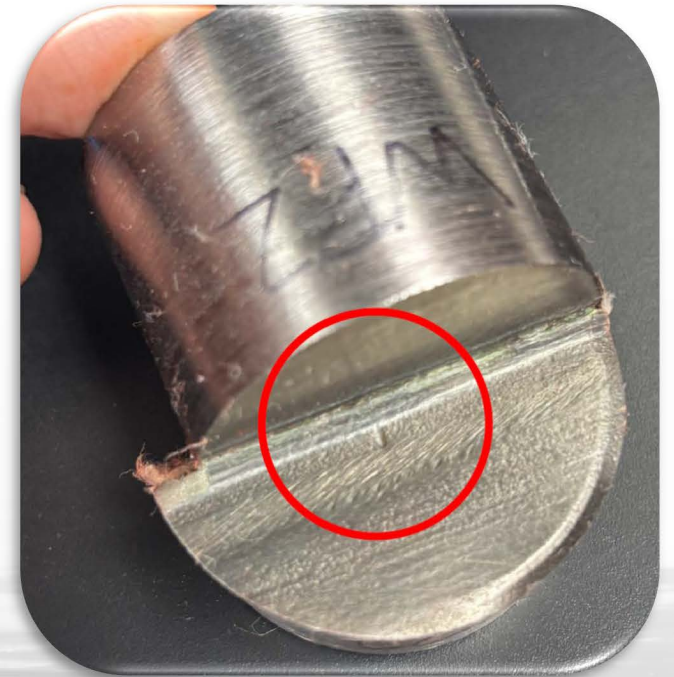
- Auburn-Foresthill Bridge
- Surface breaking linear indications
- Potential Hydrogen Cracking
  - Consistent with FHWA memo
