**Summary of SFOBB East Span Eye Bar Failure Analysis**

March 17, 2010

04-0G8404

SFOBB Emergency Eye Bar Repair

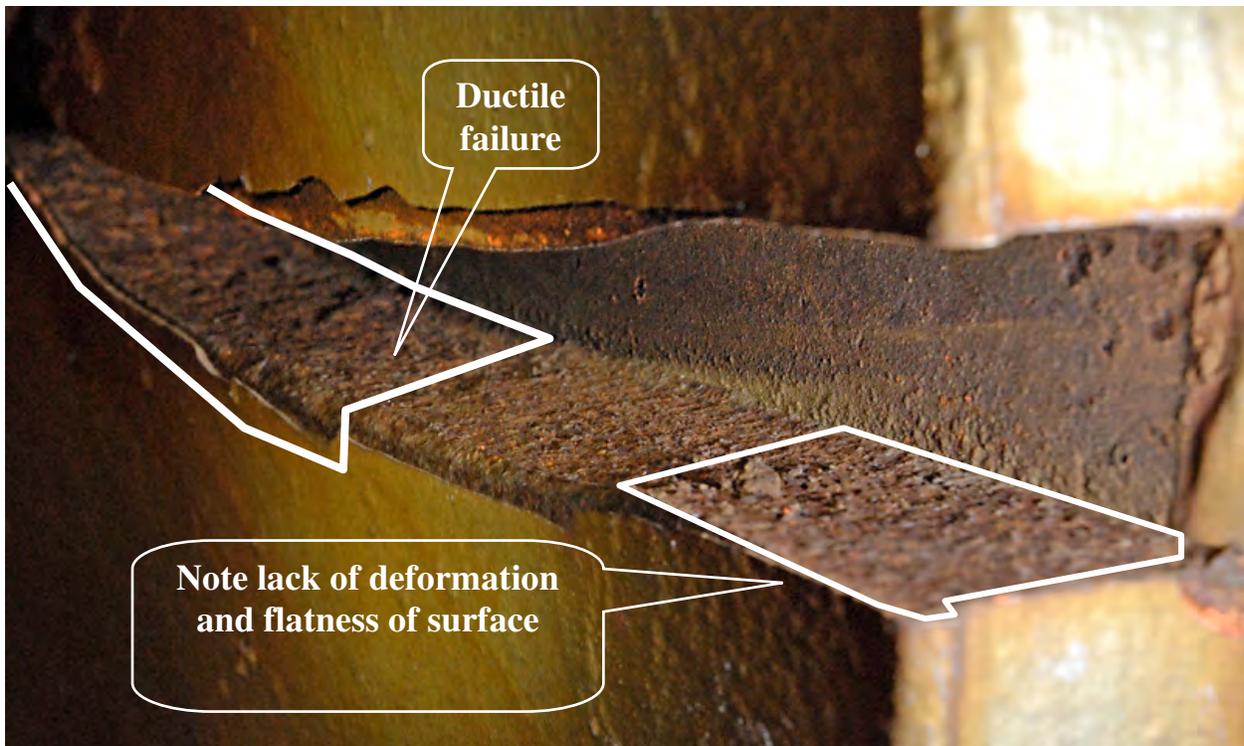
Figure 4: Close-up of the outer edge of the fracture

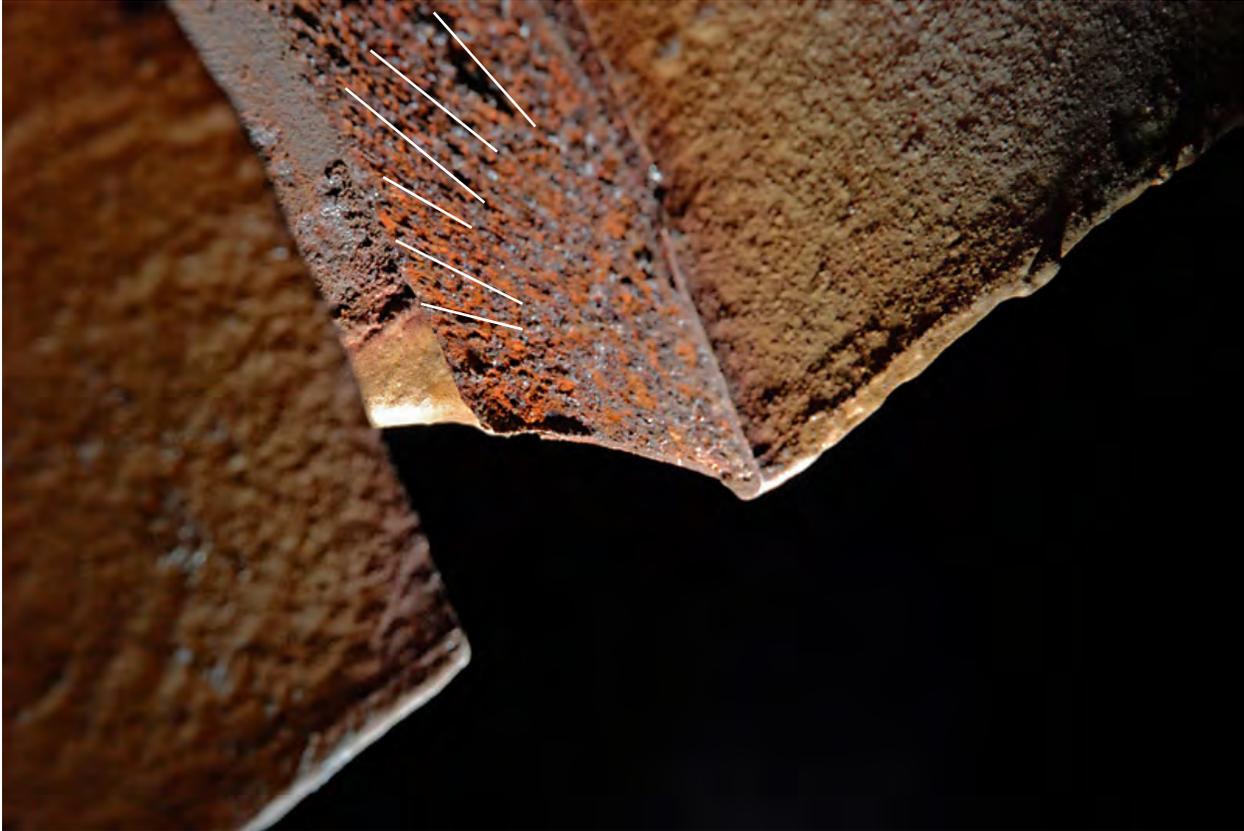
**Figure 5: Close up of fracture showing radial ridges pointing to location of crack initiation**

On the edge of the eye bar where the fracture initiated, the manufacturing process left a concave surface configuration that resulted in sharp corners at the top and bottom edge of the eye bar. Figure 6 is a microsection of the edge of the eye bar. Notice the concave surface on the left side of the picture and the arrow pointing to the fracture initiation location. This sharp corner created a point of stress concentration from which the fatigue crack initiated.

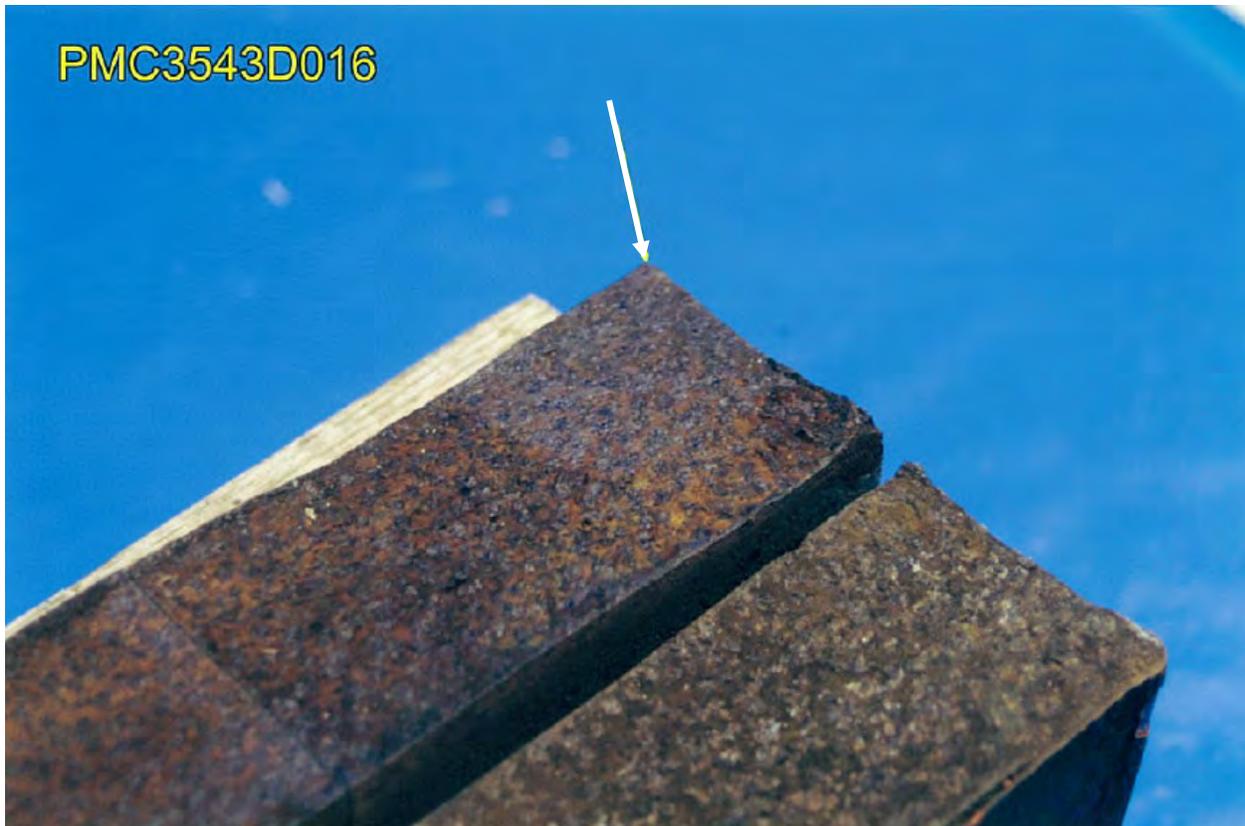
Figure 8 below shows the outer edge of the fracture face with a white arrow pointing to the fatigue fracture origin. After partial cleaning, there remained a thumbnail area emanating from this corner indicative of fatigue fracture.

**Figure 8: Mating fracture faces at the outer edge of the eye bar. Fracture origin at arrow location.**

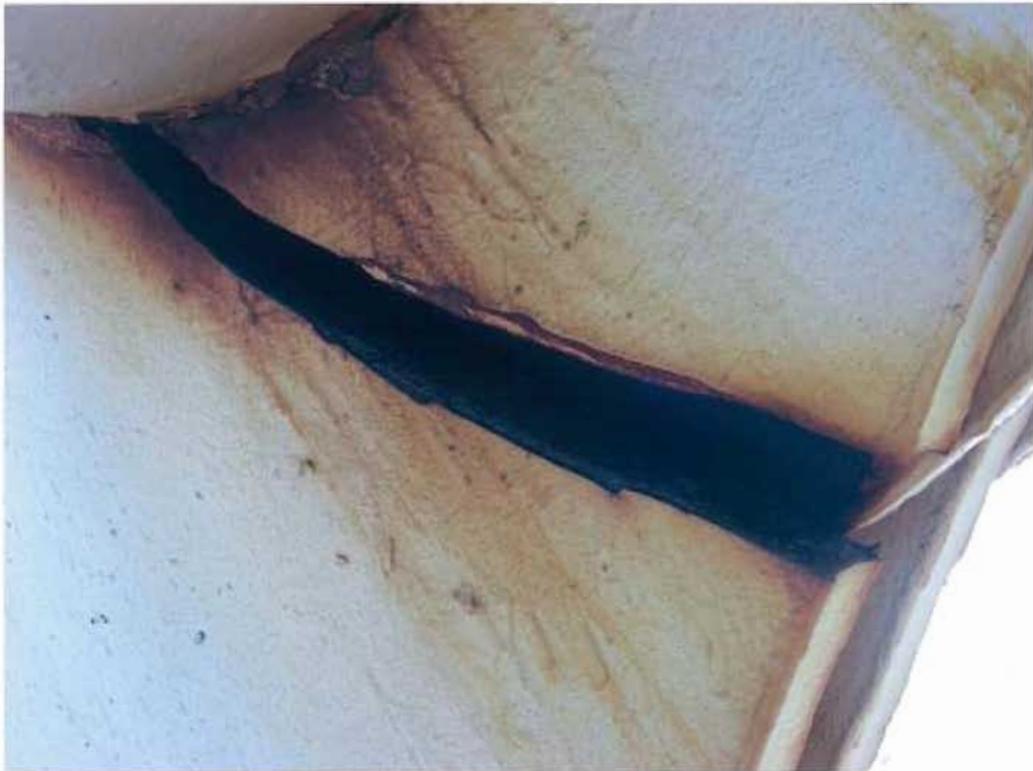
**Fig. 4 Cracked eye bar.**

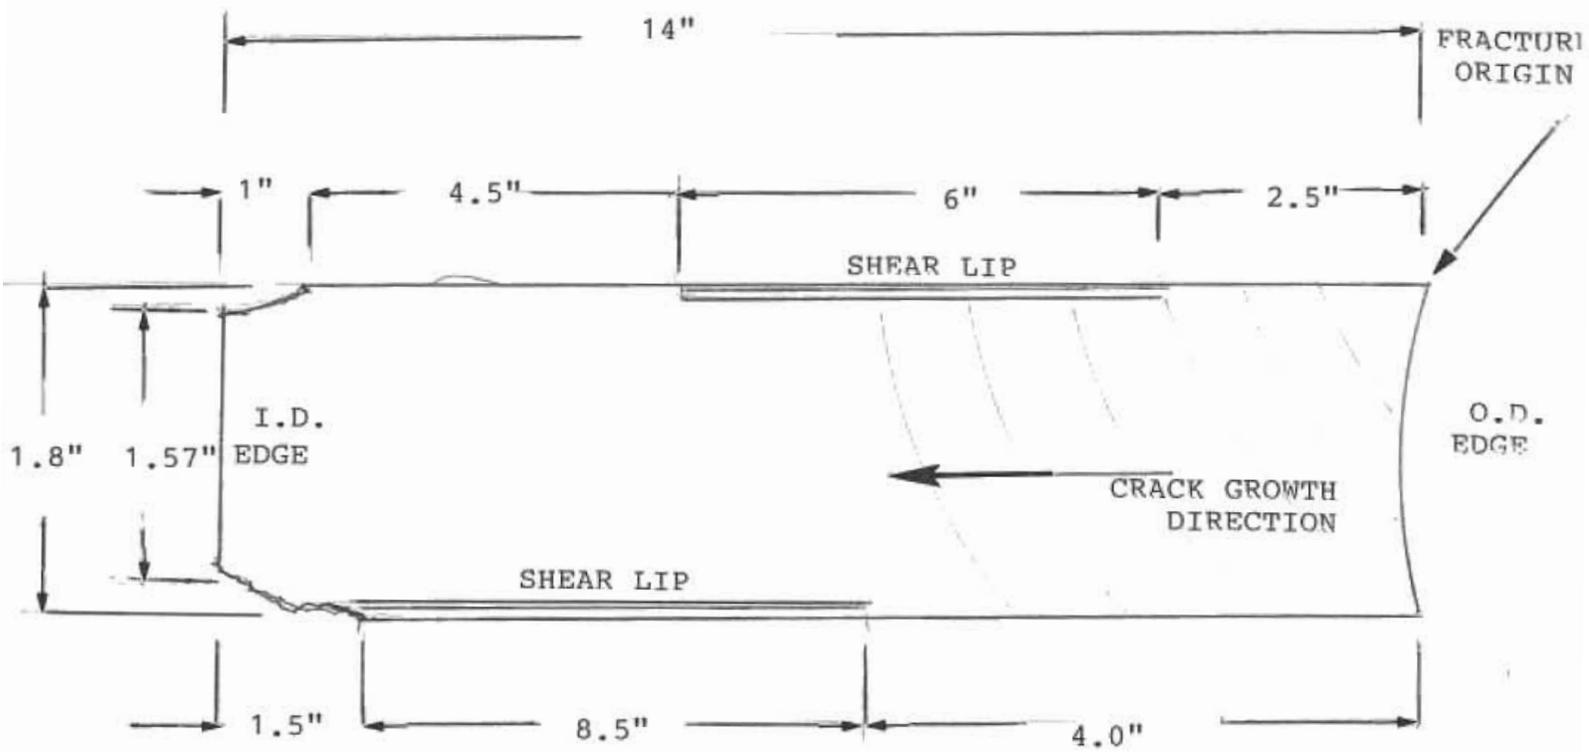
**Fig. 44** Fracture face of eye bar outboard from pin location, after cleaning of oxide layer.

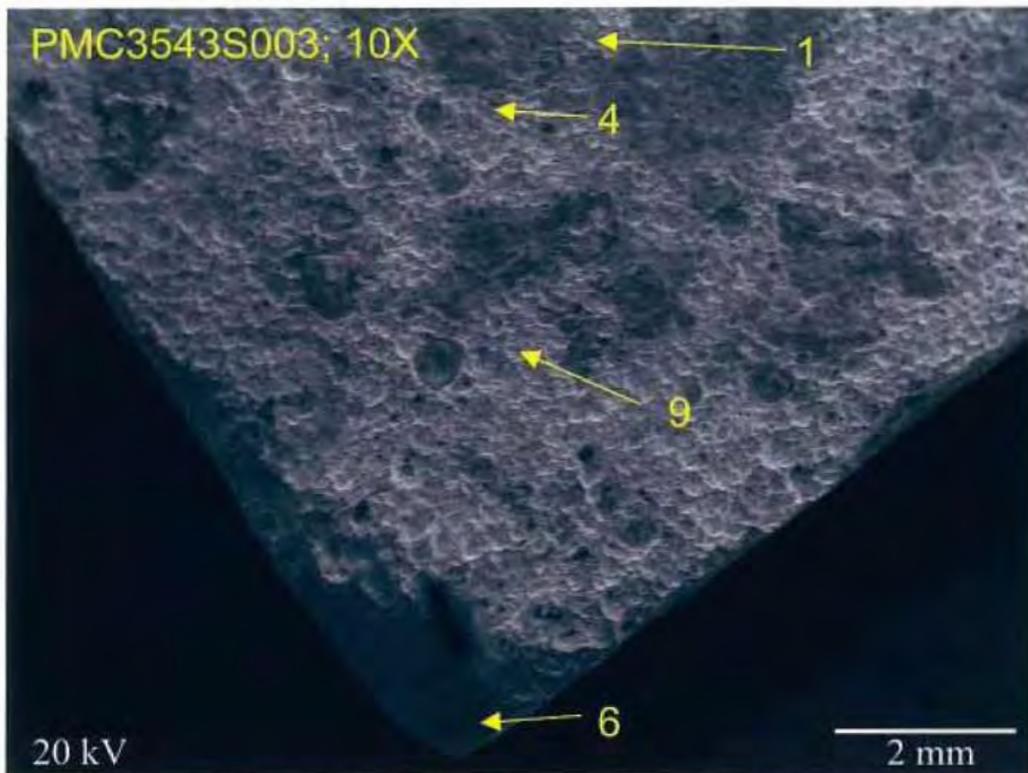
Fig. 45 S.E.M photo of eye bar fracture surface at fracture origin. 10X.

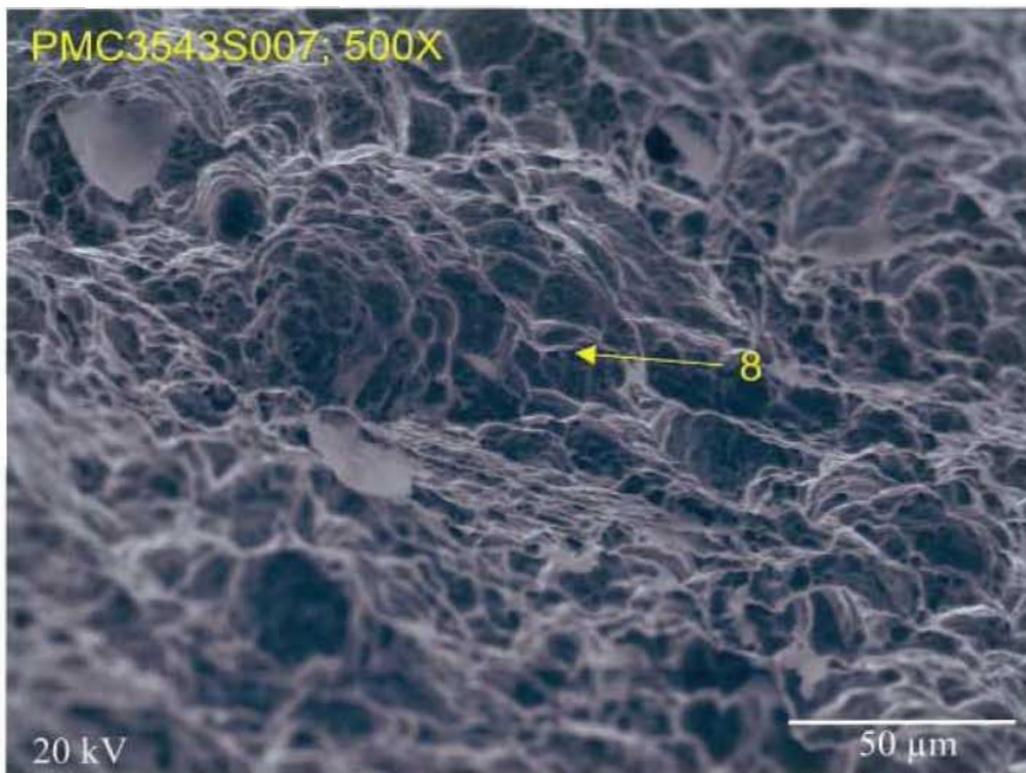
**Fig. 47 S.E.M photo of eye bar fracture surface at fracture origin, in fig. 46. 500X.**

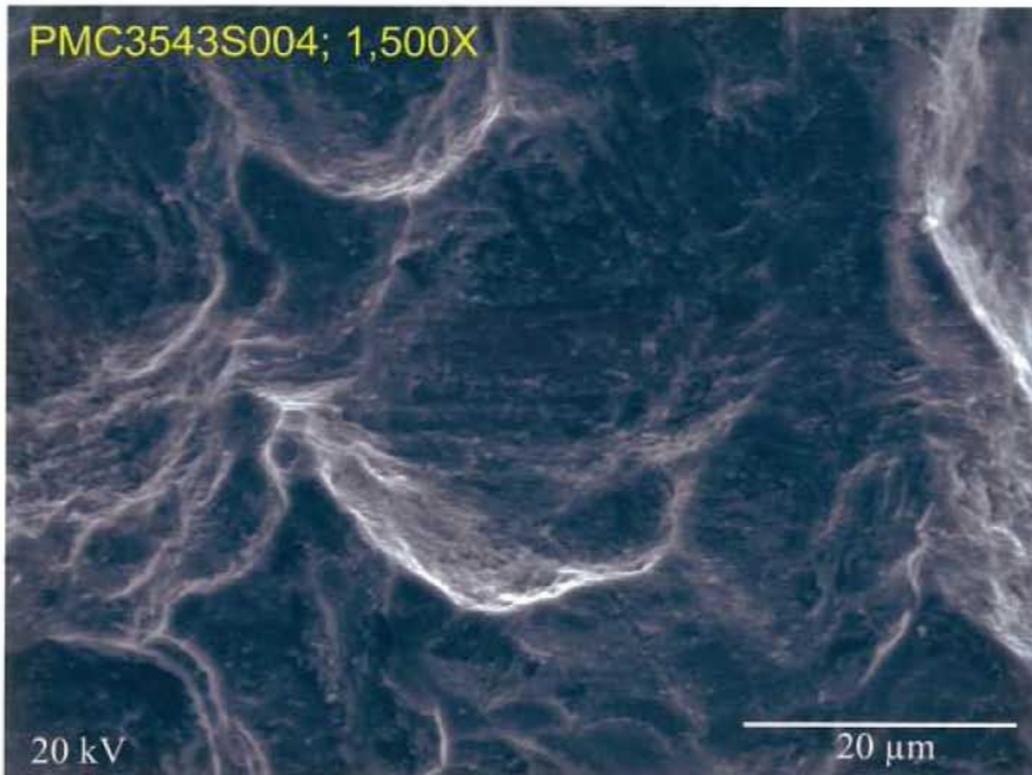
**Fig. 53 S.E.M photo of eye bar fracture surface at fracture origin, location 4 in fig. 45. 1,500X.**

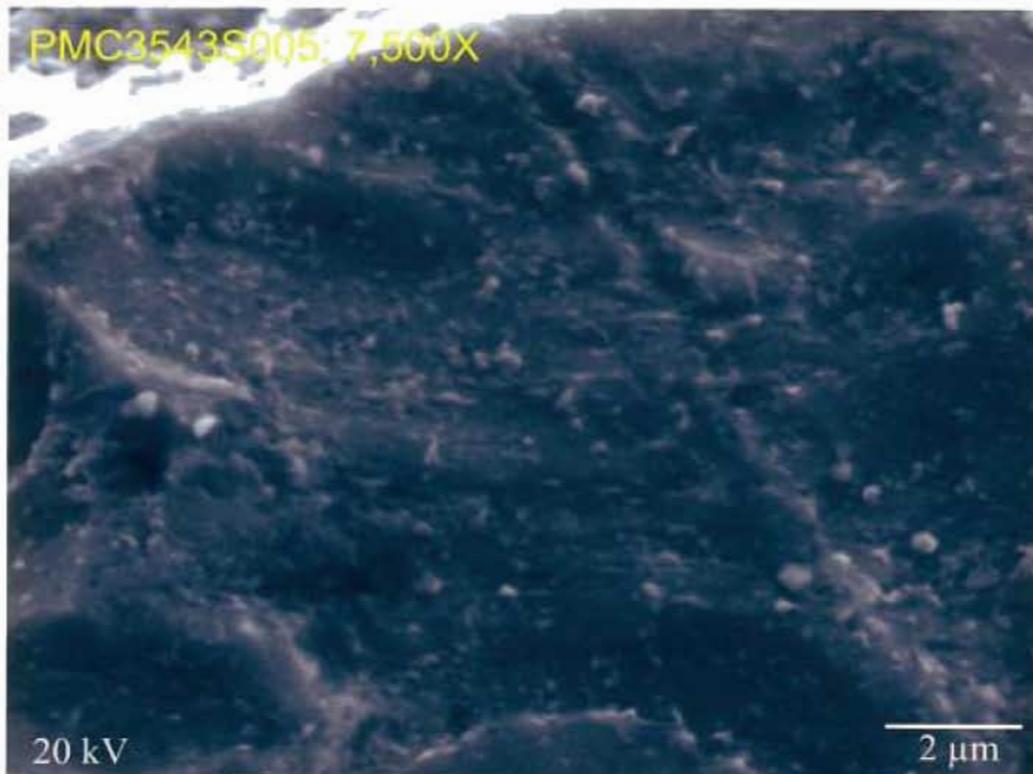
**Fig. 54 S.E.M photo of eye bar fracture surface at fracture origin, in fig. 53. 7,500X.**

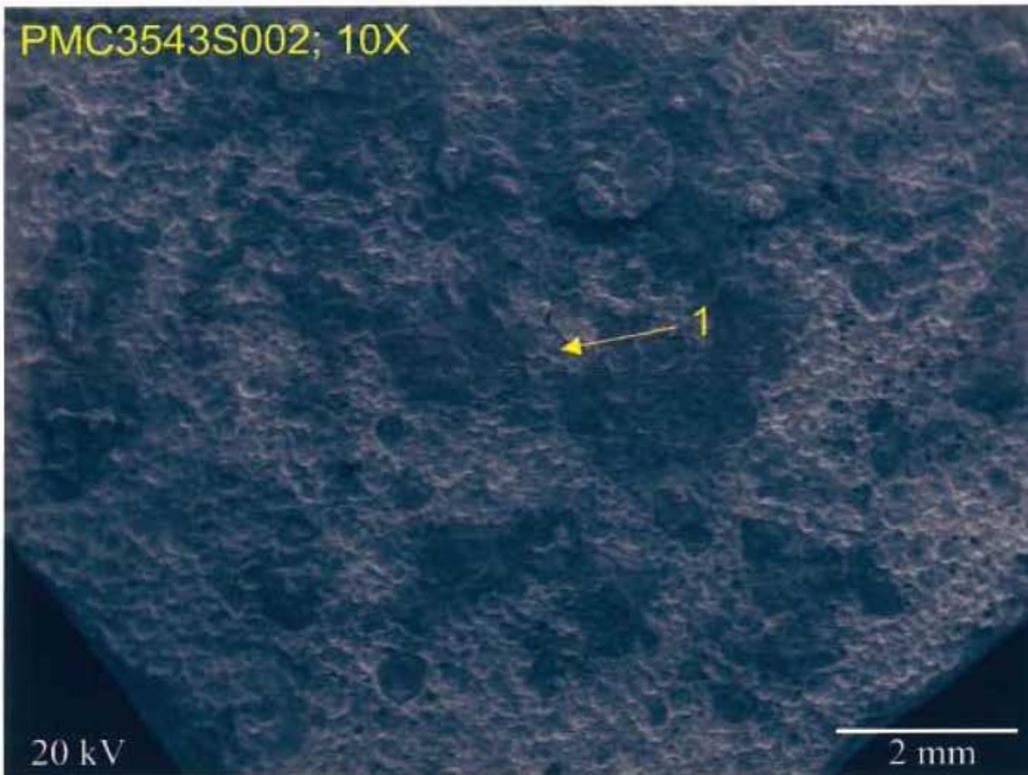
**Fig. 55 S.E.M photo of eye bar fracture surface at fracture origin, location 1 in fig. 45. 10X.**

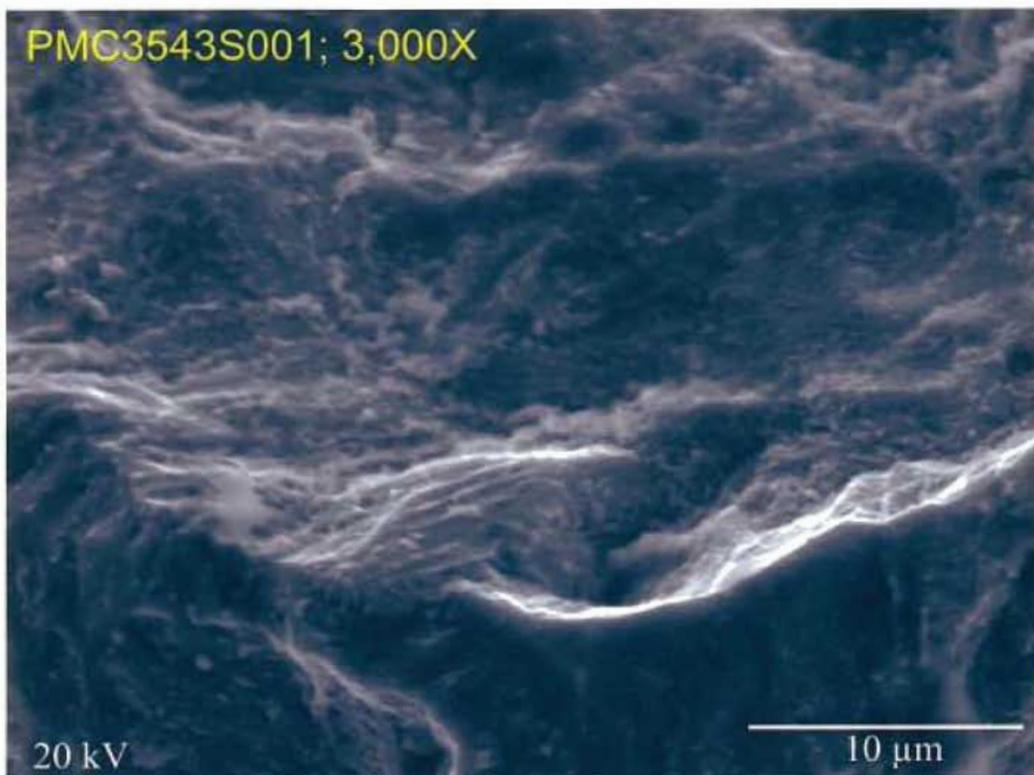
**Fig. 56 S.E.M photo of eye bar fracture surface at fracture origin, location 1 in fig. 55. 3,000X.**

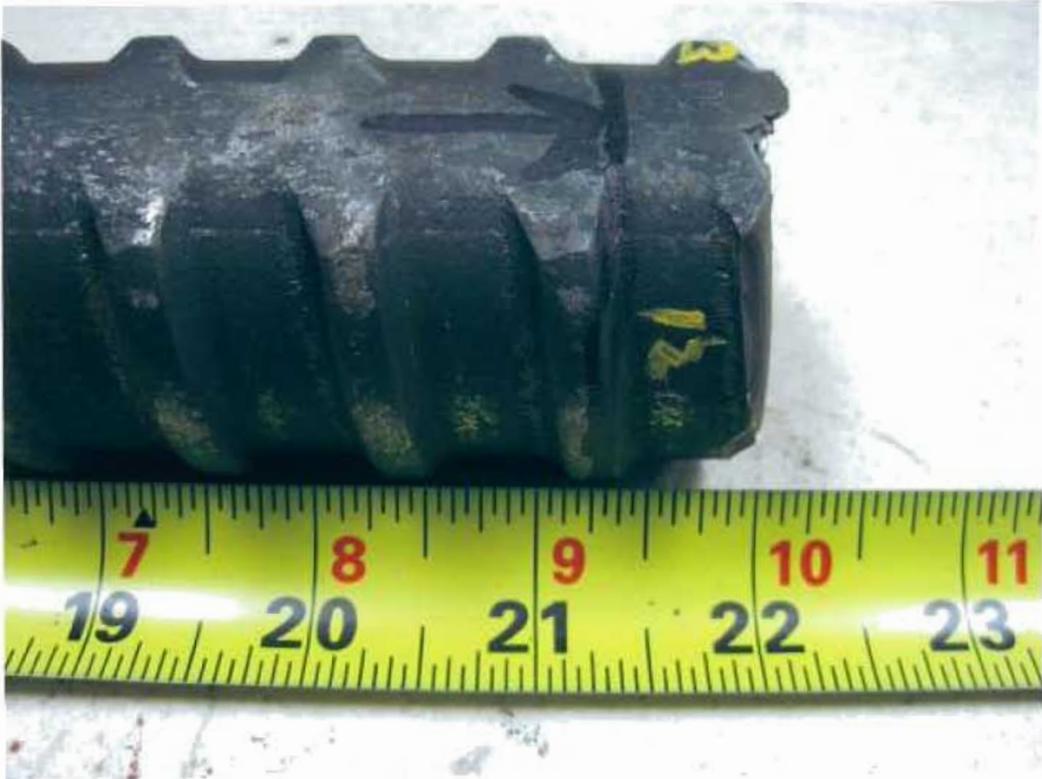
Fig. 2 As received failed support rod from east span. 12 O'clock position, fracture origin.

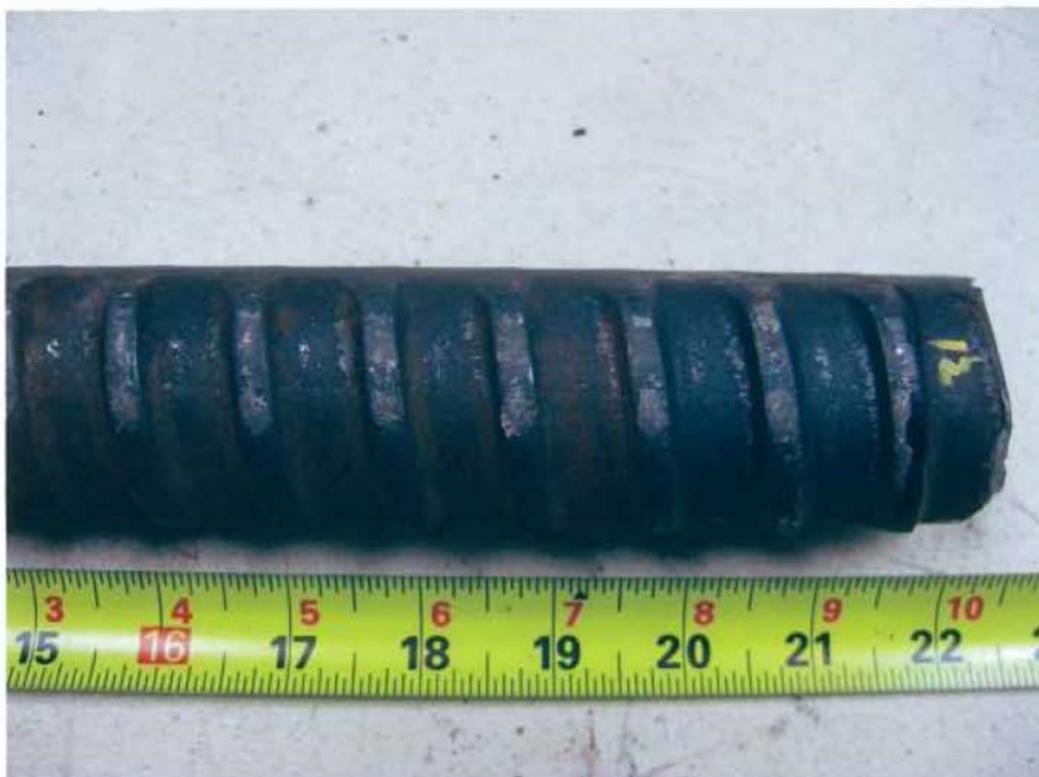
Fig. 4 As received failed support rod from east span. 12 O'clock position, fracture origin.

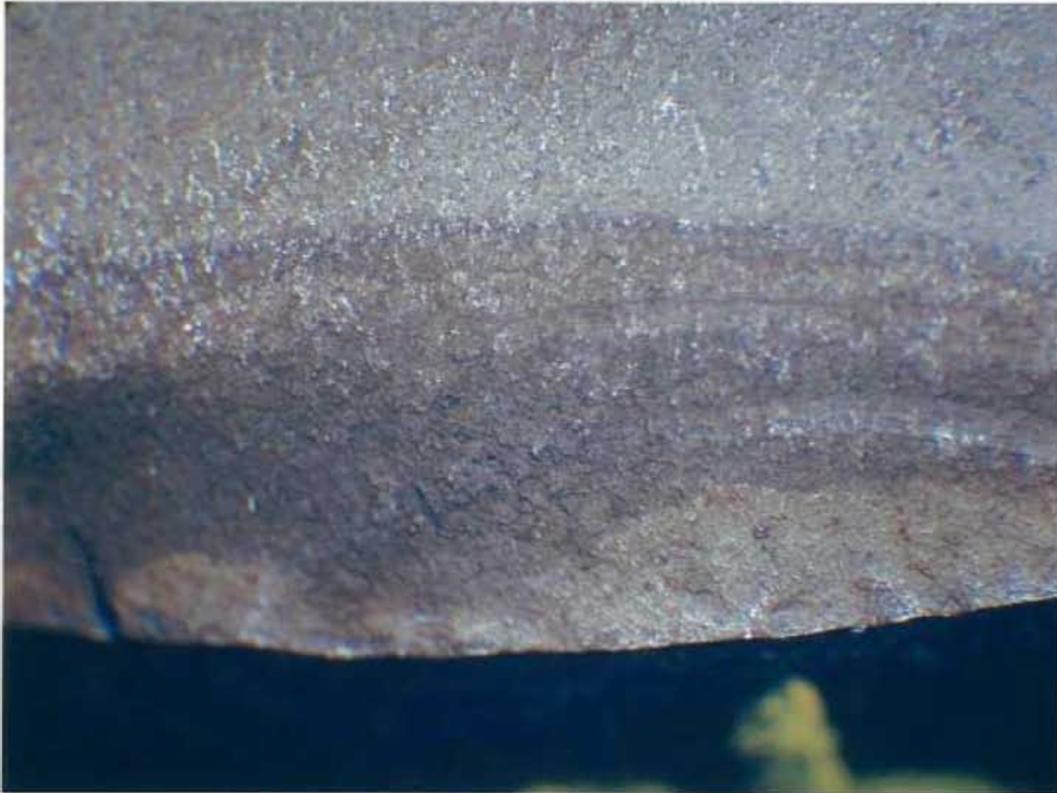
**Fig. 19** As received failed support rod from east span. Fracture origin.

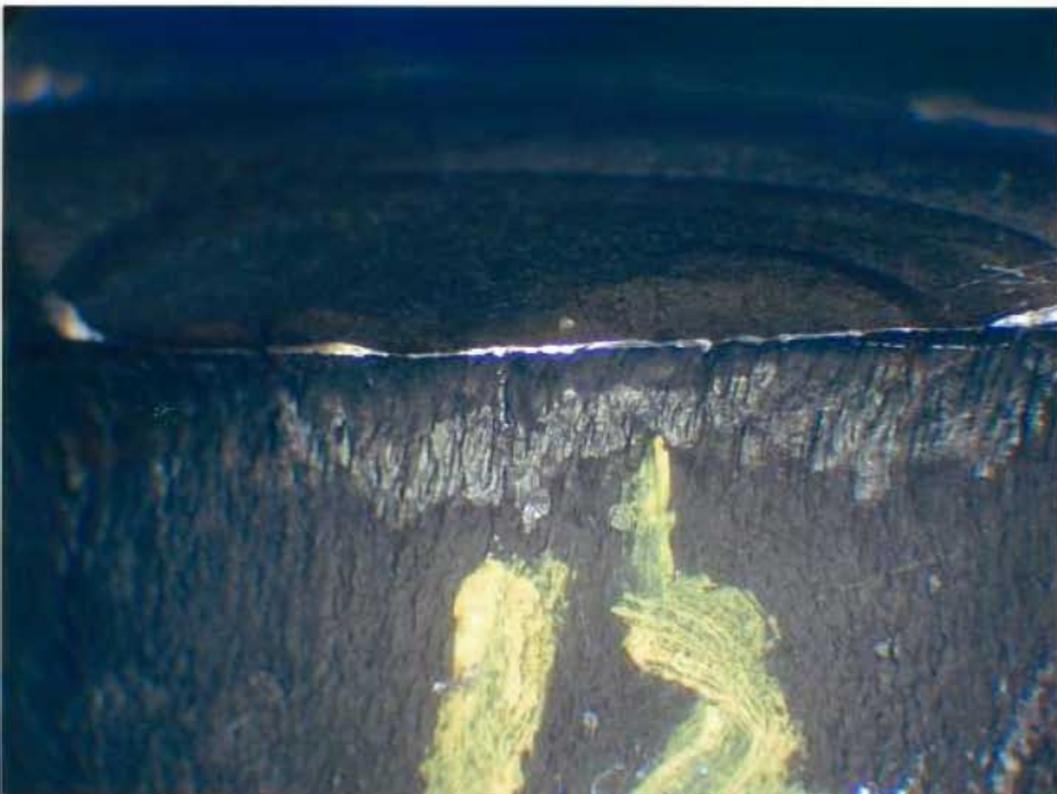
**Fig. 20** As received failed support rod from east span. Fracture origin.

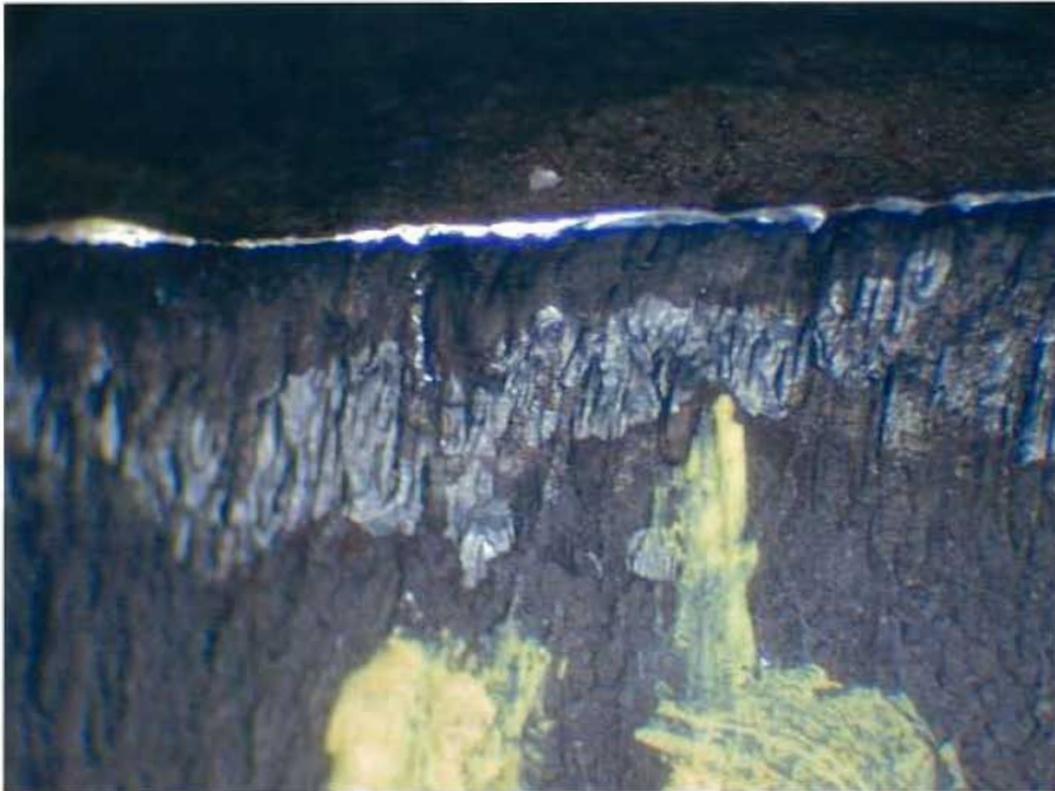
**Fig. 21** As received failed support rod from east span. Fracture origin.

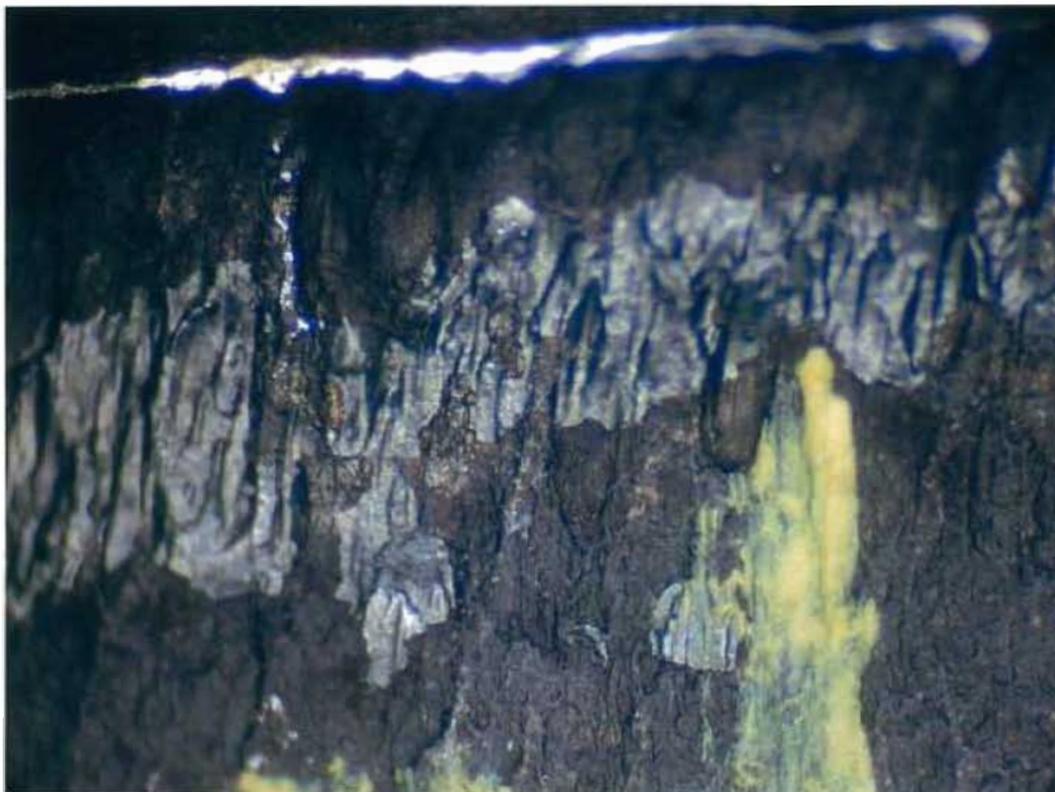
**Fig. 22** As received failed support rod from east span. Fracture origin.

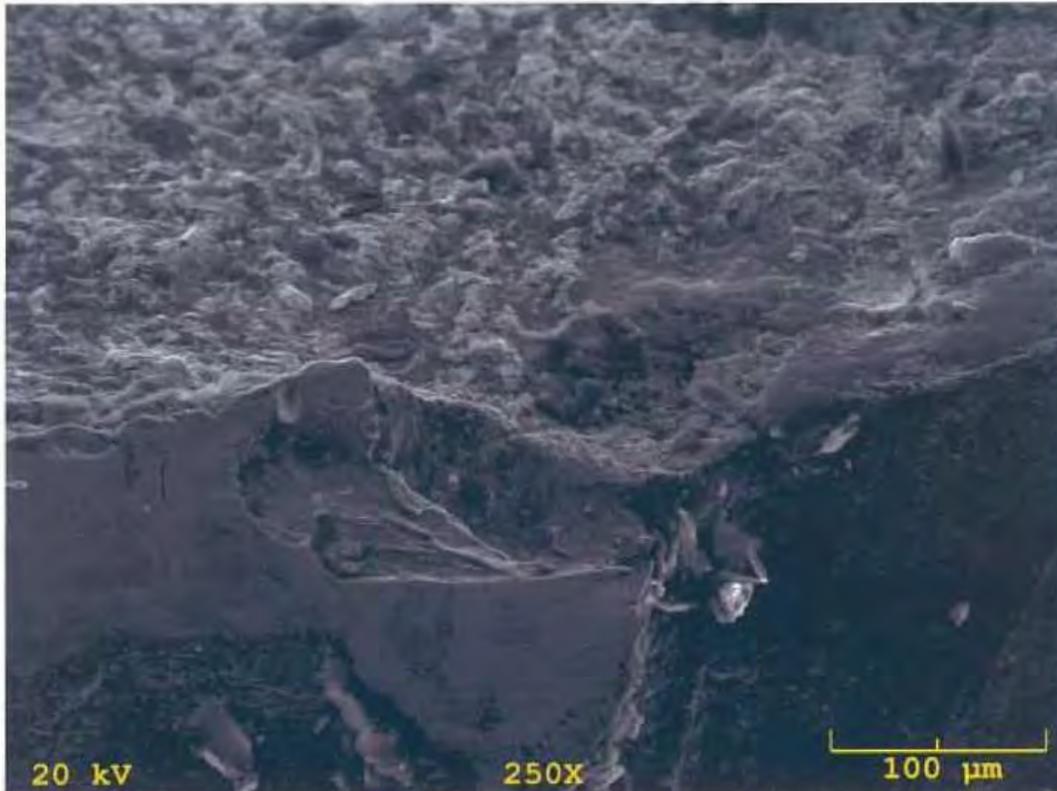
**Fig. 27 S.E.M photo of failed support rod from east span. Edge, at fracture origin. 250X.**

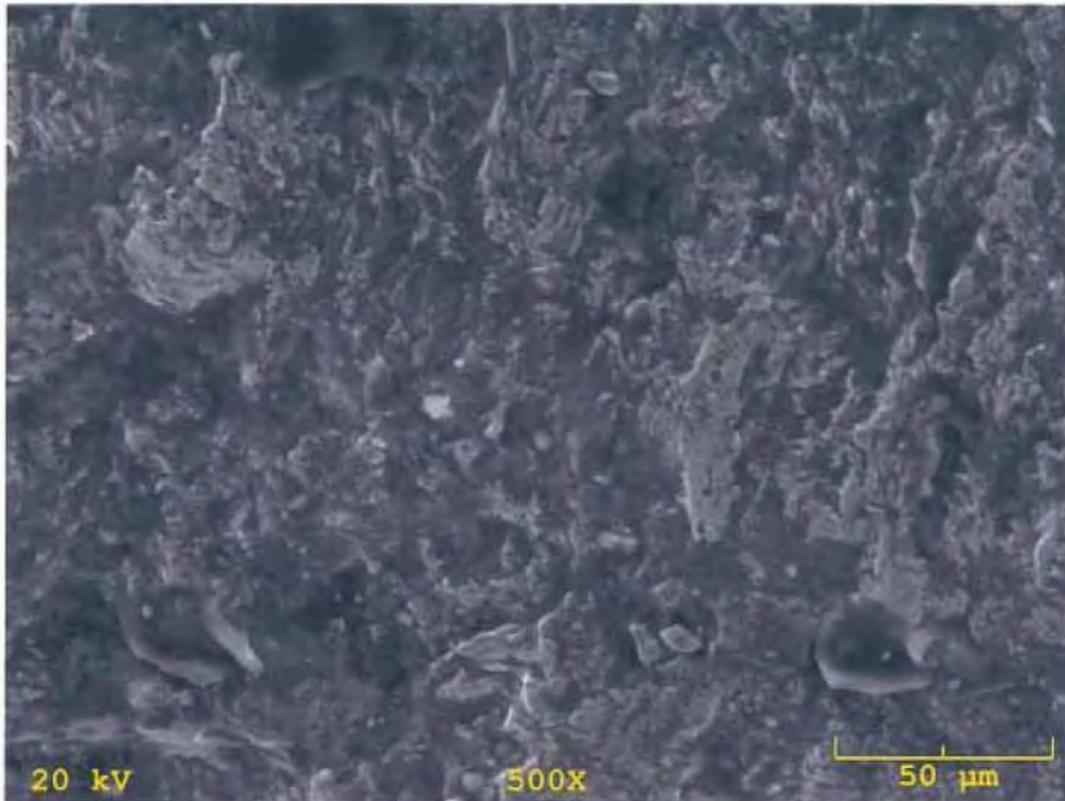
**Fig. 29 S.E.M photo of failed support rod from east span at fracture origin. 500X.**

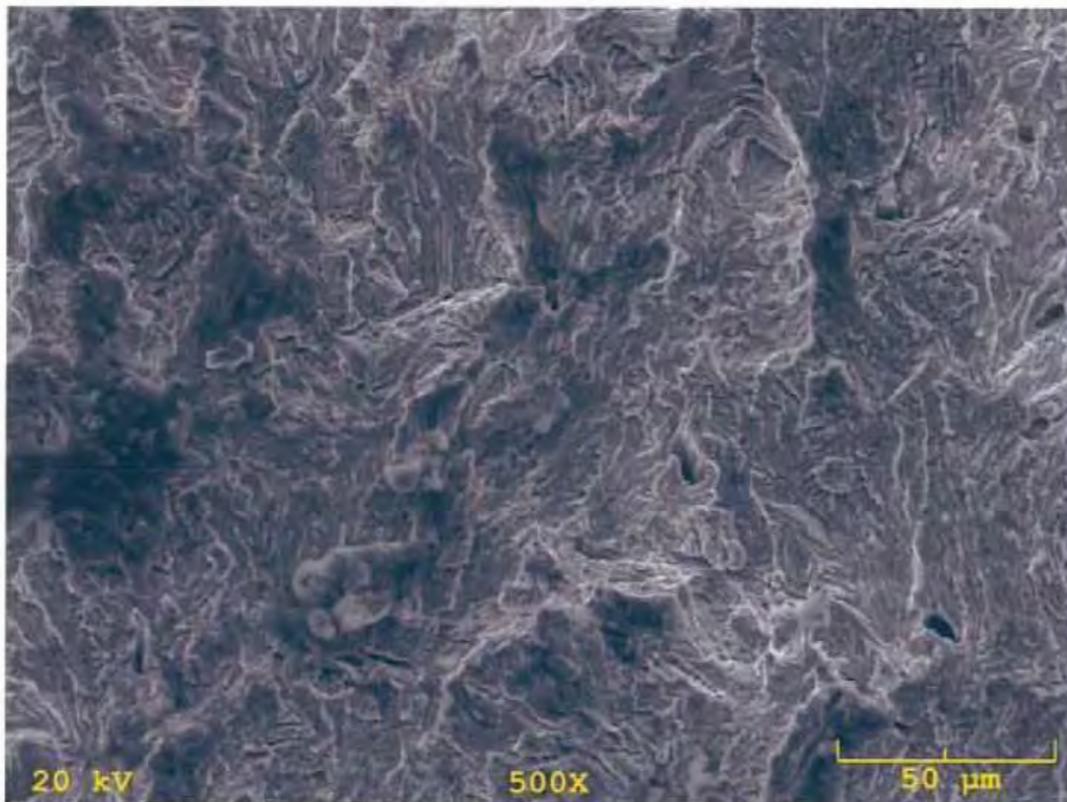
**Fig. 36 S.E.M photo of failed support rod from east span at fracture surface. Fatigue. Zone 2. 500X.**

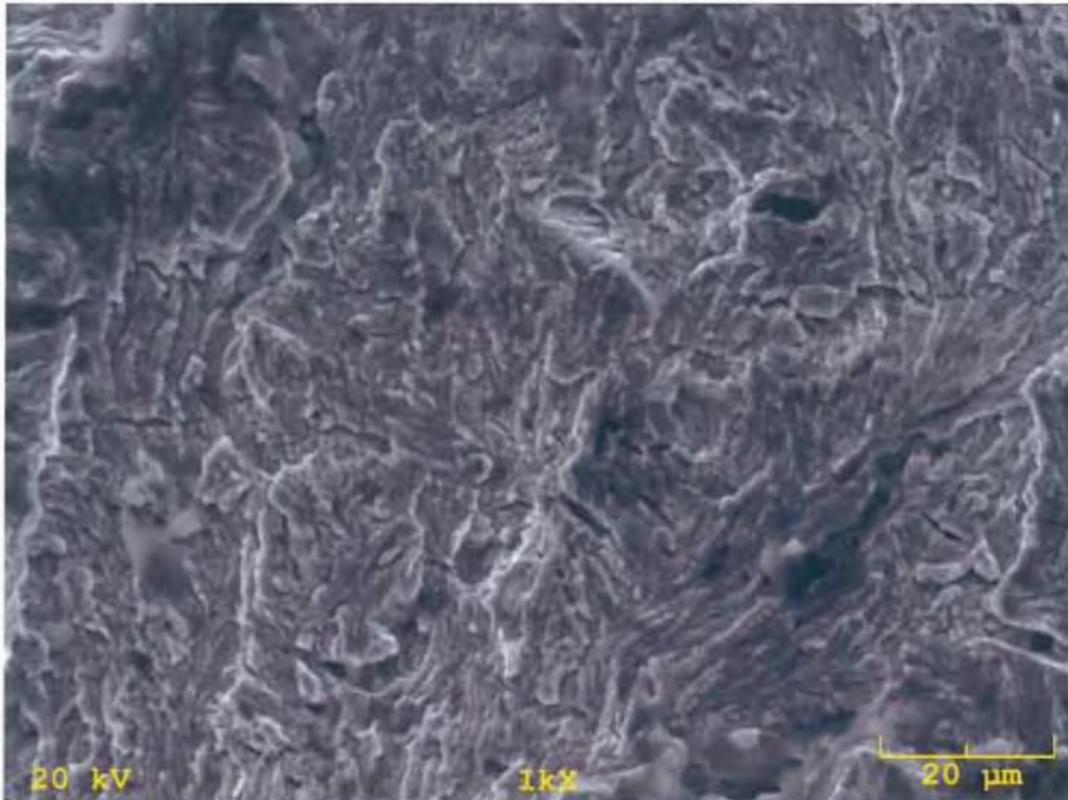
**Fig. 37 S.E.M photo of failed support rod from east span at fracture surface. Fatigue. Zone 2. 1000X.**

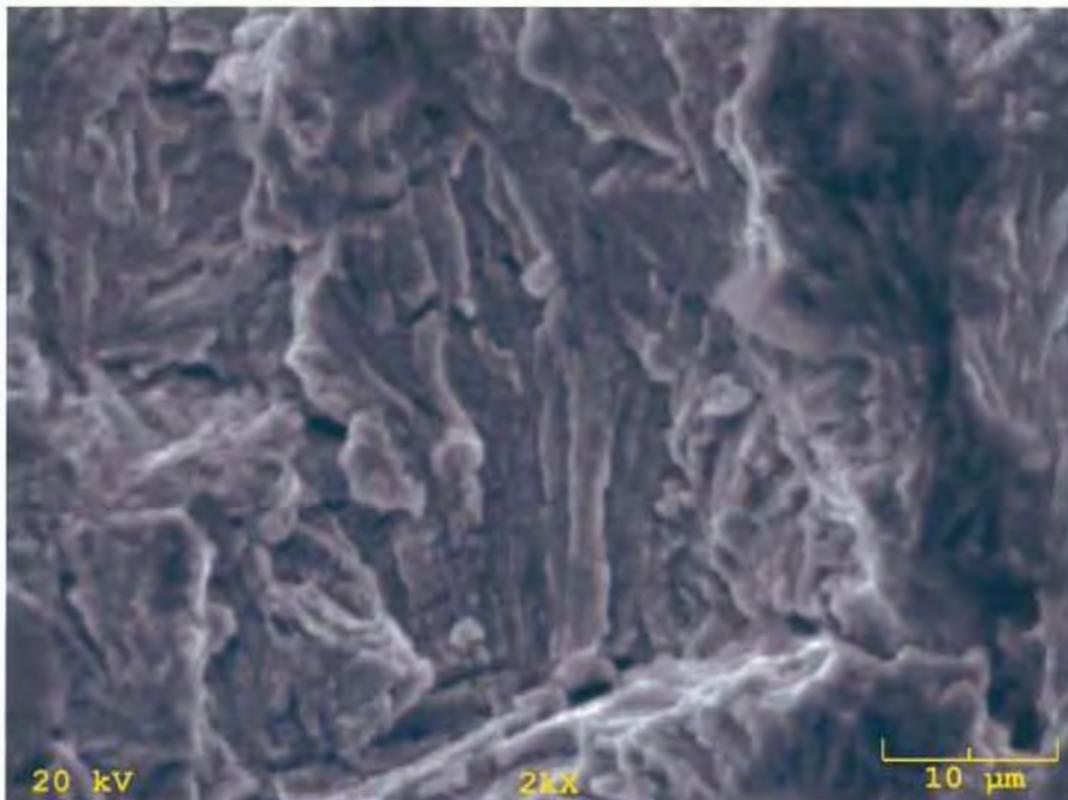
**Fig. 38 S.E.M photo of failed support rod from east span at fracture surface. Fatigue. Zone 2. 2000X.**
