1. REPORT NUMBER FHWA/CA/MI-2006/22	2. GOVERNMENT ASSOCIATION NUMBER	3. RECIPIENT'S CATALOG NUMBER
4. TITLE AND SUBTITLE CRASH TESTING OF VARIOUS ROADSIDE HARDWARE		5. REPORT DATE December 2006

CRASH TESTING OF VARIOUS ROADSIDE HARDWARE

DEPARTMENT OF TRANSPORTATION
DIVISION OF RESEARCH AND INNOVATION
OFFICE OF MATERIALS AND INFRASTRUCTURE

Research Performed by Roadside Safety Research Group

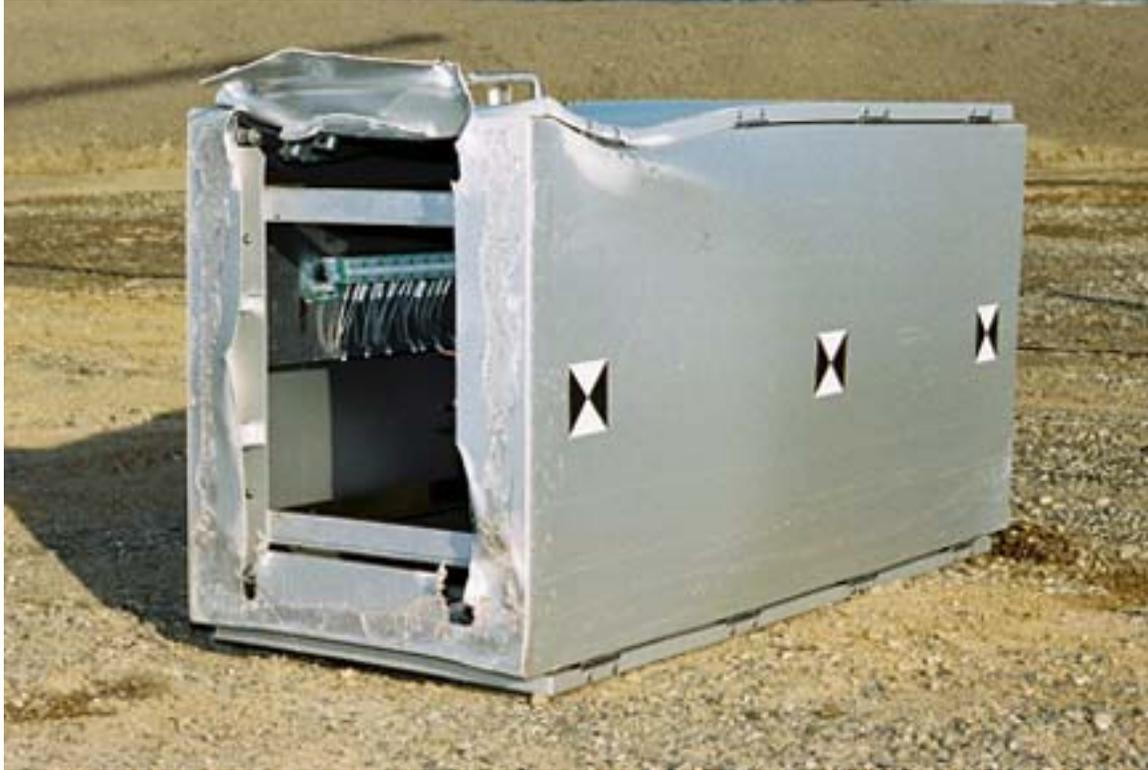
Figure 2-11. Controller Cabinet Test Article After Test 611

Article Damage: The electronic controller cabinet could not be re-used. The concrete foundation and anchor bolt system would require general repair.

The damage to the test article was extensive and would require complete replacement of the cabinet. It is not known if the electronic components installed in the rack inside the cabinet would have been serviceable after the impact because non-operating units were used to simulate the weight and placement of functioning units. The cast-in-place anchor bolts were bent and damaged enough that their re-use would be questionable. There was significant spalling of the concrete pedestal on the down-stream side as a consequence of the anchor bolts being pushed rearward. The bottom of the cabinet was torn where the anchor bolts pulled through.

Evaluation Criteria	Test Results	Assessment						
Structural Adequacy								
B. The Test article should readily activate in a predictable manner by breaking away, fracturing, or yielding.	The article broke away in an unpredictable manner with tearing and yielding of the cabinet base.	Fail						
Occupant Risk

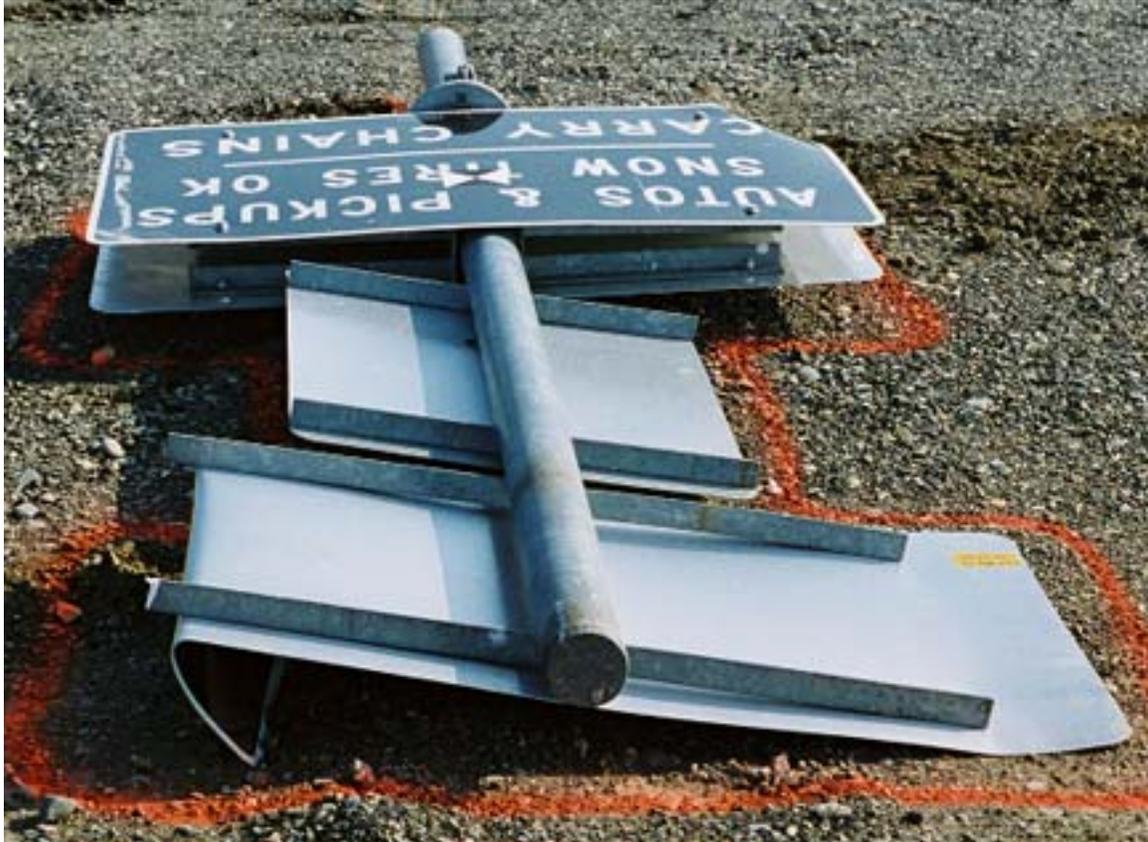
Figure 2-18. Test Article After Test 613

Article Damage: The complete sign assembly could be re-mounted in the damaged condition and would remain usable until repair could be scheduled.

Although the sign panels were somewhat deformed, the entire post assembly could be reset on the undisturbed base and remain functional until it is deemed necessary to either replace or repair the panels.

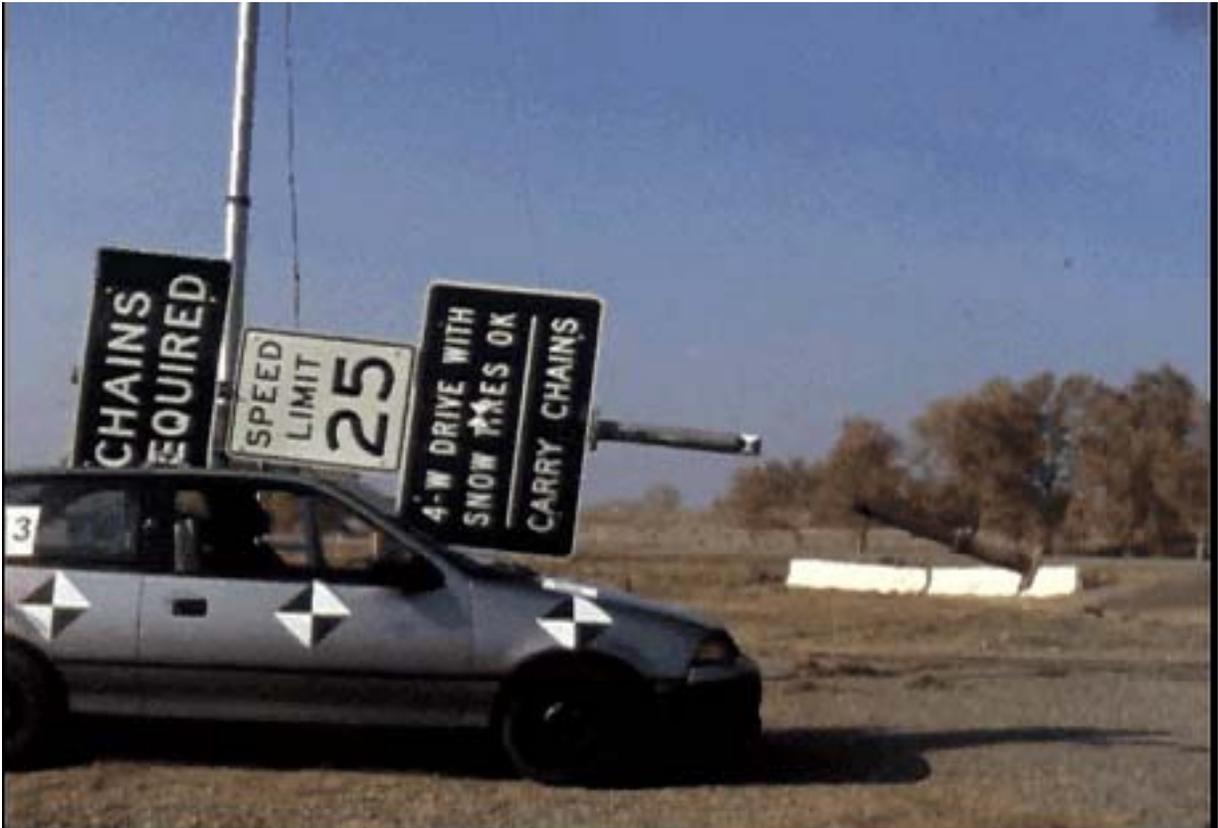
Figure 2-21. Chain Control Sign Penetration into Windshield (Test 613)

The entire front of the vehicle was moderately damaged in the initial impact with the chain control sign and was drivable but not legally operable afterwards. The hood, bumper, and grille were all affected. The bottom signs penetrated the windshield approximately 50-75 mm (2.0-3.0 in) (Figure 2-21). The roof's maximum deformation was approximately 50 mm (2.0 in). The windshield penetration and roof deformation were minor enough that there would have been no significant risk of injury to vehicle occupants.

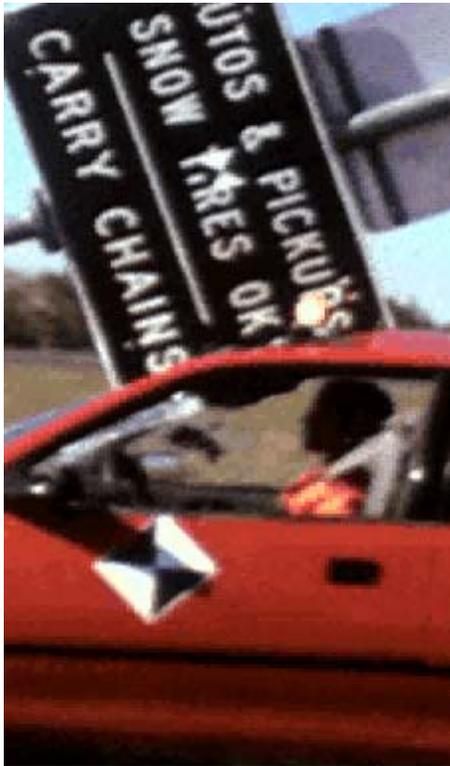
Figure 2-31. Chain Control Sign Penetration into Windshield – Test 614

The entire front of the vehicle was slightly damaged in the initial impact with the chain control sign and was drivable, but not legally operable afterwards. The hood, bumper, and grille were all affected. The bottom signs did not penetrate through the windshield, but deformed it inward approximately 50-75 mm (2.0-3.0 in) (Figure 2-31). The roof's maximum deformation was approximately 38 mm (1.5 in) at the front-center. The rear window was penetrated near the bottom-center approximately 20 mm (0.79 in) by the top sign panel (Figure 2-32). The roof deformation and the sign penetration of the windshield and rear window were minor and would have presented no significant risk to vehicle occupants.

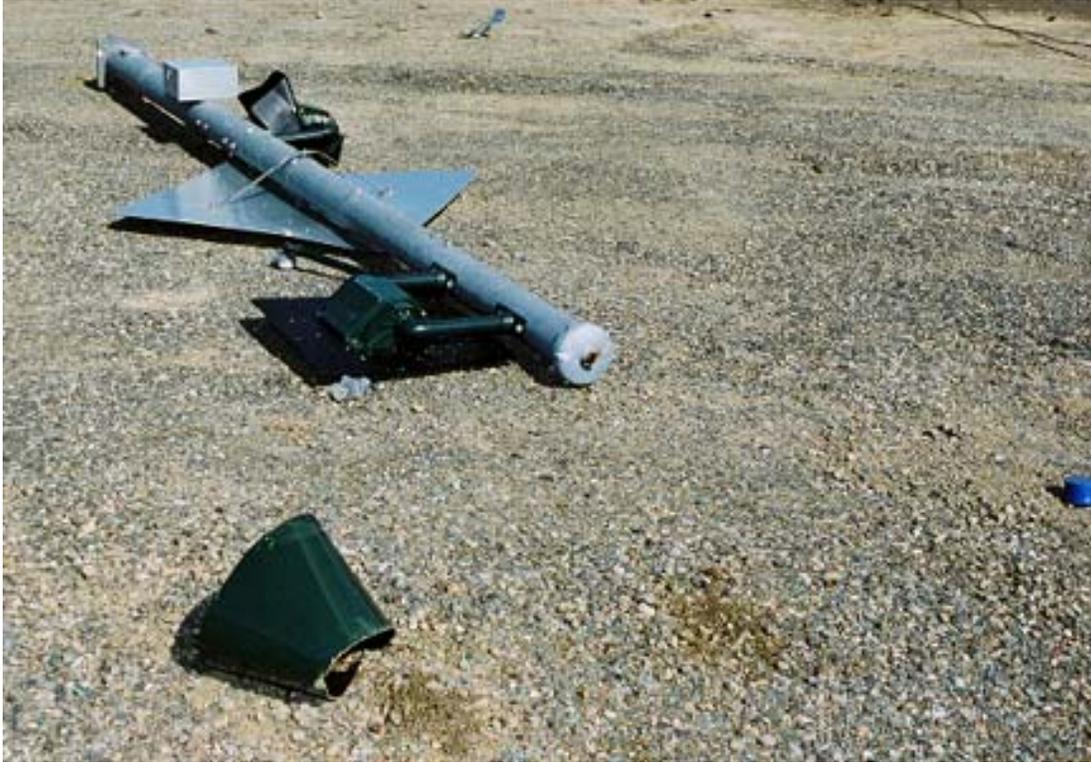
Figure 2-39. Test Article After Test 618

Article Damage: The assembly could be field-repaired by placing new components on the undamaged pole and re-erecting it on site.

The sign panels were somewhat deformed, the flashing beacons were damaged beyond repair, and the light fixture had broken away from the pole. The entire post assembly could be repaired in the field and reset on the undisturbed base or removed to a shop location for repair.

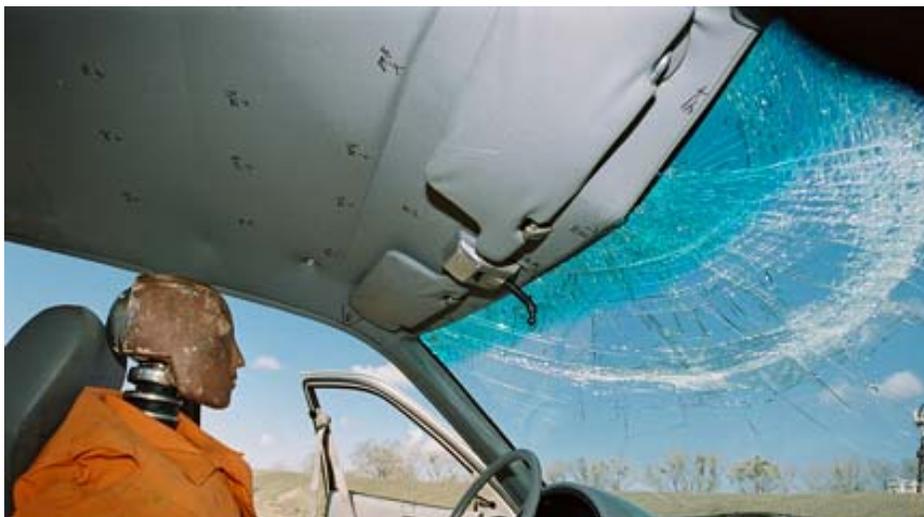
Figure 2-42. Vehicle Roof After Test 618

The entire front of the vehicle was moderately damaged in the initial impact with the test article. The vehicle was drivable, but not legally operable after the impact. The hood, bumper, and grille were all affected. The front windshield was damaged along the roofline but was not penetrated. The greatest roof deformation was centered at the top of the windshield and was found to be approximately 90 mm (3.5 in). The extent of the deformation inside the passenger compartment is evident by comparing Figure 2-41 with Figure 2-42. Because of the location of this deformation, there would have been no significant risk to vehicle occupants.

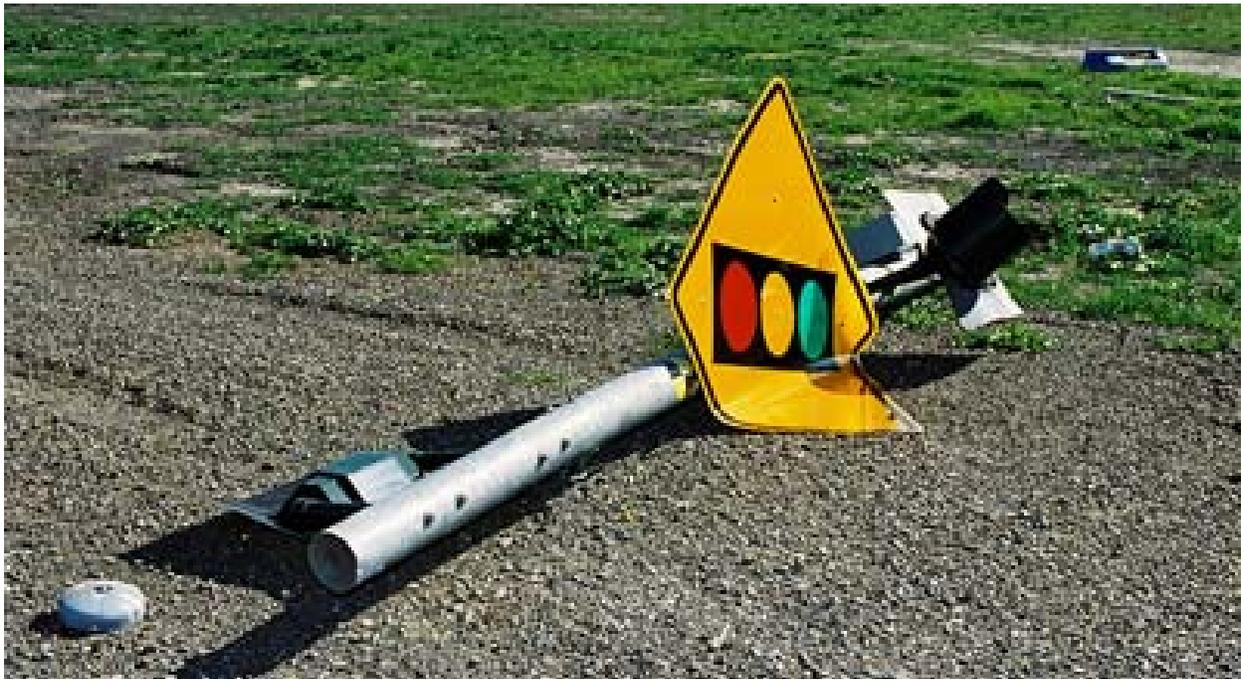
Figure 2-51. Test Article After Test 616

Article Damage: The assembly could be field-repaired by placing new components on the undamaged pole and re-erecting it on site.

The sign panels were somewhat deformed, the flashing beacons were damaged beyond repair, and the light fixture had broken away from the pole. The entire post assembly could be repaired in the field and reset on the undisturbed base or removed to a shop location for repair.

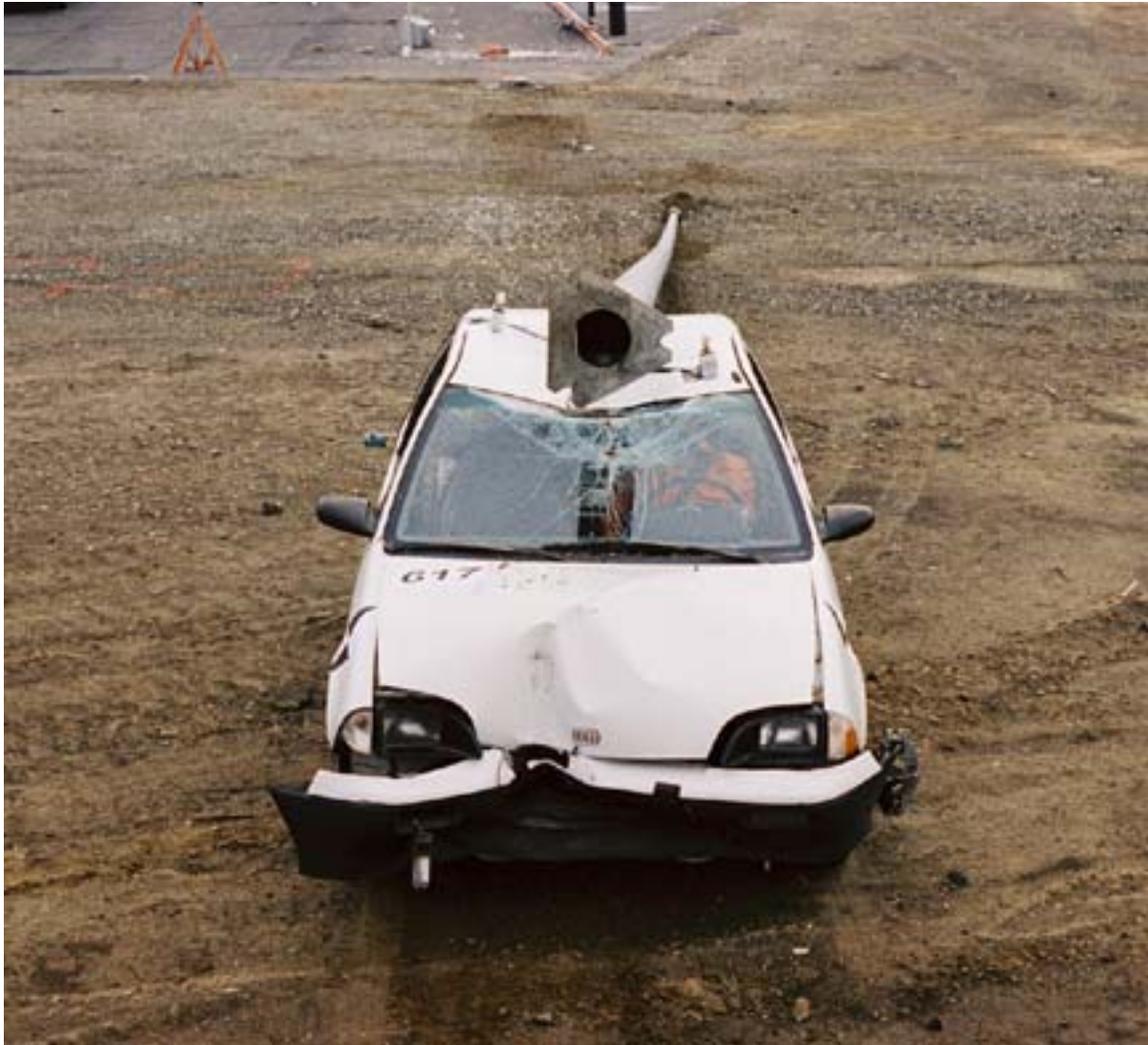
Figure 2-62. Test Vehicle After Test 617

The entire front of the vehicle was moderately damaged in the initial impact with the light standard and the vehicle was inoperable afterwards. The roof, hood, bumper, headlamp area, grille, both front fenders, and suspension components were all affected. The entire length and width of the roof was deformed by the secondary impact and presented risk to occupants. The roof's maximum deformation was approximately 64 mm (2.5 in) and was centered at the top of the windshield. The radiator was ruptured and pushed back far enough that it made contact with the exhaust manifold of the transverse-mounted engine.
