FEBRUARY 2015

Repair of Earthquake-Damaged Columns with Fractured Bars

Repairing Earthquake-Damaged Columns with Fractured Bars

Rebar couplers and fiber-reinforced polymer jackets provide a quick way to repair damaged columns

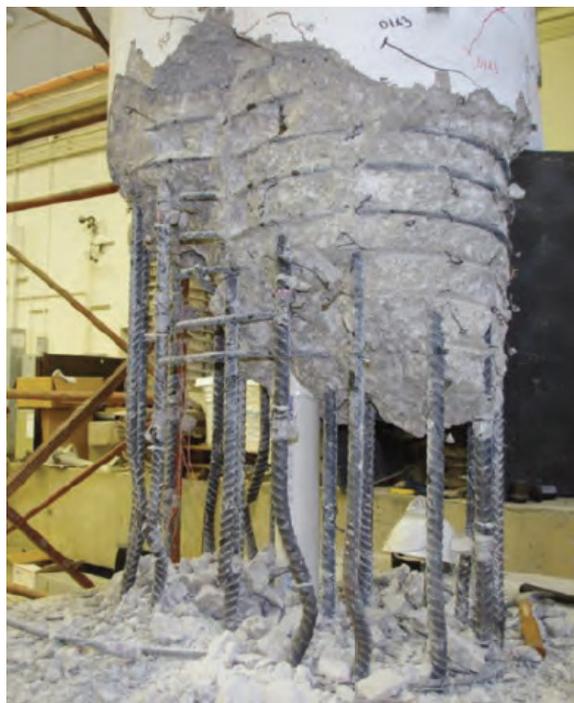
Figure 1: Concrete demolition in progress

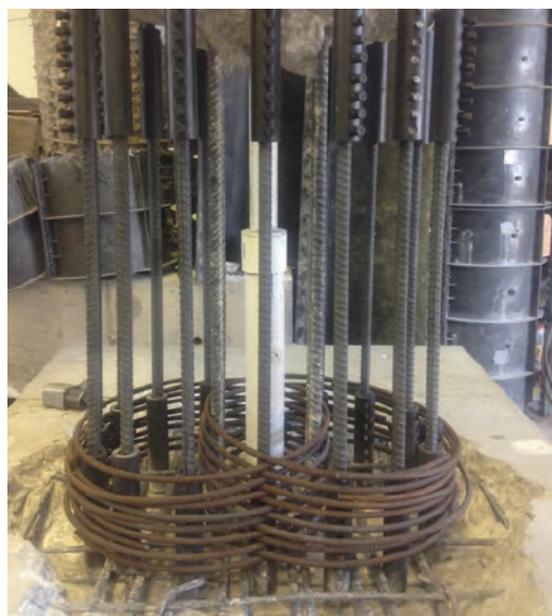
Figure 2: Column R-Calt-1 with couplers and new replacement longitudinal bar segments in place
