ROADSIDE SAFETY RESEARCH GROUP

RPMD Record ID Number: 0644

June 2011

Investigation of the Crashworthiness of Barrier Mounted Hardware: Barrier Mounted Sign and Signpost

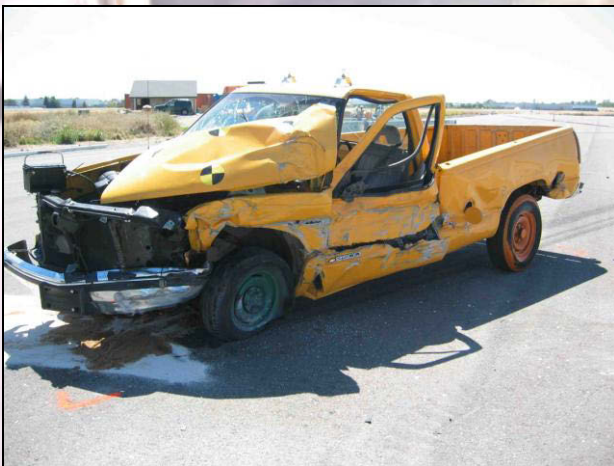
Figure 3 – Vehicle After Test

There was significant damage to the driver's side front quarter of the vehicle. The hood was pushed back and penetrated the windshield 250mm (9.8in), measured from the center of the windshield to the resting place of the hood. The driver's side front wheel was pushed backward 340mm (13.4in) from its initial location. There was a jagged slash down the entire driver's side of the truck caused by the two bolts that hold the signpost assembly to the barrier. The front grill of the truck broke off and traveled over the barrier into the opposing traffic side of the barrier. The top of the driver's side door deformed outward from the vehicle's frame. Inspection of the occupant compartment revealed that the dashboard was pushed back 202mm (8.0in). The driver side had a

peak loss of 98mm (4.0in) measured between the bottom of the dashboard and the floorboard.

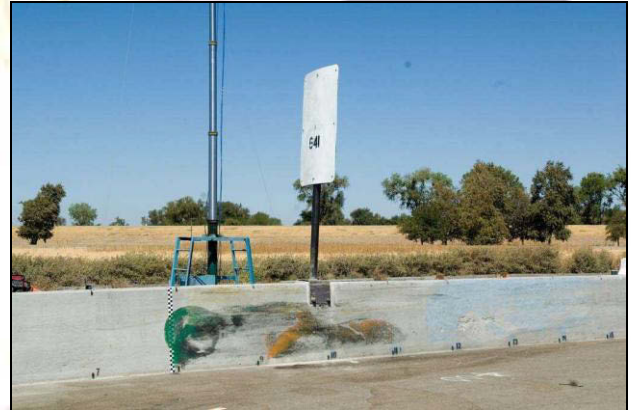
Figure 4 – Impact Area After Test

successfully redirected the vehicle with only minor cosmetic damage. Also, the signpost remained on the barrier and would require only minor maintenance. For Occupant Risk, Test SS641 failed due to the windshield being penetrated, hazardous debris, and high occupant compartment deformation. The vehicle's exit angle and rate of return into traffic were within the guidelines given for Vehicle Trajectory. Since this test failed, it is recommended that Caltrans consider not using this method of mounting signs on median barriers and develop safer ways to display signage.
