<b>1. REPORT NO.</b>  <p style="text-align: center;">FHWA/CA25-3170</p>	<b>2. GOVERNMENT ACCESSION NO.</b>  	<b>3. RECIPIENT'S CATALOG NO.</b>  
<b>4. TITLE AND SUBTITLE</b> DEVELOPMENT AND CRASH TESTING OF A CONCRETE POST-AND-BEAM BRIDGE RAILING, CALIFORNIA TYPE 86H, MASH TL-4		<b>5. REPORT DATE</b>  <p style="text-align: center;">October 2024</p>
		<b>6. PERFORMING ORGANIZATION CODE</b>  
<b>7. AUTHOR(S)</b>  Victor O. Lopez, Robert Meline, David Whitesel, Christopher Caldwell		<b>8. PERFORMING ORGANIZATION REPORT NO.</b>  <p style="text-align: center;"><b>FHWA/CA25-3170</b></p>
<b>9. PERFORMING ORGANIZATION NAME AND ADDRESS</b>  Roadside Safety Research Group California Department of Transportation 5900 Folsom Blvd., Sacramento, CA. 95819		<b>10. WORK UNIT NO.</b>  
		<b>11. CONTRACT OR GRANT NO.</b>  <p style="text-align: center;"><b>FHWA/CA25-3170</b></p>
<b>12. SPONSORING AGENCY NAME AND ADDRESS</b>  California Department of Transportation 5900 Folsom Blvd., Sacramento, CA. 95819		<b>13. TYPE OF REPORT &amp; PERIOD COVERED</b>  <p style="text-align: center;">FINAL</p>

# DEVELOPMENT AND CRASH TESTING OF A CONCRETE POST-AND-BEAM BRIDGE RAILING, CALIFORNIA TYPE 86H, MASH TL-4

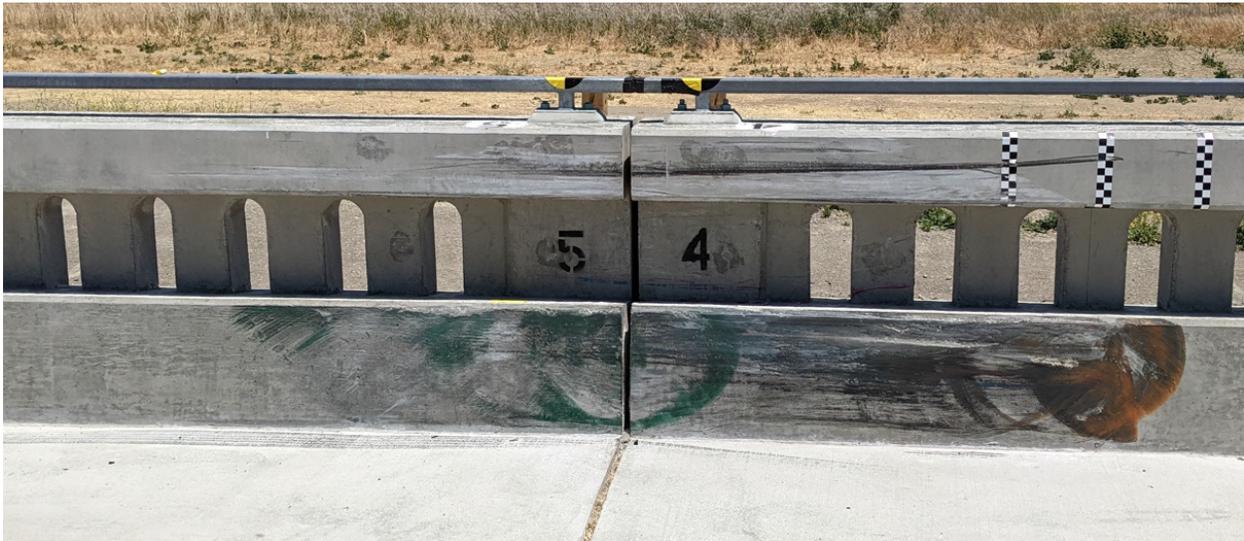
There was no significant damage to the barrier. There were minor surface scrapes on the top edge of the curb face approximately 2.0 m (6.6 ft) in length. The traffic side face of the concrete curb had marks from the painted tires and superficial marks from the bumper and side of the test vehicle. The vertical face of the concrete beam had horizontal marks from the side-view mirror rubbing up against it. Barrier damage is shown in Figure 5-7 through Figure 5-9. The orange contact marks are from the front right tire. The green contact marks are from the rear right tire. Dynamic deflection of the bridge rail was very small and unmeasurable from the overhead video. There was no permanent deflection of the Type 86H. Strain gage and string potentiometer data were collected during the test and are available upon request but are not within the Lab's Scope of Accreditation.

Figure 5-7 Test 4-10 Vehicle Marks and Minor Scrapes on Type 86H at Critical Impact Point

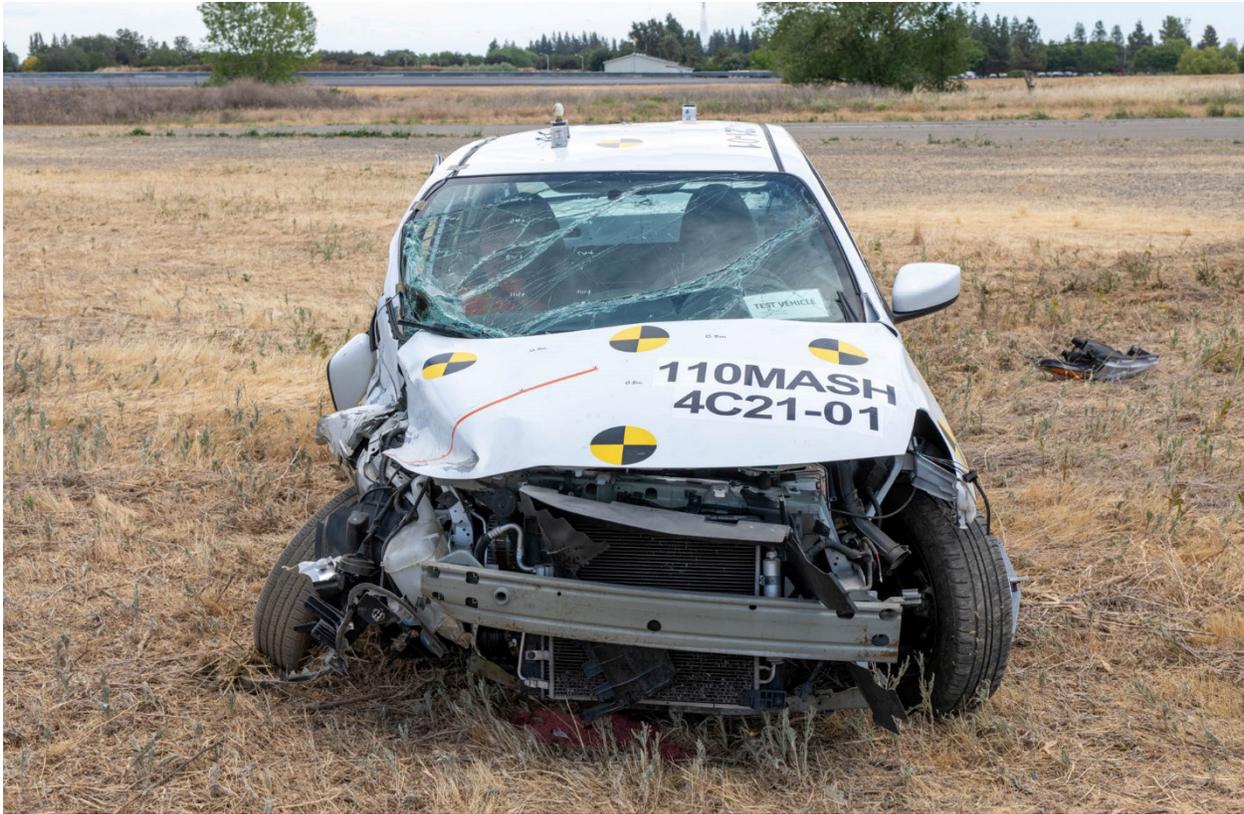
The 1100C front right corner and the passenger's side of the vehicle sustained damage during the impact. For the passenger side of the vehicle, mainly the right front and rear quarter panels were damaged, with a large indentation caused by the beam of the bridge rail. The front passenger wheel was pushed back and tilted away from the vehicle, remaining attached to the strut and steering arm. The front bumper cover, grill, and both headlights were completely detached from the vehicle. The windshield was spider-cracked across its surface, and it buckled more than 76 mm (3 in.) outward on the passenger side, lower section. This occurrence, in itself, is not considered a failure considering that the deformation was outward and away from the occupant compartment. The passenger side window shattered due to the deformation and buckling of the A-Pillar and passenger door which occurred when the vehicle struck the barrier. All the other windows remained undamaged. The front passenger wheel was damaged and tire was deflated, all remaining tires remained inflated. The airbags did not deploy because the vehicle was towed and there was no power to the airbag system. The maximum amount of passenger compartment deformation measured by known points was 168 mm (6.6 in.), which occurred on the passenger-side in the toe pan/wheel well area of the floorboard. All interior deformation measurements were below the maximum MASH 2016 limits and are shown in Appendix A: Table 10-11 through Table 10-13. As previously mentioned, the windshield deformation exceeded the MASH limit of 76 mm (3 in.) however it is not considered a failure since it bowed away from the occupant compartment. See Figure 5-10 to Figure 5-23 for pictures of the vehicle damage described above. See Appendix D for undercarriage photos showing no damage.

Figure 5-10 Test 4-10 Test Vehicle Damage (front/hood and windshield)

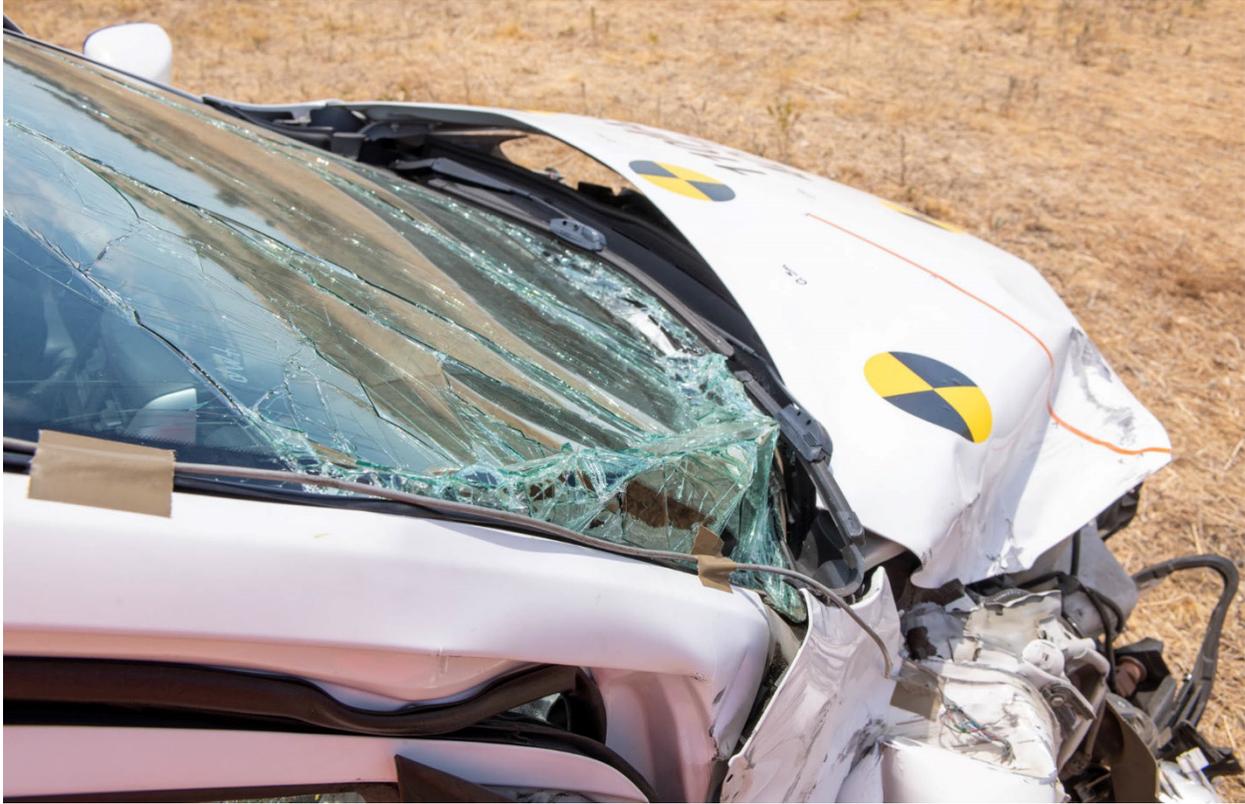
Figure 5-18 Test 4-10 Test Vehicle Damage Windshield / Exterior Deformation Away from Occupant

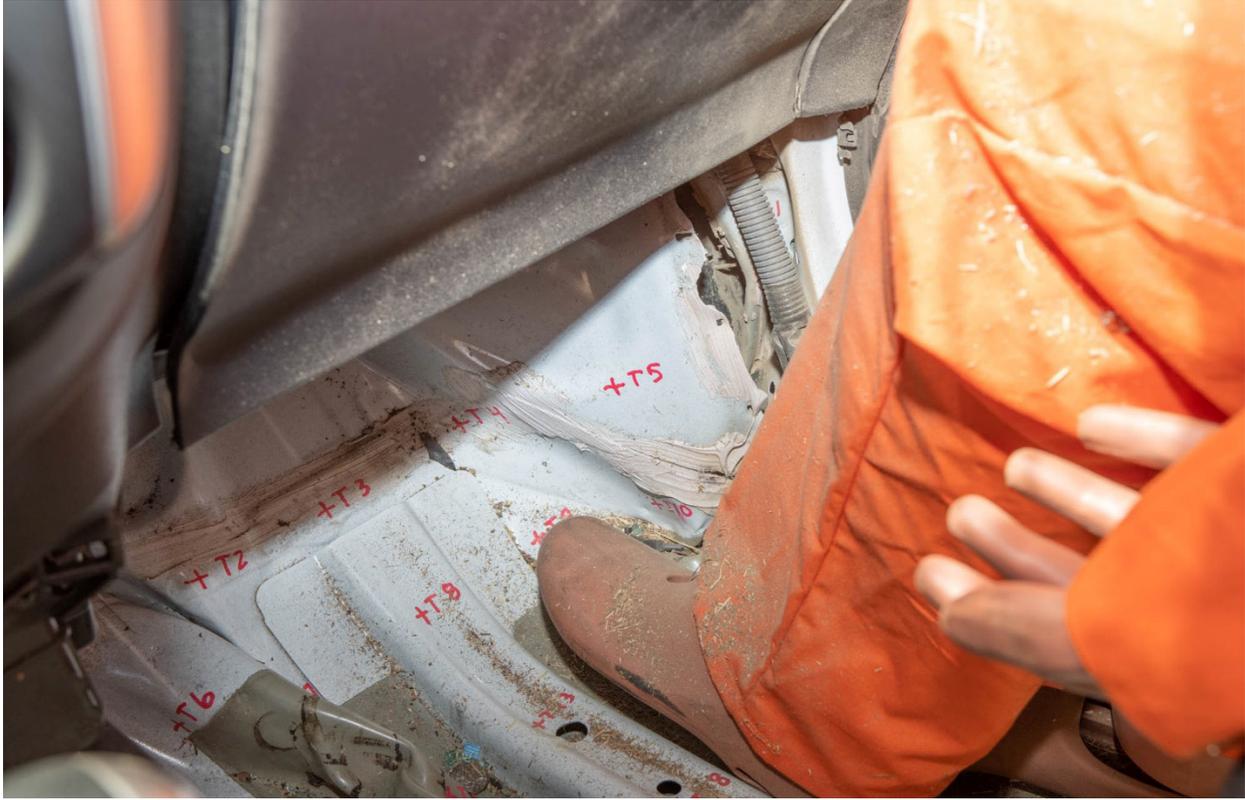
Figure 5-20 Test 4-10 Floorboard Deformation

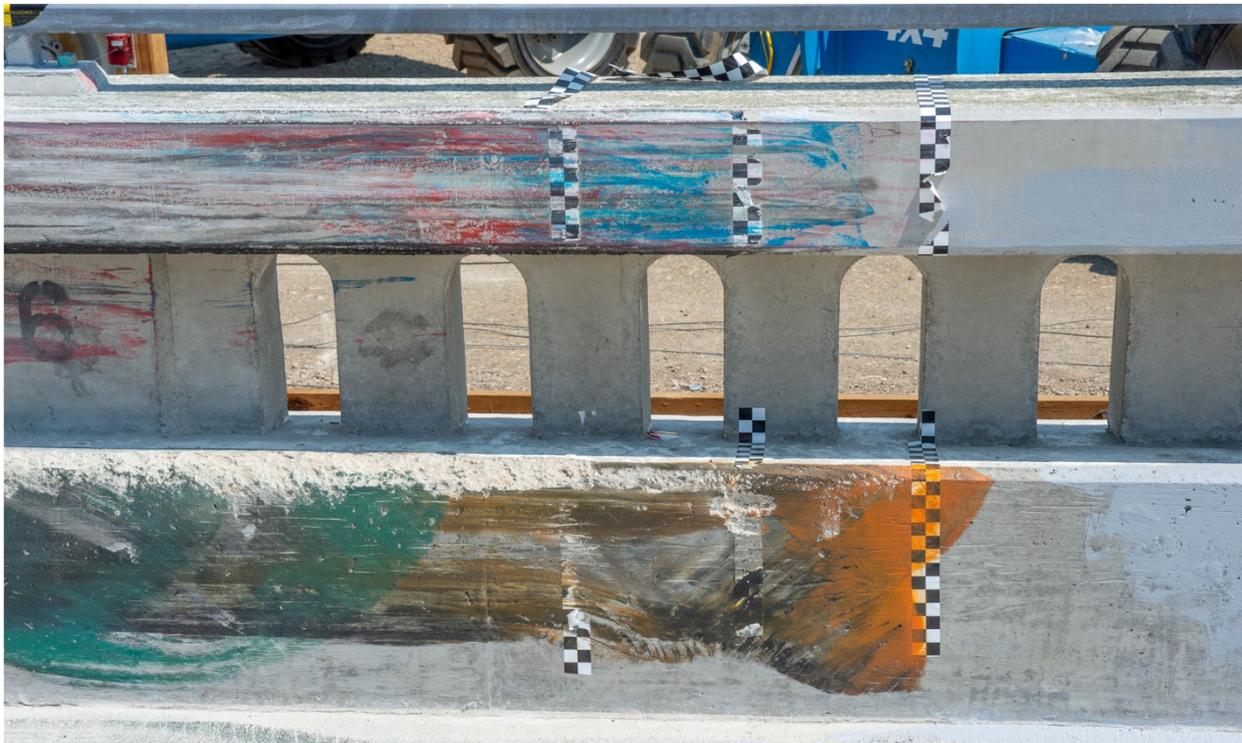
There was no significant damage to the barrier. There were moderate surface concrete spalls on the top edge of the curb face approximately 1.52 m (5 ft) in length. These spalls were likely caused by the passenger front wheel rim. There was no spalling on the beam. The face of the beam and curb had marks from the painted tires and superficial marks from the bumper and side of the test vehicle. Barrier damage is shown in Figure 6-7 through Figure 6-9. The red and blue contact marks on the beam are from the region around the passenger side headlight. The orange mark is from the front passenger side tire and the green contact marks are from the rear right tire. Dynamic deflection of the bridge rail was estimated at 7 mm (0.26 in.) using string potentiometers. The simulated bridge deck rocked downward slightly during the initial impact of the vehicle and with the tail slap. There was no permanent deflection. The bicycle rail was slightly contacted by the front corner of the hood at Post 6, but there was little snagging and the rail appeared undamaged. Strain gage and string potentiometer data were collected during the test and are available upon request but are not within the Lab's Scope of Accreditation.

**Figure 6-7 Test 4-11 Vehicle Marks with Minor Concrete Spalling on Type 86H at Critical Impact Point**

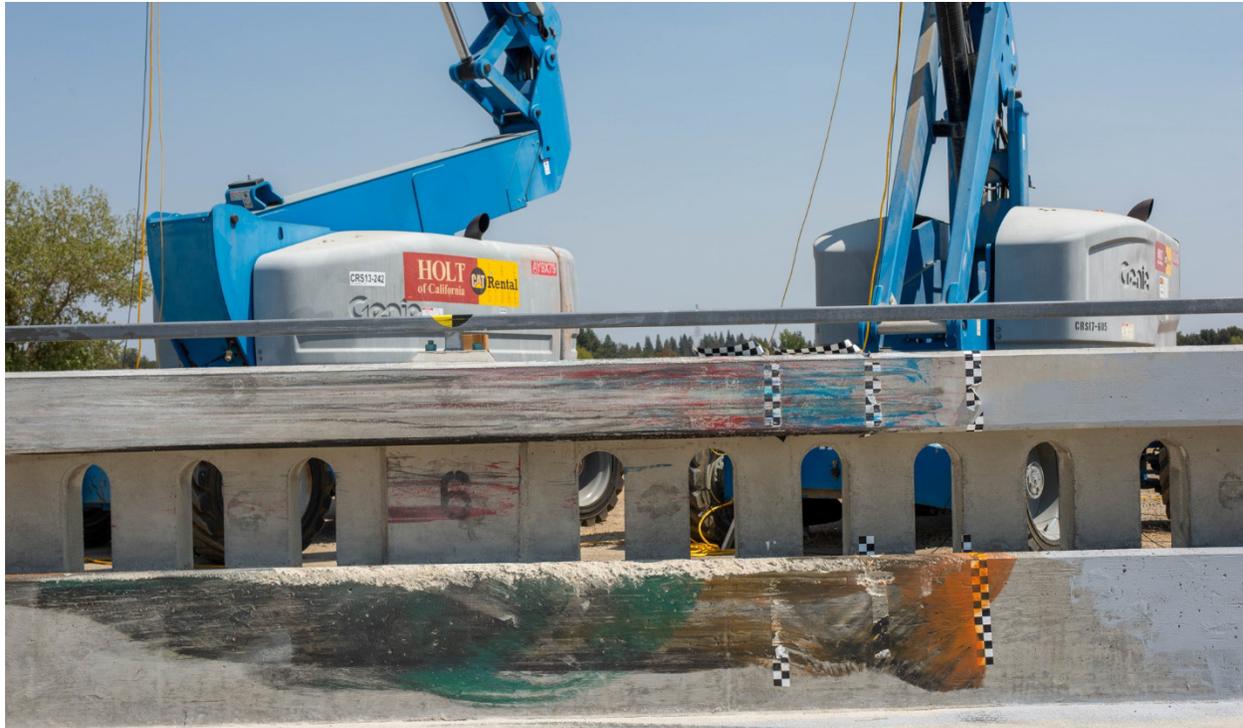
Figure 6-8 Test 4-11 Vehicle Marks with Minor Concrete Spalling on Type 86H near Post 6

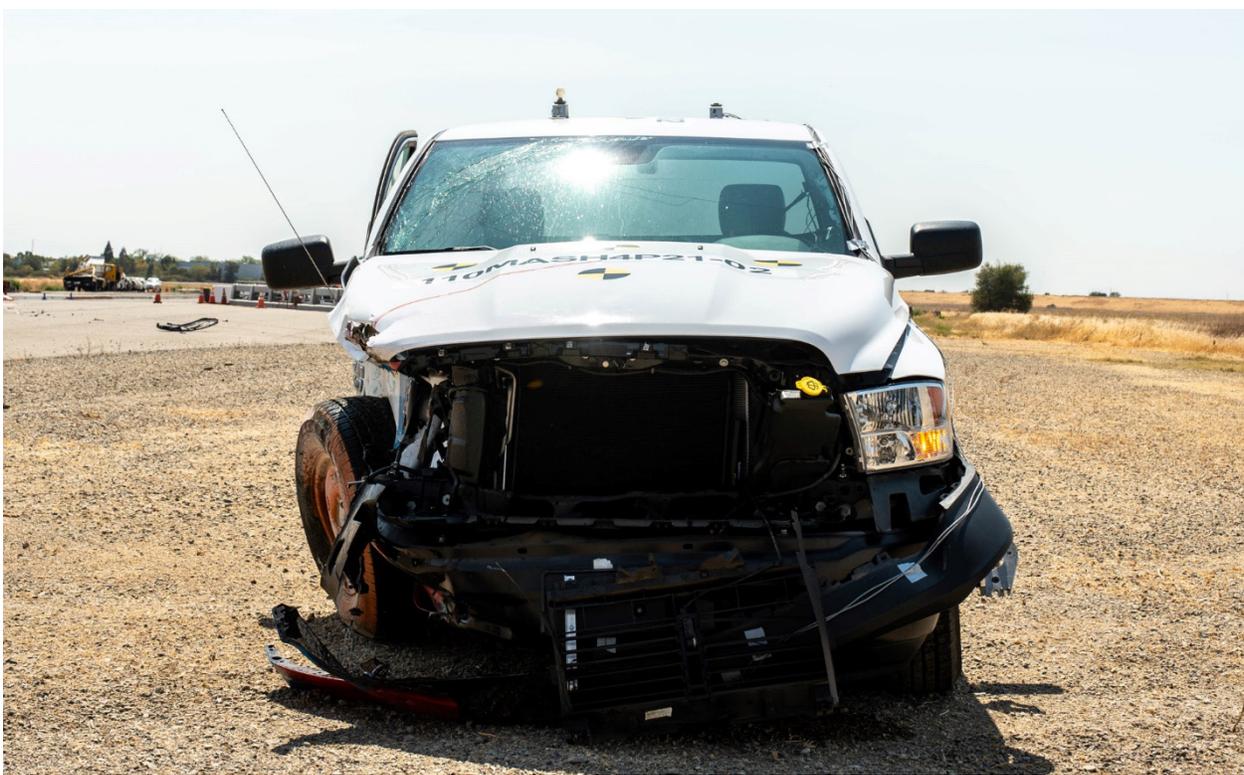
The 2270P front right corner and right side of the test vehicle sustained most of the damage from the impact. The mid-height portion of the front passenger tire and wheel impacted the top corner of the concrete curb, causing two of the lug nuts to be sheared off and a tilting of the tire into the space between the top beam and the curb. The front bumper was partially damaged, mainly the front right portion during initial impact with the barrier. The right headlight was completely shattered and detached from the vehicle as a result of the impact with the 254 mm (10 in.)-tall vertical face of the barrier beam. Most of the length of the passenger side of the vehicle including the right front fender, right doors, and the right side of the bed contacted the barrier beam. The front right corner of the hood had a small tear caused by contact with the bicycle rail at Post 6. The tearing was minor and did not affect the deformation results or the overall trajectory of the vehicle. The doors on the test vehicle all remained closed and latched during impact except for the window frame of the front passenger door which deformed outward, creating a gap between the window portion of the door and the body of the vehicle. The windshield was spider-cracked across its surface on the passenger side without any inward or outward deformation. The other window glass areas of the vehicle remained undamaged. The front grill and left headlight were also detached during the impact. The maximum amount of passenger compartment deformation measured by known points was 125 mm (4.9 in.), which occurred at the floorboard and wheel well of the passenger side. All interior deformations were below the maximum MASH 2016 limits and are shown in Appendix A: Table 10-22 through Table 10-26. See Figure 6-10 to Figure 6-20 for pictures of the vehicle damage described above. See Appendix D for undercarriage photos showing no damage.

Figure 6-10 Test 4-11 Test Vehicle Damage (front, hood and windshield)

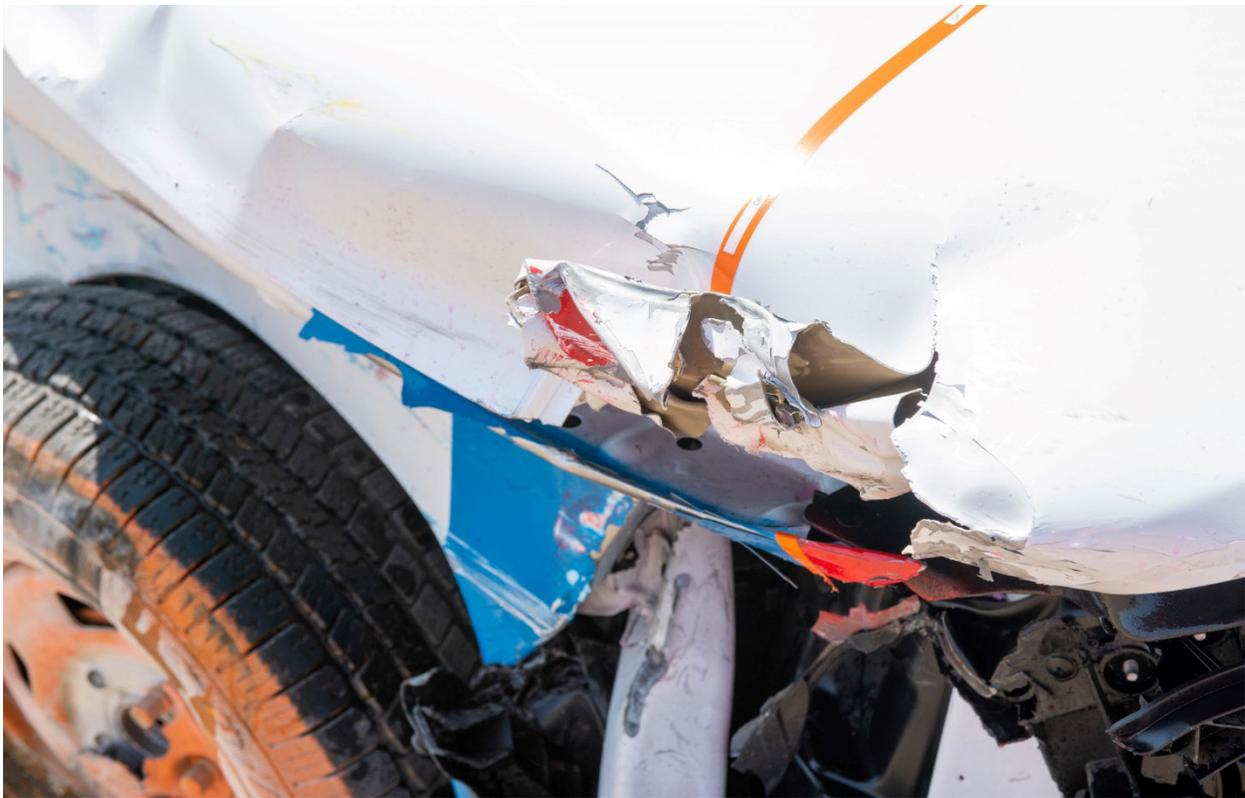
Figure 6-14 Test 4-11 Test Vehicle Hood Minor Tearing Damage (front right)

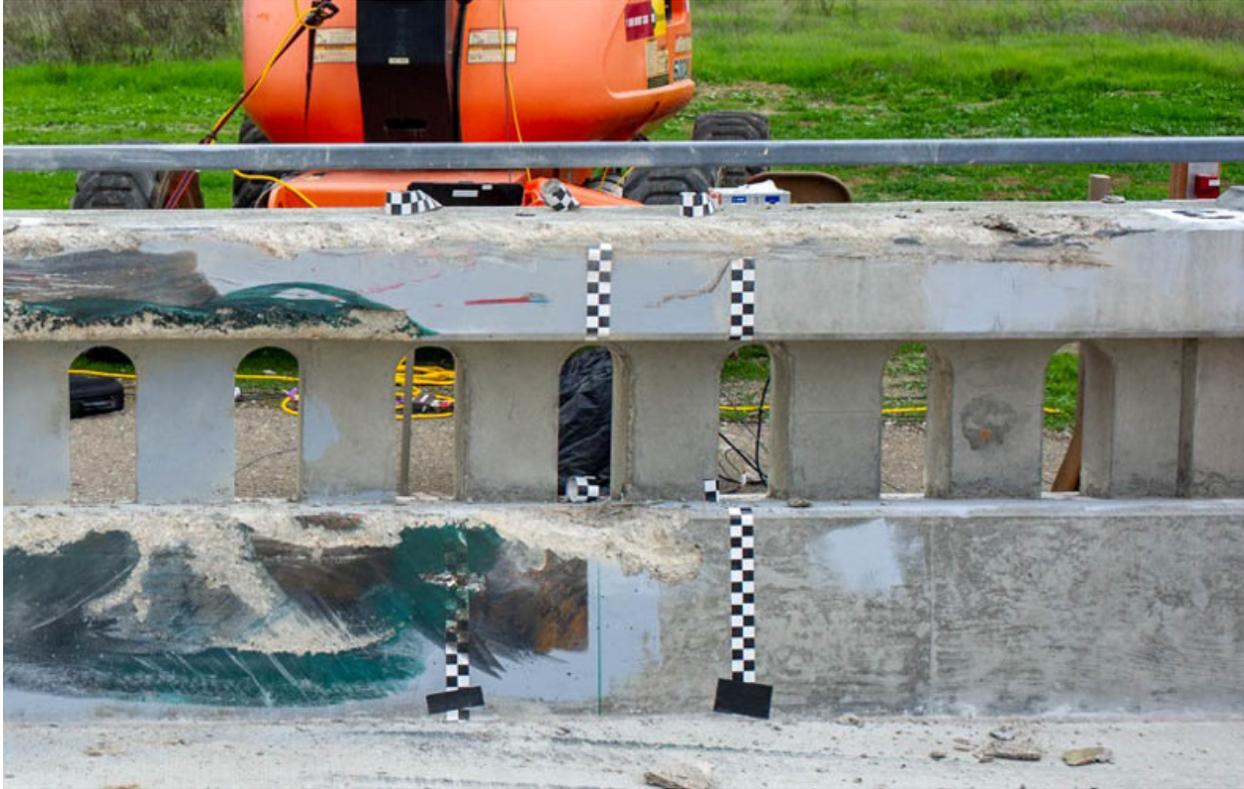
There was minor to moderate damage to the barrier face. The concrete curb was scuffed with moderate concrete spalling from the impact point to just downstream of post 6. The traffic side of the beam was scuffed with minor concrete spalling from a point just upstream of the critical impact to the expansion joint between posts 4 and 5. The spalling primarily occurred on the top corner of the curb and top corner of the beam with some minor spalling on the bottom corner of the beam. The deeper spalling of the curb was caused by the front right wheel lugs and rim during the initial impact, measured approximately 38 mm by 0.4 m (1.5 in. by 1.3 ft) maximum depth by length of spall. Additional marks and gouges may have been caused by the steel passenger steps, rear wheel and rear bumper frame. The spalling that occurred on top of the beam appears to have been caused by the bottom of the cargo box as it scraped across the surface of the beam. There were no spalls on the vertical edges of post 5 indicating that there was no snag at the post downstream of the expansion joint. No rebar was exposed and there was no evidence of concrete structural cracking. The beam-mounted bicycle railing was undamaged except for the grout pad mentioned below. Overall, the bicycle rail performed well. The bicycle rail was slightly contacted by the top of the wheel well of the test vehicle near post 6 leaving minor white and black paint marks. A small portion of the grout underneath the bicycle rail post base plates at post 6 was spalled. The minor spalling was most likely due to the impact of the lower side and rear corner of the cargo box. See Figure 7-7 through Figure 7-12 for photos of barrier damage. The orange contact marks are from the front right tire. The green contact marks are from the rear right tire. String potentiometer and strain gage data were collected at 10,000 sample/sec during the test. Strain gage data do not fall under the Scope of Accreditation but are available upon request. The dynamic and permanent deflection data were collected from string potentiometers and measured a maximum of 18 mm (0.7 in.) and less than 3 mm (0.1 in.), respectively. The edge of deck vertical motion was also measured with string potentiometers and they were very similar to the lateral bridge rail deflections. Measurements made with String Potentiometers are not within the Lab's Scope of Accreditation.

**Figure 7-7 Test 4-12 Vehicle Marks and Concrete Spalling on Type 86H at Critical Impact Point**

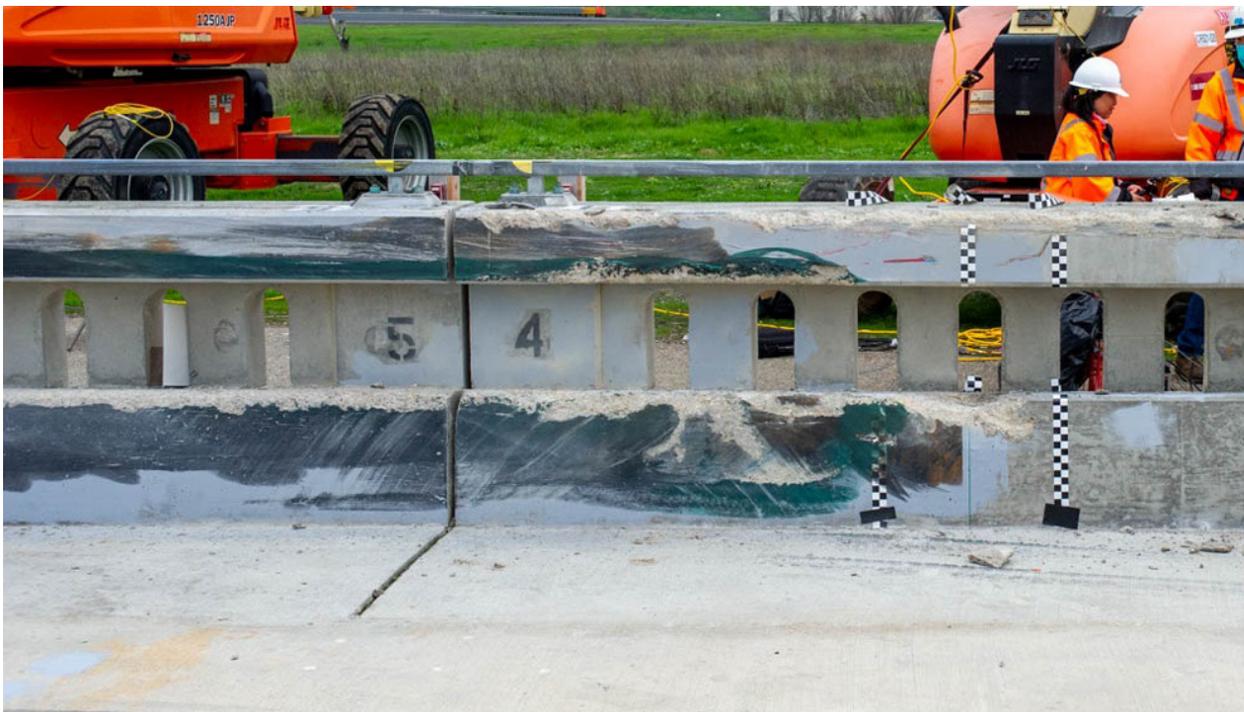
**Figure 7-8 Test 4-12 Vehicle Marks and Concrete Spalling on Type 86H at expansion joint**

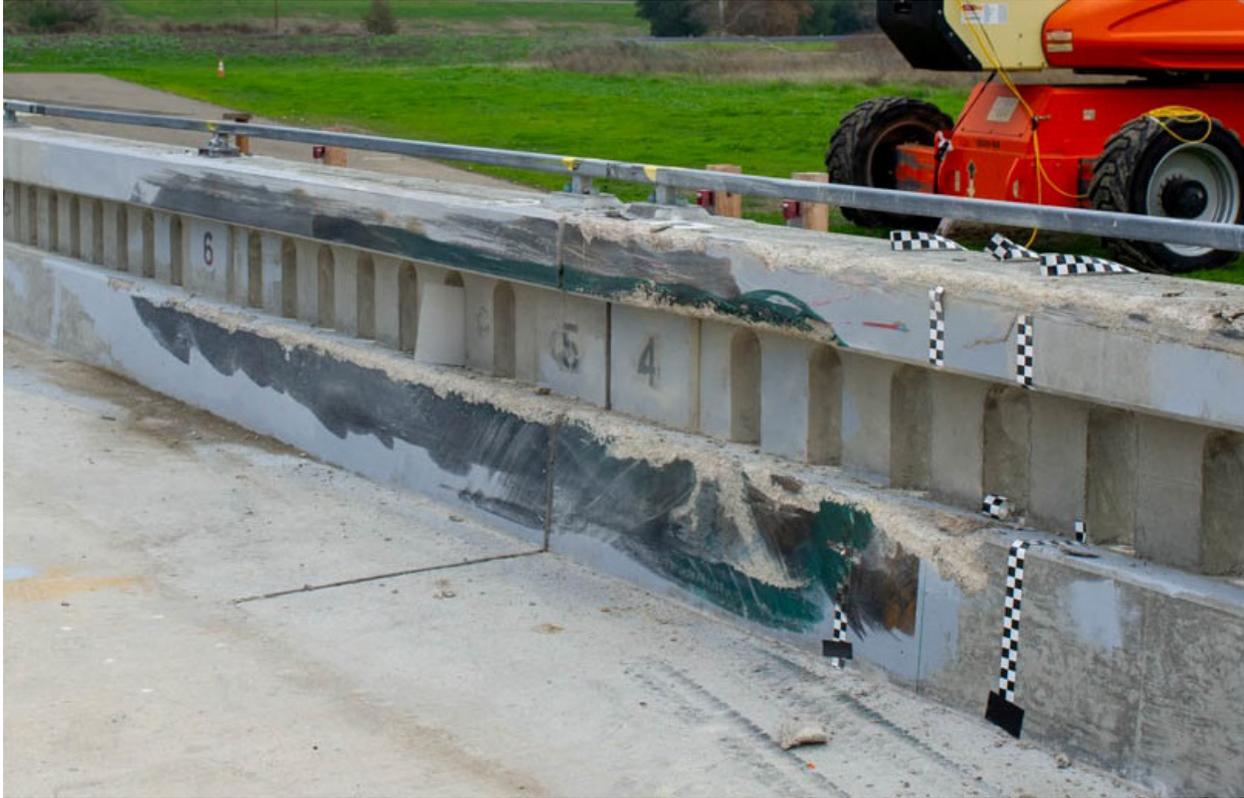
Figure 7-9 Test 4-12 Vehicle Marks and Concrete Spalling on Type 86H Looking Downstream

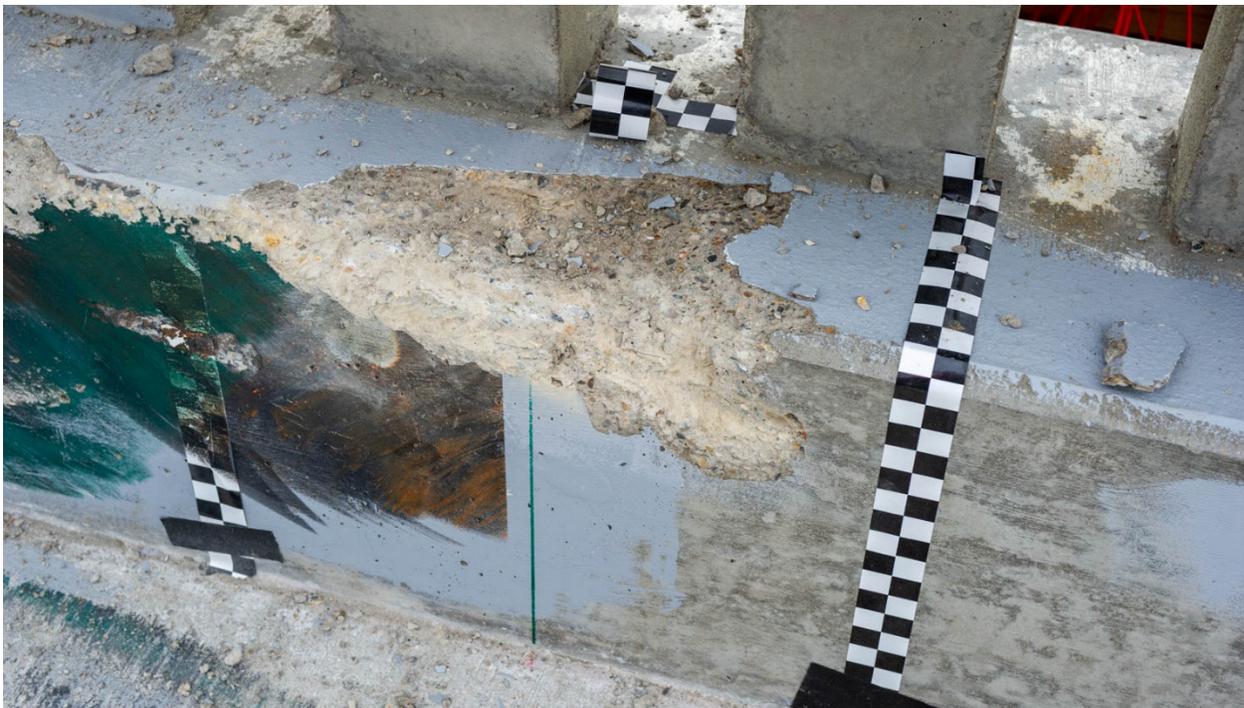
Figure 7-10 Test 4-12 Moderate Concrete Curb Spalling on Type 86H

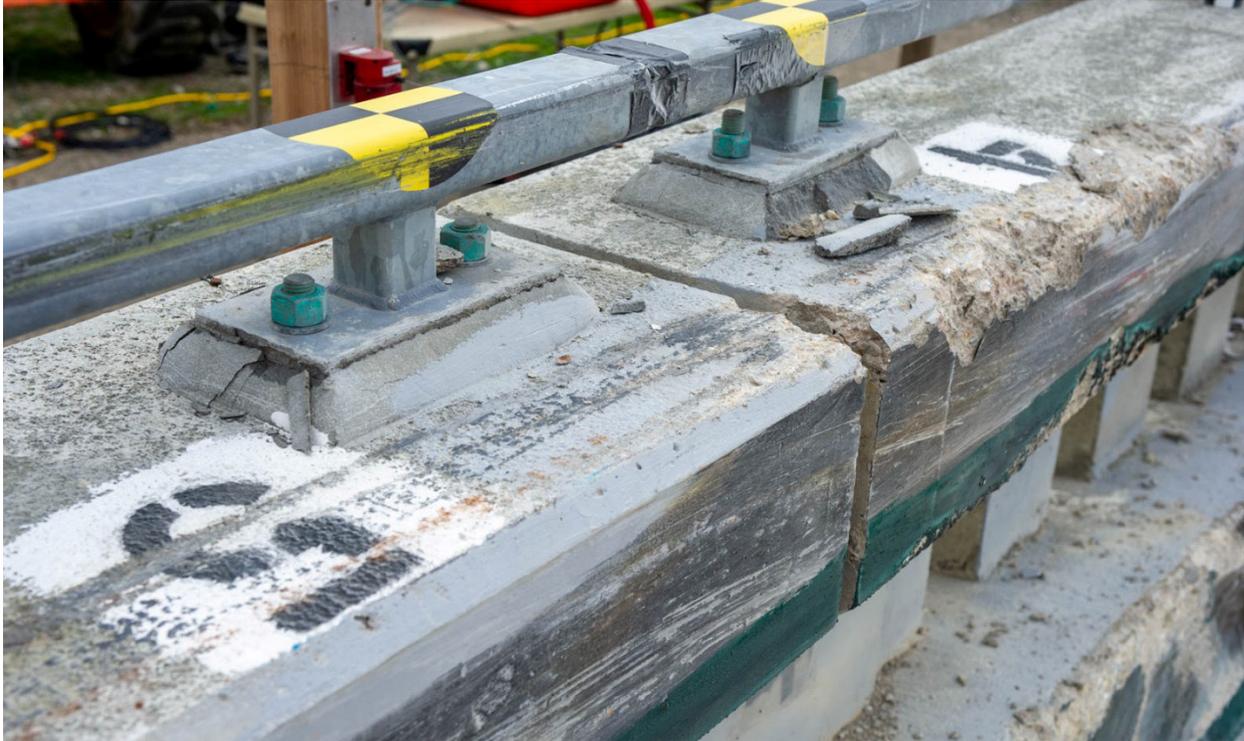
Figure 7-11 Test 4-12 Beam and Bicycle Rail Mortar Pad Spalling at the expansion joint on Type 86H

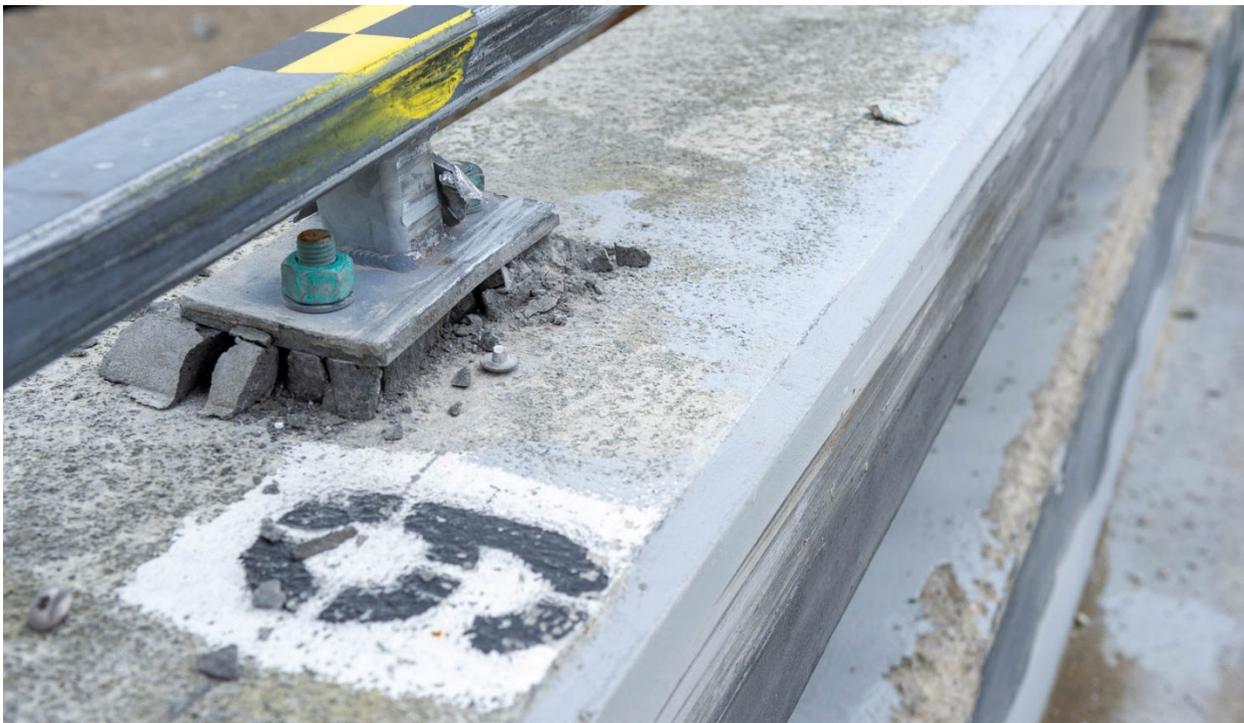
Figure 7-12 Test 4-12 Minor Bicycle Rail Mortar Pad Spalling at Post 6 Type 86H

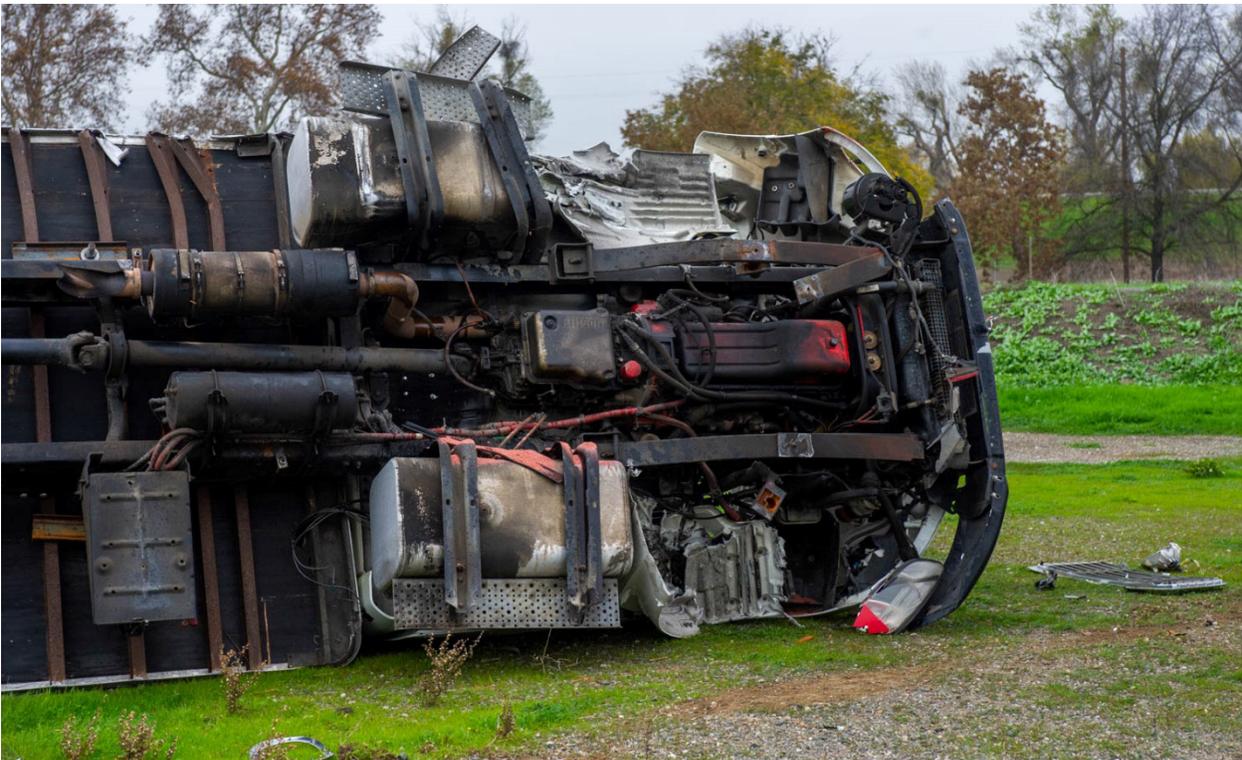
The 1000S front right corner and passenger side of the vehicle sustained most of the damage from the initial impact with the concrete post and beam system. During the impact the vehicle remained upright as it traveled downstream within the length of the bridge rail, exiting the bridge rail within the exit box criteria. Upon impact with the concrete curb and beam, the right front tire was pushed up and into the engine area, causing the U-bolt connections of the axle to fail, ultimately resulting in a complete detachment of the front axle from the truck. The front right corner of the cab initially rolled towards the barrier along with the box. However, while exiting the rail, the cab and box rolled away from the rail with enough momentum to cause the 1000S to roll onto the driver's side and slide to a stop. The detached axle continued to roll coming to a stop approximately 12 m (39 ft) downstream from the front of the van body. The van body truck came to a stop on its side, downstream from the end of the barrier rail, approximately 80.0 m (262.6 ft) downstream of the critical impact point and 11.1 m (36.4 ft) behind the traffic-face of the rail. The fact that the vehicle rolled onto its side is not a failure in the MASH 2016 criteria for this test. The passenger side of the front bumper was deformed, the passenger side headlight was damaged, and the right front fender was detached. The rear suspension remained attached as did the rear wheels and tires. All tires remained inflated. The steps on the passenger side were partially deformed and the top step was partially detached and rotated due to contact with the concrete rail. The driver's side door, A-pillar, fender, and cab roof were deformed from the impact with the ground after the vehicle left the Type 86H. All the window glass was undamaged during interaction with the test article. The cracking of the windshield occurred after the cab impacted the ground. Nearly all the damage to the cargo box also occurred when the vehicle rolled onto its side. The shear plates and bolts that were installed on the frame remained intact (see Figure 7-21 thru Figure 7-24). The bed shifted a minor amount. The threaded rods used to secure the ballast were undamaged and kept the motion of the ballast to a minimum. The maximum amount of passenger compartment deformation measured by known points was 100 mm (4 in.), which occurred at the roof. This deformation was most likely due to the impact of the driver side of test vehicle with the ground after rolling on its side after the vehicle separated from the rail. The roof deformation over the passenger side was away from the occupant compartment and therefore is acceptable. The largest deformation resulting from the interaction between the test vehicle and the barrier rail occurred at the A and B Pillars. The maximum deformation in this area was 73 mm (2.9 in.). This value is below the MASH 2016 limit of 127 mm (5 in.). The overall exterior vehicle damage is described as Moderate to Heavy. All interior deformation measurements are shown in Appendix A: Table 10-31 through Table 10-35. See Figure 7-13 to Figure 7-26 for pictures of the vehicle damage described above.

Figure 7-15 MASH 4-12 Test Vehicle Front Undercarriage and Damaged Suspension After Impact

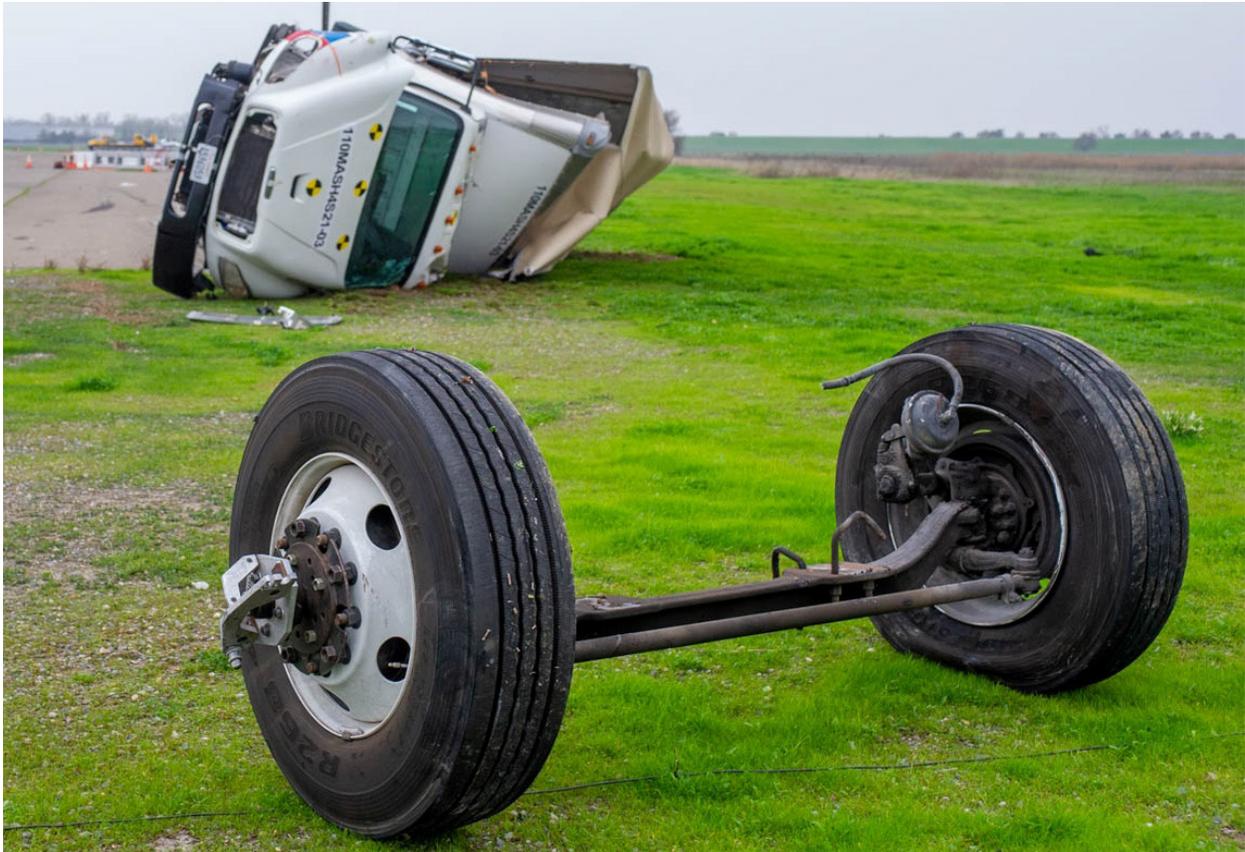
Figure 7-25 Test 4-12 Detached Front Axle (final position)
