DEPARTMENT OF TRANSPORTATION

SUBJECT: Request for CTCDC Guidance and/or Approval of Existing Signs

Caltrans District 5 is requesting CTCDC guidance and/or approval regarding existing non-standard signage for large vehicles at a roundabout.

The existing non-standard signage was installed at the northbound approach to the Roundabout at the junction of Routes 68 and 1 to advise the drivers of large vehicles (i.e. California Legal, STAA vehicles) as to how to make a right turn movement at the roundabout. (MON 68-L4.209)

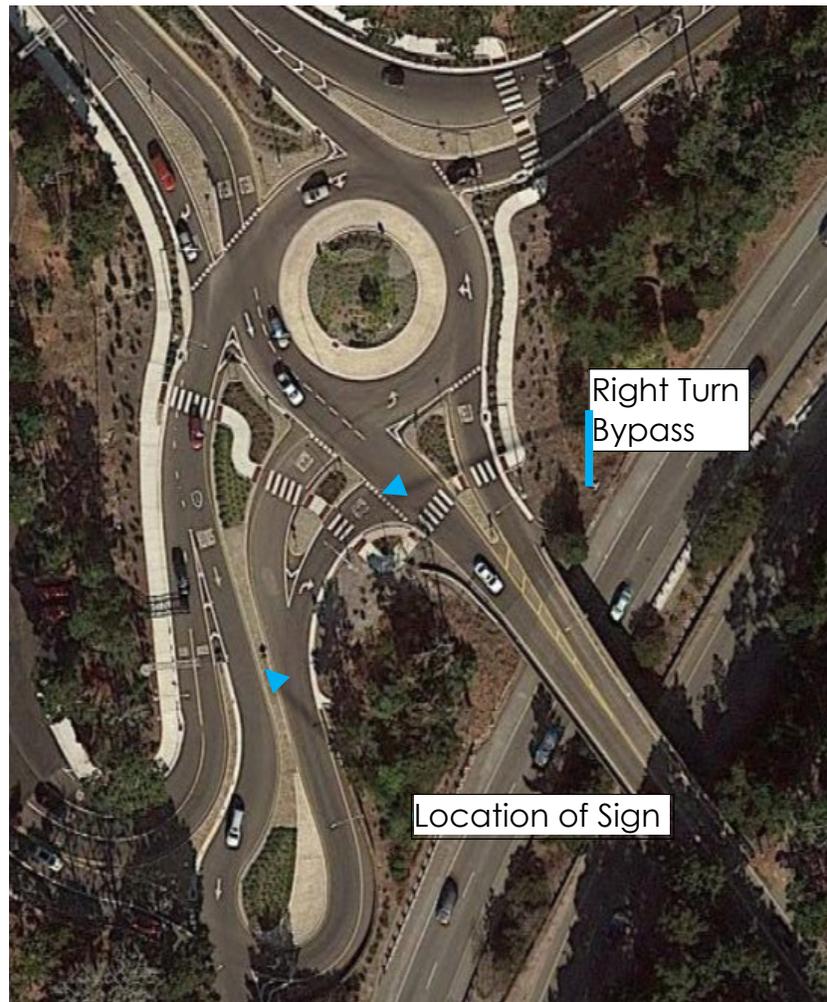
Figure 1: Aerial showing the roundabout and the location of the non-standard sign

The current non-standard sign is located as shown in Figure 1, roughly 100' in advance of the roundabout. The sign was installed near the end of construction by the design team and since it was installed, no trucks have become stuck at the roundabout. However, the reality appears to be much more complicated.

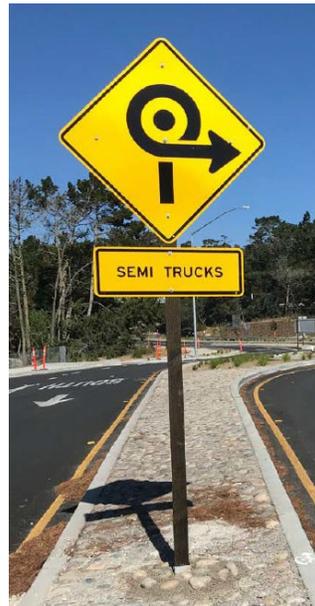
Figure 2: Current non-standard sign at this location.

Since the signage was installed, it has been argued that because trucks no longer become stuck in the roundabout that the sign is working as intended. However, if one pays close attention to the location of the previous construction area sign next to the south crosswalk as shown in figure 3, and compares that to the location of the construction area sign that is visible at the extreme left of the Figure 4, it appears that the driver proceeded to become stuck at the roundabout despite the presence of the sign. While it could be argued that he position of the sign at that time was not far enough in advance of the roundabout to provide clear guidance, there are more indications that the current sign shown in Figure 2 might also not be working as intended despite it's better positioning.

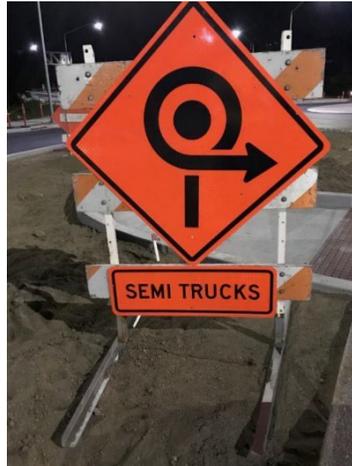
Figure 3: Non-standard “Ribbon turn” sign used during construction that was located on the south splitter island next to the crosswalk.

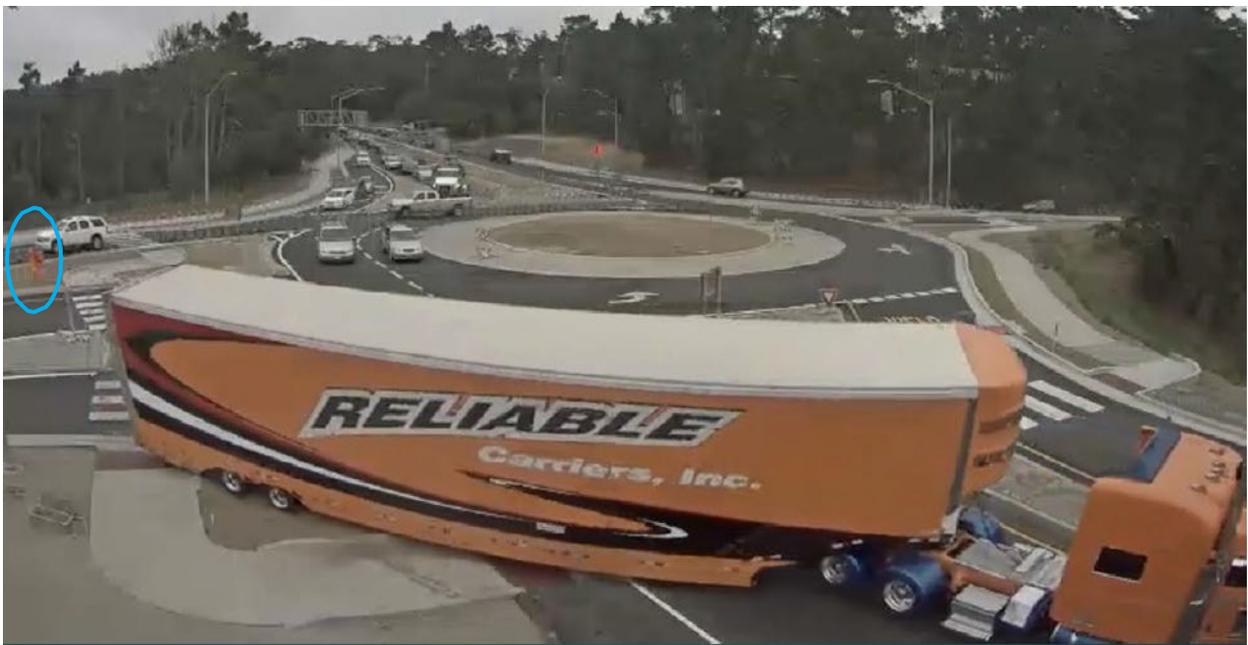
Figure 4: STAA vehicle that became stuck during construction. The location of the original “ribbon turn” sign is circled in blue, at far left.

Looking at the conditions that were present in Figure 5, during construction there was a deep depression behind the curb that caused the trailer's wheels to become stuck when the wheels off-tracked into the depression. Looking at Figure 4, it appears the depression was also present when that vehicle became stuck. At the end of construction the landscaping was installed which raised the final grade at the location in question and the finished surface is now at or above the height of the curb (Figure 6) thereby eliminating the obstruction that had previously caused vehicles to become stuck.

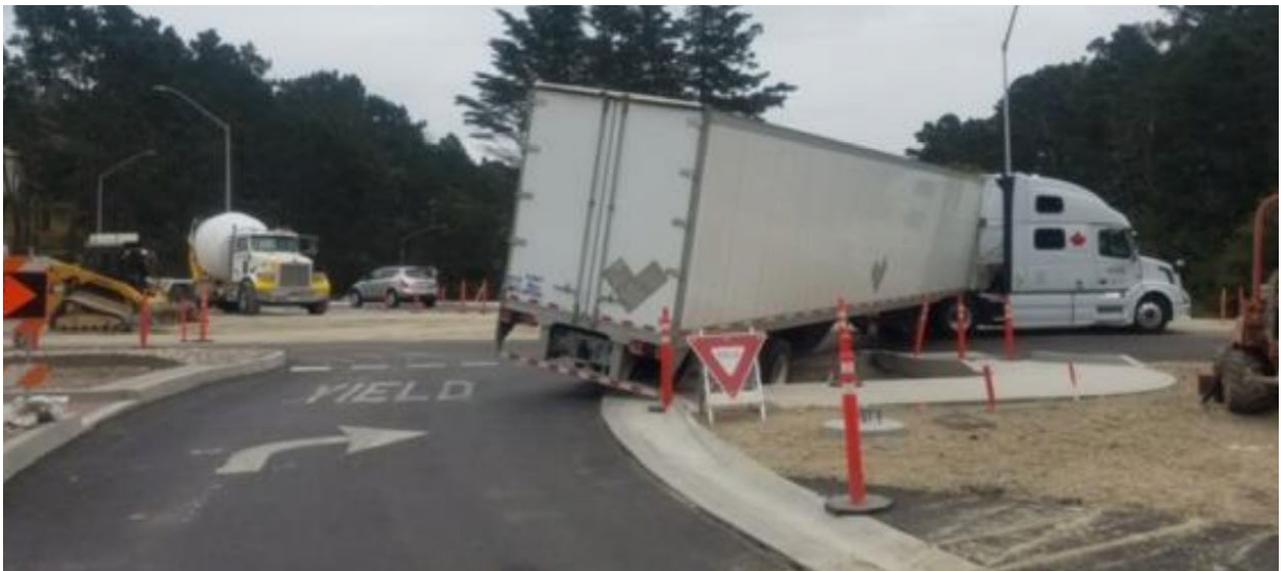
Figure 5: STAA vehicle that became stuck during construction. Note the drop-off behind the curb.

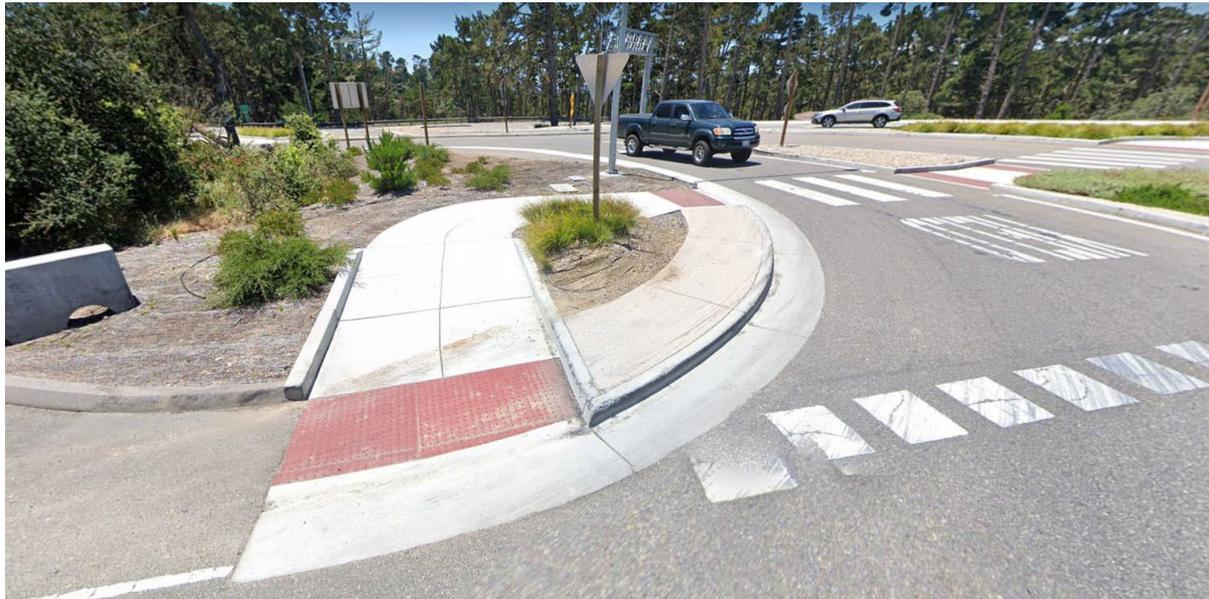
Looking at a post-construction image, (Figure 6) there has been damage caused to the curbs and the landscaping at this location due to trucks off-tracking. As can be seen in the image, the path of the trailer has off-tracked into the pedestrian areas outside of the crosswalk including the entirety of the detectable warning surface which is indicated by both the tire tracks and the damage at this location. There is also further damage to the splitter island on the eastbound exit at this location where drivers have hit the curb when presumably trying to make as wide of a turn as possible.

Figure 6: June 2019 Google Street-view image of the NB right turn bypass showing damage to the curbs and landscaping.

the right turn bypass lane does not accommodate large vehicles, however, the signage does not appear to be readily understood by all drivers. While trucks have not become stuck at the roundabout since the existing non-standard signage was installed, damage to the curbs and landscaping at this location indicate that trucks are still using the right turn bypass. Fortunately, the wheels of the trailer have off-tracked onto the landscaping and the pedestrian walkway without incident. Due to the risk posed by the truck off-tracking at this location, some type of signage is necessary from both a maintenance and safety standpoint as it is undesirable to have trucks off-track over curbs and into areas where pedestrians may be waiting at the crosswalks.

To this effect, one concept under consideration would be to use the same non-standard symbol but apply the symbol to a rectangular black-on-white regulatory sign with the legend “Right Turn”. The regulatory sign would be supplemented by the M4-4 “Truck” sign as shown in Figure 7.

The third and fourth options are proposing to use text only to communicate how trucks should use the roundabout. These options are being suggested as an alternative to the existing symbol because there is evidence that the existing symbol is not universally understood by drivers.
