TEHAMA COUNTY TRANSIT FACILITY SITE STUDY

JUNE 2010

Facility Condition Assessment for the
Proposed Tehama County Transit Facility
Paratransit Services
June 15, 2010

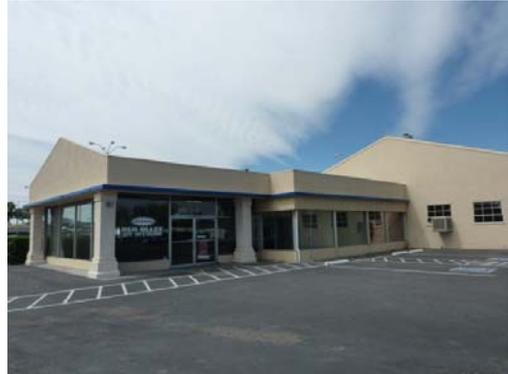
Proposed Improvements Property D

This structure will need substantial renovation, as it is showing signs of age, and, in places, water damage. Although there is a sizeable parking area on this site, it will require extensive regrading. This need is due in part to the poor condition of the paving, and also to a nearly 3-foot elevation differential between the parking area and the building that would hinder access of larger transit vehicles to the maintenance shop. Estimates for regrading, including site preparation, earthwork, baserock and paving, and baserock fill to address the elevation differential, are \$312,250. When other improvements are added, the total estimate for renovating this site is over \$1.1 million. .

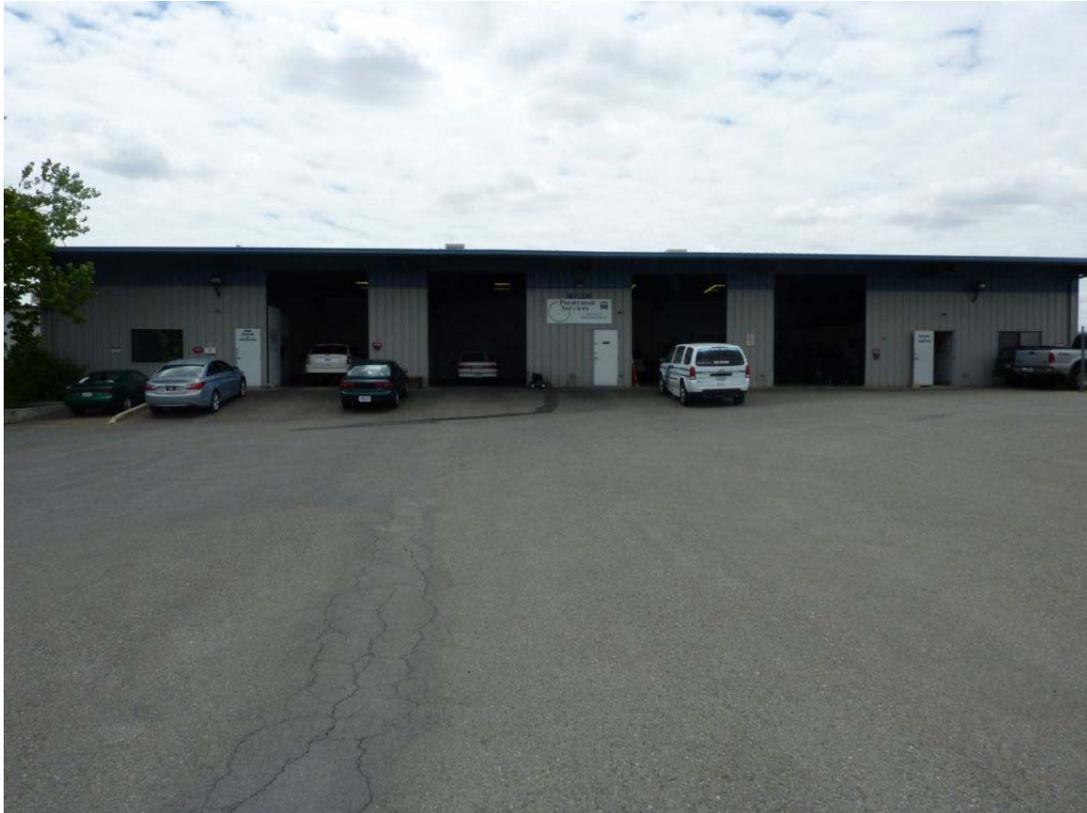
Property A
1509/1515 Schwab

Only minor improvements will be required to the exterior of the building including replacing the damaged siding and replacing the missing fasteners at the siding.

Minor improvements are required at the shop area including repairing the damaged ceiling insulation.

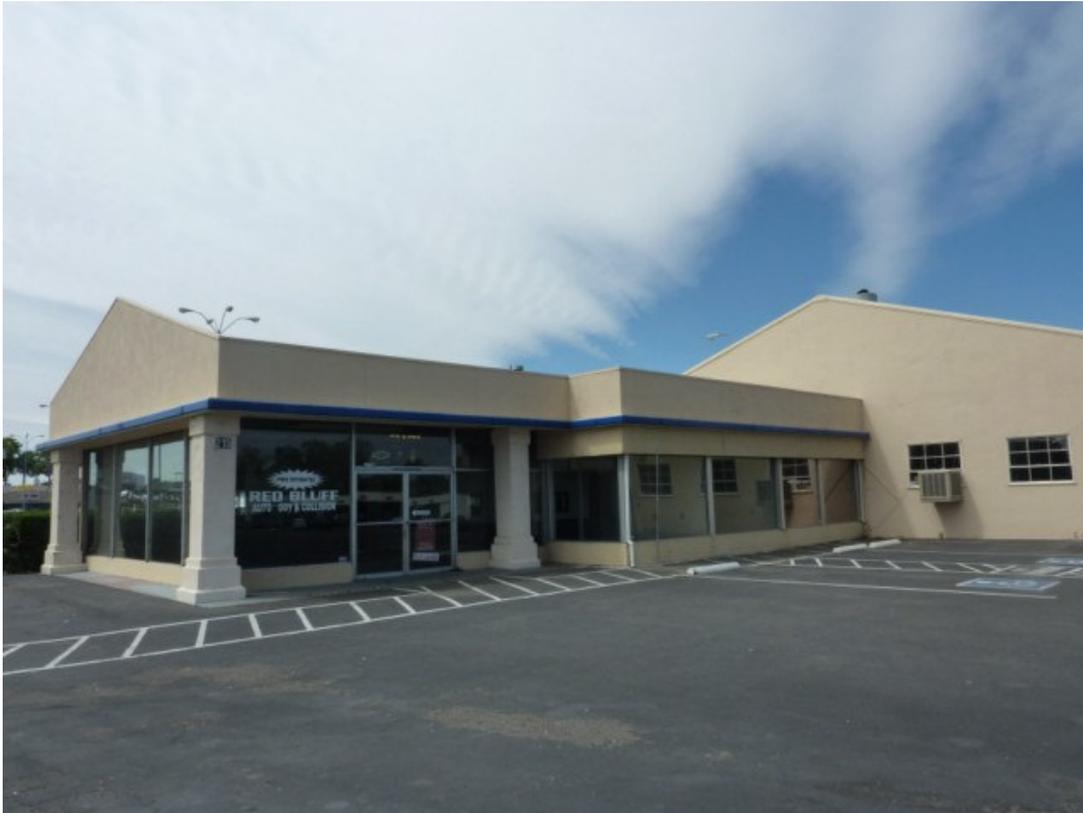
Property D
Former Helser Chevrolet Dealership
215 South Main Street

Replace main panel as it is beyond its useful life. Consider a new service from P.G.&E. for standard 3 phase power to reduce energy costs. Telecommunication and data system will need to be installed to meet the program requirements.
