## **Tree Preservation Assessment**

State Route 82 El Camino Real Roadway Renewal Project San Mateo County, CA

PREPARED BY: HortScience | Bartlett Consulting 325 Ray St. Pleasanton, CA 94566

November 2021

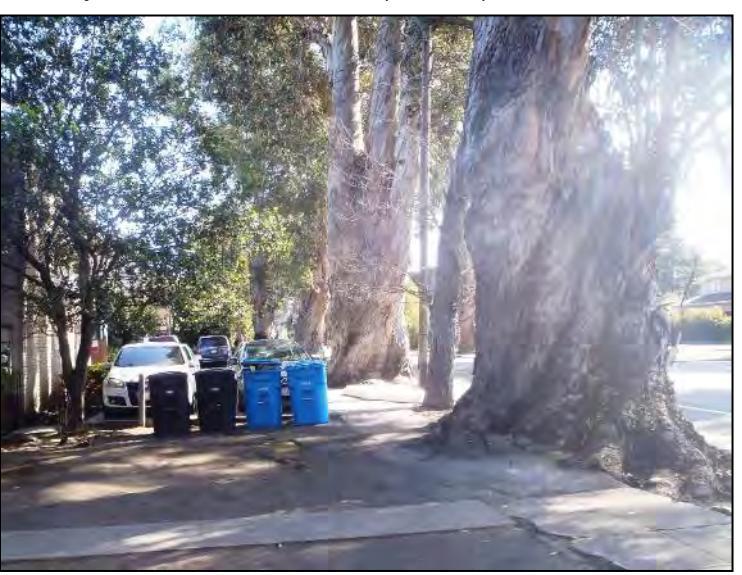
Photo 1: Looking south at blue gum #69, shows the typical growing conditions and available growing space around trees on the east side of El Camino Real.

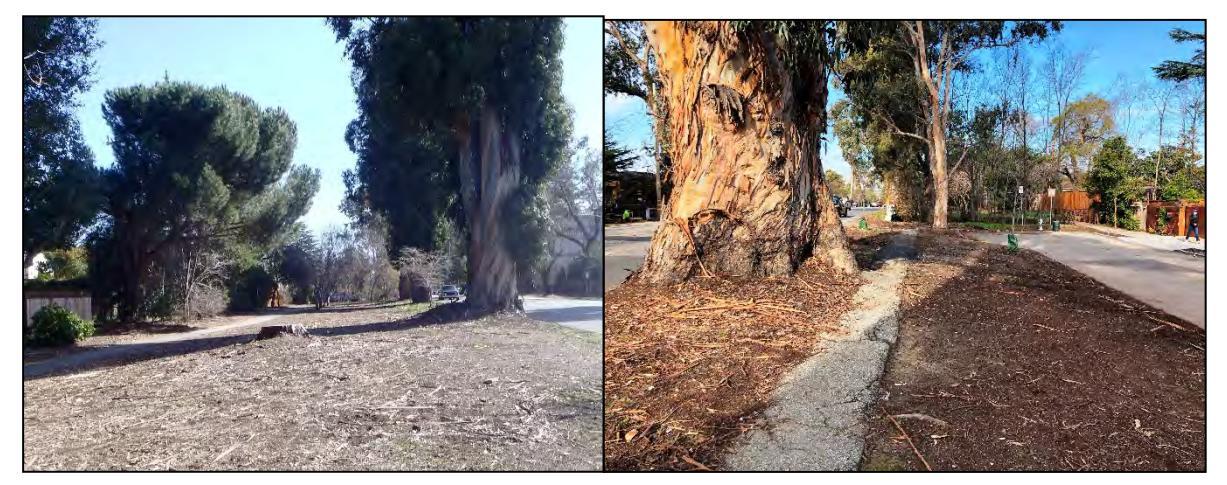
**Photo 2** (L): Looking south at blue gum #15. A substantial undeveloped area existed east of trees #2-20, however several of the trees in this area were still growing at the edge of ECR.

**Photo 3** (R): Looking north at blue gum #23, with ECR on the left and Highway Rd. on the right. Although not as extensive, there was some undeveloped land between the trees and Highway Rd.

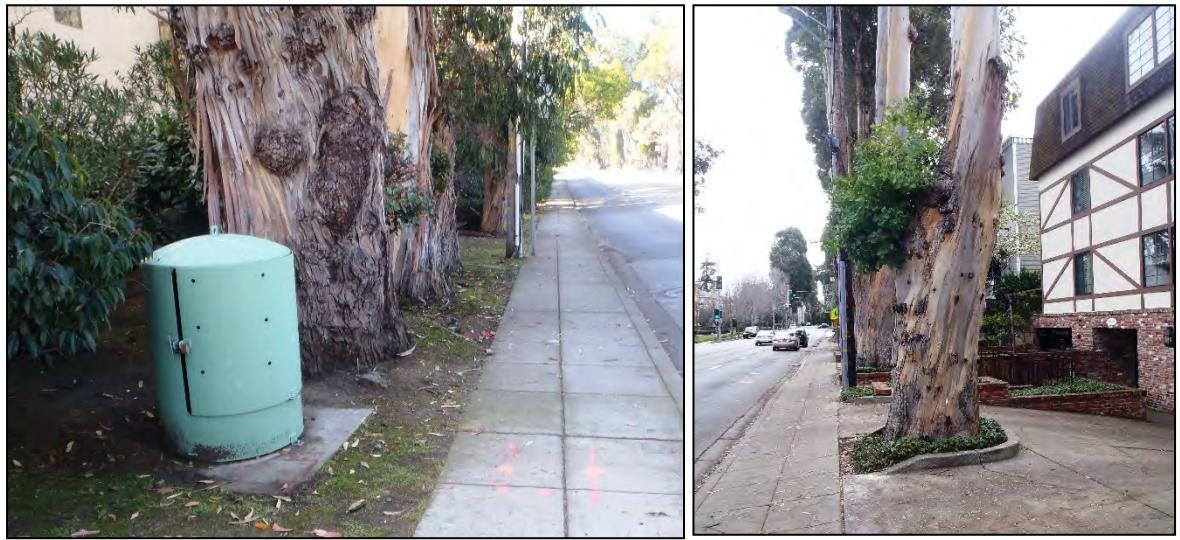
**Photo 4** (above L): Looking north at blue gum #353-355, which were growing behind the sidewalk and in what is essentially the landscape of the adjacent apartment complex. This was typical of the growing conditions on the west side of ECR.

**Photo 5** (above R): Looking south at blue gum #333. It had been preserved in a very small cutout in the concrete between two driveways.

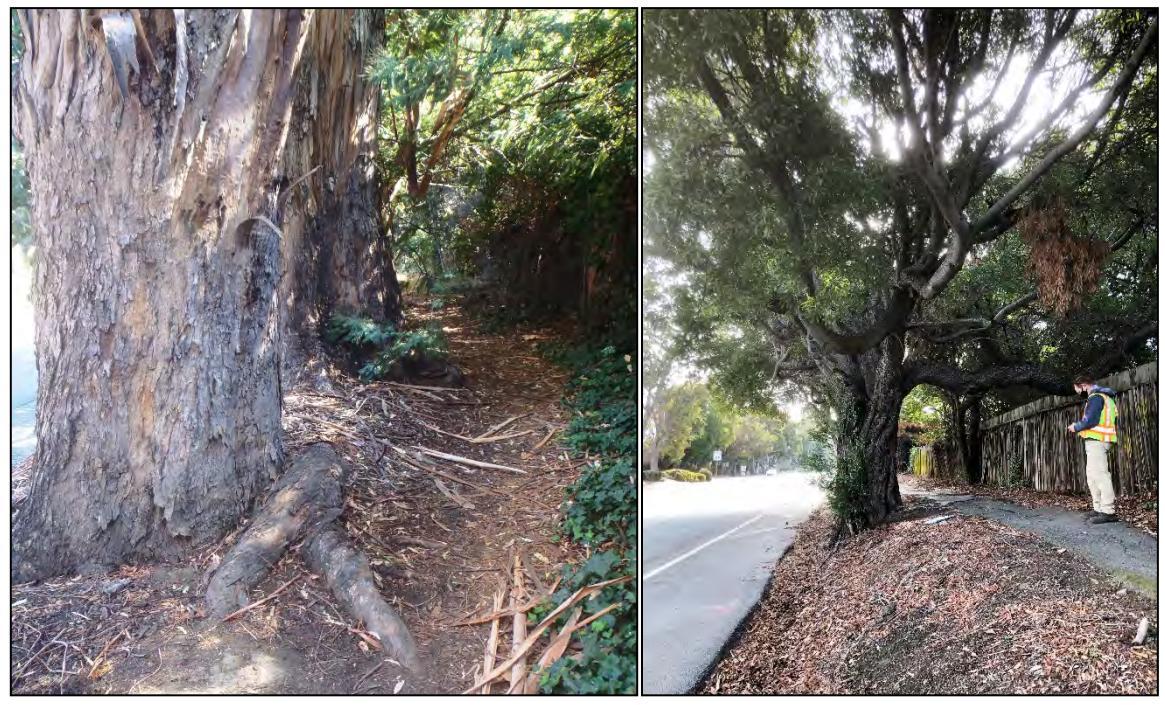
**Photo 6** (above L): Looking south at the base of blue gum #319, showing the growing condition adjacent to trees #303-321. Neither sidewalk nor curb and gutter were present in this area.

**Photo 7** (above R): Looking south at blackwood acacia #979. The tree was growing on a slope on the west side of ECR, with the sidewalk to the west (L) at a higher grade than ECR to the east (R).

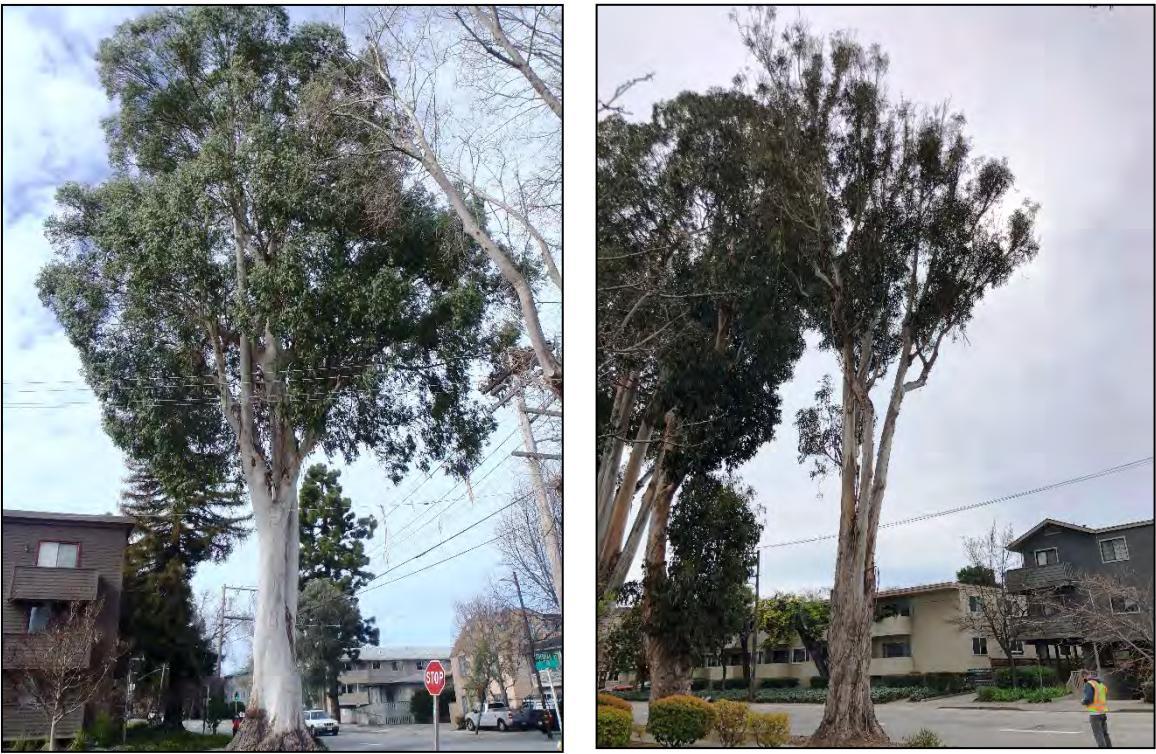
**Photo 9** (L): Looking north at manna gum #437. Although the tree had been topped and reduced, it was in good condition, with better form and structure than those in fair condition.

**Photo 10** (R): Looking southwest at blue gum #243. It was in poor condition, with a very sparse crown and moderate dieback of twigs and branches throughout the crown.

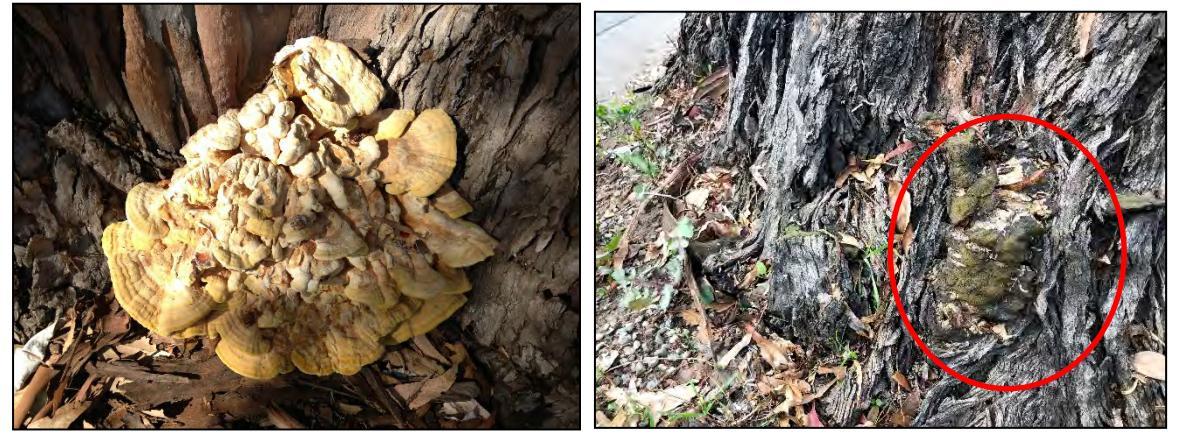
**Photo 11** (L): A typical fruiting body of sulfur fungus on a blue gum eucalyptus (not one of the trees assessed on ECR). Fruiting bodies form in late summer and early fall in the Bay Area, starting as soft, fleshy and orange and degrading to dry, chalky and white.

**Photo 12** (R): Looking at the base of blue gum #113, shows the degraded fruiting body of sulfur fungus (circle). All of the sulfur fungus observed as part of our field work was in a degraded state.

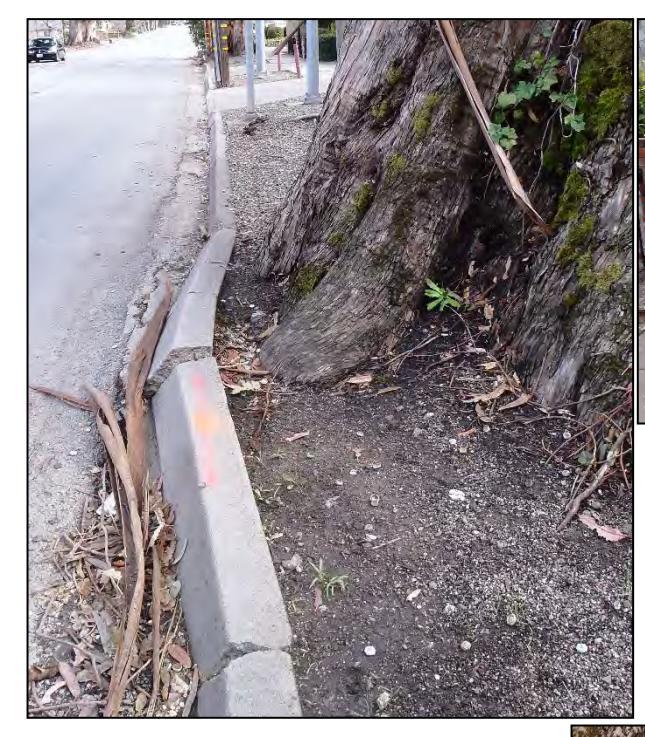
**Photos 13** (R) and **14** (above): Show the level of damage to curb and sidewalk caused by the base of blue gum #477.

In this case, the base of the tree had outgrown the available growing space, causing severe damage to both the adjacent sidewalk and curb.

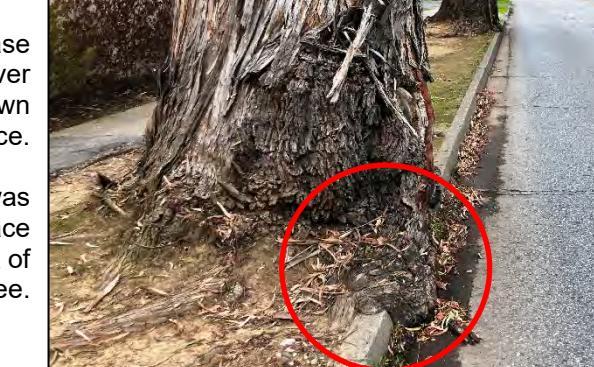
**Photo 15 (R)**: Looking south at the base of tree #193. The trunk had pillowed over the curb (circle) and the tree had outgrown the available space.

Although displacement of the curb was minor there is no way to repair or replace the curb without cutting into the trunk of the tree.

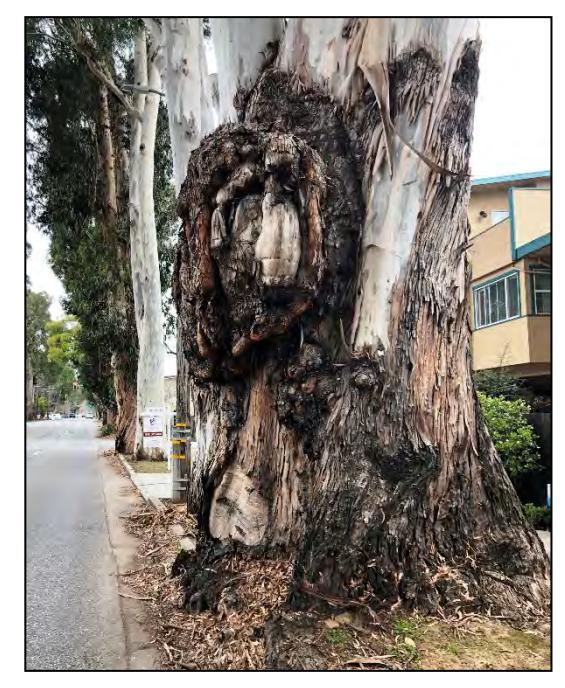
**Photo 16** (L): Looking north at the trunk of blue gum #139. The trunk had been struck multiple times, causing permanent damage.

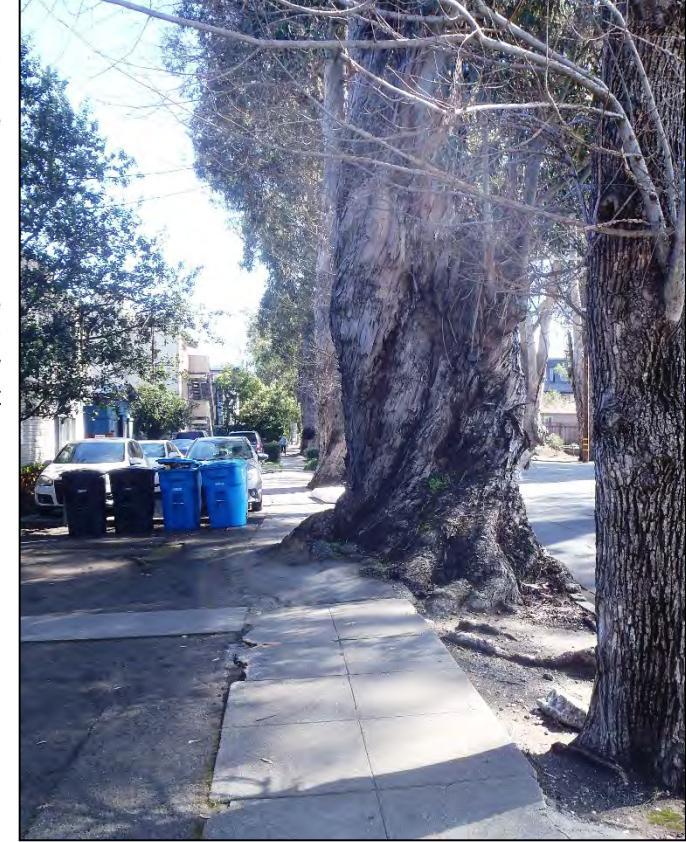
Photo 17 (R): Looking south from the driveway of 1324 ECR. This location represents one example of the proximity of trees to access points and the impact of the size of the trees.

The address is an apartment building with a driveway flanked by blue gums #68 and 69, both of which measure 65" in trunk diameter. The sheer size of the trunks creates a narrow passage for vehicles to enter/exit ECR.
