RESEARCH SUMMARY

REVIEW OF WEATHERING STEEL GUARDRAIL FOR CALIFORNIA HIGHWAYS

CALIFORNIA DEPARTMENT OF TRANSPORTATION

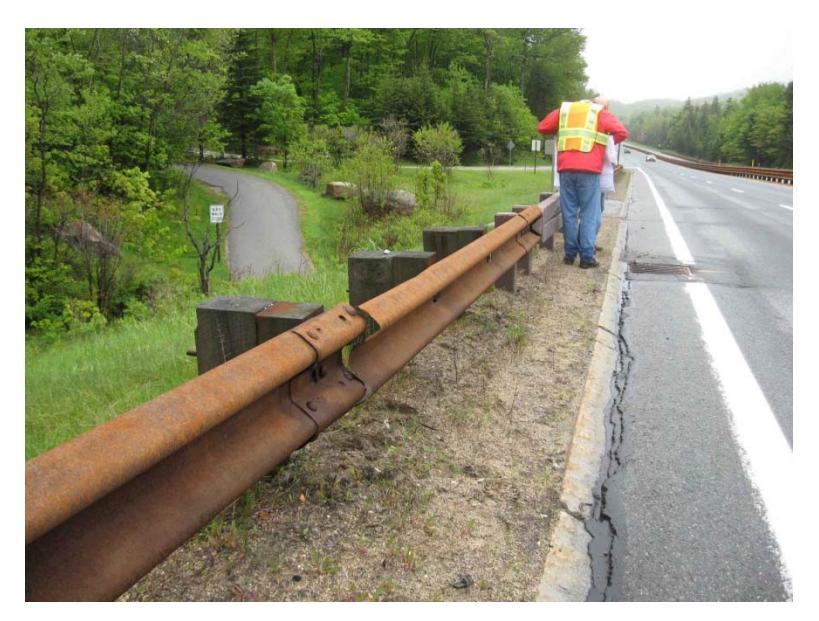
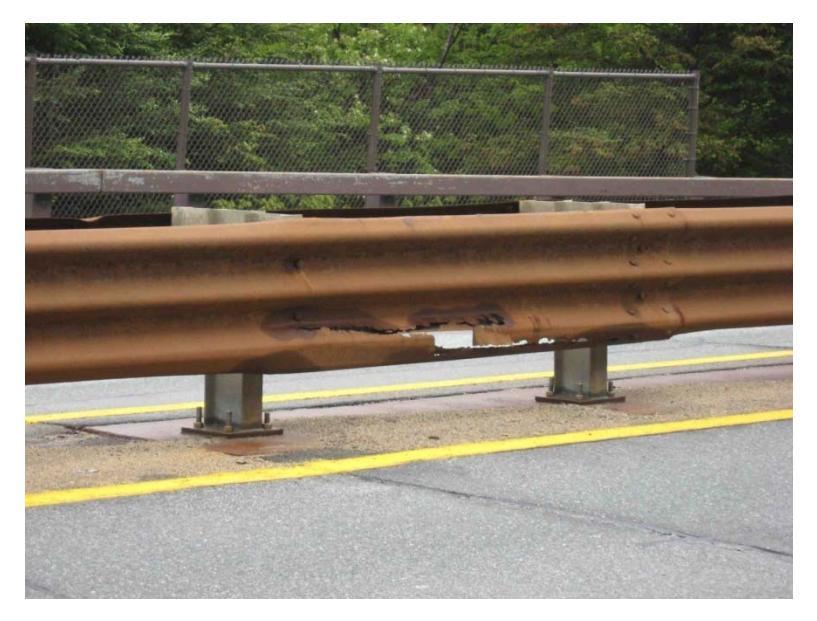
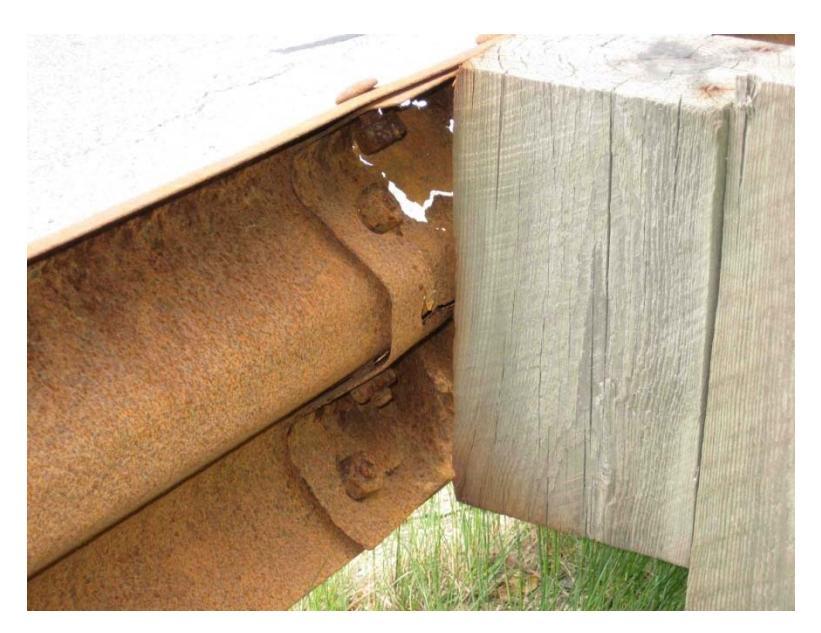
• They have had the rail deteriorate not only at the joints but also along the length of the beam. Figure **4** - Figure **6** show an installation on NH I-93 that is over ten years old.

Figure 4 - Weathering Steel Guardrail on New Hampshire's I-93

Figure 5 - Weathering Steel Guardrail on New Hampshire's I-93

Figure 6 - Weathering Steel Guardrail on New Hampshire's I-93

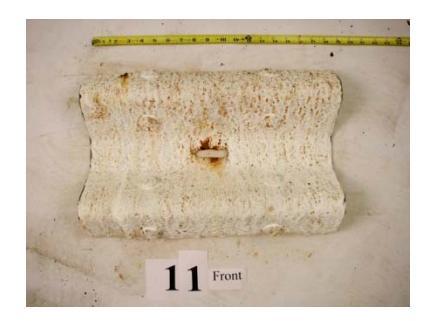
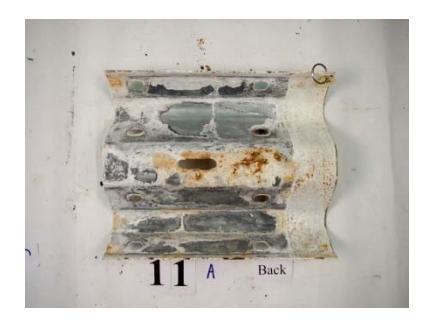
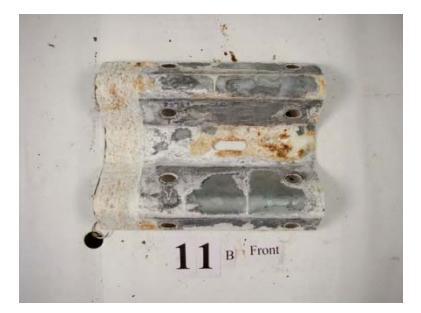
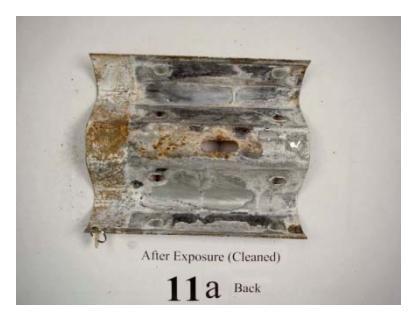
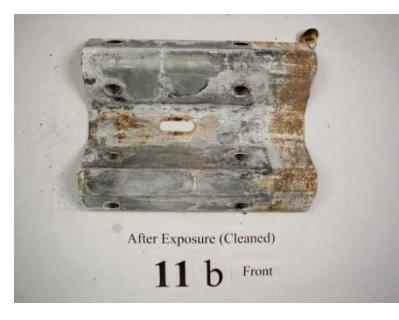
All GSGR samples were measured and met the above specifications before being placed in the salt fog chamber. There were two GSGR samples with galvanized bolts and these were control samples. Unfortunately the thicknesses of the samples after exposure were not recorded. Figure 7 - Figure 11 shows one of the GSGR samples still assembled after exposure, after it was disassembled, and after the corrosion was cleaned off.

Figure 7 - GSGR Assembled Joint after Exposure

Figure 8 - Part A GSGR Disassembled Joint

Figure 9 - Part B GSGR Disassembled Joint

Figure 10 - Part A GSGR Disassembled Joint Cleaned

Figure 11 - Part B GSGR Disassembled Joint Cleaned

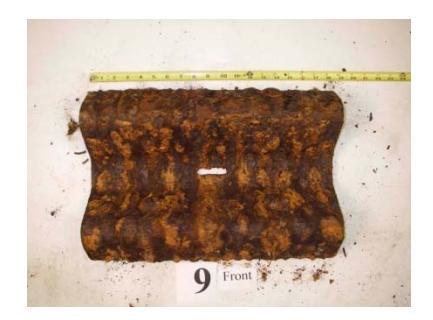
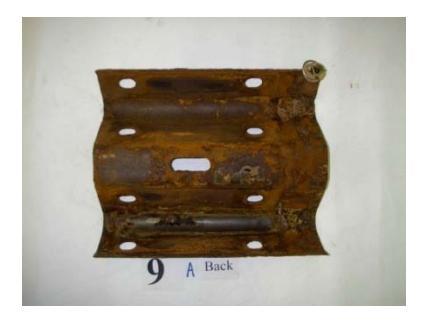
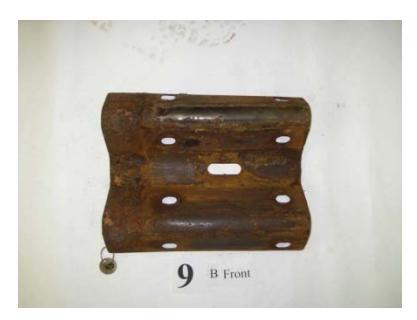
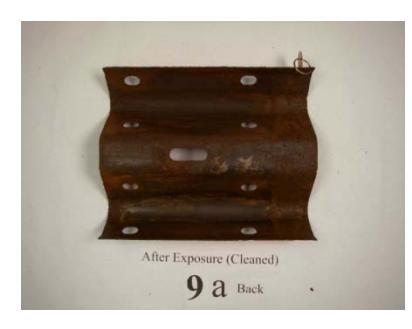
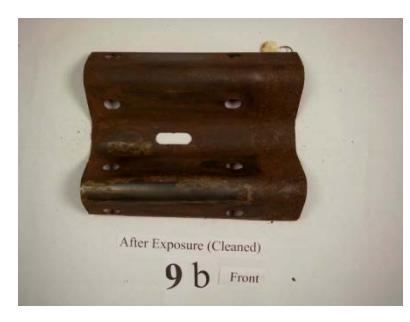
All WSGR samples were measured and met the above specifications before being placed in the salt fog chamber. There were two WSGR samples with weathering steel bolts and these were control samples. The average starting thickness of the WSGR samples was 0.100 inches. At the area where the guardrail overlapped there was an average loss of 29.6% with an average final thickness of 0.070 inches. At the outside edge where there was no overlap there was an average loss of 45.0% with an average final thickness of 0.055 inches. Figure 12 - Figure 16 shows one of the WSGR samples still assembled after exposure, after it was disassembled, and after the corrosion was cleaned off.

Figure 12 - WSGR Assembled Joint after Exposure

Figure 13 - Part A WSGR Disassembled Joint

Figure 14 - Part B WSGR Disassembled Joint

Figure 15 - Part A WSGR Disassembled Joint Cleaned

Figure 16 - Part B WSGR Disassembled Joint Cleaned

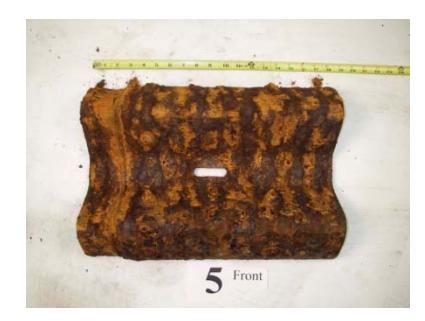
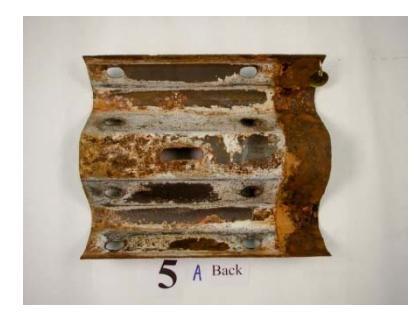
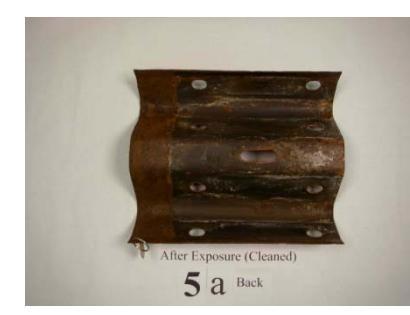
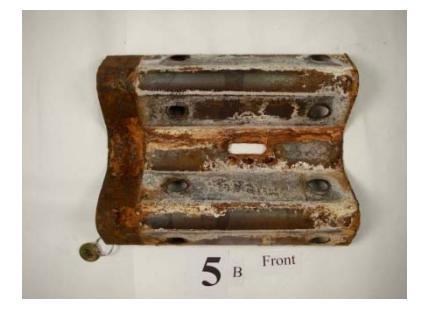
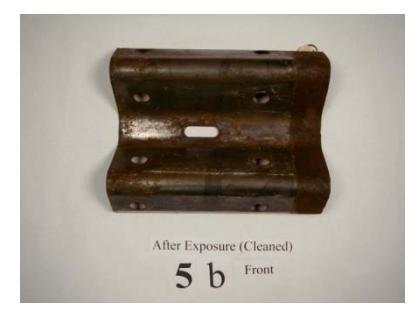
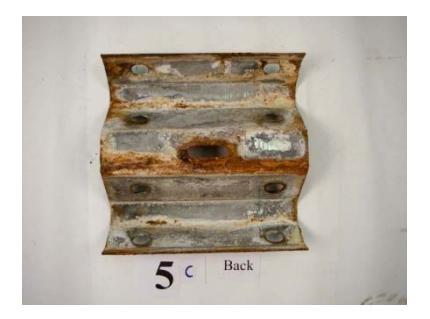
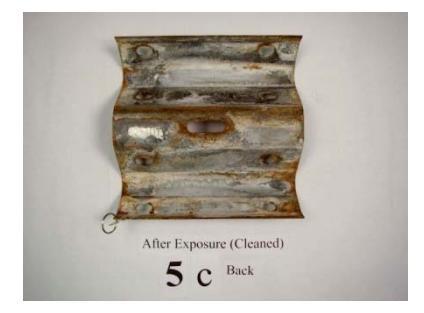
All samples that were WSGR with a GSGR insert were measured and met the above specifications before being placed in the salt fog chamber. There were two WSGR with GSGR inserts samples one with weathering steel bolts and the other with half of the bolts being Geomet 500B coated mild steel and the other half being Geomet 500B coated weathering steel. The average starting thickness of the WSGR samples was 0.099 inches. At the area where the guardrail overlapped there was an average loss of 23.9% with an average final thickness of 0.076 inches. At the outside edge where there was no overlap there was an average loss of 35.2% with an average final thickness of 0.064 inches. Figure 17 - Figure 23 shows one of the samples still assembled after exposure, after it was disassembled, and after the corrosion was cleaned off.

Figure 17 - WSGR with GSGR Insert Assembled Joint after Exposure

Figure 18 - Part A WSGR with GSGR Insert Disassembled Joint

Figure 19 - Part A WSGR with GSGR Insert Disassembled Joint Cleaned

Figure 20 - Part B WSGR with GSGR Insert Disassembled Joint

Figure 21 - Part B WSGR with GSGR Insert Disassembled Joint Cleaned

Figure 22 - Part C WSGR with GSGR Insert Disassembled Insert

Figure 23 - Part C WSGR with GSGR Insert Disassembled Insert Cleaned

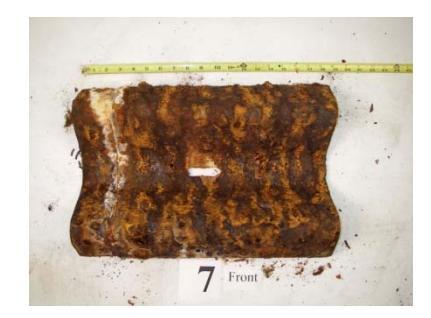
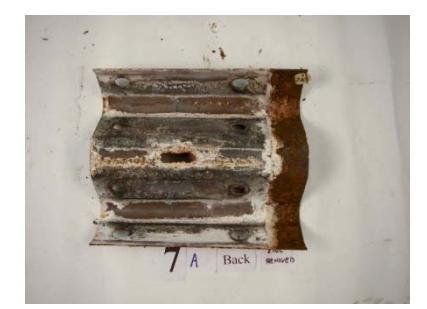
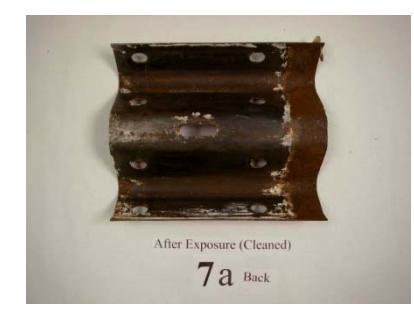
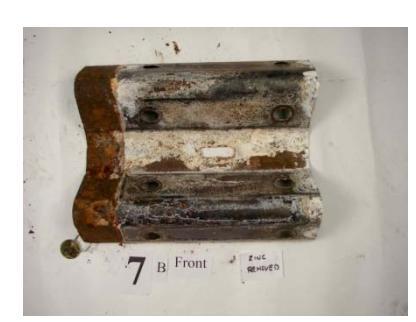
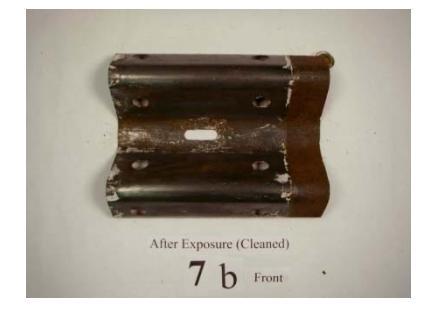
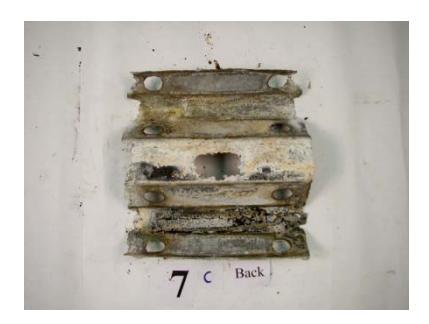
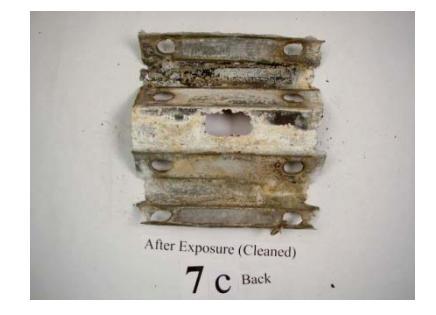
All samples that are WSGR with a zinc foil insert were measured and met the above specifications before being placed in the salt fog chamber. There were two WSGR with zinc foil inserts samples one with weathering steel bolts and the other with half of the bolts being Geomet 500B coated mild steel and the other half being Geomet 500B coated weathering steel. The average starting thickness of the WSGR samples was 0.100 inches. At the area where the guardrail overlapped there was an average loss of 25.1% with an average final thickness of 0.075 inches. At the outside edge (no overlap) there was an average loss of 35.5% with an average final thickness of 0.065 inches. Figure 24 - Figure 30 show one of the samples still assembled after exposure, after it was disassembled, and after the corrosion was cleaned off.

Figure 24 - WSGR with Zinc Foil Insert Assembled Joint after Exposure

Figure 25 - Part A WSGR with Zinc Foil Insert Disassembled Joint

Figure 26 - Part A WSGR with Zinc Foil Insert Disassembled Joint Cleaned

Figure 27 - Part B WSGR with Zinc Foil Insert Disassembled Joint

Figure 28 - Part B WSGR with Zinc Foil Insert Disassembled Joint Cleaned

Figure 29 - Part C WSGR with Zinc Foil Insert Disassembled Insert

Figure 30 - Part C WSGR with Zinc Foil Insert Disassembled Insert Cleaned

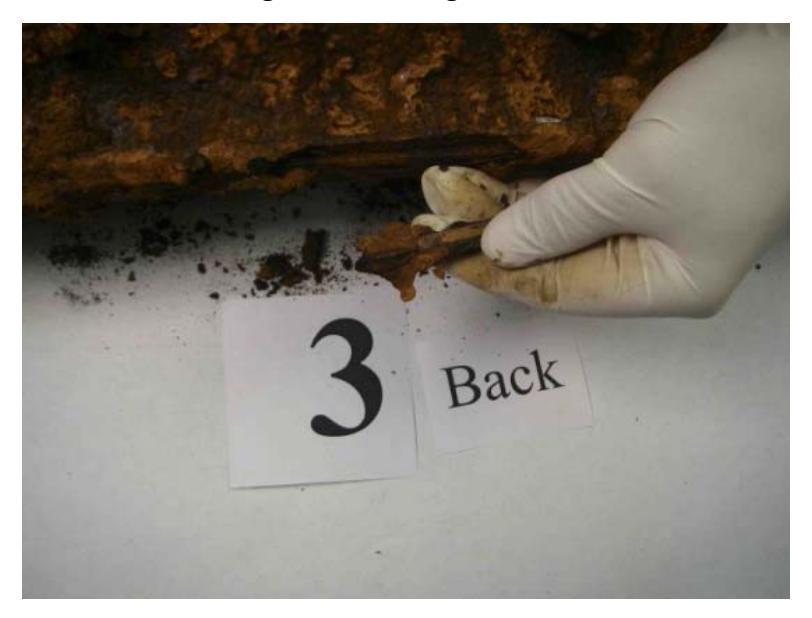
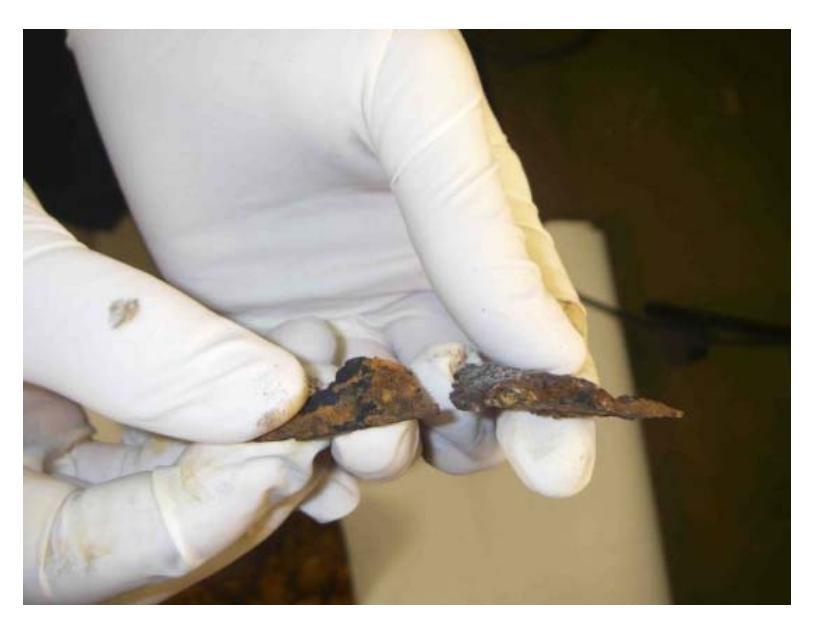
It was deemed that there was no reason to tensile test the 34-inch samples because of the high degree of deterioration after a year in the salt fog chamber. Figure **31** and Figure **32** shows damage done by corrosion after being in the salt fog chamber.

Figure 31 - WSGR with Flakey, Brittle Oxidized Surface

Figure 32 - Close-Up of WSGR Oxidized Debris

Based on the preliminary measurements of the weathering steel guardrail exposed to the salt fog chamber it is very apparent that given the right environment WSGR will undergo excessive corrosion. Inserts provided some protection to the inside surface of the joint but there was so much corrosion on the exposed surface of the joint that the insert made little difference. There was also a question as to the affect the thickness of the galvanized steel guardrail insert would have on the crashworthiness of the guardrail system. Unfortunately, there is no way to use the salt fog chamber results to compare to and quantify environmental conditions. In addition, there were not enough field samples collected to reach any statistical conclusion with tensile testing.

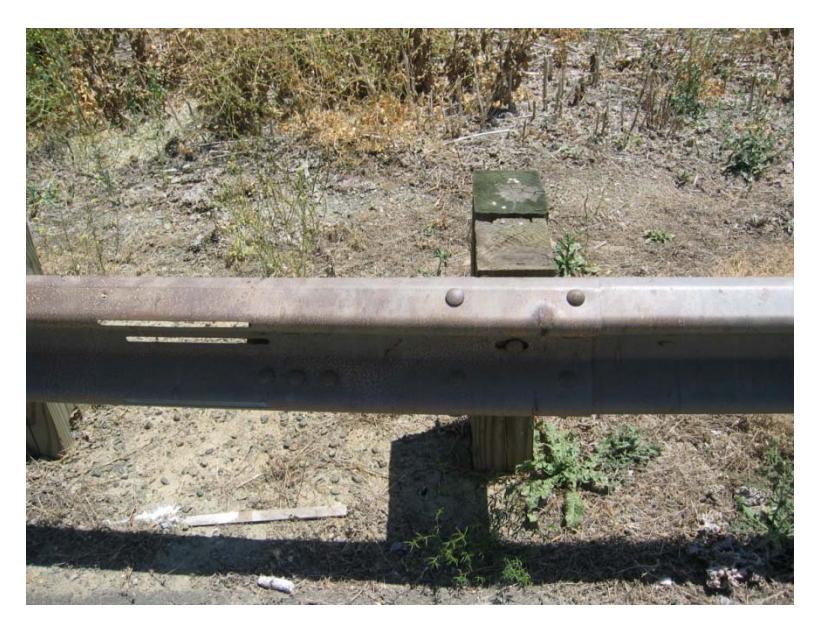
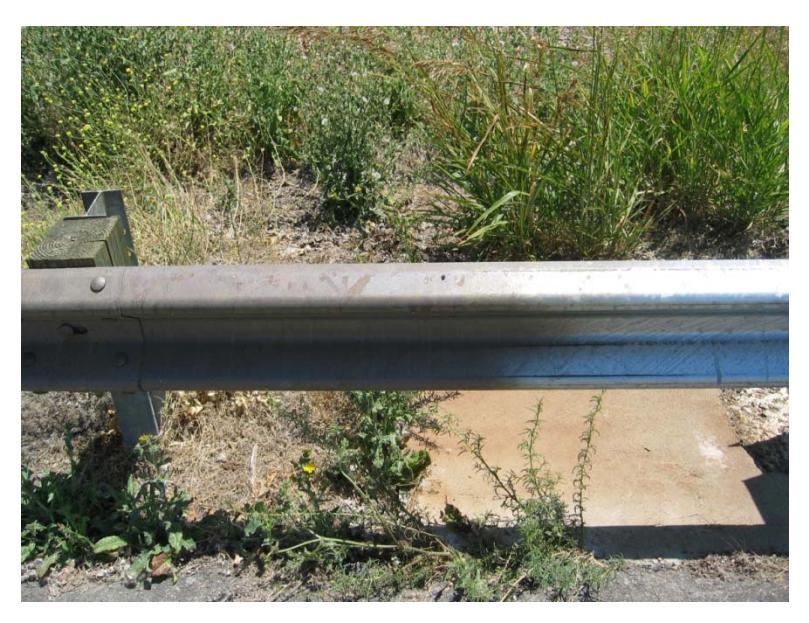
Figure 33 - Staining Product of Galvanized Steel Guardrail

Figure 34 - Comparison of Staining Product and Galvanized Steel Guardrail

Based on this research, it is our recommendation that there is no need to change current Caltrans guidelines on the use of weathering steel guardrail by limiting its use to areas where the annual rain fall is 8 inches or less. For areas where weathering steel is requested and there is an annual rain fall greater than 8 inches an accepted rust colored staining product should be used instead of weathering steel.
