Subject: DESIGN INFORMATION BULLETIN (DIB) 83-05

DESIGN INFORMATION BULLETIN No. 83 - 05
CALTRANS SUPPLEMENT TO FHWA CULVERT
REPAIR PRACTICES MANUAL

Department of Transportation
Division of Design
Office of Hydraulics and Stormwater Design

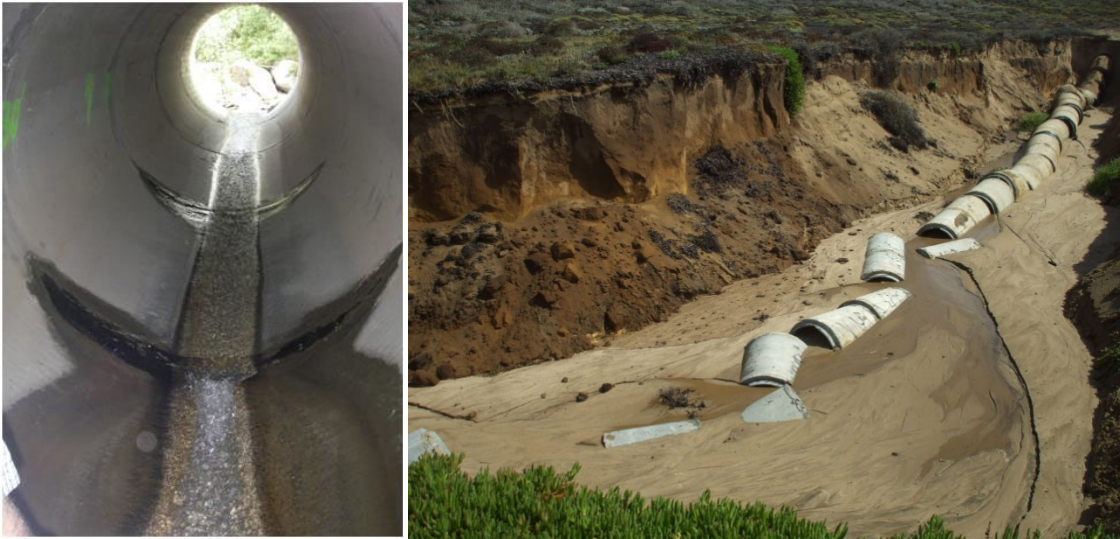
See [FHWA Culvert Repair Practices Manual Volume I](#), pages 3-32, 3-37 and 3-44. Misalignment may indicate the presence of serious problems in the supporting soil. If progressive settlement is present, joint repair should not be performed until a solution to stabilize the surrounding soil has been found. In some cases, reconstruction may be the only option. If so, where there is a need to withstand soil movements or resist disjoining forces, “positive” joints should be specified. Refer to Standard Specifications, Section 61-2 and Table 854.1 in the HDM.

**78 in. RCP with Misalignment****Failed 36" RCP**

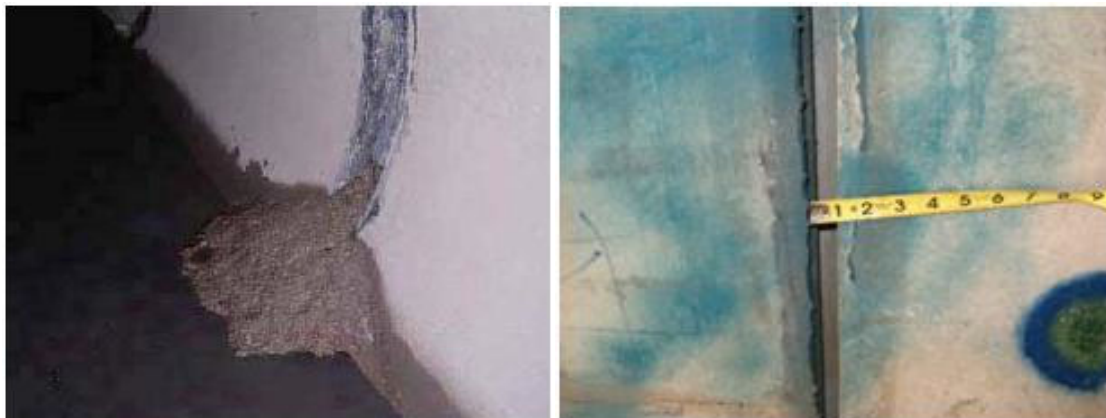
Cracked joints are more than likely not watertight even if gaskets were used. However, if no other problems are evident, such as misalignment, and the cracks are not open or spalling, they may be considered a minor problem to only be noted in inspection. Severe joint cracks are similar in significance to separated joints. Separated joints are often found when severe misalignment is found. In fact, either problem may cause or aggravate the other. Embankment slippage may also cause separations to occur. An attempt should be made to determine whether the separations are caused by improper installation, undermining, or uneven settlement of fill. If undermining is determined, an attempt should be made to determine whether the undermining is due to piping, water exfiltration, or infiltration of backfill material. It may also be necessary to test the density of the surrounding soil.

RCP Examples With Joint Separation, Missing Seal and Backfill Loss

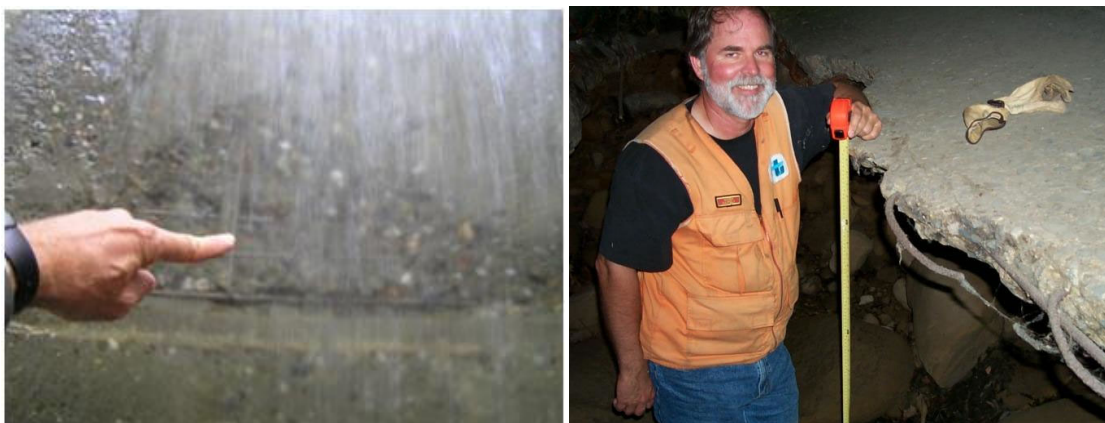
Worn RCP Invert with First Exposure of Reinforcing Steel and Severely Worn RC Arch Invert

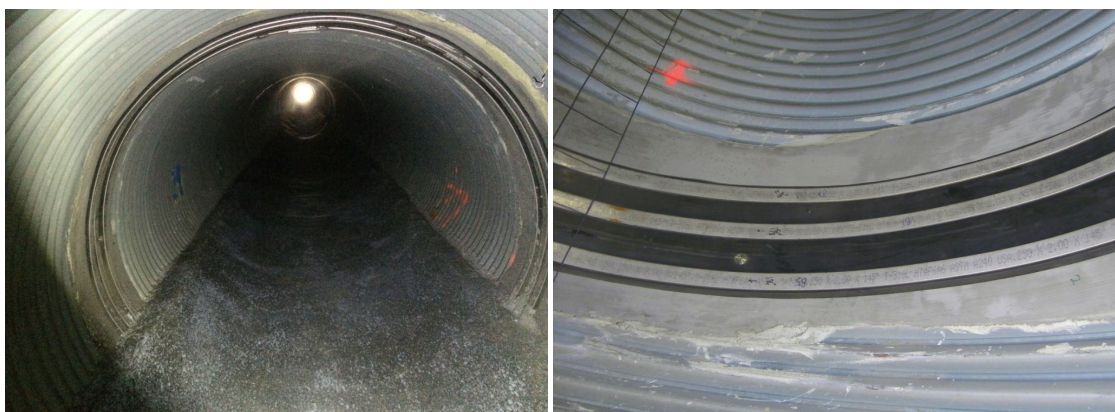
84 Inch CMP (10% Deflected) With EPDM Joint Seal and Concrete Invert Paving

If abrasion protection is needed, it may be necessary to cover the steel expansion ring with concrete, shotcrete or other authorized material. See photos below.

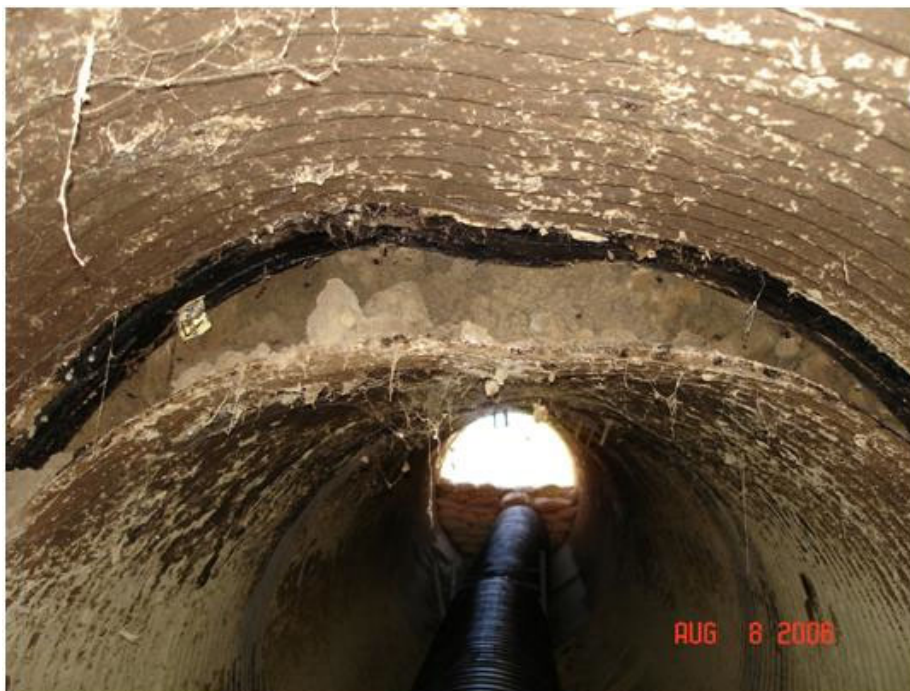
Separated Joint CMP with Physical Separation of Pipe Ends

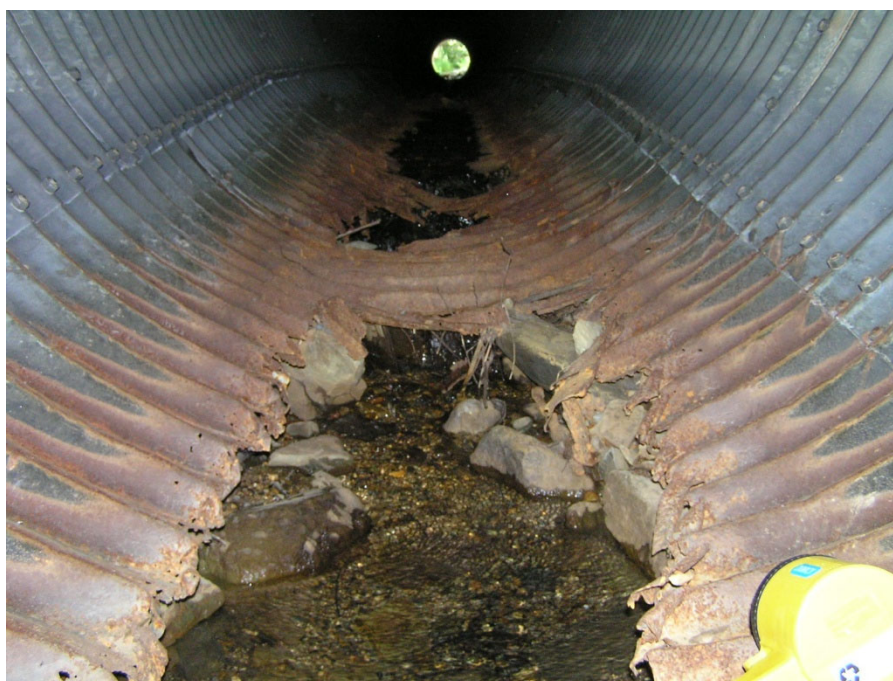
Continuation of this action, if unchecked, will ultimately lead to loss of the invert and the creation of voids under and around the culvert (see pictures below and Appendix G – Example 1).

Corrosion Accelerated by Abrasion Causing Invert Loss and Void Below

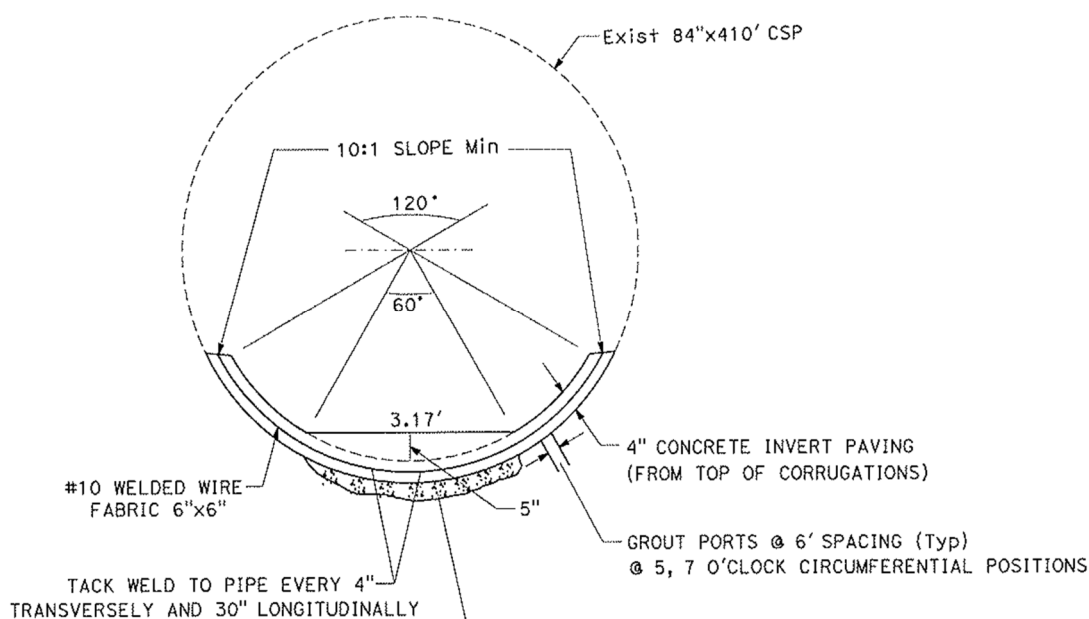
(Above) Example of Insufficient Concrete Invert Paving Design Thickness for Abrasion Level 6

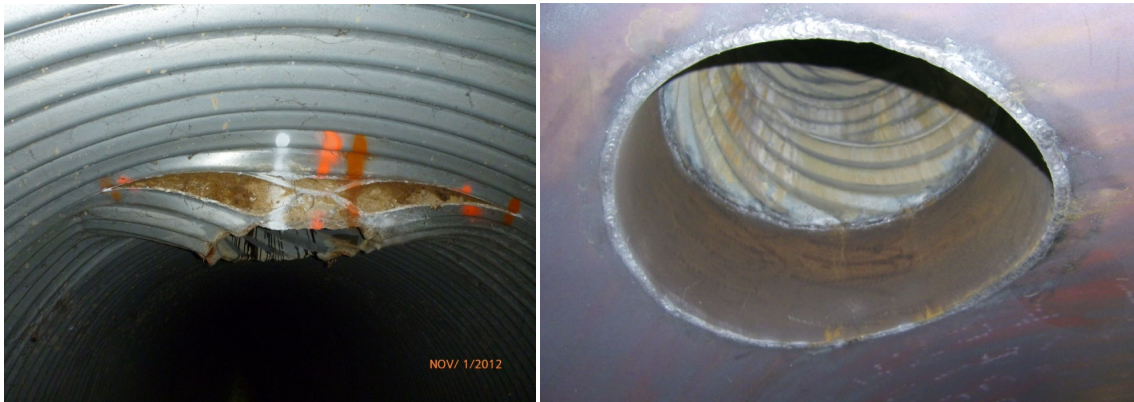
Localized Repair to 84-inch CMP in Vicinity of 18-inch Riser
12-ORA-261-PM 3.74

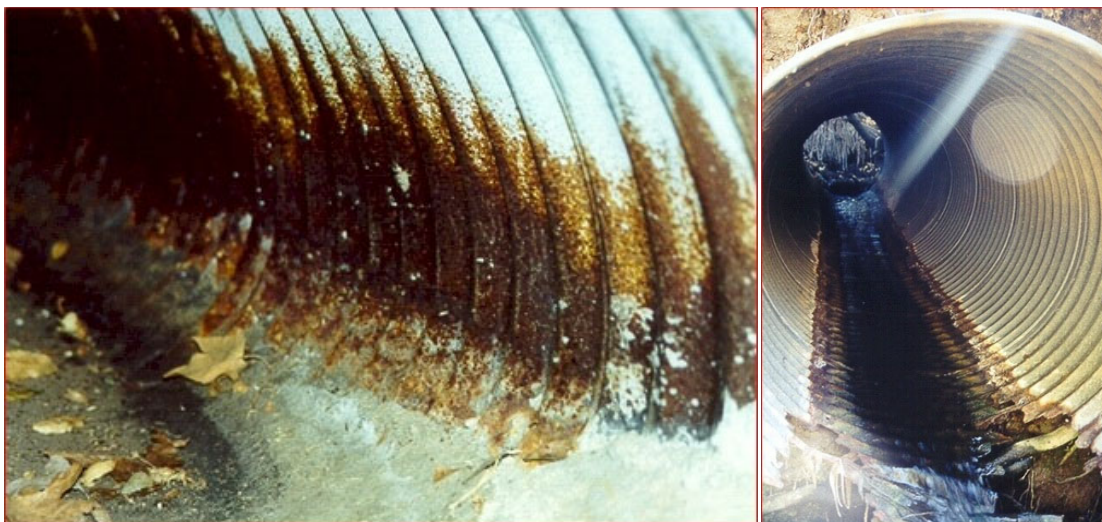
Corroded Steel Pipes

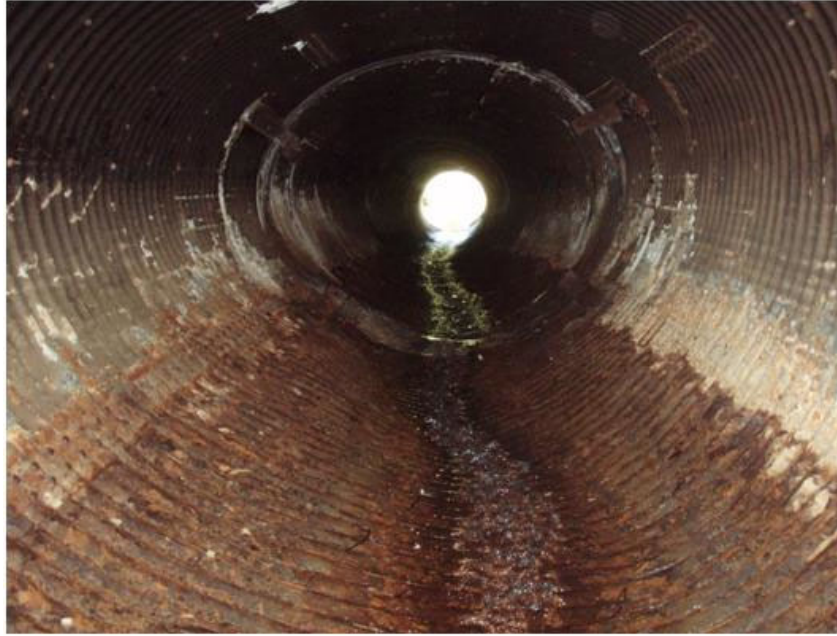
SSPP with Deflection Beyond 10-12%

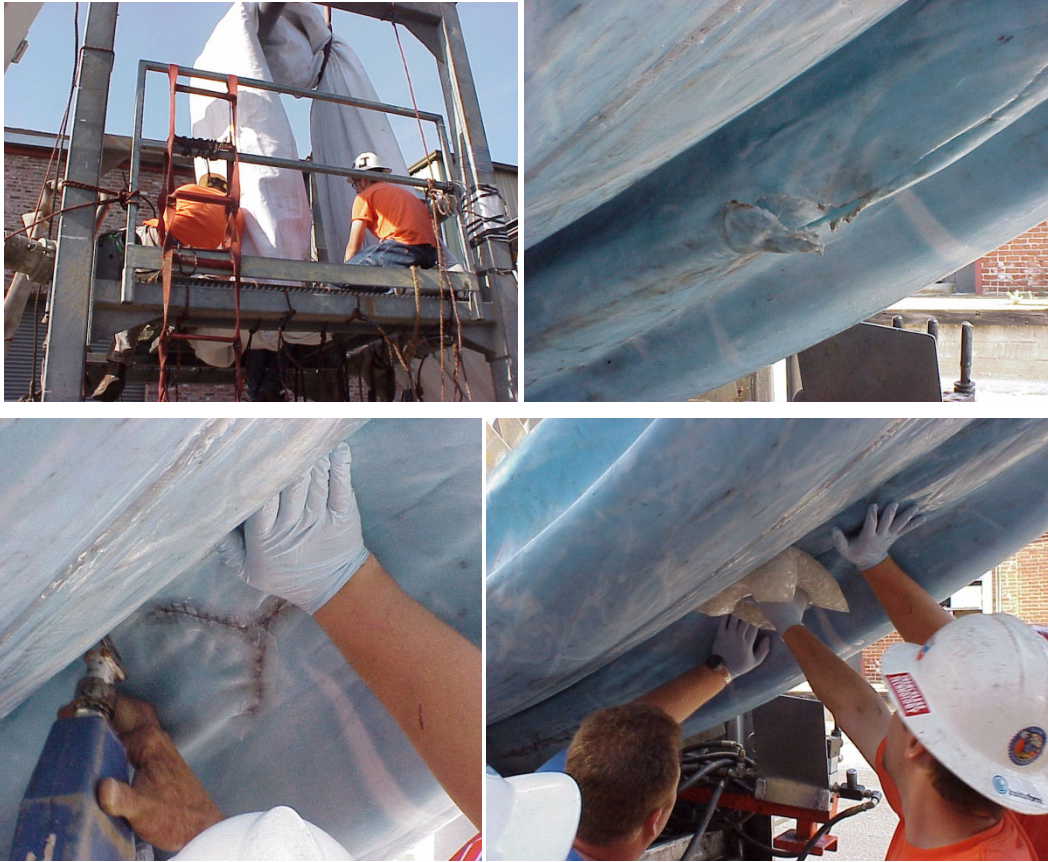
Example of Liner Tear During Installation and Subsequent Repairs

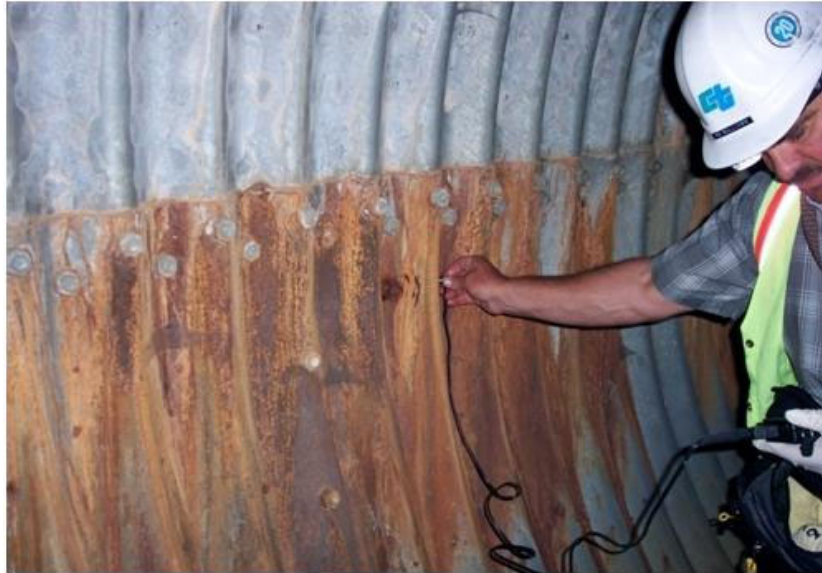
Taking Thickness Measurements. Note Evidence of Leaking Horizontal Seam at Springline

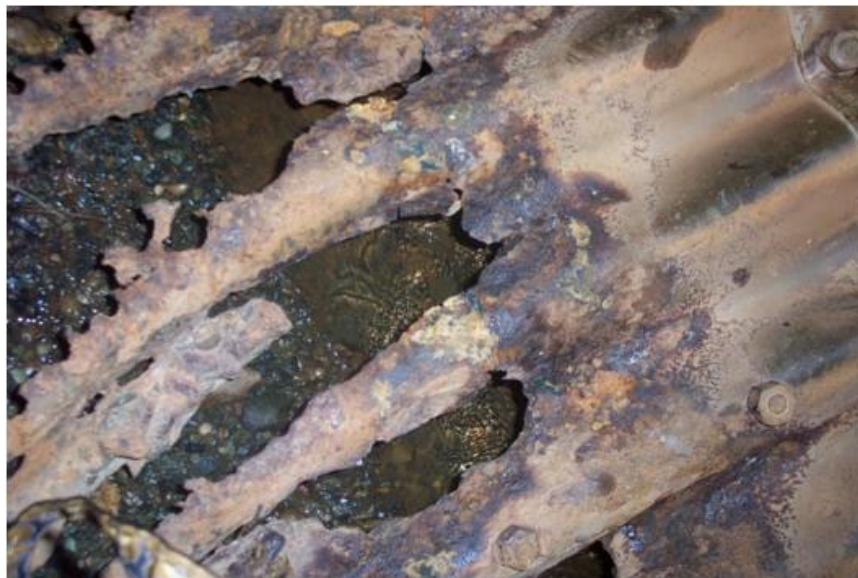
Total Loss of Invert and Existing Nuts Showing Minimal Wear

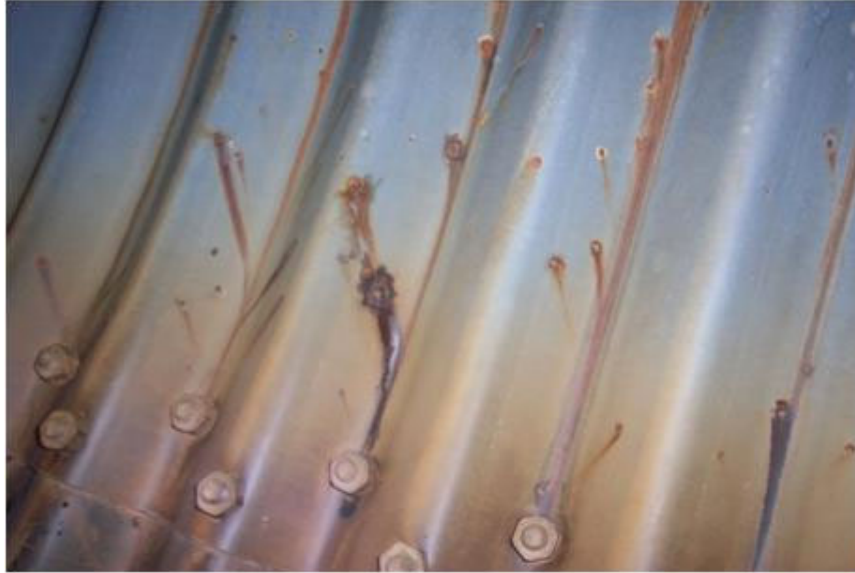
Typical Local Corrosion Cells. Note that the corrosion is coming in from the backside, thus the pipe is in worse condition than it appears. See picture of void found from probing during construction.

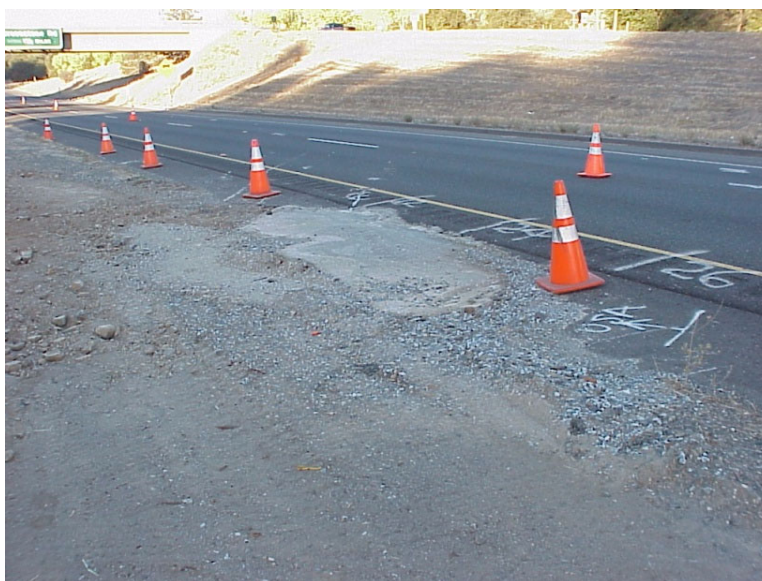
Freshly Placed Slurry where Void Migrated to Surface

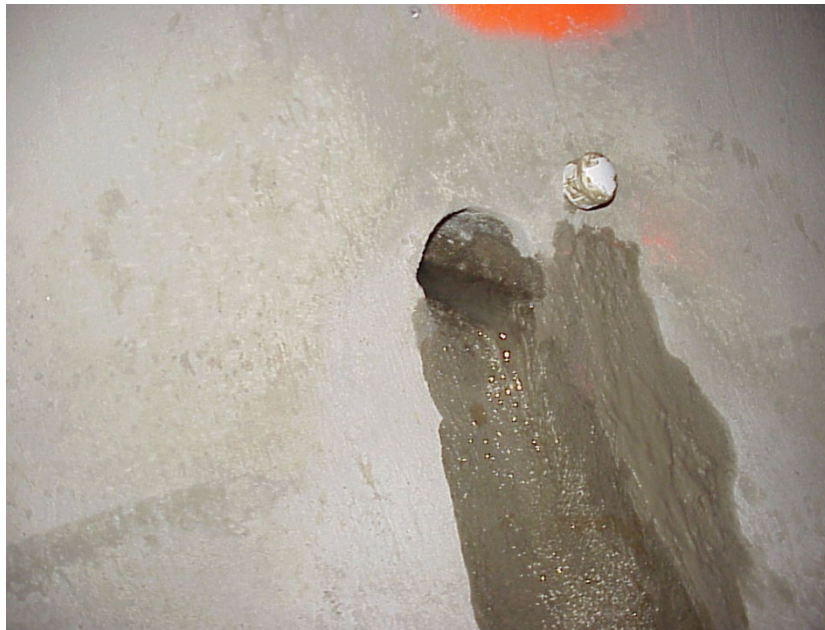
“Cored” Grout Hole in Shotcrete Used to Fill Large Void with 3-Sack Sand Slurry Leaking Groundwater During Contact Grouting. Note capped contact grout port.

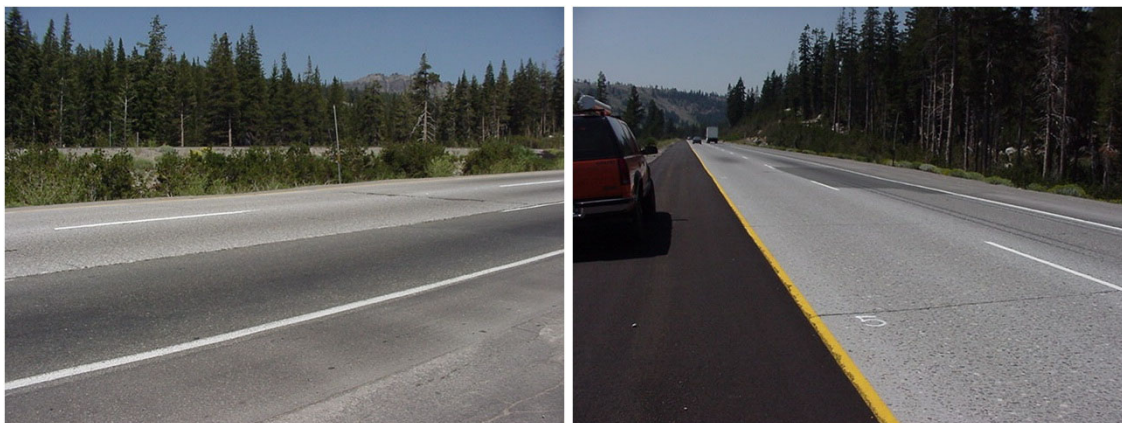
Dip in Number 1 EB Lane. Summer 2002 **Dip in entire WB freeway Section. Summer 2002**

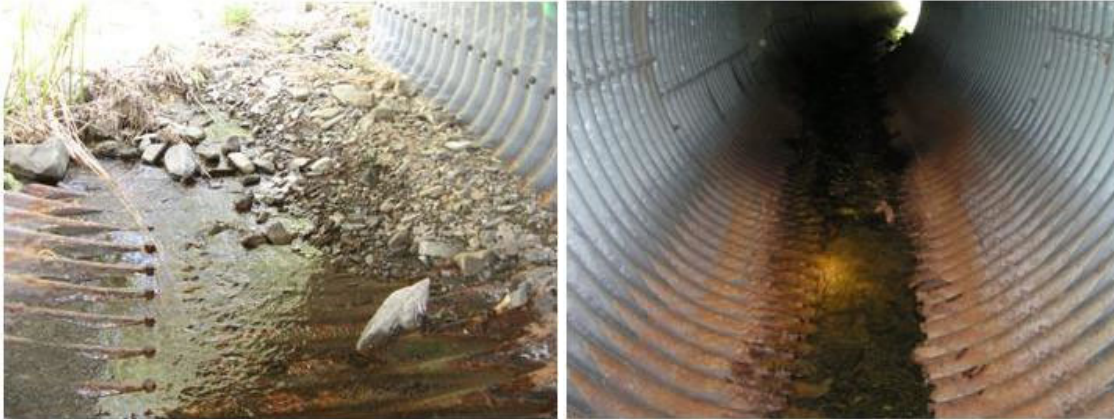
Abrasive Channel Materials and Worn Invert

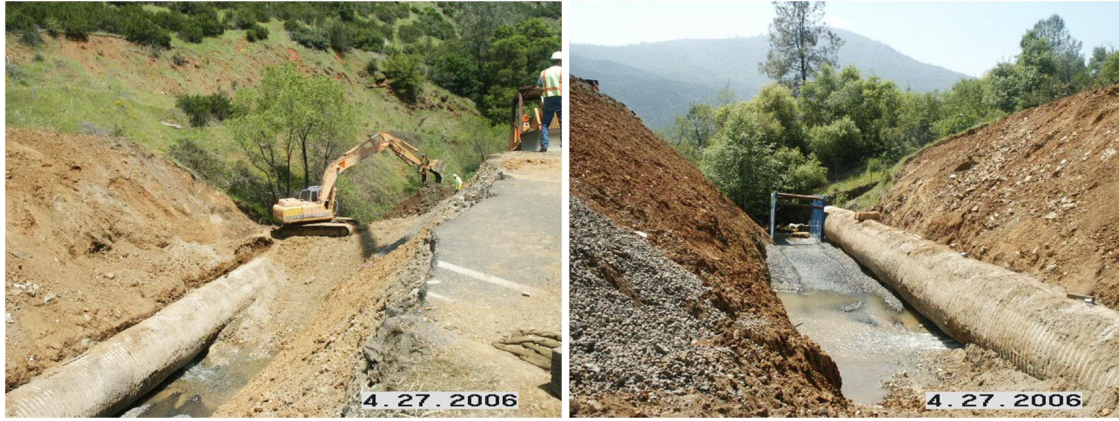
Failed Original 84" - 10-gage SSPP
