DESIGN INFORMATION BULLETIN NO. 83 - 04  
CALTRANS SUPPLEMENT TO FHWA CULVERT REPAIR  
PRACTICES MANUAL

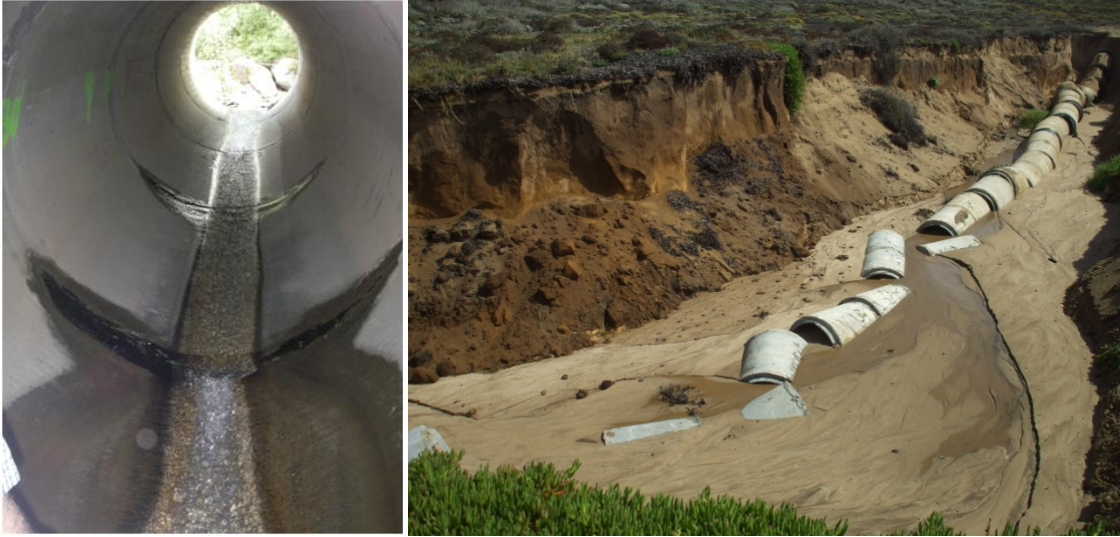
See FHWA Culvert Repair Practices Manual Volume I, pages 3-32, 3-37 and 3-44. Misalignment may indicate the presence of serious problems in the supporting soil. If progressive settlement is present, joint repair should not be performed until a solution to stabilize the surrounding soil has been found. In some cases, reconstruction may be the only option. If so, where there is a need to withstand soil movements or resist disjoining forces, “positive” joints should be specified. Refer to Standard Specifications, Section 61 and Table 854.1 in the HDM.

**78 in. RCP with Misalignment****Failed 36" RCP**

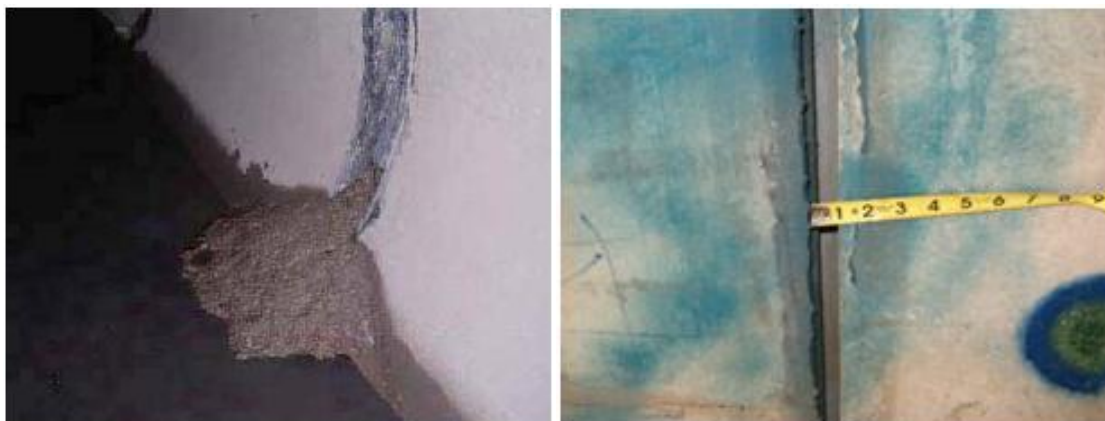
the other. Embankment slippage may also cause separations to occur. An attempt should be made to determine whether the separations are caused by improper installation, undermining, or uneven settlement of fill. If undermining is determined, an attempt should be made to determine whether the undermining is due to piping, water exfiltration, or infiltration of backfill material. It may also be necessary to test the density of the surrounding soil.

#### **RCP Examples With Joint Separation, Missing Seal and Backfill Loss**

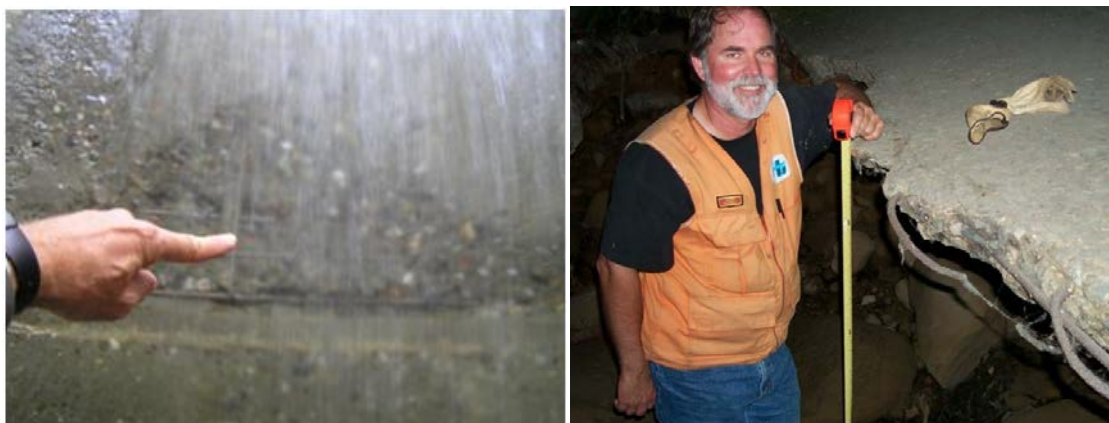
#### **Worn RCP Invert with First Exposure of Reinforcing Steel and Severely Worn RC Arch Invert**

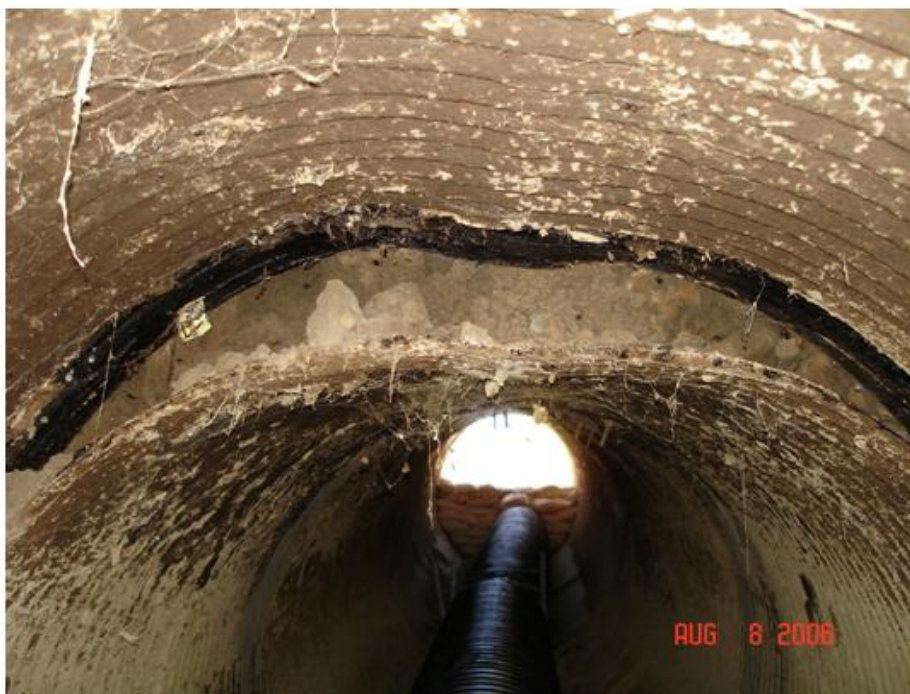
**Separated Joint CMP with Physical Separation of Pipe Ends**

If abrasion protection is needed, it may be necessary to cover the steel expansion ring with concrete, shotcrete or other authorized material. Section 15-6.05 includes specifications for installing EPDM rubber pipe joint seals onto the interior of an existing pipe or culvert 24 to 108 inches in diameter, creating a circumferential leak resistant seal at the joints.

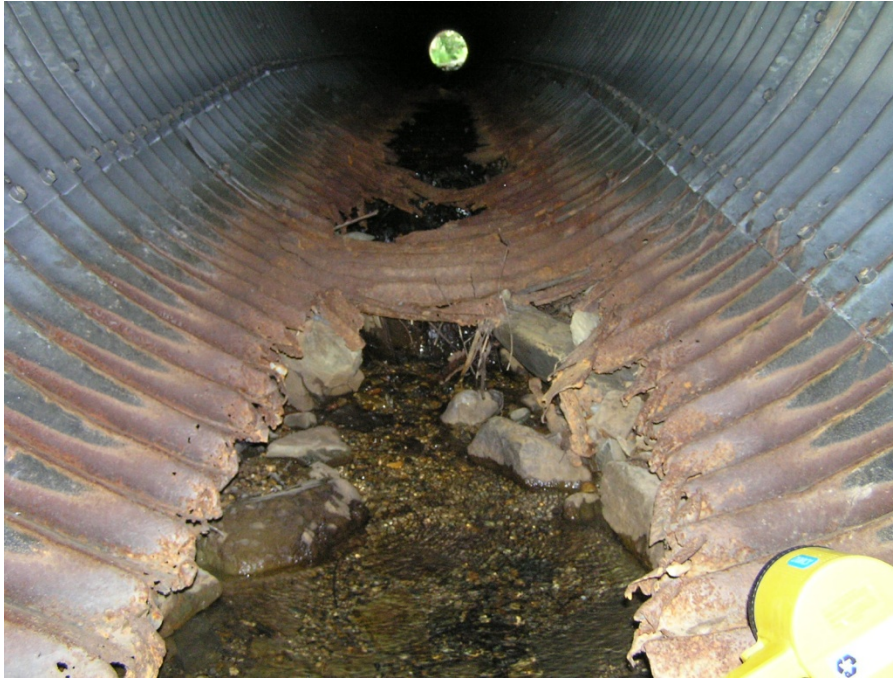
Continuation of this action, if unchecked, will ultimately lead to loss of the invert and the creation of voids under and around the culvert (see pictures below and Appendix G – Example 1).

**Corrosion Accelerated by Abrasion Causing Invert Loss and Void Below**

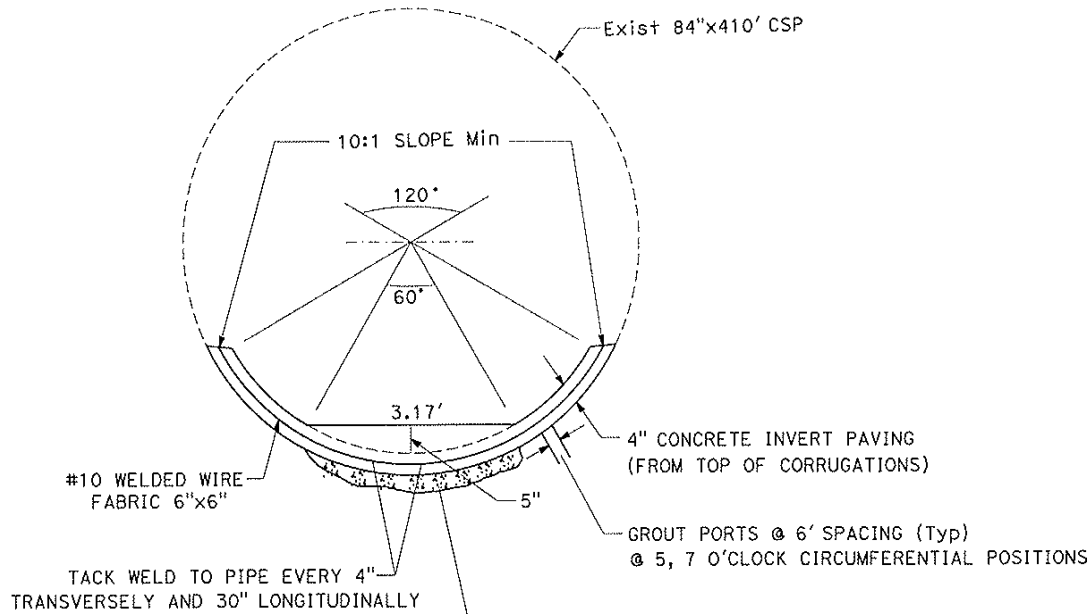
**(Above) Example of Insufficient Concrete Invert Paving Design Thickness for Abrasion Level 6**

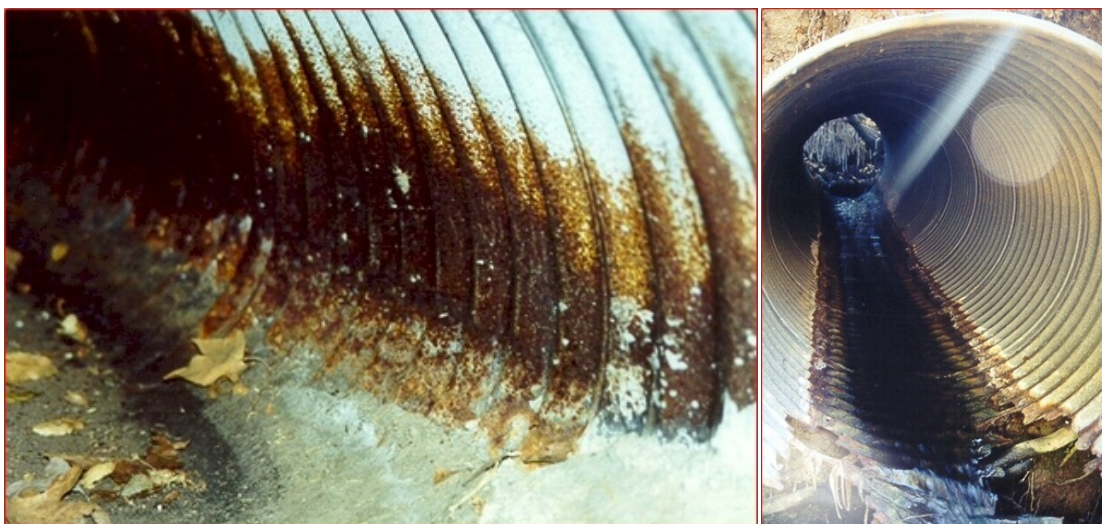
In general, in areas of high rainfall, the soils tend to be acidic and of high electrical resistivity. Acid soils are generally regarded to be corrosive, while a high electrical resistivity is indicative of low corrosivity. Some typical values of the resistivity of soils and waters are shown in Appendix C (Table 5-1). Table 5-2 in Appendix C shows a rating of the soils corrosivity as determined by specific electrical resistance. Visual indications of the relative corrosivity of various soil types are shown Table 5-3 of Appendix C.

#### **Corroded Steel Pipes**

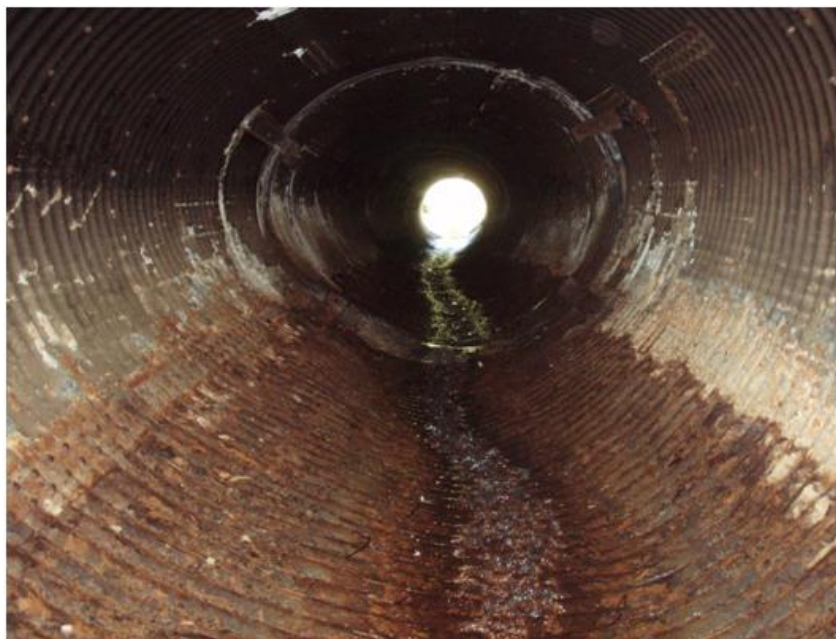
**SSPP with Deflection Beyond 10-12%**

The same discussions outlined under invert durability and shape distortion for corrugated metal pipe also apply to structural steel plate. There are ordinarily no joints in structural plate culverts, only seams. Distress in circumferential seams is rare and can result from severe differential deflection caused by a foundation or soil failure – usually as a result of invert failure (see photos in Index 5.1.2.2). Depending upon the degree of deflection, it may be possible to rehabilitate the invert, however, contrary to the recommendation under “Joint Defects” on page 6-19 of FHWA Culvert Repair Practices Manual Volume 1, and Appendix B-26 of Volume 2, internal steel expansion ring gasket joint sealing systems are not recommended for circumferential seam repairs. If it is not possible to rehabilitate the invert, and there is severe differential deflection present, replacement is recommended. However, if the host pipe can be adequately stabilized, stopping further distortion, and the soil-pipe interaction re-established, it may be feasible to rehabilitate SSPP with deflections beyond 10-12% using semi rigid pipe such as welded steel (all sizes) or fiber reinforced polymer concrete pipe (available up to 126 in. nominal diameter). See Indices 2.1.1.1.3.1, 5.1.2.2.3.1, 7.1.6.1., and 11.1.1.

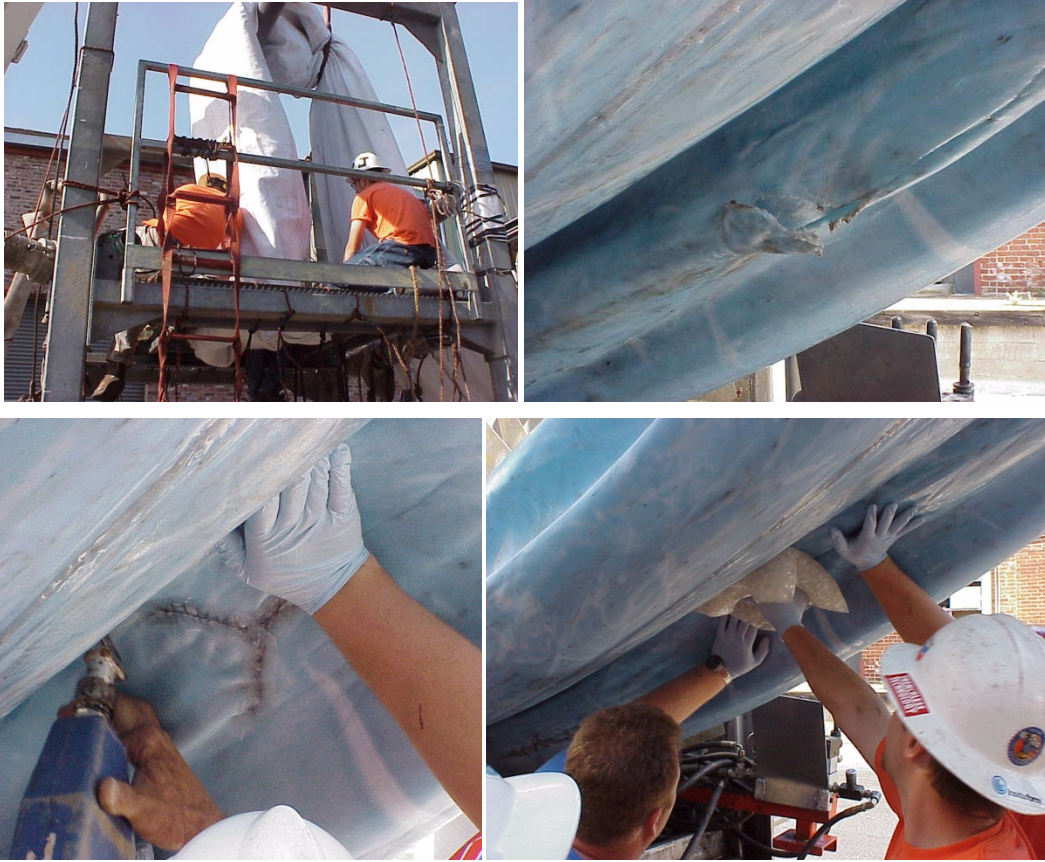
**Example of Liner Tear During Installation and Subsequent Repairs**

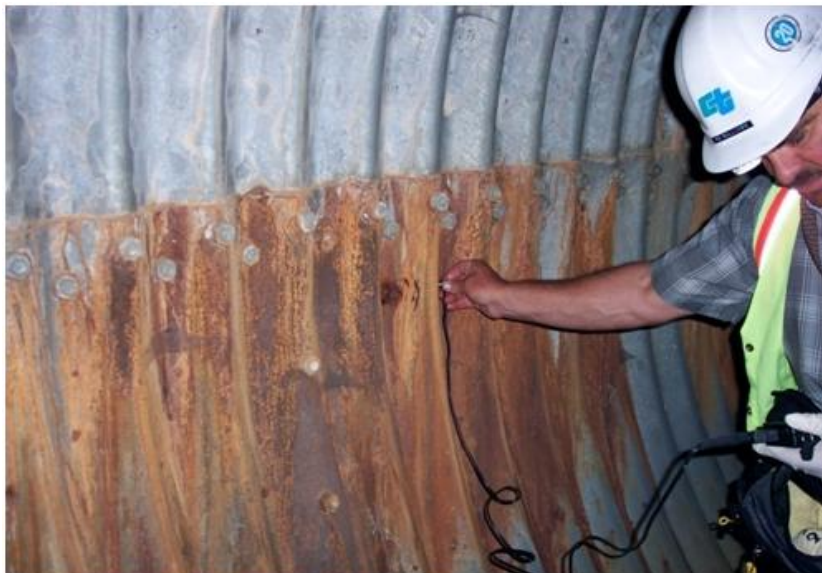
**Taking Thickness Measurements. Note Evidence of Leaking Horizontal Seam at Springline**

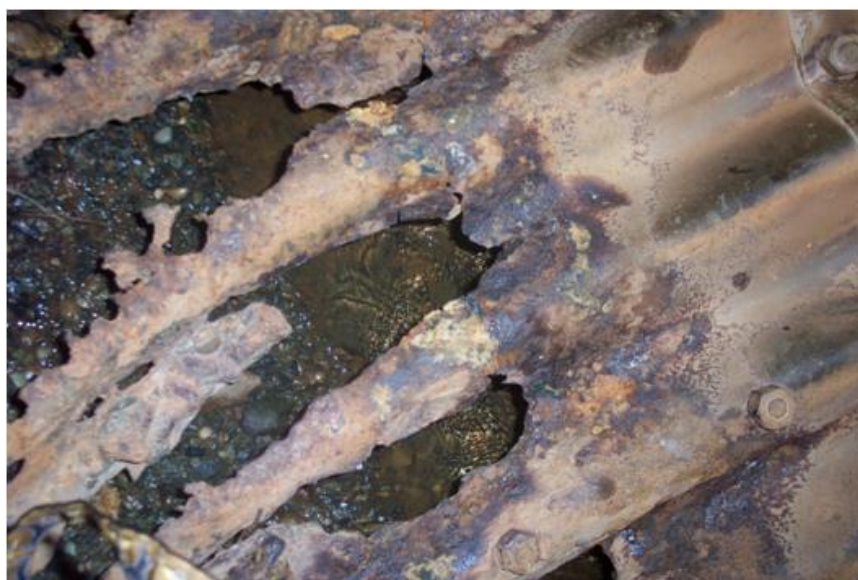
**Total Loss of Invert and Existing Nuts Showing Minimal Wear**

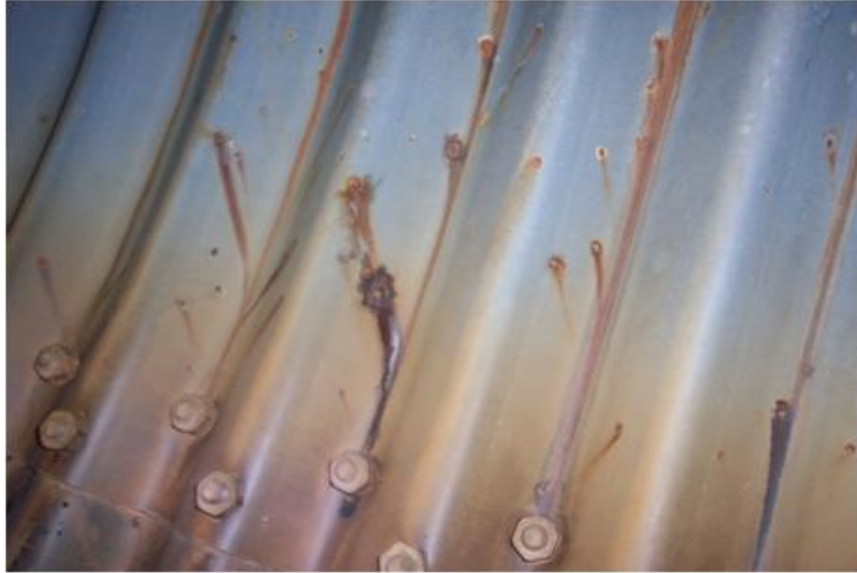
**Typical Local Corrosion Cells. Note that the corrosion is coming in from the backside, thus the pipe is in worse condition than it appears. See picture of void found from probing during construction.**

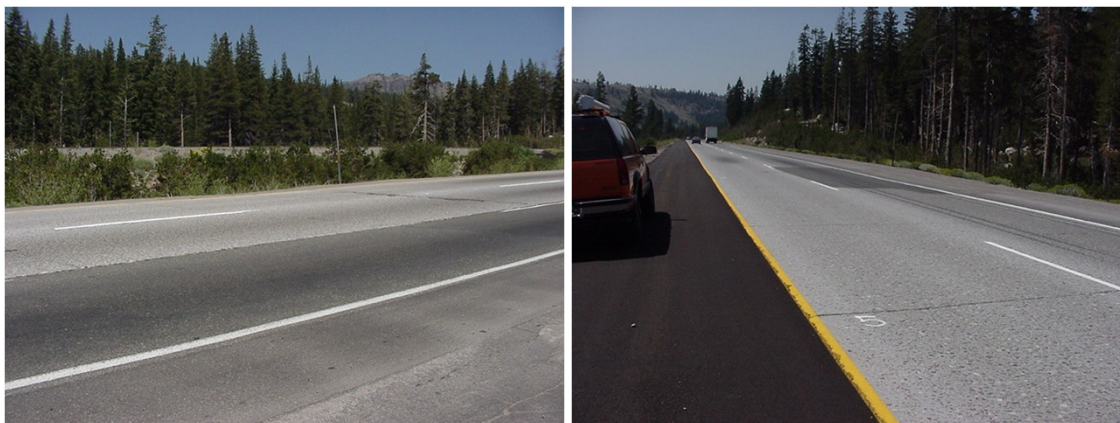
**Dip in Number 1 EB Lane. Summer 2002**   **Dip in entire WB freeway Section. Summer 2002**

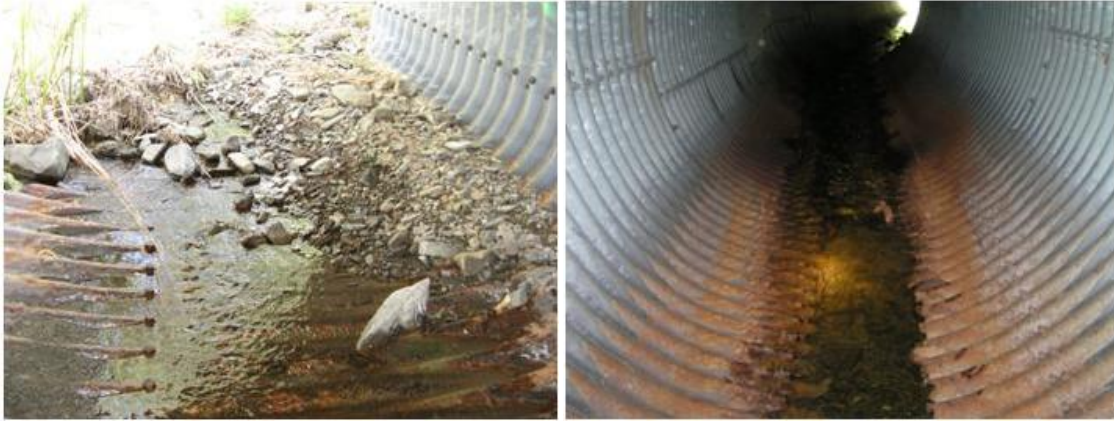
**Abrasive Channel Materials and Worn Invert**

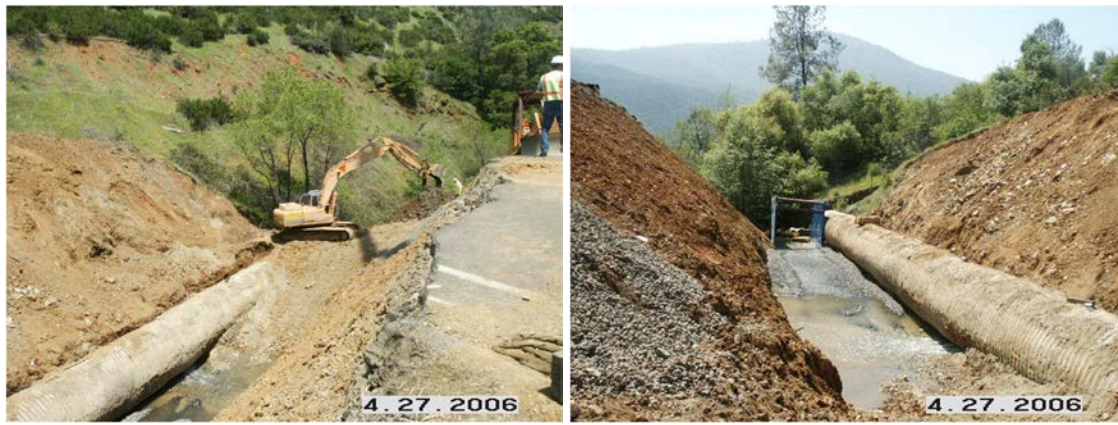
**Failed Original 84" - 10-gage SSPP**
