Roadway Departure Technical Brief No. 1

Maintenance of Traffic Barrier Systems

California Local Roads

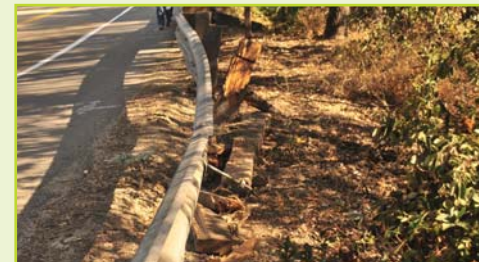
C

- If the barrier has been deflected more than 9 inches over a 25-foot length, its height has been reduced by 2 inches or more from its original height, or if any posts are missing or detached (**Photograph C**), prompt repairs should be made. These types of damage can result in greater vehicle instability in a crash, leading to rollover, barrier rupture, or barrier overrides.

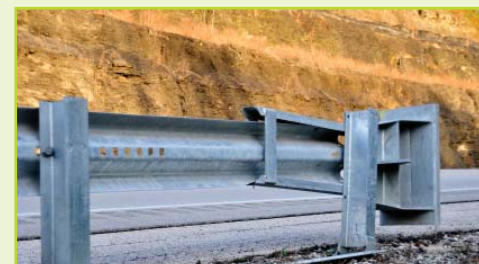
D

- If the end post is broken or if either the cable or steel bearing plate is missing (**Photograph D**), the anchorage is lost and any motorist striking the rail downstream from the terminal would likely penetrate the system rather than be redirected. Thus, if any of these components are deficient, repair work should be a very high priority.

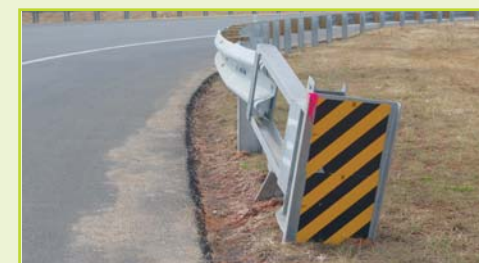
E

- For those terminal designs that incorporate an energy-absorbing head, it is critical that this head be properly aligned and in position with the W-beam rail element so the rail will “feed” into it in any head-on crash. If the impact head cannot slide along the W-beam, its energy absorbing capacity is seriously compromised, probably resulting in a more severe crash. In **Photograph E**, the impact head is misaligned, reducing or preventing its intended performance in an end-on impact. In addition, this impact head is on a curved section of rail rather than a straight section, a design error that may also compromise crash performance. And since there is no apparent hazard behind this rail, the installation itself may be longer than warranted.
