Damaged Roadside Hardware: Repair or upgrade?

California Local Roads

CATEGORY: Maintenance

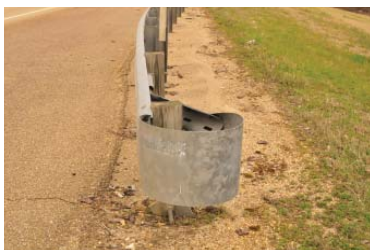
METHODOLOGY: Typical “repair” scenarios for w-beam guardrails, terminals, and crash cushions will be identified and general guidelines will be presented as an aid for determining if upgrading or redesign is a more cost-effective choice than replacement in-kind. National policy generally requires non-crashworthy terminals that are damaged to be upgraded to a design that meets NCHRP Report 350 or MASH crash criteria. Such obsolete terminals include the Breakaway Cable Terminal (BCT) design and, along high-speed roadways, the MELT terminal, shown below. The BCT Terminal has no ground strut and only two weakened posts, making field identification easy.

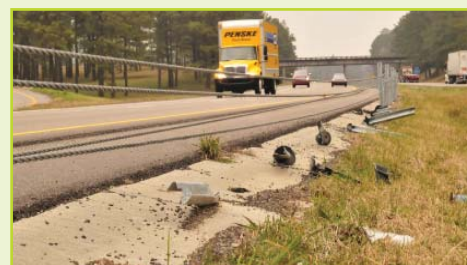
B

- Vertical tears in the w-beam that extend to the top or bottom of the rail.
- Non-manufactured holes (e.g., those caused by crash damage, lug nut damage, or corrosion) in the rail element that intersect the top or bottom edges of the w-beam.
- Any splice that is missing 2 or more bolts.
- Rail flattening, with or without post deflection.
- Barrier deflection more than 9 inches over a 25-foot length. (**Photograph A**)
- Height reduced by 2 inches or more from its original height.
- Any missing or detached posts. (**Photograph B**)

If the installation was an NCHRP Report 350 or MASH design and the damage was localized, replacement in-kind makes sense. If more than 50 percent of a run was damaged and the rail height is less than 27", it may be cost-effective to replace the entire run with Caltran's current w-beam standard. In either case, both the existing type of rail and its location should always be analyzed to determine if placement down a slope or behind a curb contributed to the barrier's failure to contain or redirect a vehicle.

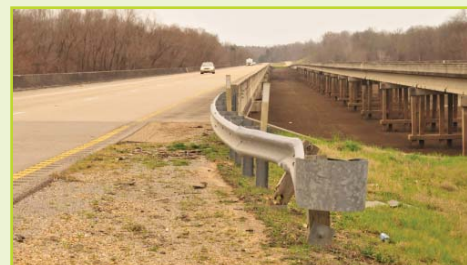
C

- This damaged BCT terminal should not be replaced in kind. Since the rail is on the departure end of the twin structures on a divided highway, the preferred action here would be removal of all w-beam rail. (**Photograph C**)

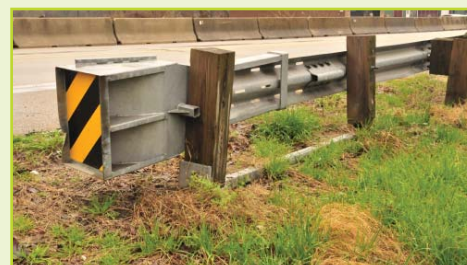
D

- If the end post is broken or missing or if either the cable or steel bearing plate is missing, the anchorage is lost and any motorist striking the rail near the terminal would likely penetrate the system rather than be redirected. (**Photograph D**)
