**DEVELOPMENT OF STAKING CONFIGURATIONS
FOR K-RAIL**

1. REPORT NO. FHWA/CA/MI-2006/21	2. GOVERNMENT ACCESSION NO.	3. RECIPIENT'S CATALOG NO.	
4. TITLE AND SUBTITLE DEVELOPMENT OF STAKING CONFIGURATIONS FOR K-RAIL		5. REPORT DATE December 2008

16. ABSTRACT Full-scale crash testing was conducted on various staking configurations for pre-cast concrete barrier (California K-rail). The staking configurations tested were developed in effort to optimize cost and worker safety. Testing was conducted in accordance with NCHRP Report 350. The tested barriers consisted of twelve or thirteen concrete segments, each 6045 mm (20 ft) in length. The segments were placed on 125-mm (5-in) AC pavement and connected together with 31.8 x 660 - mm (1.25 x-26 in) pins. Each segment was secured to the ground using 25 x 610-mm (24-in) stakes either uncapped or capped. The tests were performed at the Caltrans Dynamic Test Facility in West Sacramento, California. A total of six crash tests were conducted under Report 350 Test Level 3-11. Two testing groups were established: K-rail as a median barrier and K-rail adjacent to an excavation. Each group was tested under three staking configurations. One test fro

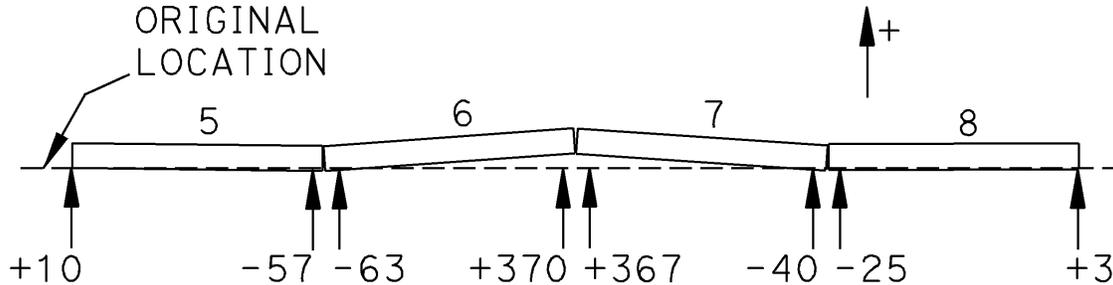
Figure 2-10. Test 671 - Barrier Static Displacements [mm]

The barrier underwent some permanent displacement as seen in the figure below (segments that did not have any measurable movement are not shown).

The pin and loop connection between sections 5 & 6, 6 & 7 (nearest to the impact point) and 7 & 8 bent and caused spalling at the joint. Sections 6 through 12 had scuffmarks. Sections 10 and 11 had minor scuffing on the top, which occurred when the vehicle rode on top of the barrier. The upstream stake in Section 6 & both stakes in Section 7 were bent. The staked, upstream slot in Section 6 had spalling. The maximum lateral static displacement was 370 mm (14.6 in), and the maximum lateral dynamic displacement was 389 mm (15.3 in) at the toe. Static measurements were taken with a tape measure and dynamic measurements were obtained via film analysis. After impact, segments 6 and 7 maintained a backward lean due to obstructions under the K-rail.

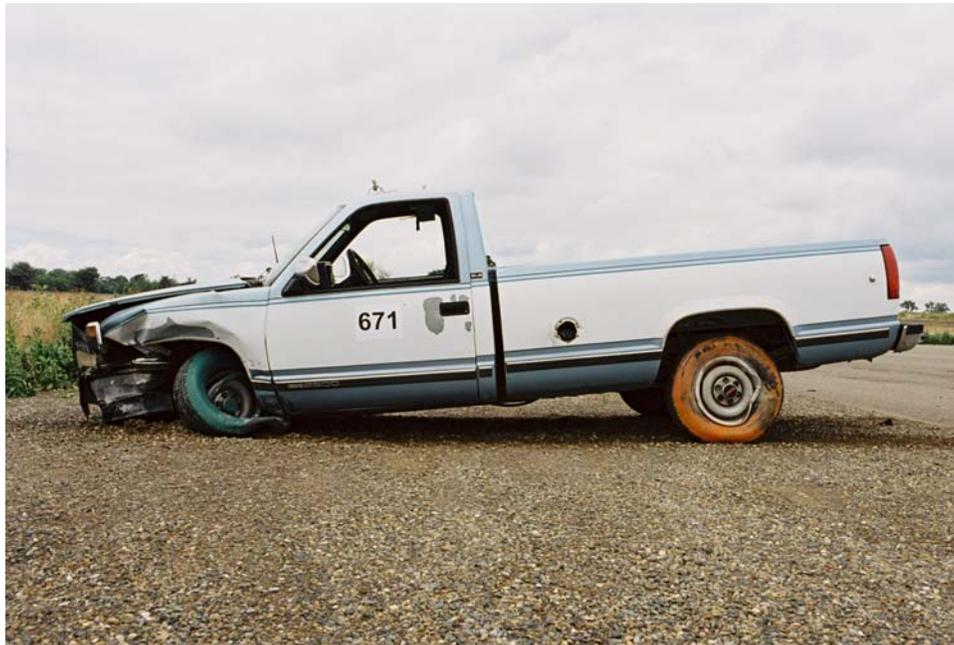
Figure 2-14. Test 671 - Side View of Vehicle Post-Impact

The initial impact damaged the left front corner of the vehicle. The left front quarter panel and bumper were crushed. The floorboard intruded into the occupant compartment by 2.5 cm (1 in). The floorboard deformation area was approximately 140 cm² (0.15 ft²) and was located at the left front corner. The tire partially slipped off of the rim. The secondary impact occurred when the vehicle contacted the ground while it was rolling. The right front quarter panel and bumper were damaged. The hub guidance assembly was slightly damaged.

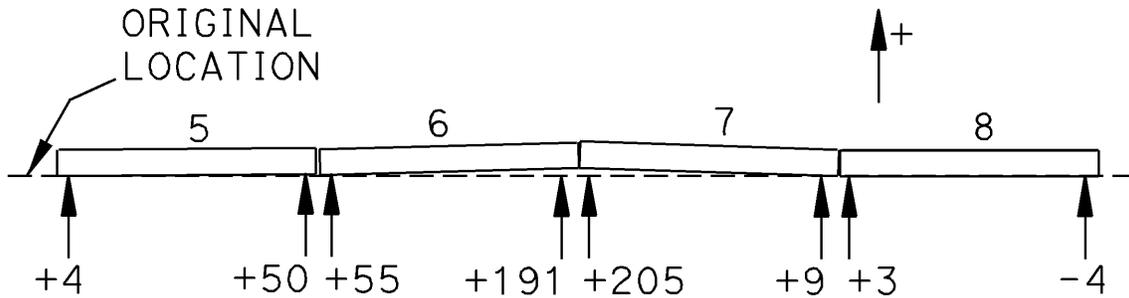
Figure 2-23. Test 672 - Barrier Static Displacements [mm]

The barrier underwent some permanent displacement as seen in the figure below.

The pin and loop connection between sections 5 & 6, 6 & 7 (nearest to the impact point) and 7 & 8 bent and caused spalling at the joint. Some stakes in Section 6 were bent and the slots they were in had spalling. Sections 6 and 7 had scuffmarks from the impact. Sections 10 through 12 had minor scuffing on the top, which occurred when the vehicle rode on top of the barrier. Section 7 underwent the most movement with a maximum lateral static displacement of 205 mm (8.1 in) and maximum lateral dynamic displacement of 256 mm (10 in) at the toe. Static measurements were taken with a tape measure and dynamic measurements were obtained via film analysis.

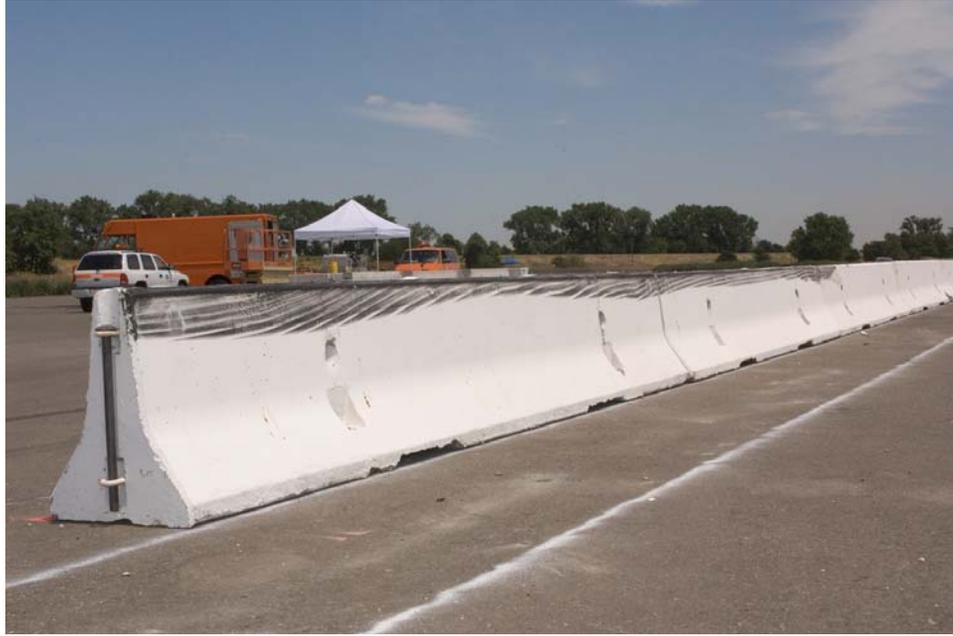
Figure 2-27. Test 672 - Scuffing on the Backside of the Barrier

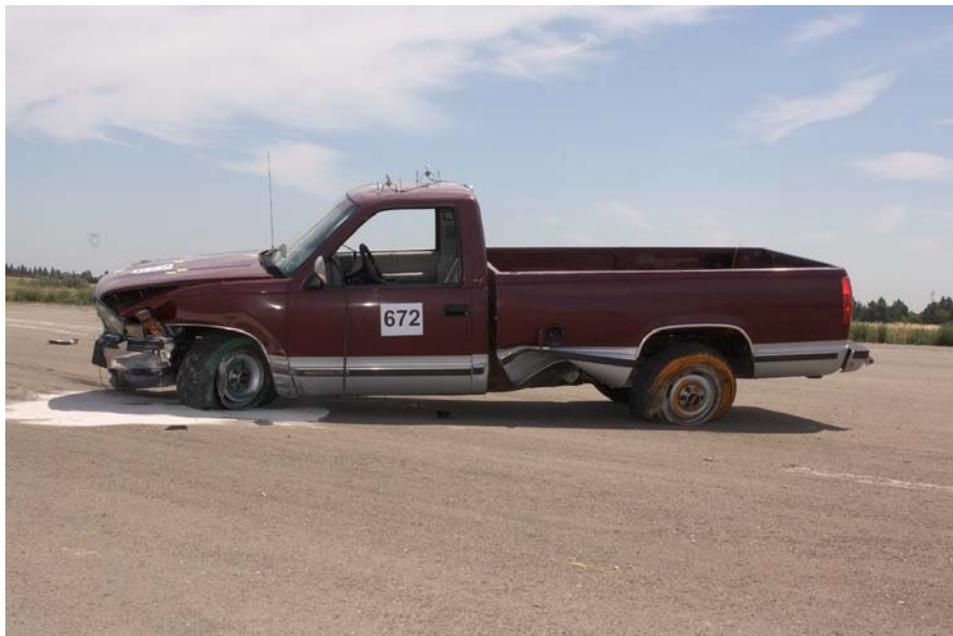
Figure 2-28. Test 672 - Side View of Vehicle Post-Impact

The initial impact damaged the left front corner of the vehicle. The left front quarter panel and bumper were crushed. Both rims on the left side were bent. The secondary impact occurred when the right side of the vehicle contacted the ground and rode along the top of the barrier. The right front quarter panel and bumper were damaged. The vehicle's left mid-section was damaged when it landed on top of the barrier. The hub guidance assembly was slightly damaged.

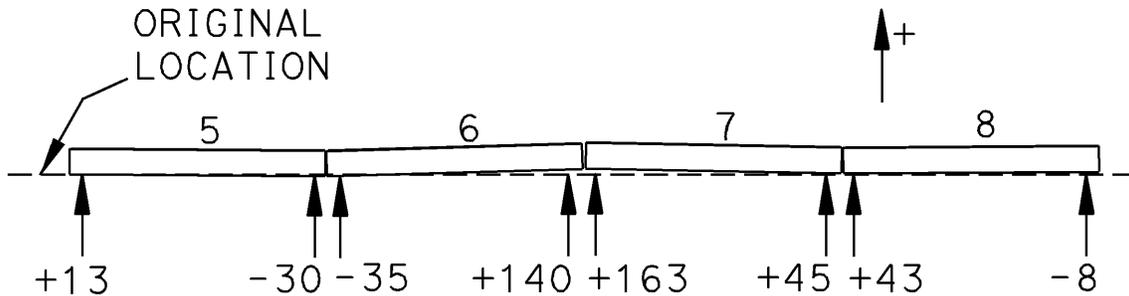
Figure 2-36. Test 673 - Barrier Static Displacements [mm]

The barrier underwent some permanent displacement as seen in the figure below.

The pin and loop connection between sections 6 & 7 (nearest to the impact point) and 7 & 8 bent and caused spalling at the joint. Section 6 had a large, vertical crack on the impact side near the impact point. Sections 6 and 7 had scuffmarks from the initial impact. Some of the stakes lifted due to the barrier rotation. The maximum lateral static displacement was 163 mm (6.4 in) with a maximum lateral dynamic displacement of 200 mm (7.9 in) at the toe. Static measurements were taken with a tape measure, and dynamic measurements were obtained via film analysis.

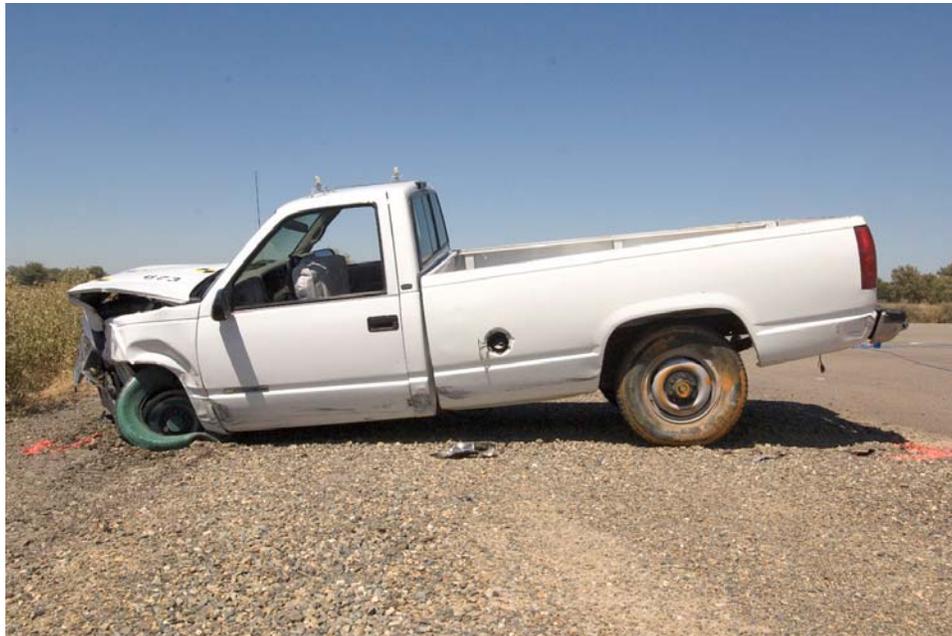
Figure 2-40. Test 673 - Side View of Vehicle Post-Impact

The initial impact damaged the left front corner of the vehicle. The left front quarter panel and bumper were crushed. A secondary impact occurred when the vehicle impacted a barrier protecting a camera. The impact was located at the left front corner again and further damaged the area. The hood was crushed inwards and the left front tire and rim were damaged. The maximum floorboard intruded^d into the occupant compartment by 3 cm (1.2 in). The floorboard deformation area was approximately 3275 cm² (3.5 ft²) and was located at the left front corner.

For Test 673, the vehicle impacted a K-rail section that had greater lateral and uplift resistance from the stakes than previous tests (due to the number of stakes and the caps); thus, Test 673's vehicle was damaged more than previous tests.

^d The floorboard deformation was greater for this test than the previous test since the vehicle impacted a fully staked section of K-rail. Upon impact, some of the vehicle's kinetic energy is absorbed by the barrier (causing the barrier to typically move) and reduces damage to the vehicle. For this project, the amount of energy transferred to the barrier was dependent on:

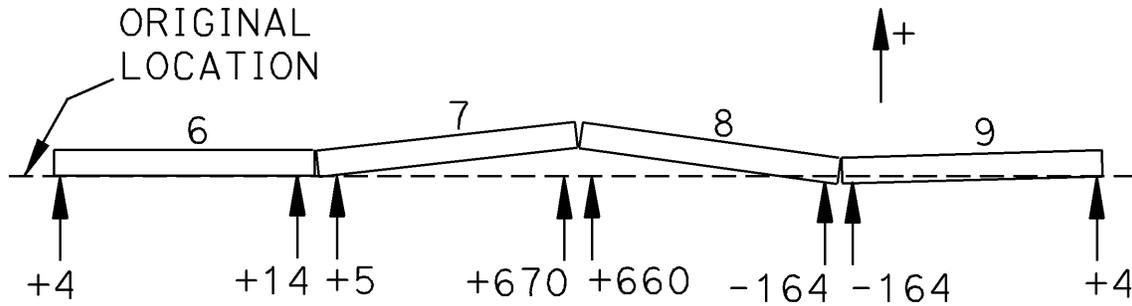
Figure 2-49. Test 674 - Barrier Static Displacements [mm]

The barrier underwent some permanent displacement as shown in the figure below.

The pin and loop connection between sections 7 & 8 (nearest to the impact point) and 8 & 9 bent and caused spalling at the joint. Section 8 had spalling at the upstream, impact-side slot due to the stake bending. The upstream, excavation-side stake in Section 8 broke through the AC. The maximum lateral static displacement was 670 mm (26.3 in). Static measurements were taken with a tape measure. Due to the angle between the vehicle targets and the camera, the dynamic displacement could not be accurately measured.

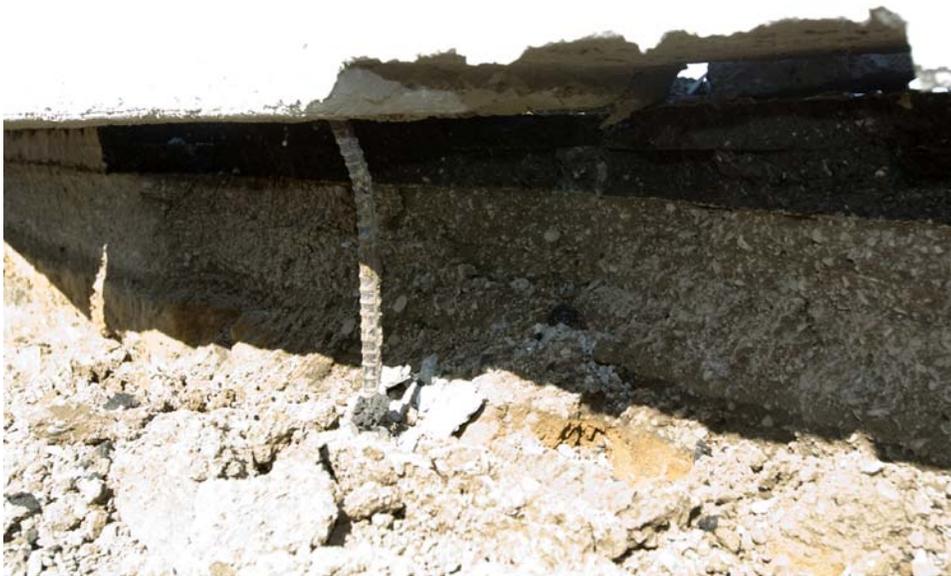
Figure 2-54. Test 674 - Damaged Pavement from Rear Stake

Although Test 674 resulted in acceptable conditions for the vehicle occupants, there were undue hazards to the work zone personnel. Failure of the AC to hold the rear stake caused a large chunk of the AC to break loose and fall into the excavation. Additionally, the barrier penetrated 670 mm (26 in) into the excavation. The Committee considered the pavement failure and the deflection as unacceptable to the work zone safety.

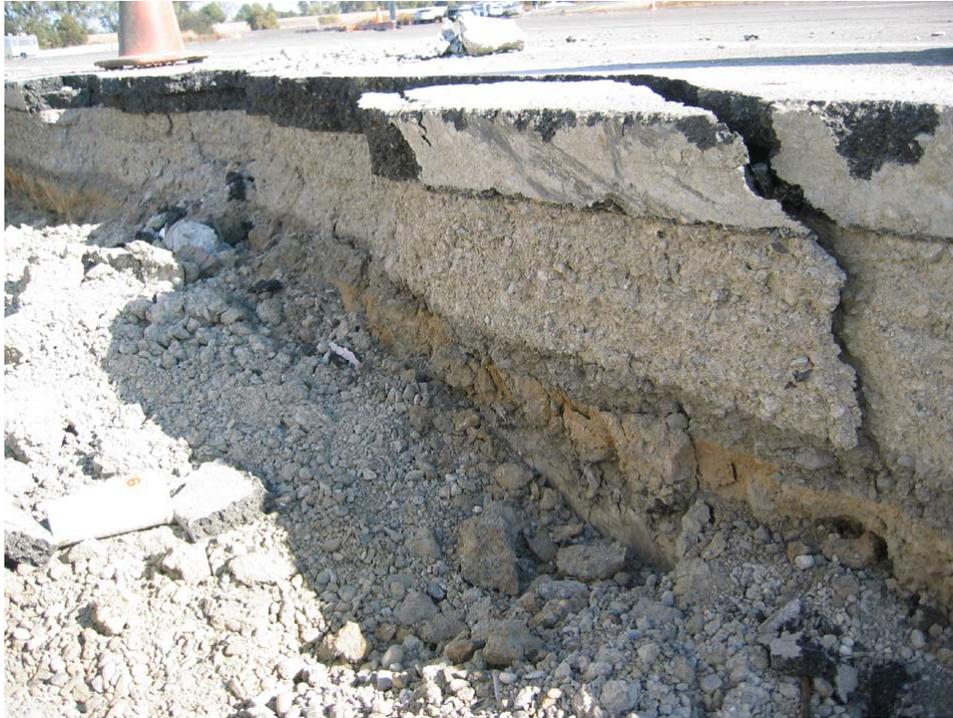
Figure 2-55. Test 674 - Pavement Damage after Barrier Removal

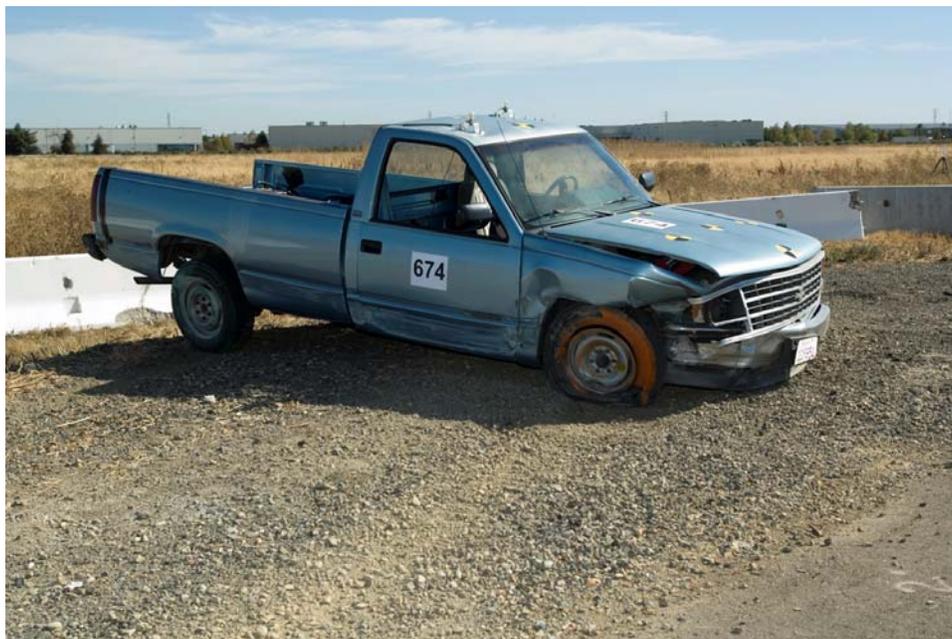
Figure 2-56. Test 674 - Side View of Vehicle Post-Impact

The impact damaged the right front corner of the vehicle. The right front quarter panel and bumper were crushed. Both front tires were damaged. The body on the right side had minor body damage from scraping against the barrier. The bottom of the tailgate detached from the bed and was held in place by the upper hinges.

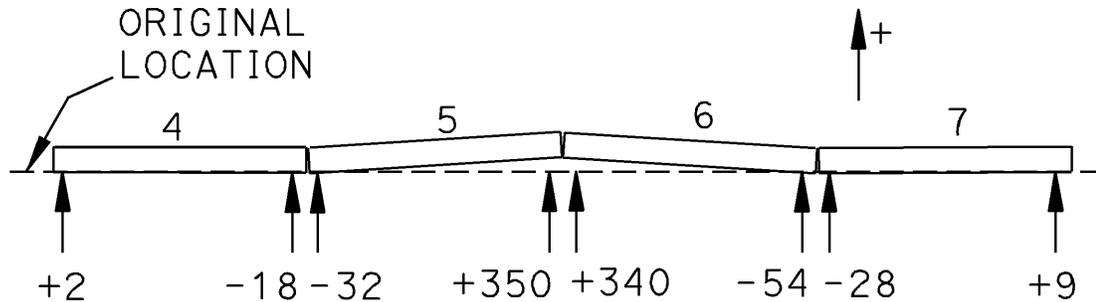
Figure 2-63. Test 675 - Barrier Static Displacements [mm]

The barrier underwent some permanent displacement as seen in the figure below.

The pin and loop connection between sections 5 & 6 (nearest to the impact point) and 6 & 7 bent and caused spalling at the joint. The slots located in the upstream end of Section 5 and downstream end of Section 6 had spalling. Sections 5 and 6 had scuffmarks on the surface from the impact. The barriers' maximum lateral static displacement was 350 mm (13.8 in) and the maximum lateral dynamic displacement was 350 mm (13.8 in) at the toe. The barrier extended over the excavation by approximately 280 mm (11.0 in). Static measurements were taken with a tape measure, and dynamic measurements were obtained via film analysis.

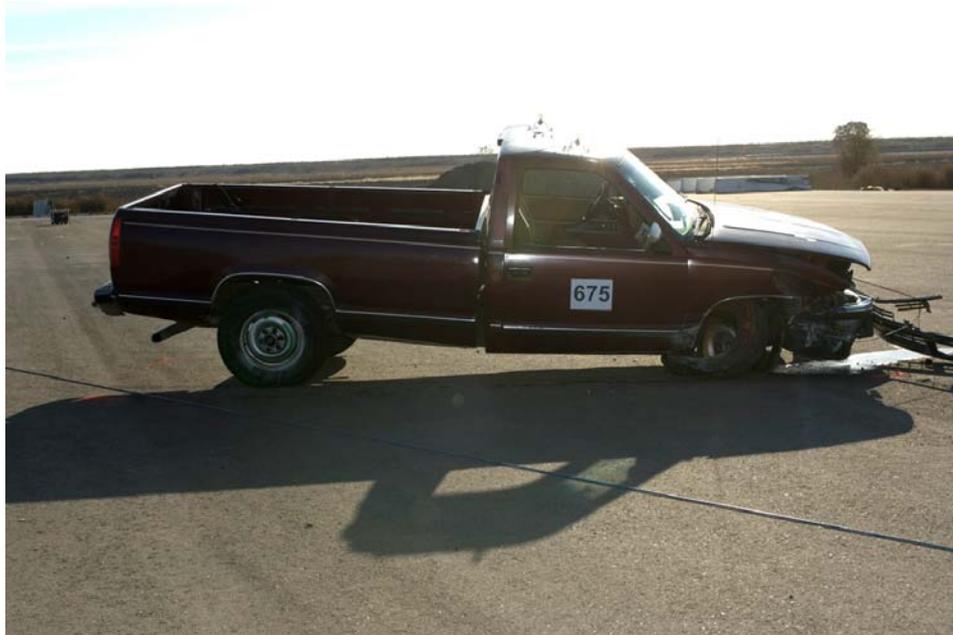
Figure 2-69. Test 675 - Side View of Vehicle Post-Impact

The impact damaged the right front corner of the vehicle. The right front quarter panel and bumper were crushed. The tire slipped off the rim. The suspension and steering assemblies were damaged. The tie rod sheered off the spindle. The hub guidance assembly was slightly damaged.

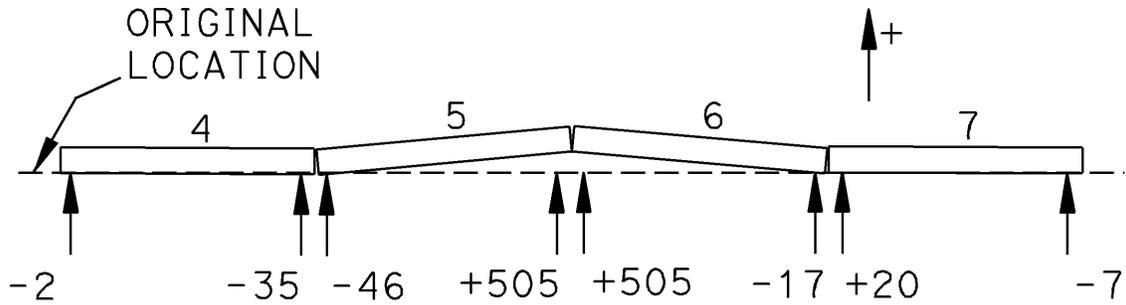
Figure 2-76. Test 676 - Barrier Static Displacements [mm]

The barrier underwent some permanent displacement as seen in the figure below.

The pin and loop connections between sections 5 & 6 (nearest to the impact point) and 6 & 7 were bent and caused spalling at the joint. Section 5 had spalling at the stake location. Sections 5 and 6 had scuffmarks from the impact. Sections 9 through 12 had minor scuffing on the top, which occurred when the vehicle rode on top of the barrier.

The maximum lateral static displacement was 505 mm (20.0 in). Due to the angle between the vehicle targets and the camera, the dynamic displacement could not be accurately measured.

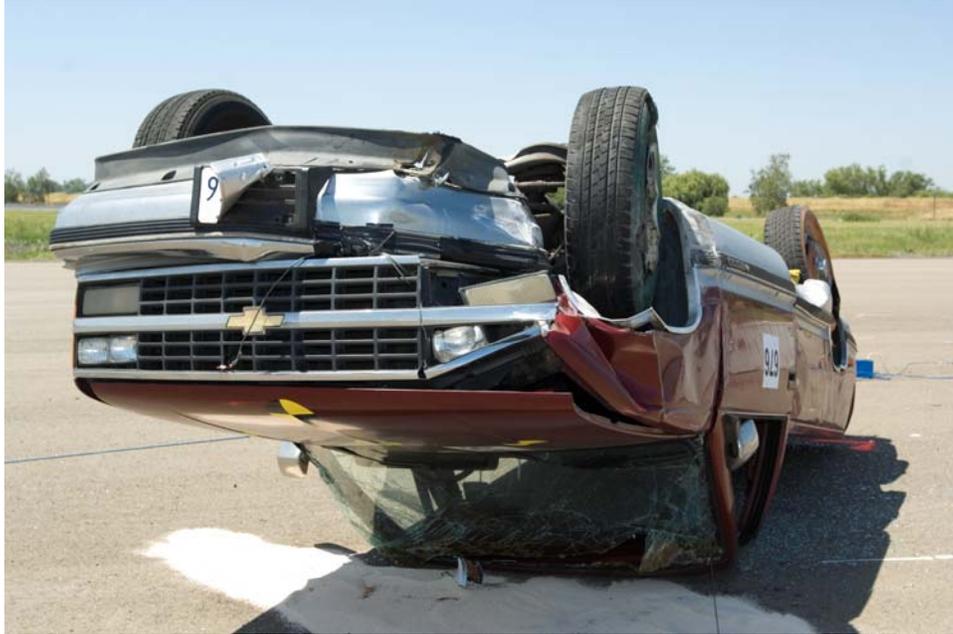
Figure 2-80. Test 676 - Vehicle Post-Impact Front View

The initial impact damaged the right front corner of the vehicle. The right front quarter panel and bumper were crushed inwards. The right front tire and right side rims were damaged. The right body panel was crushed when the vehicle rode on top of the barrier. The windshield was damaged during the rollover, but remained in place. The rear window shattered.
