1. REPORT NUMBER  FHWA/CA10-0515	2. GOVERNMENT ASSOCIATION NUMBER	3. RECIPIENT'S CATALOG NUMBER
4. TITLE AND SUBTITLE  DEVELOPMENT OF WEED CONTROL BARRIER BENEATH METAL BEAM GUARDRAIL	5. REPORT DATE  January 2011

7. AUTHOR  David Whitesel, John Jewell, Robert Meline	8. PERFORMING ORGANIZATION REPORT NO.  FHWA/CA10-0515	
9. PERFORMING ORGANIZATION NAME AND ADDRESS  Roadside Safety Research Group California Department of Transportation 5900 Folsom Blvd. Sacramento, CA. 95819	10. WORK UNIT NUMBER  FHWA/CA10-0515

# **DEVELOPMENT OF WEED CONTROL BARRIER BENEATH METAL BEAM GUARDRAIL**

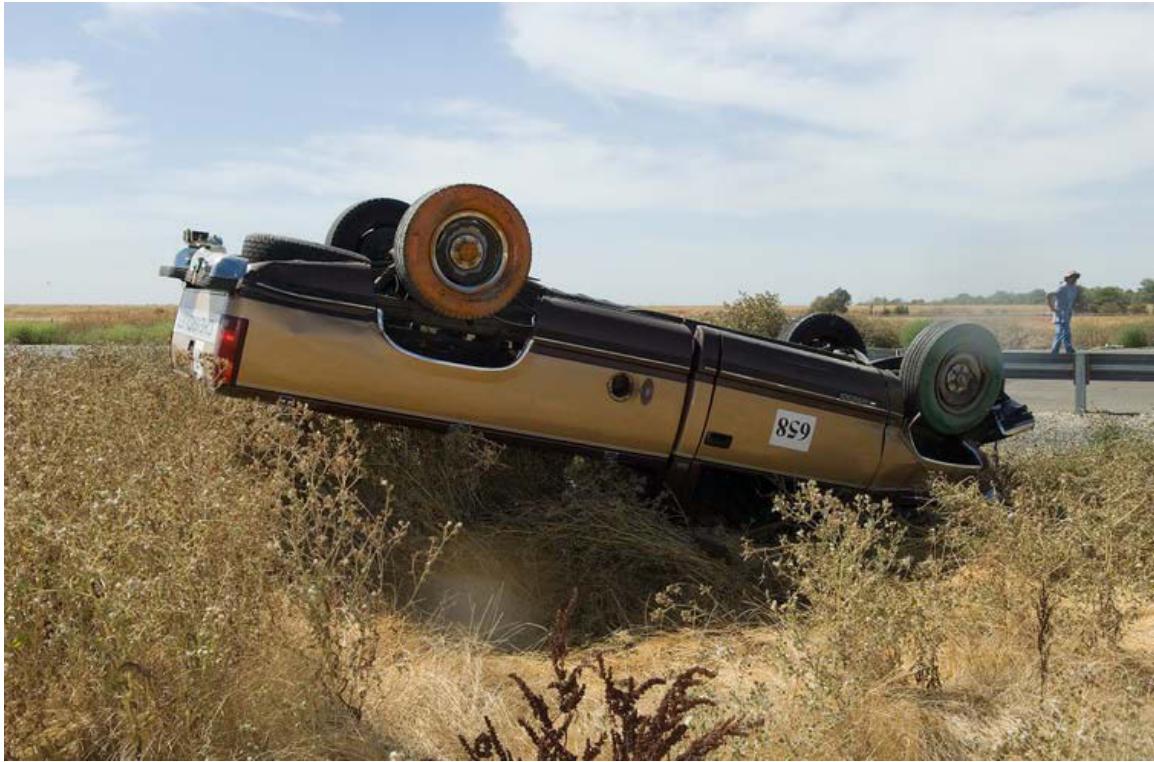
Figure 2-18 – Test vehicle after Test 658

The vehicle was extensively damaged from the w-beam rail rupture and subsequent vehicle rollover. No further analysis of vehicle damage was performed.

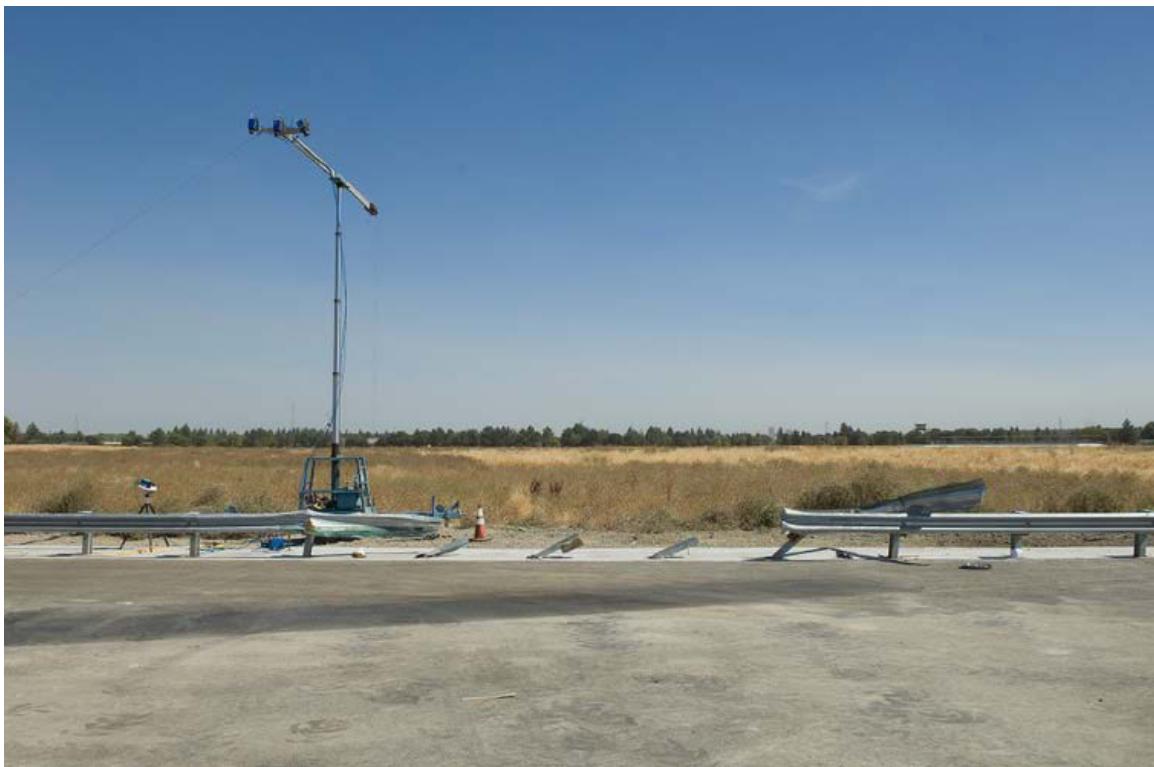
Figure 2-20 – Test 658 Test Article after Impact

**Barrier Damage:** The W-beam ruptured, allowing the vehicle to penetrate beyond the guardrail.

The main damage was the rupture of the w-beam rail. Secondly, the upstream SFT deflected toward the impact point, likely because the soil surrounding the metal tube was not adequately compacted. The rail stretched upstream of the impact point and compressed downstream of the impact point, as evidenced by movement of as much as  $\frac{1}{4}$  inch at the lap splices. Every post twisted counterclockwise, possibly also because of the inadequate anchoring of the upstream end treatment. As the rail shifted laterally (in the downstream direction), the wood post at the downstream SFT fractured (see Figure 2-22). Several blockouts also fractured during impact and were thrown from the point of impact toward the field. The blockout nearest the point of impact appeared to fracture upon impact, possibly before the post was able to rotate. Thus the reaction point of the rail would not have been raised, possibly contributing to the system failure. At the rupture point, the bottom of the w-beam element appears to have failed in shear due to contact with the top of the post at that location while the upper portion appears to have failed in tension.

Because of the results of Test 658, several design changes were made to the test article before re-testing. The test article for Test 658 was removed and replaced with a new test article. A 193.25-foot section (including end treatments) of MBGR with W6x9 steel posts was used. Again, all steel posts were driven into place without pilot holes. A 100-ft long x 4 ft-8 in section of CRMCrete was placed around 16 posts in the vicinity of impact (from the fifth post upstream of the impact point to the eleventh post downstream of the impact point). The first change made was to use an SRT end terminal instead of an SFT at the upstream end for additional anchorage. Wood posts at the SRT were driven into undersized pilot holes. An SFT was again used at the downstream end. A second significant change was to install the entire test article in native soil rather than in the AASHTO Grade A Standard Soil Pit. The native material is not as stiff as the AASHTO Standard Soil. A less stiff soil would be less likely to resist post rotation, thus making any effect the CRMCrete had on post rotation more pronounced. Third, the rubber boots used in Test 658 were replaced with expanded polystyrene foam (EPF) covered by  $\frac{1}{2}$  in of CRMCrete flash over. The EPF had a flexural strength of 33 psi and a compressive strength of 13 psi at 10% deformation. Last, the amount of crumb rubber in the mix was reduced from 4% to 3%. This mix design had a higher 28-day strength (1863 psi, 12.84 MPa) and created a more durable section to withstand cracking. The increase in compressive strength had only a minimal effect on the strength of the leave-out area with EPF since the leave-out section consisted of only  $\frac{1}{2}$  in (13 mm) of flash over.

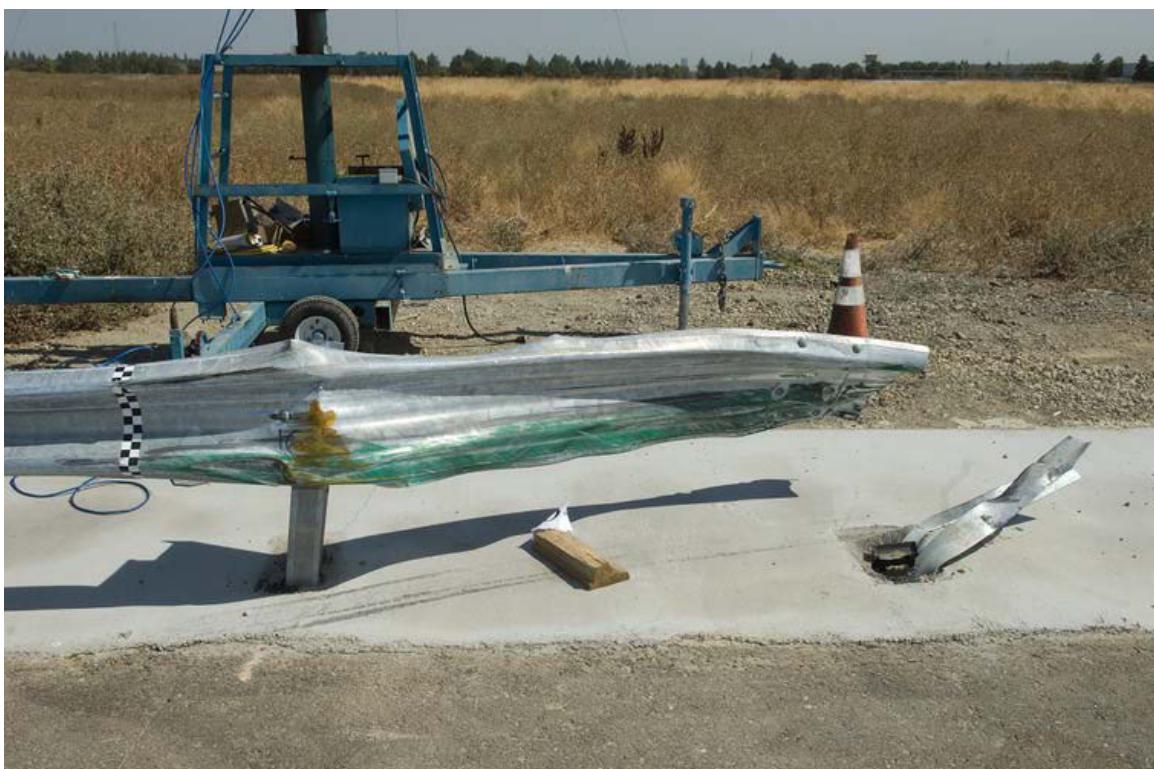
Figure 2-21 – Close-up of Impact Point

The vehicle impacted the w-beam section approximately 18 in (457 mm) upstream of Post 16, a non-splice post, with a speed of 99.8 km/h and impact angle of 25.8°. Post 16 immediately began to deflect backward, toward the field side of the guard rail. Post 16 reached its maximum deflection 0.048 s after impact. Post 17, which was downstream of Post 16, reached its maximum deflection at 0.094 s after impact. At 0.12 s after impact the left-front tire contacted post 17 and at 0.13 s after impact the front tires were redirected toward the field. At about 0.134 s after impact the w-beam completely ruptured, allowing the vehicle to pass through. When the vehicle left the CRMCrete and entered the unpaved field, it rolled over, coming to rest up-side down.

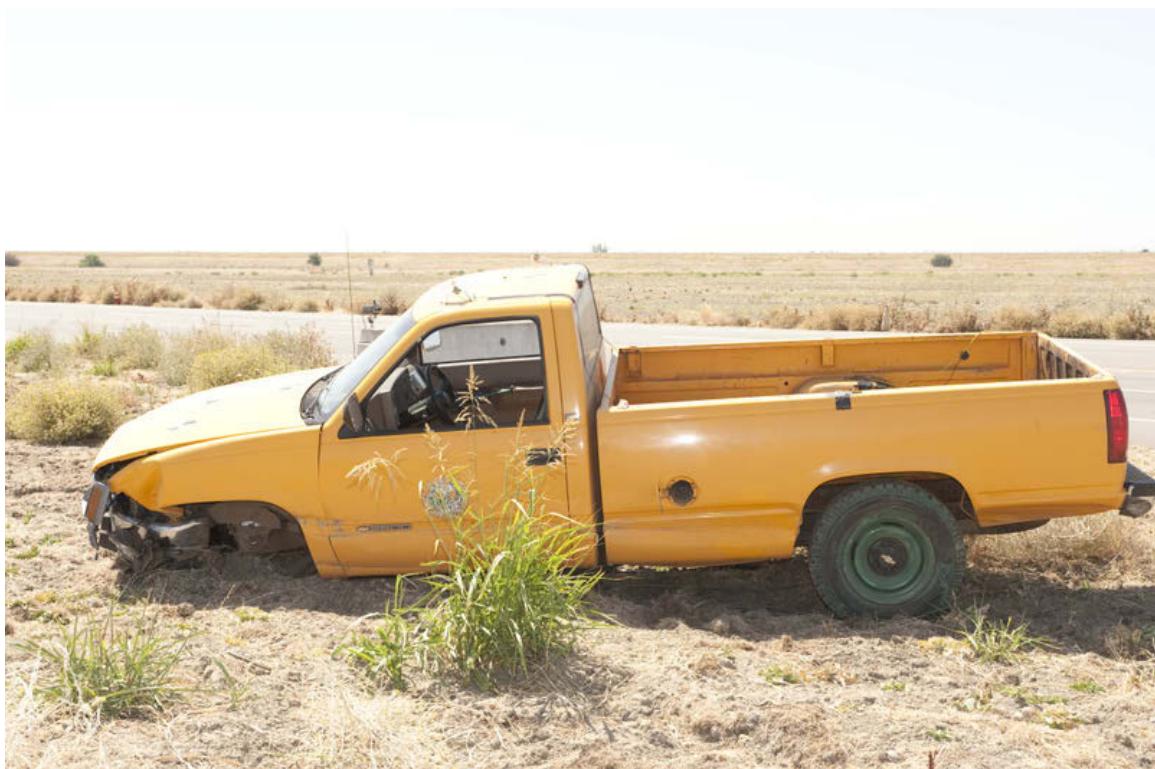
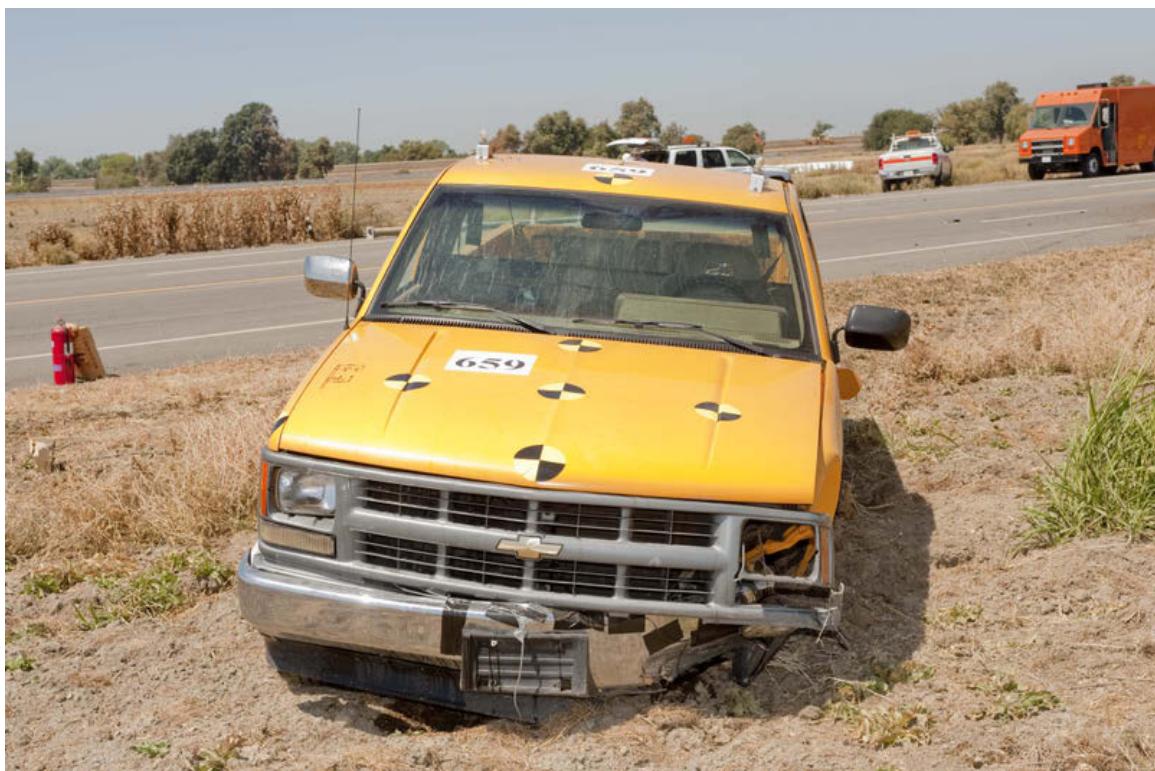
Figure 2-36 – Right Side of Test Vehicle after Test 659

Figure 2-37 – Front of Test Vehicle after Test 659

There was mild to moderate damage to the entire left side of the vehicle. The left portion of the front bumper and left front fender were pushed rearward. The left front tire and wheel assembly were detached from the vehicle. There was minor denting of the left door, left side of the bed, and left rear fender. The maximum passenger compartment deformation was one inch, between the motor panel and the rear of the occupant compartment.

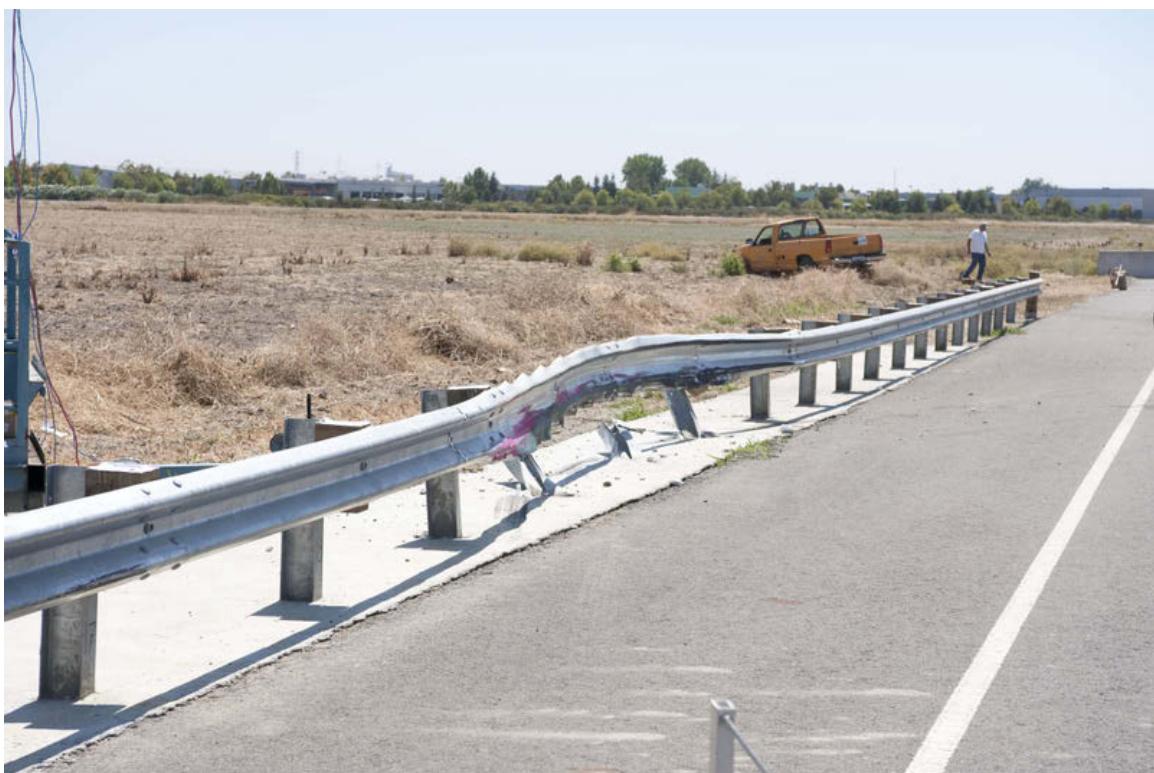
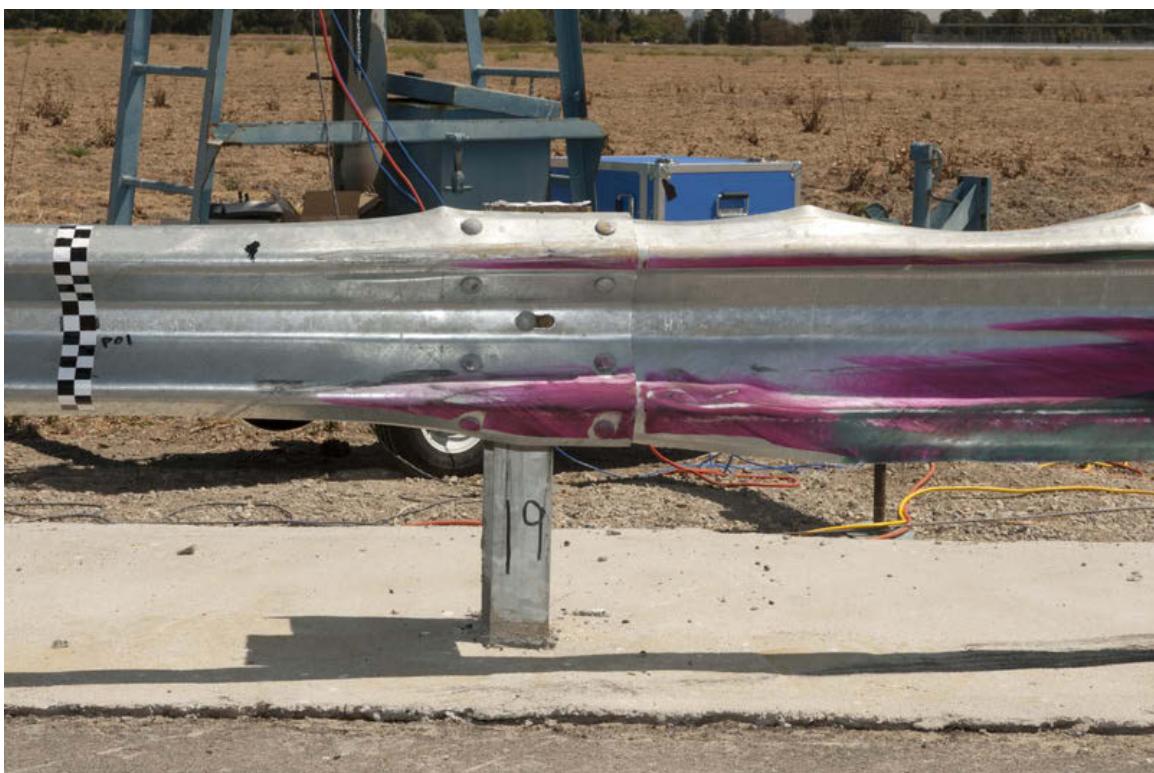
Figure 2-38 – Test Article Overview after Test 659

Figure 2-39 – Impact Point after Test 659

**Barrier Damage:** Permanent deflection at posts 19-23, with the CRMCrete in the leave-out area broken out as expected. Posts 20-22 yielded and were bent over. The W-Beam rail was deflected and deformed but intact. Maximum dynamic deflection was estimated at 40 inches (1016 mm). Maximum permanent deflection of the rail was 1.9 feet (579 mm) at approximately 14.2 feet (4.33 m) downstream of impact.

Posts 19-23 were deflected backward toward the field. Posts 20-22 were pushed over and permanently deformed. The blockouts at posts 20 and 21 were detached from the guardrail and damaged during the impact. The w-beam rail between posts 19-23 was permanently deformed. There was damage to the leave-out areas of posts 19-23 but the damage did not extend into the CRMCrete surrounding the leave-out areas. Blockout debris was found on the field-side as far as 172 feet from the point of impact but this is typical for a metal beam guardrail impact.

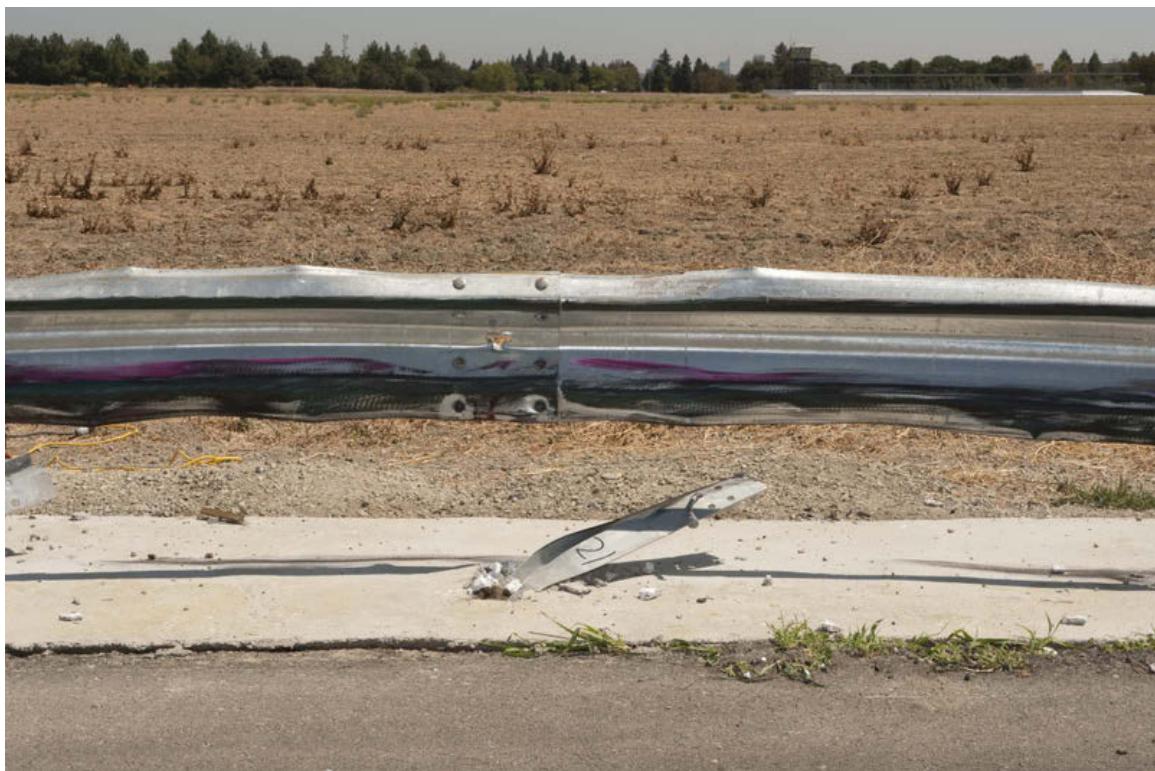
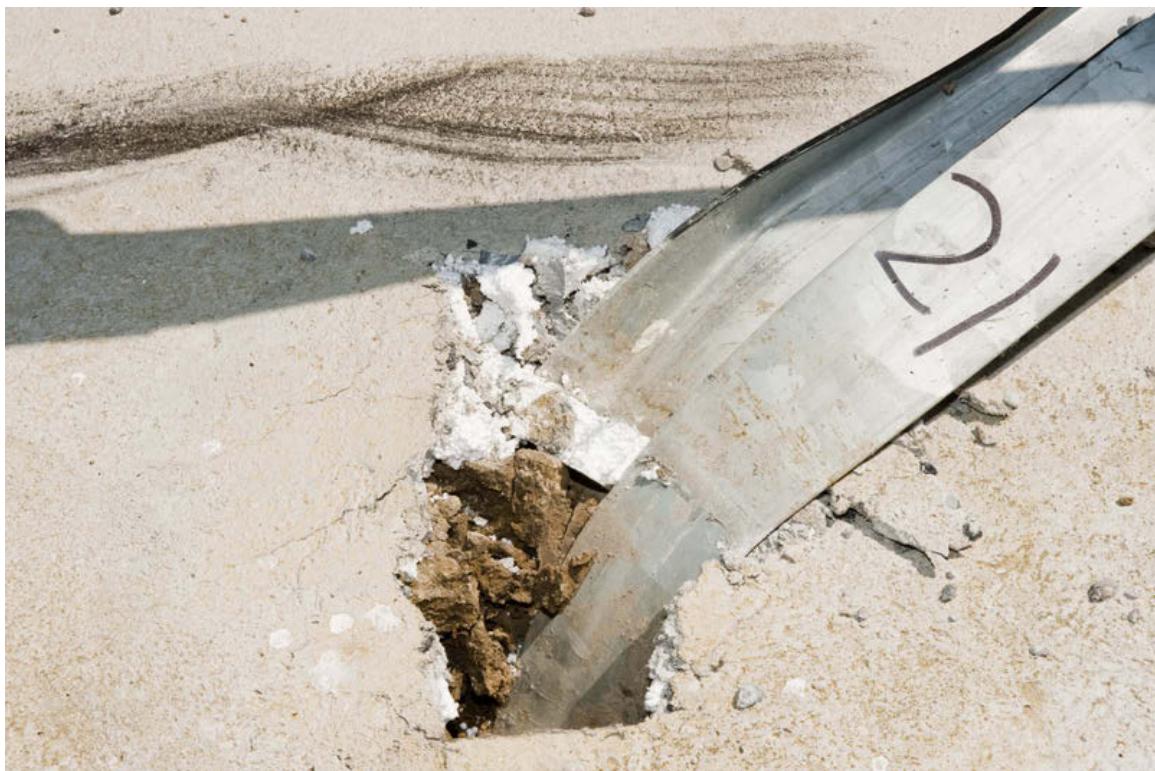
Figure 2-40 – Post 21 (Downstream of Impact Point) after Test 659

Figure 2-41 – Close-up of Post 21 after Test 659
