Concrete Overlay on Asphalt Pilot Project at Woodland SR 113: Construction

Angel Mateos, John Harvey, Miguel Angel Millan, Rongzong Wu, Fabian Paniagua, Jessica Cisneros, and Julio Paniagua

Partnered Pavement Research Center (PPRC) Project Number 3.39 (DRISI Task 3201): Implementation and Field Performance Evaluation of Concrete Overlay on Asphalt

1. REPORT NUMBER UCPRC-RR-2020-01	2. GOVERNMENT ASS NUMBER	OCIATION	3. RECIPIENT'S CATALOG NUMBER	
4. TITLE AND SUBTITLE Concrete Overlay on Asphalt Pilot Project	at Woodland SR 113: Co	nstruction	5. REPORT PUBLICATION DATE July 2021

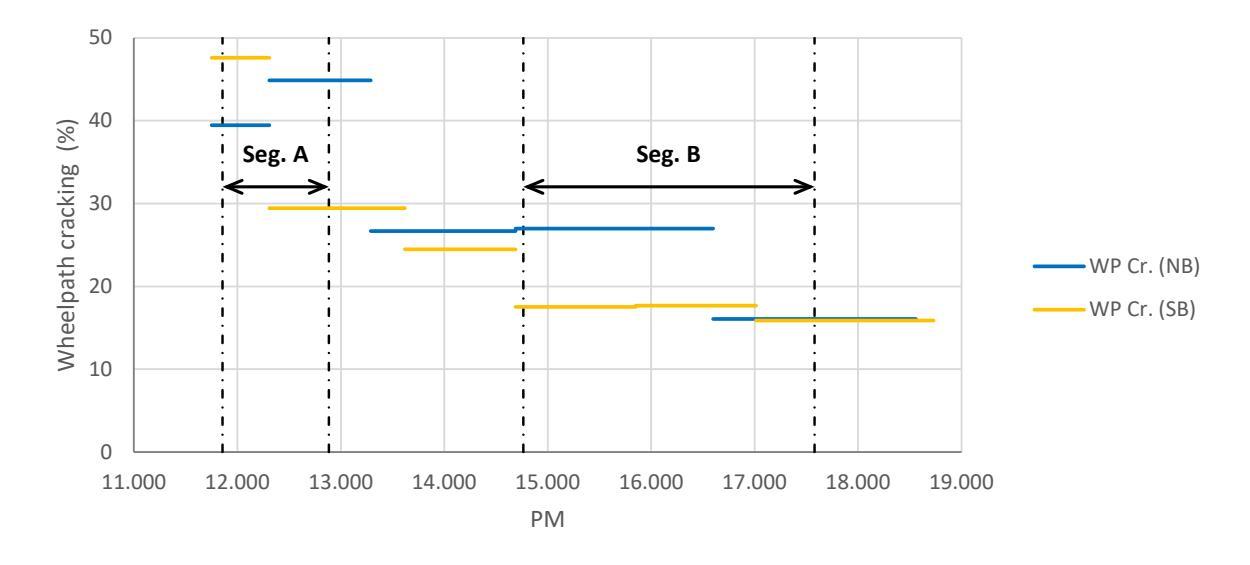
Before construction, the condition of the existing asphalt pavement at the project site was relatively poor, mainly due to the presence of alligator cracking in the wheelpaths (Figure 2.2). Cracking was more severe in Segment A than in Segment B, probably due to the greater number of trucks and their heavier weights. Rutting was relatively low, varying from 0.1 to 0.2 in. (Figure 2.3). The data used to generate Figure 2.2 and Figure 2.3 come from the Caltrans Automated Pavement Condition Survey. The evaluation of the existing asphalt pavement's condition included coring and falling weight deflectometer (FWD) testing, as explained below.

Figure 2.2: Condition of the existing asphalt pavement: cracking.

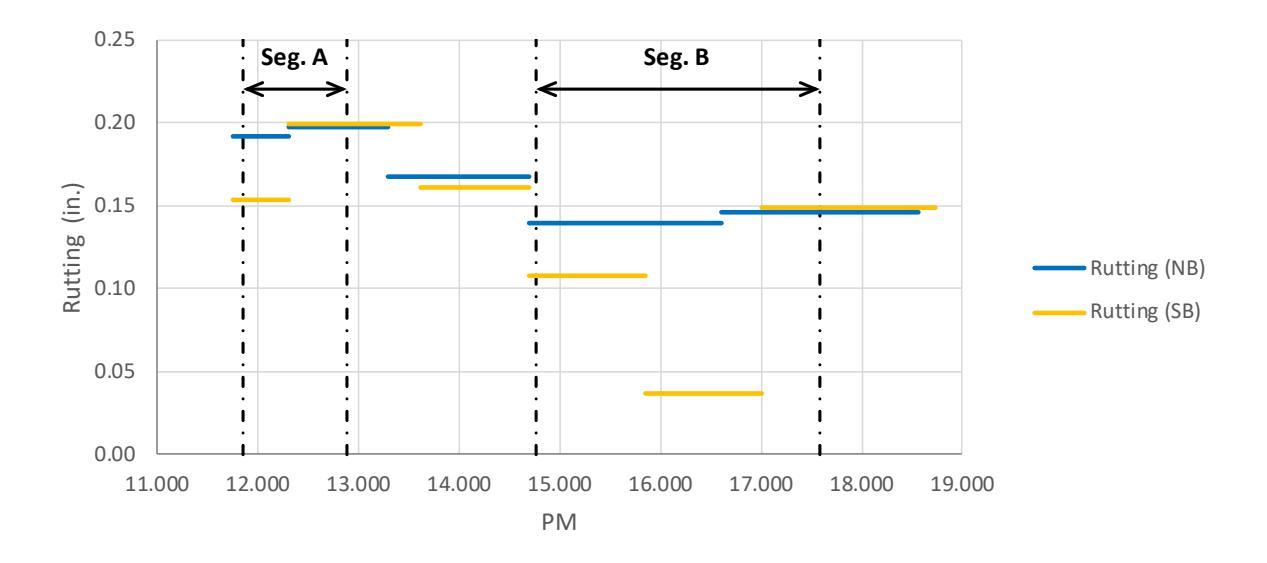
Figure 2.3: Condition of the existing asphalt pavement: rutting.

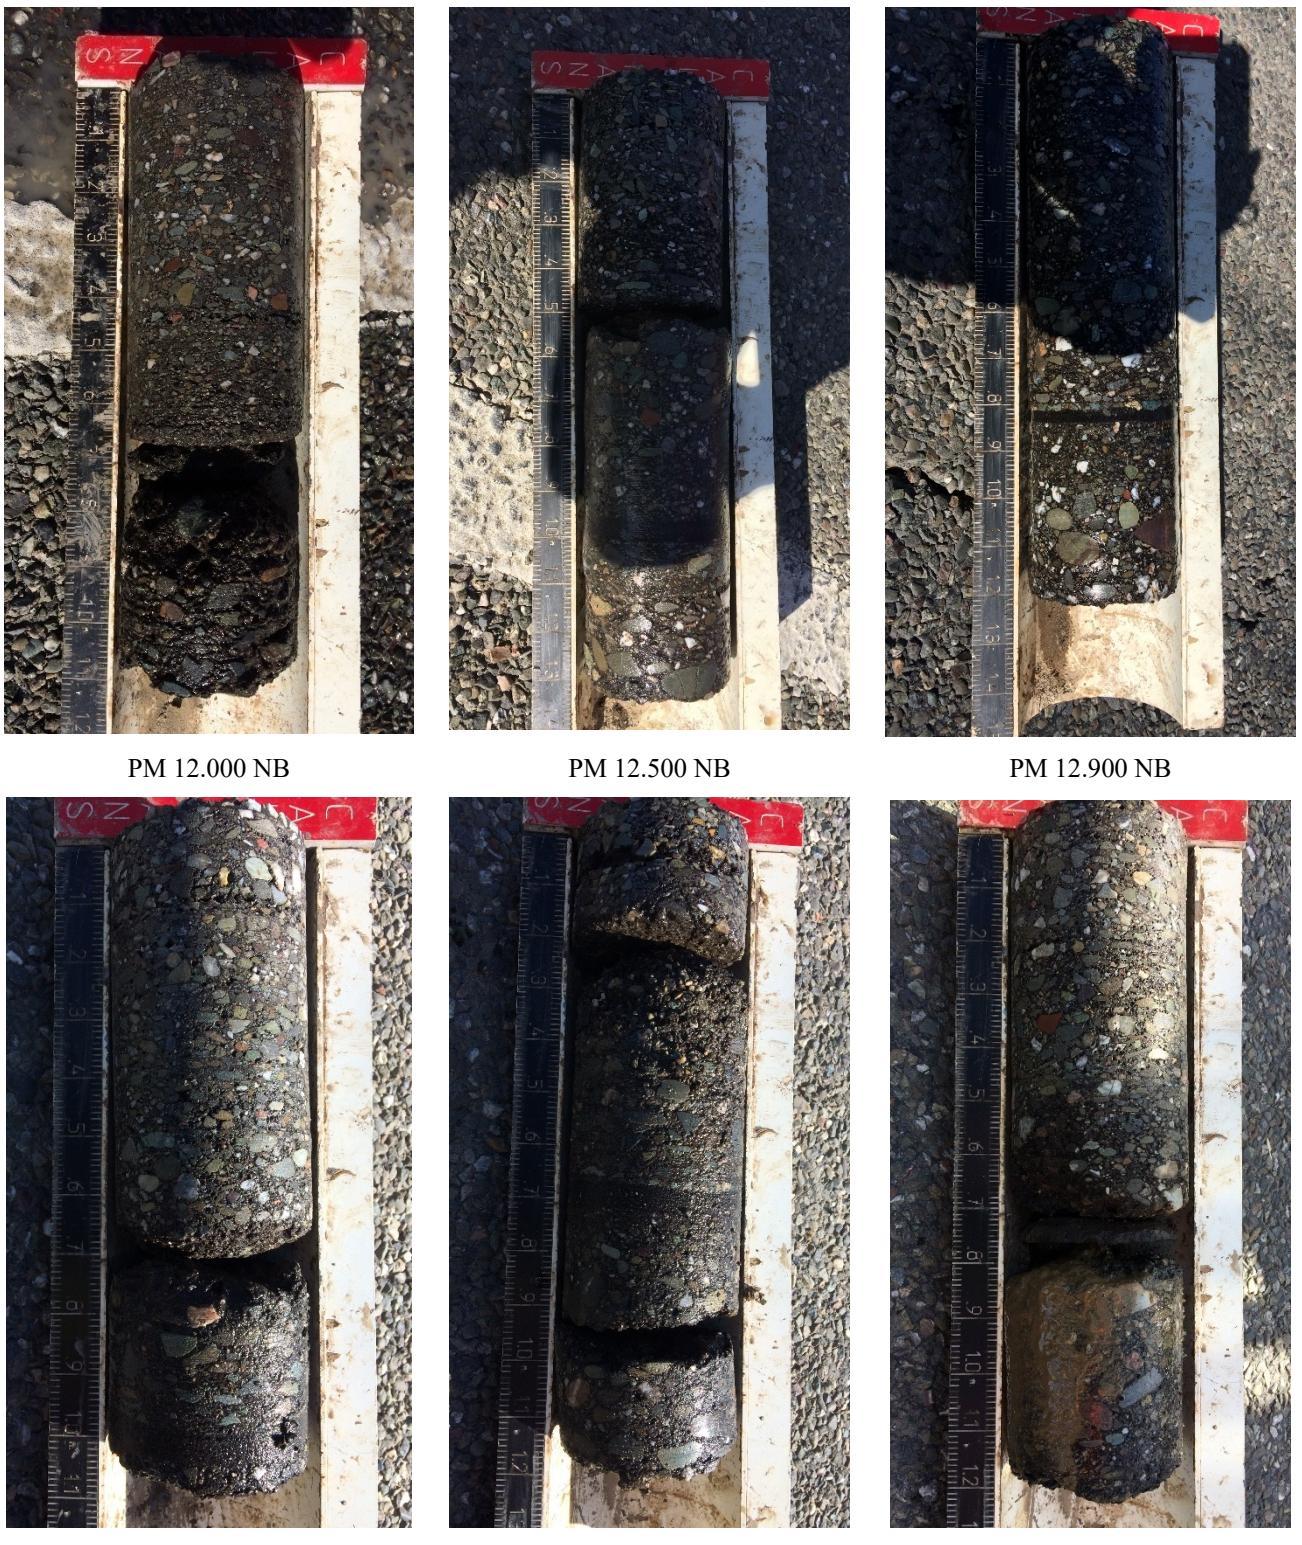
Figure 2.5: Cores extracted from between the wheelpaths: Segment A.

All the cores were extracted from spots in or between the wheelpaths. None were extracted at cracked locations or shoulders. The Segment A cores did show frequent delamination and some moisture damage (Figure 2.5) to the asphalt, but the Segment B cores showed the asphalt to be in good condition (Figure 2.6). A second set of cores was extracted from both segments on top of asphalt cracks. These cores showed that cracking had affected the full depth of the asphalt layer and that moisture had produced considerable damage in the lower asphalt lifts (Figure 2.7).

Based on these findings—the asphalt delamination risk that was seen in the Segment A cores (Figure 2.5) and the somewhat better condition of the asphalt in the top lift than in the lower lifts—a recommendation was made that the project include either a minor amount of grinding or no grinding. Ultimately, this recommendation was overridden by another recommendation included in a flooding-risk evaluation that warned against elevating the road surface.

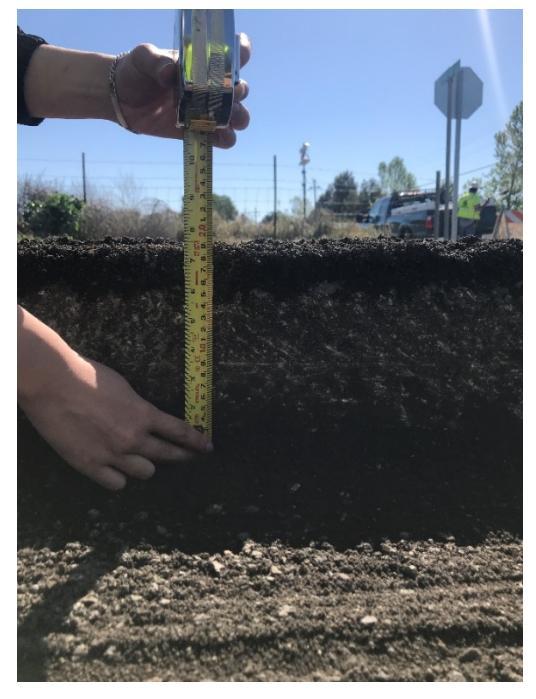
Figure 4.2: Milled asphalt thickness deeper than the 6 in. target value.

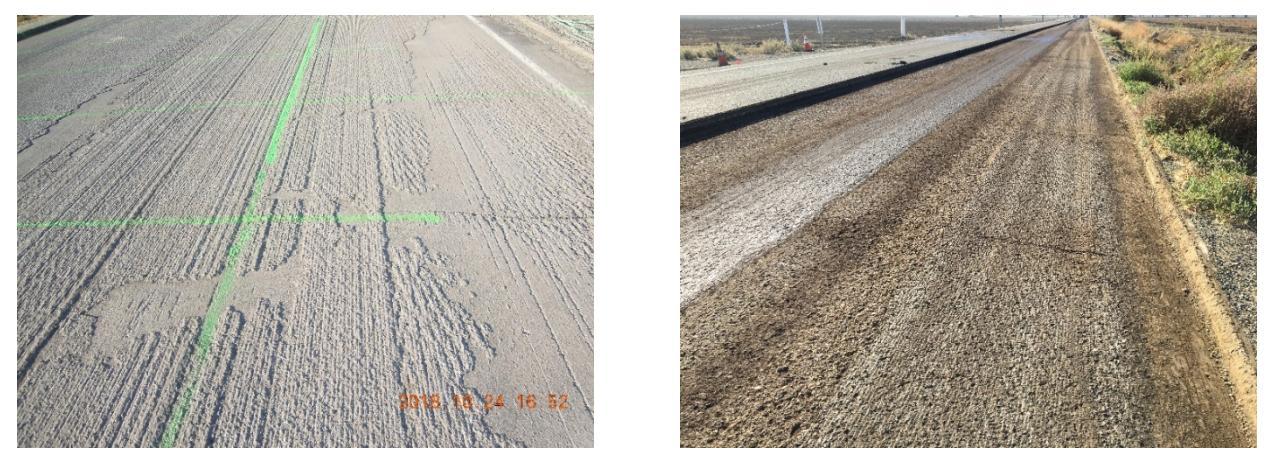
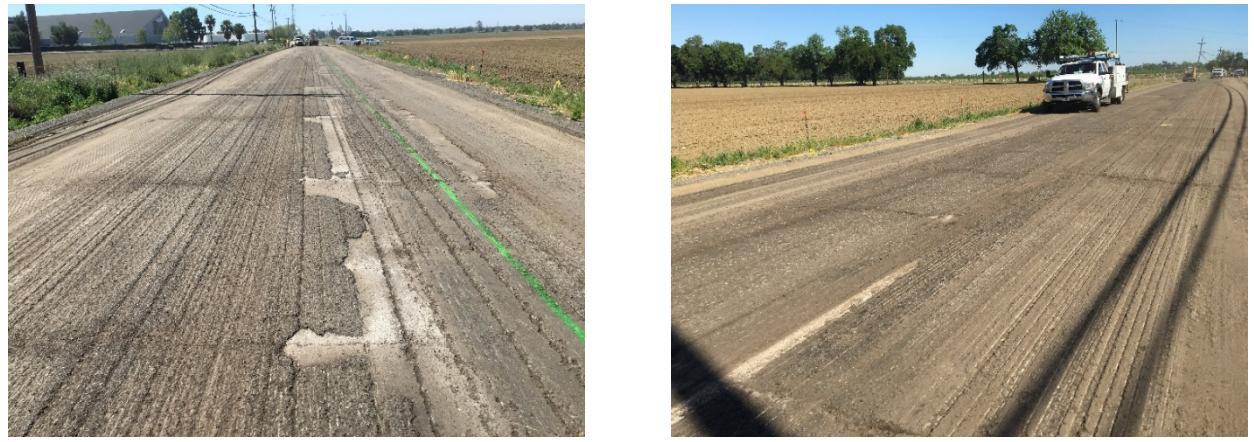
Overall, the milling operation revealed an asphalt base in poor condition. Cracking and areas of delamination were present all over the project (examples in Figure 4.3). Further, in many locations the milling operation either left an insufficient asphalt base or entirely removed the asphalt base at the shoulder edge of the roadway, as shown in the photographs in Figure 4.4. As can be seen in those photographs, the width of the available milled asphalt base was too narrow to provide a continuous support under the COA slabs, which would leave the shoulder edge of the exterior slabs resting on the aggregate subbase instead of the milled asphalt base. This structural condition may eventually cause longitudinal cracking of the concrete overlay. At some locations, the shoulder edge of the milled roadway was paved with asphalt to provide a uniform support for the COA slabs (Figure 4.5).

Segment B: Asphalt cracking and areas with delamination

Segment A: Asphalt cracking and areas with delamination Figure 4.3: Appearance of the asphalt surface after milling.

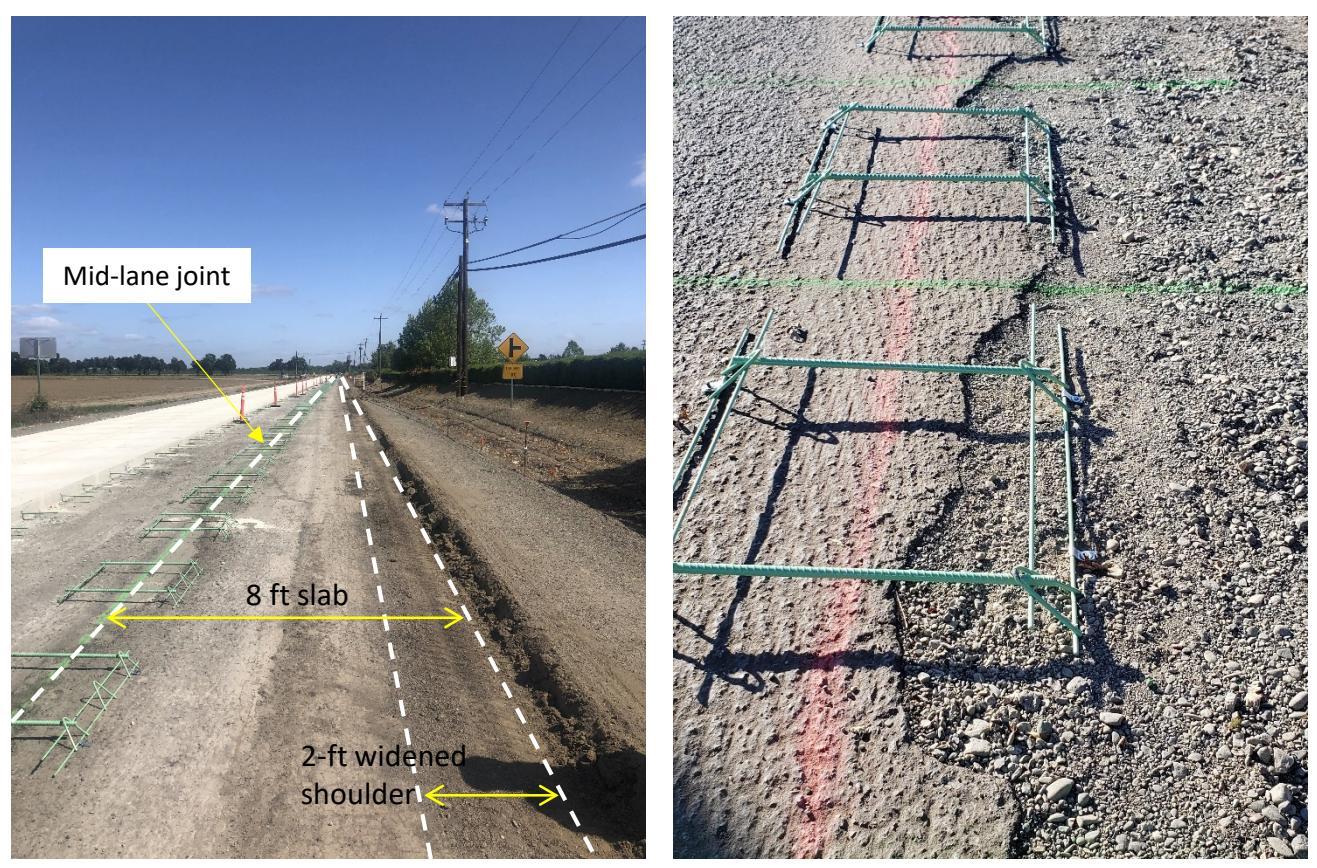
Figure 4.4: Insufficient or and missing asphalt base.

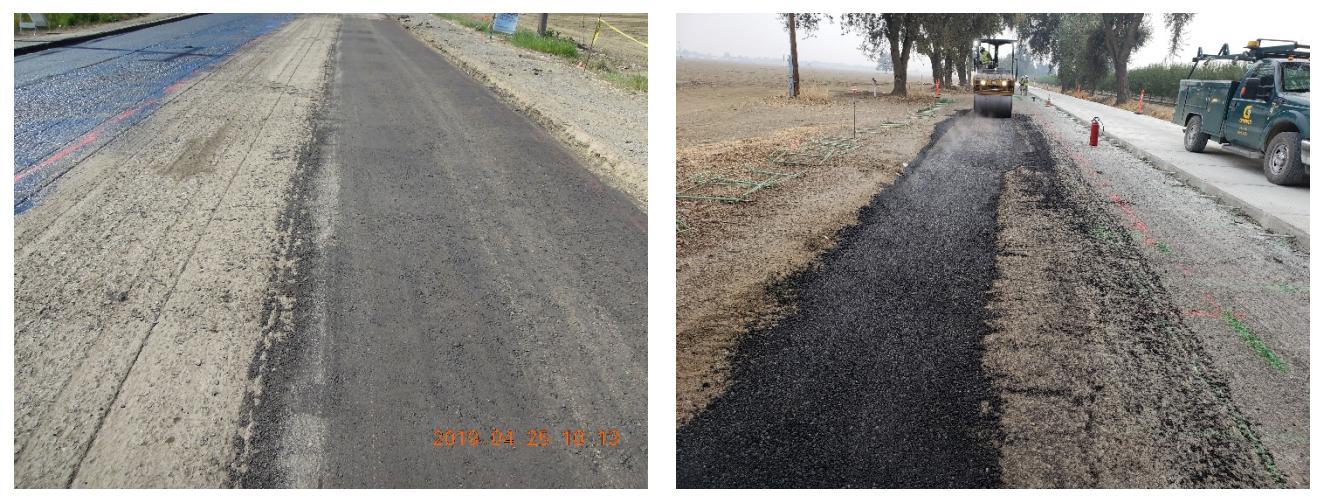
Figure 4.5: Asphalt patching on areas with insufficient or missing asphalt base.

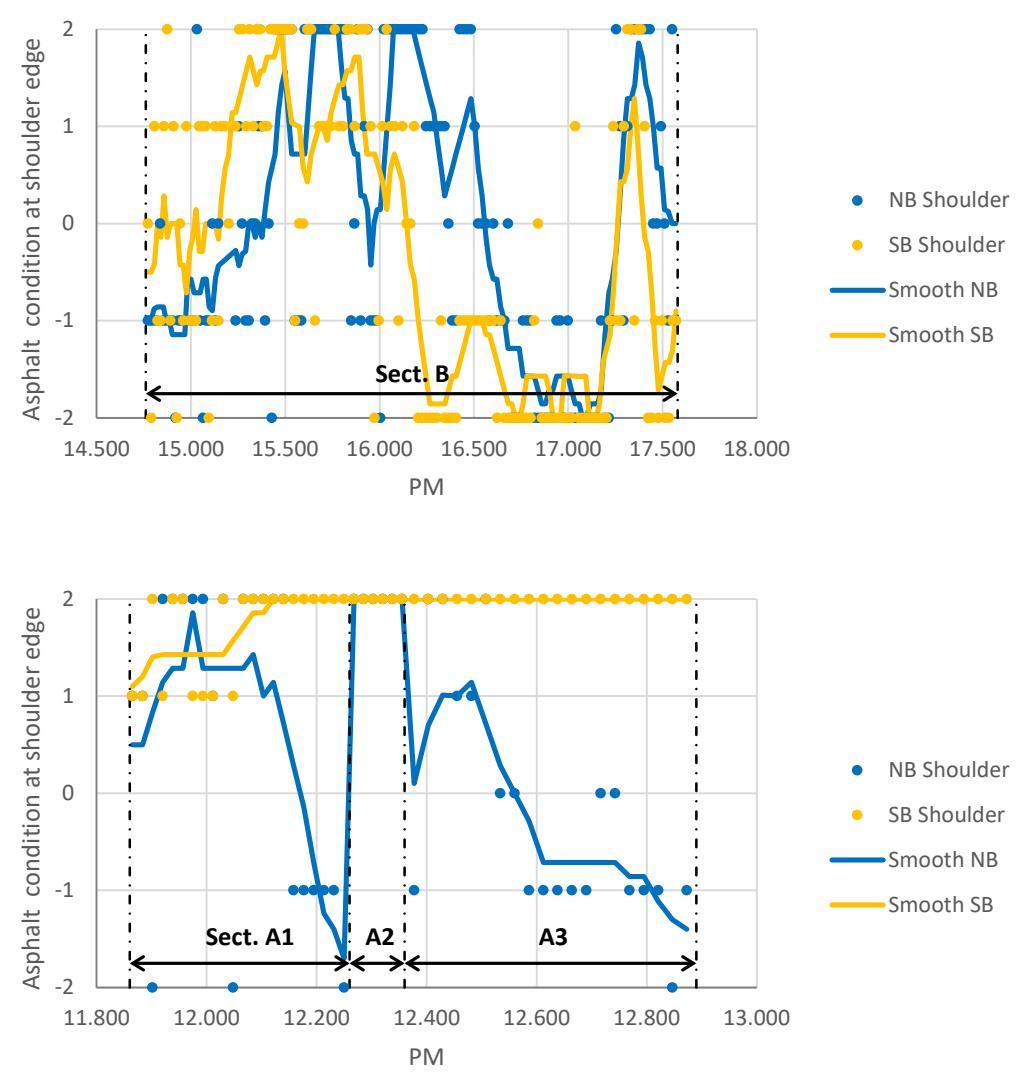
The data in Figure 4.7 indicate that the lack of asphalt base at the shoulder edge of the roadway occurs all over the project, with the exception of Segment A in the southbound direction. In Segment B, the asphalt base condition at the shoulder was especially poor. This segment's condition was attributed to (1) its original asphalt thickness only being 9 to 11 in., (2) the milling depth exceeding the 6 in. target value by 1 to 2 in., and (3) the thicker asphalt in the wheelpaths and at the center of the road than at the shoulder. As milling progressed on the overall project, the cross-slope produced by the operation occasionally exceeded the existing slope, resulting in greater milling depth at the shoulder than at the center of the roadway. This seemed to have occurred on southbound Segment B, between PM 16.000 and PM 17.580.

Figure 4.7: Asphalt condition at the shoulder edge of the COA slabs.

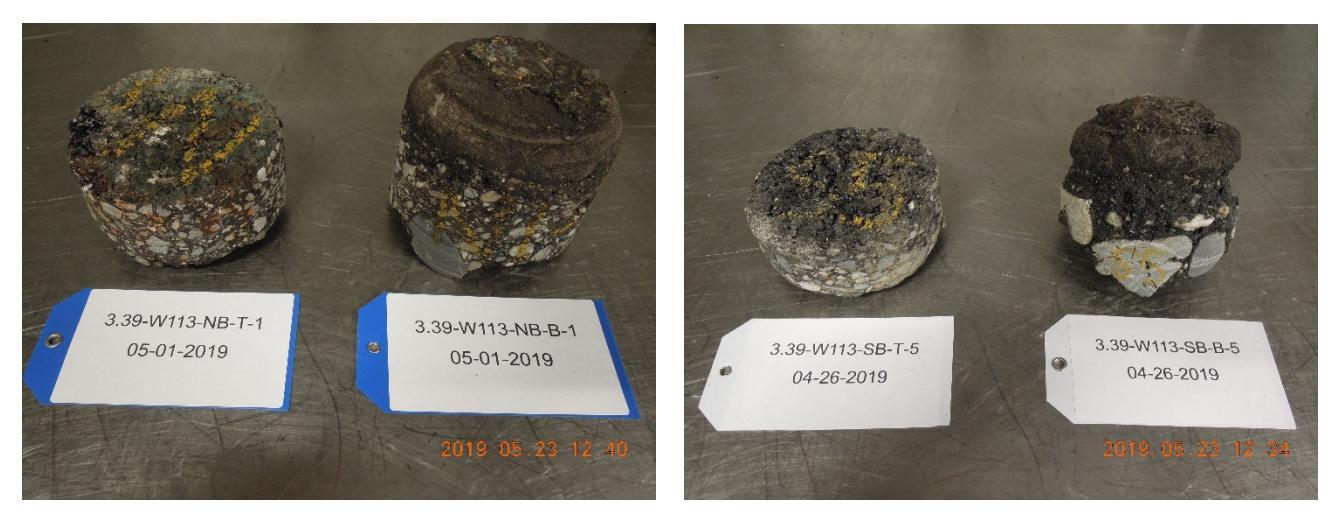
It should be noted that all the cores extracted from the newly placed RHMA-G showed debonding between the asphalt lifts. The total thickness was extracted in two pieces: (1) the top piece, which was 2.5 in. thick on average, included the newly placed RHMA-G plus bonded old HMA and (2) the bottom piece, which was 2.3 in. thick on average, included the debonded part of the old HMA (see examples in Figure 4.10).

*Note:* The top pieces of the cores (on the left in each picture) included the newly placed RHMA-G plus the bonded old HMA; the bottom pieces included the debonded part of the old HMA.

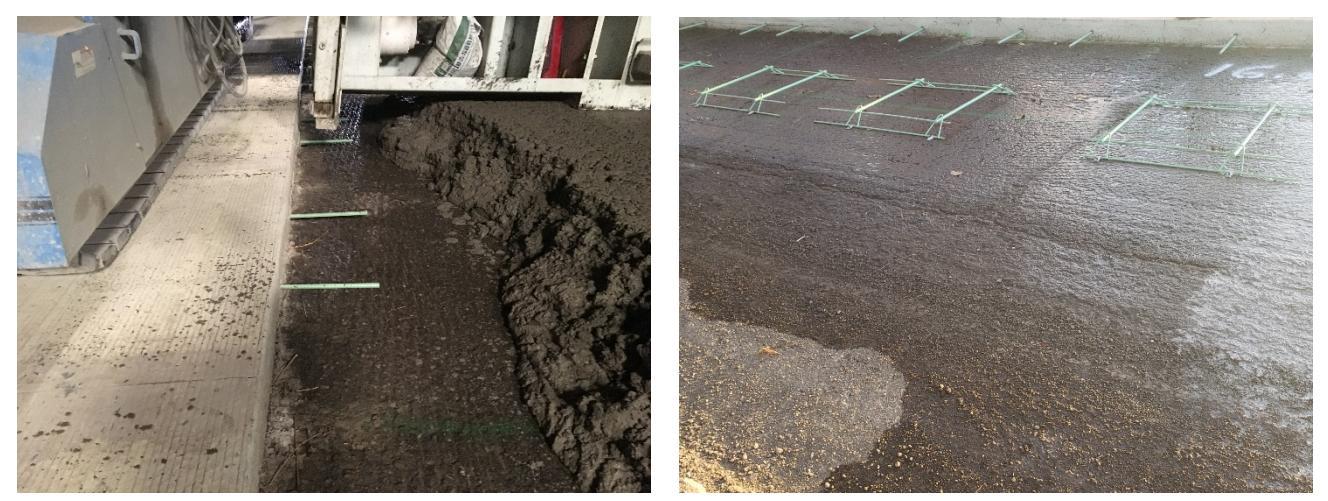
*Note:* Dirt on the asphalt surface has a negative impact on concrete-asphalt bonding. Figure 4.12: Dirt on the asphalt surface before concrete paving.

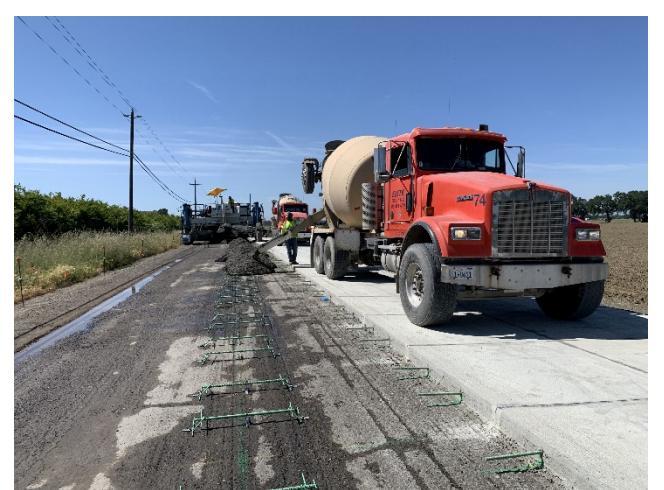
Before placement of the concrete overlay, the asphalt surface was wet conditioned by a truck that sprayed water on it. Overall, the asphalt surface was adequately wet conditioned; it was wet but free of standing water, approximating a saturated surface-dry condition (Figure 4.15, left). At some spots, however, the asphalt surface dried before the concrete was placed (Figure 4.15, right) and it would have been beneficial to have sprayed these spots with water manually. At other locations, the irregularity of the milled asphalt surface caused water ponds to form at the shoulder edge of the roadway (Figure 4.15, right). This standing water may have had a negative effect on the concrete poured at these locations.

Asphalt surface is not adequately wet conditioned: some dry areas; standing water at the shoulder
