Evaluation of the Fotokite Tethered Unmanned Aerial System for DOT Operations in Network-Deprived Areas

*Report Number: WA-RD 950.1
AHMCT Research Report: UCD-ARR-25-06-30-01
Final Report of Contract: T3372-AC*

June 30, 2025

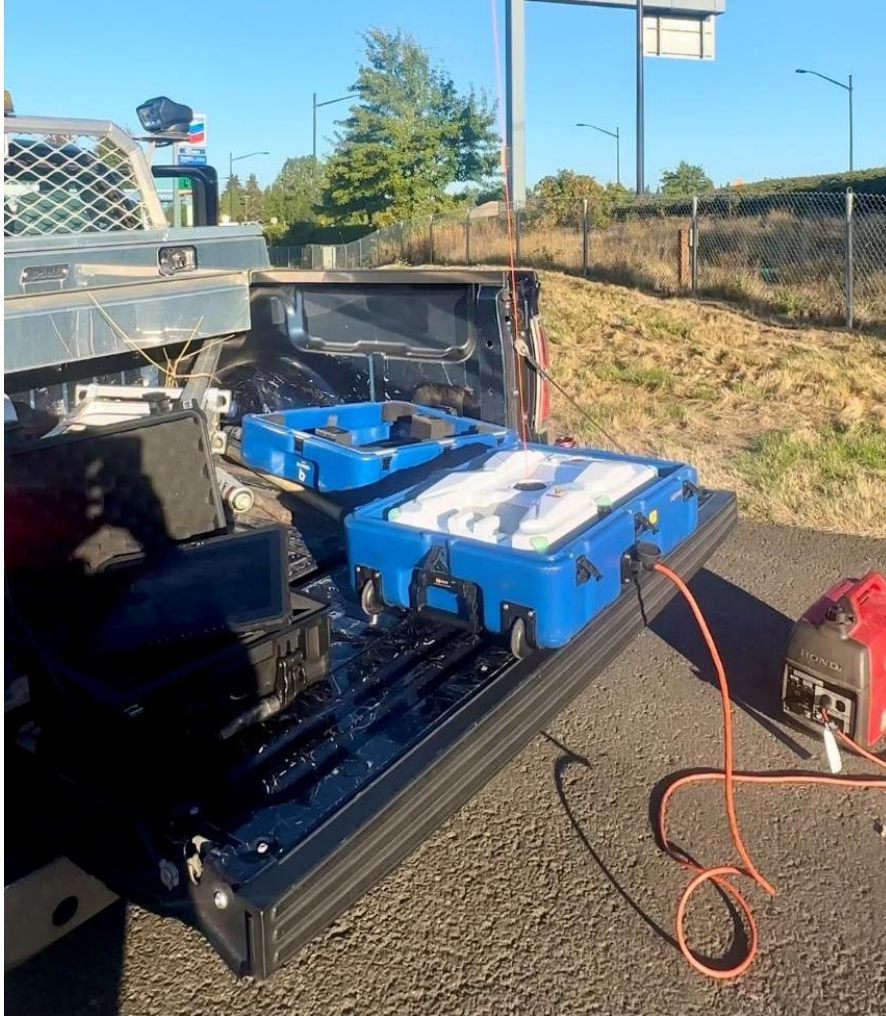
Figure 2.14: Fotokite powered by a Honda generator. Note that the cable shown in the photo was not provided by Fotokite; WSDOT used an alternative cable due to a malfunction with the original. Photo courtesy of WSDOT

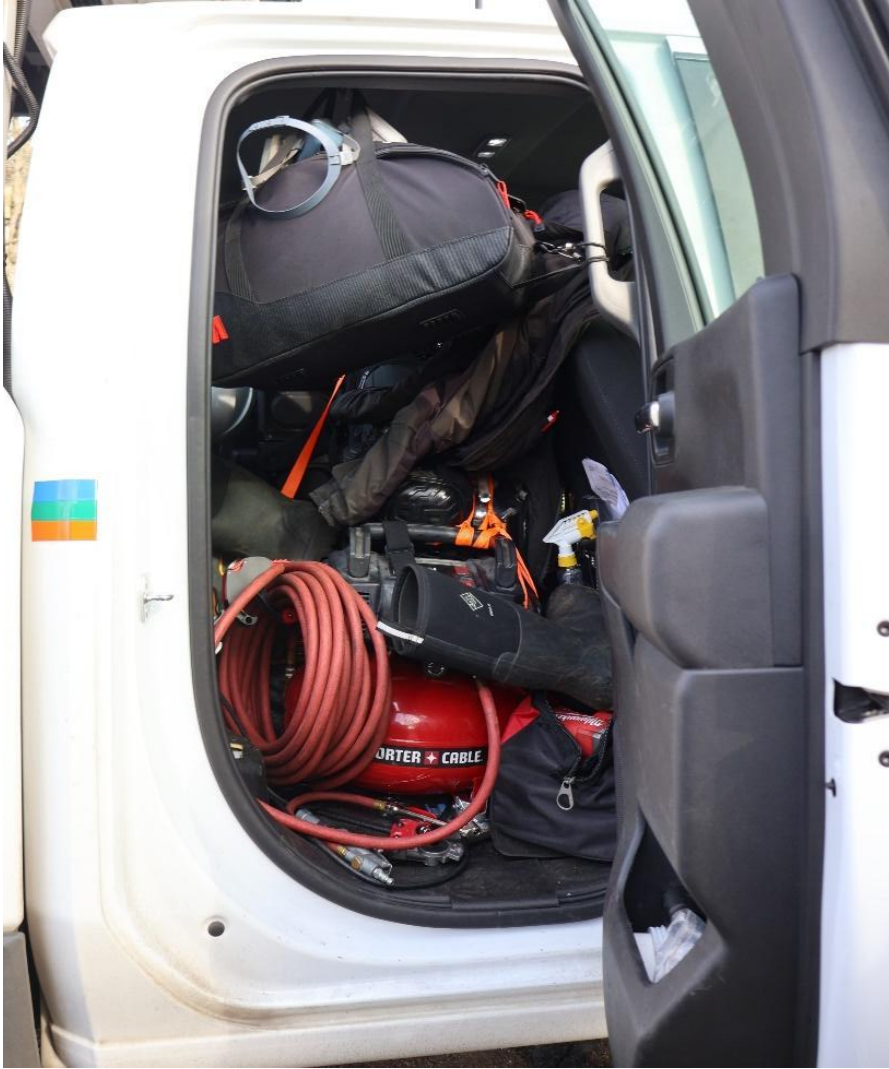
Since there is only one person per incident response truck, setting up the Fotokite portable unit system delays their ability to respond to issues quickly. However, the system has proven valuable for long-term traffic monitoring and operations. For instance, Fotokite was effectively used to monitor traffic during a Costco opening, which provided TMCs with real-time traffic congestion awareness. If the size and setup time of the Fotokite portable unit system can be reduced, it could become a more viable tool for rapid response scenarios.

Figure 3.5: WSDOT incident response truck storage. Due to the extensive equipment already required for WSDOT personnel's field operations, the size of the Fotokite portable unit can be an inconvenience for storage purposes

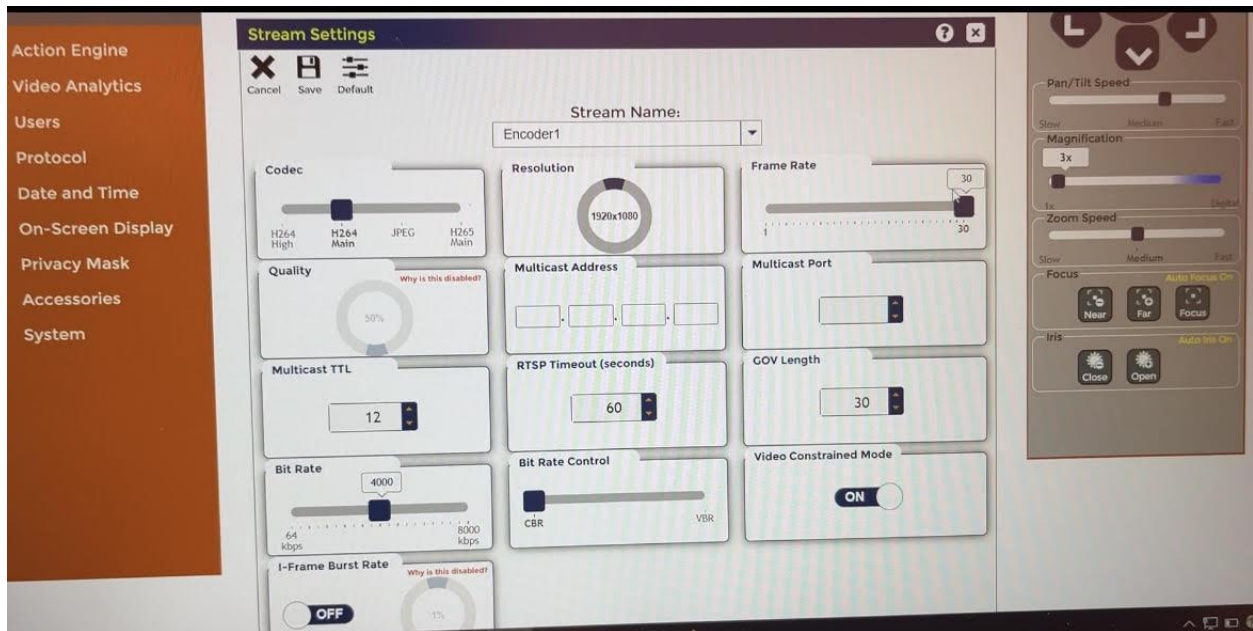
If the Fotokite team can offer user-controlled resolution settings and fully resolve the RID issues, the system could have greater value to Caltrans.

Figure 3.6: Resolution control panel for Caltrans TMC cameras. Since Fotokite does not have this feature, its live streaming footage inside Caltrans TMCs might not be as continuous as that of the existing cameras

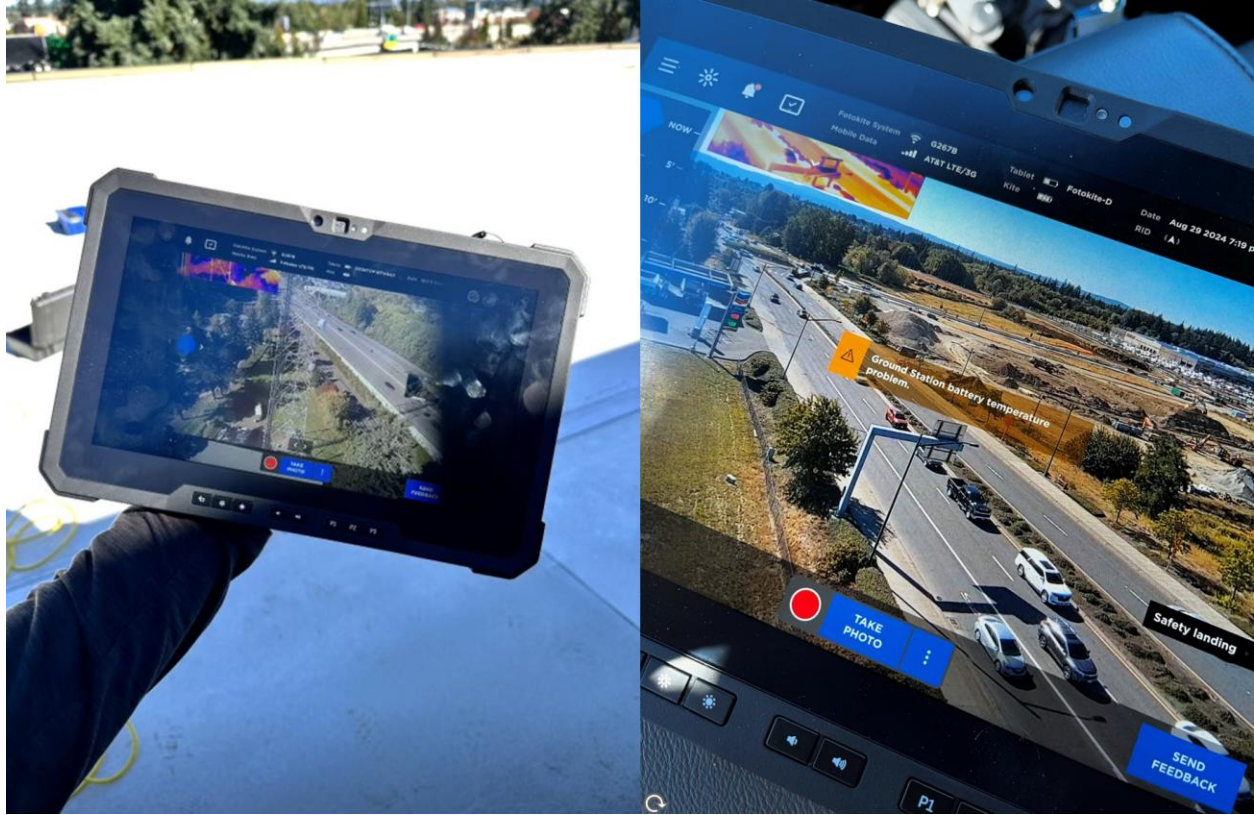
Figure 3.8: Example of the Fotokite deployment in a scheduled event. Footage was relayed back to the WSDOT TMC. Photo courtesy of WSDOT

As shown in Figure 3.8, the Fotokite system experienced a “Ground Station Battery Temperature Problem” error message after being exposed to the sun for several hours (a total flight time of 5 hours). WSDOT personnel allowed the unit to cool in the shade for about 30 minutes and then relaunched it. Fotokite was able to continue flying until the end of the traffic management operation. The error message only occurred once throughout the duration of the flight.

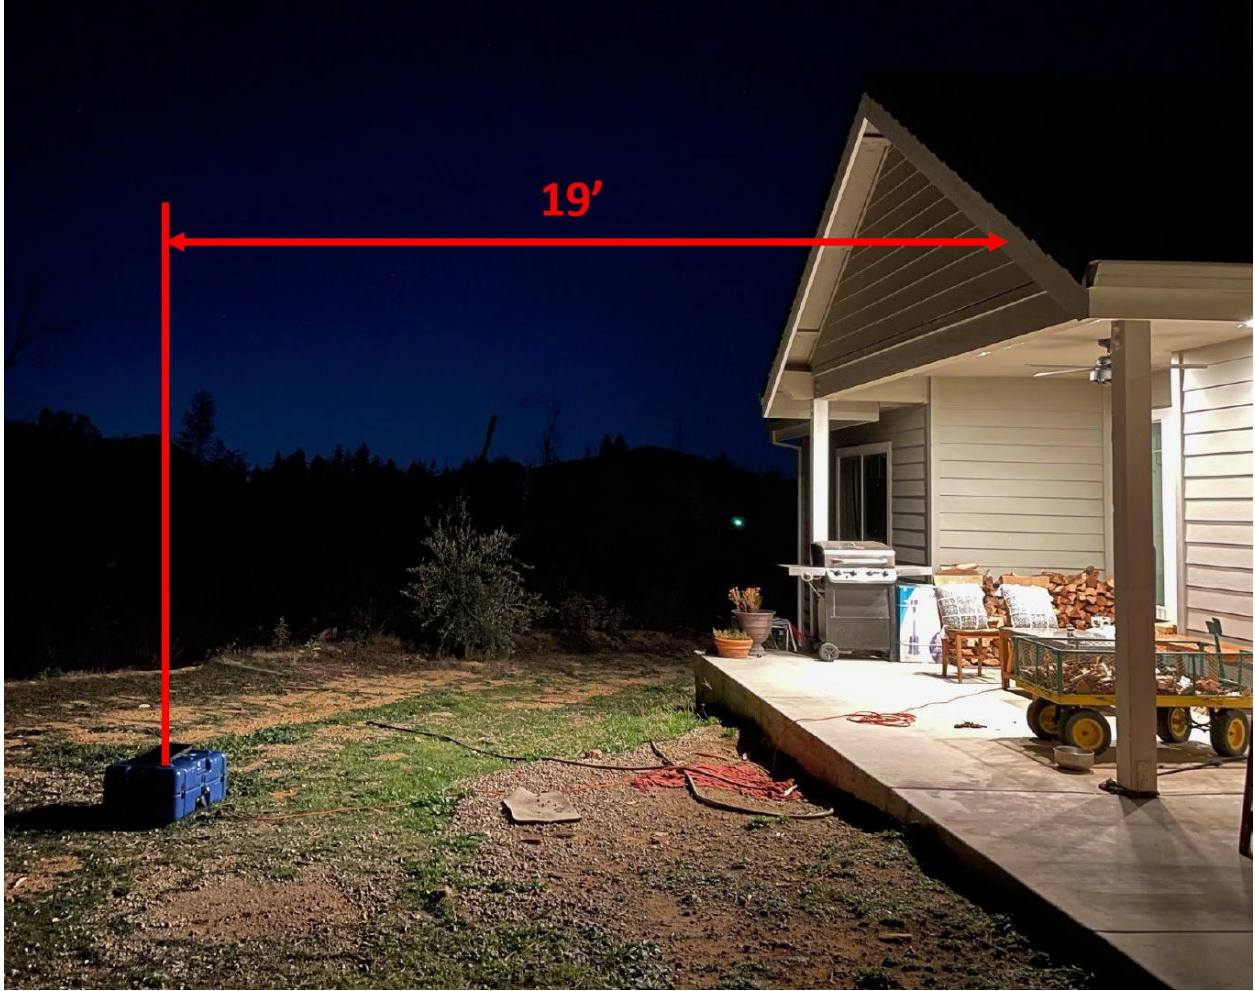
Item B.7: Caltrans District 2 Fotokite crash report for 2023

Figure B.7: Caltrans District 2 Fotokite crash report documentation demonstrating the height of the building hit

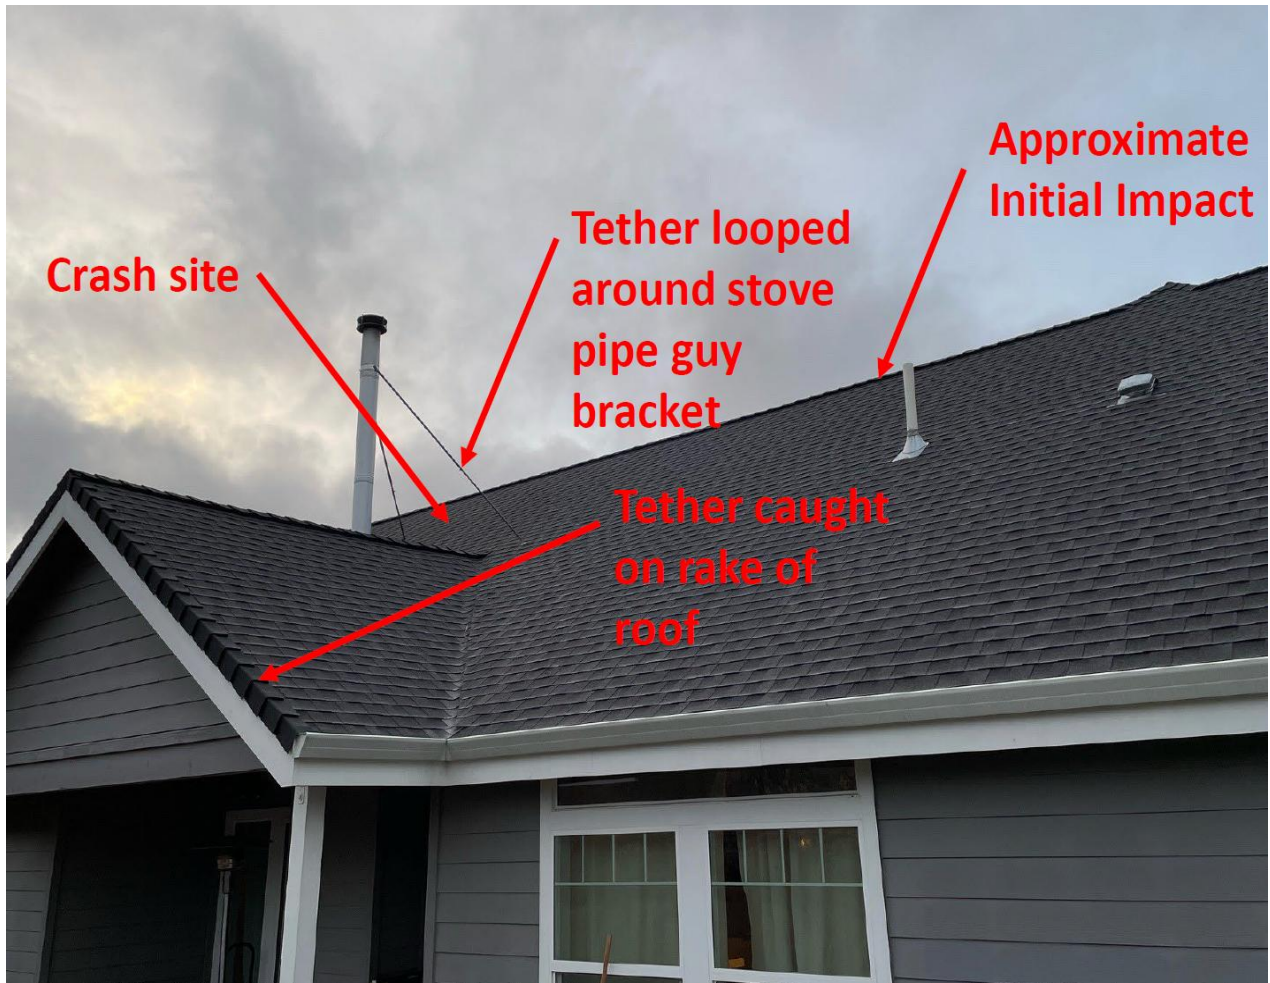
Figure B.7: Caltrans District 2 Fotokite crash report documentation demonstrating the crash site and items on the roof the UAS hit.
