Effects of Fabrication Procedures and Weld Melt-Through on Fatigue Resistance of Orthotropic Steel Deck Welds

Final Report

Report No. CA08-0607

December 2008

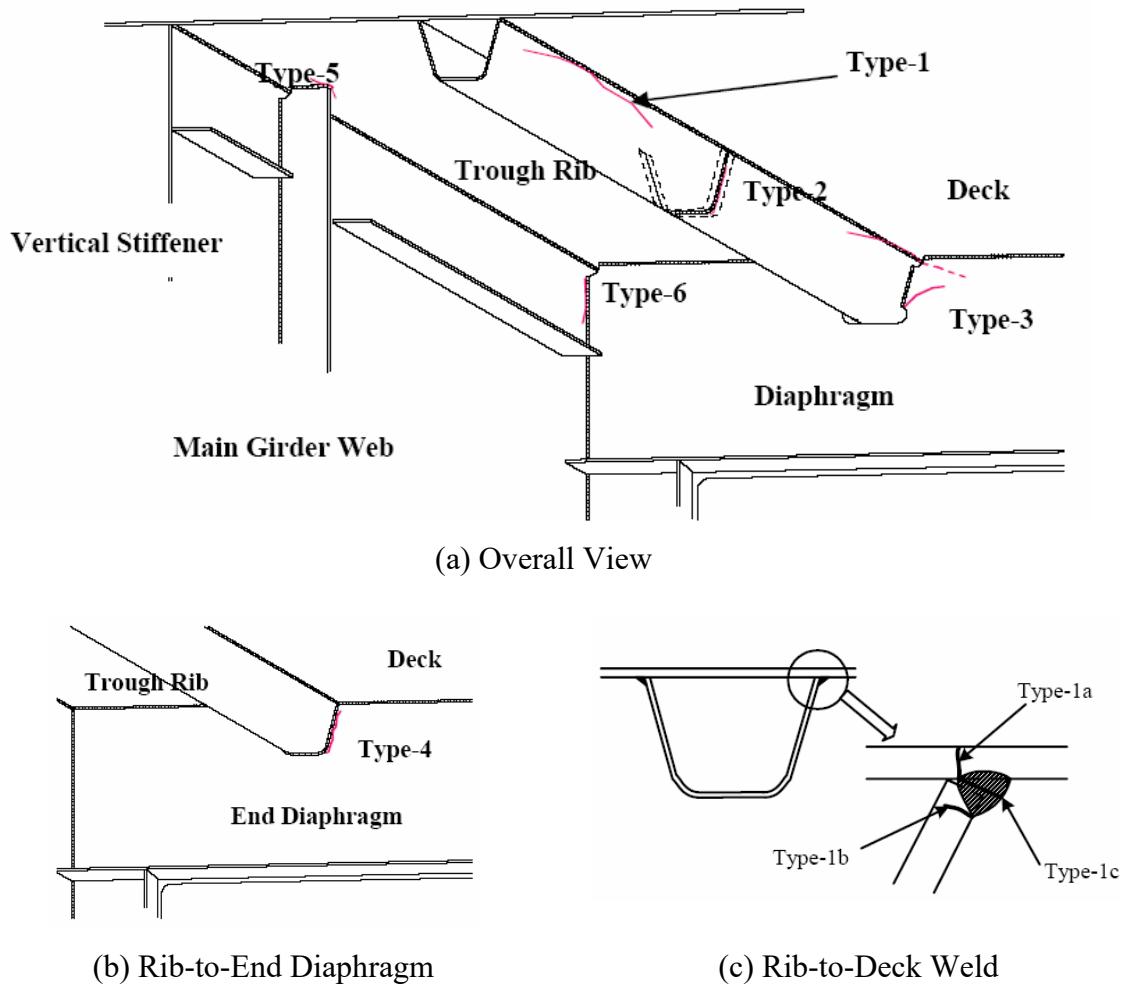
Figure 1.2 Fatigue Cracks on Orthotropic Steel Deck (Machida et al. 2003)

In Japan, a detailed investigation of the occurrence of fatigue cracks of orthotropic steel bridges in urban cities was reported by Machida et al. (2003). Figure 1.2 shows typical crack patterns. In addition to the crack at the rib-to-diaphragm junction, crack at the rib-to-deck welded joint is also a concern. The latter joints are prone to fatigue cracking because they are subjected to wheel load directly; stress concentration occurs both in the weld toe due to local plate bending and bearing stresses and in the weld root due to the characteristic deformation made of the joint from wheel load (Machida et al. 2003). Unfortunately, inspection and repair of the back side of this weld (i.e., weld root) for closed ribs is not practical due to lack of access. Cracks like type 1a in Figure 1.2(c) will not be discovered until the crack propagates thorough the entire thickness of the plate and shows sign in wearing surface.

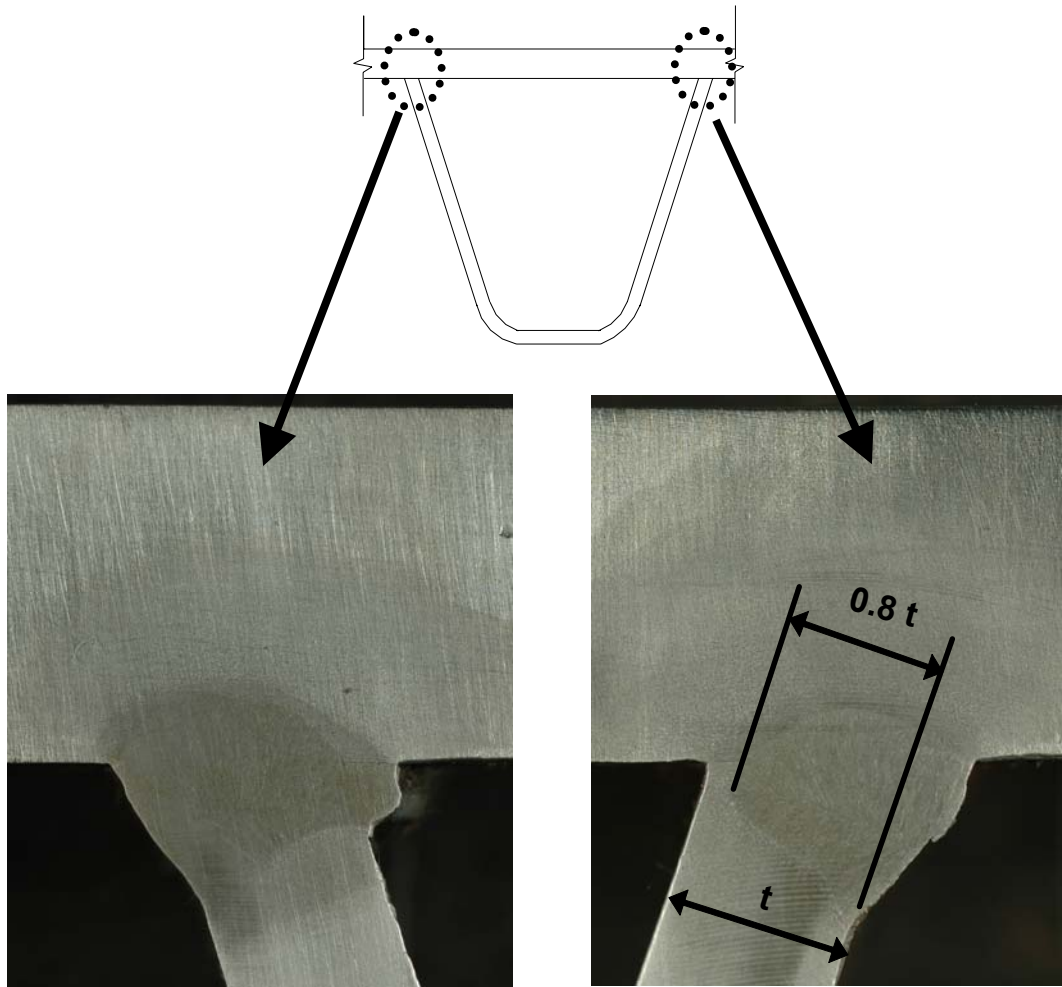
(a) with Weld Melt-Through

(b) without Weld Melt-Through

2007). In the United States, Article 9.8.3.7.2 of the AASHTO Specification code specifies 80% partial penetration groove welds. The Commentary states that partial penetration welds are generally used for connecting closed ribs with thickness greater than 6.35 mm (1/4 in) to deck plates. Such welds, which require careful choice of automatic welding processes and a tight fit, are less susceptible to fatigue failure than full penetration groove welds requiring backup bars. In practice, however, the amount of penetration into the joint components is difficult to control, and the actual weld size achieved varies due to many parameters, including power source, material, and fit-up tolerances. Because of the thin thickness (say, 8 mm) of the rib plate, weld melt-through to the back side of this weld is also difficult to avoid. Some are of the opinion that this weld melt-through might affect the fatigue resistance at these welded joints. Figure 1.5 shows two weld details of 80% PJP without weld melt-through and with weld melt-through.

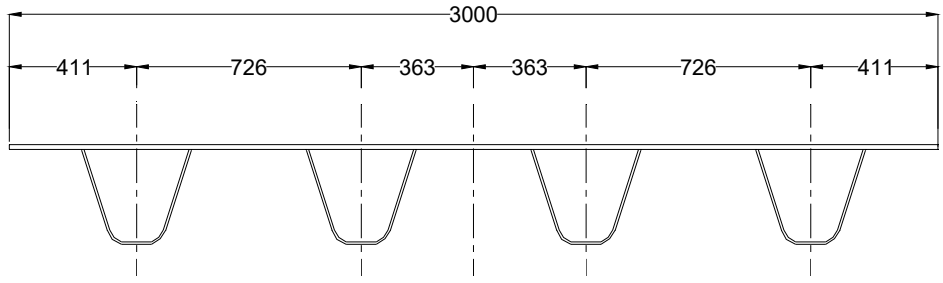
Figure 2.2 Cross Section between Support Diaphragms

The test panel contains three conditions of rib-to-deck weld details in order to provide a comparison of their fatigue resistance. The weld conditions are: (a) 80% PJP groove weld without weld melt-through; (b) 100% PJP groove weld with evident continuous weld melt-through; (c) 80% or 100% PJP with intermittent weld melt-through every 1 m (i.e., alternating between the weld conditions (a) and (b) every 1 m).

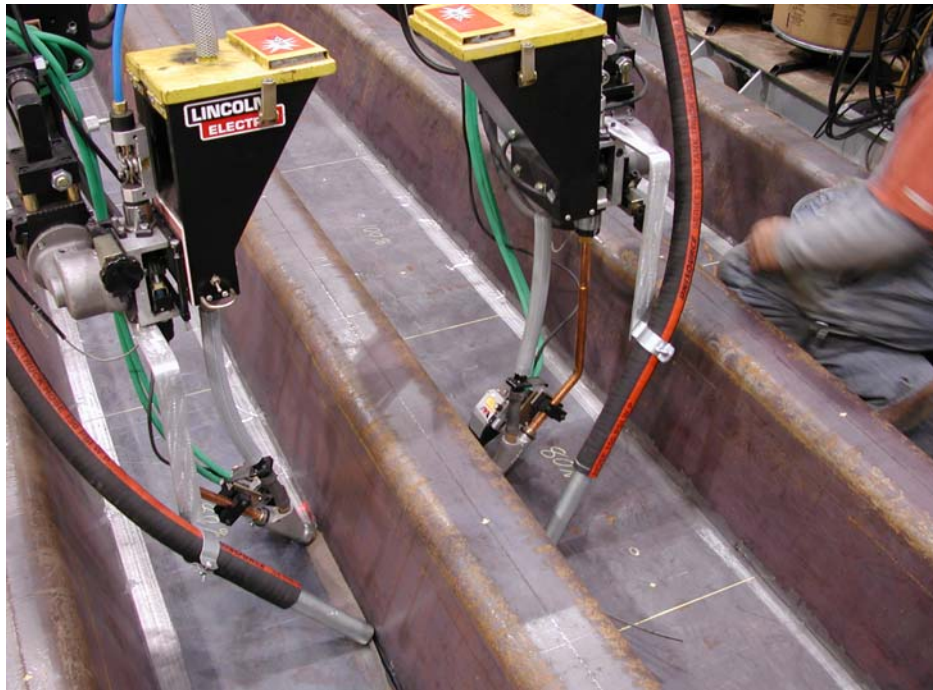
Figure 2.5 Submerged Arc Welding Operation

In order to achieve the desired weld conditions, a continuous 5 m long mock-up was welded with acceptable results. For specimen fabrication, the ribs were fit to the deck plate with a maximum allowable gap of 3 thousandths of an inch, and tack welded to the deck plate with 13 mm tack welds. The tack welds were ground down prior to rib-to-deck plate welding to minimize the tack weld profile. A rib was welded to the deck plate at a time using a Panjaris type gantry Submerged Arc Welding (SAW) with two single electrode heads to weld both sides of a rib simultaneously. The weld reinforcement was minimized to between 2 and 3 mm. Figure 2.5 shows a SAW welding operation used to connect the ribs to the deck plate. An evident view of the weld melt-through backside of the weld is shown in Figure 2.6.

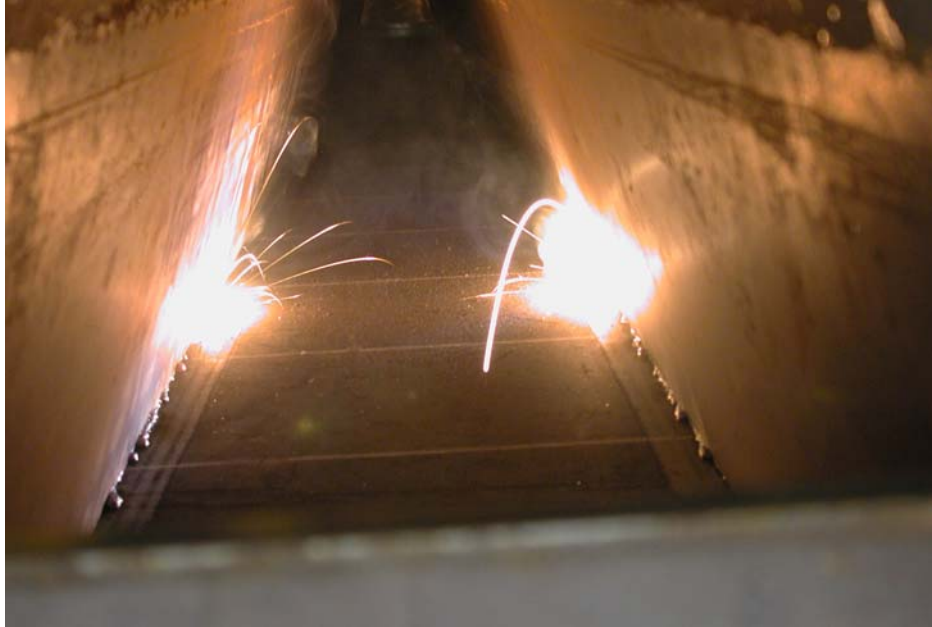
Figure 2.6 View of Weld Melt-through Inside of Rib

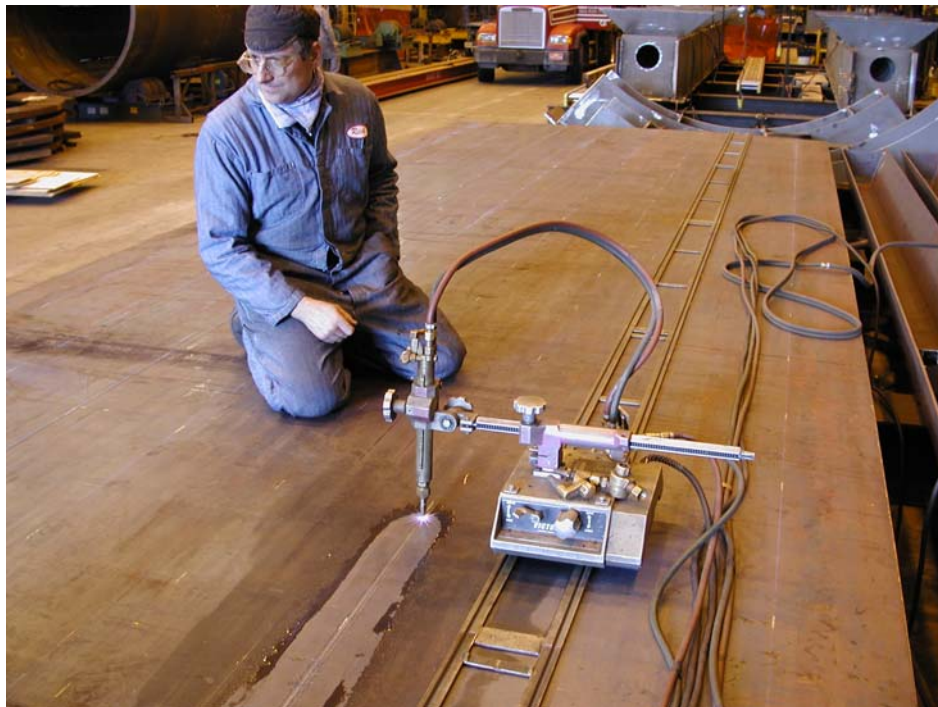
Figure 2.7 Heat Straightening Operation

deck welds to control the distortion in the transverse (i.e., width) direction, and the bottom parts of the ribs were heated to control the distortion in the longitudinal direction. Heat straightened locations for the specimens are shown in Figure 2.8.

For the other three panels (Specimens 4, 5, and 6), the amount of pre-cambering was determined from the welding distortion pattern observed from the other 3 specimens that were not pre-cambered. Depending on the measured distortion level after welding, the pre-cambered panels were also heat straightened to satisfy the plate flatness requirement. Pre-cambering involved placing shim plates at each end of the panel, clamping down the sides, and weighting down the center. A view of pre-cambering is shown in Figure 2.9. Since the first pre-cambered panel (Specimen 6) did not produce a significant difference in as welded distortion compared with the same weld condition panel (Specimen 3), additional shims and heavier weight were used for the next two panels (Specimens 4 and 5) [see Figure 2.10 and Table 2.2]. Support diaphragms were installed until deck plates satisfied the flatness requirement.

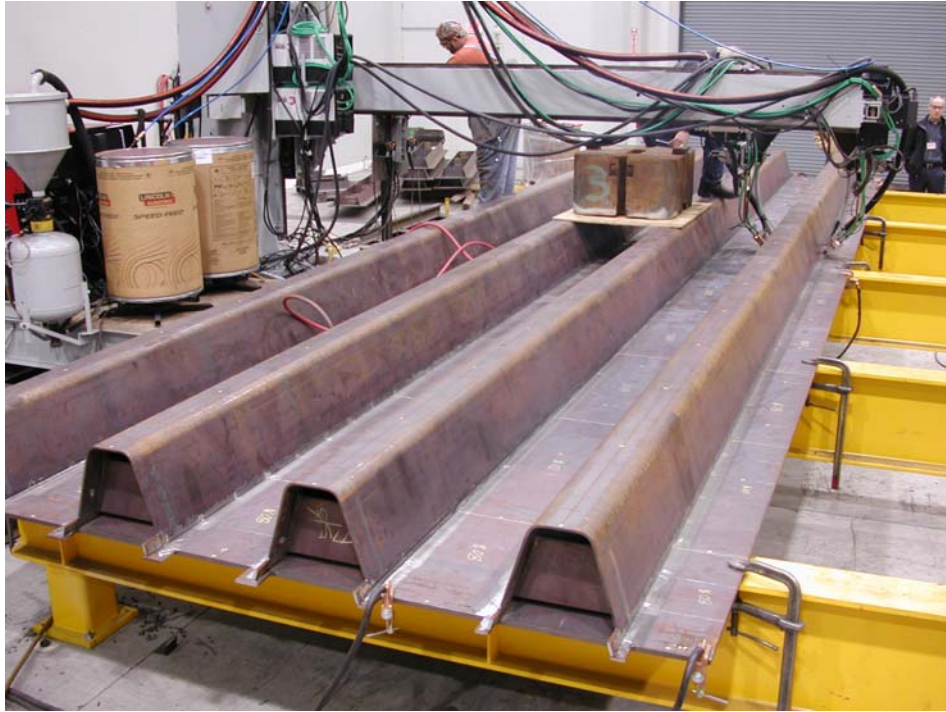
Figure 2.9 Pre-Cambering

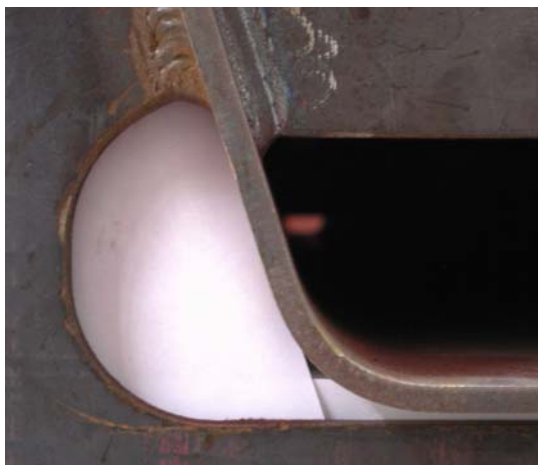
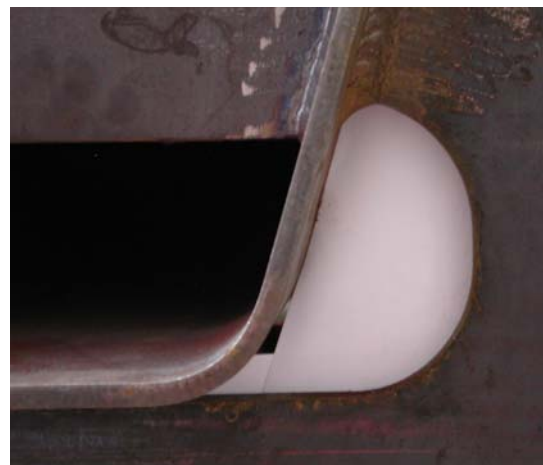
(b) Left Side

(c) Right Side

Figure 2.20 Intersection of Rib with Diaphragms

As explained in Section 1.1, the AASHTO Specification requires at least a distance of 25 mm from the top of the free cutout to the bottom of the bulkhead plate [see dimension d in Figure 2.20(a)]. Figure 2.20(b) and (c) shows the photo views of the corresponding detail of one fabricated specimen (Specimen 1). The specified d in the design drawing was 20 mm, which was slightly less than the required 25 mm (see Figure 2.4). The measured values of d are summarized in Table 2.3. As shown in the table, the measured d values were less than the required 25 mm.

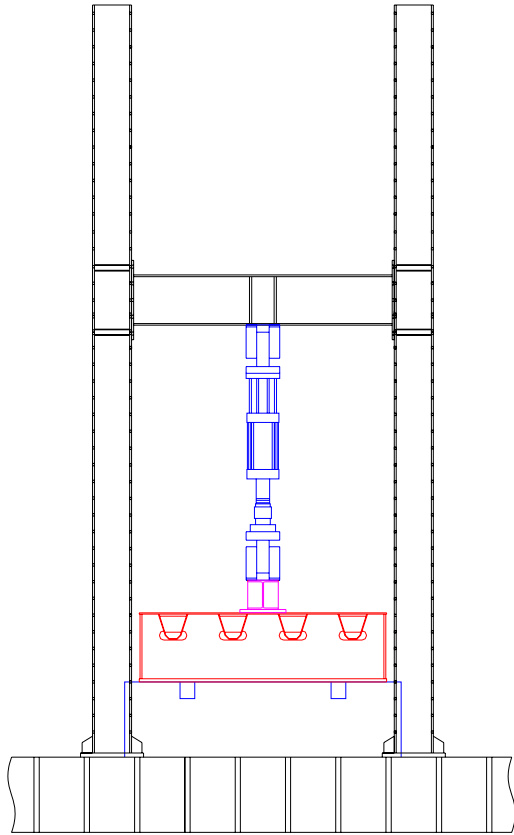
Figure 2.22 End View of Test Setup

specimen was supported by three concrete blocks, 0.9 m high from the floor. In order to accommodate flexible support conditions, a half-circular rod (diameter = 13 mm) was inserted below the base plate of the end supports for testing of Specimens 2 to 6. The specimen was loaded using hydraulic actuators at midspan. The loads from each actuator at midspan were uniformly distributed through a spreader beam to the loading pads simulating 250 mm×510 mm tire contact area of a wheel recommended in the AASHTO LRFD code. A 6.4 mm thick neoprene rubber pad with the same hardness as the tires was placed under the spreader beam to ensure that the load is uniformly distributed over the contact area.

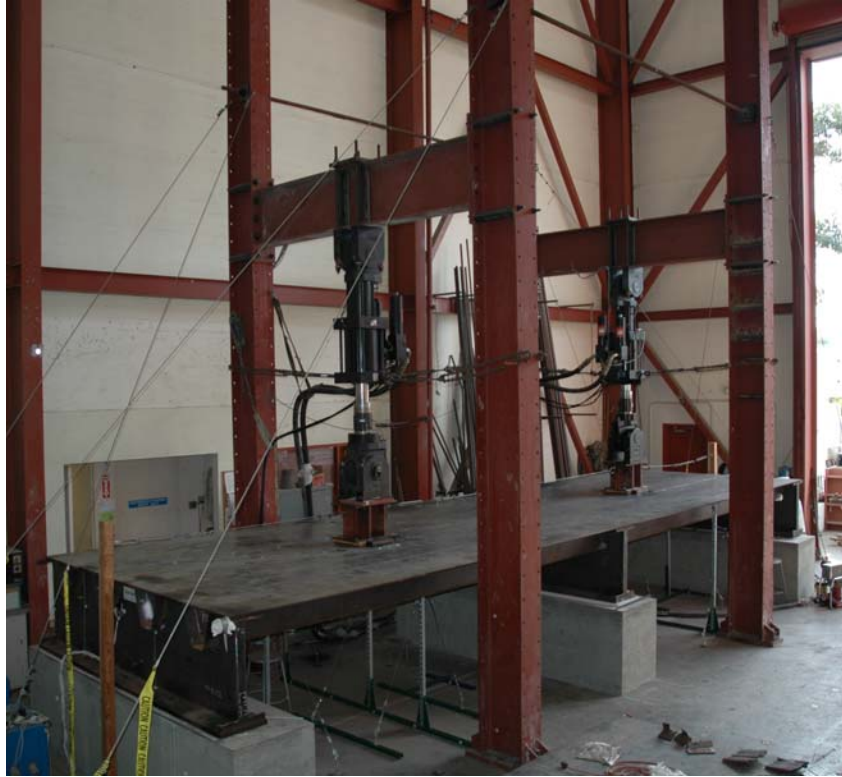
Figure 2.24 East Test Setup (Specimens 2 and 3)

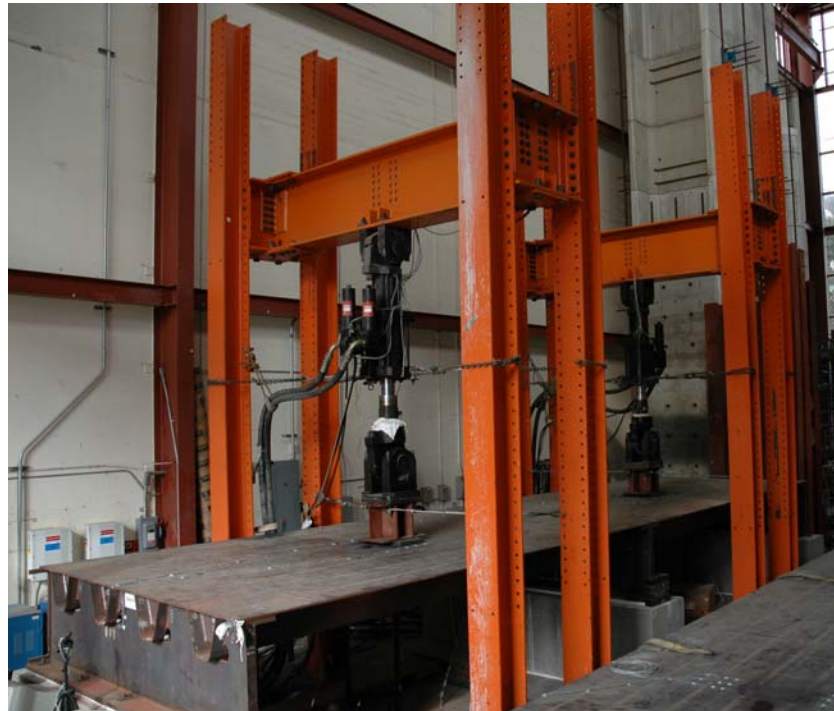
Figure 2.25 West Test Setup (Specimens 1, 4, 5, and 6)

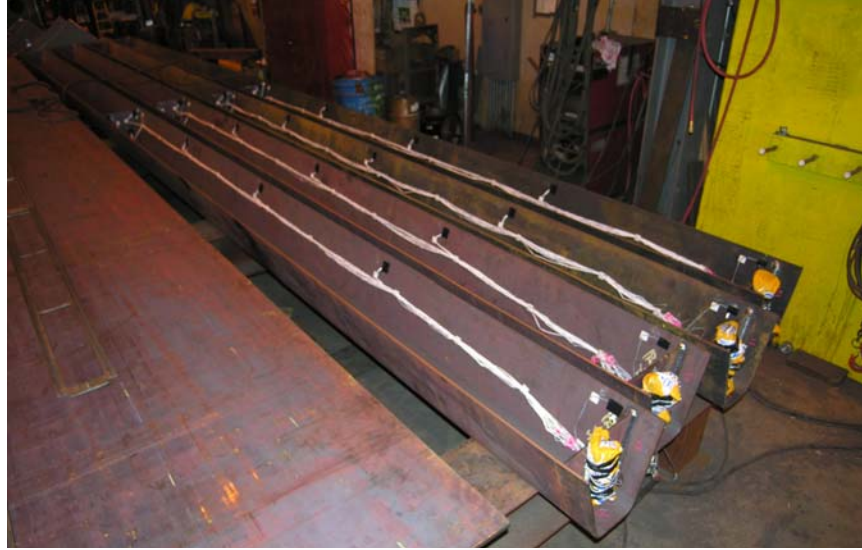
Figure 2.48 Strain Gage Instrumentation Inside of Ribs

Both uni-axial strain gages and strain gage rosettes were installed on the rib walls adjacent to the rib-to-deck welds near the loading locations to measure the local strains. Figures 2.34 to 2.47 show layouts of the gages installed on the rib walls for specimens. Most of the strain gages were installed on the interior two ribs, Ribs R2 and R3. For some locations in Specimens 1, 4, and 5, back-to-back strain gage rosettes were placed on both sides of rib walls. Strain gages on the inner surface of rib walls were installed prior to rib-to-deck welding in order to get access to inside of the closed ribs (see Figure 2.48). These strain gages inside were placed 38 mm away from the bottom of deck plate to avoid excessive heat exposure during welding operation. The outer surface gages on rib walls were positioned between 15 mm and 38 mm away from the bottom of the deck plate. As shown in Figures 2.34 and 2.36, component 1 of strain gage rosettes and uni-axial strain gages were oriented in the transverse direction, perpendicular to the rib-to-deck weld. Component 2 of strain gage rosettes was oriented in the longitudinal direction, parallel to the rib-to-deck weld.

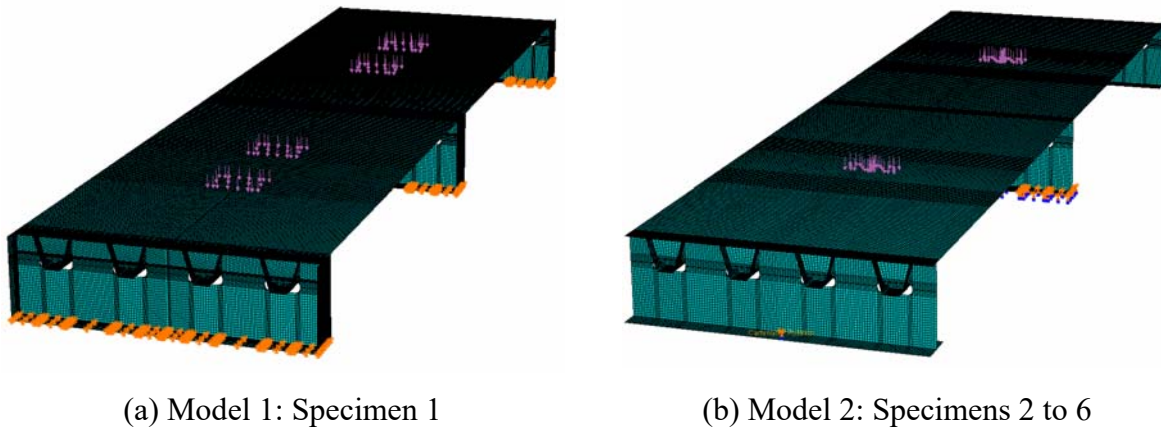
Figure 3.1 ABAQUS Modeling

In order to predict the stress fields prior to testing, finite element models were developed using the structural analysis software ABAQUS (ABAQUS Inc. 2005). Figure 3.1 shows Model 1 for Specimen 1 and Model 2 for Specimens 2 to 6. 3-D shell elements with six degrees of freedom per node were used. For the boundary condition of Model 1, all the nodes at three base plates were restrained for translations. The boundary condition of Model 2 were revised such that the base plate at the middle support diaphragm was restrained for translations, and the base plates at end support diaphragms were allowed to rotate. End stiffener plates at all support diaphragms were removed for Model 2. For the loading condition of Model 1, a pair of wheel axle loads of 190 kN (380 kN total) spaced 1200 mm apart are centered at midspan. The loading condition for Model 2 was revised such that a single wheel axle load of 188 kN are centered at midspan. The loads are uniformly distributed over the contact area through the 250 mm × 510 mm wheel prints,.

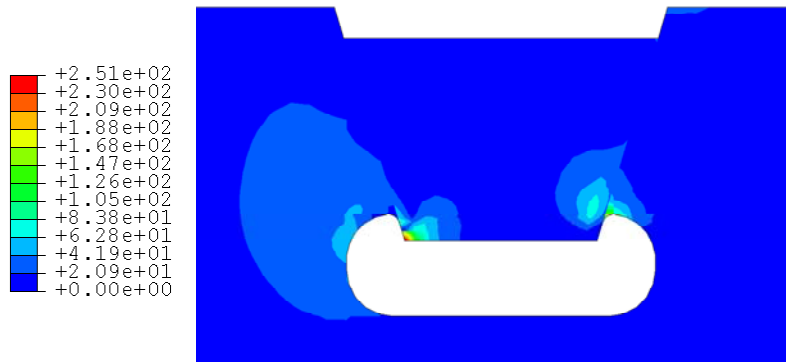
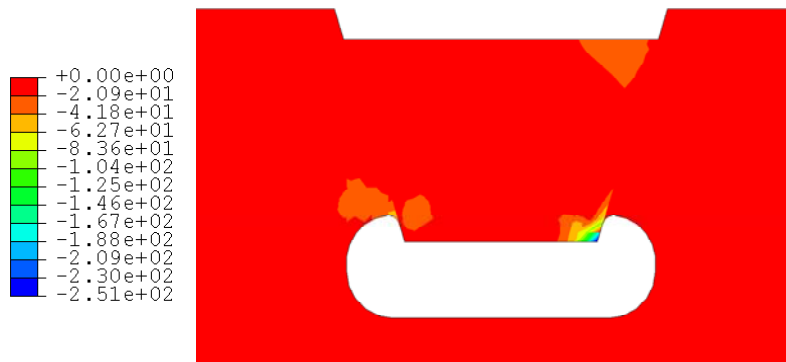
(a) Maximum Principal Stress on South Side (in Tension)

(c) Minimum Principal Stress on South Side (in Compression)

Figure 3.15 Model 1: Principal Stress Contour or Tensor at Detail A (MPa)

Figure 3.15 shows the principal stress contour on both sides (south and north sides) of the bulkhead and diaphragm plate at Detail A on the end diaphragms (see Figure 3.12 for a compass direction and the location of Detail A). As shown from the principal stress contour, the bottom corner of the bulkhead and the diaphragm cutout at rib-to-diaphragm connection are critical. The contour of the maximum principal stress in tension and the minimum principal stress in compression on both sides of the bulkhead and the diaphragm plate are shown in Figure 3.15(a) to (d). The principal stress directions are also shown in Figure 3.15(e) to (h). At a bulkhead location of about 25 mm away from the corners of the bottom and the side of the bulkhead, the predicted maximum principal stress is 60 MPa in tension on the south-west side of Detail A and 49 MPa on the north-west side. The minimum principal stress on the bulkhead is 49 MPa in compression on the south-east side and 61 MPa on the north-east side. At a diaphragm location of about 25 mm away from the top of the free diaphragm cutout and 38 mm apart from the side corner of the bulkhead, the predicted maximum principal stress is 37 MPa in tension on the south-west side and 36 MPa on the north-east side. The minimum principal stress on the diaphragm at the same location is 24 MPa in compression on the south-west side and 61 MPa on the north-east side.

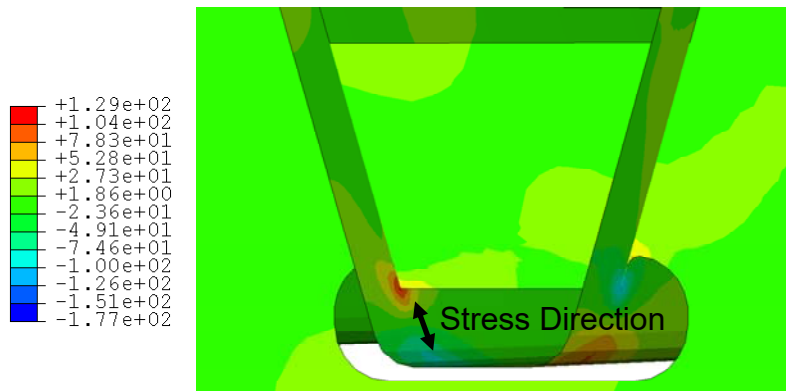
(c) Stress in the Transverse Direction

Detail B which corresponds to Detail A in Model 1, is shown in Figure 3.22. Figures 3.23 and 3.24 show the predicted stress contours on the rib at the end support diaphragm for Model 2. It is shown that the stress field and the critical region are similar to those of Model 1, but the magnitude of stresses is much lower than that in Model 1. The contours of the maximum principal stress in tension and the minimum principal stress in compression for the interior side of the rib below the bulkhead are shown in Figure 3.23(a) and (b), and for the interior side of the rib near the diaphragm cutout are shown in Figure 3.24(a) and (b). At the same location as in Model 1, about 13 mm below the bottom corner of the bulkhead on the west side of the rib, the predicted tensile stress in the transverse direction is approximately 61 MPa (166 MPa in Model 1) and the compressive stress is 75 MPa (189 MPa in Model 1). On the east side of the rib at the same location, the predicted compressive stress on the rib is approximately 56 MPa (151 MPa in Model 1) and the tensile stress is 77 MPa (197 MPa in Model 1). The significantly reduced magnitude of stresses in Model 2 is mainly due to the reduced load level.

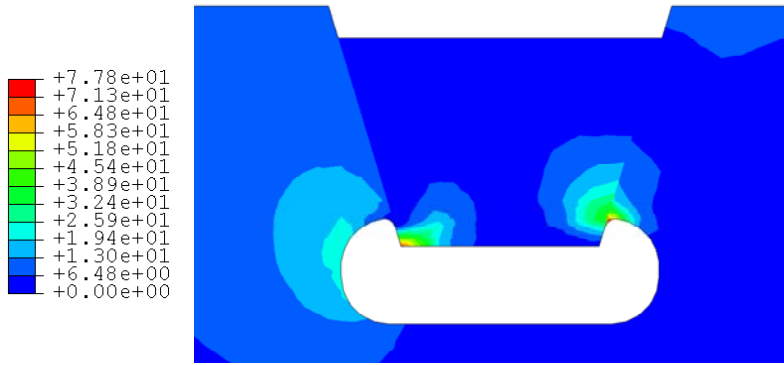
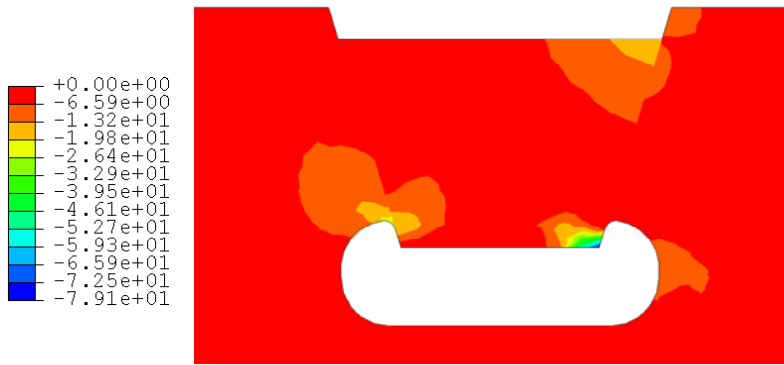
(a) Maximum Principal Stress on South Side (in Tension)

(c) Minimum Principal Stress on South Side (in Compression)

Figure 3.25 Model 2: Principal Stress Contour or Tensor at Detail B (MPa)

Figure 3.25 shows the principal stress contours on both sides (south and north sides) of the bulkhead and diaphragm plate at Detail B (see Figure 3.22). The stress field and the critical region are also similar those of Model 1, but the magnitude of stresses is much lower than that in Model 1. The contours of the maximum principal stress in tension and the minimum principal stress in compression on both sides of the bulkhead and the diaphragm plate are shown in Figure 3.25(a) to (d). The principal stress direction is also shown in Figure 3.25(e) to (h). At the same bulkhead location as in Model 1, about 25 mm away from the corners of the bottom and the side of the bulkhead, the predicted maximum principal stress is 18 MPa (60 MPa in Model 1) in tension on the south-west side and 17 MPa (49 MPa in Model 1) on the north-west side. The minimum principal stress on the bulkhead is 16 MPa (49 MPa in Model 1) in compression on the south-east side and 18 MPa (61 MPa in Model 1) on the north-east side. At the same diaphragm location in Model 1, about 25 mm away from the top of the free diaphragm cutout and 38 mm away from the side corner of the bulkhead, the predicted maximum principal stress is 18 MPa (37 MPa in Model 1) in tension on the south-west side and 18 MPa (36 MPa in Model 1) on the north-east side. The minimum principal stress on the diaphragm at the same location is 12 MPa (24 MPa in Model 1) in compression on the south-west side and 28 MPa (61 MPa in Model 1) on the north-east side.

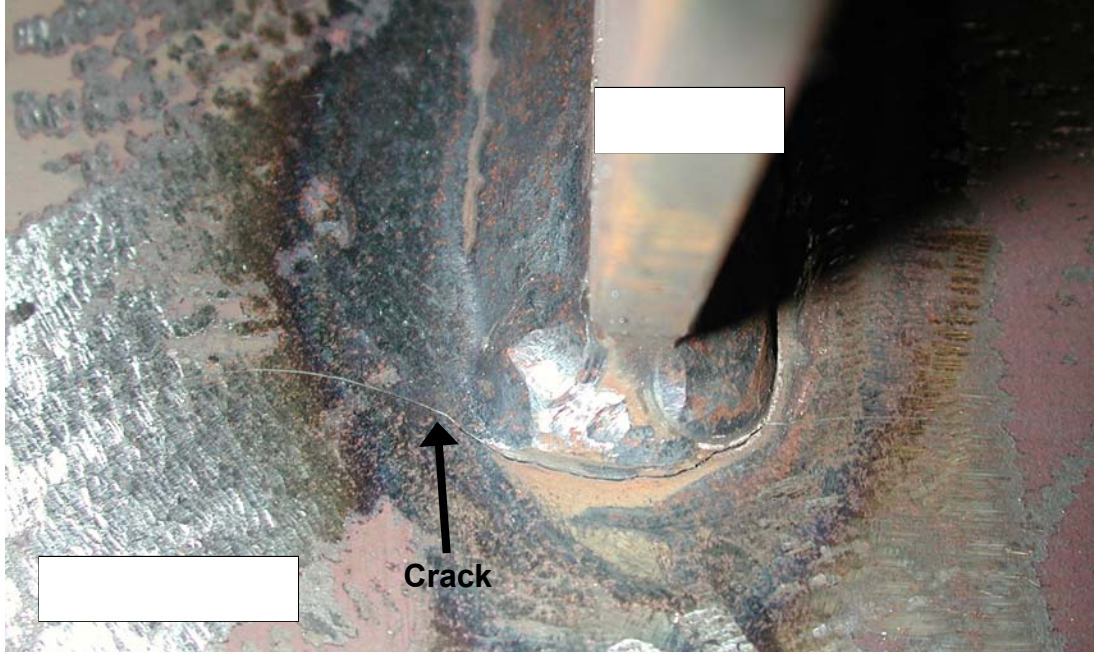
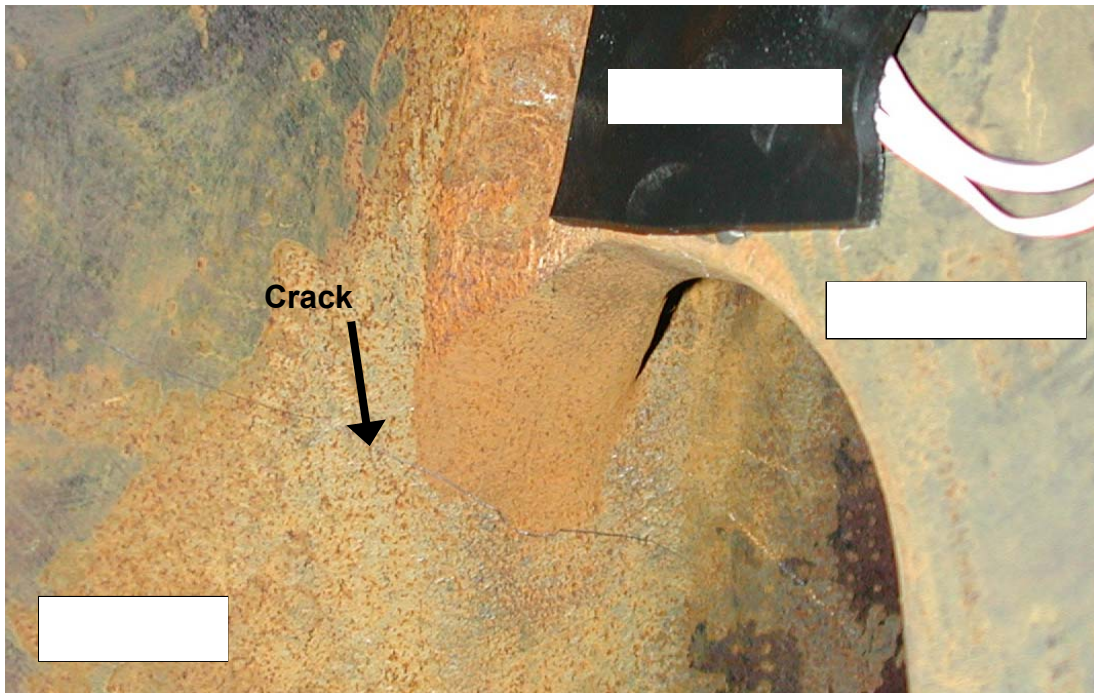
Figure 4.4 Specimen 1: Crack Pattern on the Rib below bulkhead and diaphragm cutout

Large fatigue cracks were observed at 6 locations at end supports. Figure 4.4 shows typical crack patterns on the rib below the bulkhead, as viewed from inside of the rib, and the diaphragm cutout, as viewed from outside of the rib. These fatigue cracks were produced by out-of-plane distortion due to torsion in the ribs at the end diaphragms.

(a) View from Inside of Rib

(b) View from Outside of Rib

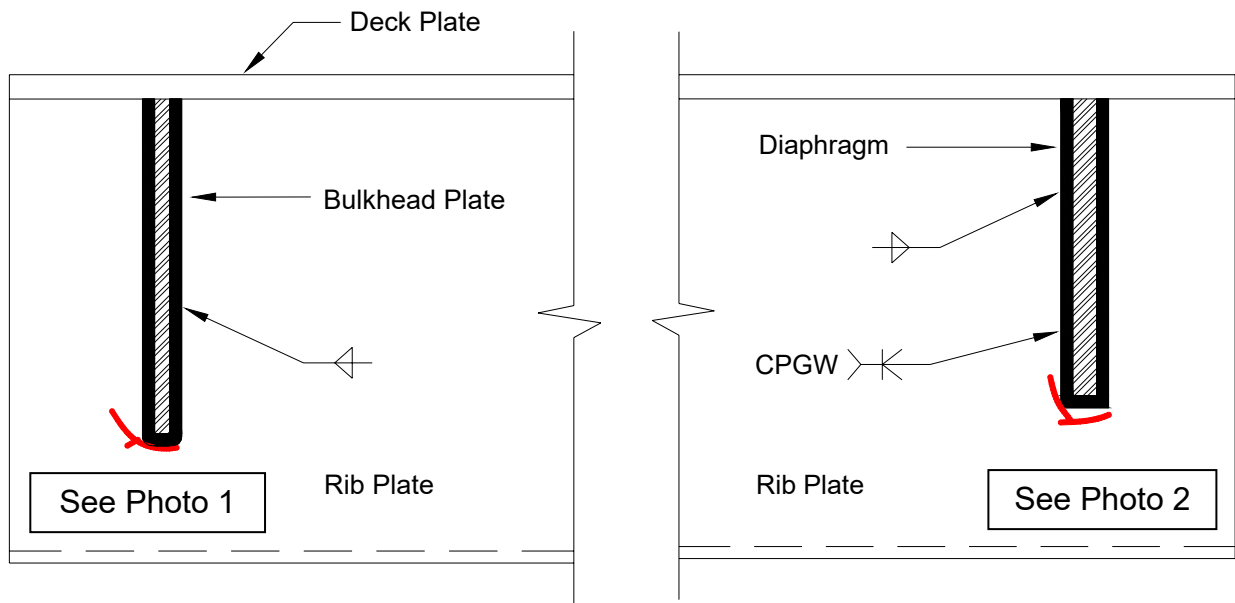
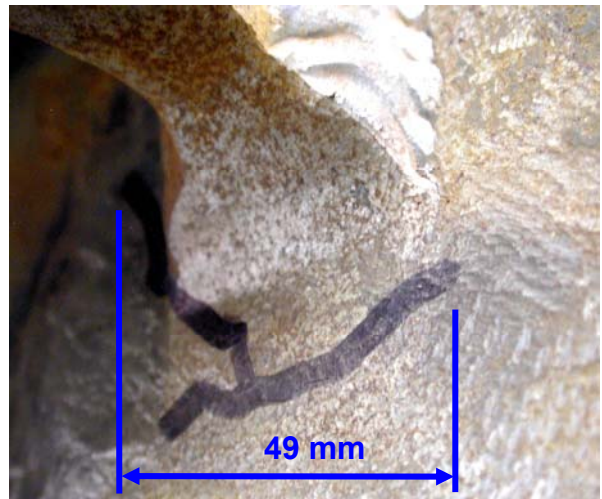
Figure 4.5 Specimen 1: Fatigue Crack at D1-R2-East

Magnetic particle test was conducted to inspect the distortion-induced fatigue cracks at the end supports; the mapped cracks and photo views are shown in Figures 4.5 to 4.10. The horizontal length of the cracks measured varies from 25 mm to 106 mm. As verified by cutting the cross section through the cracks in Specimen 2, it shows a tendency that the cracks first initiated at the lower end of bulkhead-to-rib fillet weld. The cracks that initiated at the weld toe then propagated through the rib wall and tended to interconnect with another crack initiated from a location near the end of CJP weld on the outside of the rib (see Figure 5.30 for the cross section of the crack). Considering the large size of the cracks observed at 1 million cycles and the variation of the measured strains near the cracks, the cracks might have initiated much earlier than 1 million cycles.

(a) Inner Surface of Rib

(b) Outer Surface of Rib

(c) Photo 1

(d) Photo 2

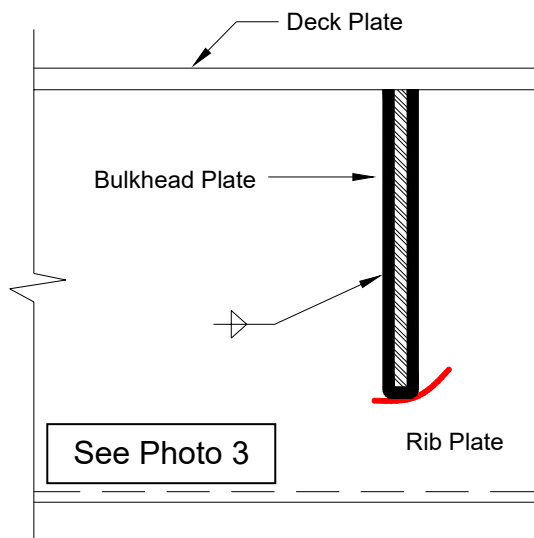
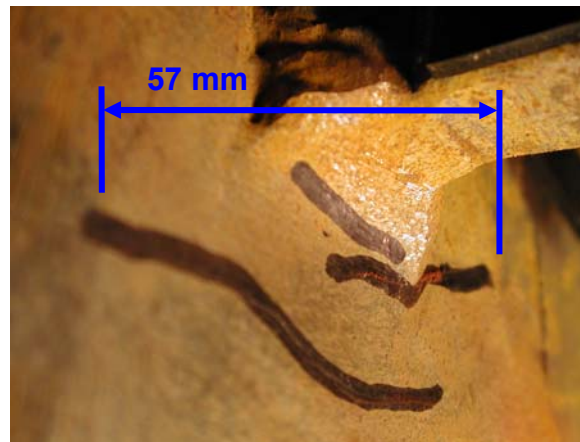
Figure 4.6 Specimen 1: Fatigue Crack at D1-R2-West

(a) Inner Surface of Rib

(c) Photo 3

(d) Photo 4

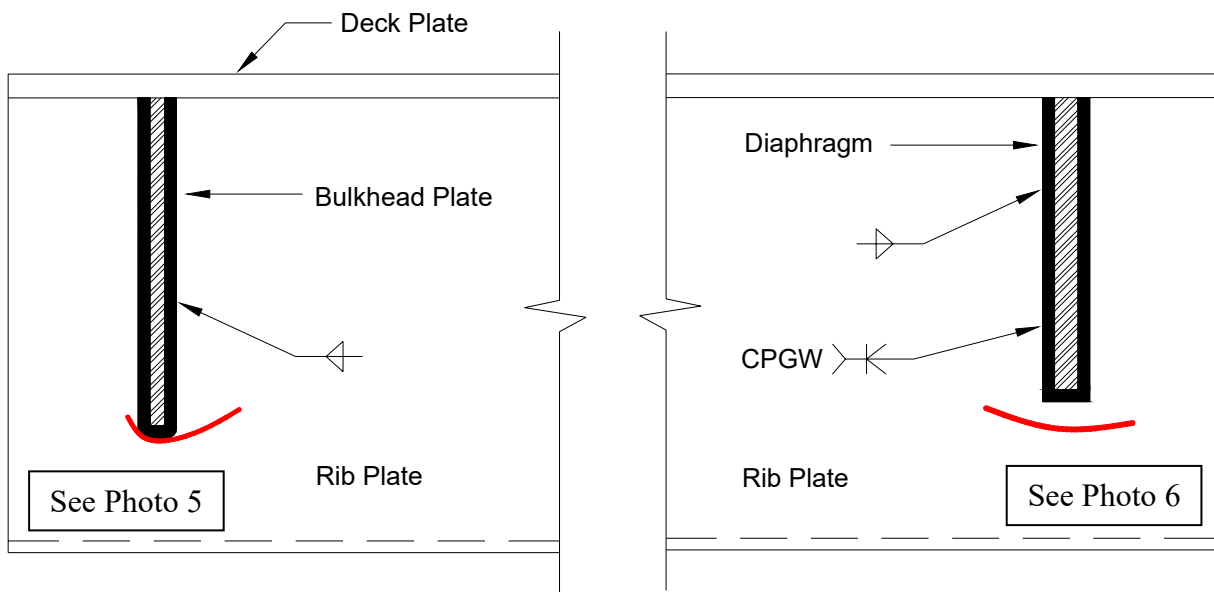
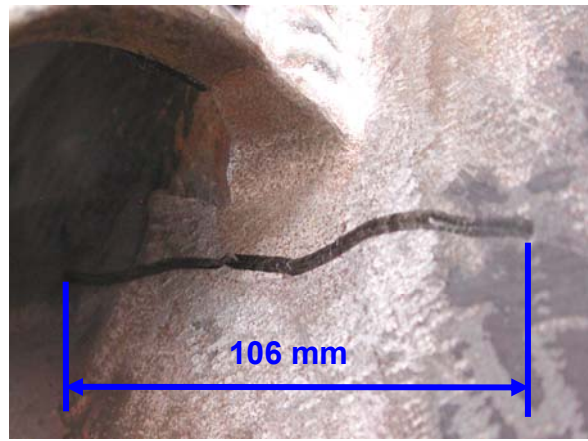
Figure 4.7 Specimen 1: Fatigue Crack at D1-R3-East

(a) Inner Surface of Rib

(b) Outer Surface of Rib

(c) Photo 5

(d) Photo 6

For the strain gage rosette r3 placed on the bottom corner of the bulkhead inside of the rib R3, the maximum stress range was 27.8 MPa (mean stress = 14.4 MPa) at 0.1 million cycle mark. But Figure 4.13 shows a significant variation of the stresses during the latter cycles. This variation of the stresses at the bulkhead was due to stress redistribution caused by a crack initiated from the rib-to-bulkhead weld toe below the bulkhead and propagated into the rib wall (see Figure 4.7 for the crack near strain gage rosette r3).

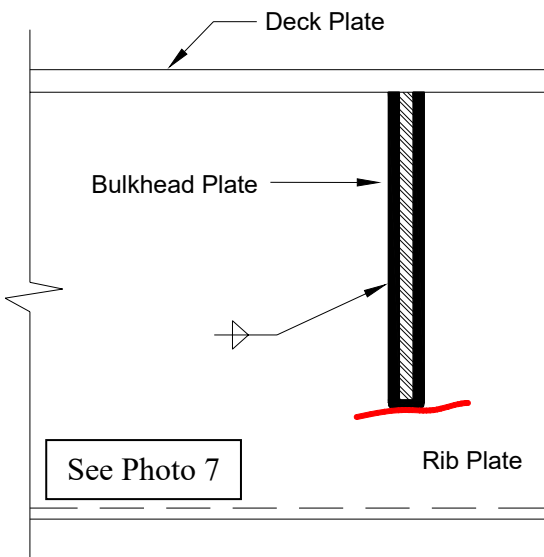
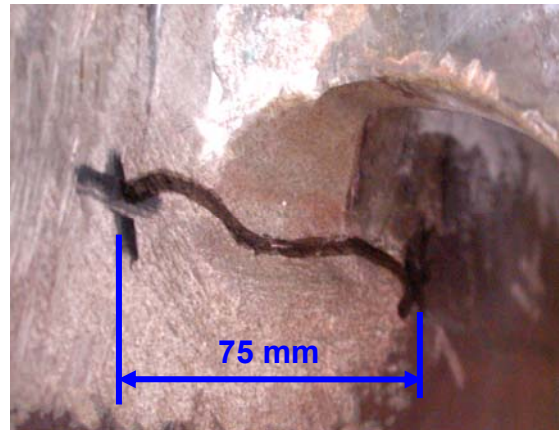
Figure 4.8 Specimen 1: Fatigue Crack at D1-R3-West

(a) Inner Surface of Rib

(c) Photo 7

(d) Photo 8

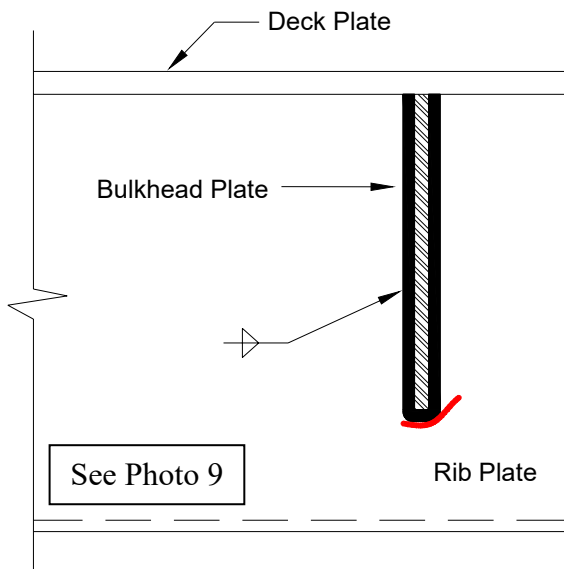
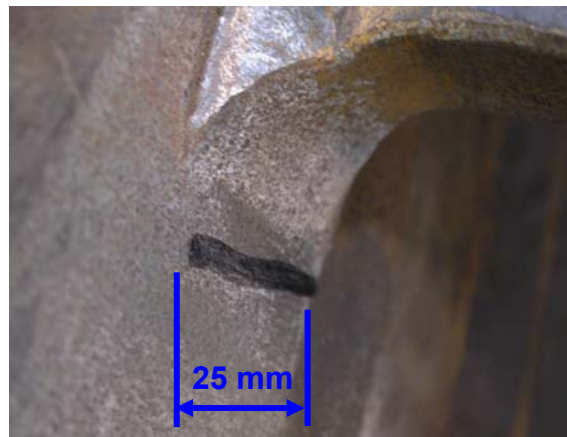
Figure 4.9 Specimen 1: Fatigue Crack at D3-R2-East

(a) Inner Surface of Rib

(c) Photo 9

(d) Photo 10

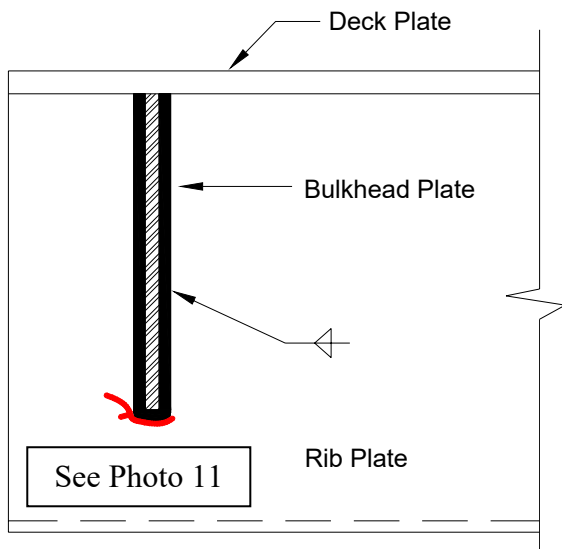
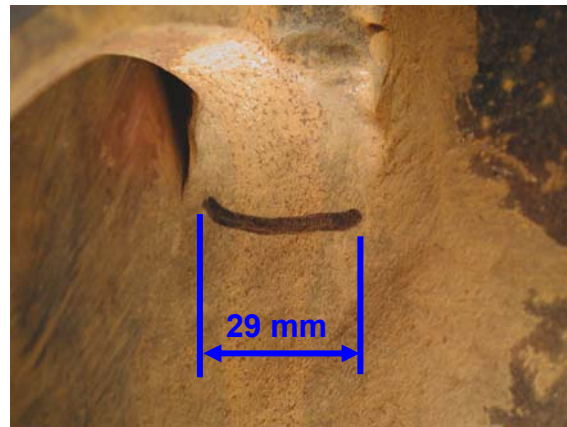
Figure 4.10 Specimen 1: Fatigue Crack at D3-R3-West

(a) Inner Surface of Rib

(c) Photo 11

(d) Photo 12

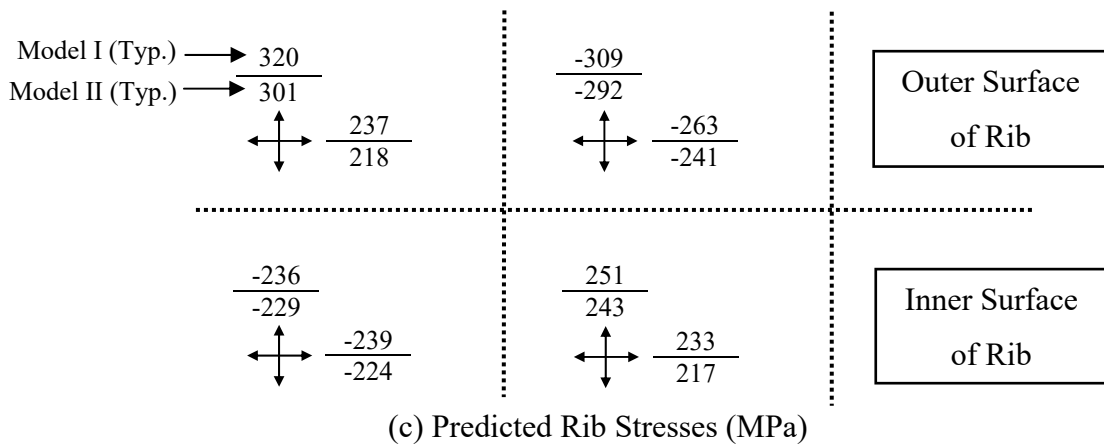
Figure 4.16 Model Configuration and Predicted Rib Stresses at Cutout Location (MPa)

Since fatigue cracking occurred very early due to high level of loading and the restraining boundary condition, the magnitude of loading was reduced by 50% (i.e., 188 kN) to reflect a half axle of HS-15 truck that the width of specimen can accommodate. The tandem axle configuration with dual pads was also modified to a single axle to be consistent with the truck configuration specified in the AASHTO Specification. Another modification made was the boundary condition at the support diaphragms. In order to create a more flexible boundary condition at the supports, a half-circular rod (diameter = 13 mm) was inserted between the base plate of the end diaphragm and the concrete support block to accommodate a free rotation of the support. The end stiffener plates were also removed from all diaphragms. Figure 4.17 shows the modifications made to the support boundary conditions for testing of each of the remaining specimens. The finite element analysis results verified that the stresses at end diaphragms were significantly reduced with the modification of the loading scheme. The stresses were reduced by approximately 10% with the modified boundary conditions (see Figure 4.16).

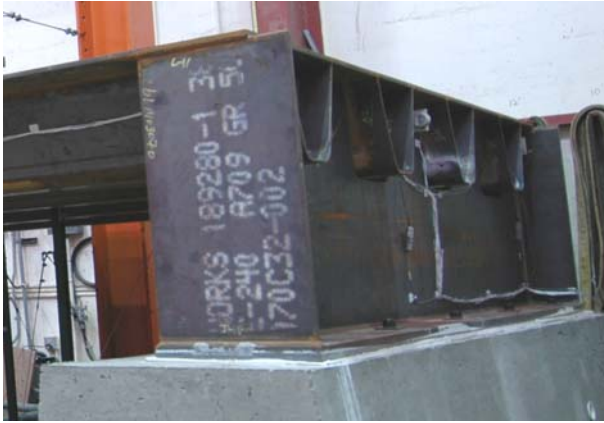
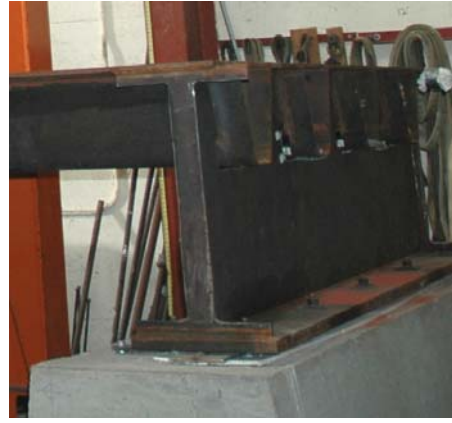
before Modification

after Modification

(a) Removal of End Stiffener Plates

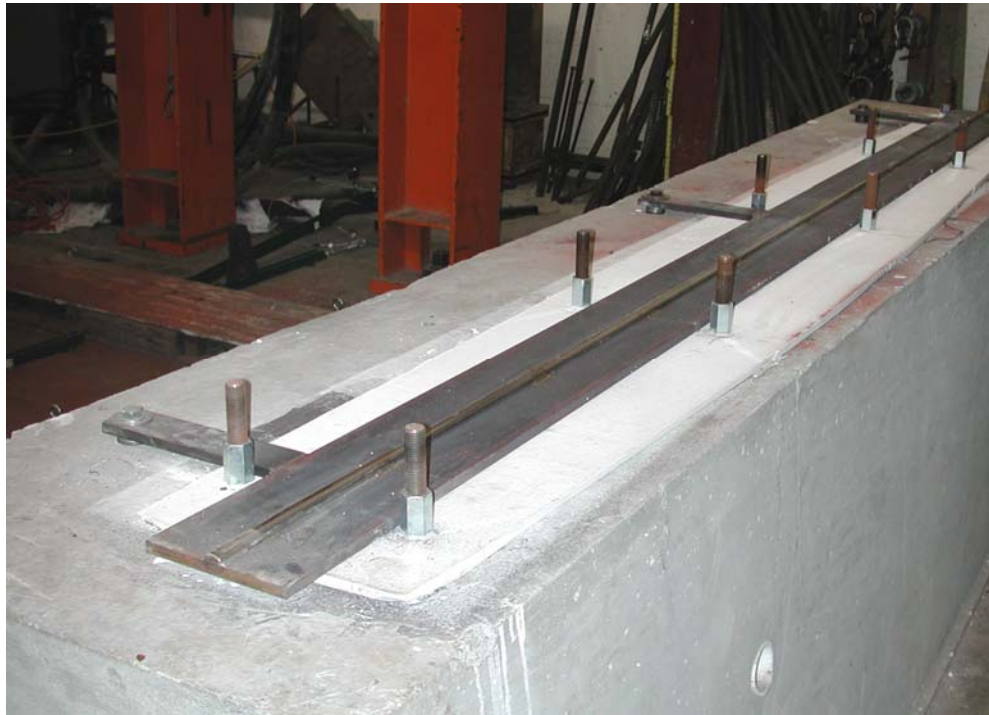
Figure 4.17 Boundary Condition Modifications

(b) A Half-Circular Rod beneath Base Plate

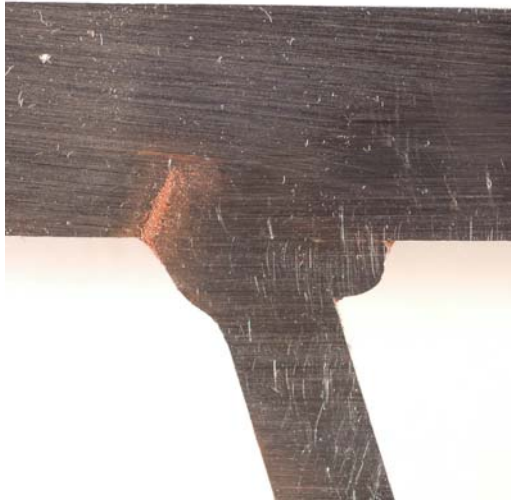
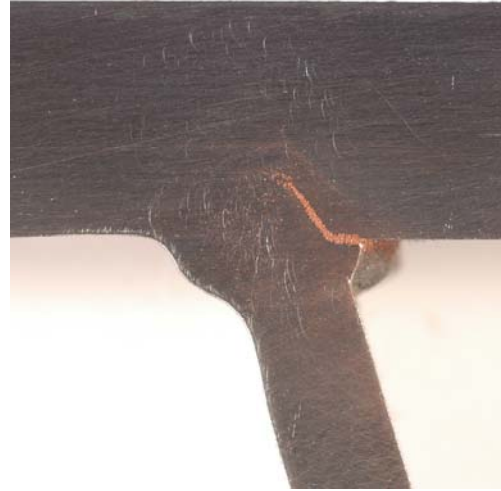
Figure 5.18 Typical Crack Pattern at Rib-to-Deck PJP Welds

(a) Crack from Weld Toe

(b) Crack from Weld Root
