Effects of Fabrication Procedures and Weld Melt-Through on Fatigue Resistance of Orthotropic Steel Deck Welds

Final Report

Report No. CA08-0607

December 2008

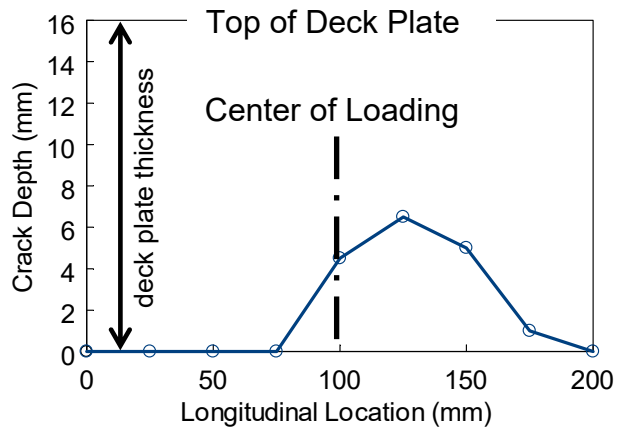
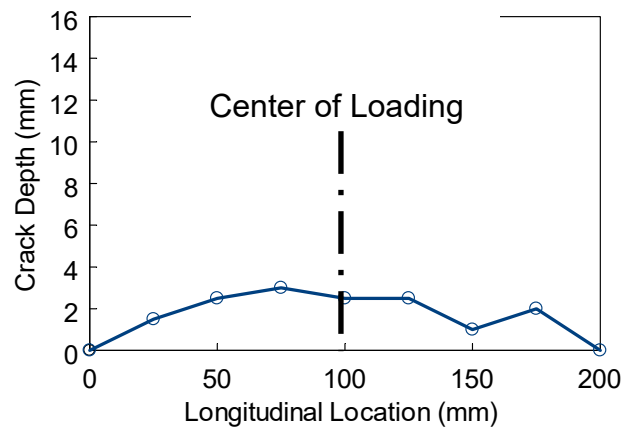
Figure 5.19 Specimen 2: Depth of Crack Initiating from Rib-to-Deck PJP Welds

Cracks from the weld toe on the bottom of the deck plate were identified in Specimen 2 at three locations (C1, C2, and C3). Figure 5.19 shows the crack depth at location C2 and C3, measured vertically from the bottom side of the deck plate. A cross section through the crack in C1 of Specimen 2 was cut, and it verified the linear crack indication as shown in Figure 5.20. One crack was identified at the location of C1 in Specimen 3, and the plot of the crack depth is shown in Figure 5.21. Cracks were identified at three locations (C1, C2, and C3) in Specimen 6, among which the cracks initiated from the weld toe at C1 and C2 and the crack initiated from the weld root at C3. The plots of the crack depth at these locations are shown in Figure 5.22.

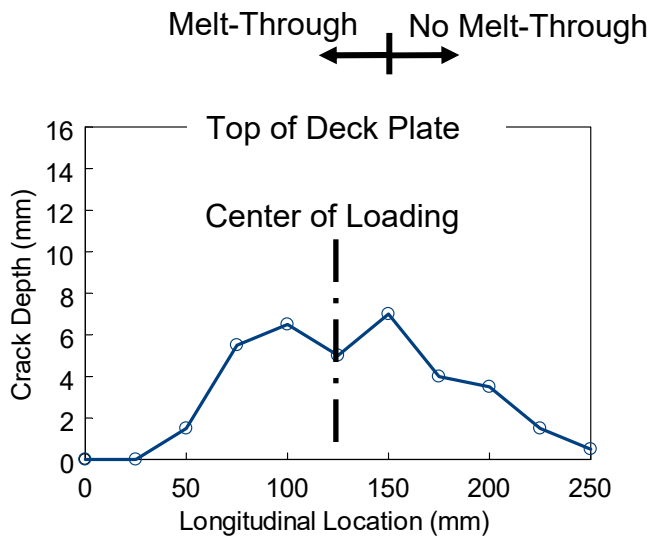
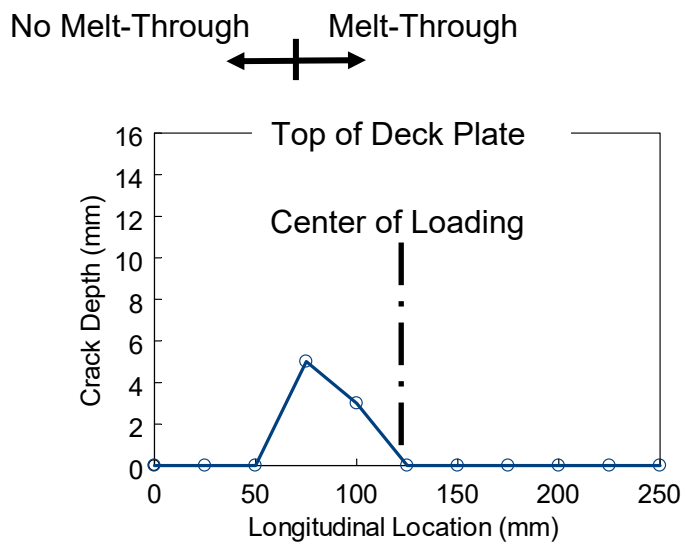
Figure 5.22 Specimen 6: Crack Depth at Rib-to-Deck PJP Welds

(a) Location C1

(b) Location C2

(c) Location C3

Of the seven cracks listed in Table 5.14, six cracks were initiated from outside of the rib at weld toe. Only one location (C3) in Specimen 6 had a crack that initiated from inside the rib at the weld root. The crack length was the shortest among all seven identified cracks, but the crack initiated from the transition from 80% PJP to 100% PJP welds (see Figure 5.22). No such crack was identified in another specimen (Specimen 3) with similar weld condition. Nor were Specimens 2 and 5 that had continuous weld melt-through. Since no other specimens showed weld root cracking, this limited database would suggest that discontinuous weld melt-through is not desirable.

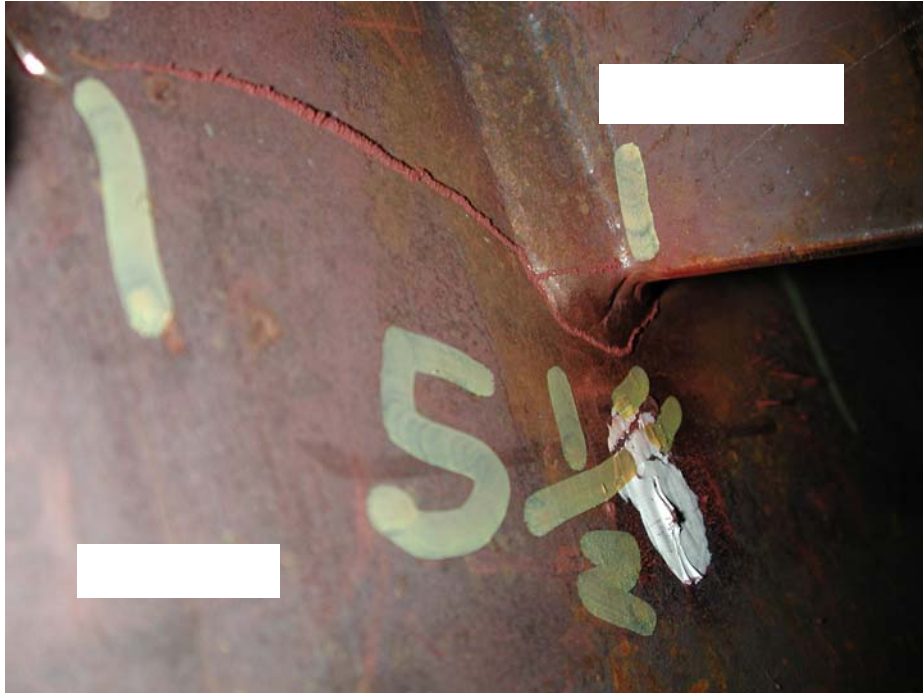
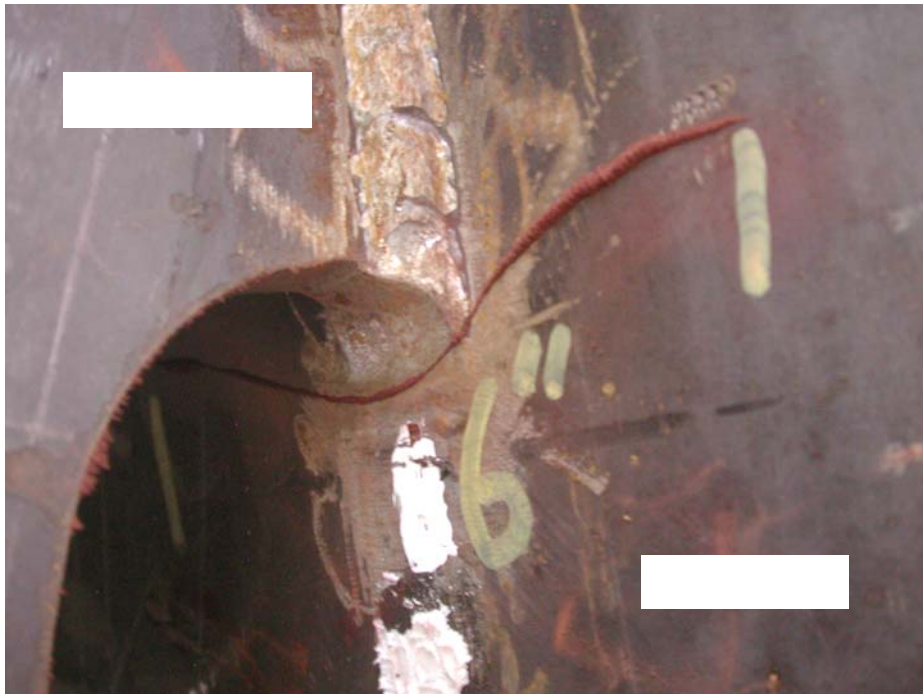
Figure 5.29 Specimen 5: Observed Crack Pattern at End Supports (at 8 M cycles)

Figure 5.29 shows an observed crack pattern on the rib walls below the bulkhead and the diaphragm cutout at the end supports. A cross section through the crack is shown in Figure 5.30. Most of the cracks on the rib walls initiated at the weld toe below the bulkhead in tension cycles. Cracks that initiated at the weld toe below the bulkhead in compression cycles did not propagate as quickly as those initiated in tension cycles. Table 5.13 summarizes the length of the rib wall cracks, measured horizontally in the longitudinal direction at each million cycles. No cracks were identified at the interior support.

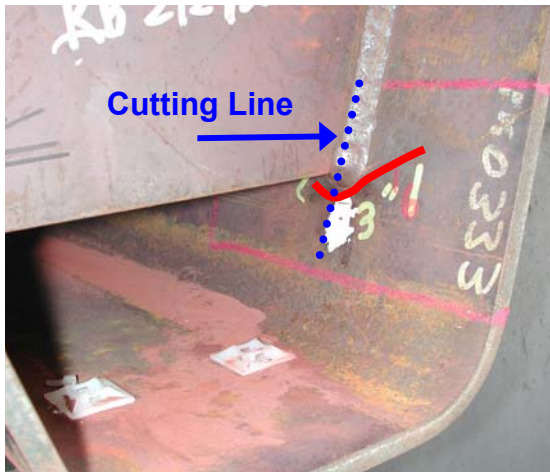
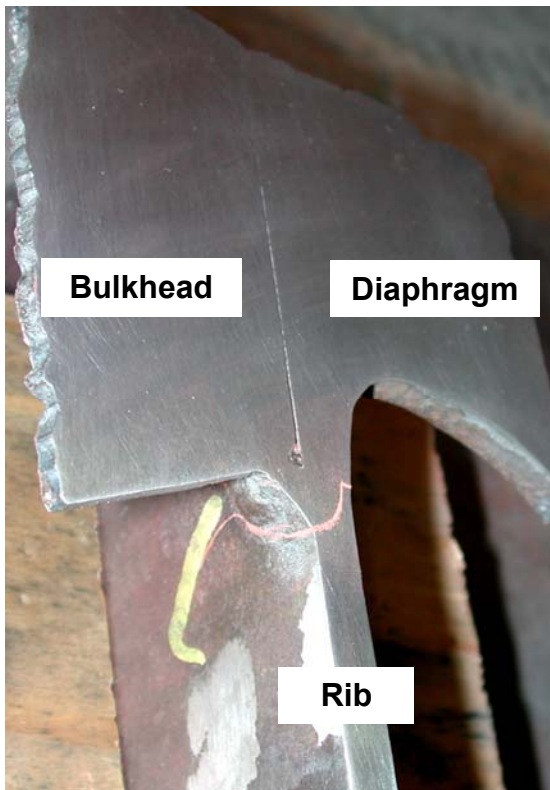
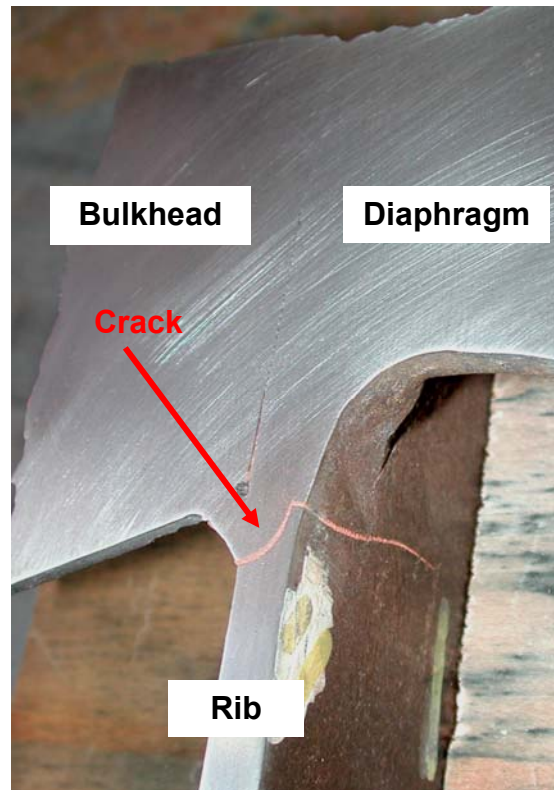
Figure 5.30 Cross Section through the Crack at End Support

(a) View from Inside of rib wall

(b) View from Outside of rib wall

(c) Cross Section

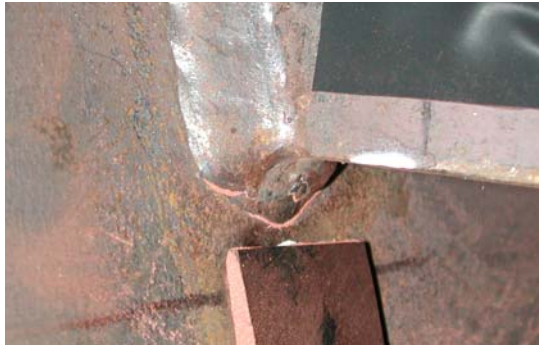
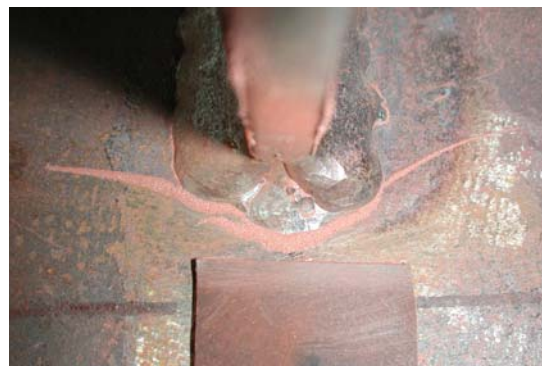
Figure 5.31 Specimen 4: Cracks at Rib-to-Bulkhead Welded Joint (D1-R2-East)

(a) 1 million cycles

(g) 6 million cycles

(h) 6 million cycles (different view)

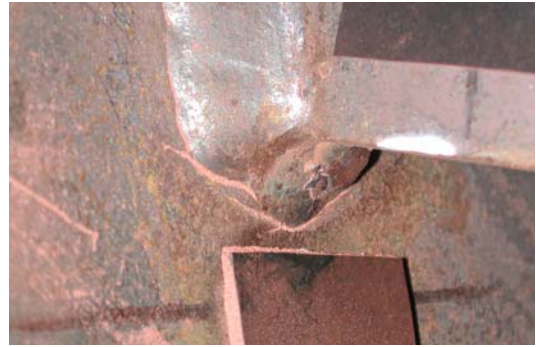
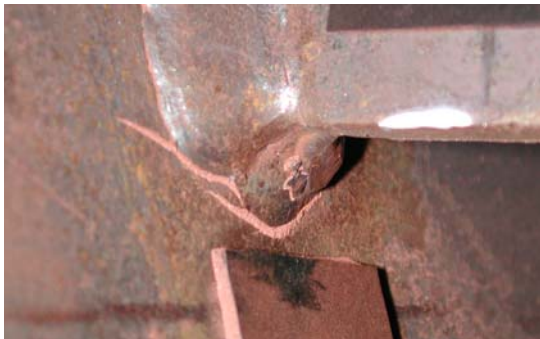
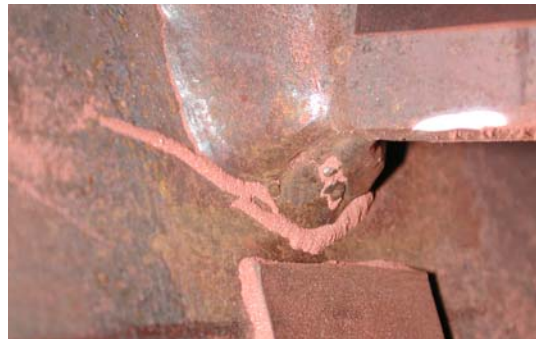
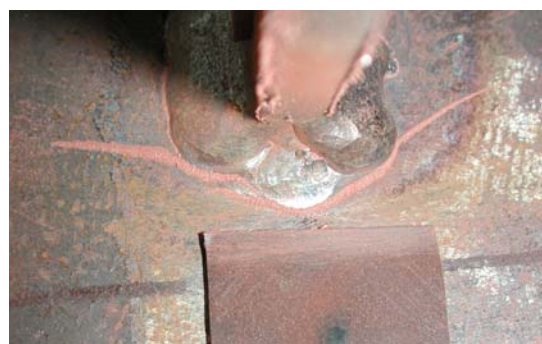
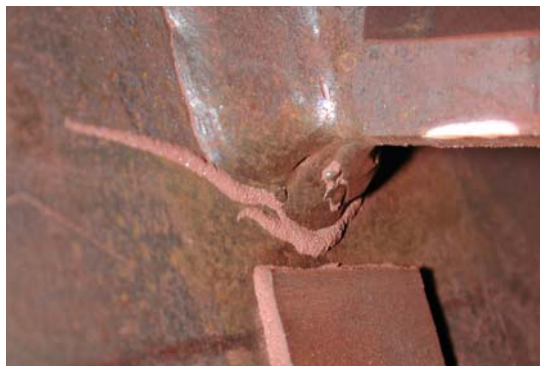
(b) 2 million cycles

(c) 3 million cycles

(d) 4 million cycles

(f) 5 million cycles (different view)
