1. REPORT NUMBER CA10-1095	2. GOVERNMENT ASSOCIATION NUMBER	3. RECIPIENT'S CATALOG NUMBER	
4. TITLE AND SUBTITLE Effects of Four-Lane Highways on Desert Kit Fox and Swift Fox: Inferences for the San Joaquin Kit Fox Population		5. REPORT DATE April 30, 2010	6. PERFORMING ORGANIZATION CODE

**Effects of Four-Lane Highways on Desert Kit Fox and Swift Fox:
Inferences for the San Joaquin Kit Fox Population**

**State of California, Department of Transportation
Division of Research and Innovation, Office of Materials and Infrastructure Research**

Prepared by
Anthony P. Clevenger¹
Angela V. Kociolek¹
Brian L. Cypher²

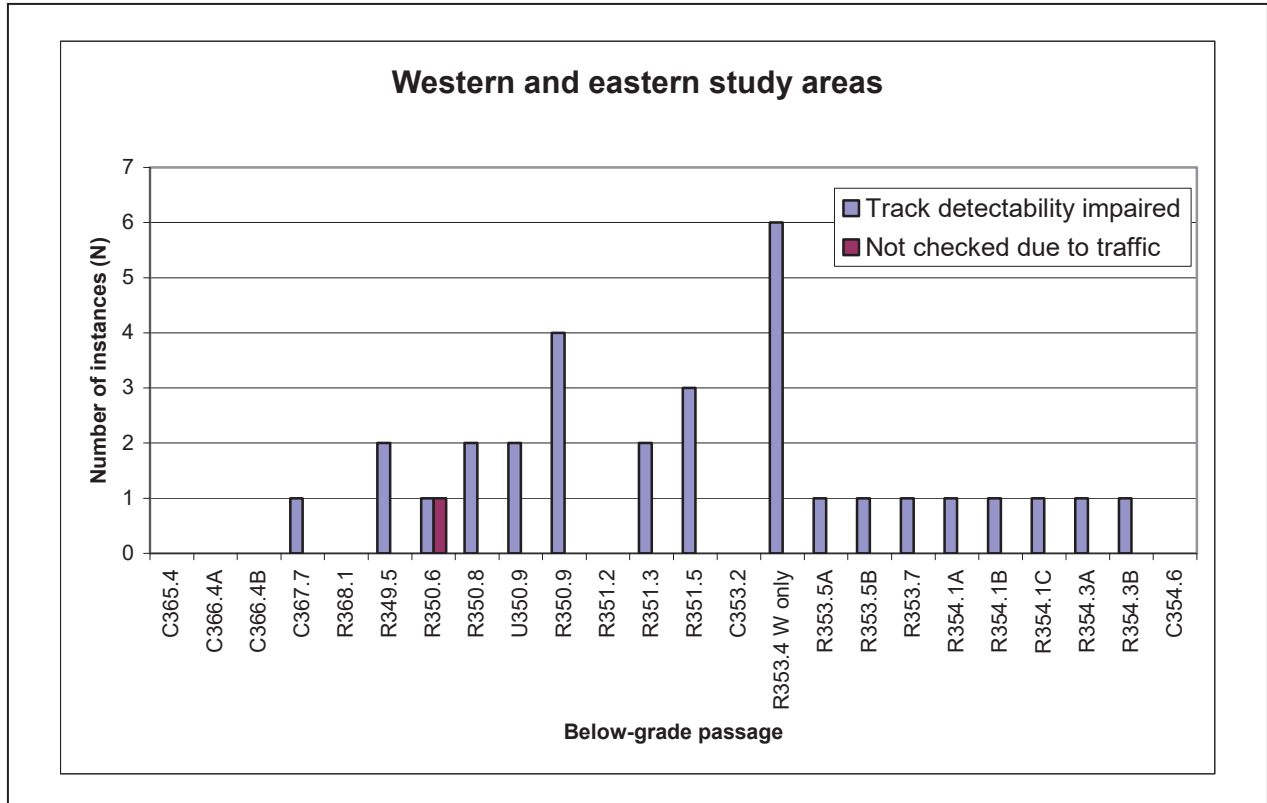
Figure 9. Number of instances when track bed condition precluded track detectability. There was an instance where a culvert was not monitored because of an unsafe traffic situation.

On some monitoring days, standing water, snow drifts, snow-packed entrances, or frozen track beds precluded the ability to detect tracks in some below-grade passages (Figure 9). The two culverts in which complete swift fox crossings were detected (R368.1 and R351.2) did not have these issues.

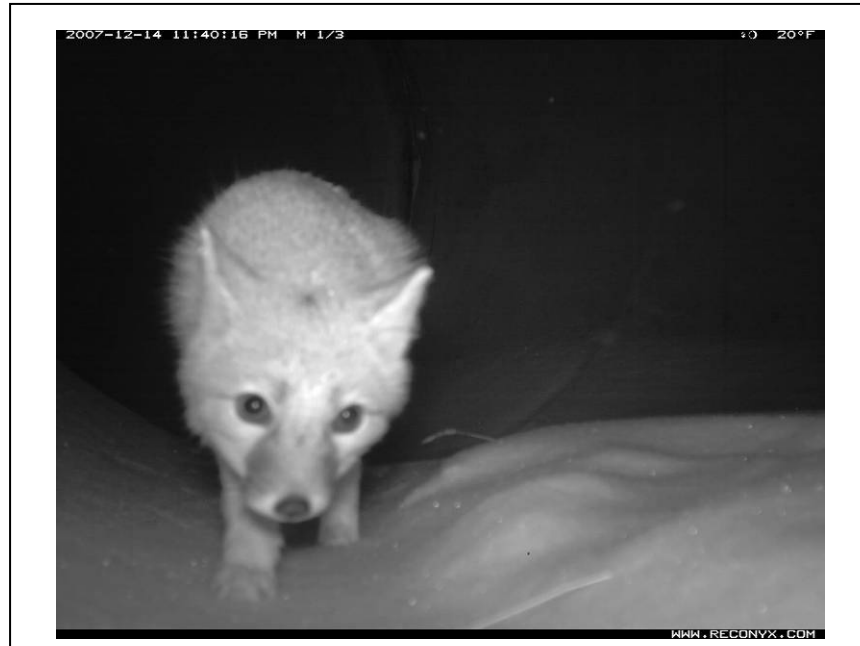
Figure 10. Swift fox documented inside reinforced concrete pipe culvert (R351.2) confirms a crossing occurred via the culvert. Snow can be seen in foreground.

Probable swift fox tracks were originally detected at R351.2 (western study area) on 7 November 2007 and again on 13 November 2007; both sets of tracks indicated the fox moved just inside or around the entrance of the culvert but not through. On 21 November 2007, swift fox tracks were found at both ends of the culvert heading in the same direction indicating a complete crossing through the culvert. On several other occasions swift fox tracks were found only on one side or the other. To confirm tracks at R351.2 as swift fox tracks, a temporary camera was placed at one entrance on 28 November 2007. On 14 December 2007, an unmarked swift fox was documented on camera (Figure 10) and tracks at both ends were heading in the same direction. It is speculated that this fox may have been hunting rodents that have been detected in this structure (Figure 11).

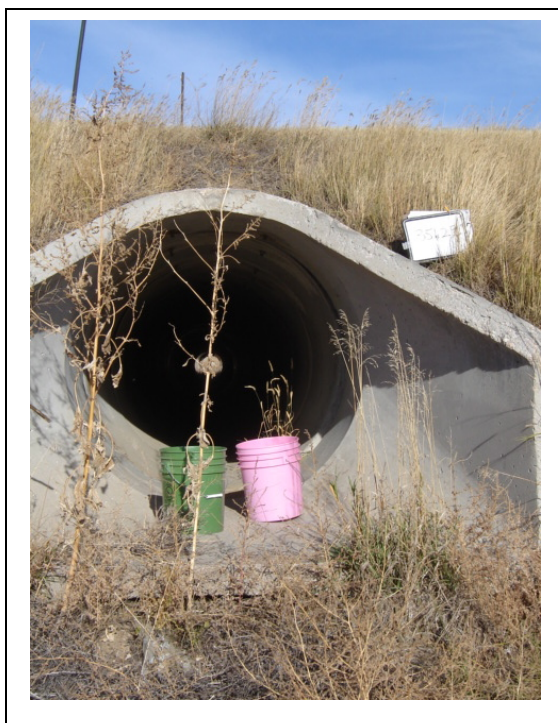
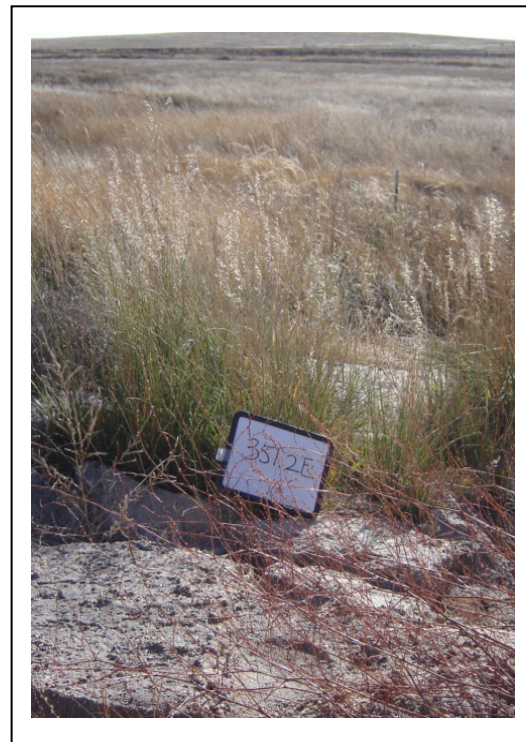
Figure 13. View of R351.2 entrance (152 cm [60 in]) in diameter (left) and adjacent landscape (right).

One more complete crossing by a swift fox was noted in R351.2 on 6 January 2008. The R351.2 structure and adjacent landscape are pictured in Figure 13.
