**Division of Research and Innovation
Technical Documentation Page**

Evaluation of Methods to Reduce Speeds in Work Zones

AHMCT Research Report: UCD-ARR-12-06-30-06
Final Report of Contract: 65A0275, Task ID: 2247

June 28, 2012

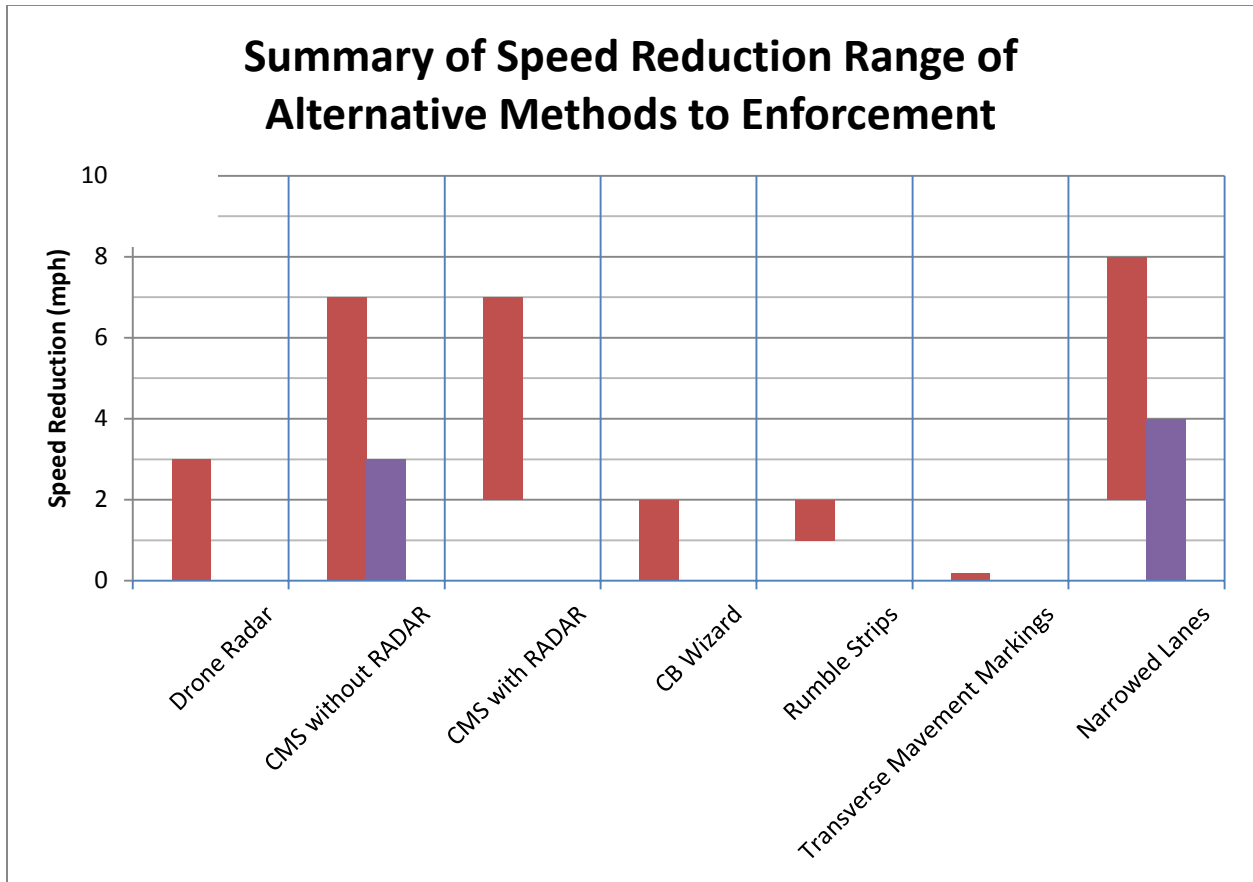
Figure 1: Summary of alternatives to the use of police enforcement (from data in [3], page 8)

It is clear from the data in this figure that use of CMS units with radar results in the largest speed reduction among the alternative enforcement methods considered. This suggests that the introduction of the CMS type device as a candidate to supplement COZEEP/MAZEEP operations in work zones can result in speed reduction without employing additional dedicated uniformed officer(s) and patrol vehicle(s) on site. Evaluating this and developing field experience in using a specific type of CMS unit that is presently used by CHP form the main part of this research.

Alternative methods of using police units on highways for speed reductions have been examined in the past. Many of the previous studies are discussed and summarized in a NCHRP report [2]. A plot of this summary in the form of a bar chart is depicted in Figure 1.

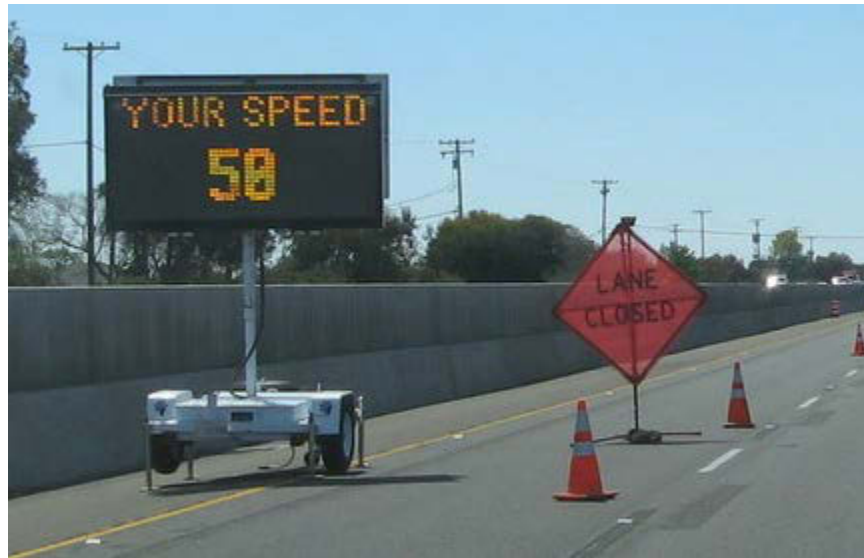
The particular CMS unit used in this study consisted of a display panel approximately eight feet wide and four feet high with an active LED matrix capable of displaying several lines of message. The entire unit was mounted on a trailer that would allow it to be towed to any location on the highway (Figure 2). The entire system is mounted on a self-contained, solar powered trailer which also houses the computer that manages the message displayed. The CMS with radar is an OEM (Original Equipment Manufactured) and all modifications are performed by CHP. The CHP-CMS trailer can be programmed to display messages such as lane closure advisories and reduced work zone speed limits. An onboard Doppler Effect radar unit is used to determine the speed of oncoming traffic and triggers a warning message display if the measured speed exceeds a certain preset threshold value. The programmed messages can be displayed intermittently with the measured speed to remind the oncoming vehicle of its speed.

Figure 2: The CHP-CMS Trailer

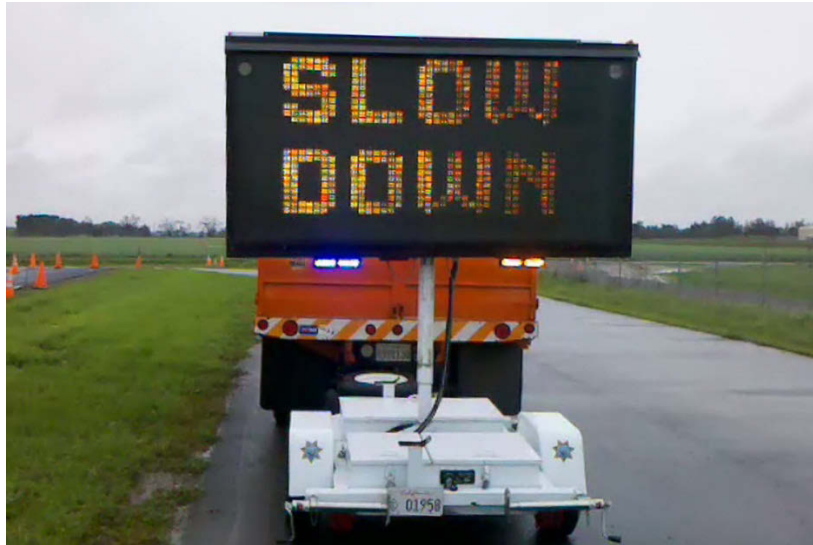
This CMS unit is owned and operated by the CHP and it is equipped with a blue and amber flashing light (standard color light used on CHP vehicles) mounted on the bottom of the display panel. At distance, the flashing light mimics the presence of a CHP patrol vehicle (hence the name CHP-CMS) thus strengthens the CMS's figure of authority. In case of driver being distracted from road condition, the flashing light is intended to capture driver's attention due with its strong visual cue and improves alertness (Figure 3).

Figure 3: CHP-CMS Trailer Showing Blue and Amber Lights

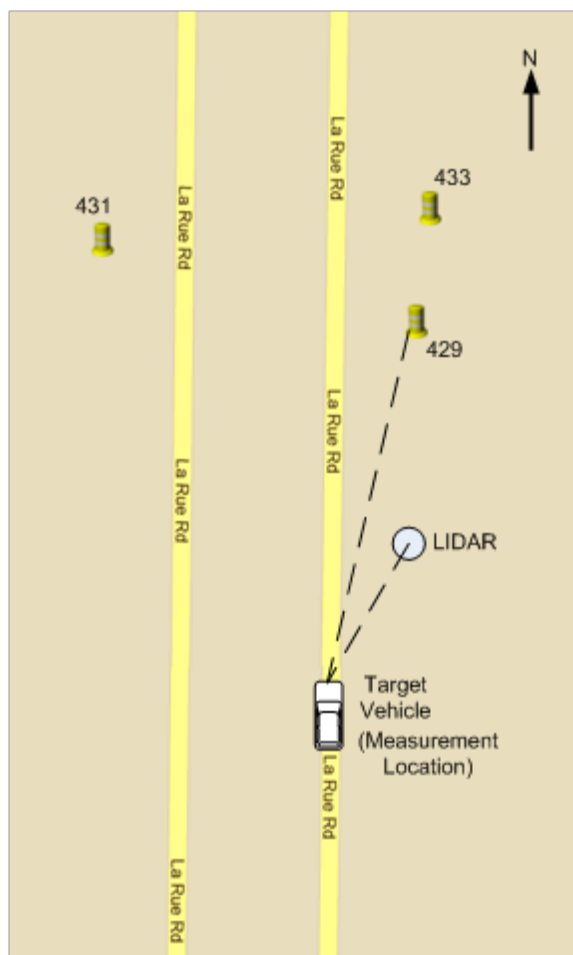
Figure 4: iCone placements in speed accuracy test (not drawn to scale)
(Map data ©2013 Google)

iCone 429 was positioned downstream of the measurement location and aimed upstream at the northbound traffic. The iCone's specification indicates a detection range of approximately 150 to 200 feet from the iCone's location. Therefore, the LIDAR operator was positioned between the iCone and measurement location, approximately 130 feet upstream of iCone 429. At this location there was a tree that was used to help the operator stay out of sight of the driver's view for as long as possible. In this set up, the LIDAR operator tracked vehicles and obtained a speed reading for vehicles approximately between 20 to 70 feet upstream of his/her location, which would be the segment of roadway where the iCone is likely to obtain a speed reading. Only northbound traffic was recorded with the LIDAR gun. In order to determine whether iCone measurements are biased towards the lane adjacent to their placements, iCones 431 and 433 were placed approximately across from each other, both aiming north, covering a approximately five

A set of tests were conducted on a north-south segment of La Rue Road near UC Davis on November 12, 2010. This road is a two-way, four-lane (two lanes in each direction) street with a median approximately the width of one lane and a speed limit of 30 MPH. Three iCones and one LIDAR unit (with an operator) were placed as shown in Figure 4.

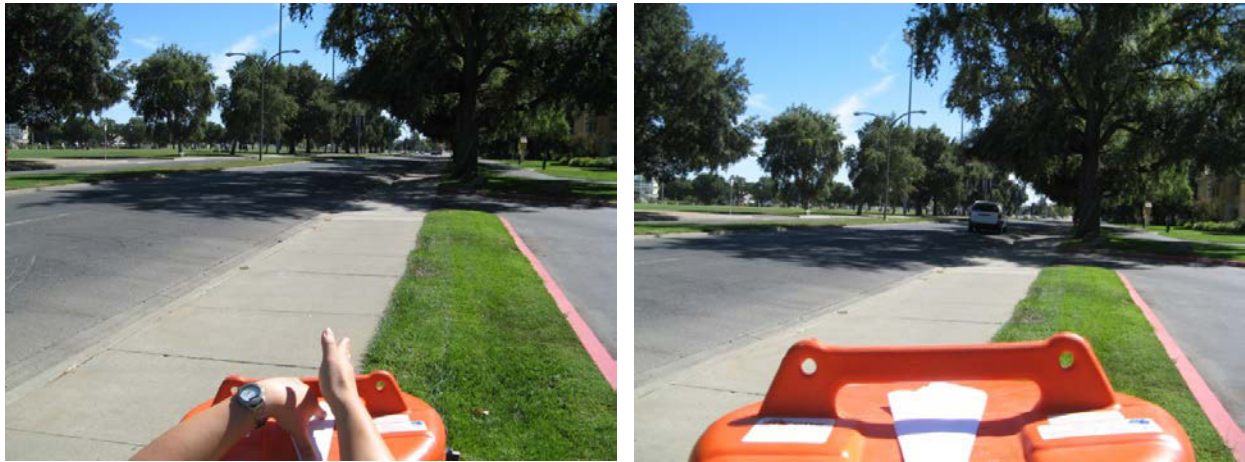
In aiming the iCones, each iCone arrow was initially placed parallel to the road and then the iCone was rotated slightly towards the roadway. Figure 5 shows the iCone aiming process from the operator's point of view.

Figure 5: Aiming iCones.

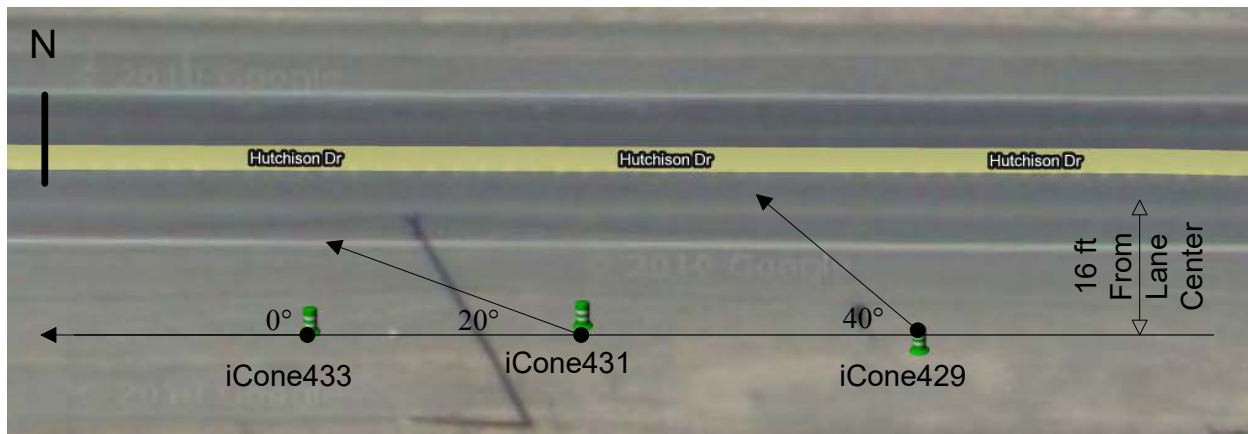
In the orientation test, three iCones were placed the same distance from the lane center, as shown in Figure 6. In this test, iCone 433 was placed with an orientation of 0° , parallel to the road. iCone 431 was oriented at 20° towards the road and iCone 429 at 40° towards the road. All iCones had the same offset of 16 feet from the center of the nearest lane. The offset of 16 feet was selected to represent placement of the iCones outside a 10 foot shoulder. The target of speed measurements was assumed to be at the center of the nearest lane (6 feet for half of the width of the target lane and 10 feet for the width of the shoulder).

Figure 6: iCone placement for orientation test
(Map data ©2013 Google)

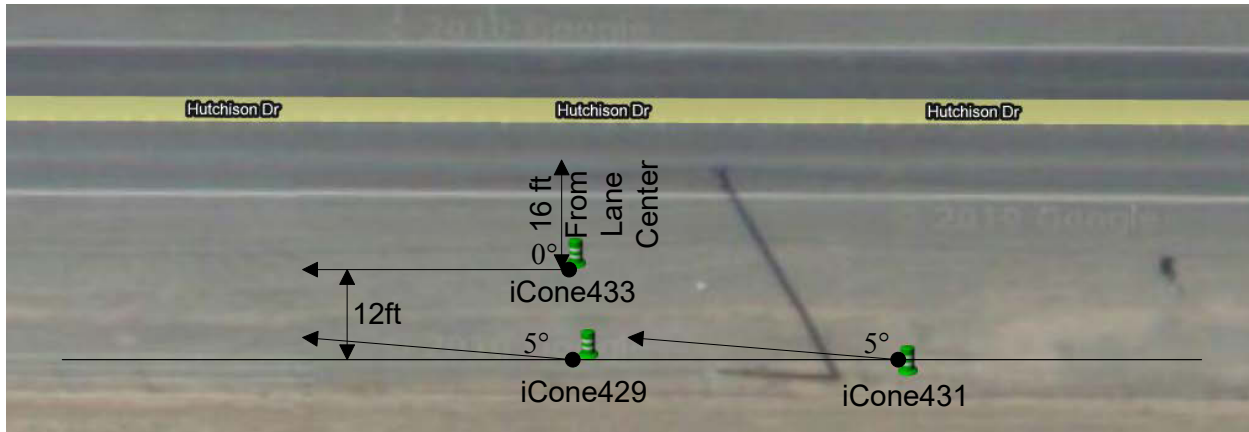
In the position test, the configuration of the iCones is shown in Figure 7. The iCones 433, 431 and 429 were placed, respectively, with offsets of 16 feet, 28 feet and 28 feet from the center of the target lane. The 28 feet distance was selected to represent one additional lane of offset.

Figure 7: iCone placement for position test
(Map data ©2013 Google)

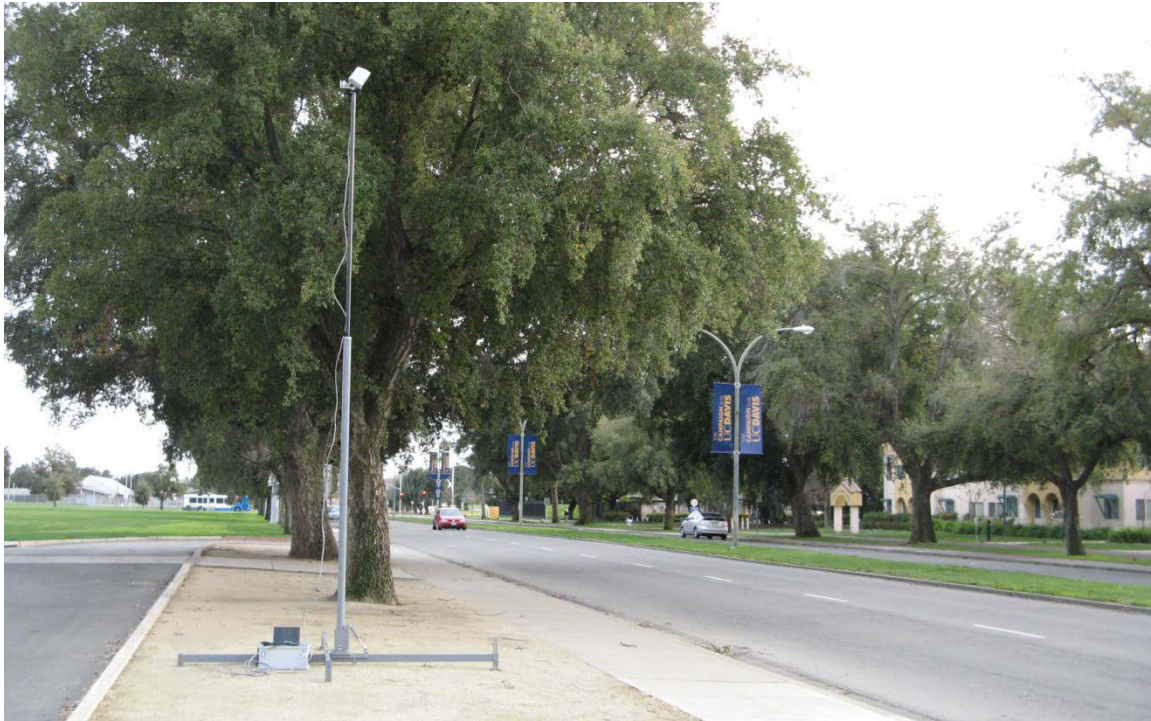
In this test, the number of vehicles detected by the RTMS for each lane was used to calculate traffic volume/count and was tested against manual counting of traffic volume/count. The test was performed on November 12th, 2010 at the same location as the iCone test of that date. In order to test the RTMS, an easily deployable mast was designed to mount the RTMS unit at a height. The mast is shown in Figure 8. The mounting height of the RTMS as shown in this figure was 19 feet and during the test on November 12th 2010, it was placed with an offset of 12 feet to the edge of the road.

Figure 8: RTMS Mast for Rapid Deployment (View Looking South, Nov 12, 2010)

The offset distance of 12 feet was chosen to emulate the scenario where the RTMS is set up beyond the shoulder of the freeway in a work zone evaluation. During the test, manual counting of vehicles passing in the area measured by the RTMS was performed for all lanes of traffic. As shown in Figure 8, there were two northbound lanes and two southbound lanes with a median which was one lane wide. The RTMS unit was placed next to the northbound lanes. The test data was collected for a period of 20 minutes and showed 123 northbound vehicles and 174 southbound vehicles in manual counting versus 120 northbound and 151 southbound vehicles in RTMS counting. This data indicates that the RTMS unit missed the number of vehicles by 2.4% in the near side lanes and by 13.2% in the far side lanes. This can be due to the shadowing effects (See Appendix B). Observation of the RTMS display unit during the testing showed that the system was, sometimes, registering “ghost” vehicles outside the boundaries of the far side lanes. This effect was mitigated by manually adjusting the lane range assignments on the RTMS. The final conclusion from this test is that RTMS units can provide relatively accurate measurement of traffic volume/count for near side lanes. It is therefore recommended that RTMS units be used in the manner described here for obtaining traffic volume/count in work zone testing for near side lanes. Near side lanes are defined as lanes adjacent to the location of the RTMS mast.

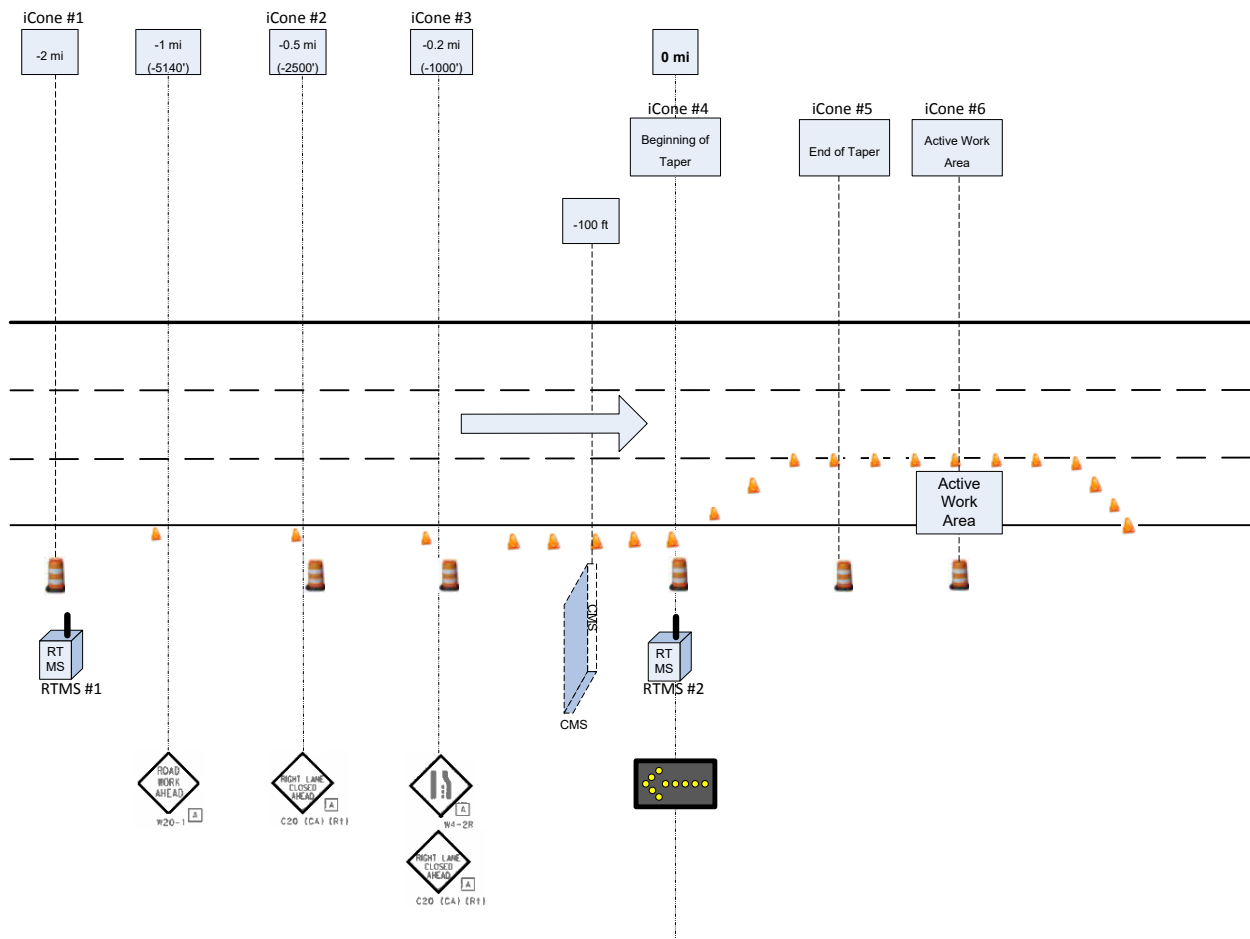
to obtain base-line values for average traffic speed, volume and headway. Discussions with Caltrans field personnel indicated that an approximate distance of two miles upstream of the beginning of taper is the proper location for these first set of sensing units. The next two iCones were distributed in-between the first work zone sign (stating: “Road Work Ahead”) and the beginning of taper. Data from these two iCones can provide information on speed changes due to the advisory signage for the work zone. The next set of iCone/RTMS pair was positioned at the beginning of taper to measure the number of vehicles remaining in the closing lane. This was also near the location of the CMS sign as recommended by Caltrans field personnel for the first test on March 22nd, 2011. The fifth iCone was then positioned at the end of taper which was upstream of where highway workers would be present. This was also the area that the reduction in lane(s) was completed in the work zone. The sixth and last iCone was positioned somewhere in the active work area of the work zone preferably approximately in the middle of this area to provide data on the final average traffic speed in the area closest to the highway workers. In the test performed, the work zone was along the fast lane of the highway (left side). The mirror image of this layout as shown in Figure 10 is used.

Figure 9: Proposed Sensor Layout for Work Zone Testing.

The sensor layout discussed served as a baseline configuration for field testing. The layout was adjusted to its final configuration based on logistics at a specific work zone and the requirements set forth by the Caltrans personnel in charge of a work zone.

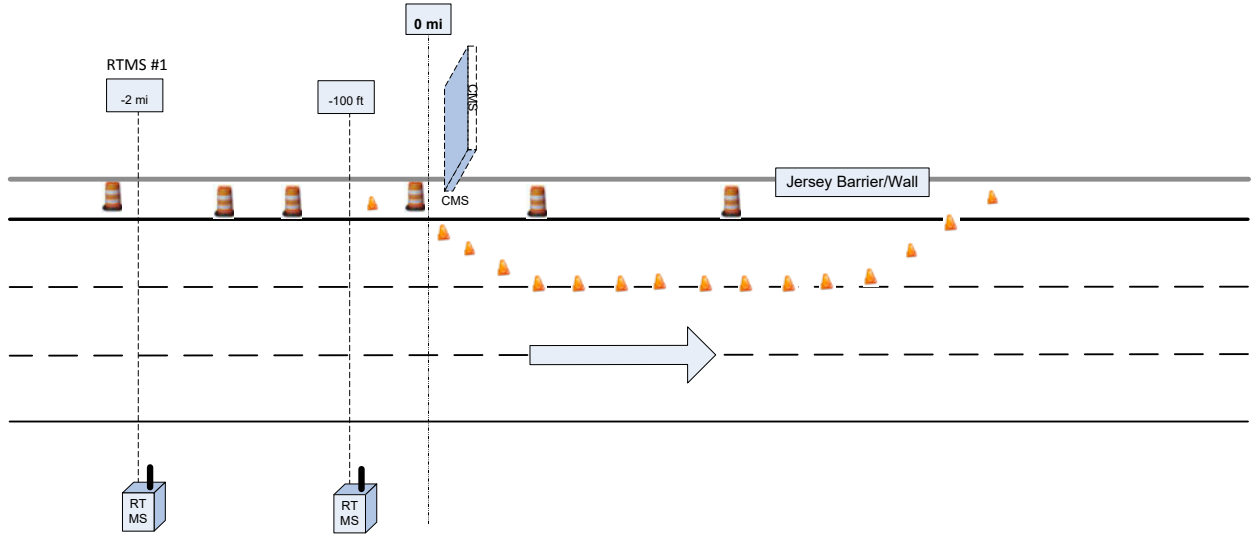
Figure 10: Proposed Sensor Layout for Work Zones on the Left Side of a Highway.

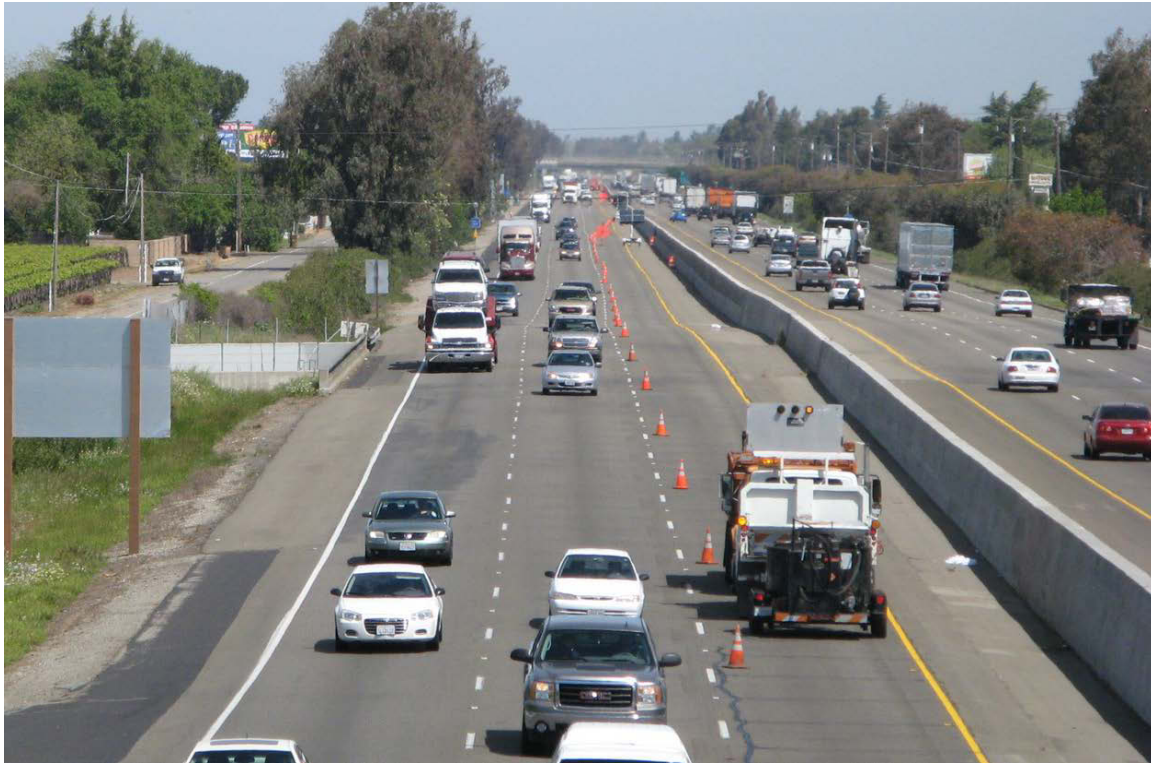
The work zone for the two April 15th, 2011 tests is shown in Figure 11. The test on March 22nd, 2011 was performed on the same highway upstream of the depicted location. A visual walk through of the April 15th work zone as seen from the view of the driver is depicted in Figure 12.

Figure 11: View Looking Down At the Test Work Zone of April 15, 2011.

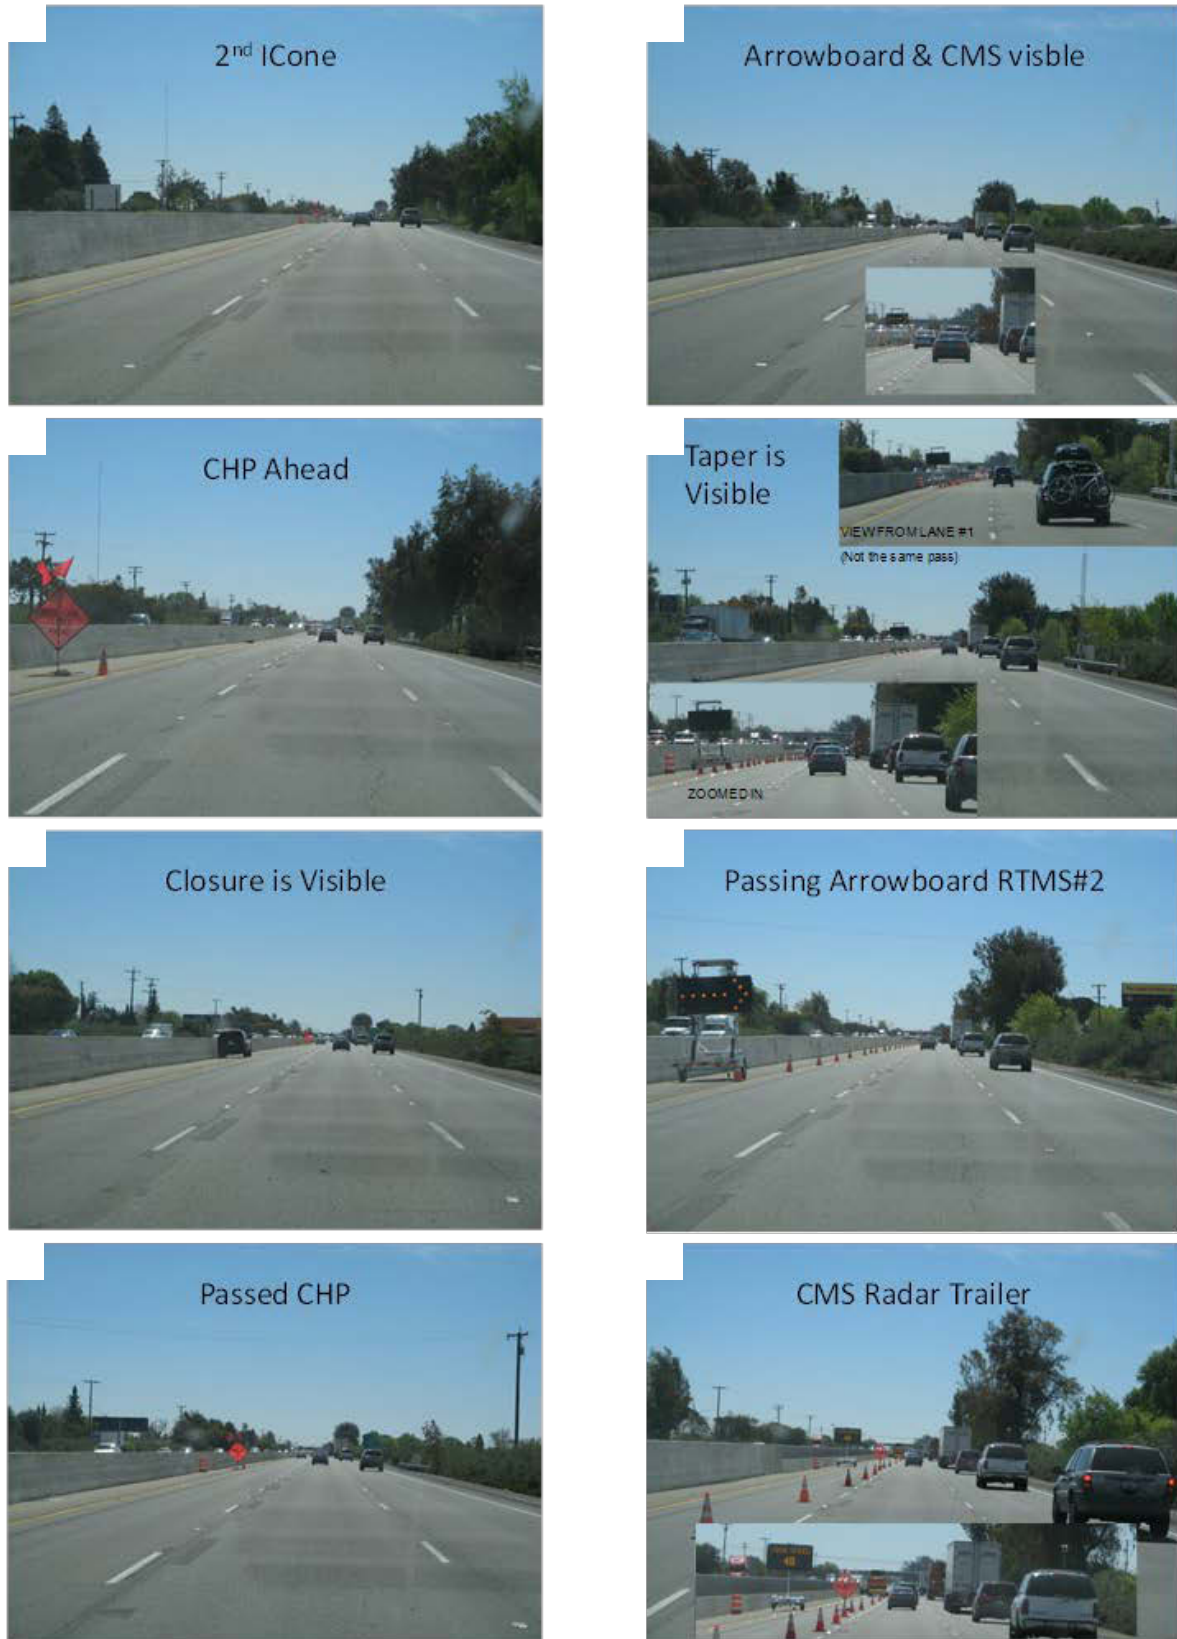
Figure 12: Pictorial Walk Through of the Test Work Zone on April 15, 2011

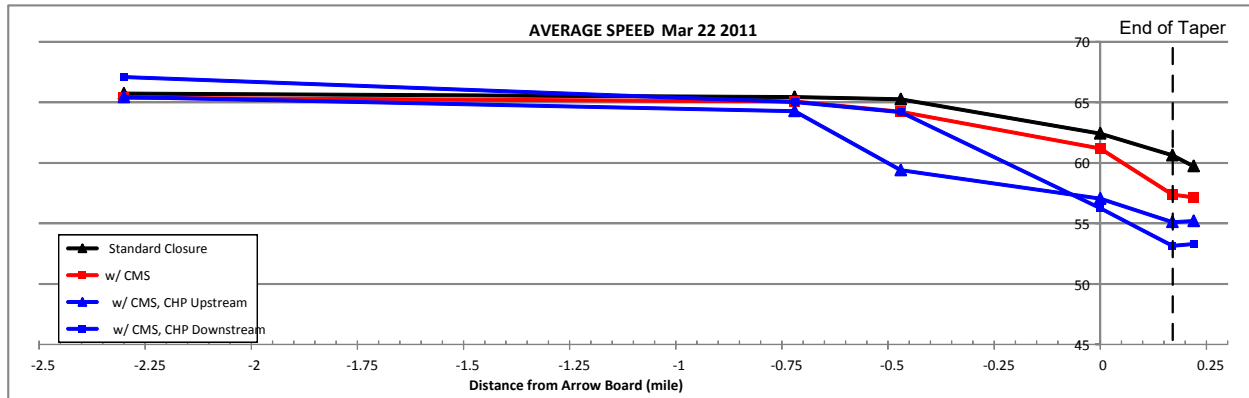
In this section, the test data from the six iCones from the three tests is discussed followed by the data obtained from the downstream RTMS. Figure 13 provides a summary plot of the six iCone speed measurements for testing of four different configurations on March 22nd, 2011. The horizontal axis plots the iCone location from the zero reference point in miles. The vertical axis is the average speed measured by the iCones in MPH. The four configurations consist each of speed measurements with no CHP-CMS and no CHP vehicle (indicated in black), CHP-CMS unit in place (indicated in red), CHP-CMS unit and CHP vehicle upstream (indicated in blue triangle), and CHP-CMS unit and CHP vehicle downstream (indicated in blue square).

Figure 13: iCone data from March 22, 2011 test.

The data in these plots clearly show that the CHP-CMS unit is effective (at least in the three tests) in positively influencing the driver behavior resulting in a reduction in average traffic speed from the upstream highway speed of approximately 68.0 to 34.6 MPH at the end of taper (fifth iCone or the second to last mark from the right in the plots). Furthermore, the same data indicates that the closure alone may be responsible for approximately 5.1 to 5.7 MPH of this reduction. The data also indicates that when there is a CHP vehicle upstream of CHP-CMS there is a local reduction of speed near the CHP vehicles but the speed at the end of taper is not significantly affected. The same local effect of the CHP vehicle in speed reduction was also observed in Test 2 of the April 15th test. This is illustrated in Figure 15. During this test, an unusual level of traffic congestion was developed, therefore it was not clear how much of the reduction in speed shown in Figure 15 is from the local effect of the CHP vehicle and how much is from the intrinsic traffic congestion. The main conclusion is that the data clearly indicates that the CHP-CMS trailer can be an effective deterrent for reduction of average traffic speed in a work zone.

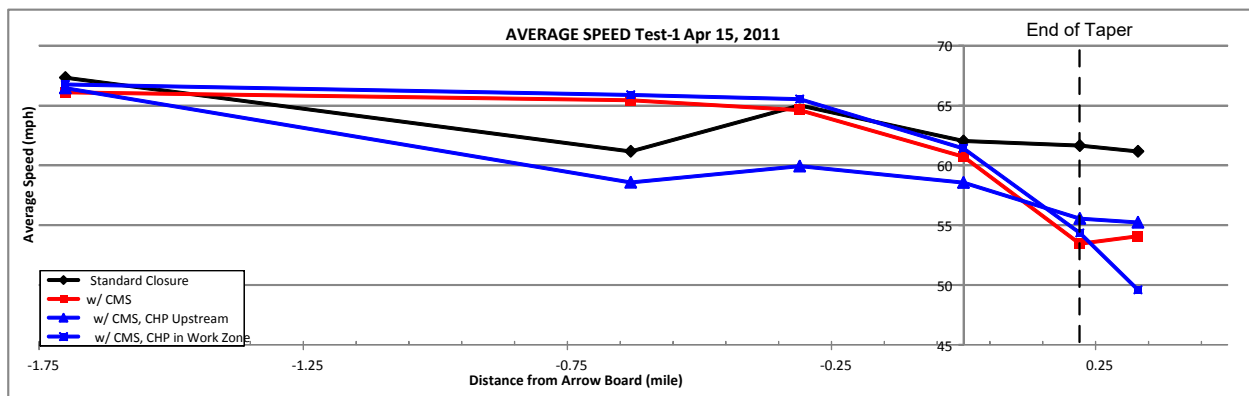
In the April 15th series of tests the CHP-CMS unit was positioned at the end of the taper rather than at the beginning due to lack of available shoulder space in the location of the taper. Plots in Figure 14 and Figure 15 represent average traffic speeds for the same configurations described for the March 22nd test. The plots in these three figures in combination with aerial views of the highway section where the iCones were placed are provided in Appendix C.

Figure 14: iCone Data from Test 1 (Morning Hours) on April 15, 2011.

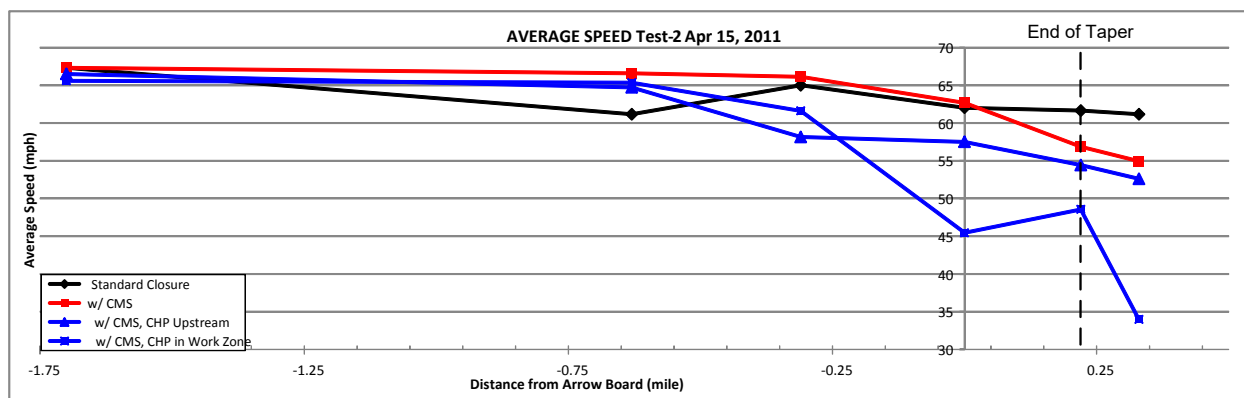
Figure 15: iCone Data from Test 2 (Afternoon Hours) on April 15, 2011.

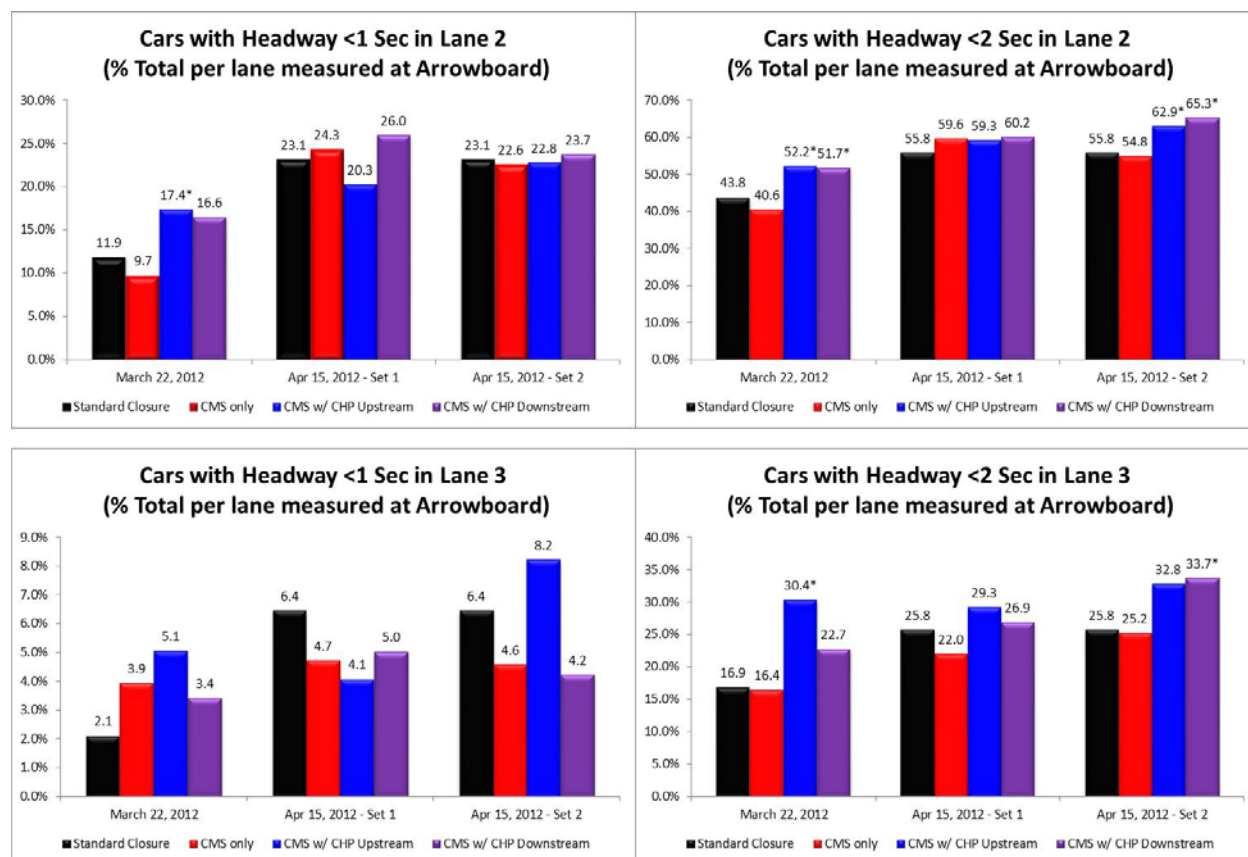
Finally the CHP-CMS unit with the CHP vehicle downstream of the CHP-CMS location is shown in purple. There are a total of four plots, two plots for the number two lane and two plots for the number three lane. Each of the two threshold values for headway is plotted per lane.

Figure 16: RTMS Data: Headway Data from All the Three Tests

A visual inspection of the data in the plots shows that the addition of the CHP-CMS unit to a standard lane closure produced no consistent effect on the percentage of vehicles with less than ideal and minimally ideal headways. A similar observation can be made for the addition of a CHP vehicle, both upstream and downstream of the CHP-CMS unit.

A chi-square (χ^2) test using a 2 x 2 contingency table was conducted to determine the statistical significance of the differences between the standard closure and other conditions. A difference is considered significant if $\chi^2 \geq 3.841$, indicating a probability level (p-value) of less than 0.05. The significant differences are denoted with “*” in Figure 16. The CHP-CMS unit’s effect on headway is inconclusive. The existence of significant increases in percentage points in some plots of the CHP-CMS with the CHP vehicle suggests that there may be a risk of causing drivers to follow each other too closely.

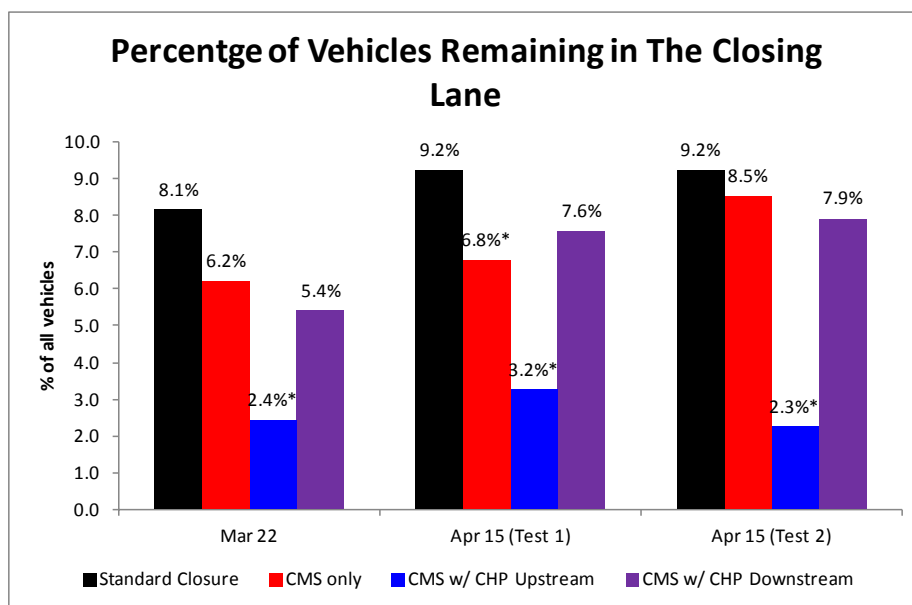
The other aspect of the RTMS data is the per-lane traffic volume/counts. This data is obtained by manually counting all vehicles in the video footage produced by the onboard camera of the RTMS. The percentage of vehicles remaining in the closing lane (No. 1 lane) is then used as an indicator of late merging behavior. The percentage data is plotted in Figure 17.

Figure 17: RTMS Data: Percentage of Vehicles Remaining in Closing Lane at the Beginning of Taper from All Three Tests

The data suggests there are reductions in the percentage of vehicles remaining in the closing lane at the beginning of taper. The Chi-square analysis was also performed for this set of data. The presence of the CHP-CMS unit only resulted in significant reduction for one of the three tests ($\chi^2 = 5.1872$ for Test 1 of April 15th). The presence of the CHP-CMS with the addition of the CHP vehicle upstream resulted in significant reduction in all three tests ($\chi^2 = 16.4471, 34.7272, 28.9308$, for March 22nd, Test 1 of April 15th and Test 2 of April 15th, respectively). The presence CHP-CMS unit with the CHP vehicle downstream resulted in no significant reduction of late-merging vehicles. The reductions associated with the CHP vehicle located upstream are consistently significant.

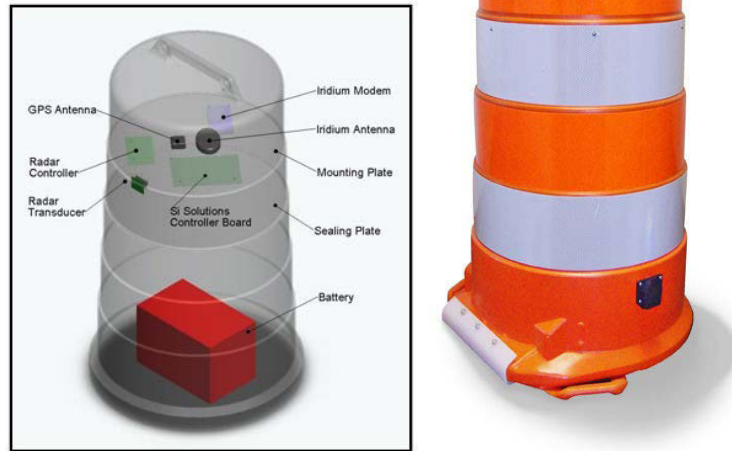
Figure A - 1: Inside/Outside of an iCone (Note the switch near the top and charging port on the base).

The electronics are located towards the top of the barrel, whereas the battery is fixed to the base of the barrel. The overall appearance of the iCone closely resembles that of a regular traffic control barrel, but there are a few subtle differences: there is a switch near the top of the barrel, a charging port on the base, and an arrow sticker on the top of the iCone to aid in aiming during deployment. This non-threatening appearance minimizes its influence on the motorists, making the iCone system an ideal candidate for recording traffic speed data inconspicuously. A device that catches a driver's attention may cause them to slow down, thus introducing bias in the data collected.

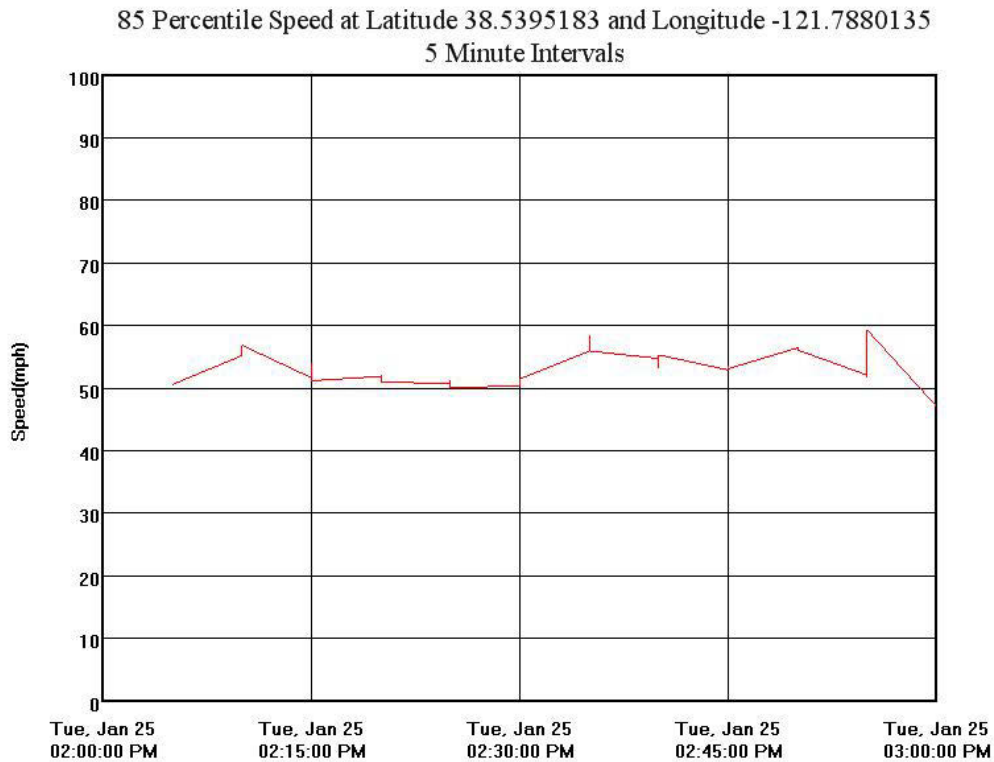
Figure A - 7: Sample *.jpg plot output

Upon clicking on “ Get Historical Report”, a pop-up window presents the user a selection of items such as the desired time, the time interval (Figure A - 4), the smoothing interval (Figure A - 5), etc., to view or download for post processing. The data can be exported to a text file (Figure A - 6) or plotted on an image (Figure A - 7), as shown below.

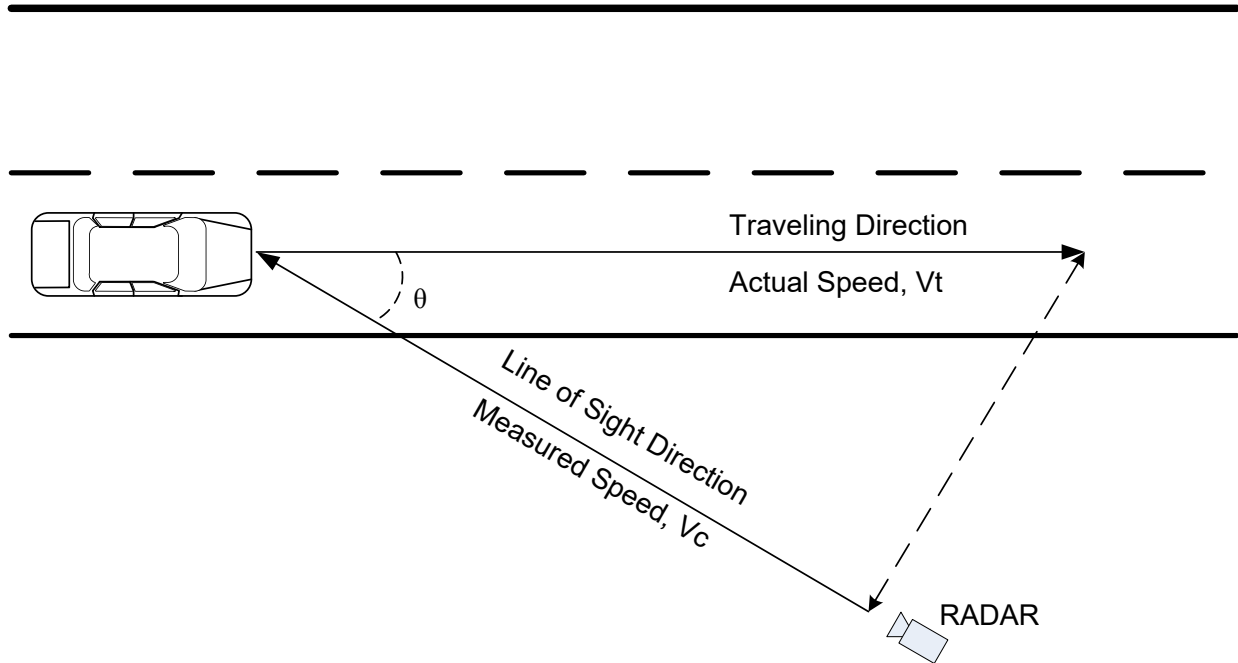
The radar unit inside the iCone detects the relative speed between the observers and the observed based on the Doppler Effect. In the case of traffic monitoring, the “line of sight” of the radar doesn’t always match the target vehicle’s direction of travel, as depicted in Figure A - 8. This mismatch causes the measured relative speed between the observer and the target vehicle being different from the actual traveling speed of the vehicle. This phenomenon is called the Cosine Effect. The speed measured by the radar is merely a component of the vehicle’s velocity parallel to radar’s line of sight and is therefore less than the actual traveling speed of the vehicle.

Figure A - 8: Radar device on the shoulder, not in line with the car's traveling direction. The relative velocity between the vehicle and the radar was less than the vehicle's actual traveling speed.

The relationship between the actual traveling speed and the measured speed can be determined from Figure A - 8 in the following equation:

In most cases the angle is small such that $v_t \approx v_c$ with $\theta \rightarrow 0$ is an adequate approximation of the traveling speed of the target vehicle. The opposite extreme case is when the radar's line of sight direction is perpendicular to the traveling direction, i.e. $\theta = 90^\circ$. In this case the measured speed will be zero regardless of the traveling speed of the target vehicle. However, this situation assumes the ideal condition where the angular beam width of the radar is infinitely narrow. For practical purposes, it can be assumed that the beam width of the iCone's radar is wide enough such that the Cosine Effect is negligible. The sensitivity of to the Cosine Effect is evaluated by placing multiple iCones at different angles and comparing the measured speeds on the same section of a road. The evaluation result can be found in the main body of this report.
