1. REPORT NUMBER FHWA/CA15-0918	2. GOVERNMENT ACCESSION NUMBER	3. RECIPIENTS CATALOG NUMBER	
4. TITLE AND SUBTITLE DEVELOPMENT OF AESTHETIC, LOW-MAINTENANCE GUARDRAIL SYSTEM ALTERNATIVES		5. REPORT DATE November 2015

DEVELOPMENT OF AESTHETIC, LOW-MAINTENANCE GUARDRAIL SYSTEM ALTERNATIVES

STATE OF CALIFORNIA
DEPARTMENT OF TRANSPORTATION
DIVISION OF RESEARCH, INNOVATION AND SYSTEM INFORMATION
OFFICE OF SAFETY INNOVATION AND COOPERATIVE RESEARCH

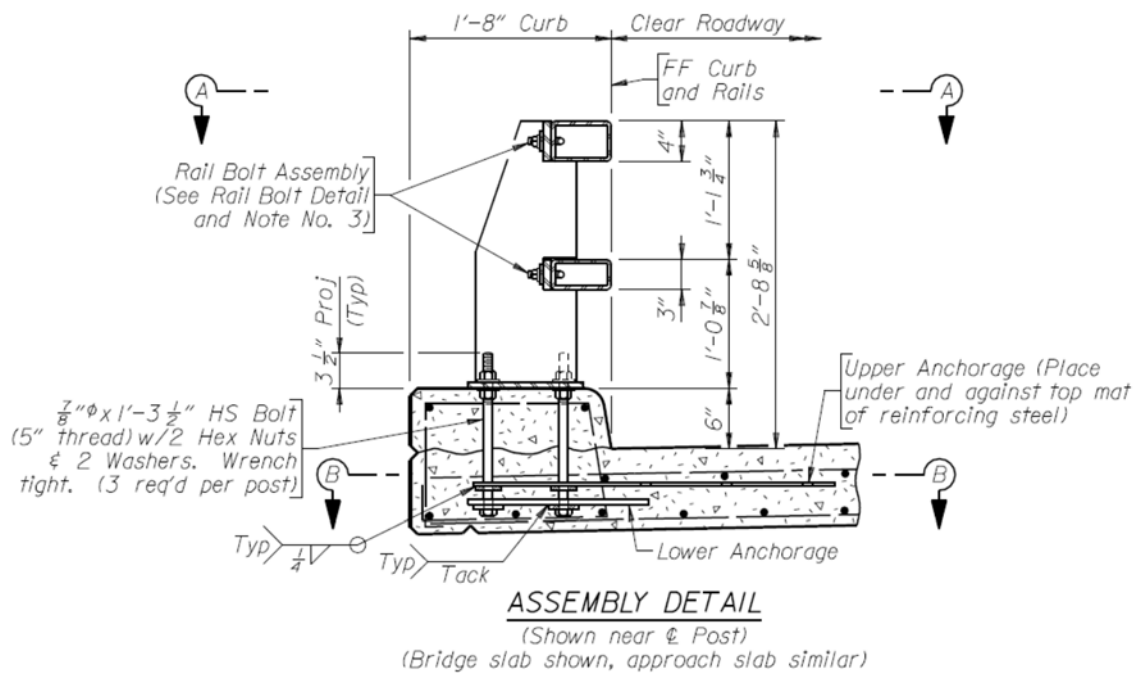
Figure 1-1 Profile of Wyoming TL-4 Bridge Rail (Excerpt from Wyoming DOT TL4 Bridge Railing Sheets)

The ST-10 Bridge Rail used for the test conducted in this report is a modified version of the Wyoming TL-4 Bridge Rail³. The two rails have similar profiles but the Wyoming Rail's lower rail is 3 inches (76 mm) tall and the ST-10 Rail's lower rail is 4 inches (102 mm) tall. The change was made so that the ST-10 parts would be uniform and would require less stock in maintenance yards. Since the difference in profile between the ST-10 and Wyoming Rail is minor, it was deemed that the ST-10 would not need to be crash tested and the change was accepted by the FHWA.

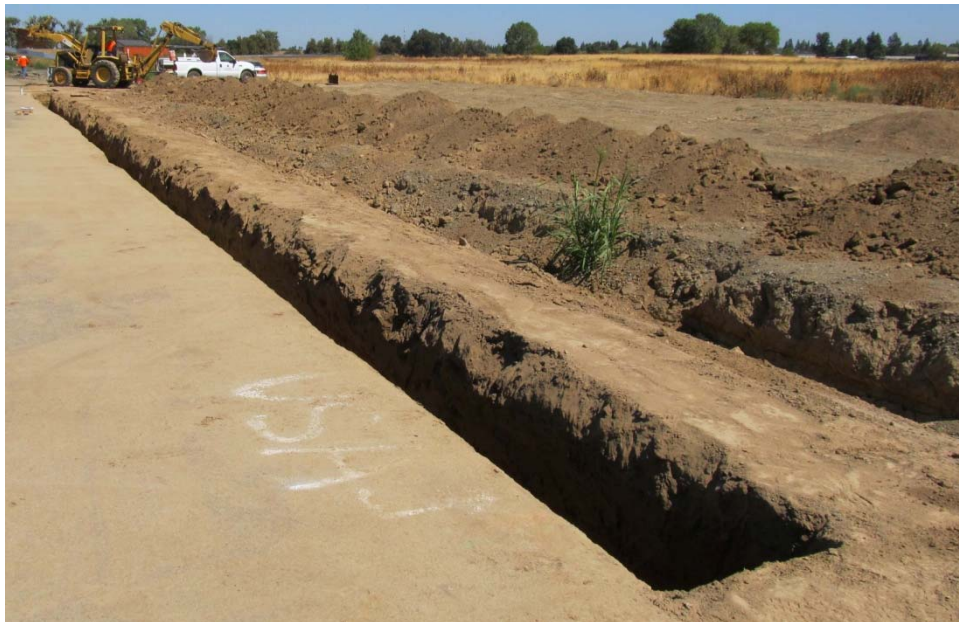
Figure 2-1 Excavation

During the installation of the foundation's rebar the back of the barrier's upper edge of the trench footing had some erosion. The erosion was due to the workers having to move around in the trench to assemble the rebar cage for the concrete foundation. The erosion caused the top of the trench to be larger than the bottom by an average of 11 inches (279 mm). This wear on the edges is typical of a field installation for a foundation of this type.

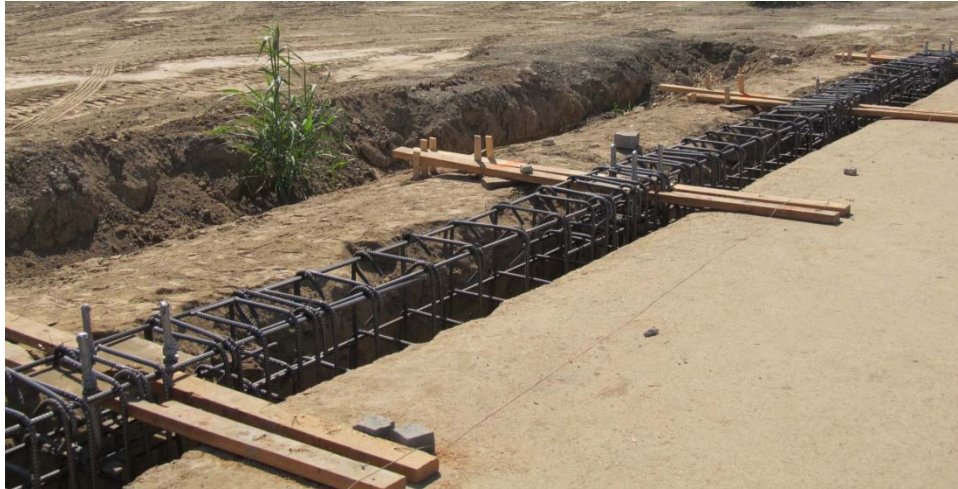
Figure 2-2 Rebar for Barrier

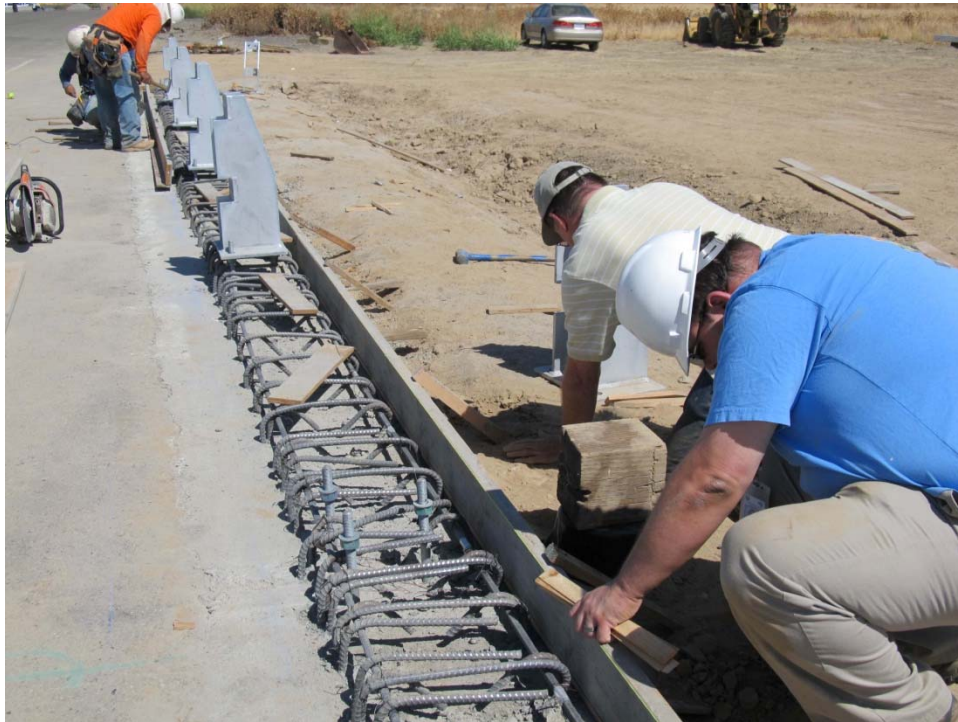
Figure 2-3 After the First Concrete Placement

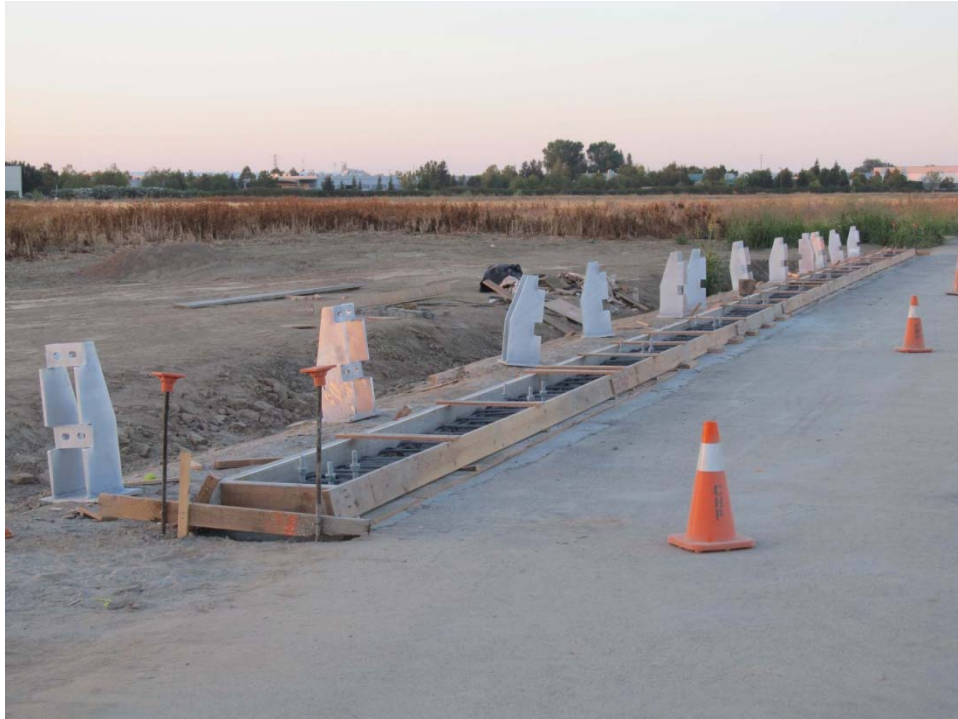
Figure 2-4 Before the Second Concrete Placement For Curb

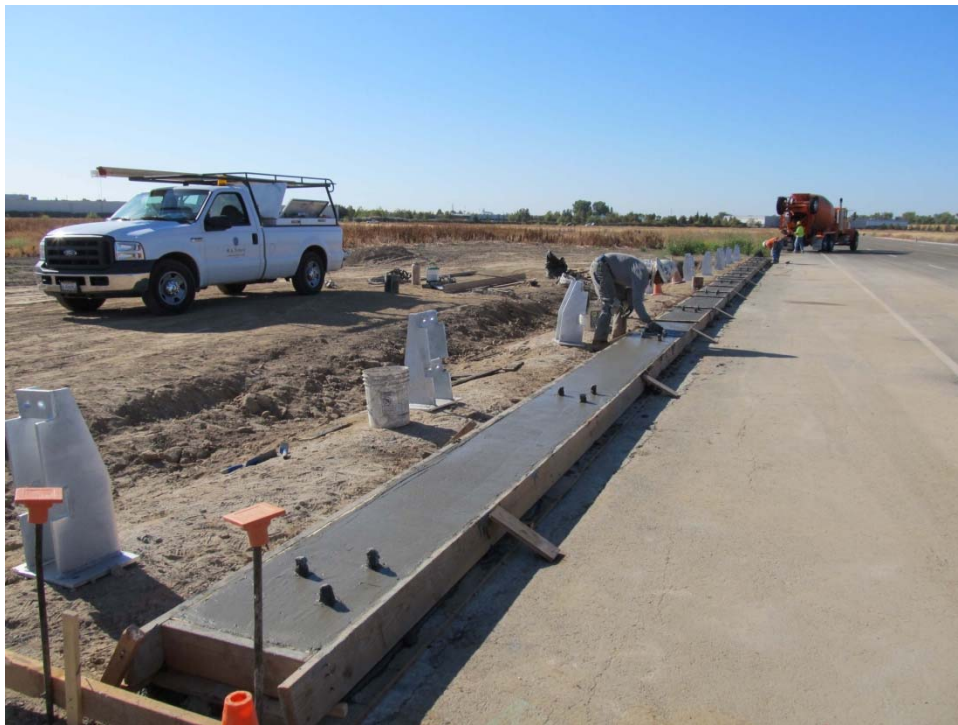
Figure 2-5 After the Second Concrete Placement

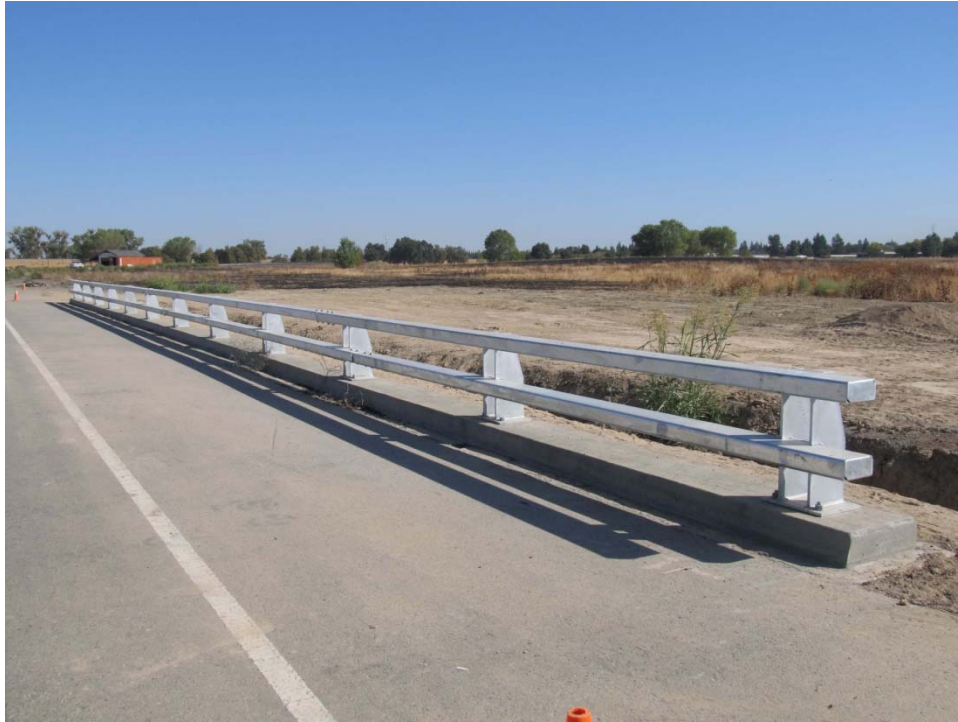
Figure 2-6 Completed Barrier Construction Front

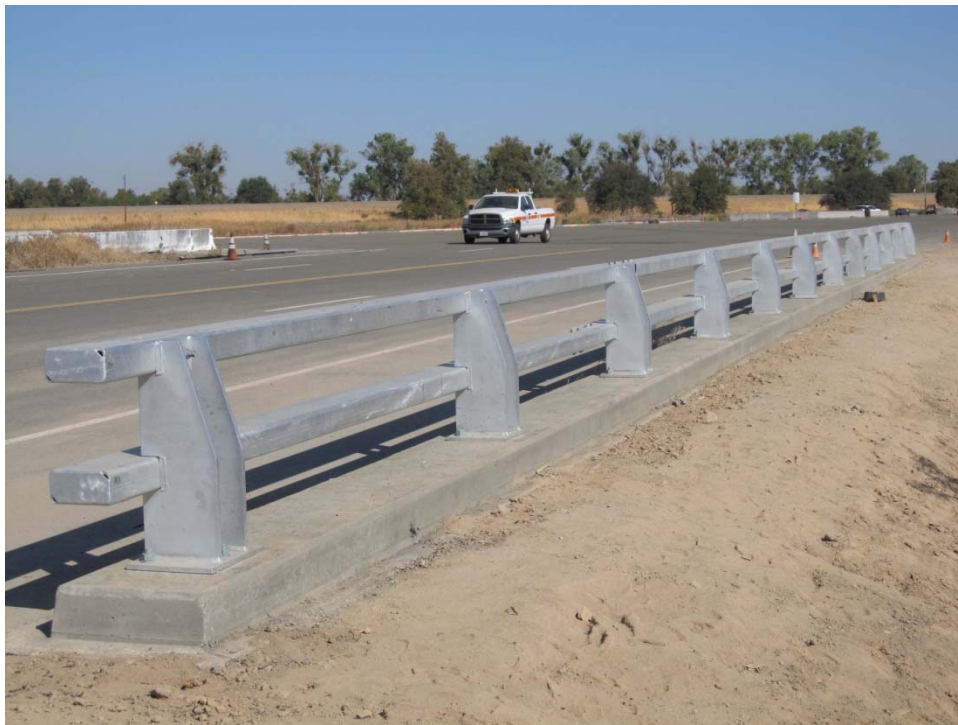
Figure 2-7 Completed Barrier Construction Back

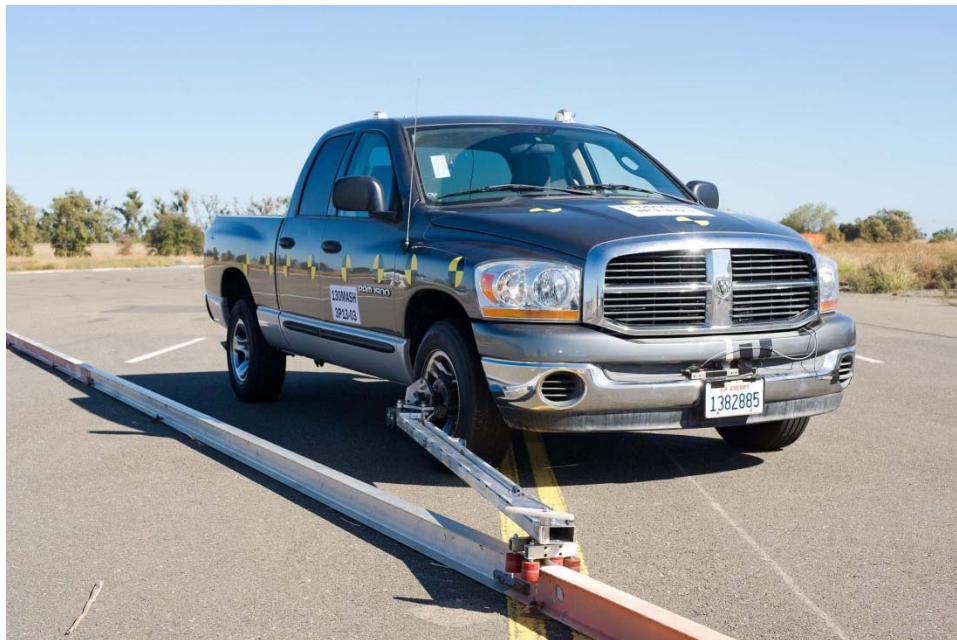
Figure 4-1 Test Vehicle Guidance System

A rail guidance system directed the vehicle into the barrier. The guidance rail, anchored at 12.5-ft (3.8-m) intervals along its length, was used to guide a mechanical arm that is attached to the front passenger side wheel of the vehicle (Figure 4-1). A high density polyethylene arm on the front end of the guidance arm was used to trigger the release mechanism on the guidance arm, thereby releasing the vehicle from the guidance system before impact. A 0.375-in (10-mm) nylon rope was used to pull the guidance arm away from the vehicle after the release was triggered.

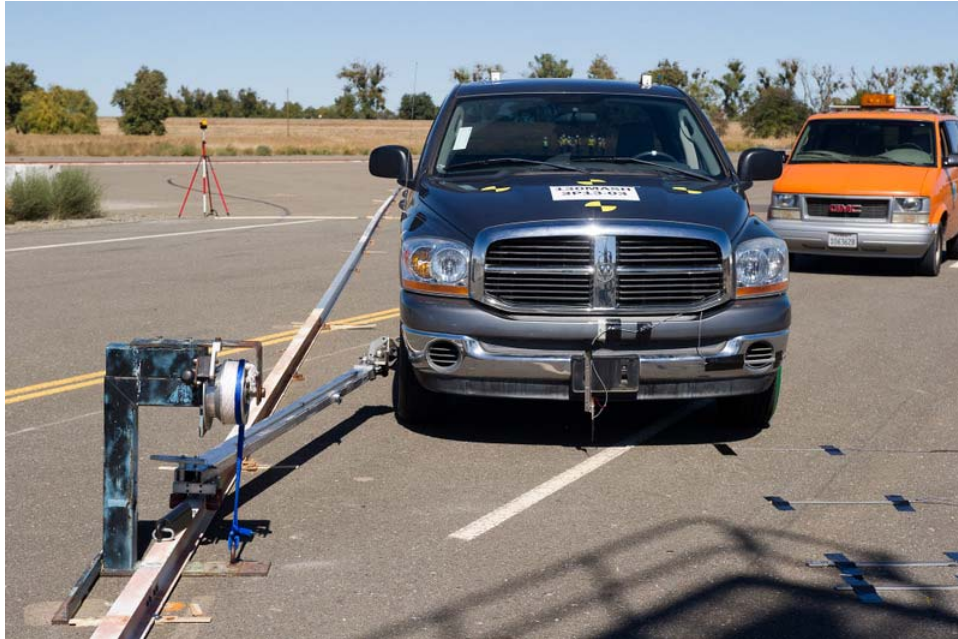
Figure 4-2 Guidance Arm Release Mechanism

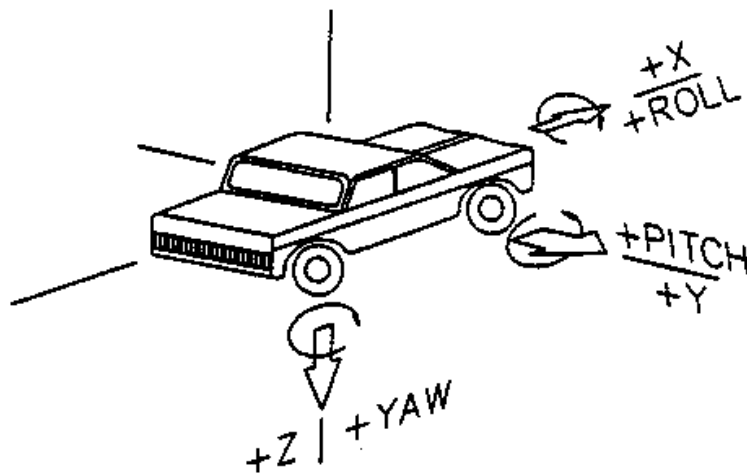
Figure 4-3 Vehicle Coordinate Sign Convention

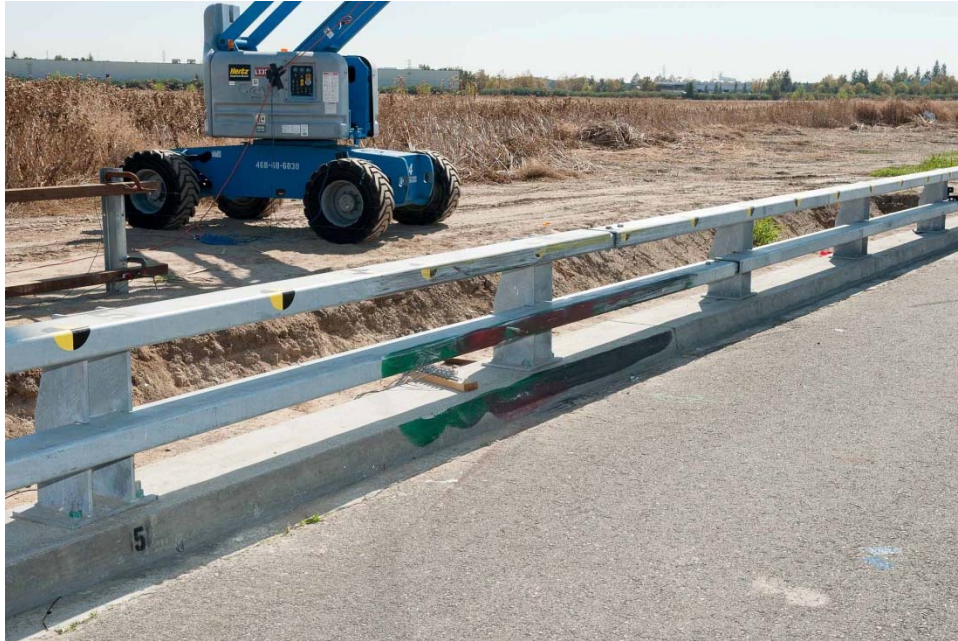
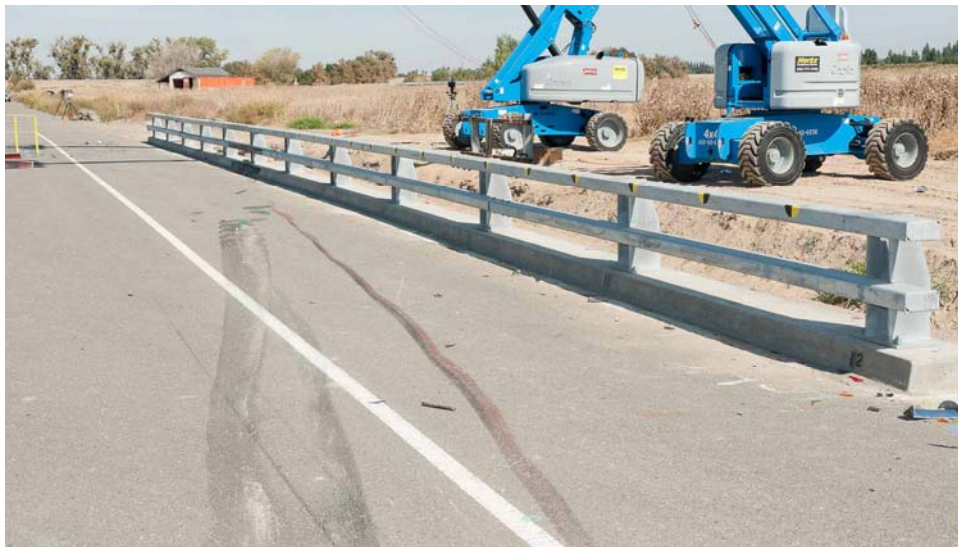
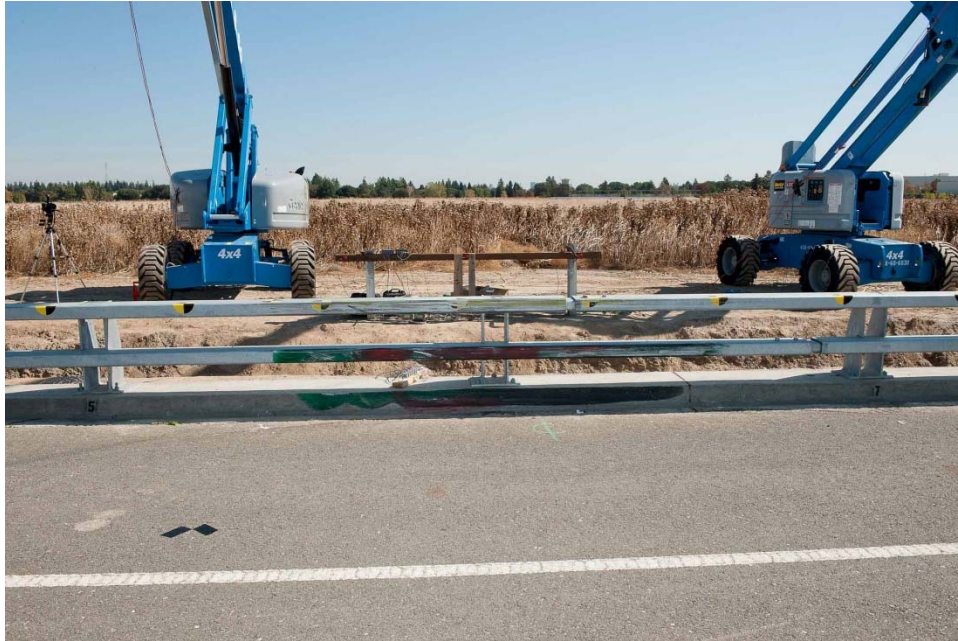
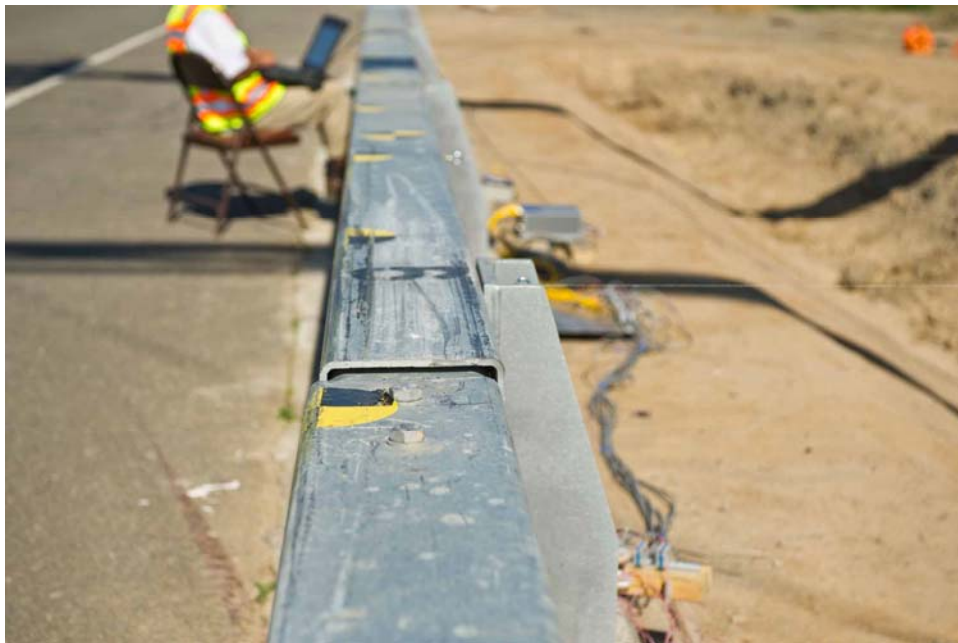
Figure 5-4 Test Article After Test 130MASH3P13-03 Looking Downstream

Figure 5-5 Test Article After Test 130MASH3P13-03 Looking Upstream

Figure 5-6 Test Article After Test 130AMSH3P13-03 Looking Across

Figure 5-7 Test Article After Test 130MASH3P13-03 Close Up

There was only cosmetic damage to the test article. The only maintenance that might be done is to use paint to cover over the marks left by the vehicle's tires.

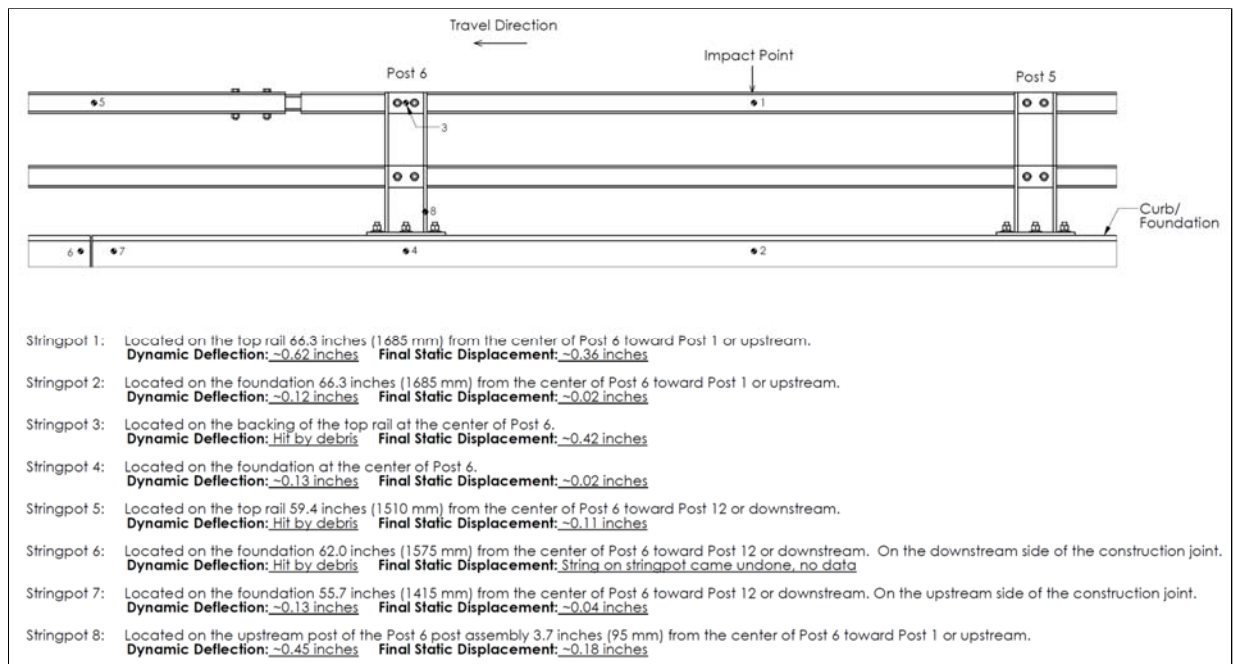
Figure 5-8 Locations and Summary of Stringpot Data*

Eight string potentiometers (stringpots) were used on the top rail and on the back of the curb in the area of the impact to record the barrier's lateral movement, see Figure 5-8 for location and summary details. The stringpots on the curb recorded a maximum dynamic deflection of 0.13 inches (3 mm) and maximum static displacement of 0.04 inches (1 mm). All but one of the stringpots on the top rail were hit by debris and were not able to provide dynamic deflection measurements. The one top rail stringpot that was not hit by debris was located at the point of impact and recorded a maximum of 0.62 inches (16 mm) of dynamic deflection. Although most of the top rail stringpots were not able to provide dynamic deflection measurements they were able to provide static displacement measurements. The maximum static displacement of the top rail was measured as 0.42 inches (11 mm).

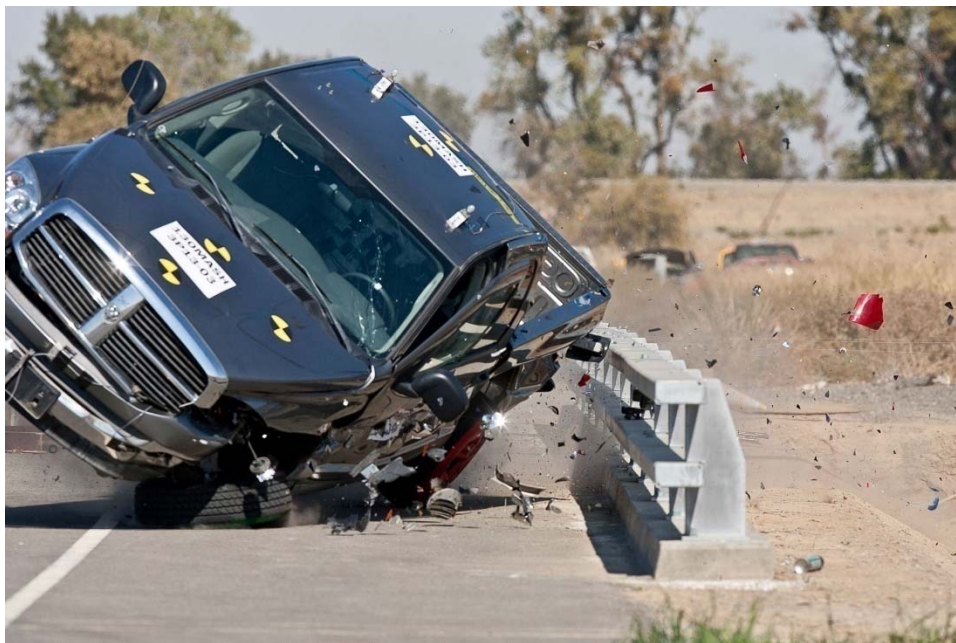
Figure 5-9 Vehicle Riding on Drive Side Front Tire

Damage to the vehicle is shown in Figure 5-10 through Figure 5-16. Impact with the test article caused the driver side front tire and hub assembly to break off of the vehicle. The left side of the vehicle sustained the majority of the damage, with the left front corner of the vehicle being pushed back into the vehicle from the impact with the barrier. The left side of the vehicle was damaged as the vehicle was redirected parallel to the barrier and the vehicle's momentum pushed the vehicle into the barrier. Additional scraping damage to the paint and door handles on the vehicle's left side was caused by the vehicle rolling onto its side. The driver side window was shattered when the side mirror broke off during the vehicle's roll onto its side; the shattered window was not caused by the impact with the barrier.

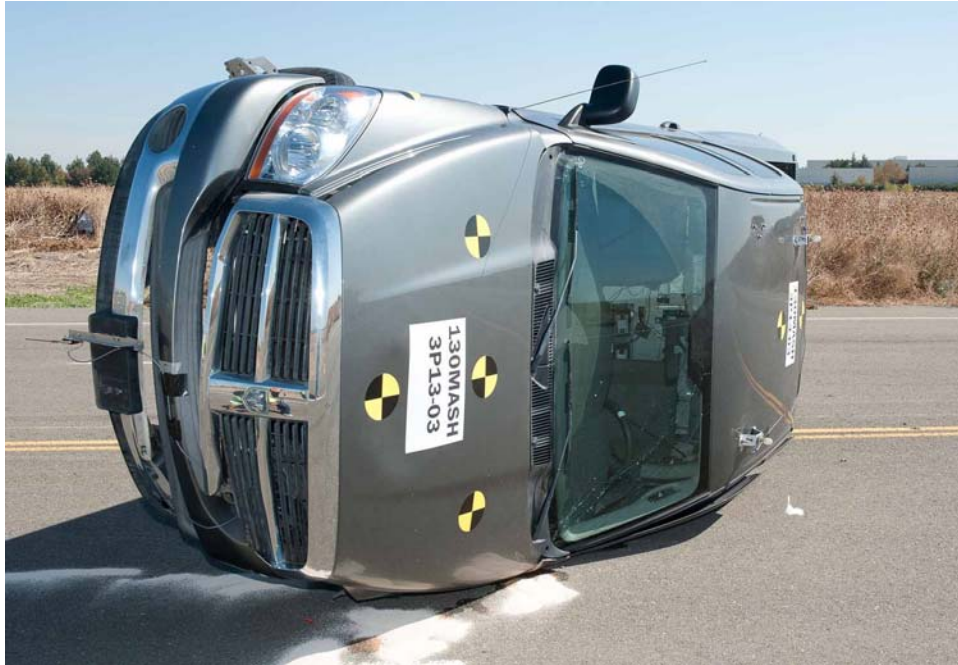
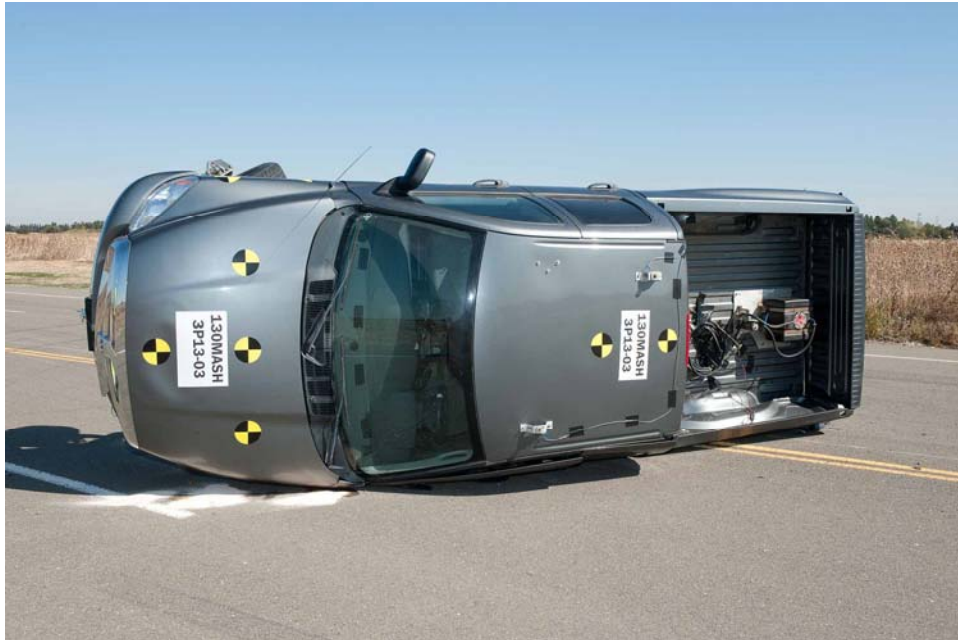
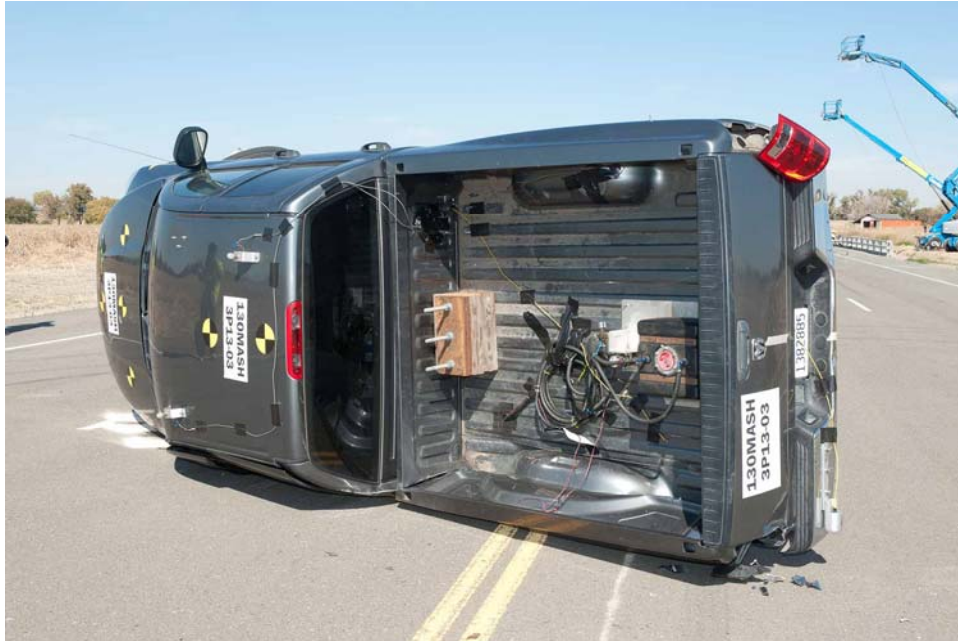
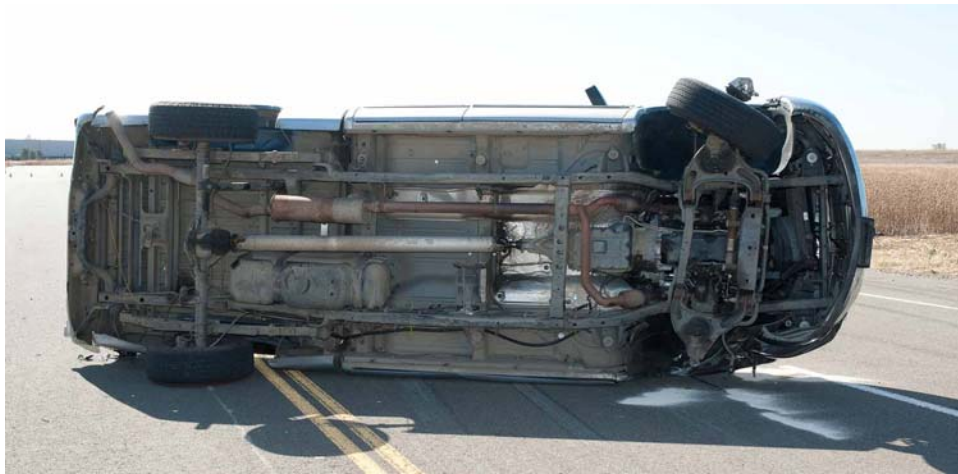
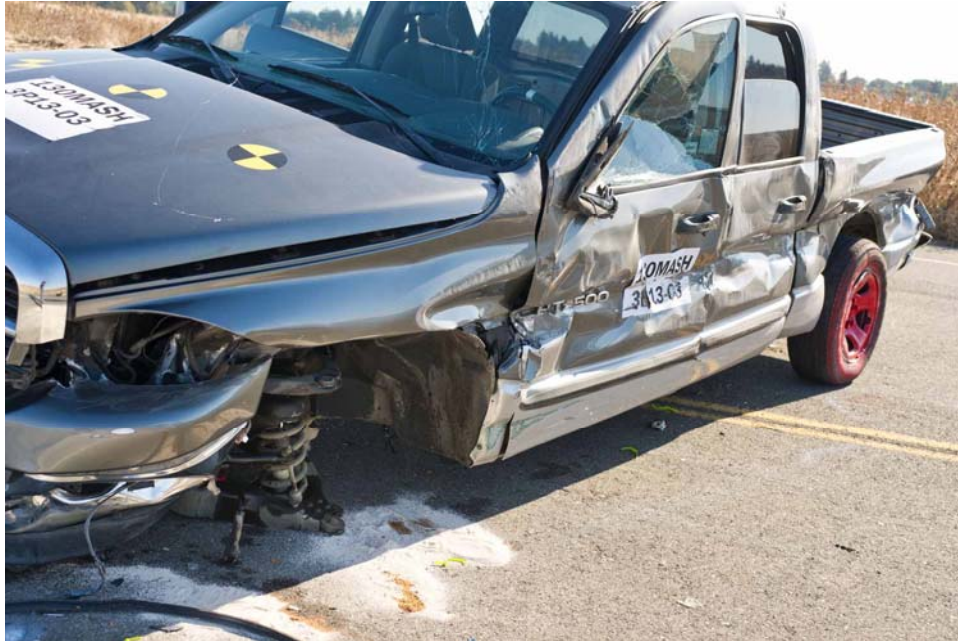
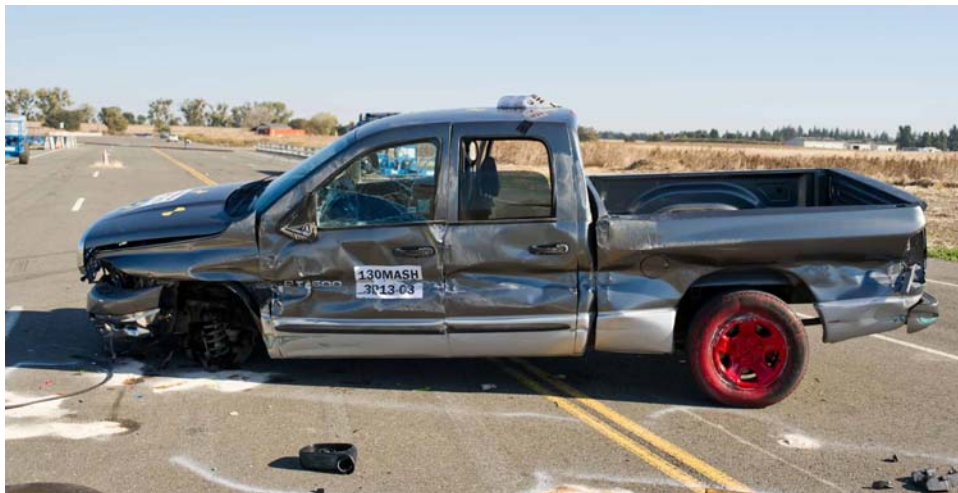
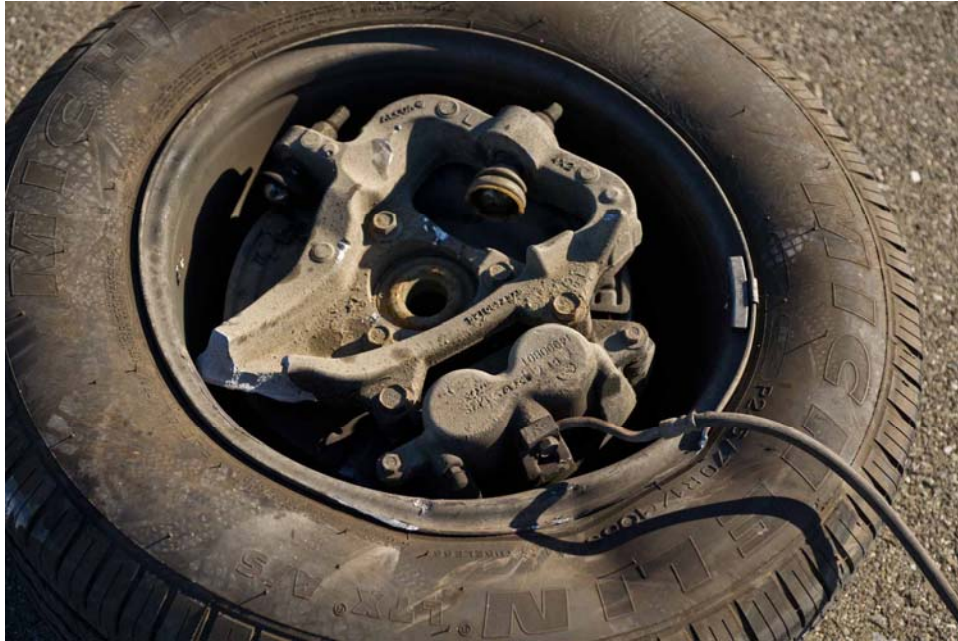
Figure 5-10 Front of Vehicle on Its Side After Test 130MASH3P13-03

Figure 5-11 Top of Vehicle on Its Side After Test 130MASH3P13-03

Figure 5-12 Back of Vehicle on Its Side After Test 130MASH3P13-03

Figure 5-13 Bottom of Vehicle on Its Side After Test 130MASH3P13-03

Figure 5-14 Front Corner of Upright Vehicle After Test 130MASH3P13-03

Figure 5-15 Side of Upright Vehicle After Test 130MASH3P13-03

Figure 5-16 Driver Side Tire and Hub Assembly

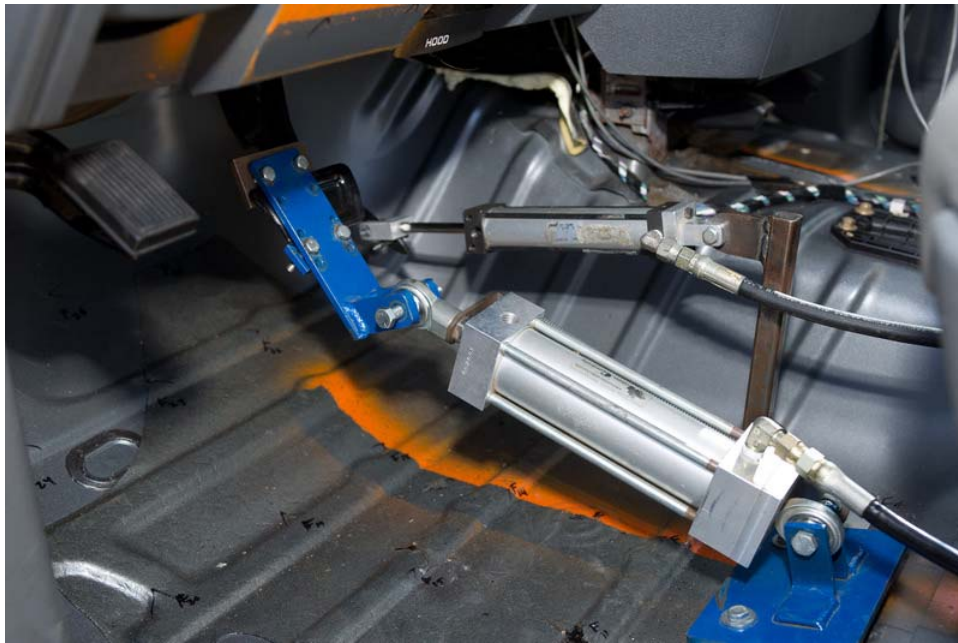
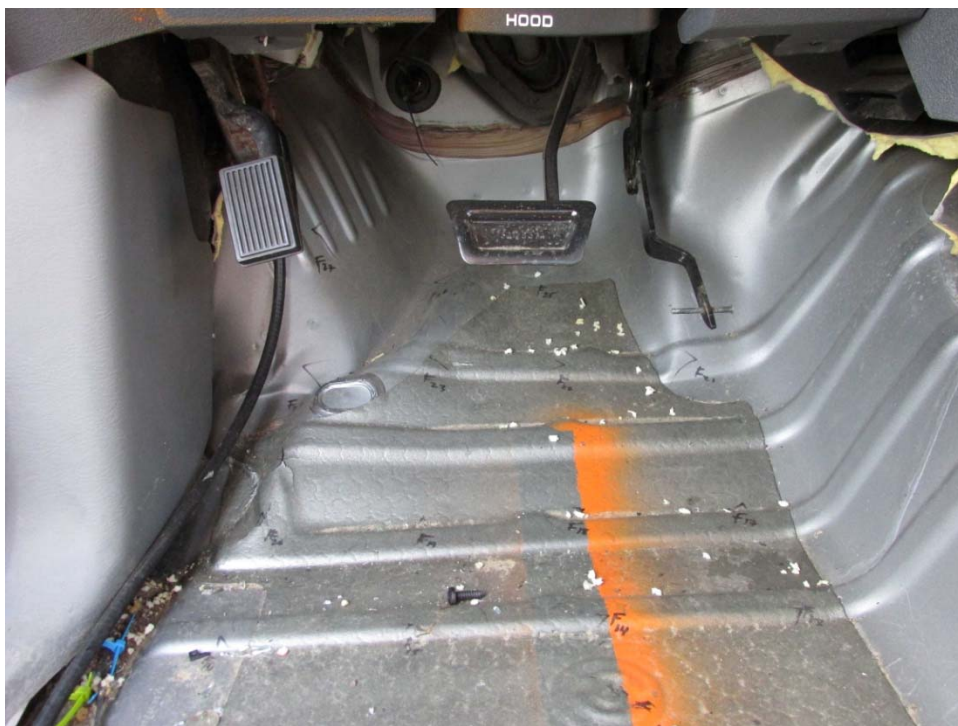
Figure 5-17 Vehicle Floorboard Pretest 1

Figure 5-18 Vehicle Floorboard Pretest 2

Figure 5-19 Vehicle Floorboard Post Test

Figure 5-17 through Figure 5-19 shows the floorboard of the vehicle before and after impact with the test article. Table 10-3 shows the measurements of the occupant compartment before and after impact with the test article. The maximum deformation measured in the occupant compartment was 2.8 inches (70 mm) in the longitudinal direction on the wall of the floorboard near the engine compartment firewall, see Figure 5-19.
