1. REPORT NUMBER FHWA/CA15-0918	2. GOVERNMENT ACCESSION NUMBER	3. RECIPIENTS CATALOG NUMBER	
4. TITLE AND SUBTITLE DEVELOPMENT OF AESTHETIC, LOW-MAINTENANCE GUARDRAIL SYSTEM ALTERNATIVES		5. REPORT DATE November 2015

DEVELOPMENT OF AESTHETIC, LOW-MAINTENANCE GUARDRAIL SYSTEM ALTERNATIVES

STATE OF CALIFORNIA
DEPARTMENT OF TRANSPORTATION
DIVISION OF RESEARCH, INNOVATION AND SYSTEM INFORMATION
OFFICE OF SAFETY INNOVATION AND COOPERATIVE RESEARCH

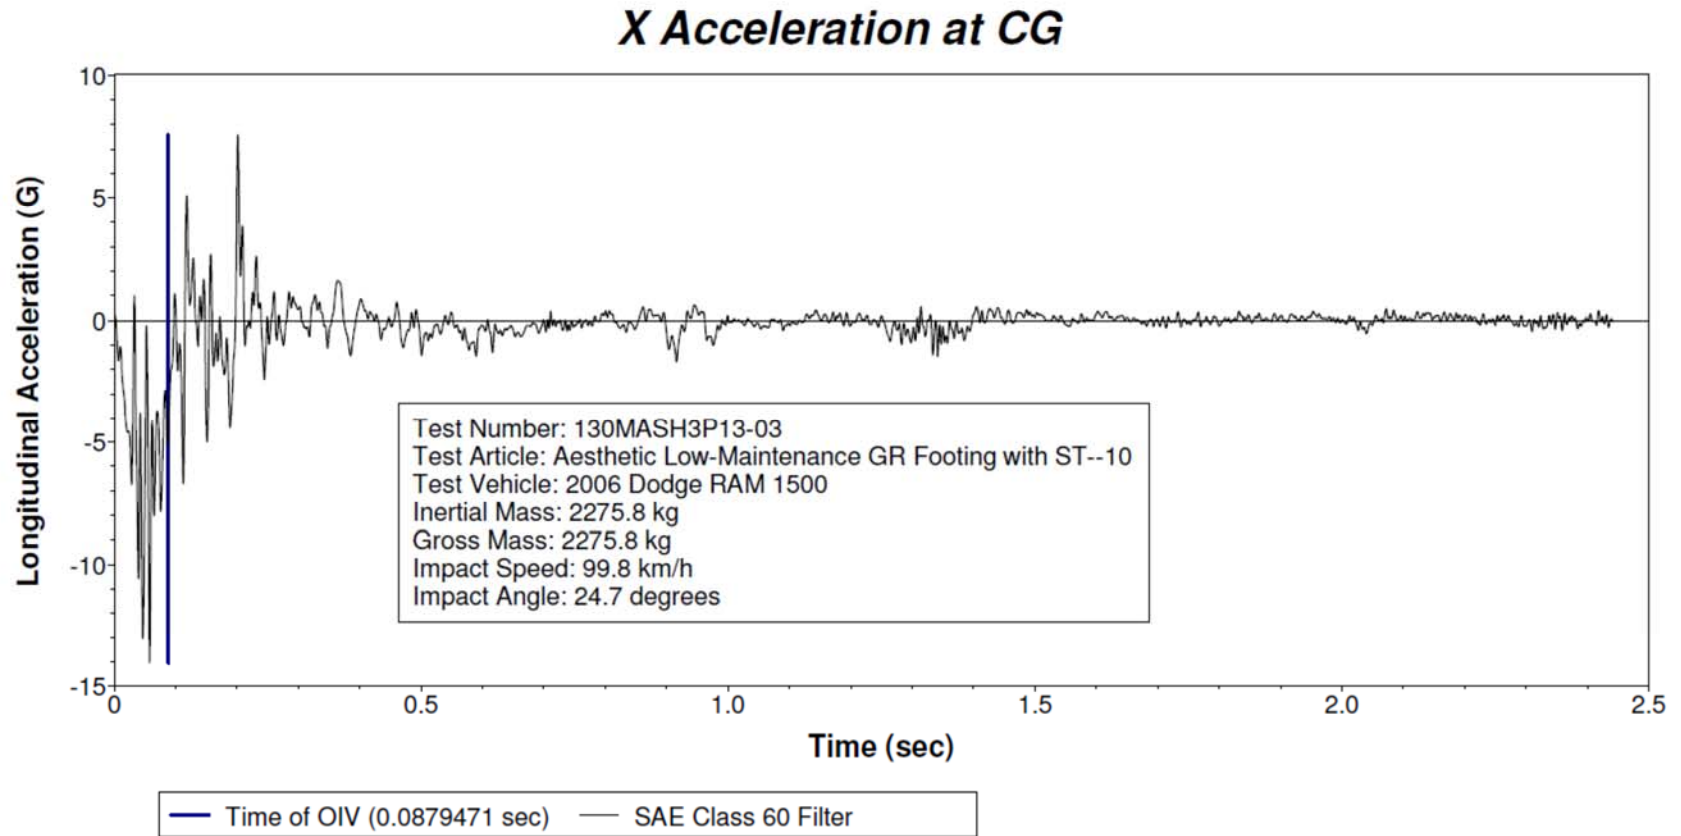
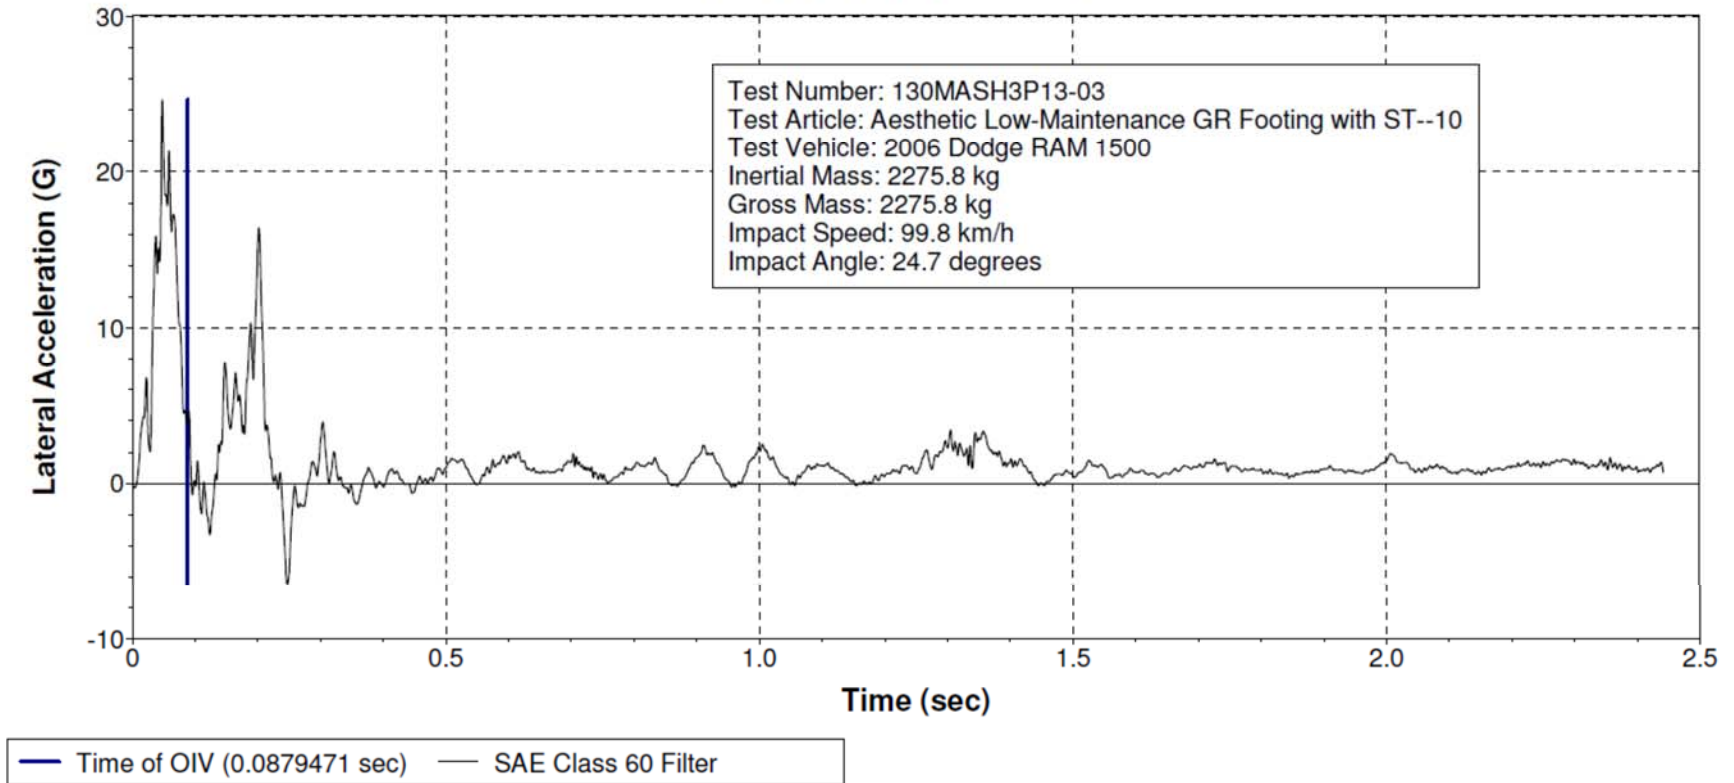
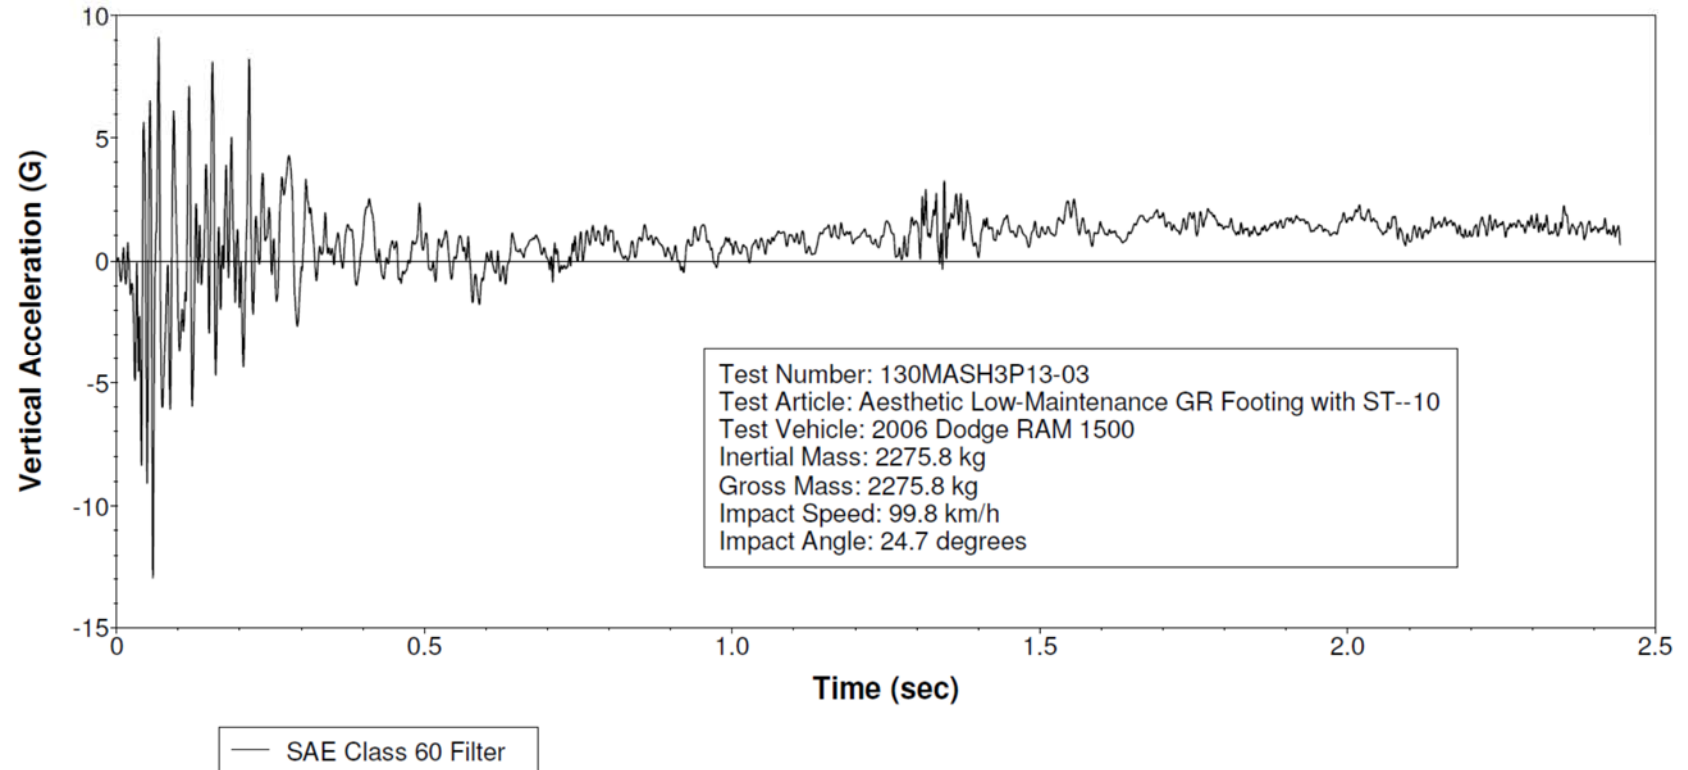
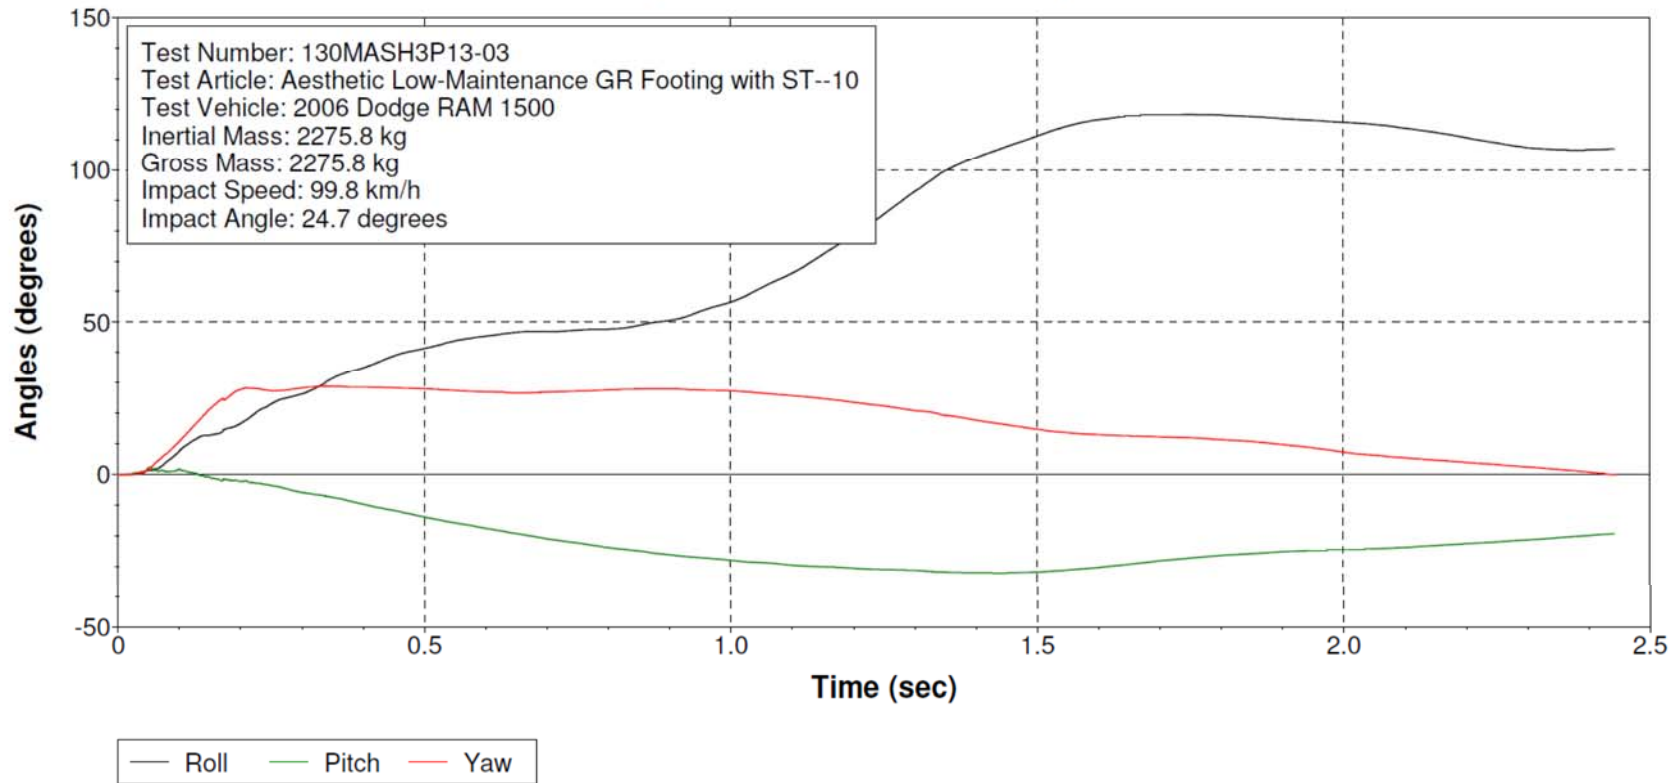
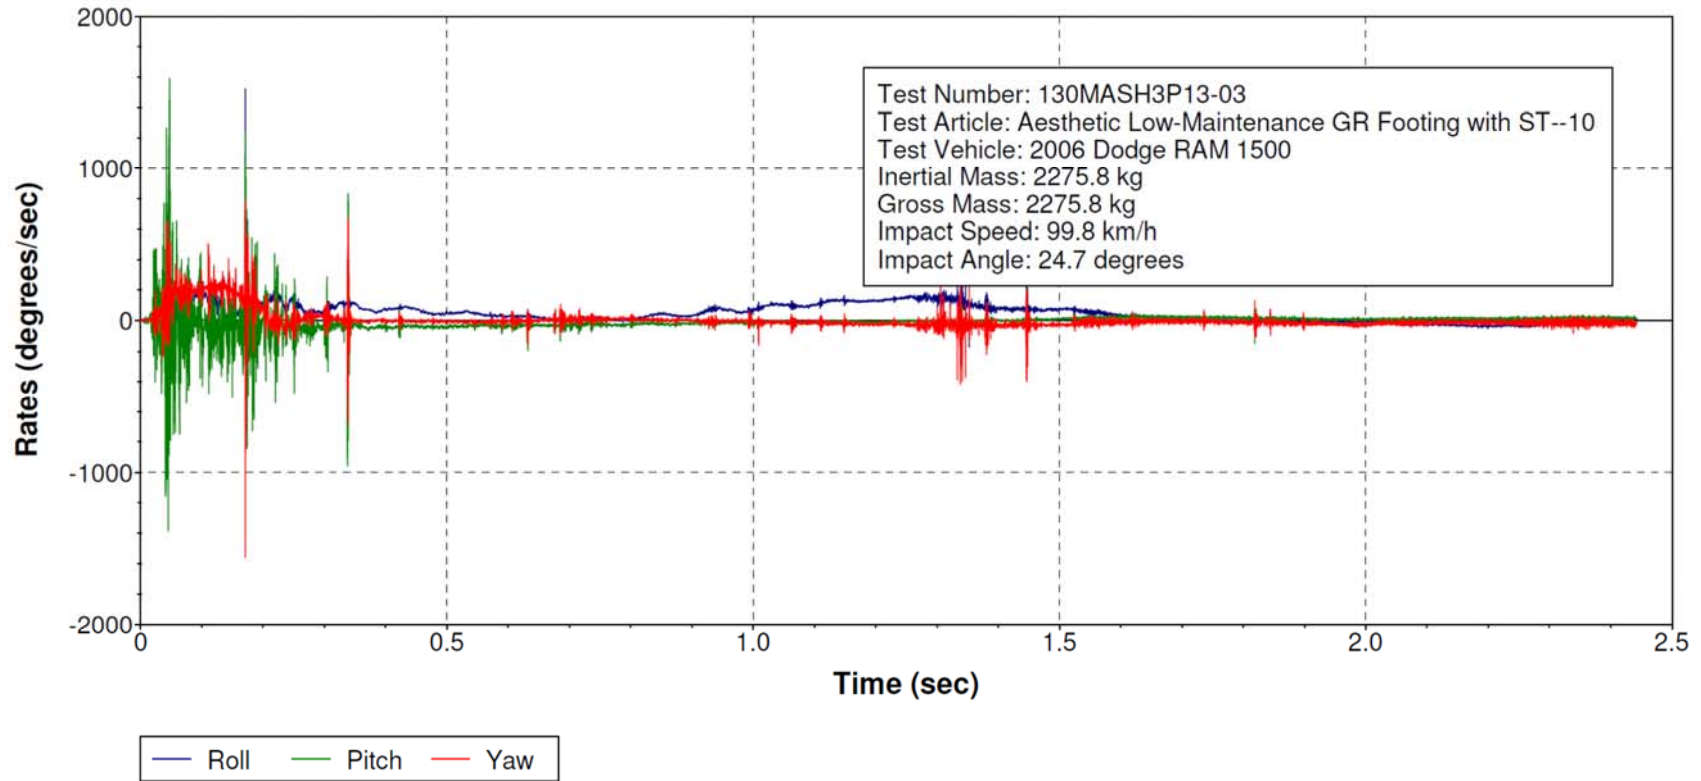
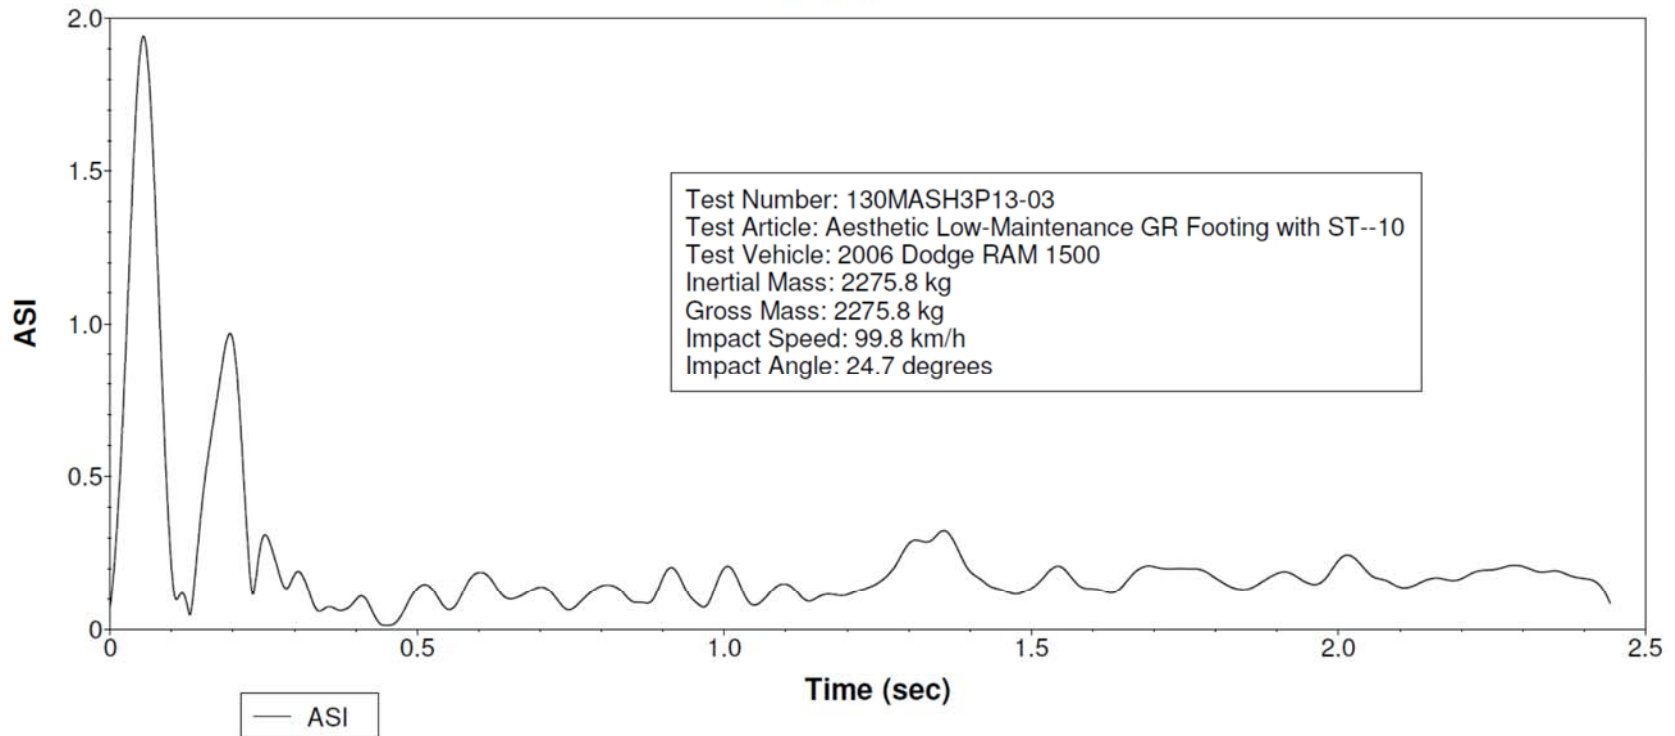
Figure 10-9 Vehicle Longitudinal Accelerometer trace for Test 130MASH3P13-03

Figure 10-10 Vehicle Lateral Accelerometer trace for Test 130MASH3P13-03

Figure 10-11 Vehicle Vertical Accelerometer Trace for Test 130MASH3P13-03

Figure 10-12 Vehicle Angular Displacements for Test 130MASH3P13-03

Figure 10-13 Vehicle Angular Rate of Change for Test 130MASH3P13-03

Figure 10-14 Acceleration Severity Index for Test 130MASH3P13-03

The data curves are shown in Figure 10-9 through Figure 10-14 include the accelerometer and angular rate sensor records from the test vehicle. They also show the velocity and displacement curves for the longitudinal and lateral components. These plots are required to calculate the occupant impact velocity defined in MASH. All data were analyzed using TRAP.

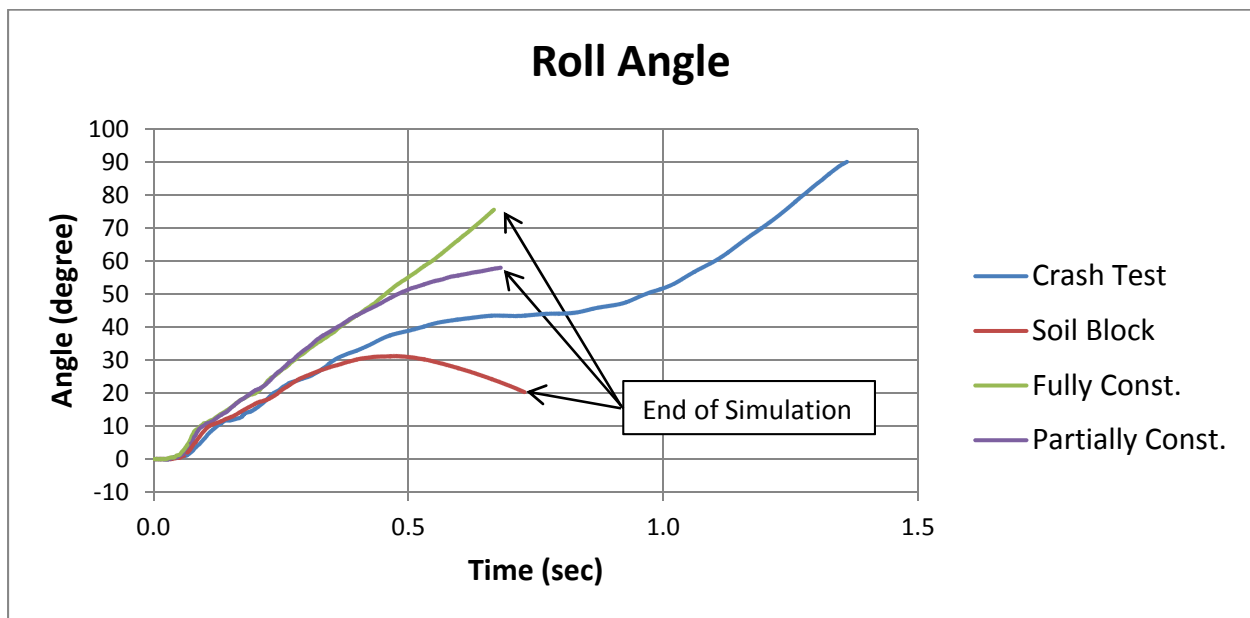
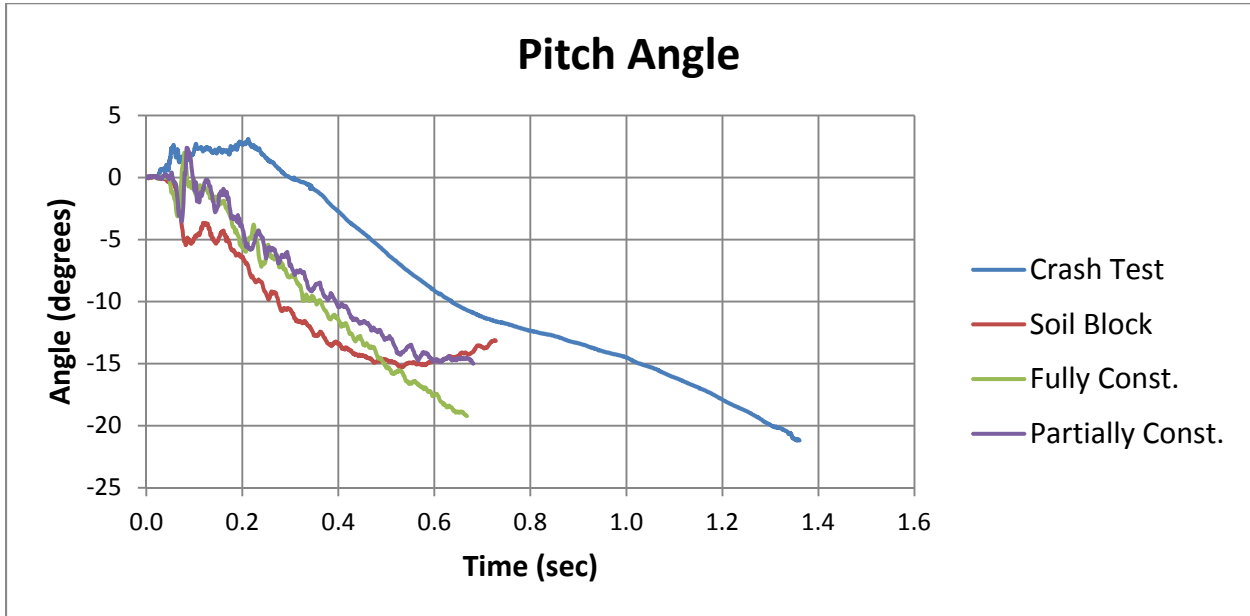
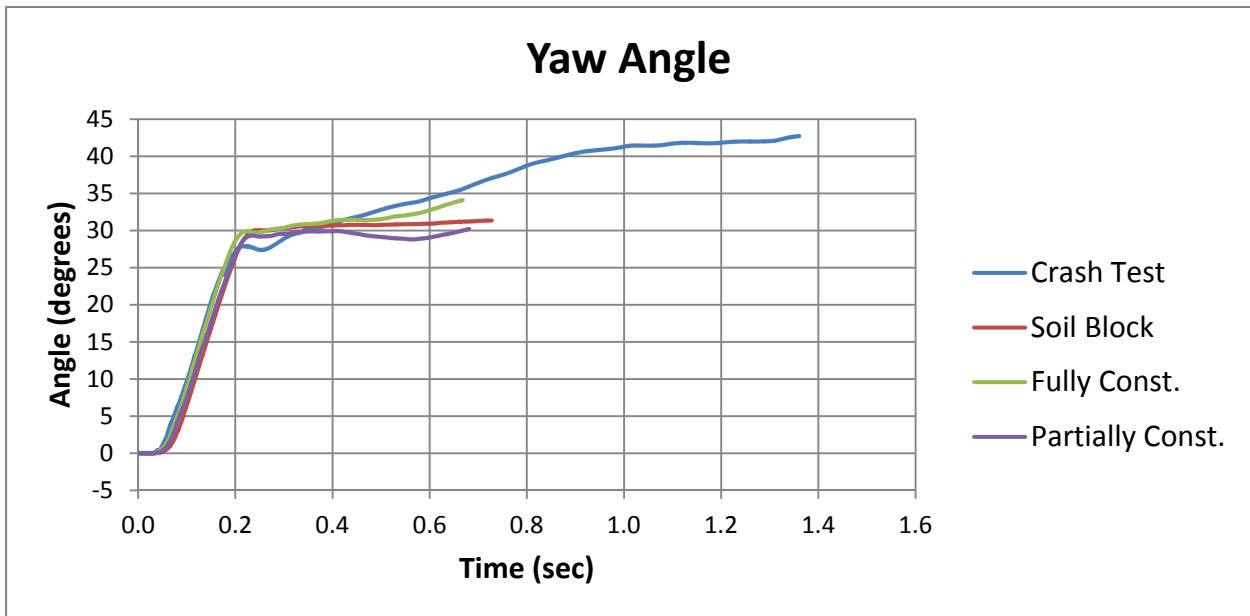
Figure 10-22 Comparing Crash Test and Simulation Roll Angles

Figure 10-23 Comparing Crash Test and Simulation Pitch Angles

Figure 10-24 Comparing Crash Test and Simulation Yaw Angles

The vehicle pitch angles for the crash test, the Fully Constrained model, and the Partially Constrained model have similar linear slopes once their angles start to decrease. The Soil Block model's vehicle pitch angle has a more parabolic shape compared to the crash test and the other two models. The yaw angles are very similar for the crash test and the simulation models.
