1. Report No. CA19-2543	2. Government Access No.	3. Recipient's Catalog No.	
4. Title and Subtitle Investigation of Polyester Concrete Overlay Rehabilitation Strategy to Extend the Service Life of Concrete Bridge Decks		5. Report Date October 2019

**INVESTIGATION OF POLYESTER CONCRETE OVERLAY
REHABILITATION STRATEGY TO EXTEND THE SERVICE
LIFE OF CONCRETE BRIDGE DECKS**

Draft Final Project Report

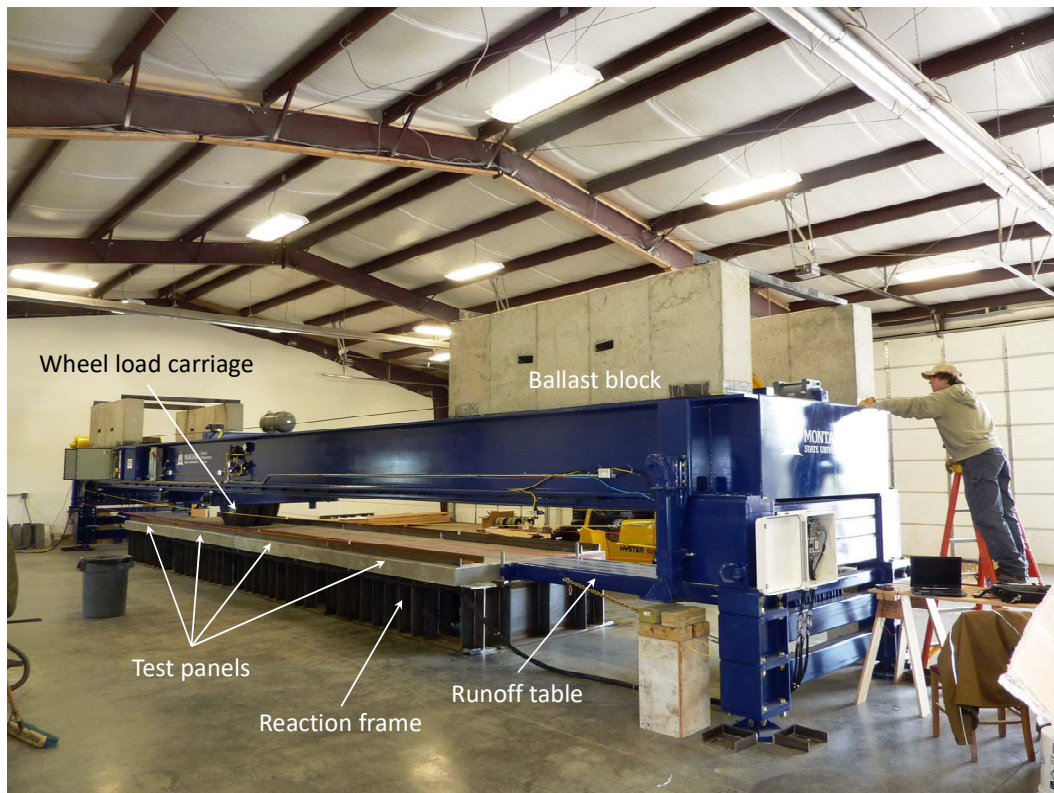
Figure 1: Automated bridge deck tester.

For testing, the deck panels were anchored in a reaction frame positioned under the rolling wheel loading device, as shown in Figure 1. The basic configuration of the reaction frame was developed during Phase I and is discussed in detail in Cuelho and Stephens (2013). To generate the expected stresses in the panels, the reaction frame was designed to provide the support conditions associated with the box-girder configuration, i.e., full restraint (no rotation or vertical translation) along the longitudinal edges of the panels, and simple support across the transverse panel edges. Another very important practical design consideration for the frame was that the bottom side of the panels had to be reasonably accessible for the purposes of monitoring crack development and measuring displacements.

The automated bridge deck tester (ABDT), designed and fabricated by Applied Research Associates, Inc. (Randolf, VT), was used to distress the test panels (Figure 1). This device can apply a rolling wheel load across a testbed 35 ft. in length at loads up to 30 kips. The load is applied through a single dual-wheel assembly equipped with 315/80 R 22.5 HSU2 tires rated for high load carrying capacity (load rating L = 9,090 lb. per tire for duals). Application of the load is accomplished through two 12-inch pneumatic cylinders which react against a stiff frame. The wheel carriage assembly was pulled back and forth across the test panels using a cable and winch assembly (Figure 4). The ABDT has the capability of applying load either unidirectionally or bidirectionally, with the loading in this project being applied bidirectionally. The total length of the ABDT is about 55 feet to accommodate runoff tables on both ends of the test area. The runoff tables provide sufficient acceleration and deceleration distance for the wheel to reverse direction and resume trafficking the test panels at a constant speed. The wheel carriage assembly

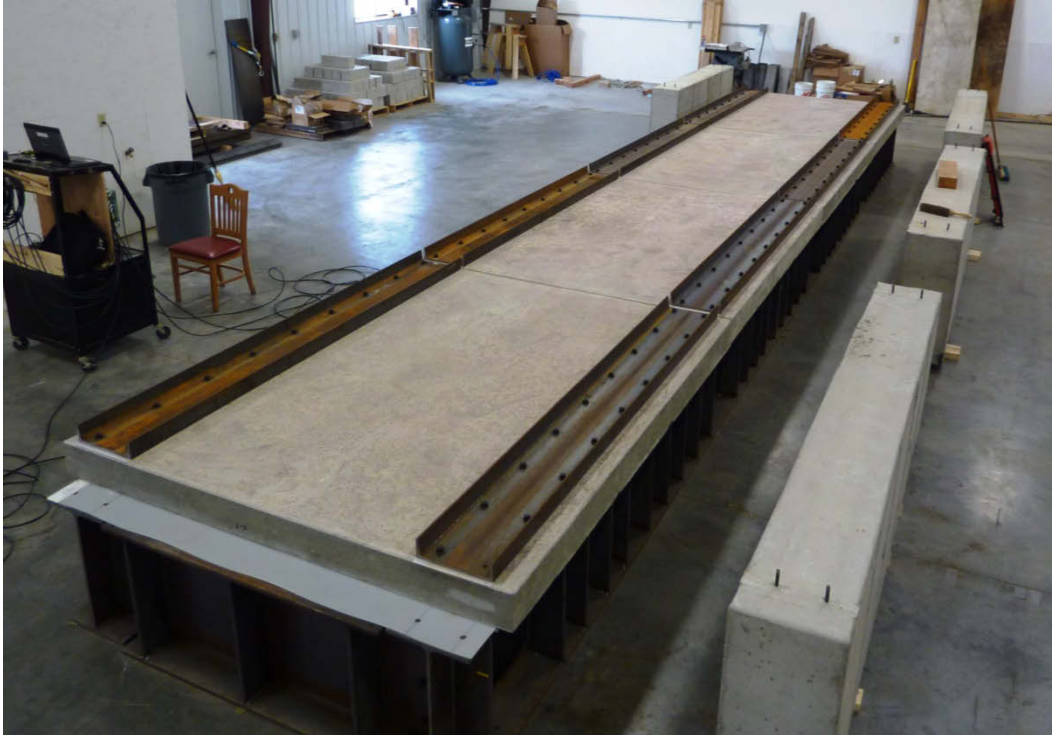
Figure 2: Test slabs mounted on reaction frame.

The reaction frame was designed to simultaneously accommodate four deck panels, and consisted of two continuous support beams along the longitudinal edges of the panels with short cross beams under the transverse edges that are shared between adjacent panels (Figure 2).

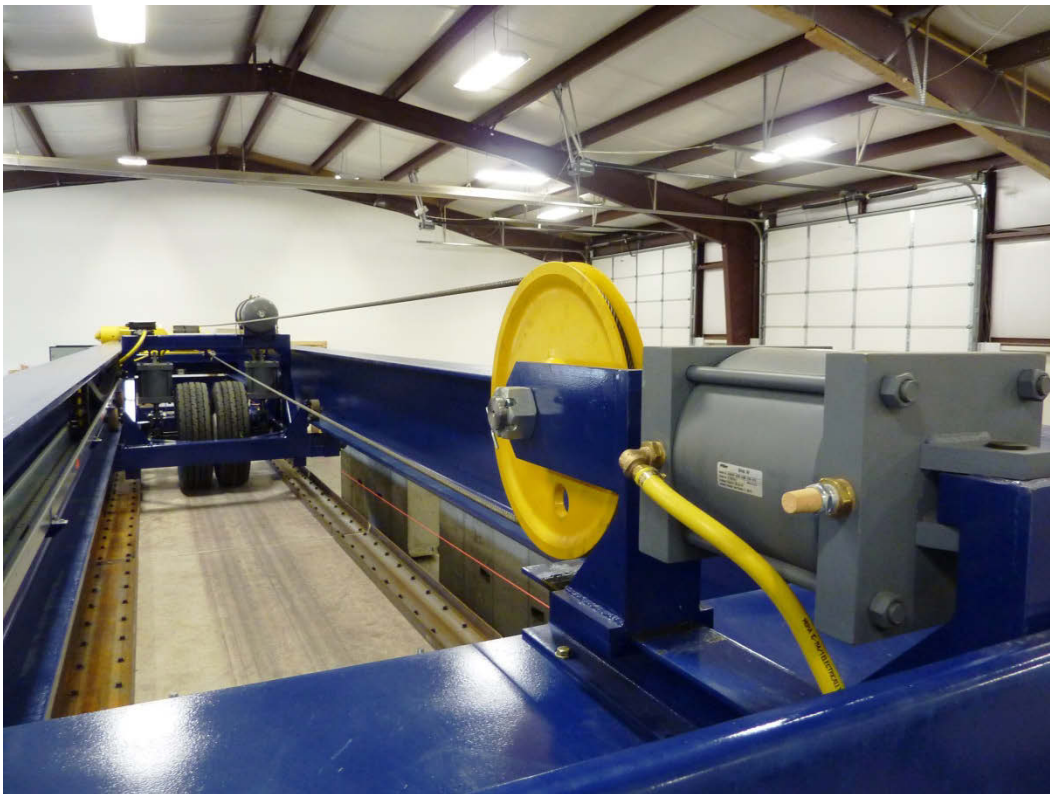
Figure 4: Drive cable and carriage assembly.

traveled at 8.8 ft/sec in these tests, the maximum speed of the device. At this speed, the ABDT could make 575 passes per hour, 13,800 passes per day (total, counting both directions). The height of the ABDT (and consequently the elevation of the applied load) is adjustable to accommodate a variety of sample heights. Concrete ballast blocks were cast to provide additional reaction for higher applied loads (greater than about 15 kips). The ballast blocks were positioned on top of the test frame at both ends.

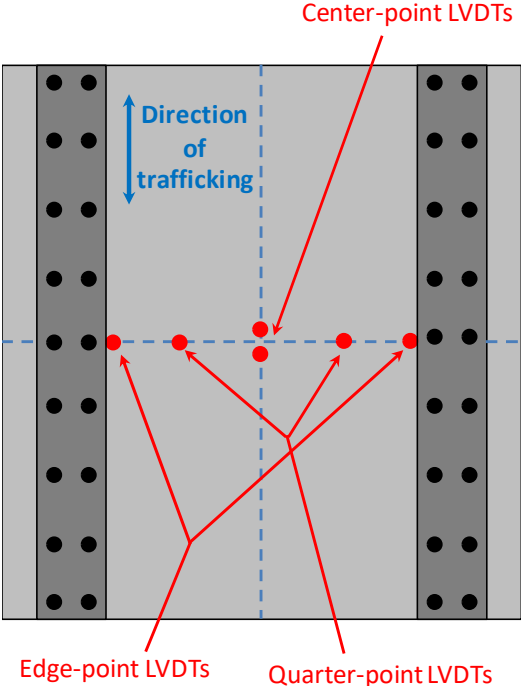
Figure 5: Locations of displacement measurements under each test panel.

Displacement and load were the primary measurements made using instrumentation. Vertical displacement measurements were made in six locations along the transverse centerline on the underside of each test panel: two at the center-point, two at the quarter-points, and two at the edge-points, as shown in Figure 5 and Figure 6. Linearly variable displacement transformers (LVDTs) were used to make the displacement measurements. Three additional LVDTs were used to monitor movement of the reaction frame with respect to the concrete floor, and another LVDT was simply placed on the floor, not attached to anything, to monitor potential creep or drift in the gauges. The LVDTs were calibrated to have a total range of 0.25 inches and an accuracy of ± 0.0001 inches. Deformation was calculated as the difference between either center or quarter point deflection and the edge deflection. Load was measured indirectly using a pressure gauge in line with the two pneumatic cylinders that applied the downward force through the load carriage. The number of passes was collected using an optical sensor. All the information from these sensors was sent to a CR9000 data logger (Campbell Scientific, Inc. (Logan, UT)). The data logger was programmed to scan the LVDTs and pressure cell at 200 Hz and record a single maximum and minimum value for each sensor over a five-minute period, resulting in two stored data points for each sensor every five minutes.

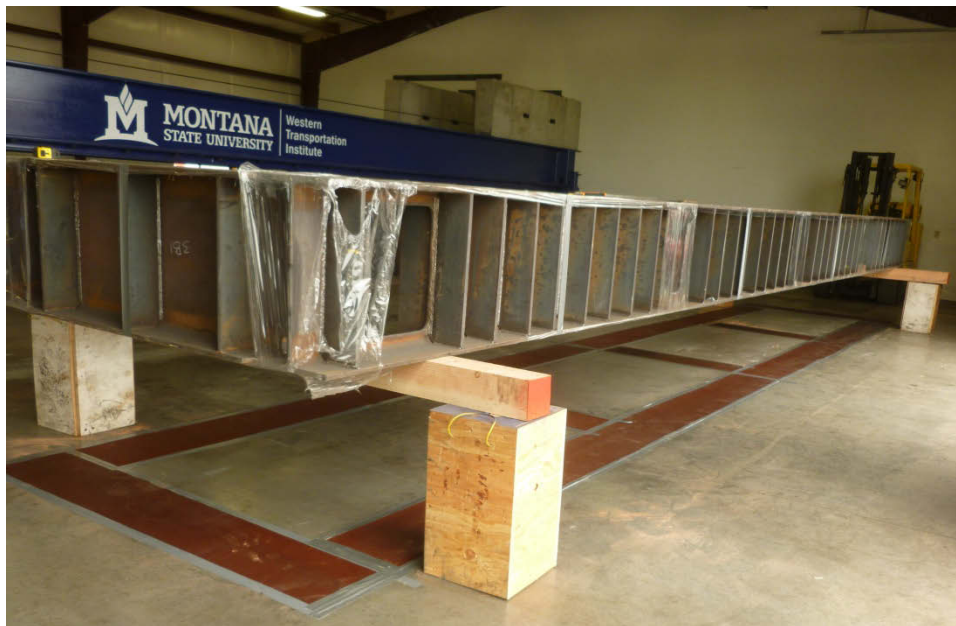
Figure 7: Reaction frame ready to be grouted to the floor.

The first step was to elevate the reaction frame above the place where it was to be grouted to the floor. Because the lab floor was slippery, a piece of rough geosynthetic was taped in place where the grout was to be spread (Figure 7). The grout was mixed and placed on the surface of the geosynthetic (Figure 8), and the frame was gently set in place. Plastic wrap was used to keep the grout from fully adhering to the various surfaces (specifically frame to grout, panels to grout, c-channels to grout) to aid disassembly at the end of the project. A panel being grouted to the frame is shown in Figure 9. As shown in Figure 9, four pieces of rebar were used to guide the panel into position to ensure that all the bolt holes in the reaction frame lined up with holes cast in the deck panel. Burlap was used on the surface of the plastic wrap on top of the deck panels to facilitate spreading of the grout (see Figure 10).

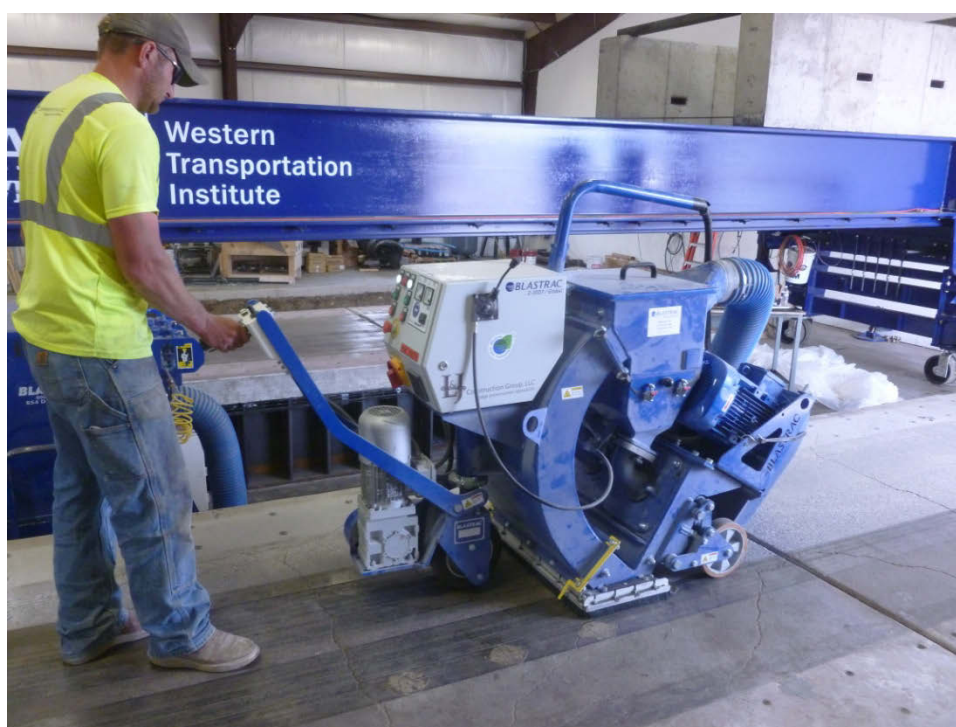
Figure 13: Shot blasting the deck panels in preparation for the polymer overlay.

Kwik Bond Polymers (Benicia, CA) PCC™-1121 polymer-based overlay system was used as the sole rehabilitation technique during this project (product data sheet in [Appendix X](#)). Six of the eight deck panels were treated in a single day, excluding the Control test panels where no treatment was used. The panels were steel shot blasted and cleaned using compressed air in accordance with California's Standard Specifications Section 15-501C(2) *Prepare Concrete Deck Surface*. L & J Construction Group, LLC (Ennis, MT) shot blasted the panels using a Blastrac 2-30 DS Electric Concrete Shot Blaster and 854 Dust Collector in preparation for the polymer overlay (Figure 13). The shot blaster made a single pass across the deck surface and removed only a very thin layer of material.

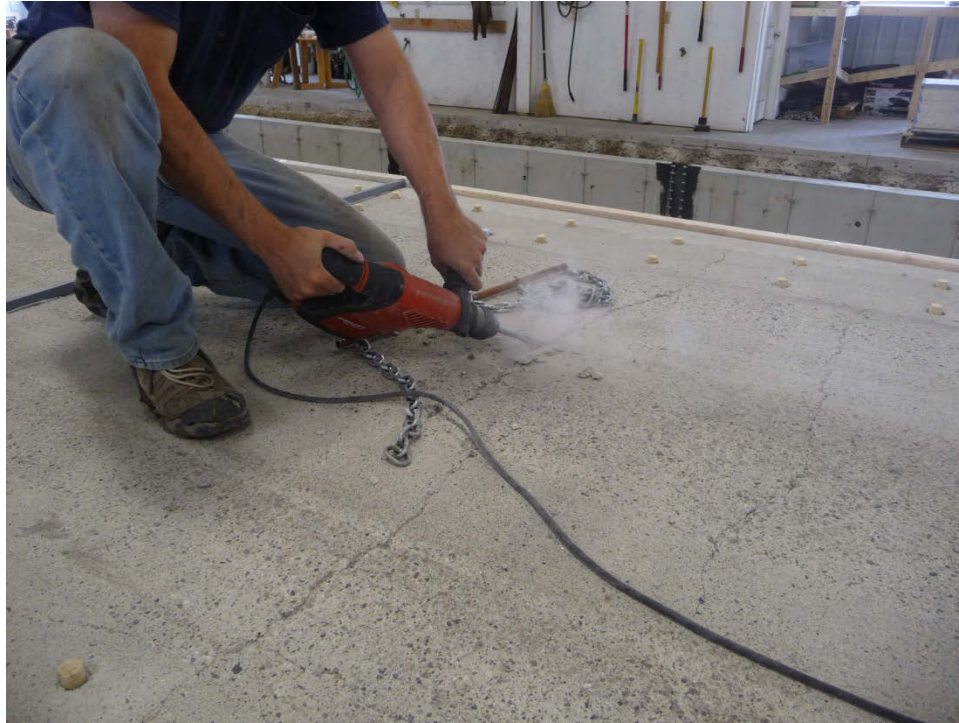
Figure 14: Removal of spalled concrete.

Several areas on the M25 panels had experienced delaminations, as discovered using sounding techniques (ball-peen hammer and chain-drag). A hammer-drill with a chisel bit was used to remove loose concrete in these areas (Figure 17). The depth of the concrete removal was generally less than about a half inch (Figure 15). The majority of the delaminations occurred on the M25_b test panel (Figure 16) and only a limited area on M25_a. The affected areas were documented during the visual assessments as discussed in greater detail below and illustrated in the crack maps in [Appendix X](#). The delaminated areas were not filled with concrete but were filled with the polymer overlay during the remaining installation.

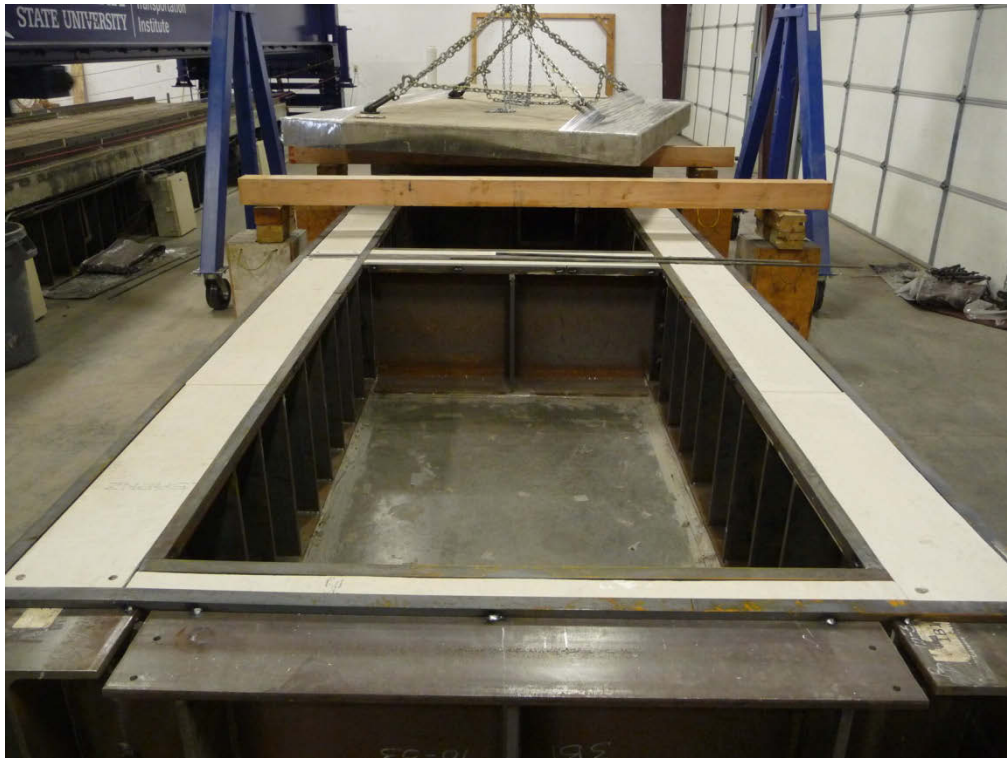
Figure 21: Height adjustment for control panels.

The thickness of the rehabilitated deck panels was increased by $\frac{3}{4}$ in.; however the control test panels remained at their original thickness (6.5 in.). The surface of the test panels were required to be at the same level to facilitate smooth trafficking; therefore, it was necessary to raise the control panels up $\frac{3}{4}$ in. This was accomplished by adding $\frac{3}{4}$ in. x 2 in. steel stock around the perimeter of the reaction frame flange, and filling the interior with concrete board (Figure 21). An illustration of this clamping configuration is illustrated in Figure 22.
