## Road Safety Assessment (RSA)

SR 126 – Santa Paula to Fillmore  
Ventura Co., California  
July 2014

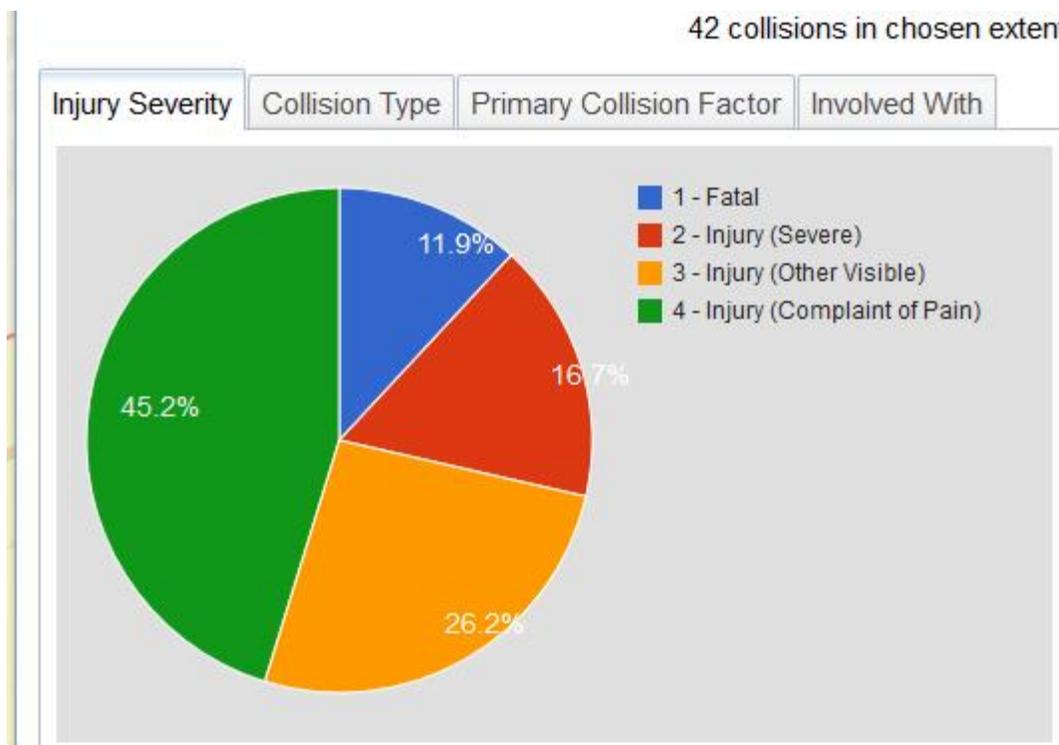
# Figure F6 PCF: Improper Turn

Injury Severity	Collision Type	Primary Collision Factor	Involved With
		<b>Primary Collision Factor</b>	<b>Collisions</b>
			<b>Percentage</b>
		08 - Improper Turning	42
			100%

Exploring those two PCFs a bit more closely, we clearly see the connection between "Unsafe Speed" and Rear-End Crashes [Figure F5]. Likewise, we see a clear linkage between "Improper Turn" and "Hit Object" [Figure F6].

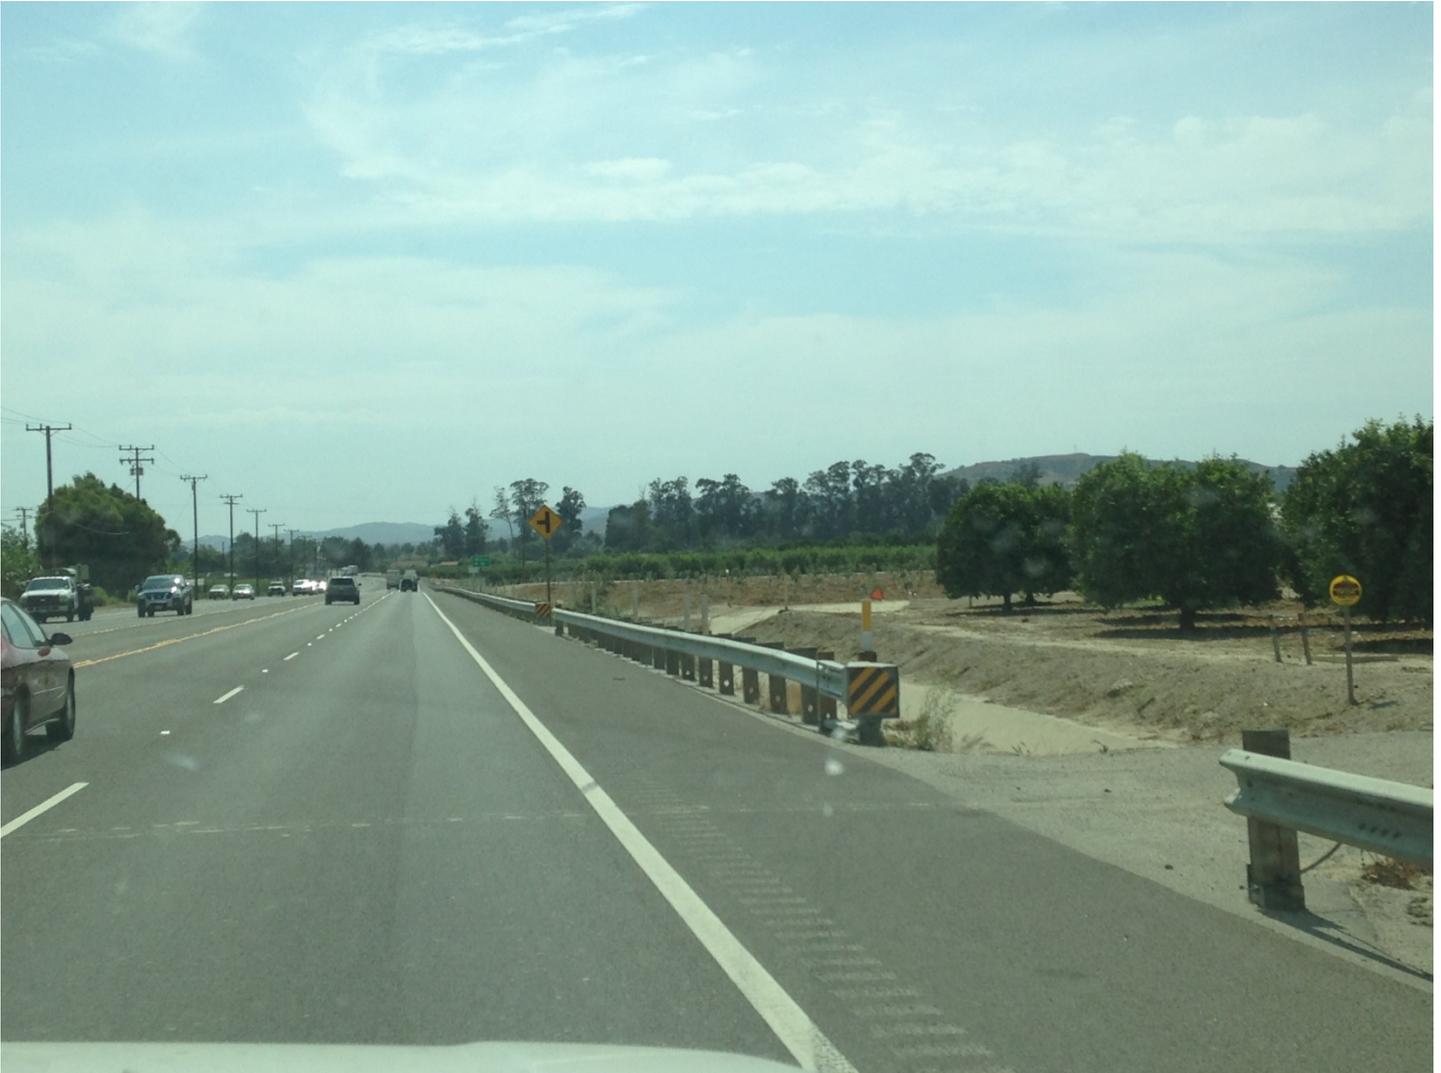
Combining and closing closely spaced driveways, as seen here, could reduce the number of access points (traffic conflict points) as well as eliminate a guardrail end treatment

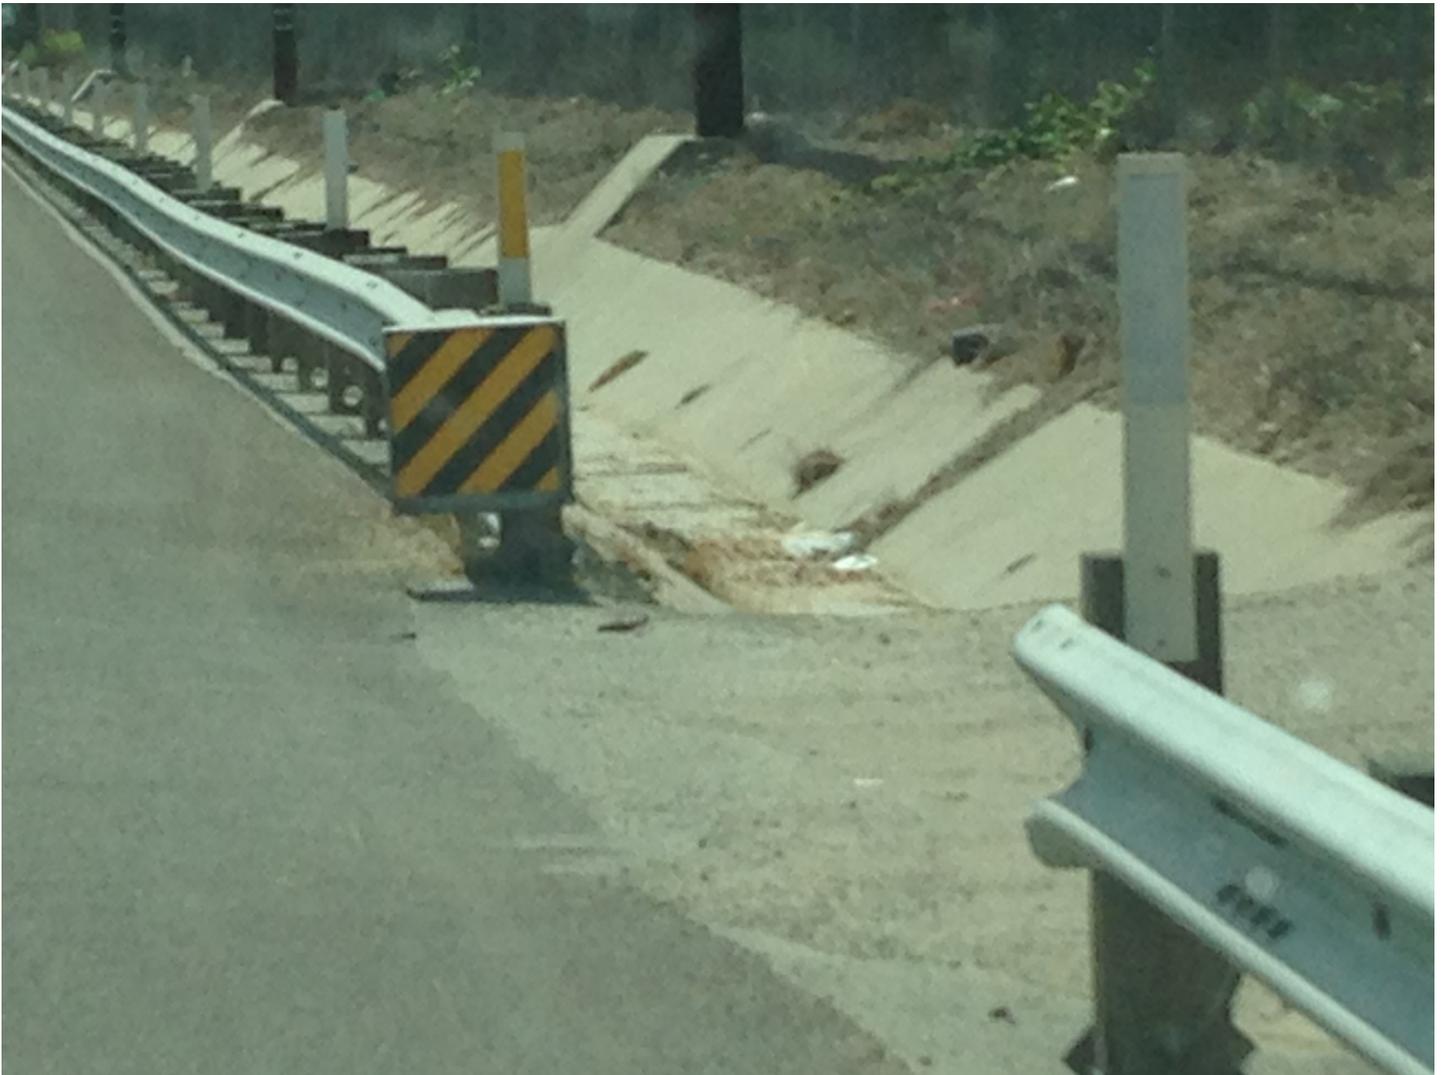
Narrow driveway aprons make turns difficult, even for small vehicles

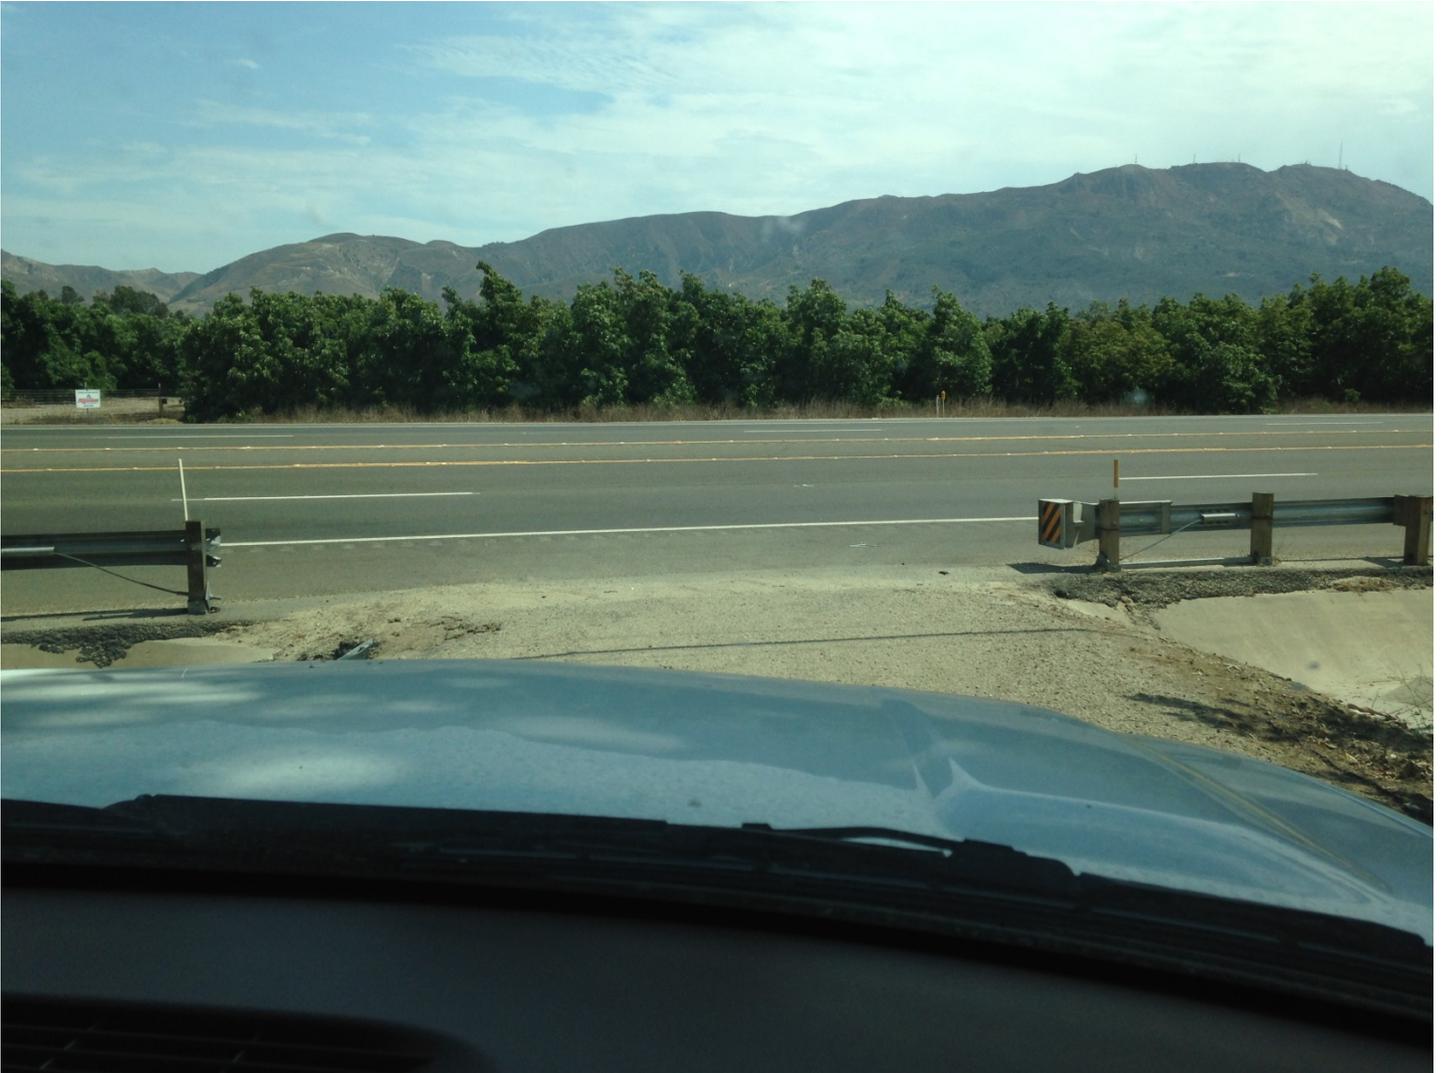
Narrow driveway aprons make turns difficult, even for small vehicles

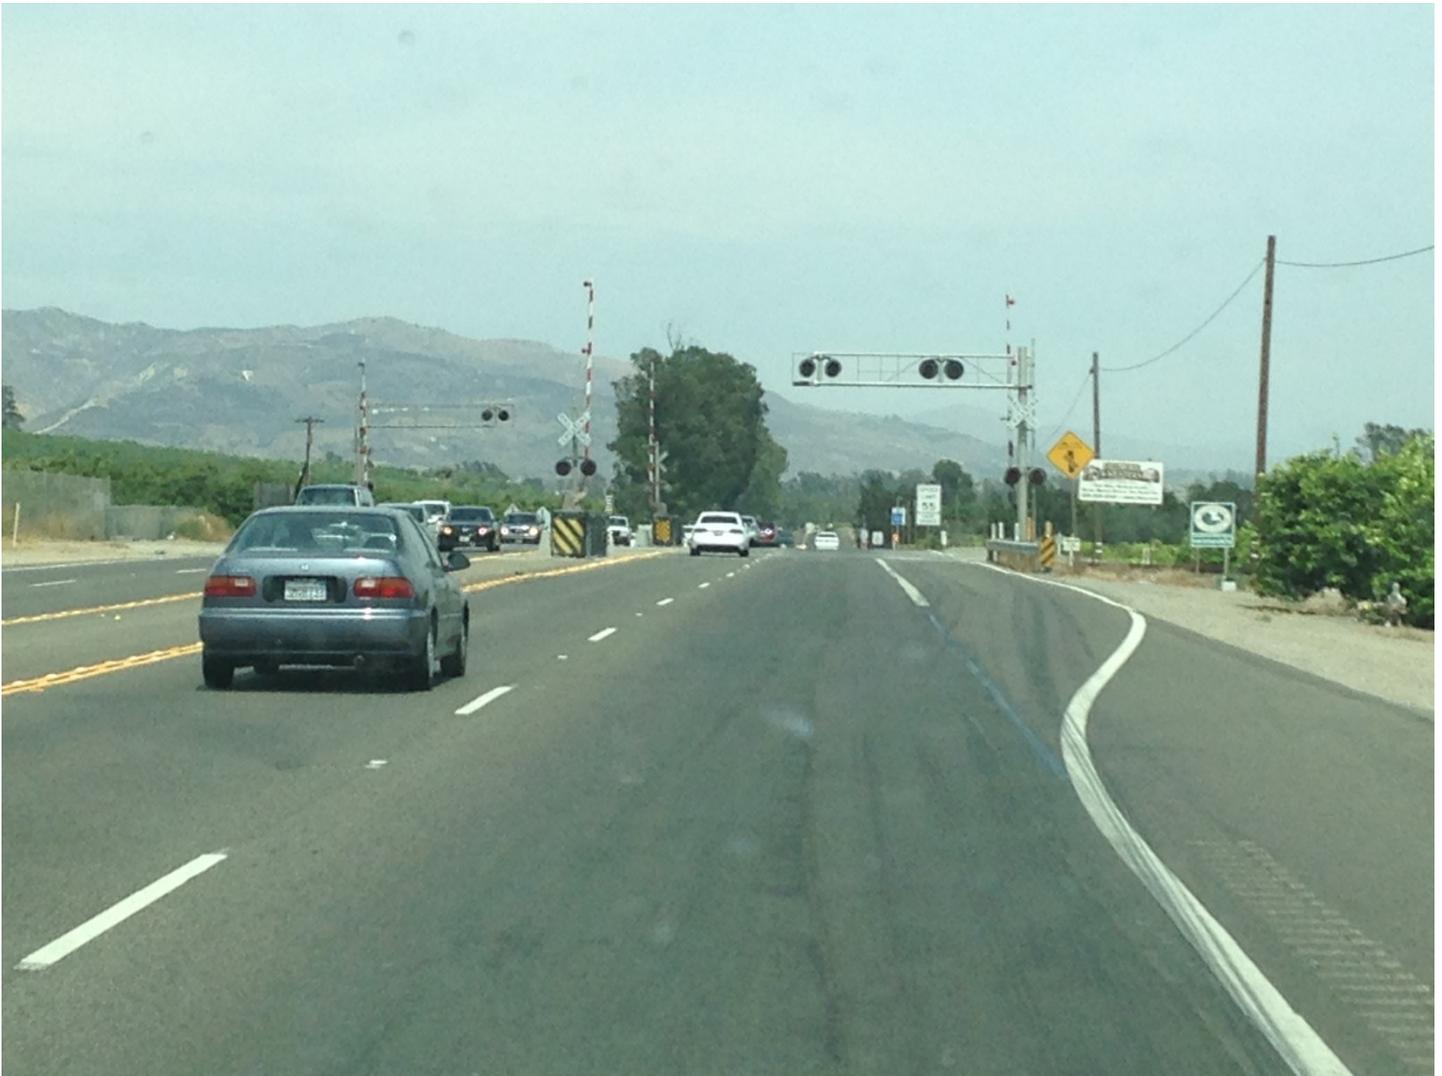
Sespe Rd RR Crossing, looking west. Note the marked pullout area for vehicles legally required to stop.

The Sespe Creek crossing approaches include a widened shoulder (pull-out area) meant to enable those vehicles (certain trucks and buses) legally required to stop at the crossing to not impede following traffic. This targeted widening was absent from the Hallock crossing, causing non-exempt vehicles to have to stop in an active travel lane. Several rear-end crashes here may have been caused, in part, by drivers not expecting a vehicle to be stopping or slowing when signals and gates have not been activated by an approaching train.

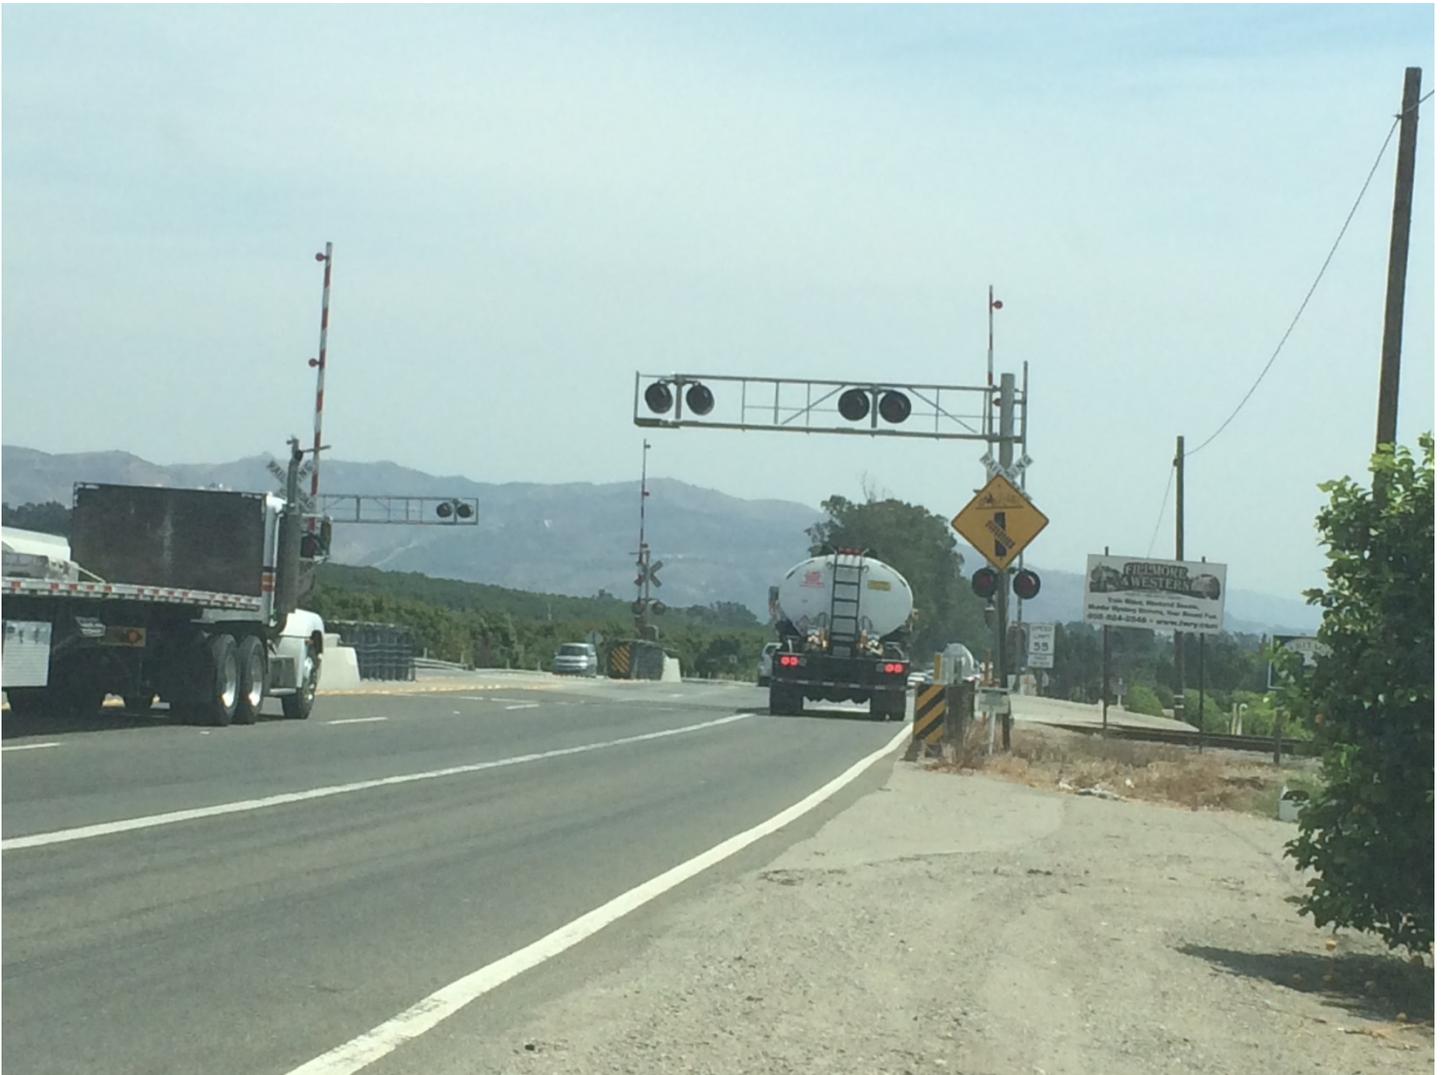
Sespe Rd RR Crossing, looking west. A tanker has used the designated pullout area to stop outside of the active travel lane.

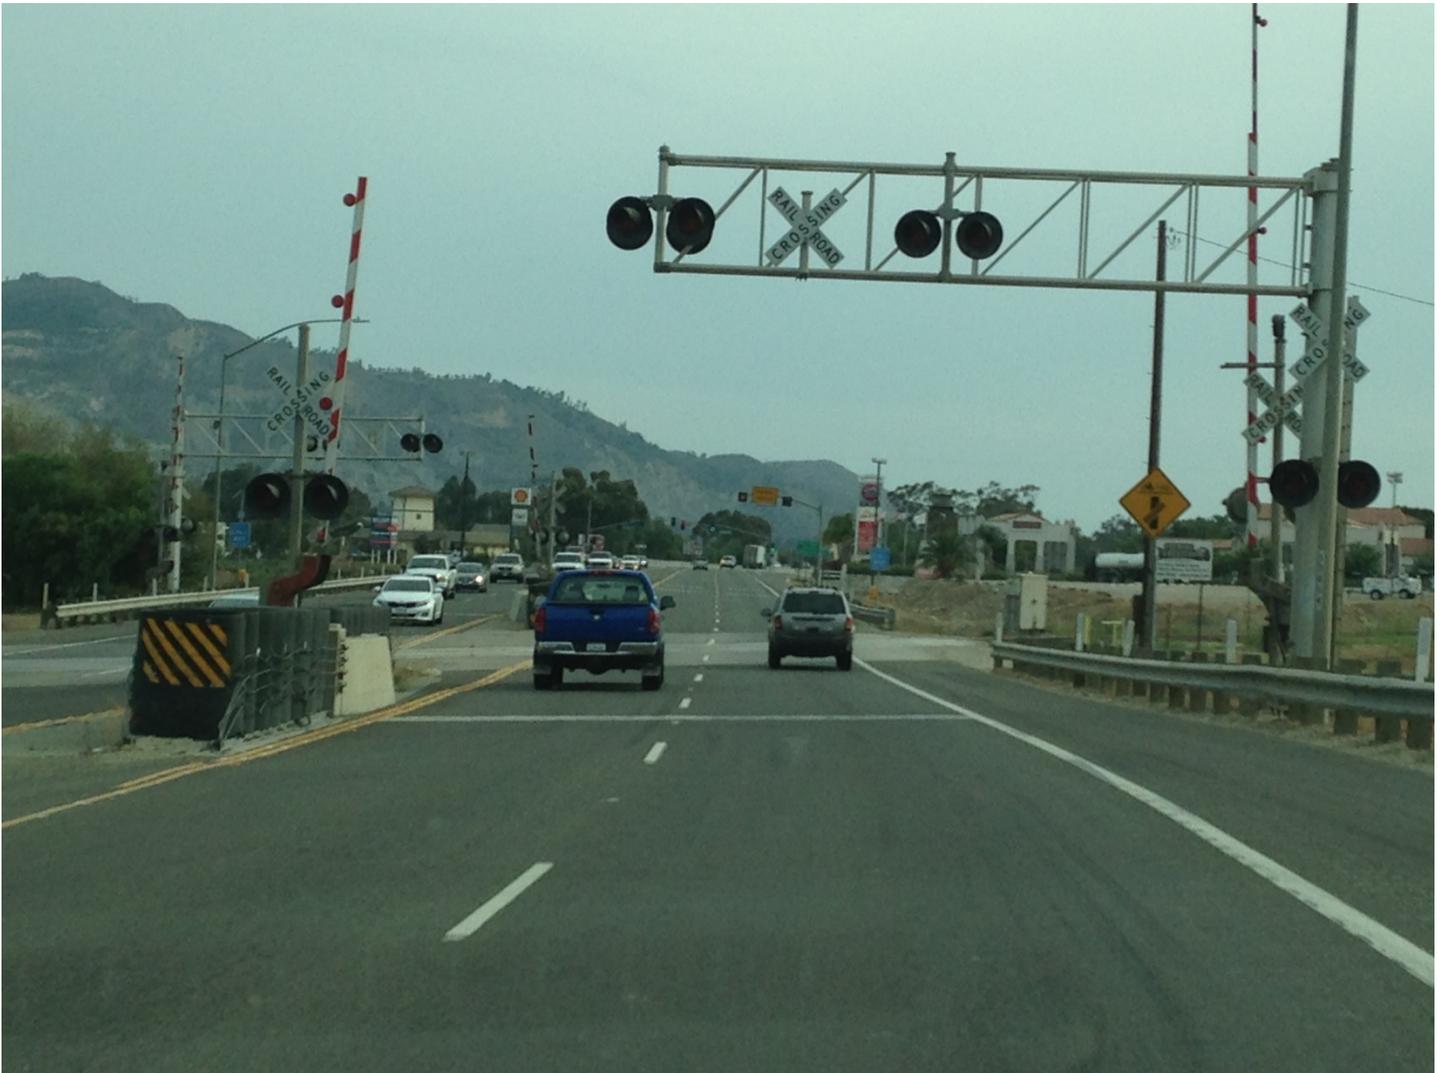
Hallock Drive RR Crossing, looking west. Note the absence of a marked pullout area for vehicles legally required to stop.

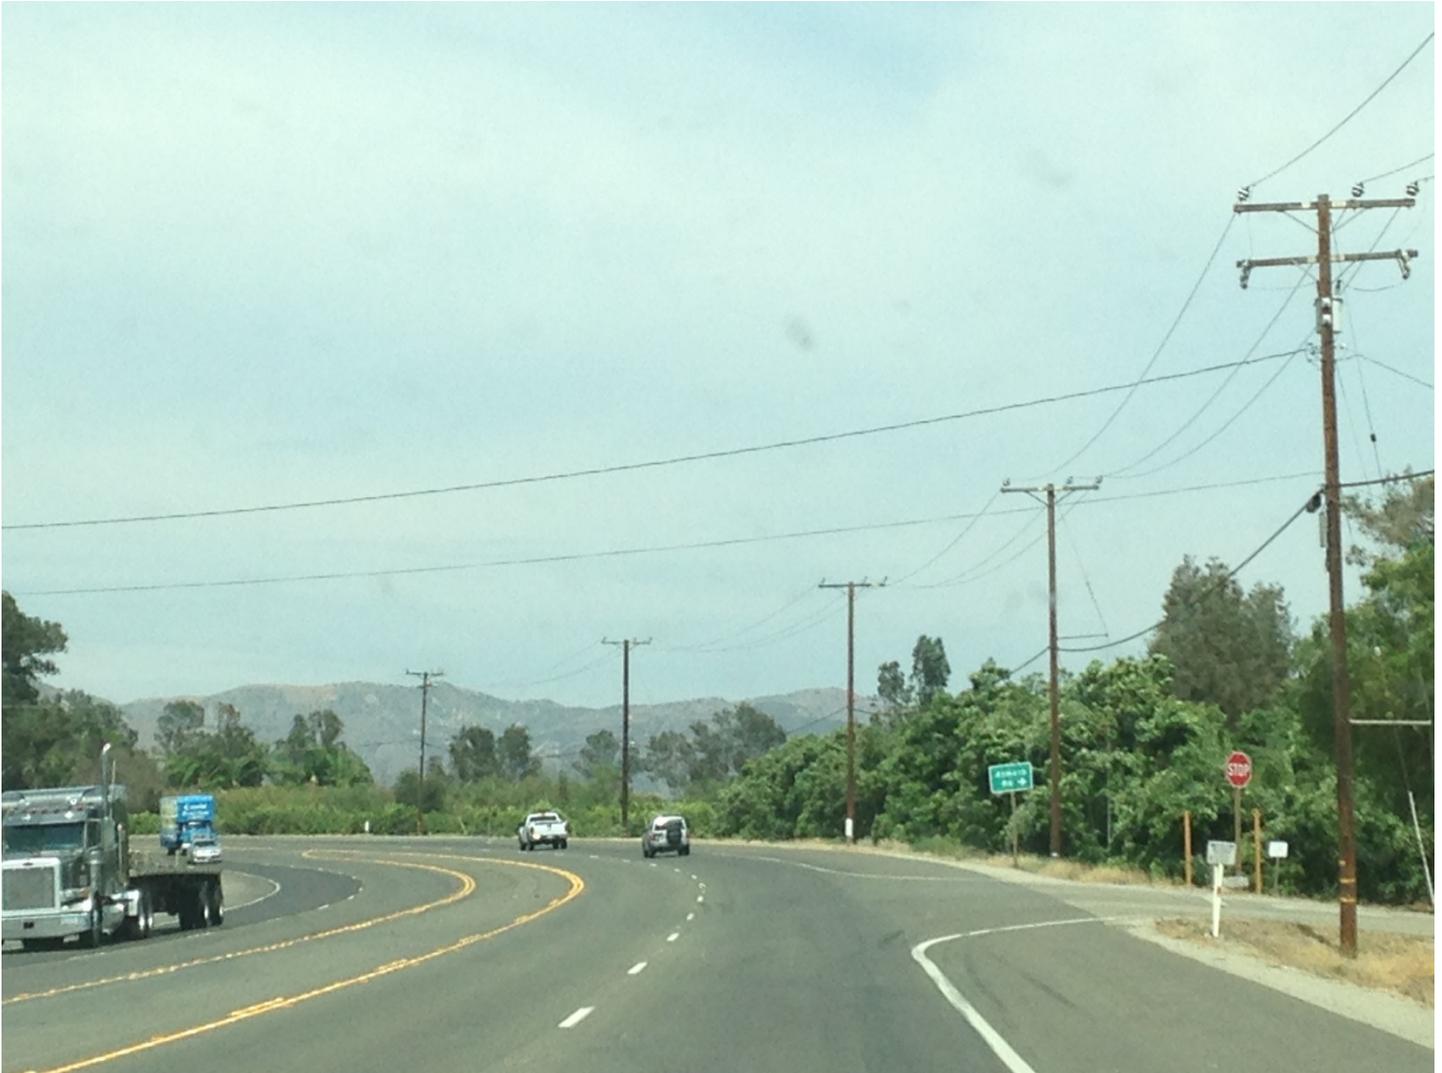
Placing chevrons along the outside of a curve and installing luminaires would enhance the driver's ability to track the curve as well as see and react to conflicting turns into and out of the side road.

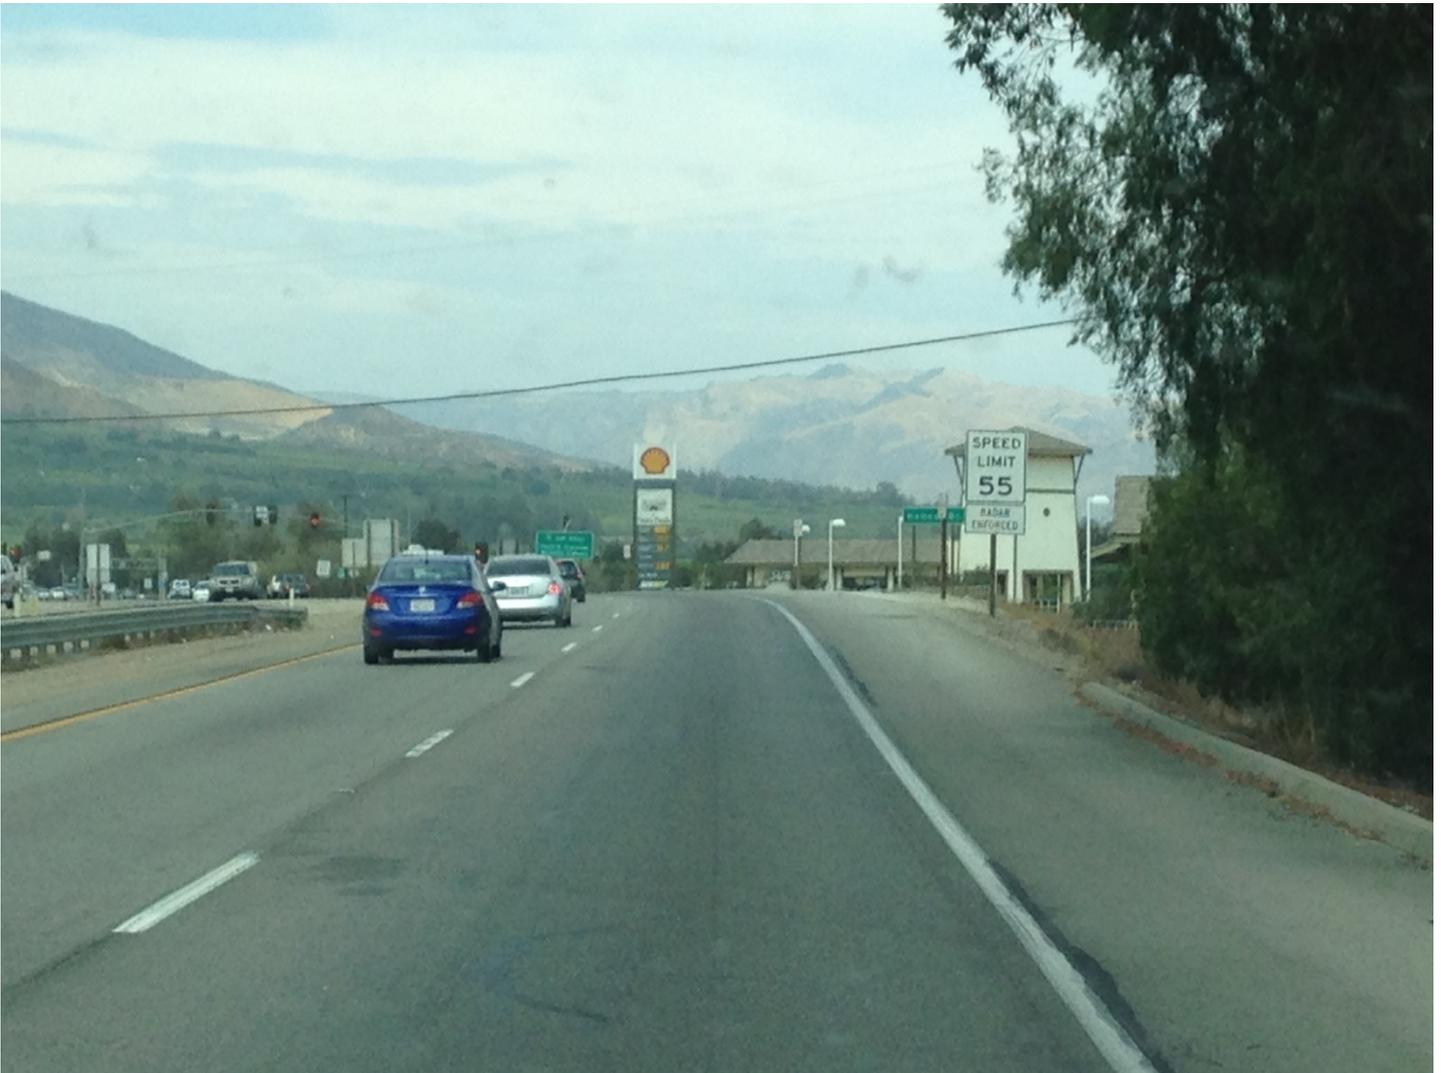
Drivers approaching Hallock Drive on the eastern end of the freeway section of SR 126 see a service station directly ahead of them. The signalized intersection is offset to the left and may not be readily detected at night or if a large truck blocks the driver's view.

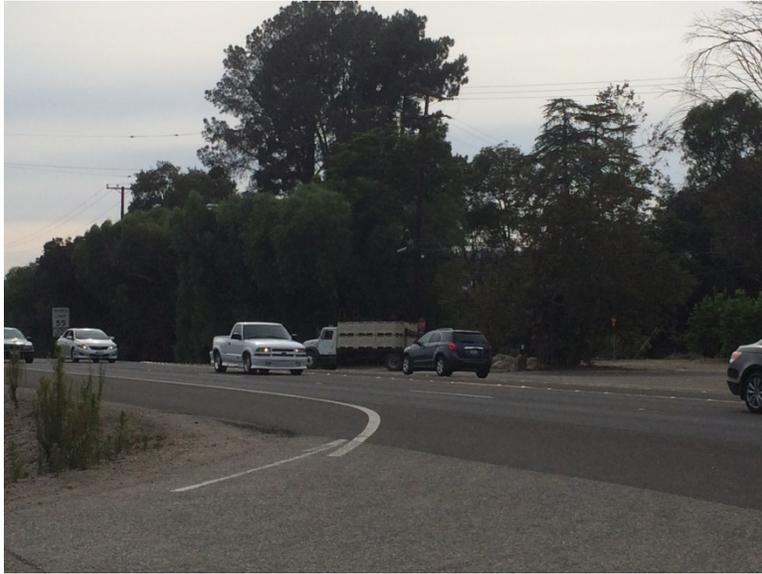
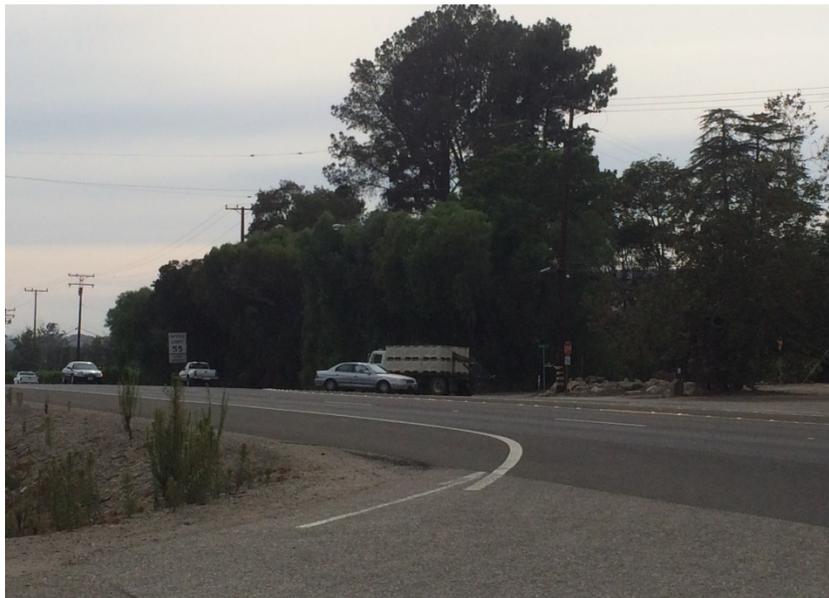
Rather than wait for a gap in eastbound traffic, this farm vehicle driver chose to turn right (west) and still had to wait for an eastbound car turning left to “shield” his turn

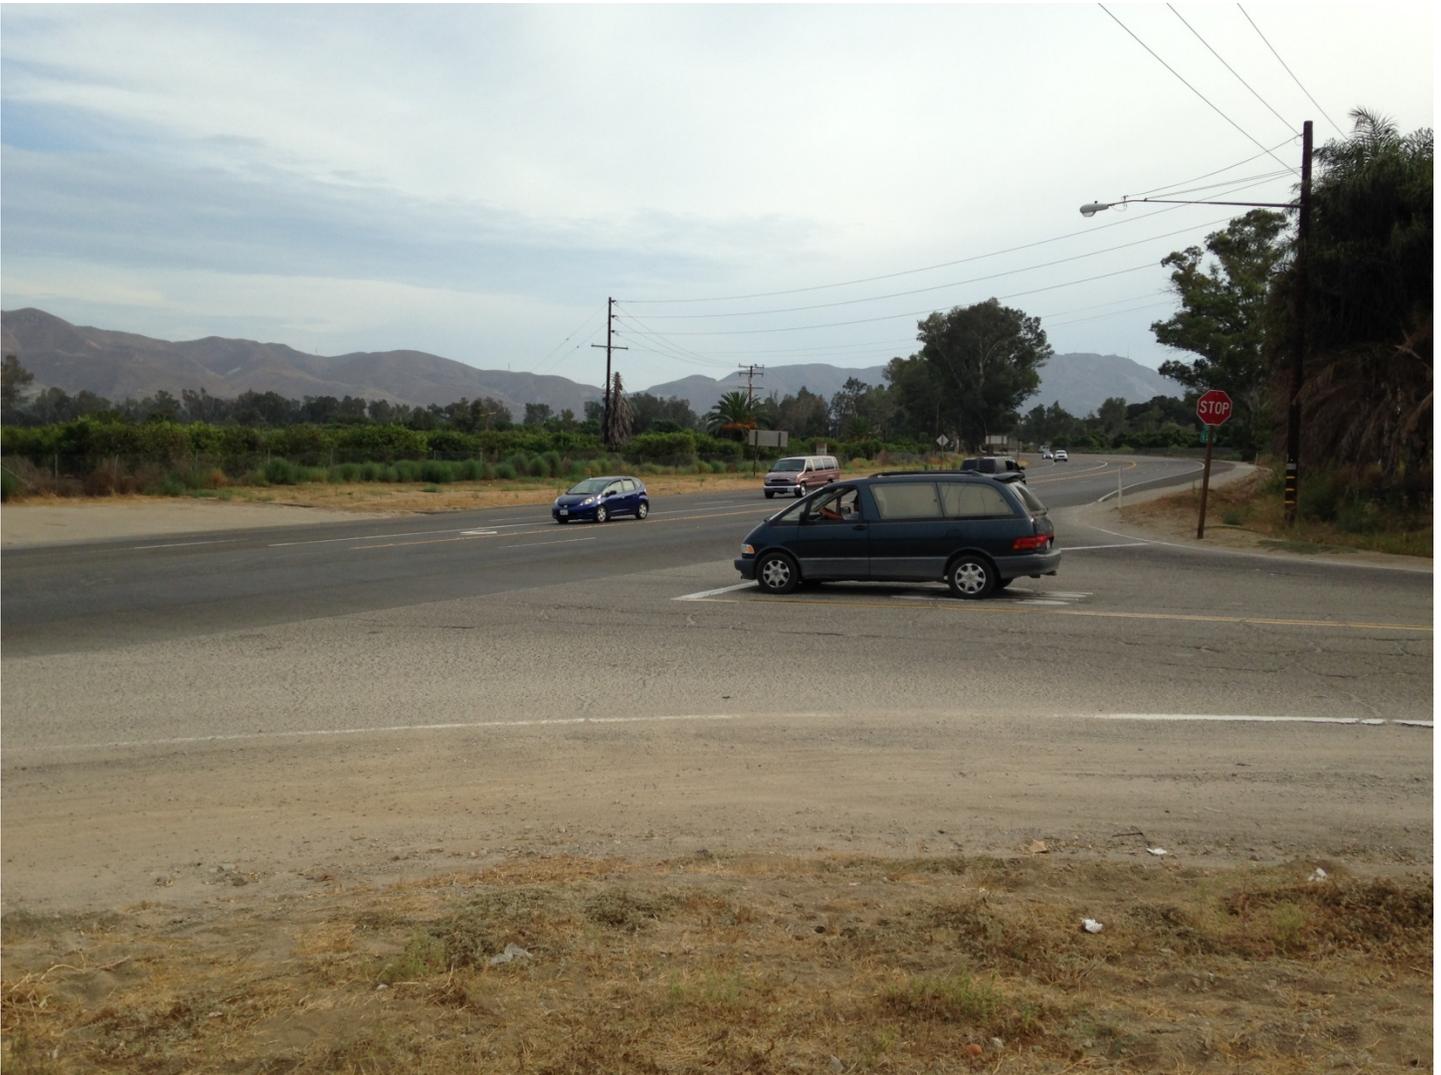
Owing to the high volume, high speed approach traffic on SR 126, very few drivers were observed to wait for a gap in traffic to execute a left turn as this driver did.

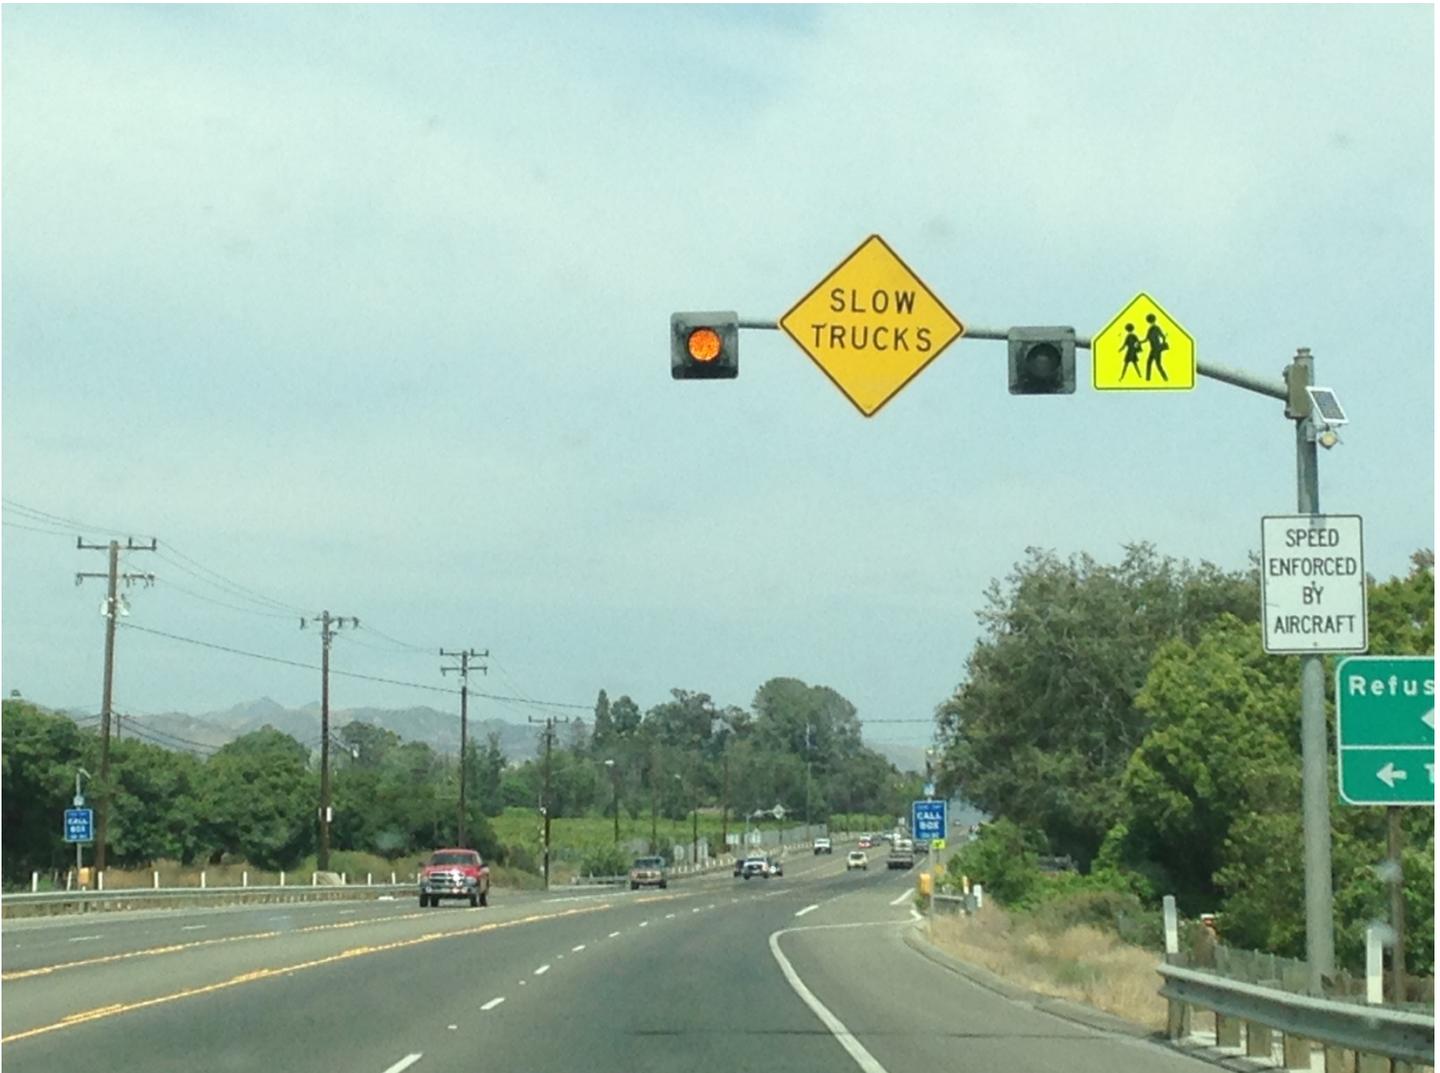
The cantilever sign here seems to emphasize being vigilant for slow trucks more so than for pedestrians.

Note also the sign clutter (directional sign and speed enforcement sign) and the tree line obscuring the driver's view of the school.

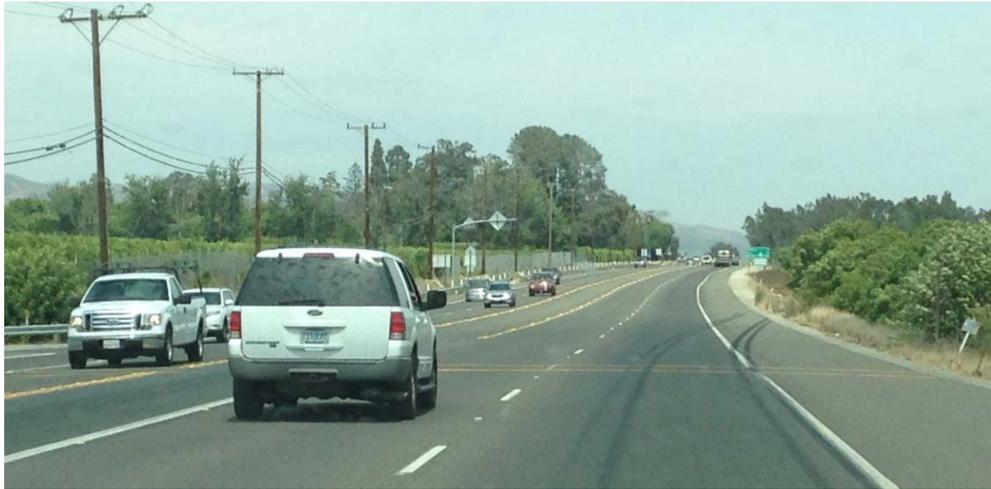
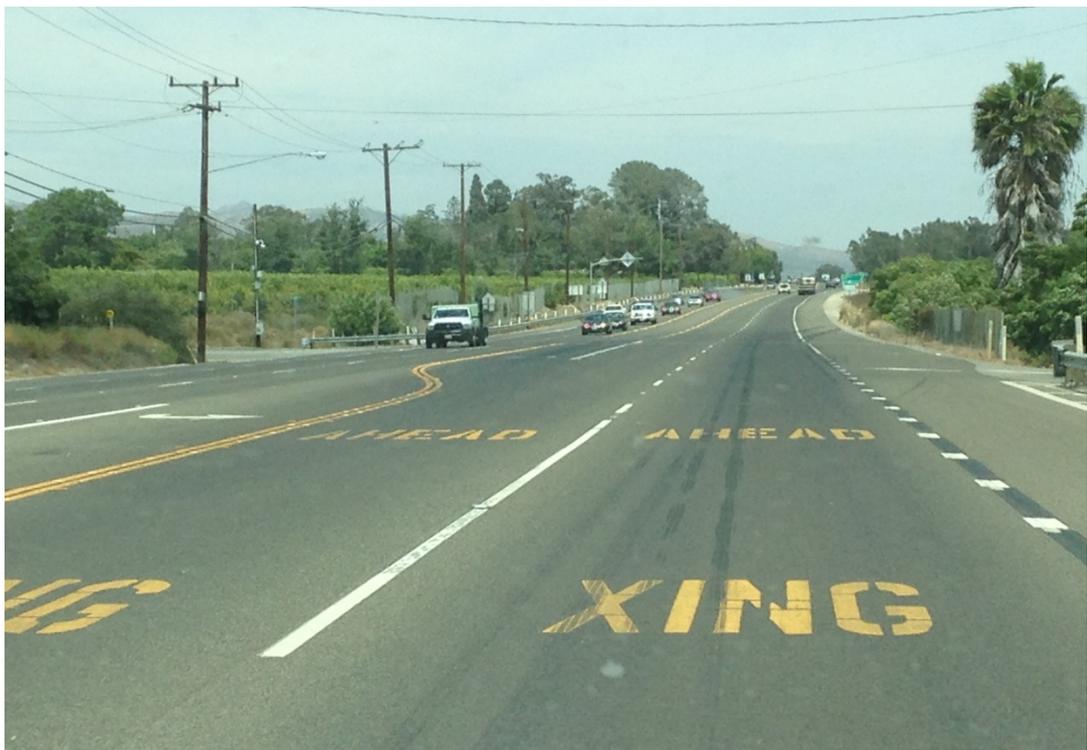
Even as the driver is almost over the stenciled “XING” marking (bottom photo), the crosswalk that it refers to is almost invisible until the driver is almost upon it (top photo).

There exists a worn, marked crosswalk leading from the west corner of Toland Rd. to the east corner of the school property. In practice, the crosswalk is very seldom used. The sidewalk leading from the school to the crosswalk is almost hidden from view and partially overgrown with weeds and shrubs.

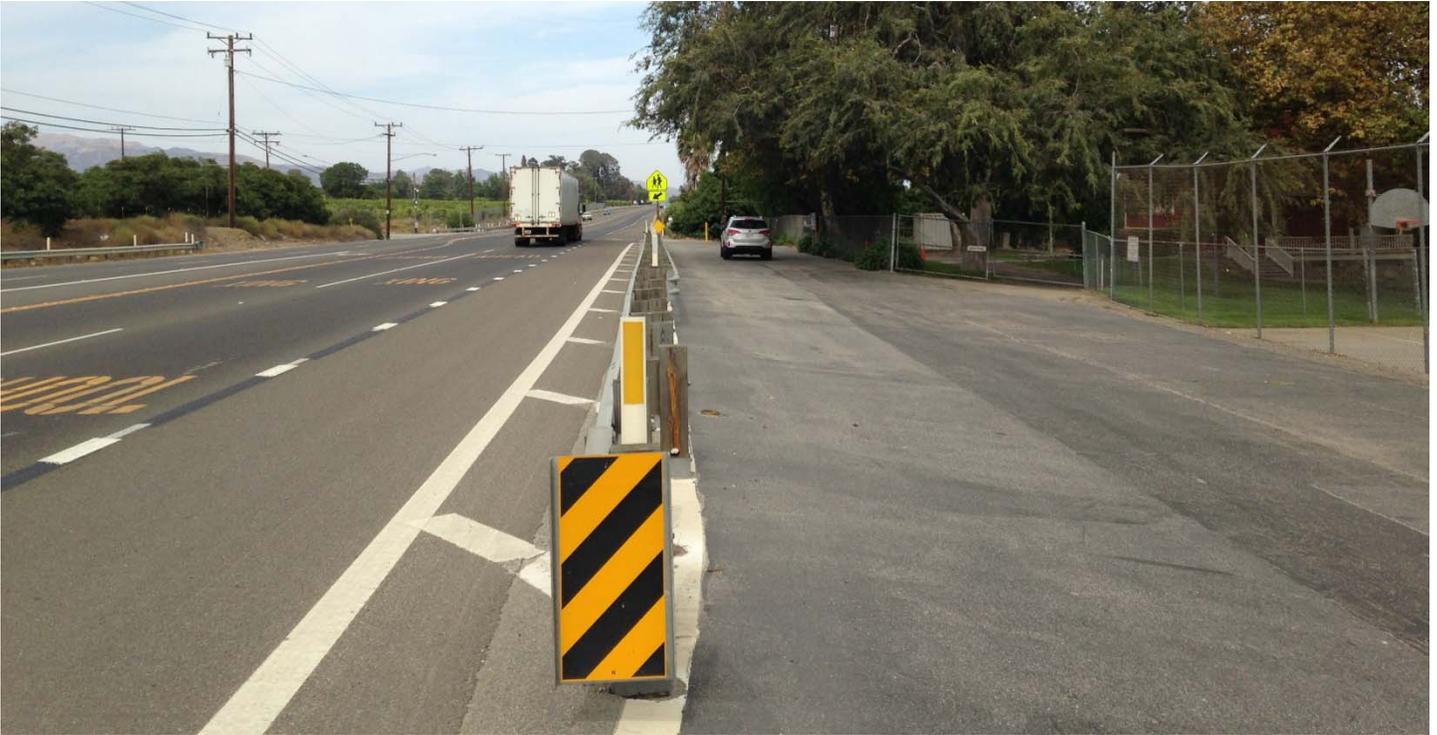
The outer lane marked with a skip line may encourage drivers to pull out to discharge children on the traffic side of the MBGR or might entice impatient drivers to bypass slow drivers in the through lanes.

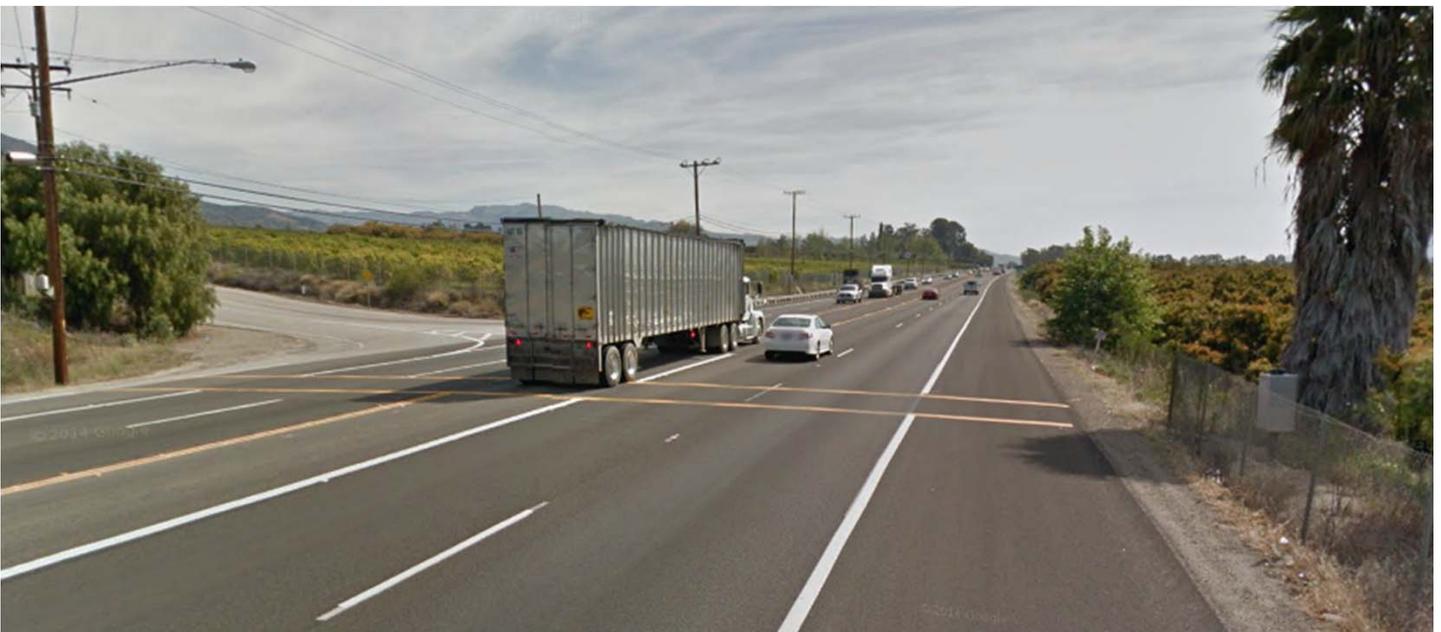
Because of the desire to locate the south end of the crosswalk near the northeast corner of the school, the crosswalk bisects the eastbound left turn lane (seen here partially blocked by one of the many trucks destined for the disposal area off Toland Rd.).

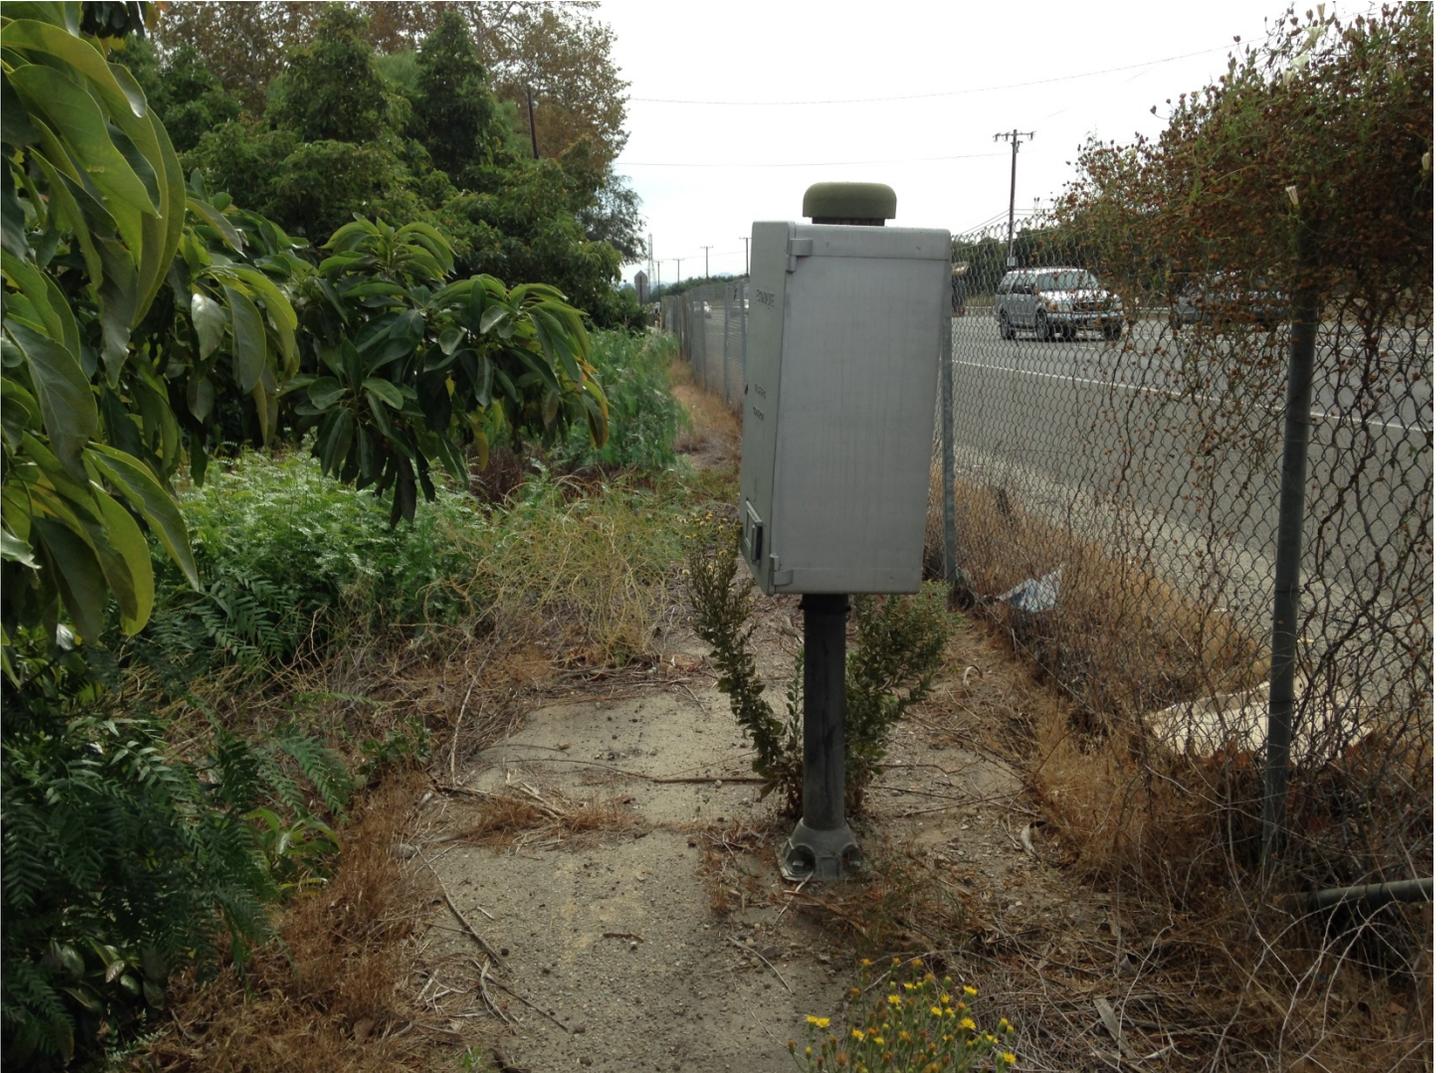
View of sidewalk on south side of SR 126, looking back from near the marked crosswalk. The overgrown vegetation and post-mounted cabinet do not provide a pedestrian-friendly environment.
