## Road Safety Assessment (RSA)

SR 126 – Santa Paula to Fillmore  
Ventura Co., California  
July 2014

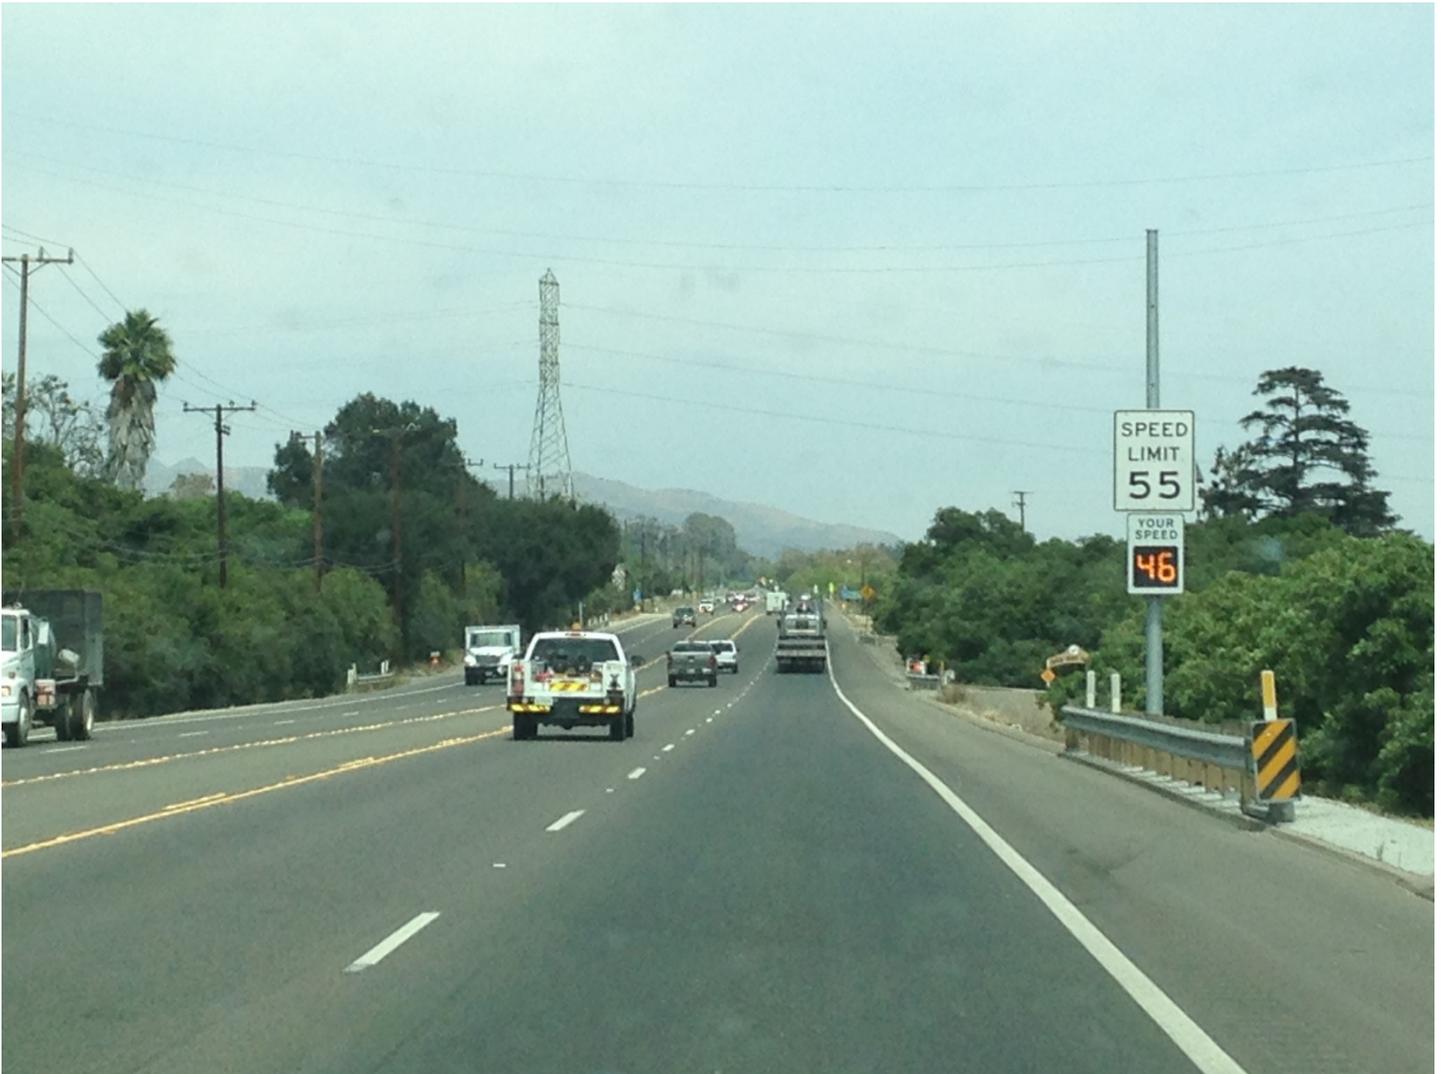
Speed feedback signs erected a few years ago have had mixed results and rely on a sustained enforcement effort to encourage compliance.
