# ARID REGION NON-VEGETATIVE EROSION CONTROL STUDY

## Final Report

## Barstow, Dunaway Road, and Hinkley Sites

**CTSW-RT-10-211.12.15**

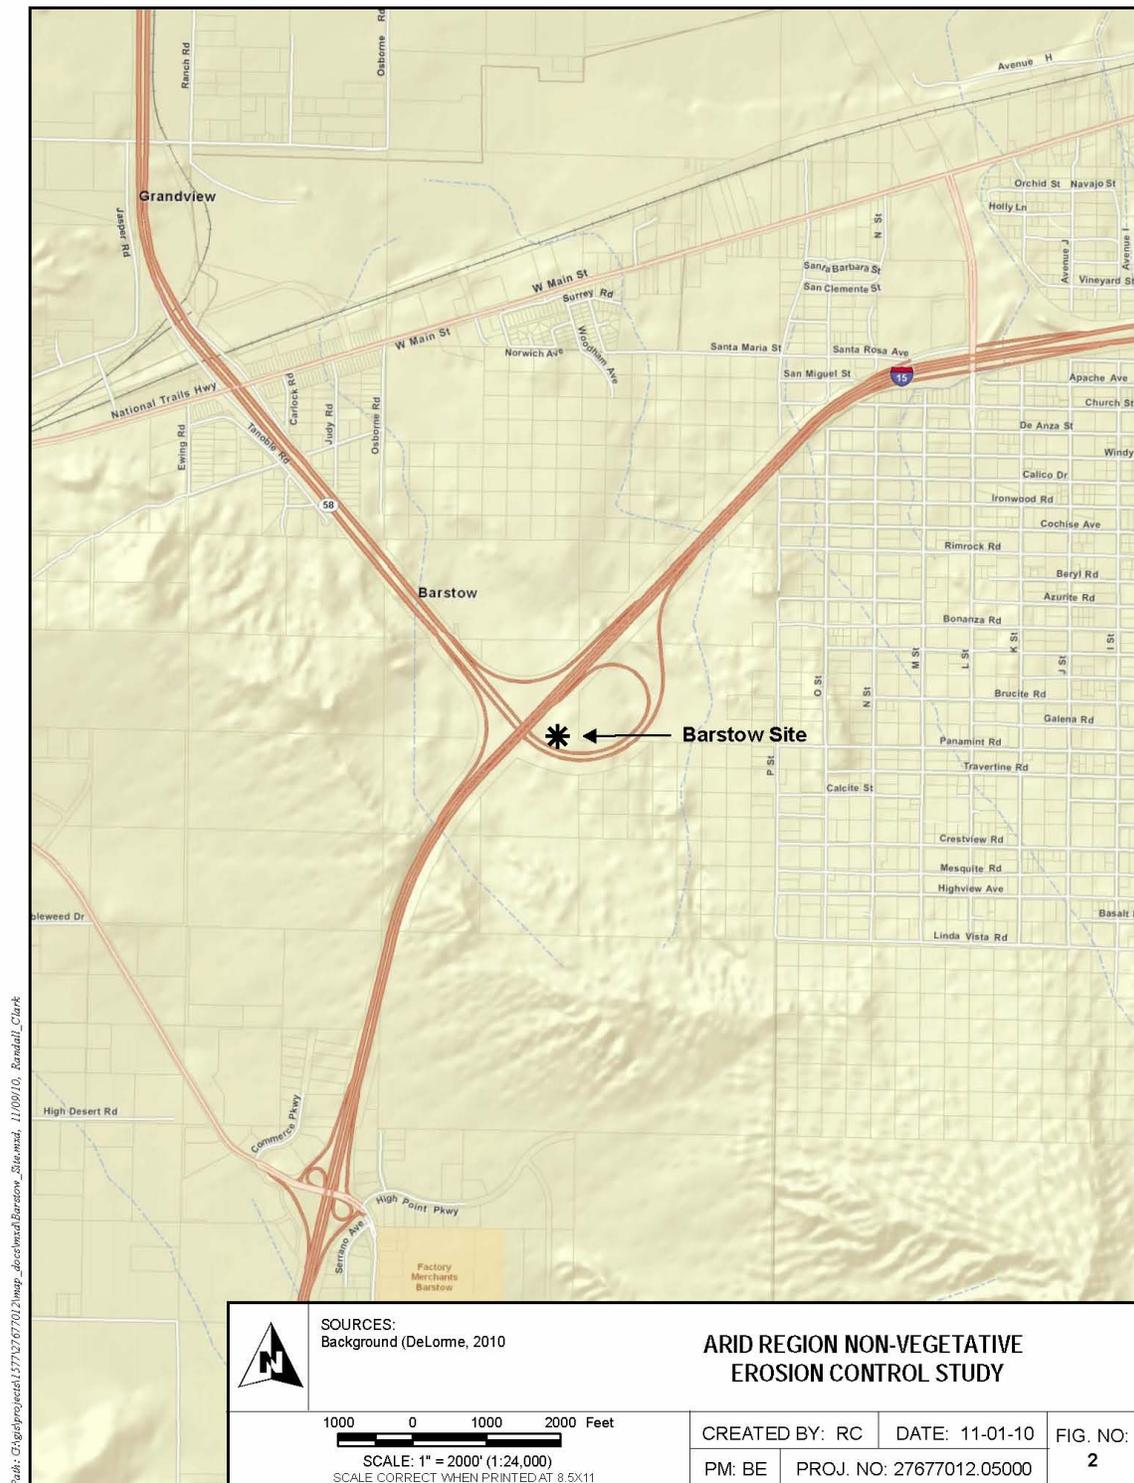
Figure 2-2 Barstow Site Location

The Barstow site is located within the State Route (SR)-58 loop of the Interstate (I)-15 and SR-58 interchange in Caltrans District 8 (Figure 2-2). For the Barstow site, the south- and north-facing slopes were both listed in the study plan as potential experimental locations. The south-facing slope is the preferred slope, since erosion control is more of a challenge historically for the Caltrans Maintenance Department on this slope and due to site conditions. The south-facing slope has wide, flat shoulders between the edge of the pavement and the toe of slope that allows for the storage of equipment and plenty of horizontal slope length to site two replicate test plot systems. Also, the south-facing slope is on the inside of a curve and therefore more protected from accidents than the north-facing slope on the outside of the curve. The angle of the slope is approximately 35 percent.

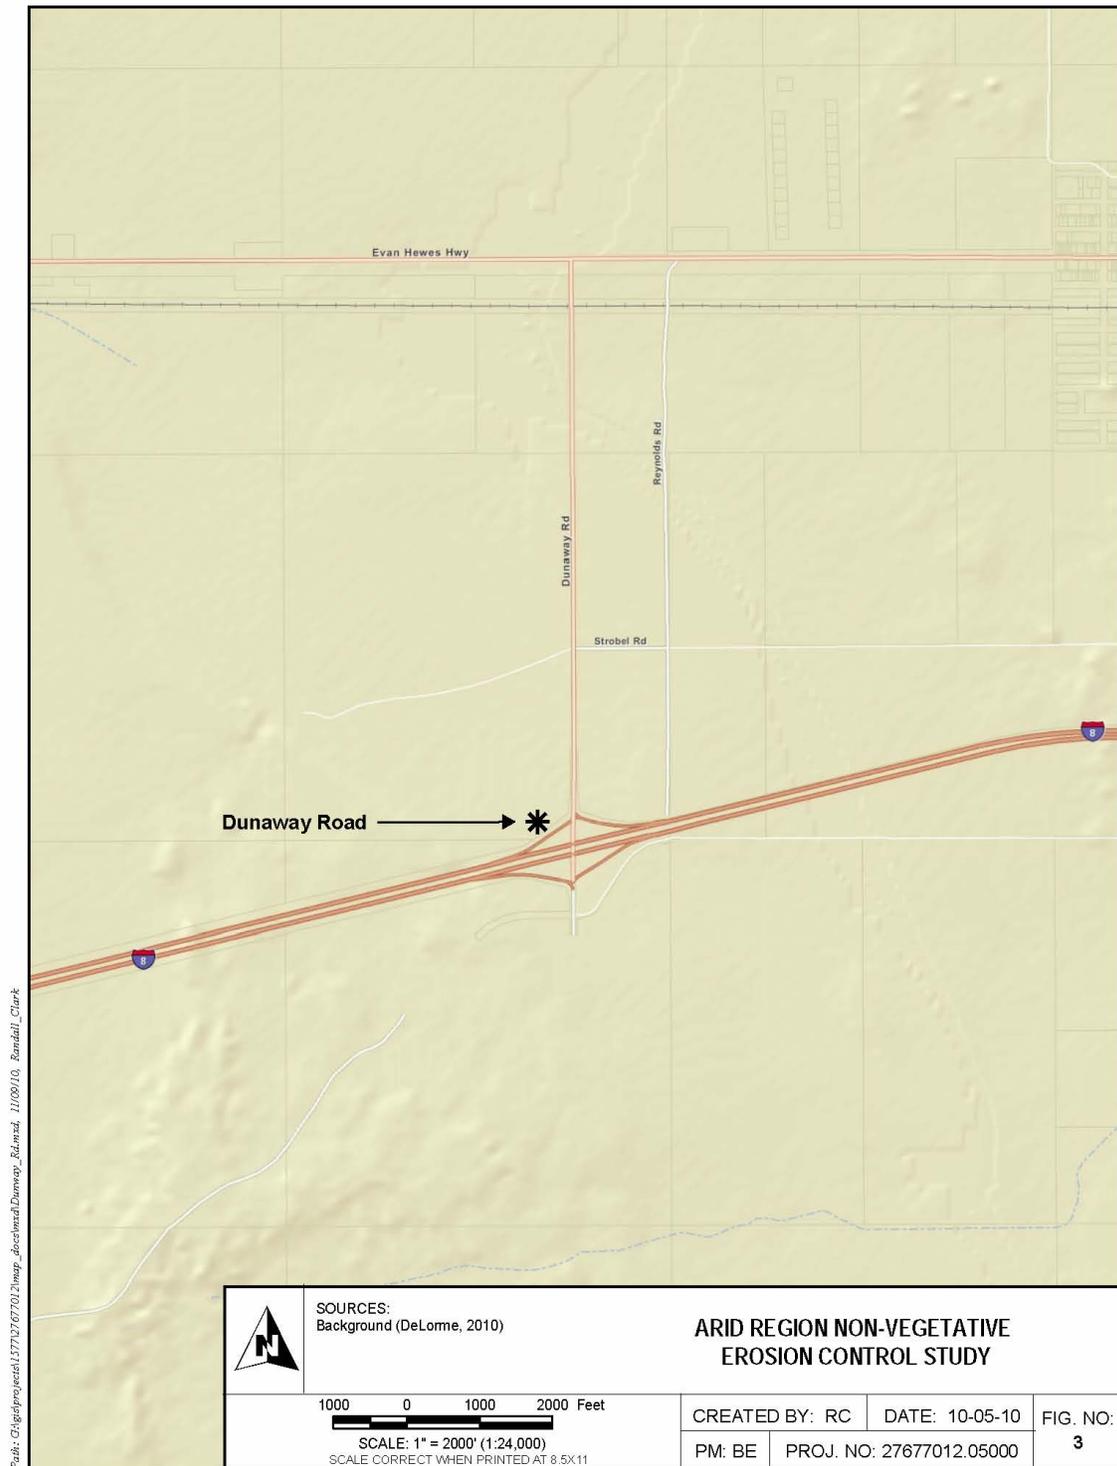
Figure 2-3 Dunaway Road Site Location

The Dunaway Road site is located on the north slope of the Dunaway Road on-ramp to westbound I-8 in Caltrans District 11 (Figure 2-3). The interchange consists of large, wide fill slopes within the Caltrans right-of-way. Specifically, the on-ramp portion of this interchange between Dunaway Road and westbound I-8 offers the best opportunity, with a long north-facing slope that has sufficient horizontal space to co-locate two replicate test plot systems. Access is from Dunaway Road north of the freeway via a dirt access road below the fill slope. The distance between the toe-of-slope and the right-of-way fence line is approximately 50 feet, providing sufficient area to store sampling equipment. The slope is approximately 44 percent.

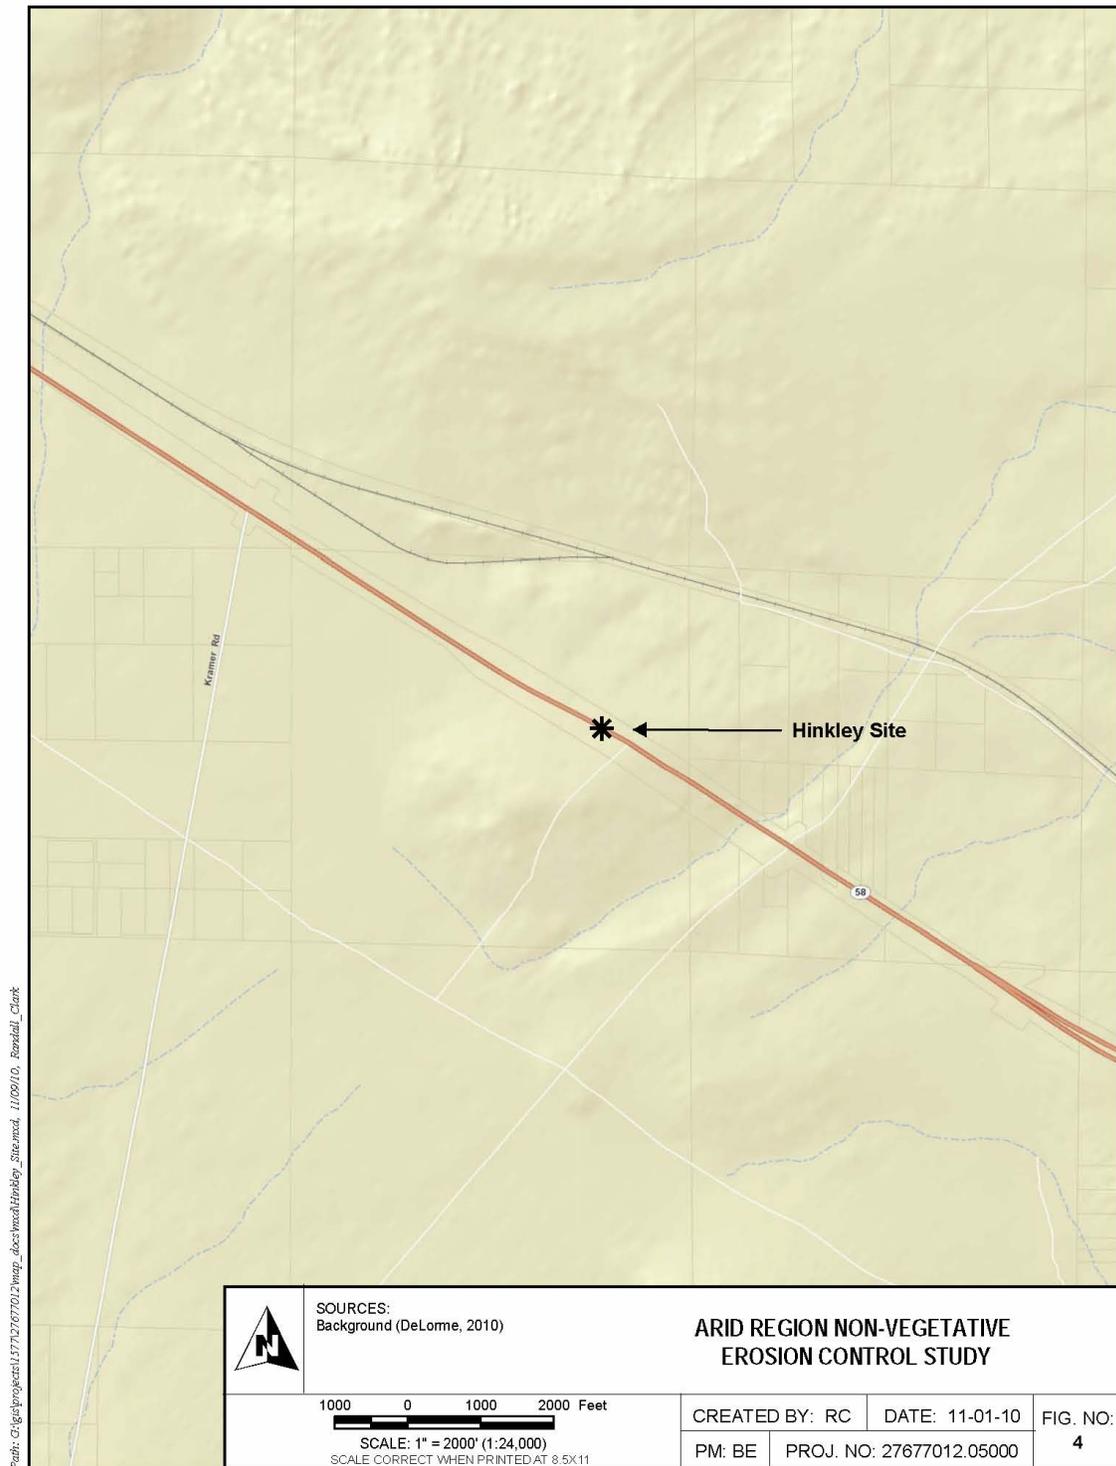
**Figure 2-4 Hinkley Site Location**

The Hinkley site is located on SR-58 approximately 25 miles west of the I-15 and SR-58 interchange in Caltrans District 8 (Figure 2-4). The Hinkley site has wide, flat shoulders on both sides of the freeway, and adequate horizontal slope length to accommodate two replicate test plot systems. As with the Barstow site, both the south- and north-facing slopes are listed in the Study Plan. The major difference between the slopes is that the south-facing slopes are shorter than the north-facing slopes, with a slope length of 36 feet compared to over 60 feet on the north-facing slopes. The angle of the slope is approximately 41 percent.

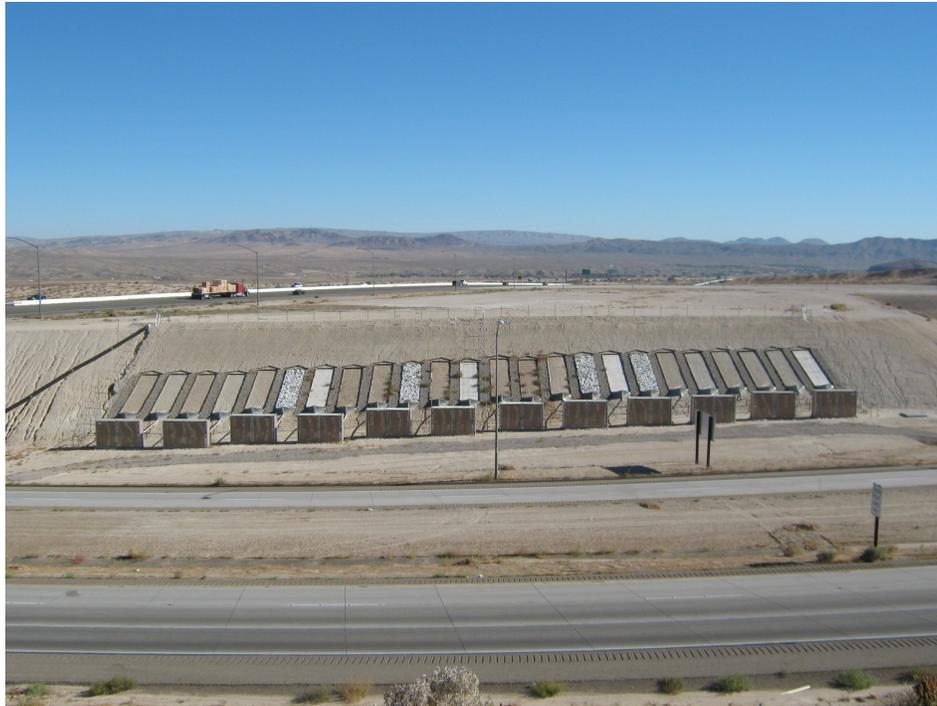
**Figure 2-5 Barstow Site**

Figure 2-5 through Figure 2-7 show the design of the three project sites. The toes of the slopes were adjacent to the highway at both the Barstow and Hinkley sites, whereas the top of the Dunaway Road site was adjacent to the highway on-ramp. An experimental unit consists of 12 test plots designed to evaluate five erosion control products against the untreated control ( $[5 + 1] \times 2 = 12$  treatments). Each project site contains two experimental units.

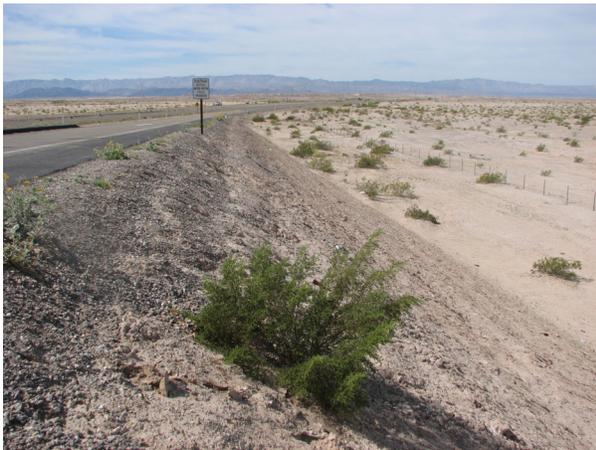
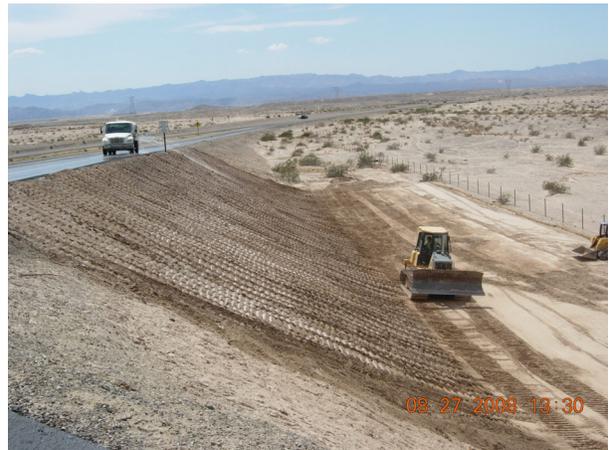
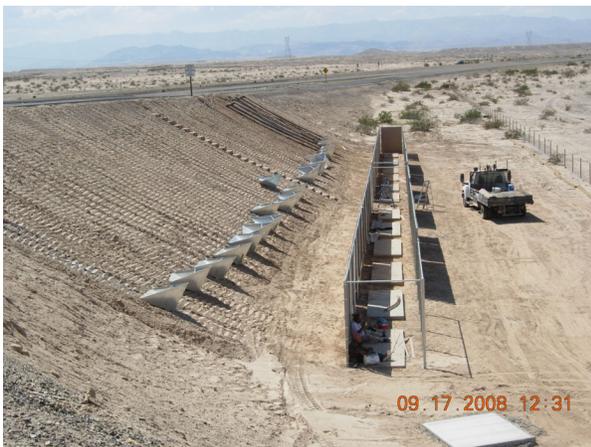
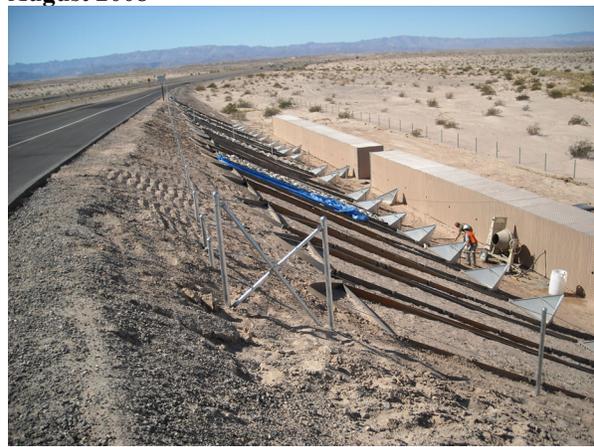
**Figure 2-8 Construction Stages at the Dunaway Road Project Site**

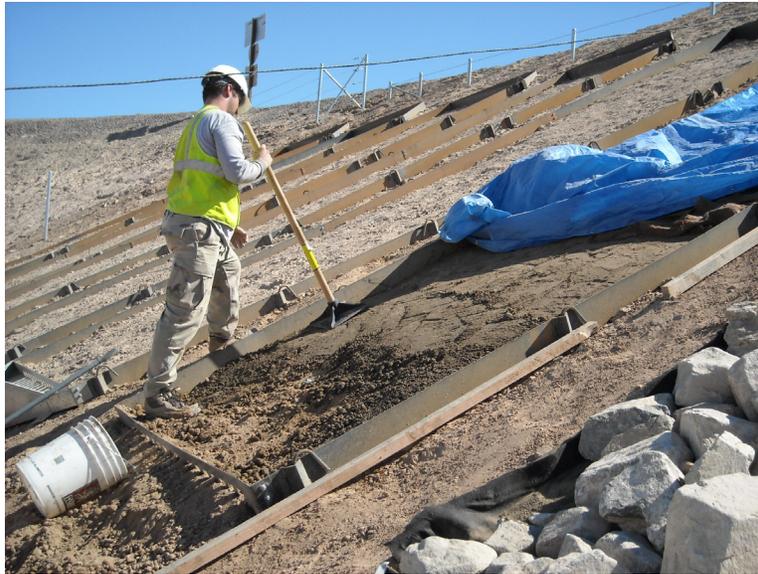
Figure 2-9 depicts the SC application process. Due to the steep grade of the slopes as well as the relatively small area where the product was to be applied, manual application of the product was required. This process proved to be laborious.

**Figure 2-9 Soil Cement Application Process**

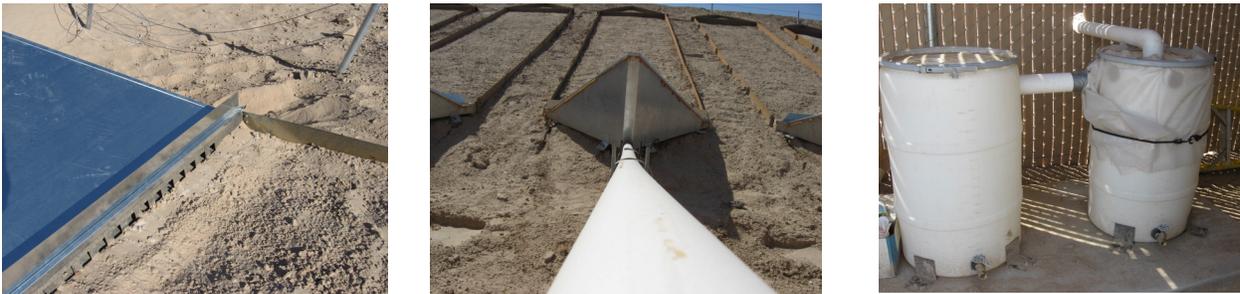
The runoff measurement system consisted of a two-barrel system to collect surface runoff flow and sediment (Figure 3-1). Runoff captured in the collection system consisted of precipitation that fell directly onto the test plots. Test plots were designed with runoff diverts at the top of the structure to avert potential runoff from entering the test plots. Precipitation that fell directly on the test plot was captured as sheet flow runoff into the collection system. Runoff and sediment moved over the slope and passed through a rock screen into a triangular flume, and into a collection pipe sized for the flow intensity of a 24-hour, 100-year storm. Ultimately, runoff and sediment flowed into a splitter barrel, designed with six evenly distributed holes carefully machined at the same level on the barrel. One of these holes was connected to a splitter barrel that collected the total flow that overflowed out of the splitter barrel. This value was based upon the maximum amount of runoff that could be collected by a 189-liter (55-gallon barrel) in a 100-year storm for a full-length test plot. The remaining holes were designed to discharge runoff when capacity was reached. It should be noted that the collection barrel system was modified during the Study as described in Section 3.2.3.1.

**Figure 3-1 Splitter Barrel Runoff and Sediment Collection System**

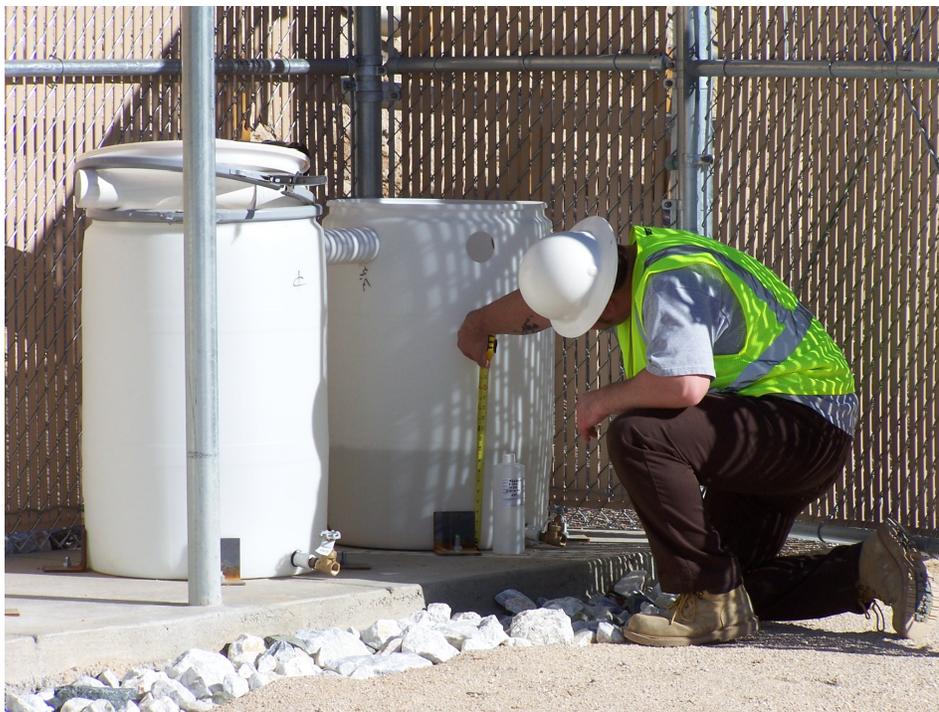
Figure 3-2 shows sediment in a barrel being measured externally using a measuring tape.

**Figure 3-2 Sediment Measurement Method**

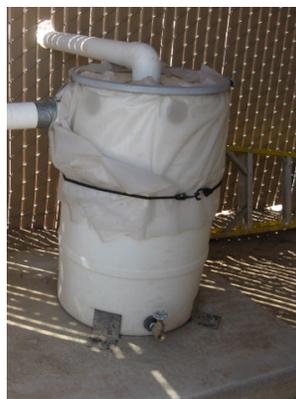
The field staff at the Dunaway Road project site modified the apron design to incorporate large, hollow “spacers” underneath each discharge orifice that would prevent the plastic aprons from making contact with the barrel near the orifice opening and allow free discharge of runoff. Figure 3-3 displays the collection barrel with the plastic apron. The hollow “spacers” were secured by a bungee cord.

**Figure 3-3 Plastic Apron with Spacer**

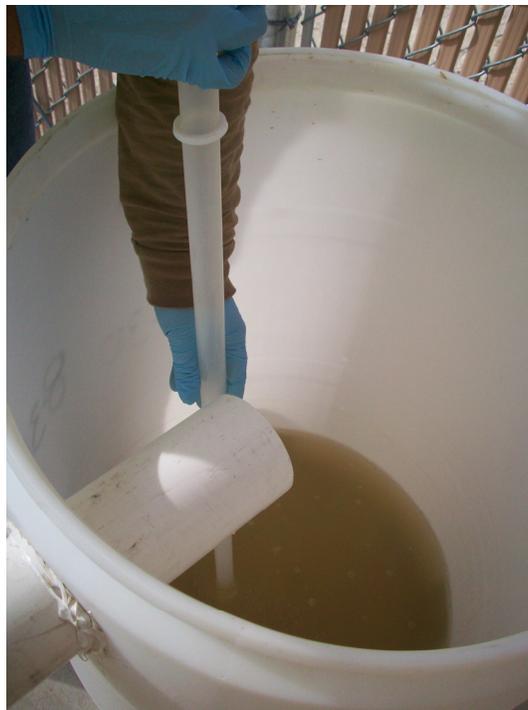
The drum sampler was inserted into center of the runoff column through the top of the collection barrel, as shown in Figure 3-4. Aliquots collected by the drum sampler were deposited in a 1 L plastic sample bottle. Samples were then labeled and submitted to the laboratory for analysis.

**Figure 3-4 Drum Sampling Method**

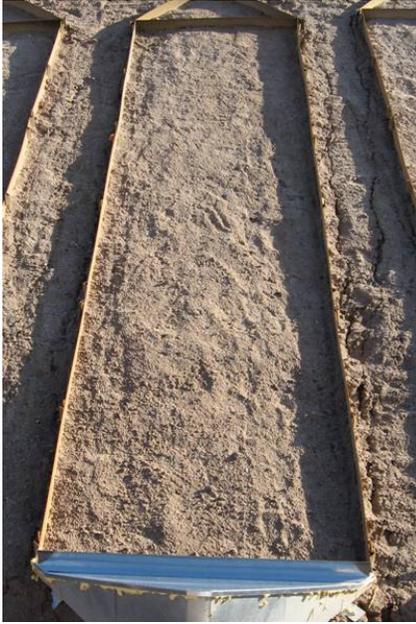
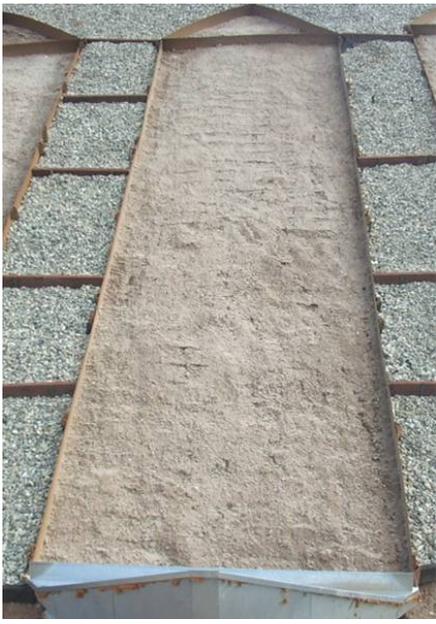
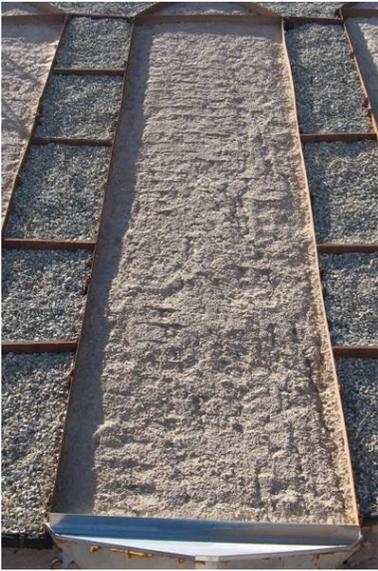
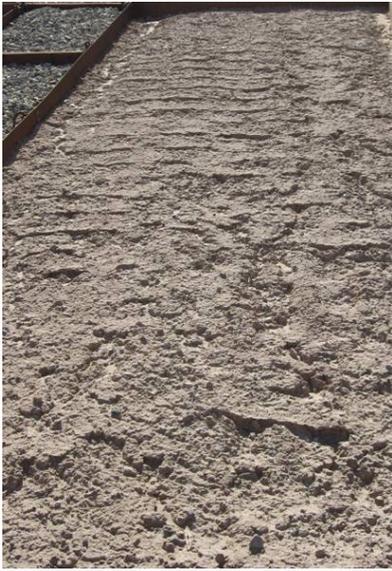
Dunaway Rd 11-312 Plot DEA11-PP

**Table 4-7 Example of Chronological Degradation of PolyPavement™ Test Plot**

a) October 2008	b) January 2010

c) September 2010	d) September 2010- Detail

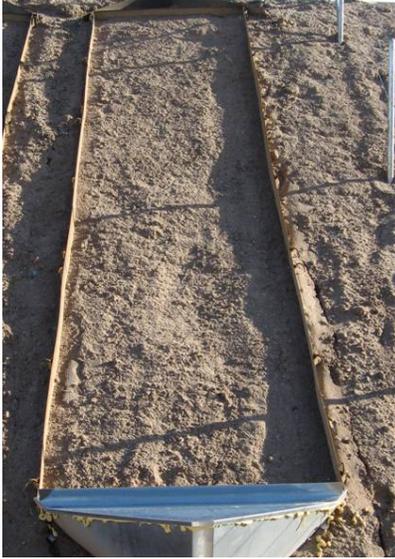
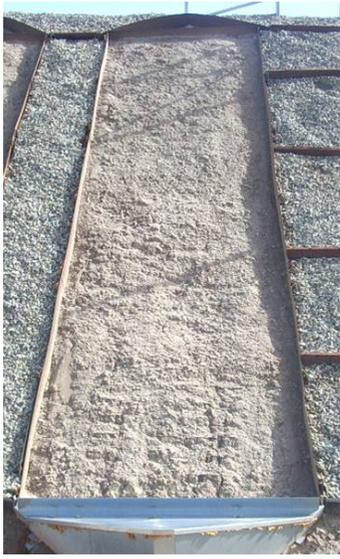
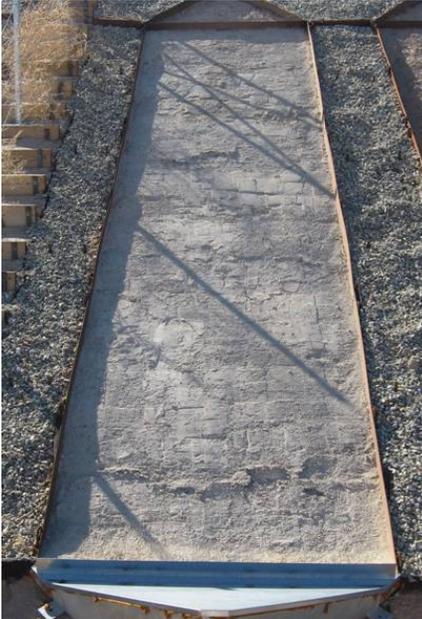
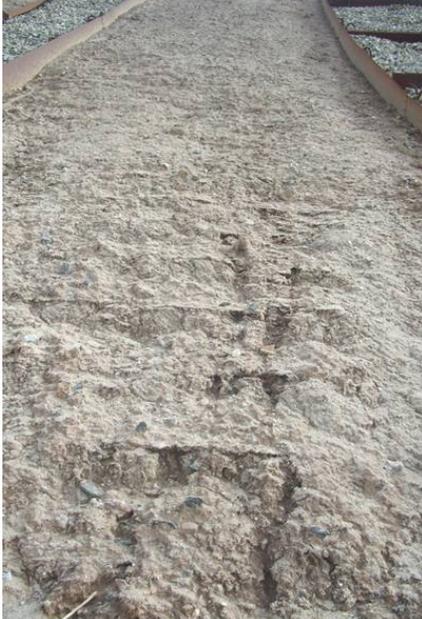
Dunaway Rd 11-314 Plot DWA01-SS

**Table 4-8 Example of Chronological Degradation of Soil Seal Test Plot.**

a) October 2008	b) January 2010

c) September 2010	d) January 2010- Detail

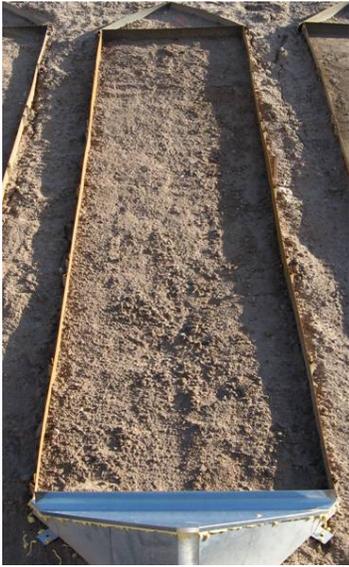
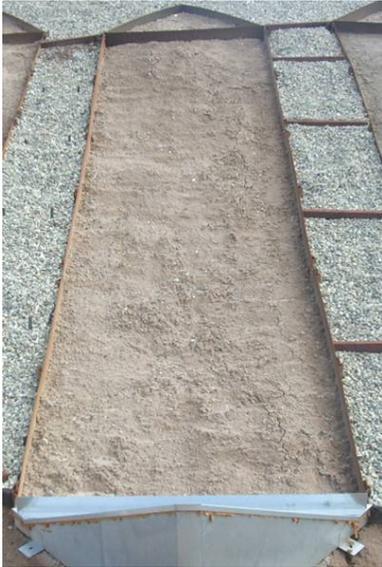
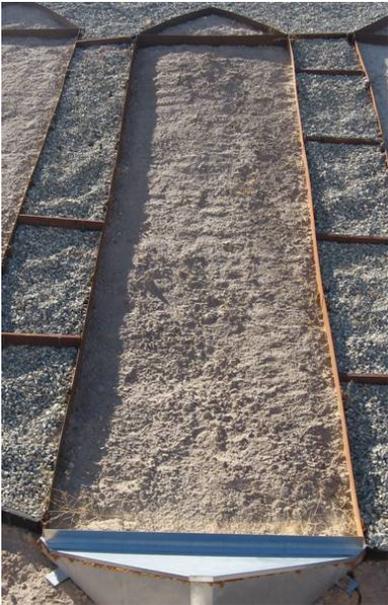
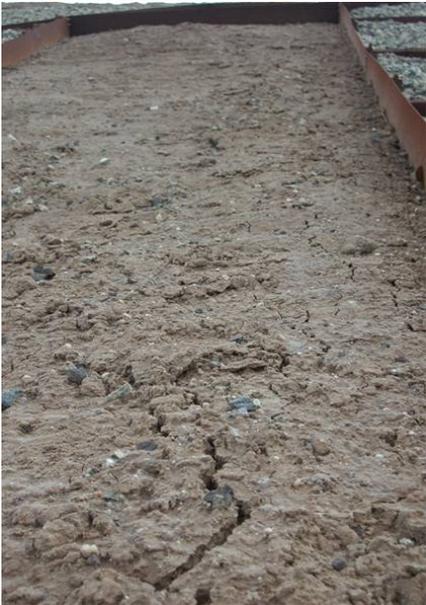
Dunaway Rd 11-305 Plot DEA04-ST

**Table 4-9 Example of Chronological Degradation of SoilTac® Test Plot.**

a) October 2008	b) January 2010

c) September 2010	d) January 2010- Detail

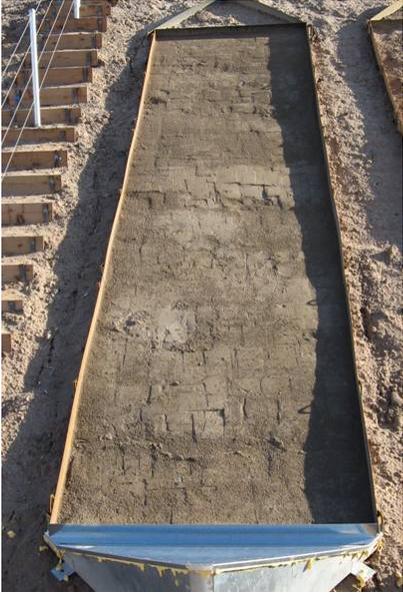
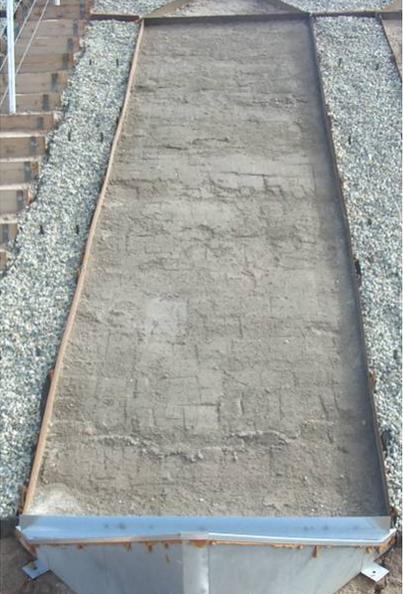
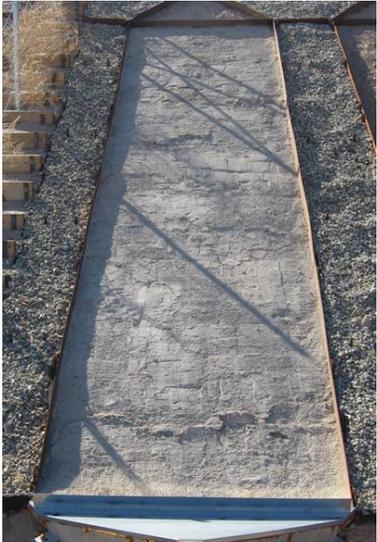
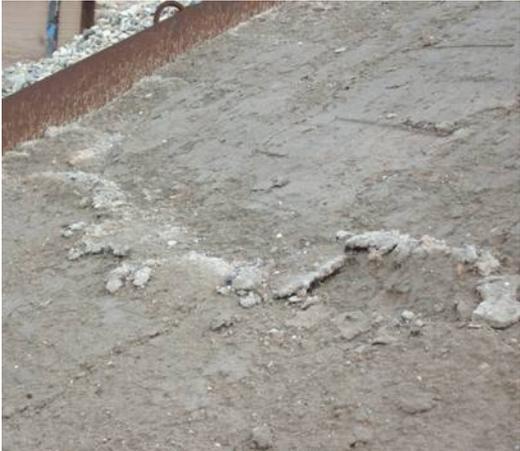
Dunaway Rd 11-325 Plot DWA12-SC

**Table 4-10 Example of Chronological Degradation of Soil Cement Test Plot.**

a) October 2008	b) January 2010

c) September 2010	d) January 2010- Detail

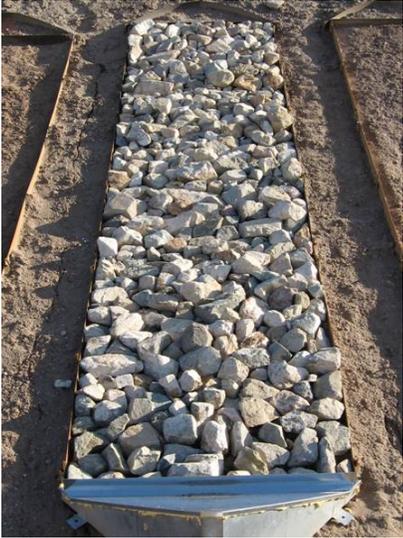
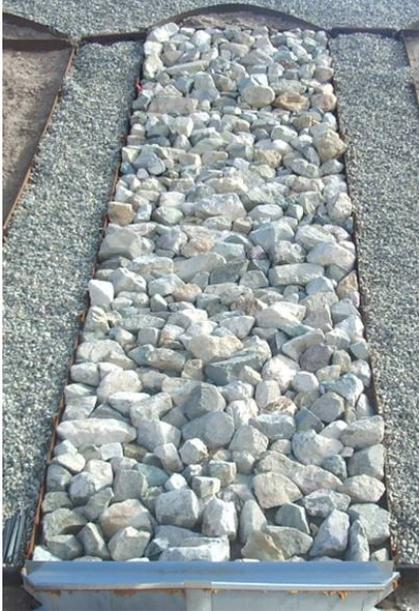
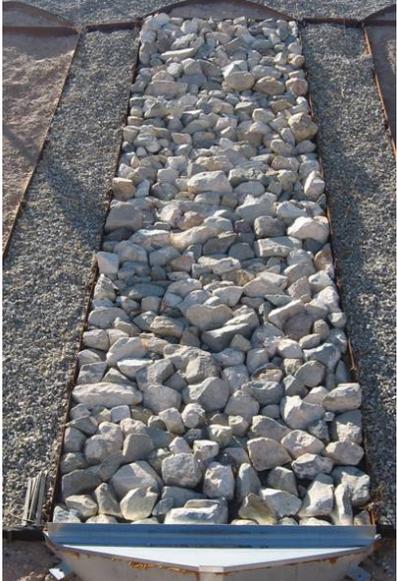
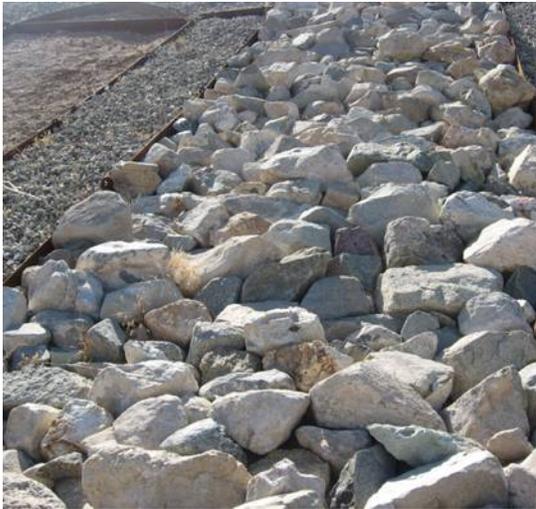
Dunaway Rd 11-318 Plot DWA05-RS

**Table 4-11 Example of Chronological Degradation of Rock Slope Protection Test Plot.**

a) October 2008	b) January 2010

c) September 2010	d) September 2010- Detail

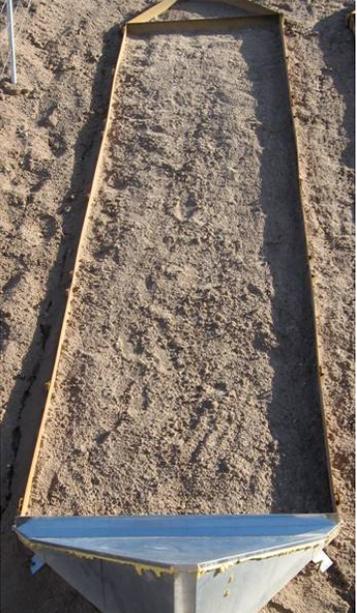
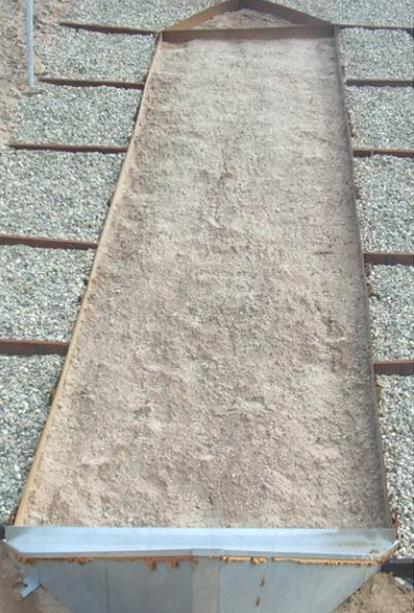
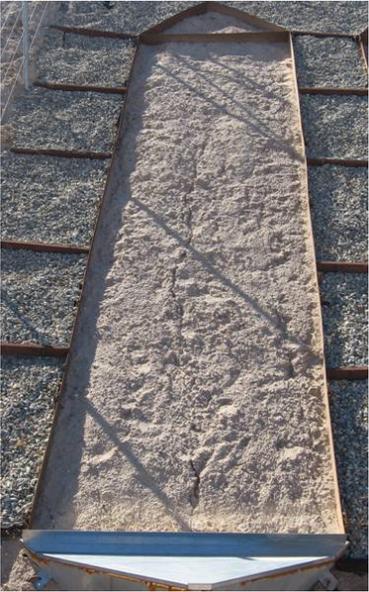
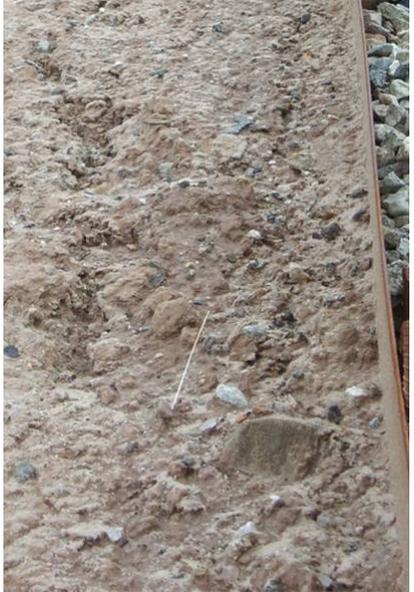
Dunaway Rd 11-313 Plot DEA12-CT

**Table 4-12 Example of Chronological Degradation of Control Test Plot.**

a) October 2008	b) January 2010

c) September 2010	d) January 2010- Detail

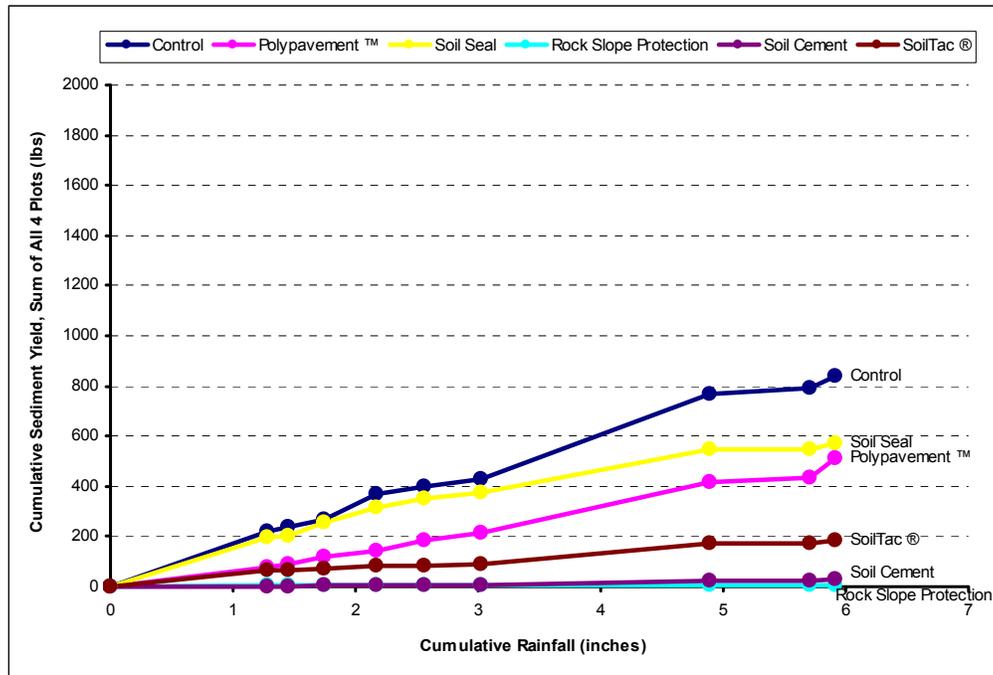
The cumulative sediment yield for each erosion control product and control is plotted against cumulative rainfall total in Figure 5-1 and against the number of elapsed days since product application in Figure 5-2. RSP and SC show substantially lower sediment yield than the control. Figure 5-2 shows a sharp increase in sediment yield for PP and SS after about 450 elapsed days. This corresponds to approximately mid January 2010. However, control also shows a sharp increase in sediment yield at about the same point in time. Because the common environmental variables could affect both control and erosion control product in a similar manner, it is appropriate to evaluate the effectiveness of a product in terms of the control-to-product reduction in sediment yield. For example, even when a particular erosion control product shows a large increase in sediment yield at some point in time, the percent reduction in sediment yield from the control at that time could be similar to the previous reductions. In such a case, the erosion control product still might be considered to be effective in reducing sediment yield. For this reason, plots of control-to-product percent reduction were also prepared against cumulative rainfall total (Figure 5-3) and against number of elapsed days since product application (Figure 5-4). Percent reduction, rather than actual reduction, in sediment yield was graphed in Figure 5-3 and Figure 5-4. This is because actual reduction was generally higher for higher control sediment yields, while the percent reduction was fairly independent of control sediment yield and hence would more clearly show any systematic changes in erosion control product performance.

Figure 5-1 Dunaway Road Data Analysis of Cumulative Sediment Yield with Cumulative Rain

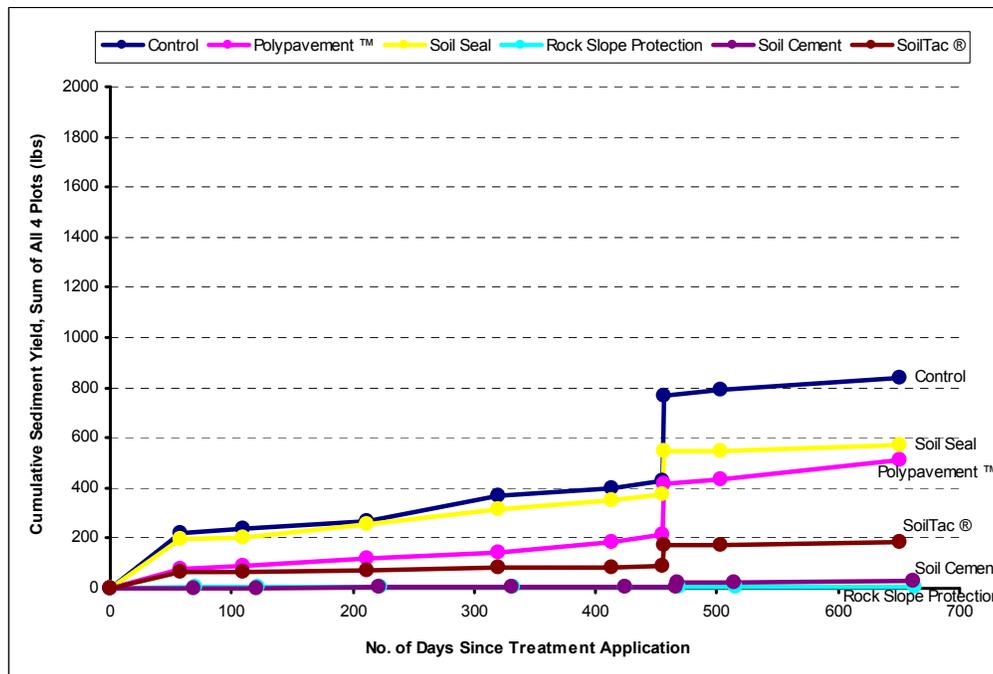
Figure 5-2 Dunaway Road Data Analysis of Cumulative Sediment Yield and Days Elapsed

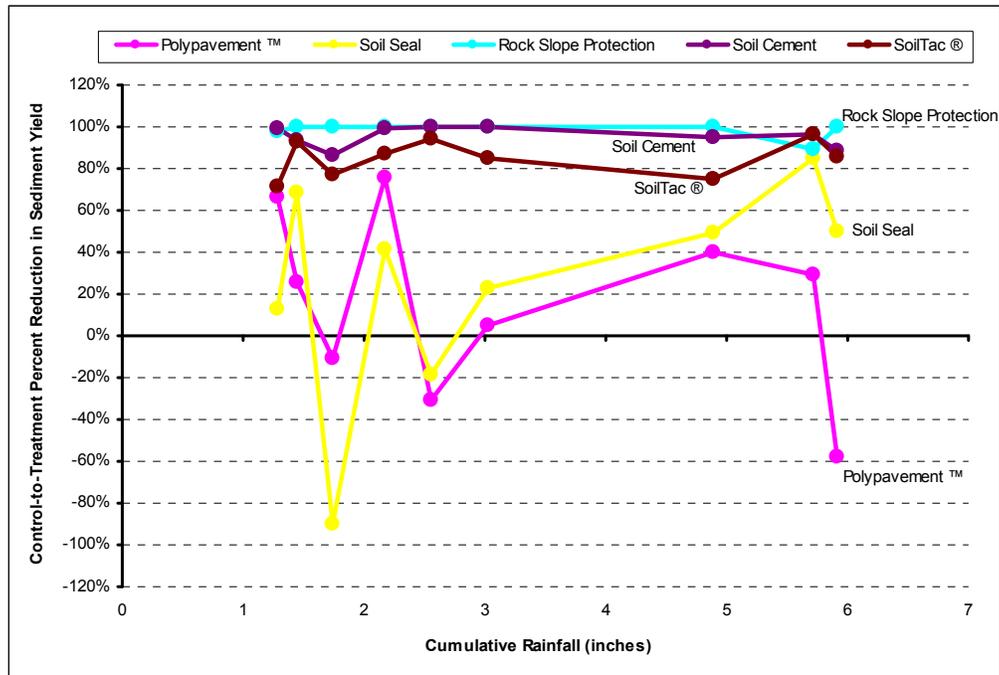
Figure 5-3 does not show evidence of performance degradation as cumulative rainfall total increases. However, it does show a downward sloping line for PP at the last storm event, suggesting possible degradation in the performance of PP. A comparison of the performance of the five erosion control products in Figure 5-3 indicates that RSP, SC, and ST have substantially better and consistent performance (i.e., greater percent reduction in sediment yield) than SS and PP.

**Figure 5-3 Dunaway Road Data Analysis of Cumulative Rainfall and BMP Sediment Yield Reduction**

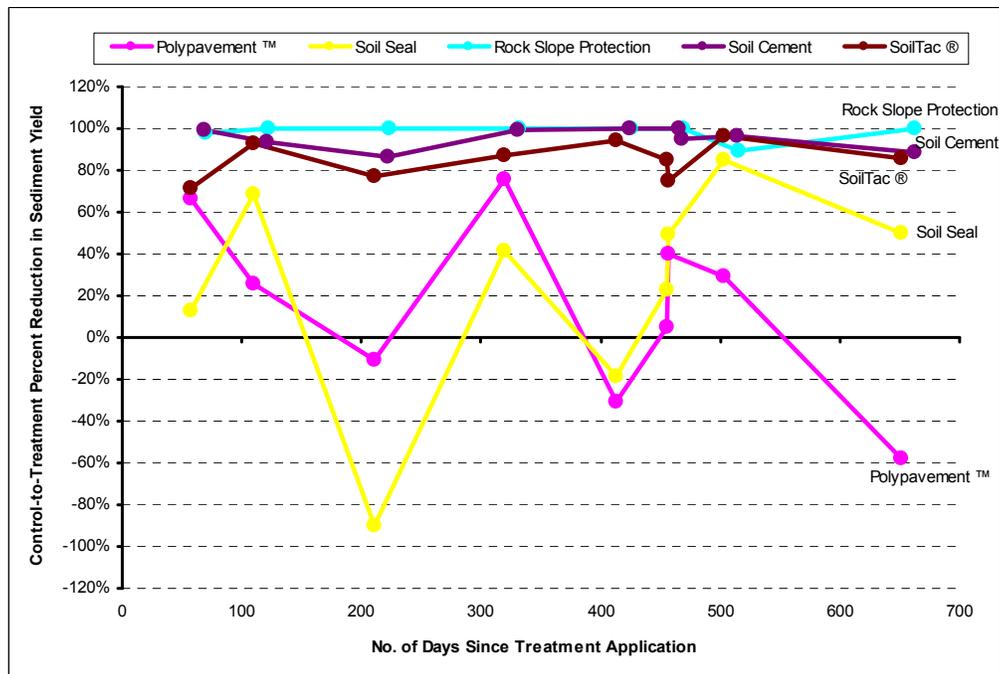
Figure 5-4 shows a graph of control-to-product percent reduction in sediment yield versus the number of elapsed days since product application. It shows the effect of product age on erosion control product performance. Figure 5-4 again shows no evidence of systematic degradation or break in the performance of any of the five products except for PP. The time series plot for PP shows a downward sloping line for the last three events, suggesting possible performance degradation after about 12 months.

**Figure 5-4 Dunaway Road Data Analysis of Days Elapsed and BMP Sediment Yield Reduction**

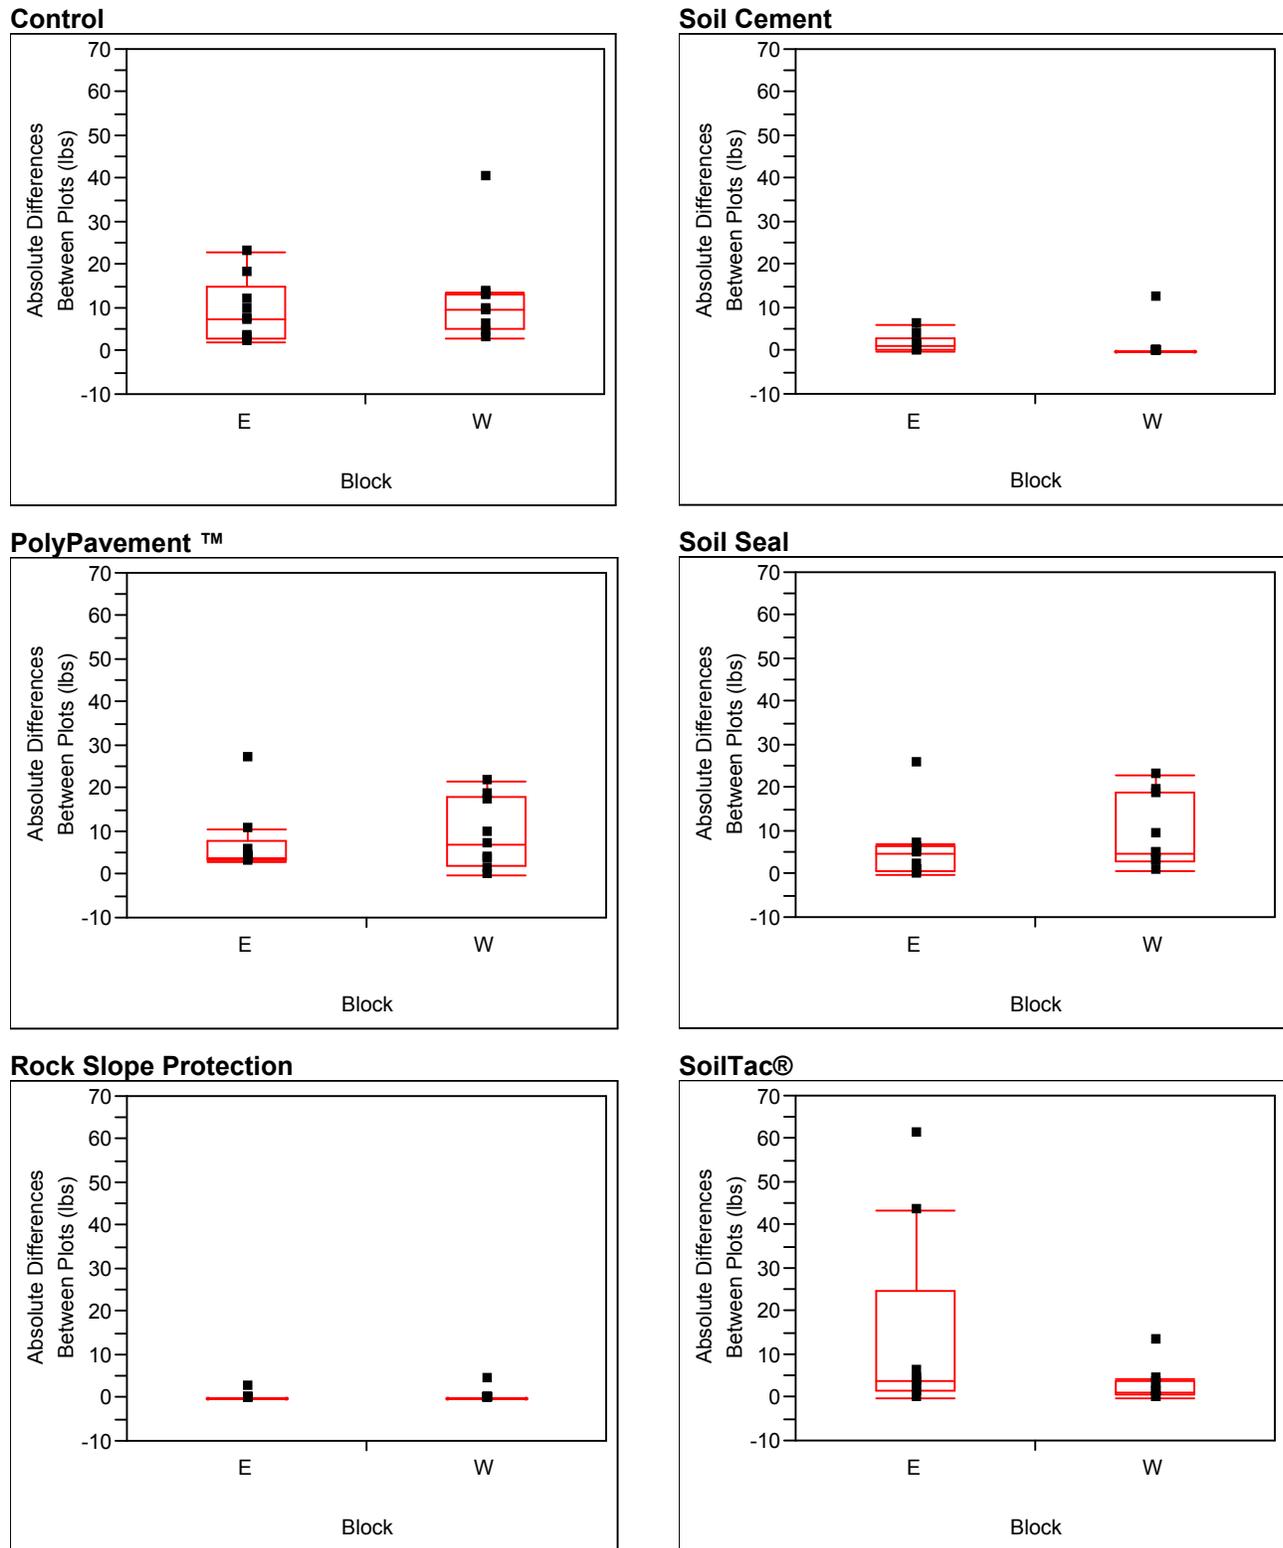
Figure 5-5 shows box plots of plot-to-plot replicate variability in sediment yield within each of the two blocks for each product. Key statistics of the box plot data are included in Appendix G. This replicate variability represents the effect of small-scale soil and topography changes between plots. Because each block had its own control and erosion control products in a block were compared to the matched control in the block, it was appropriate to assess the small-scale variability separately for the two blocks.

Figure 5-5 shows that plot-to-plot replicate variability is small for RSP and SC, and large for CT, PP, SS, and ST. The results of subsequent ANOVA identified plot-to-plot variability as being significant in affecting reduction in sediment yield for PP. Large plot-to-plot replicate variability could mask a significant reduction in sediment yield for the affected products. The plot-to-plot variability was taken into account in subsequently testing hypotheses of performance among erosion control products.

**Figure 5-5 Box Plots of Replicate Variability in Sediment Yield between Plots in Each Block at Dunaway Road Site**

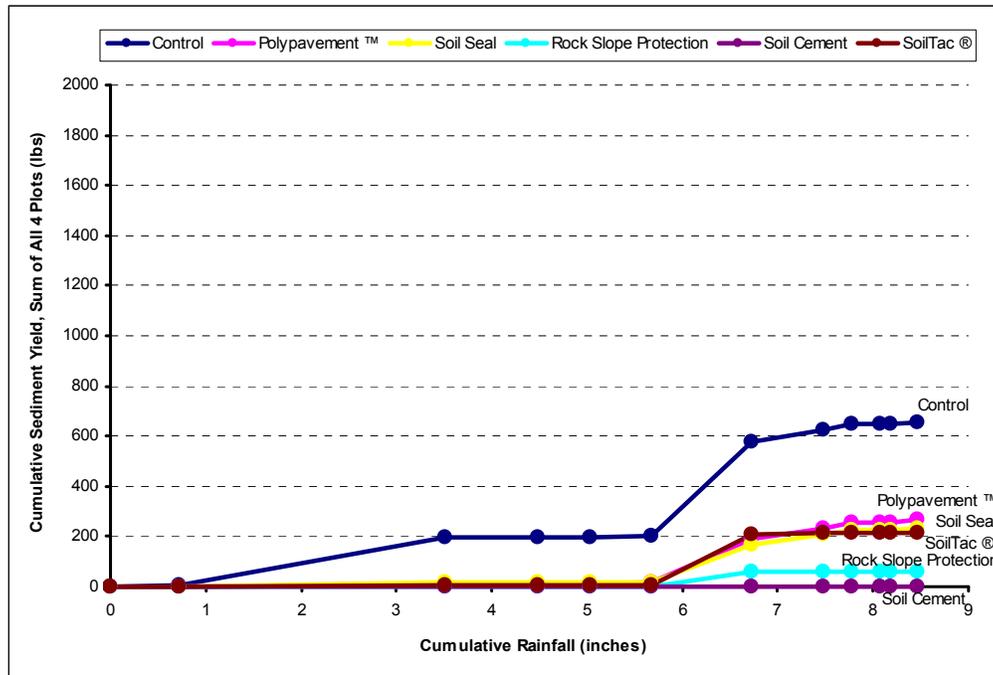
The cumulative sediment yields for each erosion control product and control are plotted against cumulative rainfall total in Figure 5-6 and against the number of elapsed days since product application in Figure 5-7. Figure 5-7 shows a sharp increase in sediment yield for PP, SS, and ST after about 500 elapsed days. This corresponds to approximately December 2009. However, control also shows a sharp increase in sediment yield at about the same point in time. To evaluate erosion control product performance relative to control, control-to-product percent reductions in sediment yield were examined. Figure 5-8 and Figure 5-9 show plots of control-to-product percent reduction in sediment yield versus cumulative rainfall total and the number of elapsed days since product application, respectively. These plots do not show any evidence of degradation or break in performance of RSP, SC, and ST. For PP and SS, the plots suggest possible performance degradation after about 500 days as indicated by generally downward sloping lines and a sharp decline in the percent reduction during the last storm event, particularly for PP.

**Figure 5-6 Barstow Site Data Analysis of Cumulative Rainfall and BMP Sediment Yield Reduction**
