# ARID REGION NON-VEGETATIVE EROSION CONTROL STUDY

## Final Report

## Barstow, Dunaway Road, and Hinkley Sites

**CTSW-RT-10-211.12.15**

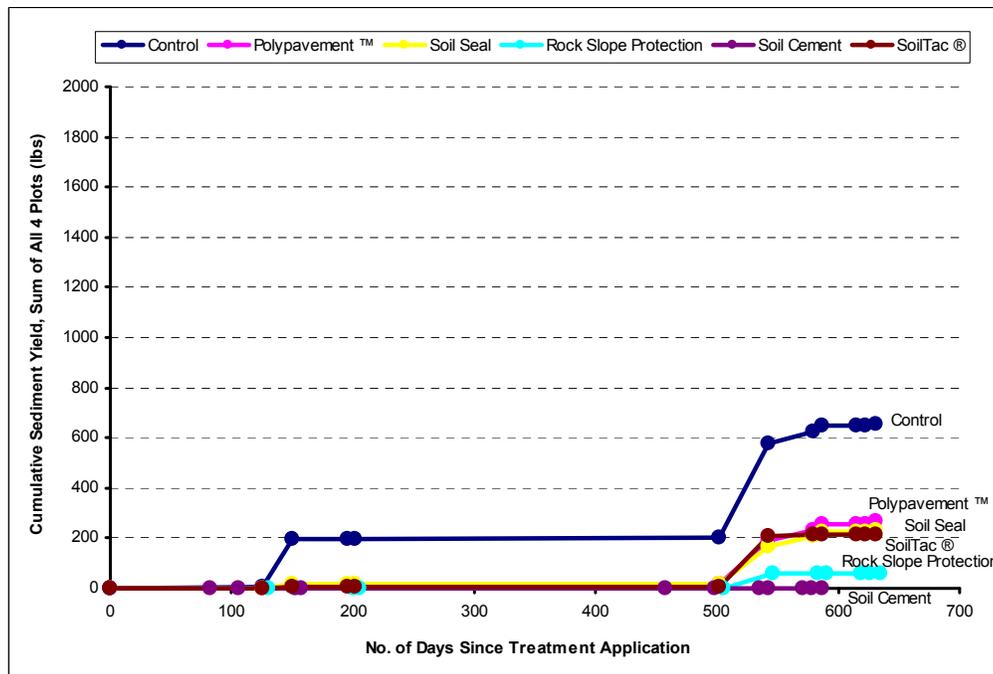
The cumulative sediment yields for each erosion control product and control are plotted against cumulative rainfall total in Figure 5-6 and against the number of elapsed days since product application in Figure 5-7. Figure 5-7 shows a sharp increase in sediment yield for PP, SS, and ST after about 500 elapsed days. This corresponds to approximately December 2009. However, control also shows a sharp increase in sediment yield at about the same point in time. To evaluate erosion control product performance relative to control, control-to-product percent reductions in sediment yield were examined. Figure 5-8 and Figure 5-9 show plots of control-to-product percent reduction in sediment yield versus cumulative rainfall total and the number of elapsed days since product application, respectively. These plots do not show any evidence of degradation or break in performance of RSP, SC, and ST. For PP and SS, the plots suggest possible performance degradation after about 500 days as indicated by generally downward sloping lines and a sharp decline in the percent reduction during the last storm event, particularly for PP.

**Figure 5-7 Barstow Site Data Analysis of Cumulative Sediment Yield and Days Elapsed**

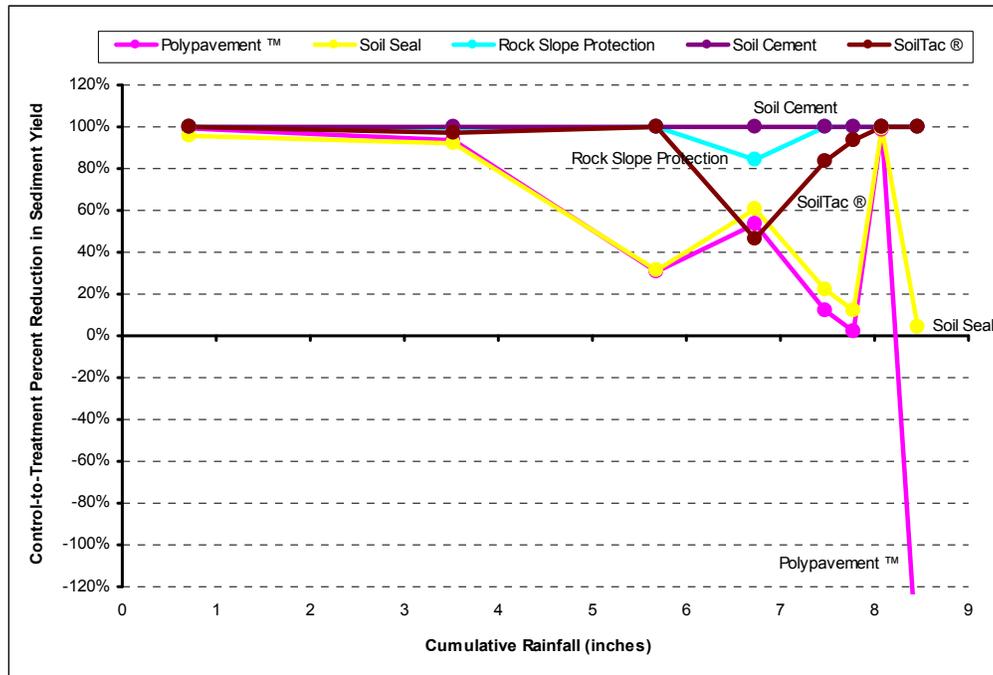
A comparison of the performance of the five erosion control products in Figure 5-8 and Figure 5-9 indicates that RSP, SC, and ST have substantially better and consistent performance (i.e., greater percent reduction in sediment yield) than SS and PP.

Figure 5-8 Barstow Site Data Analysis of Cumulative rainfall and BMP Sediment Yield

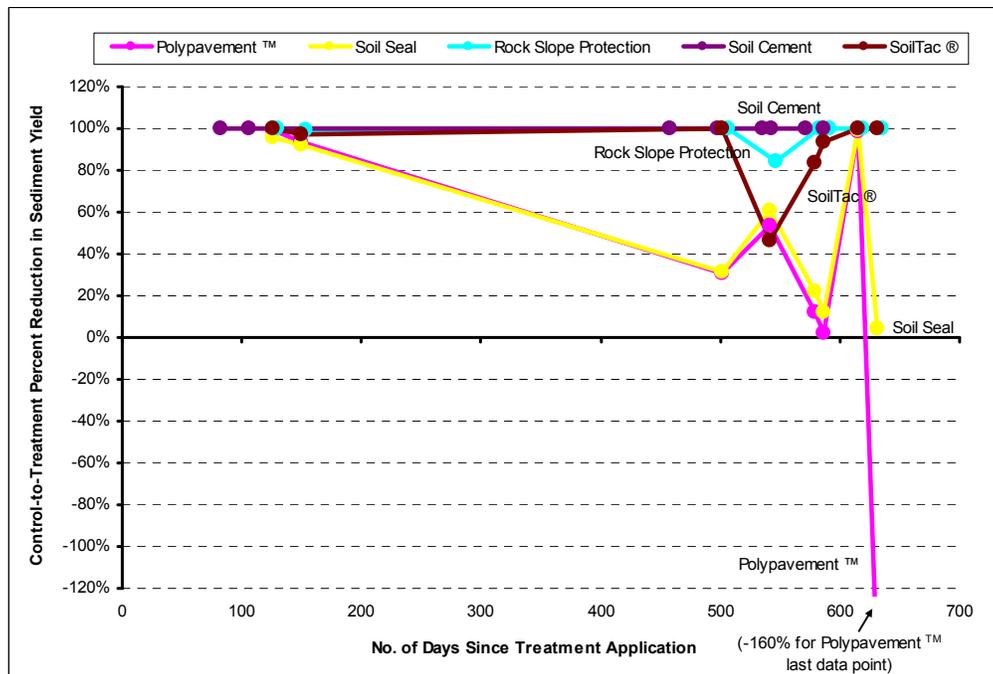
Figure 5-9 Bartstow Site Data Analysis of Days Elapsed and BMP Sediment Yield Reduction

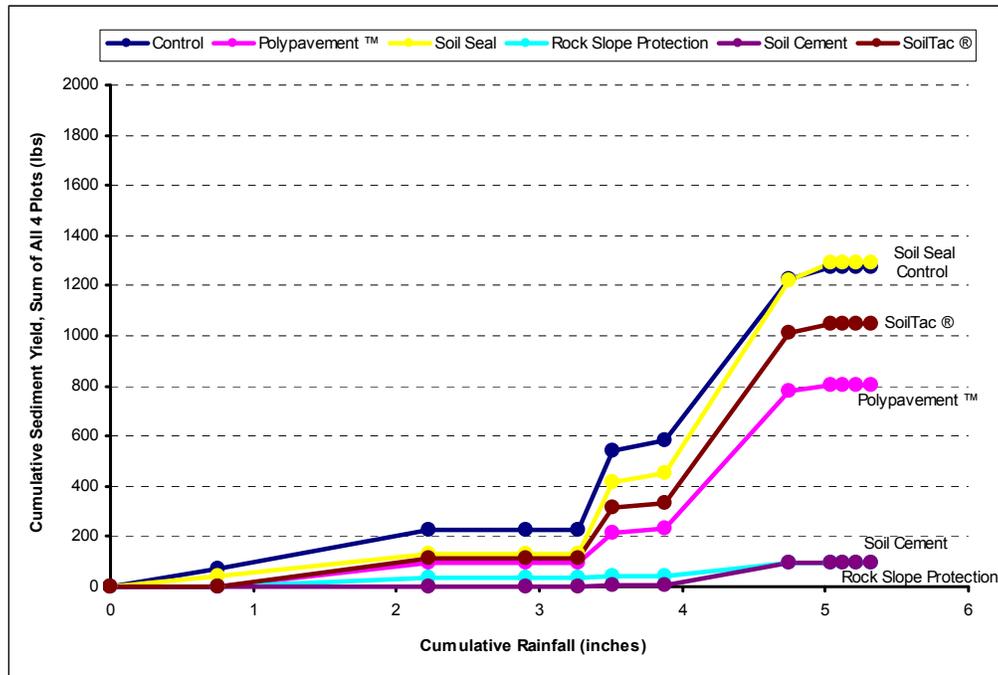
The cumulative sediment yields for each erosion control product and control are plotted against cumulative rainfall total in Figure 5-10 and against the number of elapsed days since product application in Figure 5-11. Figure 5-11 shows a sharp increase in sediment yield for PP, SS, and ST after about 500 elapsed days. This corresponds to approximately December 2009. However, control also shows a sharp increase in sediment yield at about the same point in time. To evaluate erosion control product performance relative to control, control-to-product percent reductions in sediment yield were examined. Figure 5-12 and Figure 5-13 show plots of control-to-product percent reduction in sediment yield versus cumulative rainfall total and the number of elapsed days since product application, respectively. These plots do not show any evidence of degradation or break in performance of RSP and SC. For ST, SS, and PP, the plots generally show downward sloping lines, suggesting possible degradation in performance after about 12 months for PP and ST, and after about 6 months for SS. However, for the last plotted event, the percent reduction is close to 100% for the five erosion control products, showing a contrary effect for ST, SS, and PP.

Figure 5-10 Hinkley Site Data Analysis of Cumulative Sediment Yield with Cumulative Rain

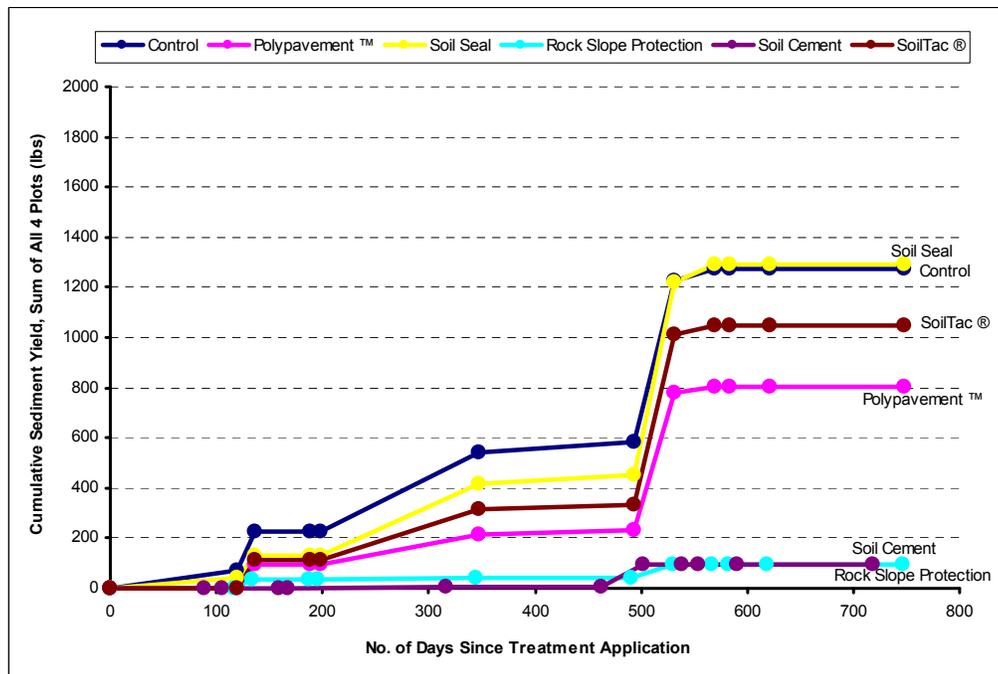
Figure 5-11 Hinkley Site Data Analysis of Cumulative Sediment Yield and Day Elapsed

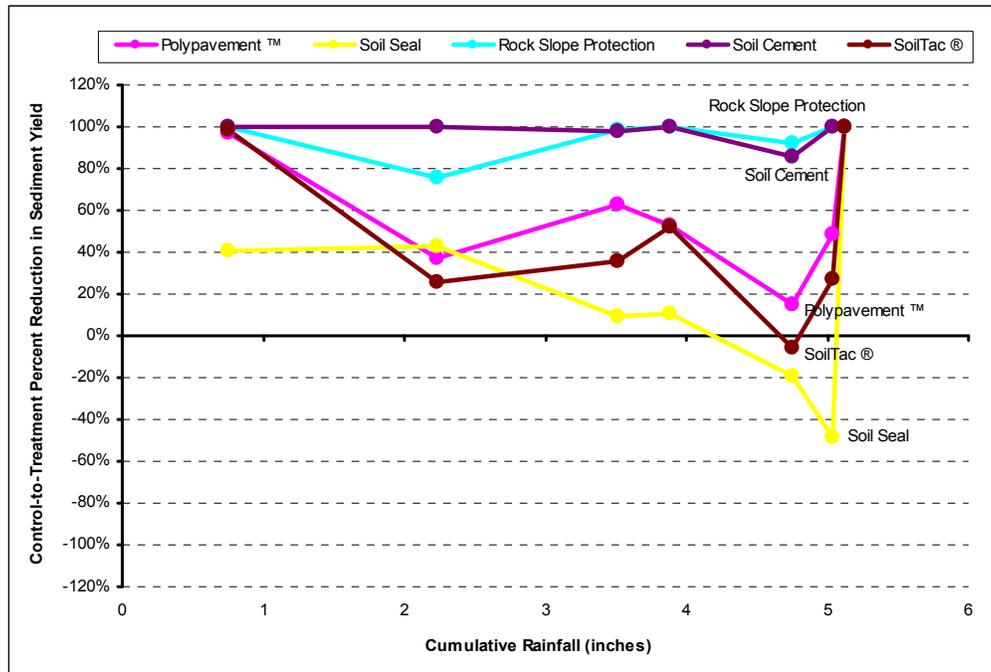
A comparison of the performance of the five erosion control products in Figure 5-12 and Figure 5-13 indicates that SC and RSP have substantially better and consistent performance (i.e., greater percent reduction in sediment yield) than the other three erosion control products.

Figure 5-12 Hinkley SiteData Analysis of Cumulative Rainfall and BMP Sediment Yield Reduction

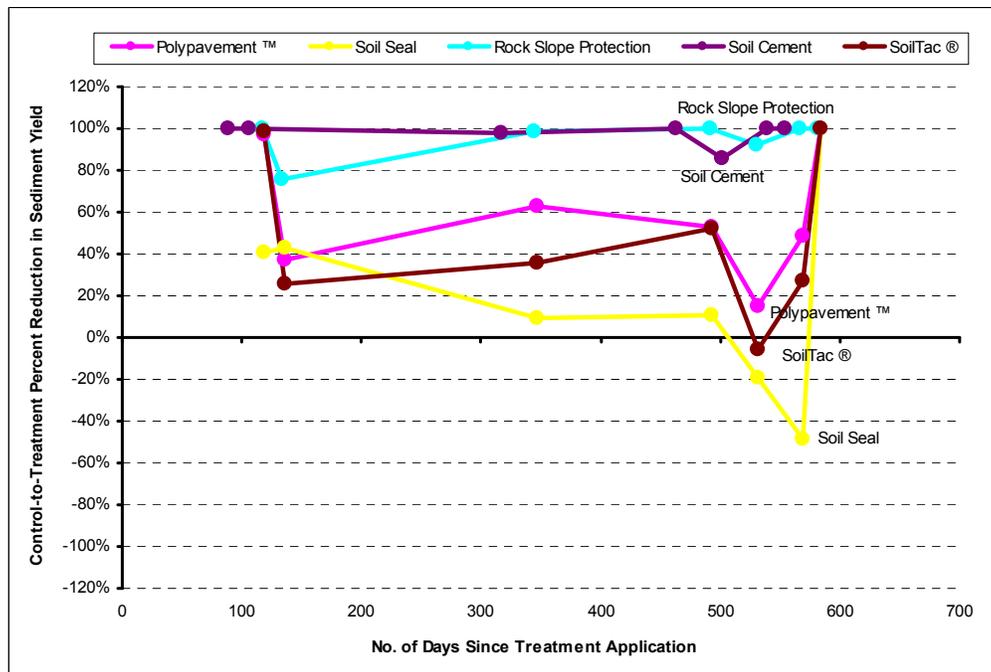
Figure 5-13 Hinkley Site Data Analysis of Days Elapsed and BMP Sediment Yield Reduction
