Soil Resource Evaluation II

RTA # 43A0168

Task order 19

Soils and Revegetation Lab
University of California, Davis

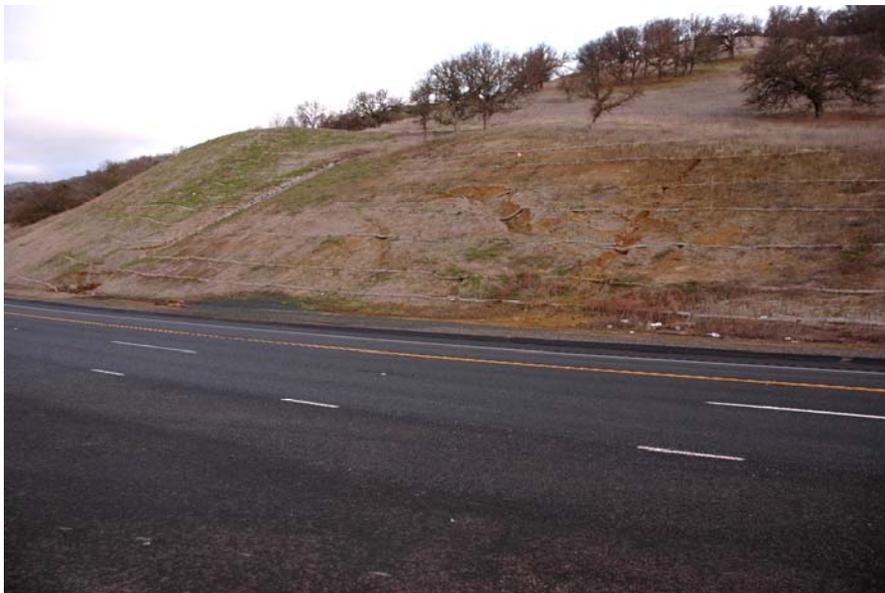
Figure 1. Lake county site (LAK 20 mile 46.0). This site had been constructed and revegetated one growing season earlier and had sparse vegetation, few natives, and decreasing erosion control cover from blankets and wattles. A shallow slip in the center of the slope resulted from subsurface seepage and out sloped bedding planes.

This south-facing, 2:1 (H:V) site is located on low organic matter content, fractured residuum weathered from siltstone, mudstone and shale with scattered out sloped bedding planes. The site was cut and surface amended (hydroseed, hydromulch and straw wattles) one year previous, but during the first winter season some medium sized (20 x 50 foot) surface slips developed. Surface infiltration rates of the weathered

Table 1. Surface infiltration data measured by rainfall simulator.

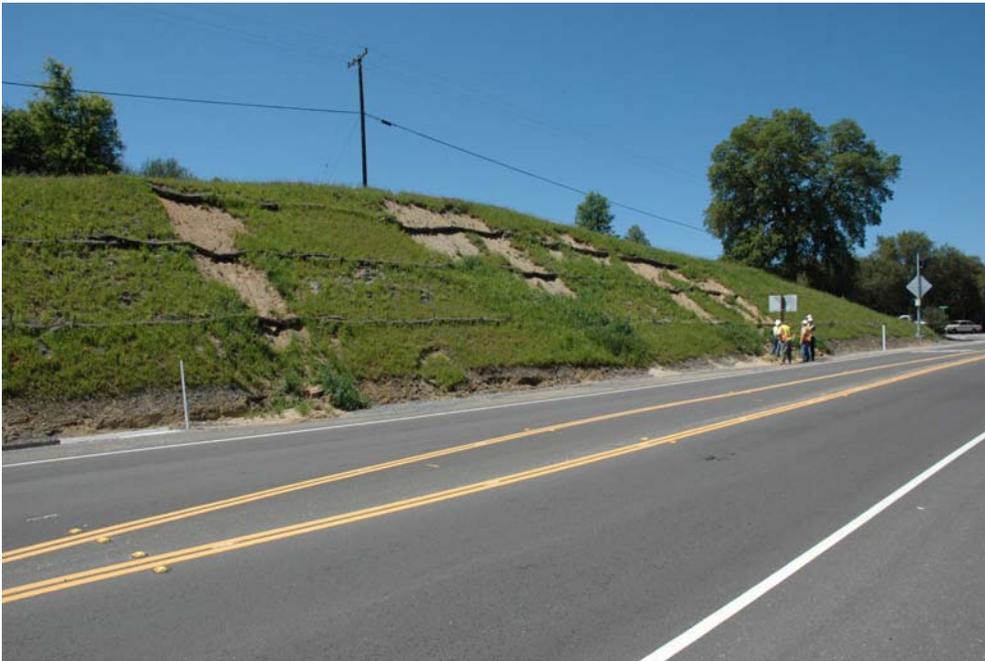
Photo 2. Decomposed granite cutslope in Placer county (PLA 49 mile 21). This site had been constructed one year earlier with shallow topsoil overlay over dense decomposed granite substrate. Vertical teeth marks from the backhoe, a steep slope and a low infiltration rate in the subsurface contributed to saturation and slumping of the surface amendment.

This east-facing, 1.5:1 (H:V) site is located on low organic matter content, decomposed granite (DG) saprolite. The site was graded and seeded one season previously by application of 15 cm (6 inches) of mineral fines and duff over a planar DG subsurface that was cut and smoothed by excavator bucket. This surface overlay had since slipped

The listed rainfall amount for a 100 year event (15 minute storm) is 2.9 in/hr (74.1 mm/hr). This decomposed granite material was estimated to have a saturated conductivity of 3.6 in/hr (91 mm/hr) when tilled. Therefore, the treatment selected was to use coarse organics to hold pores open after tillage so that the DG material would not pack tight and decrease infiltration. Deep tillage was recommended for two reasons, first to key the loose surface horizons into the underlying rock and secondly to provide adequate rooting depth for summer active shrubs.

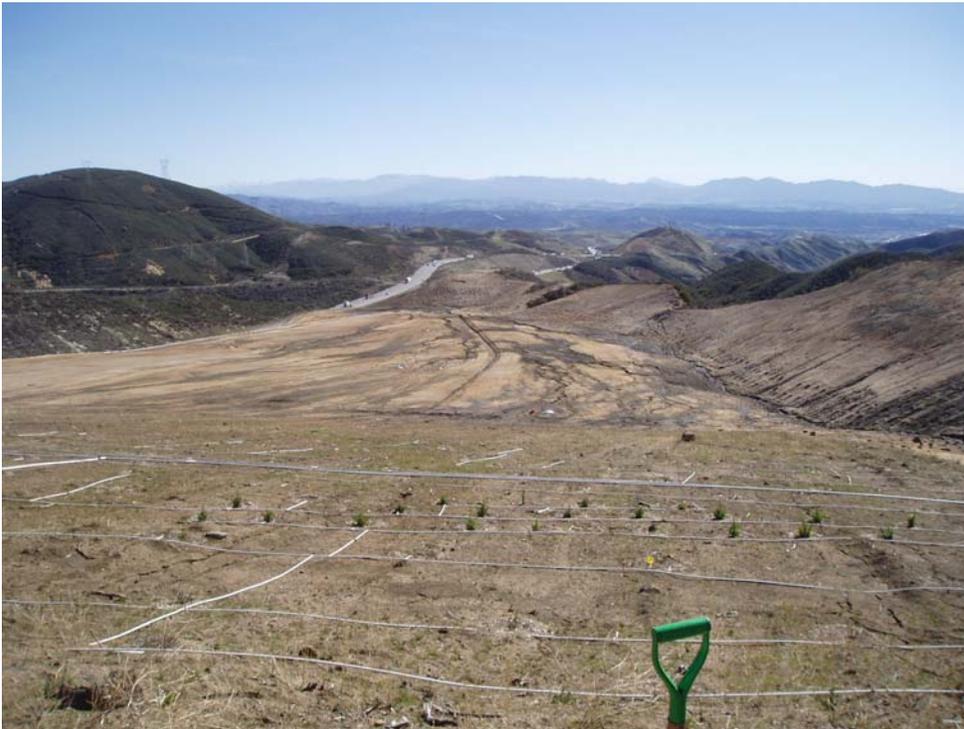
Photo 3. Templin site in Los Angeles county. The site was deeply excavated and 8 to 10 inches of loose ground substrate was bladed over low permeability shale. The area was revegetated during the previous winter and grass was just emerging from seed. Container plantings were installed near irrigation lines.

The “flats” portion of the site was located between the sloped area at the west end of the site and the chain link fence running out toward the midline of the site. This area had south-facing 5:1 slopes made of 8 to 10 in (200 to 250 mm) of loose siltstone fill over undisturbed shale. Infiltration on the untilled area of the site was 1.1 in/hr (28.7 mm/hr), while on the area with the loose overlay it was 1.2 in/hr (30.4 mm/hr). The water storage capacity on the overlay portion would be approximately 1.6 inches (41 mm) based on textural analysis. Although rainwater may infiltrate fast enough for some storm conditions, the thin overlay soil will soon fill with water and overland flow will start. These measurements were made with a portable rainfall simulator and may be higher than true equilibrium rates because of they were not run for a typical full measurement time needed due to lack of water on site and because site conditions at the time of measurement were dry and took extra water to reach equilibrium.

All sites were covered with a thick (3/8 inch; 10 mm) layer of hydromulch through which young grass plants were germinating.

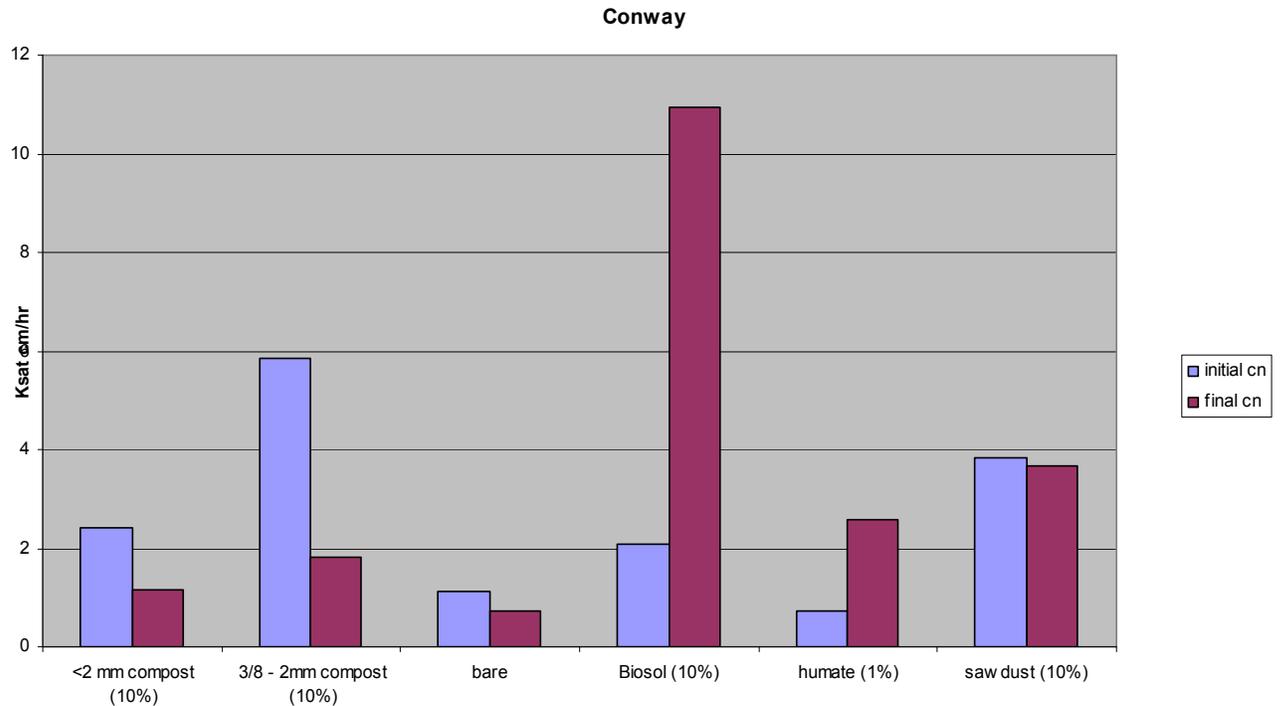
2.6.1. Conway infiltration measurements

The initial saturated conductivity measurements showed that both compost amendments, as well as the sawdust amendment, significantly increased initial Ksat when compared to the control bare soil. The 3/8 – 2mm compost exhibited the greatest increase of Ksat being 5 times faster than the bare. The fibrous content of the organic amendments appeared to be important, since the non-fibrous materials did not significantly increase infiltration.

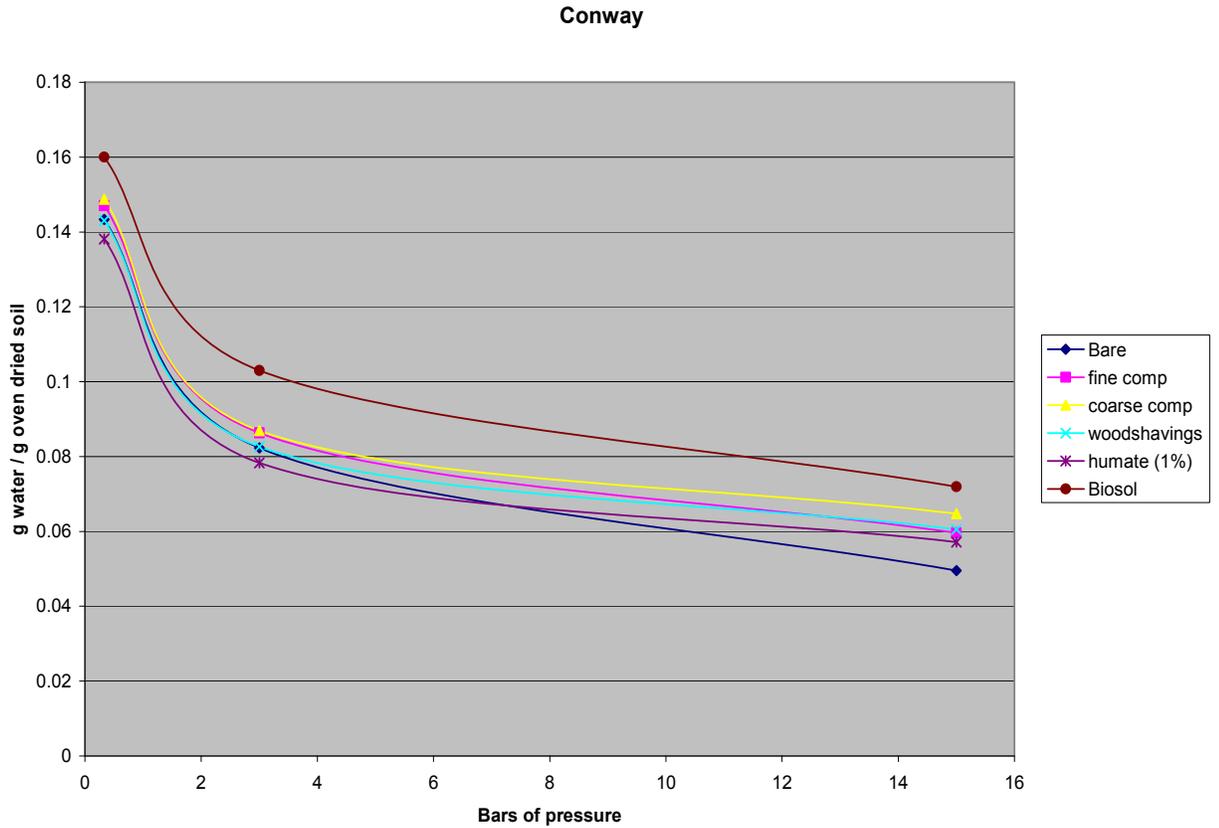
Conway water holding capacity data:

All soil amendments contained more water at dry (- 15 bar) conditions compared to the bare soil treatment. The fungal biomass and the composts or sawdust materials were all significantly higher. The total amount of water released between -0.33 and -15 bar pressure levels were found to be the greatest in the bare, fungal biomass, and < 2 mm compost treatments, but these treatments did not differ statistically. Compared to the beneficial increase in infiltration, soil amendment had moderate but significant functional improvement in water holding capacity. The fibrous organic amended substrates at 15 bar matric tension had 20 % (< 2 mm), 31 % (2 mm to 3/8 inch) or 22 % (sawdust) more water holding capacity compared to the bare unamended soil, all significantly greater than the unamended substrate.

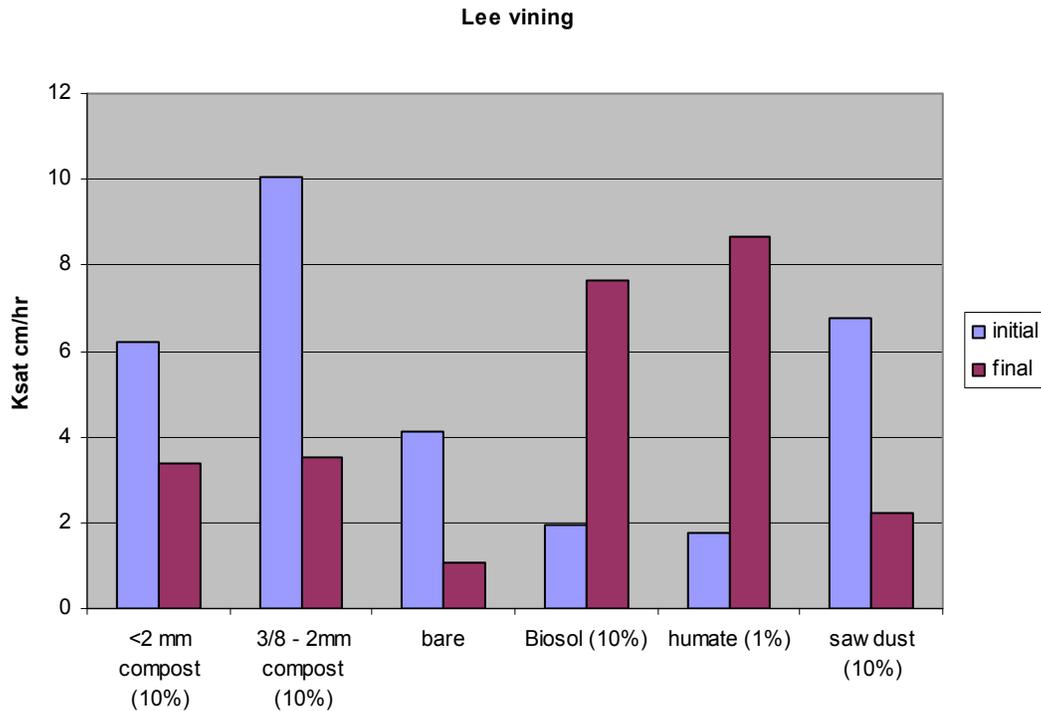
2.6.2. Lee Vining infiltration measurements

The initial saturated conductivity measurements on the Lee Vining substrate showed that both compost amendments, as well as the sawdust amendment, increased Ksat compared to the control bare soil. The 3/8 – 2 mm compost exhibited the greatest increase of Ksat, being 2.5 times faster than the bare. The fungal biomass and humate amendments reduced infiltration rates at the time of incorporation, compared to the bare substrate treatment.

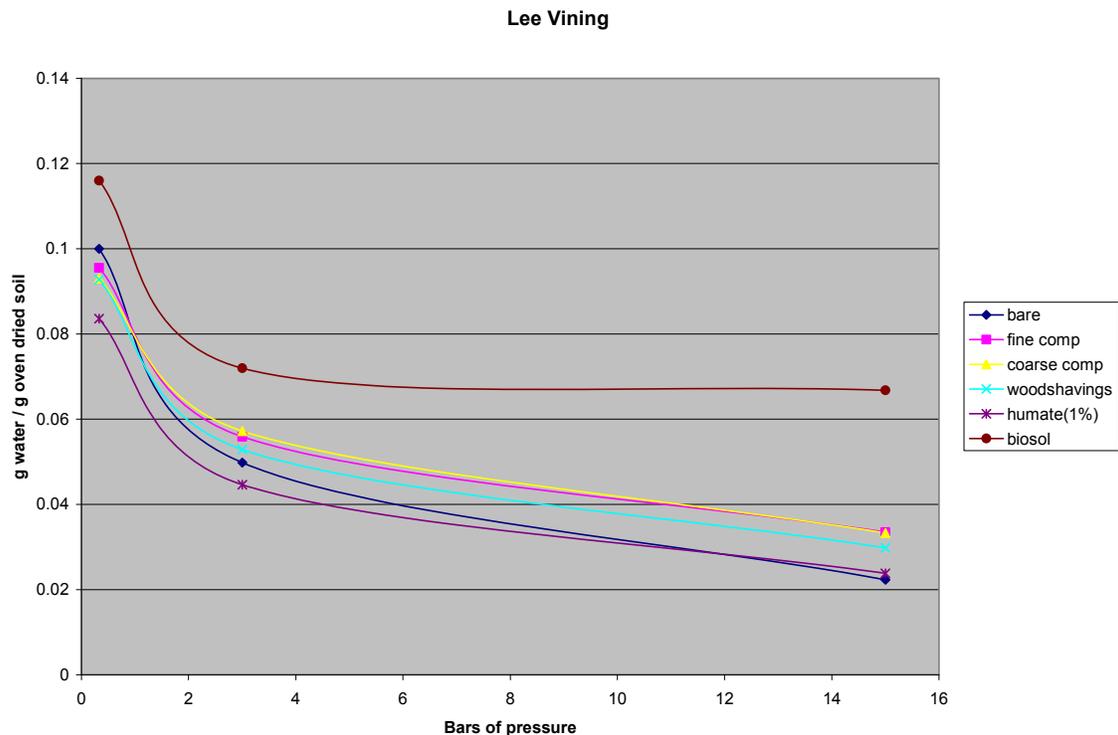
Lee Vining water holding capacities:

The fungal biomass treatment significantly ($p < 0.05$) retained the most water among the treatments at all measured pressure levels. At the 15 bar level, the fungal biomass and two compost treatments contained more water than the bare soil. The total amount of water released between 0.33 and 15 bar pressure levels were found to be the greatest in the bare soil (0.078 g water / g dried soil). The least amount of water was released from the fungal biomass treatment. All other treatments were between the bare and fungal biomass, and were not significantly different from each other. At 15 bar matric tension, compost amendment resulted in a 50 % increase in WHC for < 2 mm and 2 mm to 3/8

fraction, and 34 % more water for sawdust amended samples compared to bare mineral soils. These increases were all statistically significant, but still are relatively low levels of water holding capacity (approximately 3 % v/v).

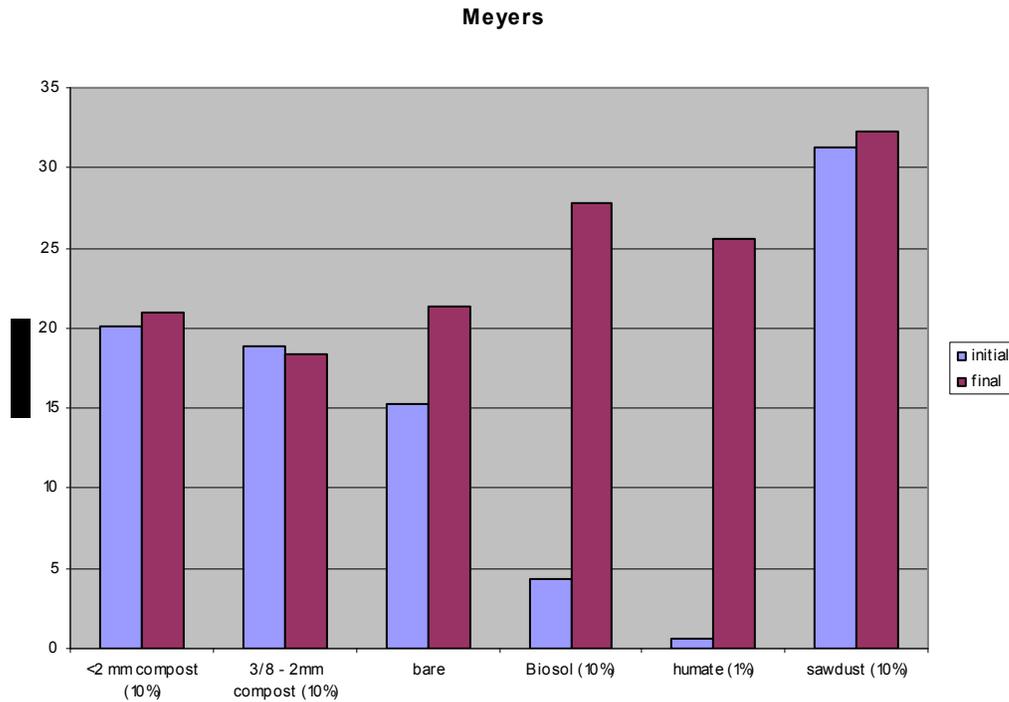
Meyers infiltration measurement

The sawdust treatment was the only treatment significantly greater than the bare treatment shortly after initial Ksat measurements. Compost amendments provided non-significant increases. The fungal biomass and humate treatments had large, significant increases to Ksat after the wetting / drying process. The process that caused this increase is not known.

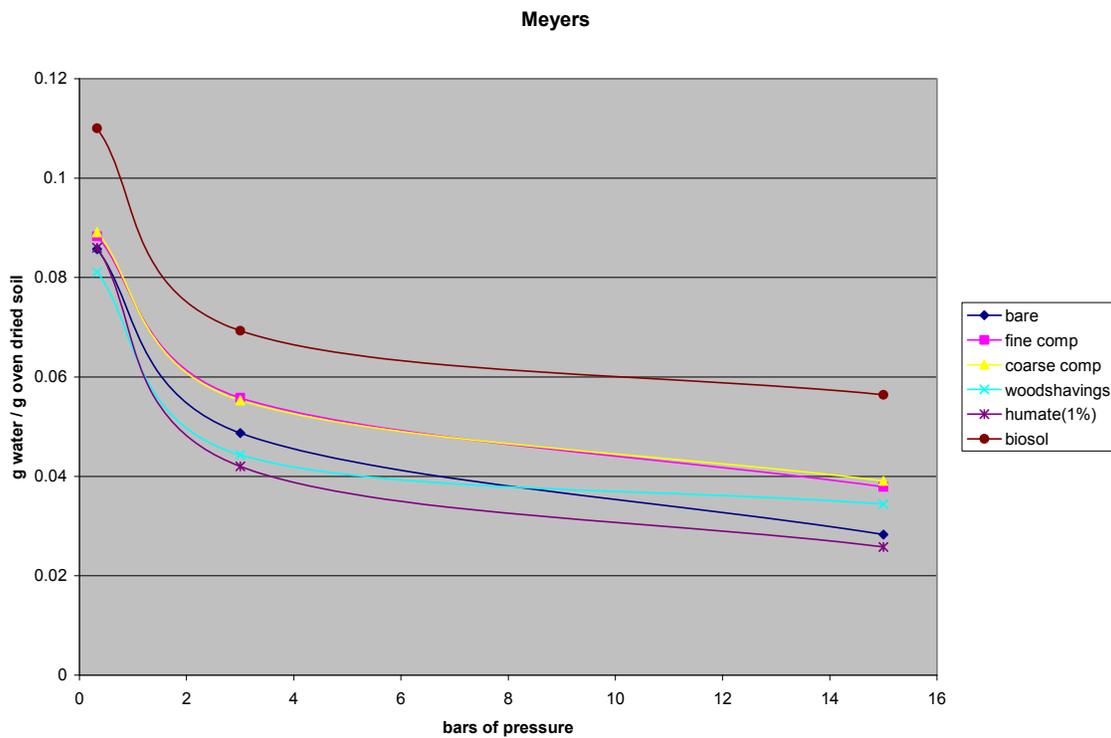
Meyers water holding capacities:

The fungal biomass treatment significantly ($p < 0.05$) retained the most water amongst the treatments at all pressure levels. At the 15 bar level, the fungal biomass and two compost treatments contained more water than the bare soil. The total amount of water released between 0.33 and 15 bar pressure levels was statistically the same amongst all treatments, ranging from 0.046 to 0.06 g water / g dried soil. At 15 bar matric tension, the compost amended samples had 39 % (2 mm to 3/8 inch), 34 % (< 2 mm) greater water holding capacity than the bare unamended soils, while the sawdust had 21 % increase. The compost water contents were significantly greater ($p = 0.05$) but the sawdust were non-significant.

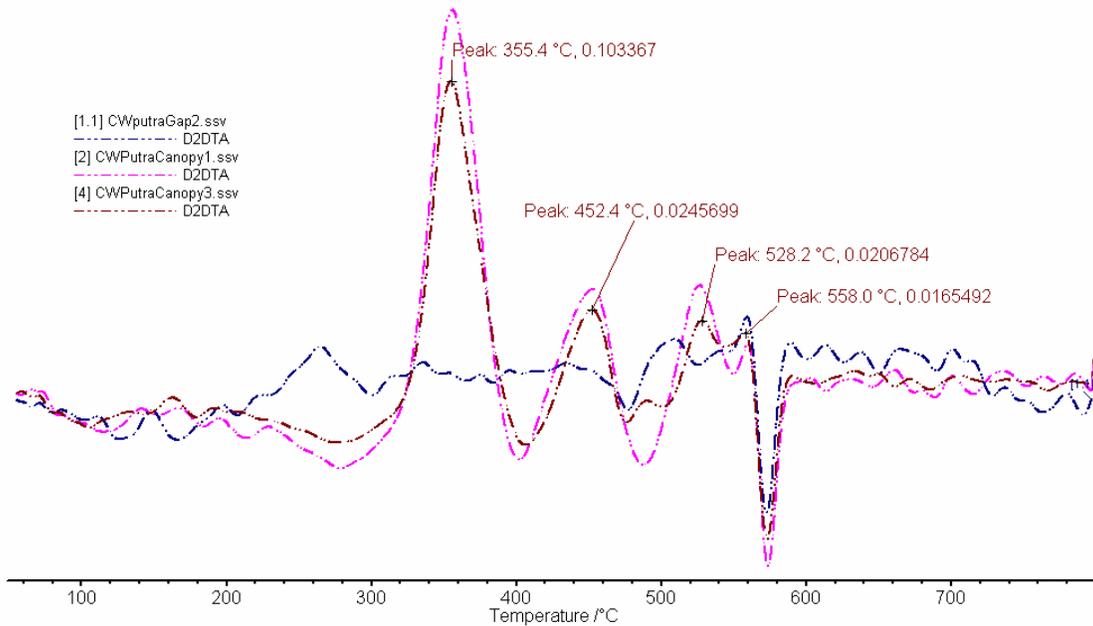
Figure 1. Differential thermal analysis of Conway summit canopy samples (magenta and brown lines) versus gap substrates (dark blue line).

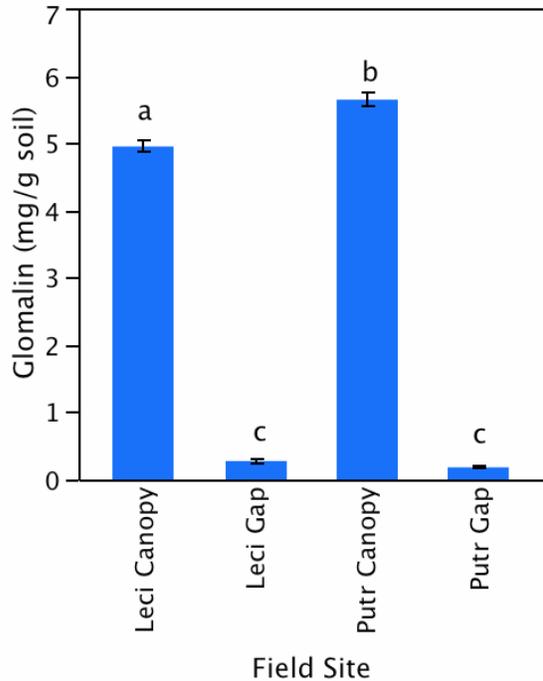
Fig 2. Content of mycorrhizal exudate (glomalin) using ELISA test method on basin wildrye (Leci) and antelope bitterbrush (Putr) vegetation samples at the Conway summit cut slope (MON 395).

Aggregates in the 1000 - 2000 μm size range of the *Purshia* canopy soil comprised 20.6 % of the total soil volume compared to only 8.1 % in the gap soil. The *Purshia* canopy also had over 4 times greater infiltration rate. These canopy soils had a correspondingly greater glomalin content (Fig 2) compared to gap soils. Similarly, canopy soils under *Leymus* had 9.3 % of the soil volume formed of aggregates, while the gap had none and the *Leymus* canopy had 50% greater infiltration. Glomalin contents were also much higher in the *Leymus* canopy compared to the gap.

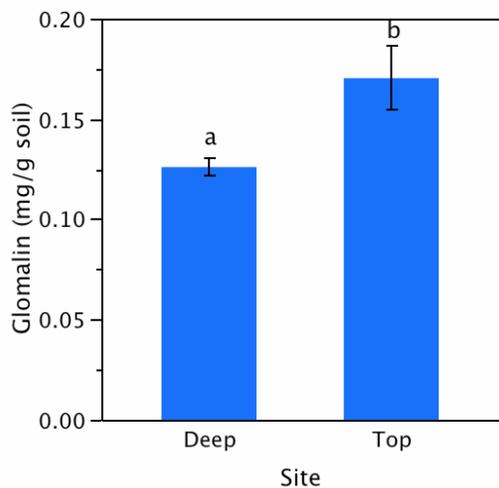
Fig 3. Content of mycorrhizal exudate (glomalin) associated with grass vegetation versus non-vegetated soils from the Bullion Bend fill site (ELD 50).

Substrates at this site were only weakly aggregated (Table 1). Even so, the rooting of native grasses has elevated glomalin in the soil horizons with roots compared to the non-rooted (deep) volumes. However, these levels are about 2 or 3 % of those measured in the better aggregated soils at Conway Summit. Infiltration levels were less in the vegetated (top) soils than the non-vegetated (deep). Evidently, the accumulated glomalin was not functioning to increase infiltration.

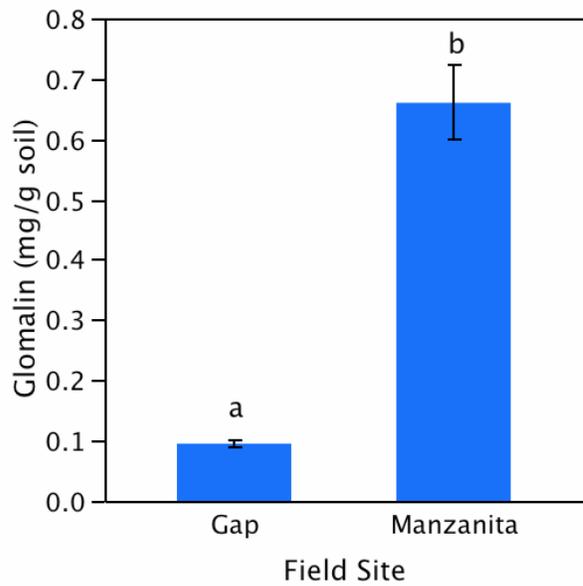
Fig 4. Content of mycorrhizal exudate (glomalin) associated with manzanita canopy soils versus non-vegetated gap soils at the Blue Canyon cut site (PLA 50).

Although aggregate content of the soil was similar in the 1000- 2000 um range, the 250- 1000 um range had significantly more (17.8 %) aggregates than the gap soil (10.6 %). More glomalin was isolated from the Manzanita canopy soil than from the barren gap soil. But, these glomalin levels are about 10 % of those measured at Conway Summit.

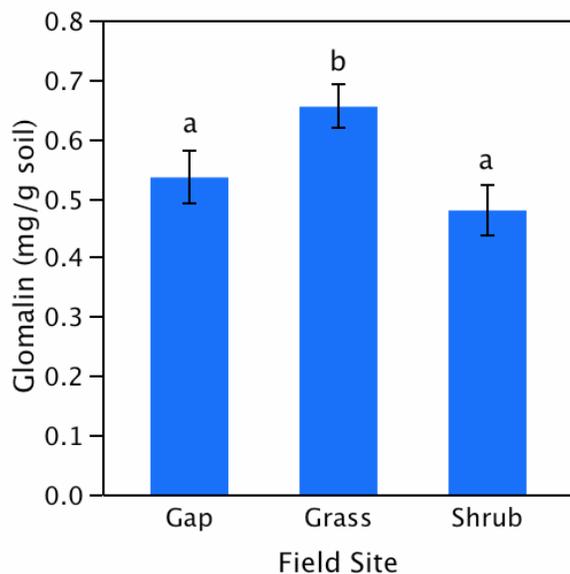
Fig 5. Content of mycorrhizal exudate (glomalin) associated with different vegetation at the Meyers chain-on (ELD 50 x 89).

The glomalin levels show slight increase under grass plants, but this is not expected to be relevant in field situations. These soils may aggregate poorly due to their decomposed granite mineralogy, or plant growth may not have occurred for a sufficient time, or the plant and mycorrhizal combination may have been suboptimal.

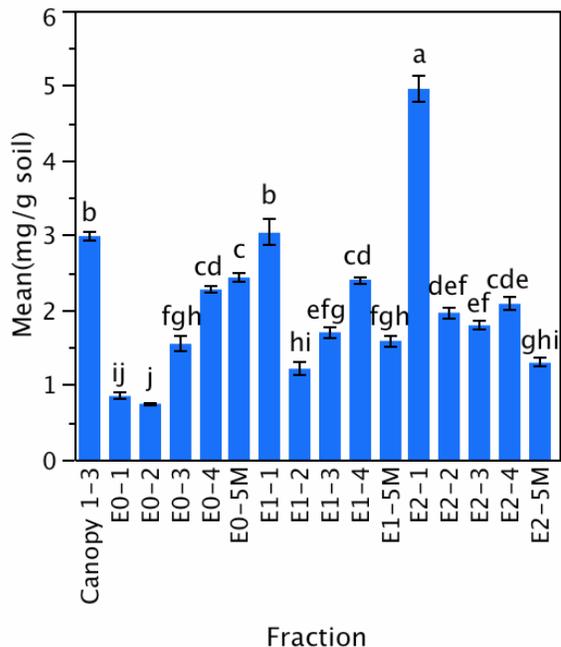
Figure 6. Canopy Samples without 1-2mm Organic Fraction

In Figure 6, the glomalin content of the canopy soil is graphed without the small organic chunks in the coarse sand fraction. This graph shows a pattern of increasing glomalin with size in unsonicated samples (E0 series) but decreasing glomalin in larger particle size fractions in samples sonicated with high energy (E2). This pattern confirms that the source of the aggregate binding strength is attributed to mycorrhizal produced glomalin and that the energy level delivered to E 2 samples is strong enough to break these larger particles down to clay sized primary particles. The process partially occurs in slightly sonicated samples (E1), indicating that some aggregates are weaker than others.

The first trend observed between the Canopy (Fig 6) and the Gap (Fig 7) is that the gap samples are about 20 % as high as the canopy samples. The gap samples, collected between plant canopies with no visible organic matter content or inputs, indicate little change with energy and particle size fraction. The pattern of increased levels of glomalin content in clay sized fraction is similar whether the substrates are either not sonicated (E0) or intensely sonicated (E2). These gap samples do not show signs of soil aggregates associated with glomalin.

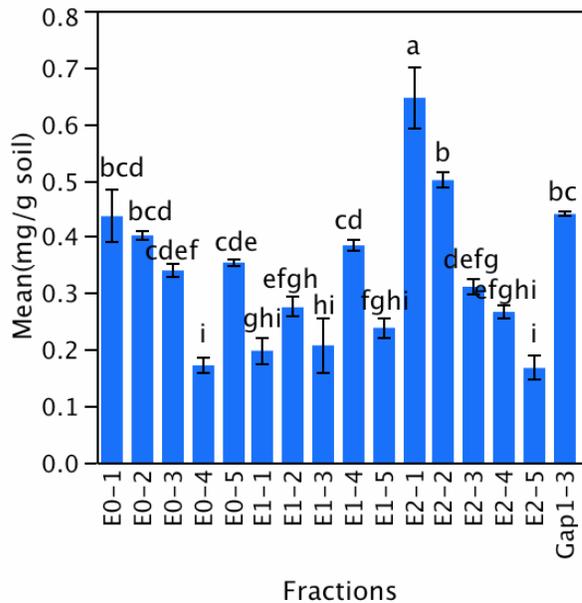
Figure 7. Gap Samples without 1-2mm Organic Fraction

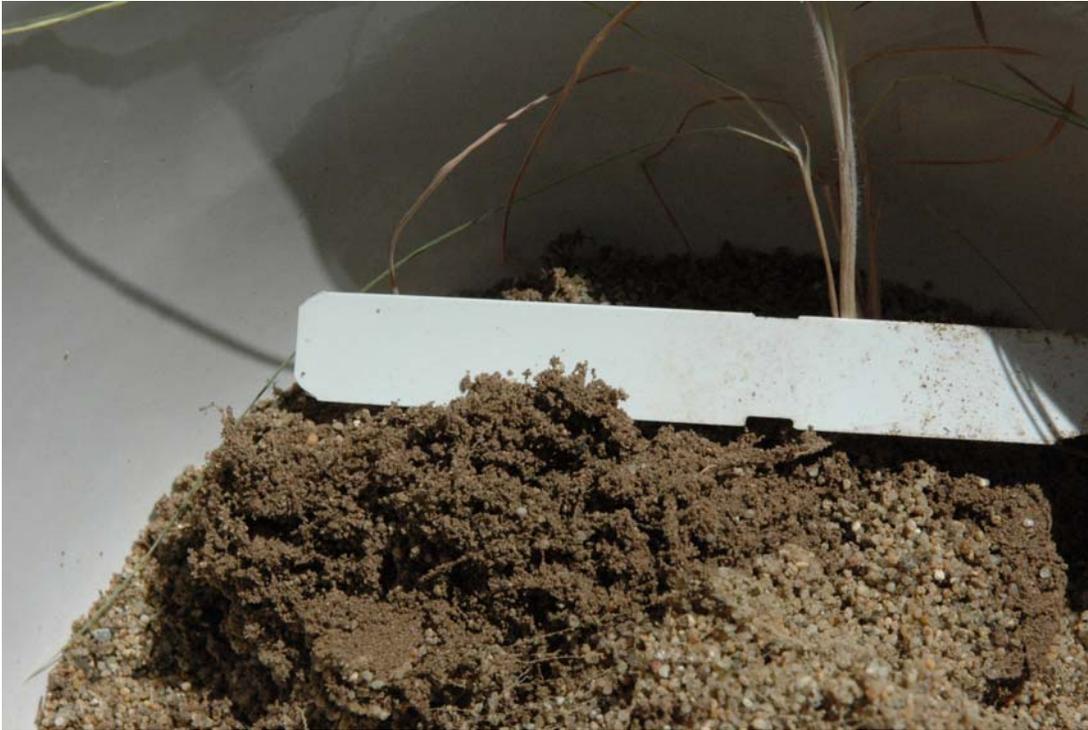
Photo 4. Regeneration of small aggregates of fine soil into sand sized aggregates after four months of growth of Big squirreltail (*Elymus multisetus*) in growth chamber conditions.

After four months growth of *Achillea millifolium* or *Elymus multisetus* with either commercial or ambient mycorrhizal inocula, plants in 0.5 L pots in growth chamber conditions on Conway summit substrate showed a significant ($p = 0.10$) increase in glomalin compared to uninoculated pots. This indicates that at least some of the components needed for aggregate generation (in this case, mycorrhizal exudation and/or glomalin production) start the first season after establishment. The application of this finding is to assure vigorous plant growth and mycorrhizal colonization soon after slope construction is completed.

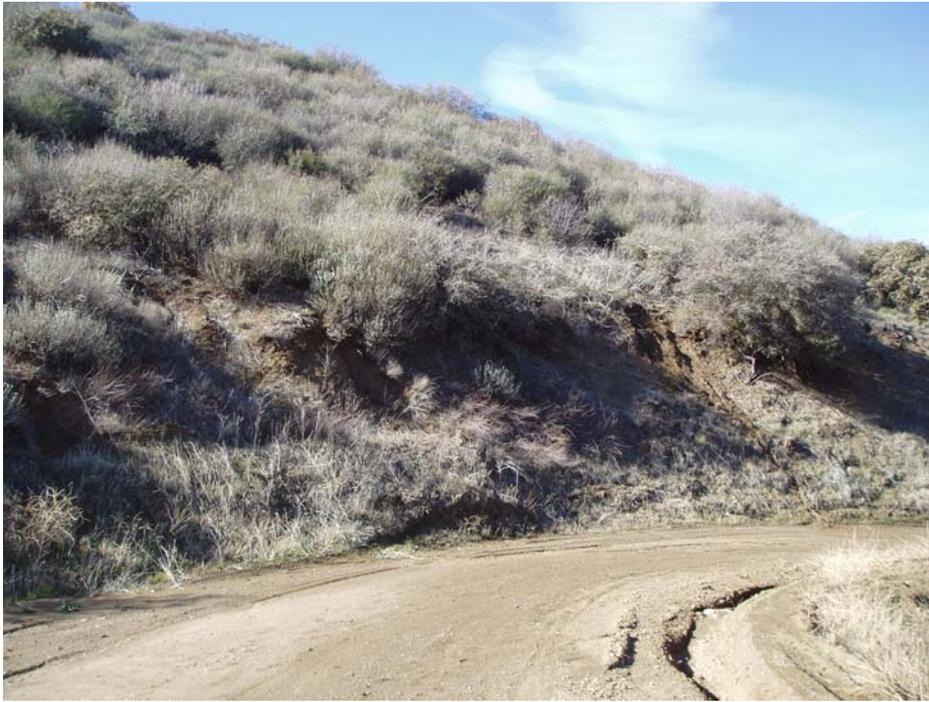
Figure 3. Native, vegetated reference area with deep, porous soil and no surface erosion except on oversteepened roadcut slope breaks.

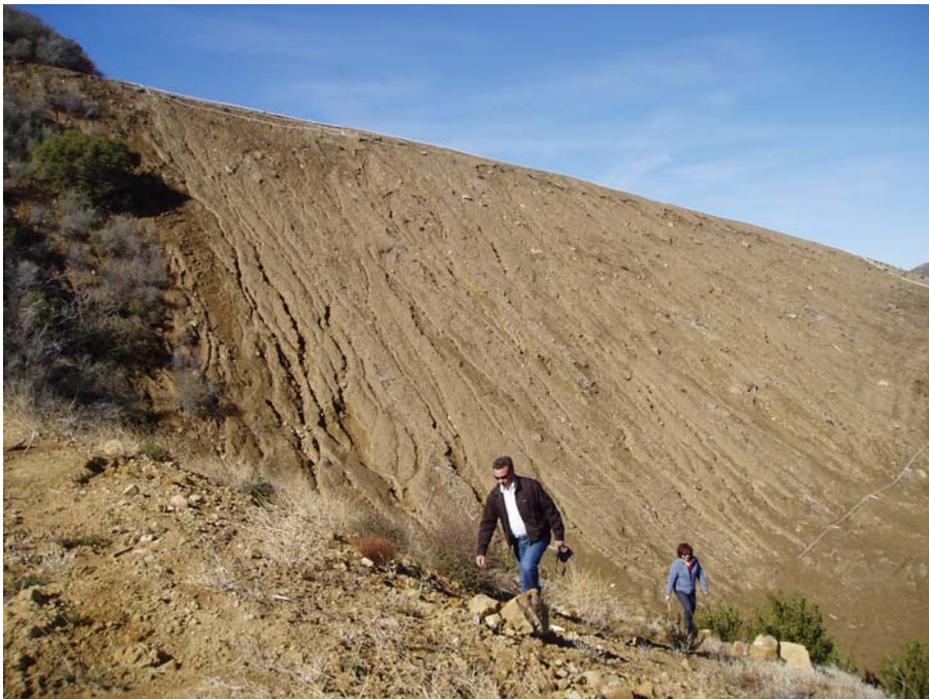
Figure 4. Fill slope adjacent to access road in Site 9. Most rills are initiated on the slope as indicated by the lack of channels coming over the upper road edge. Lag gravels and pedestalled gravels were commonly visible on the slope face. This indicates reduced infiltration into the weathered fines and increase overland flow. This scenario is expected to develop on the rest of Site 5 substrates within the next decade.

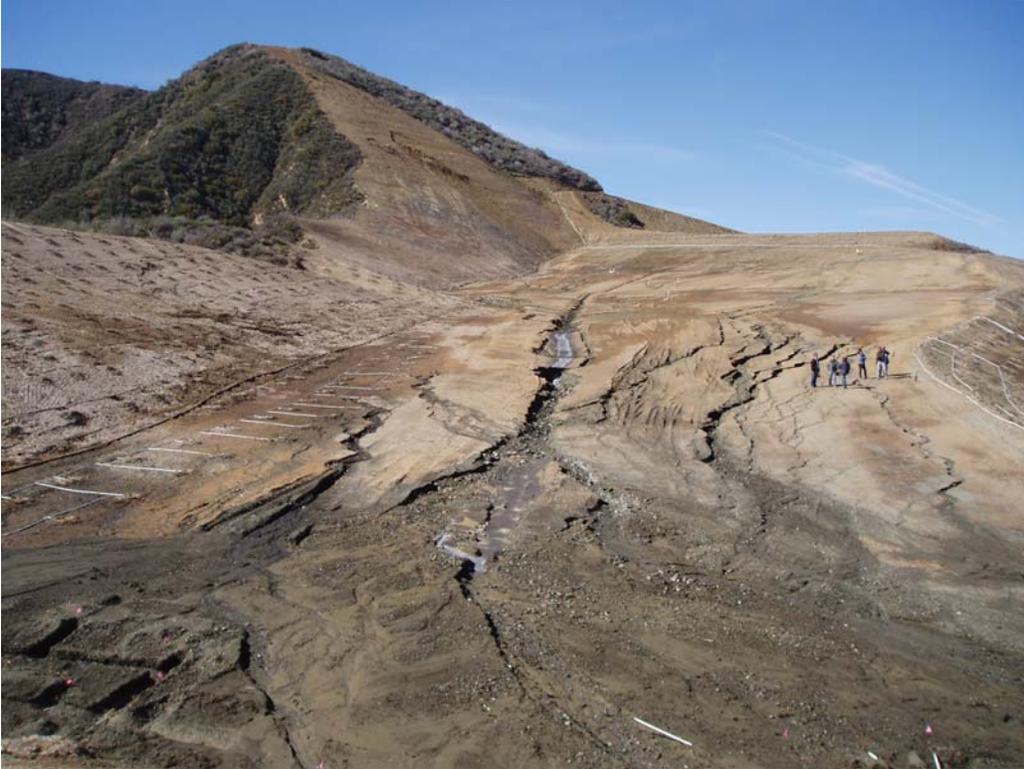
Figure 8. Overview of the Site 5 impacted area showing surface rills.

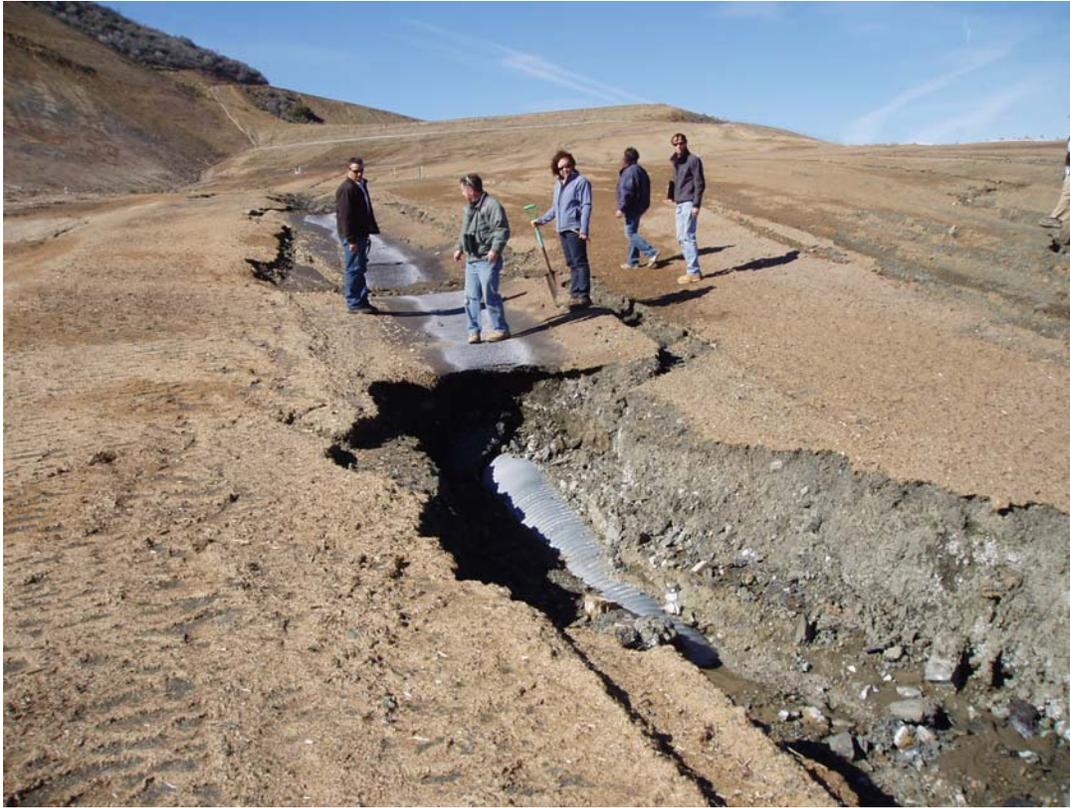
Figure 9. Head cutting under asphalt drain. Also visible in center of Figure 8.

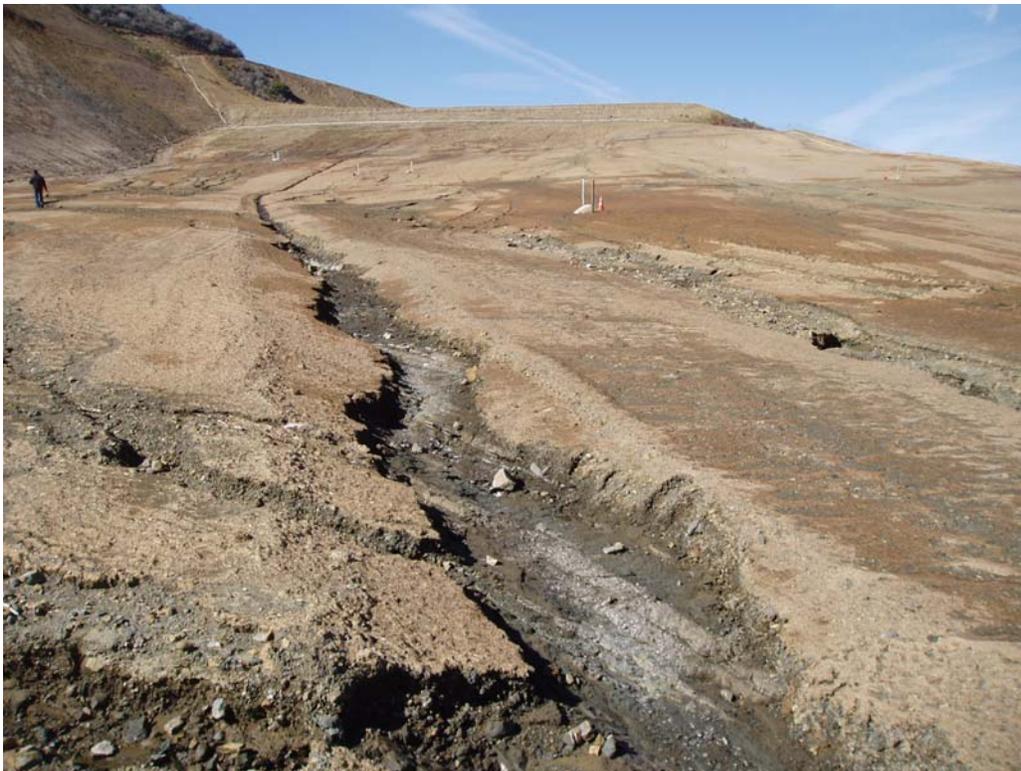
Figure 10. Shallow depth of rootable substrate overlaying low-permeability sedimentary rock common throughout Site 5.

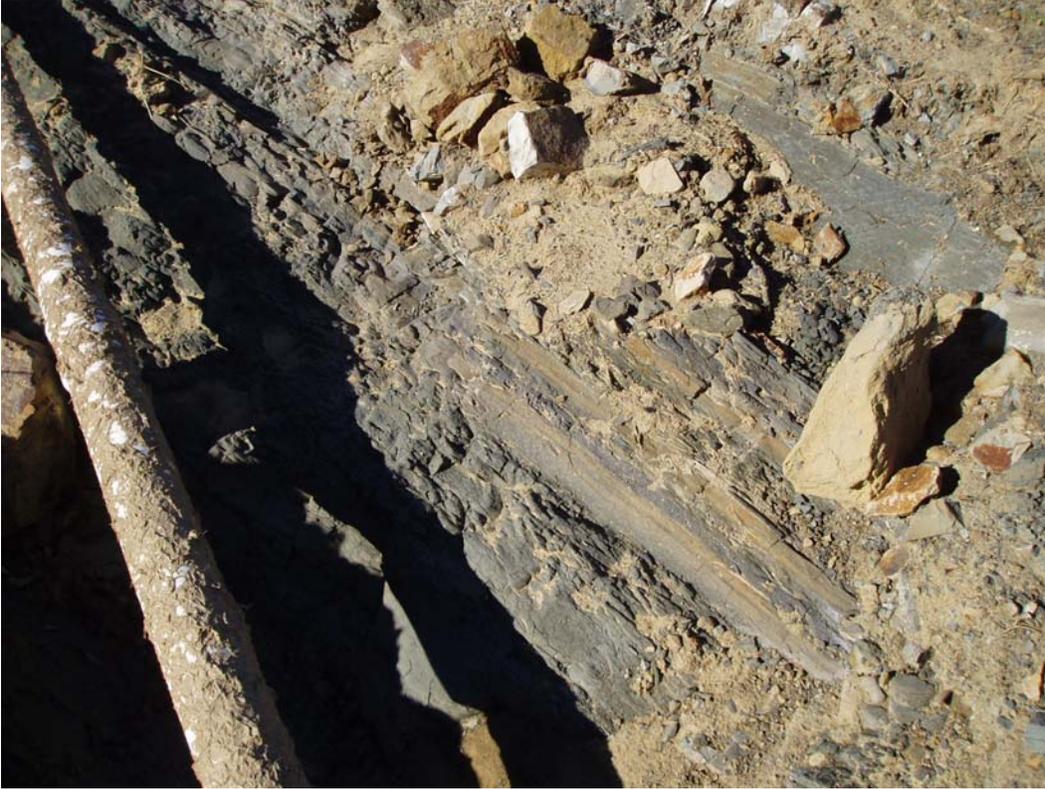
Figure 11. Low permeability rock in-place lying close to the substrate surface.

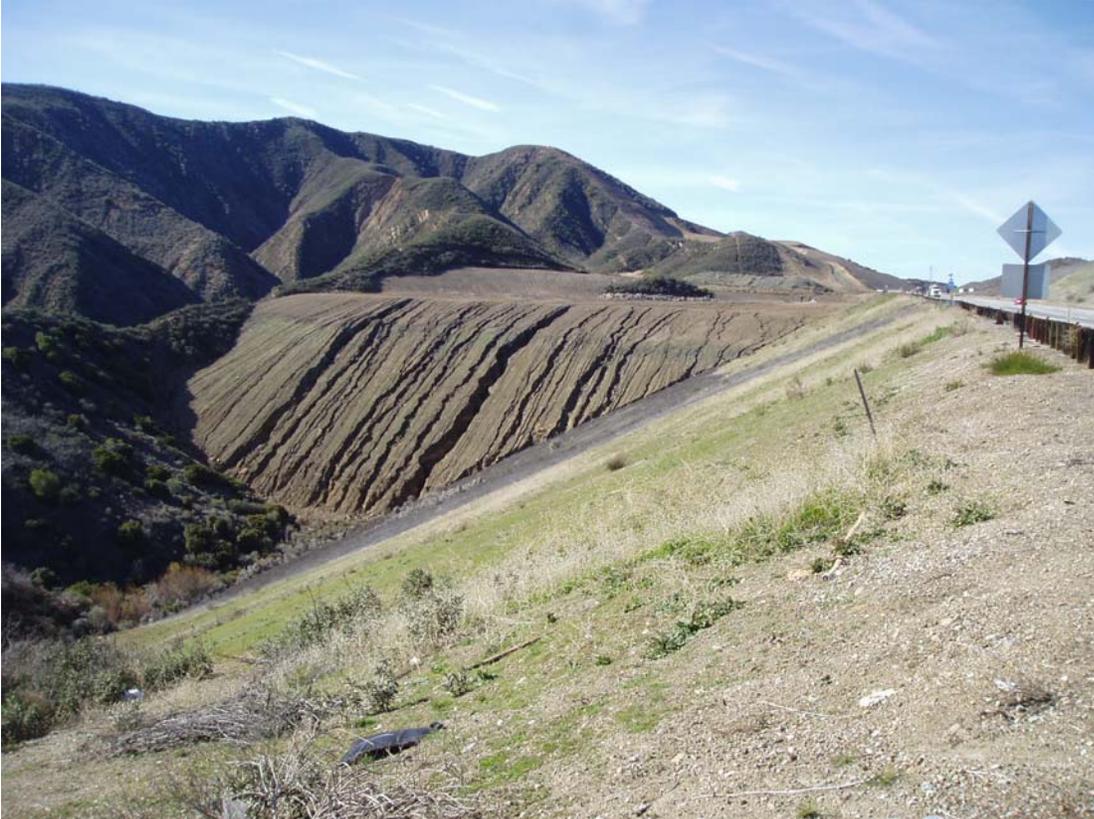
Figure 12. Rills and gullies from overland flow from rest of site.

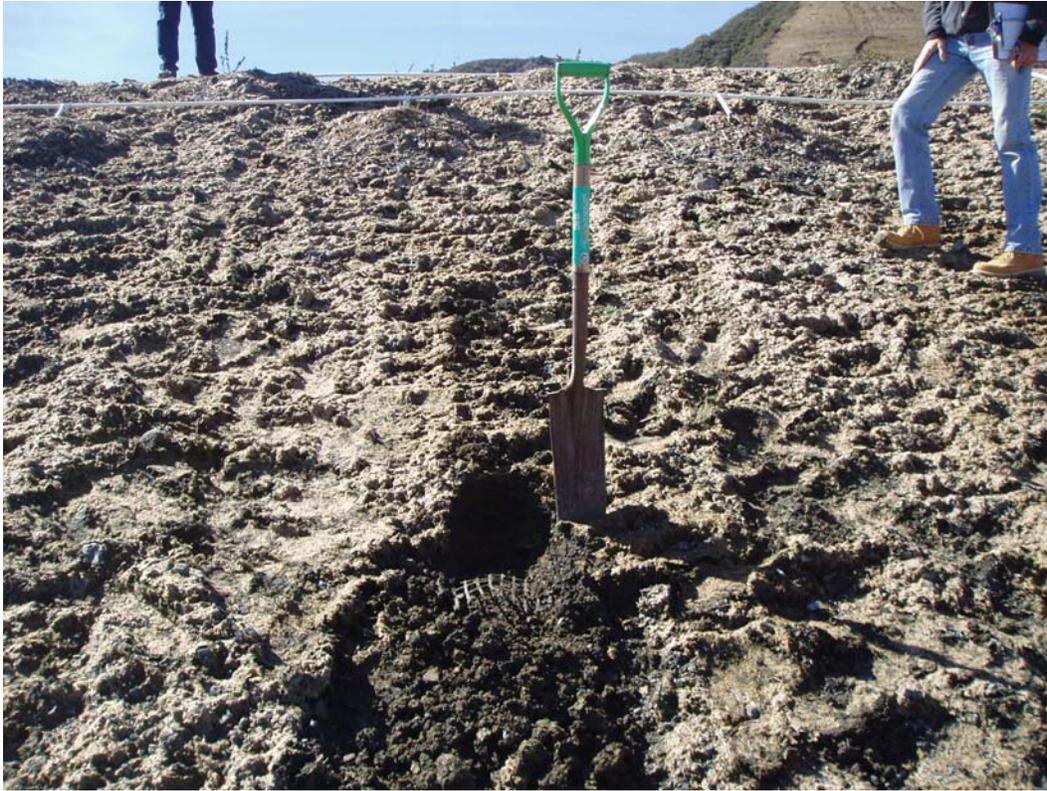
Figure 13. Exposed edge of geogrid on buttress slope.

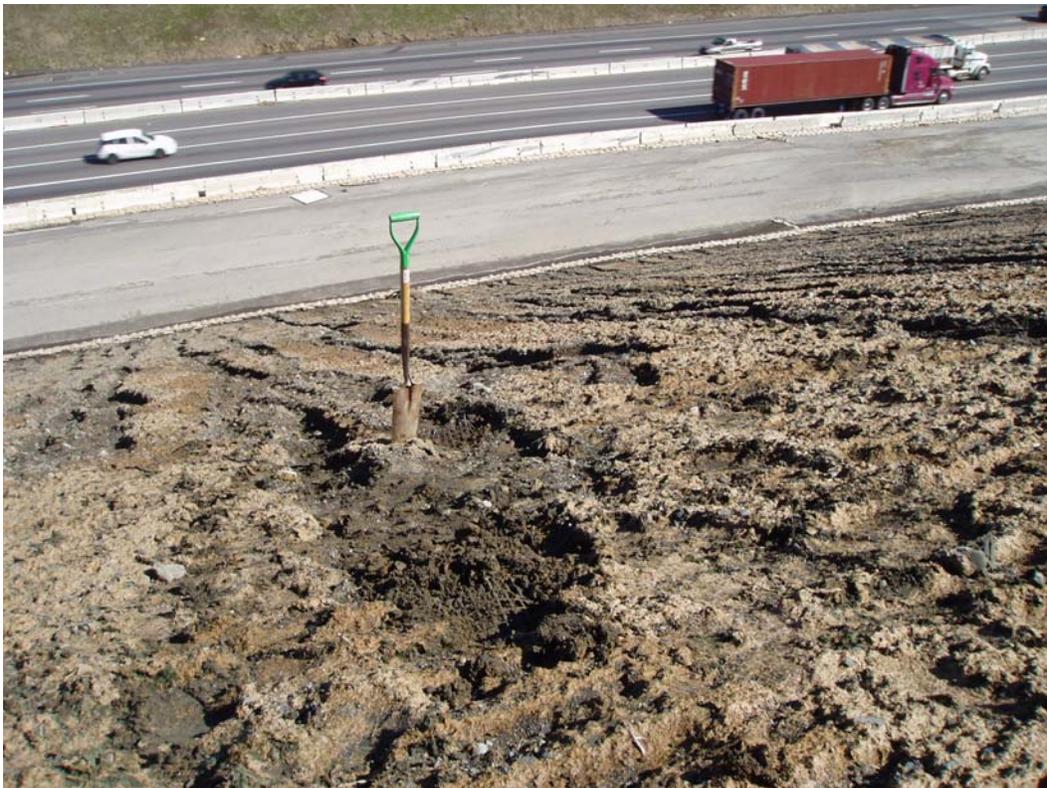
Figure 14. Exposed geogrid on the Buttress slope, with unstabilized slope surface caused by overland flow.
