# **Natural Environment Study**

State Route 74 Safety Project

From Antonio Parkway/La Pata Road to Cristianitos Road

12-ORA-74 PM 2.93/5.06

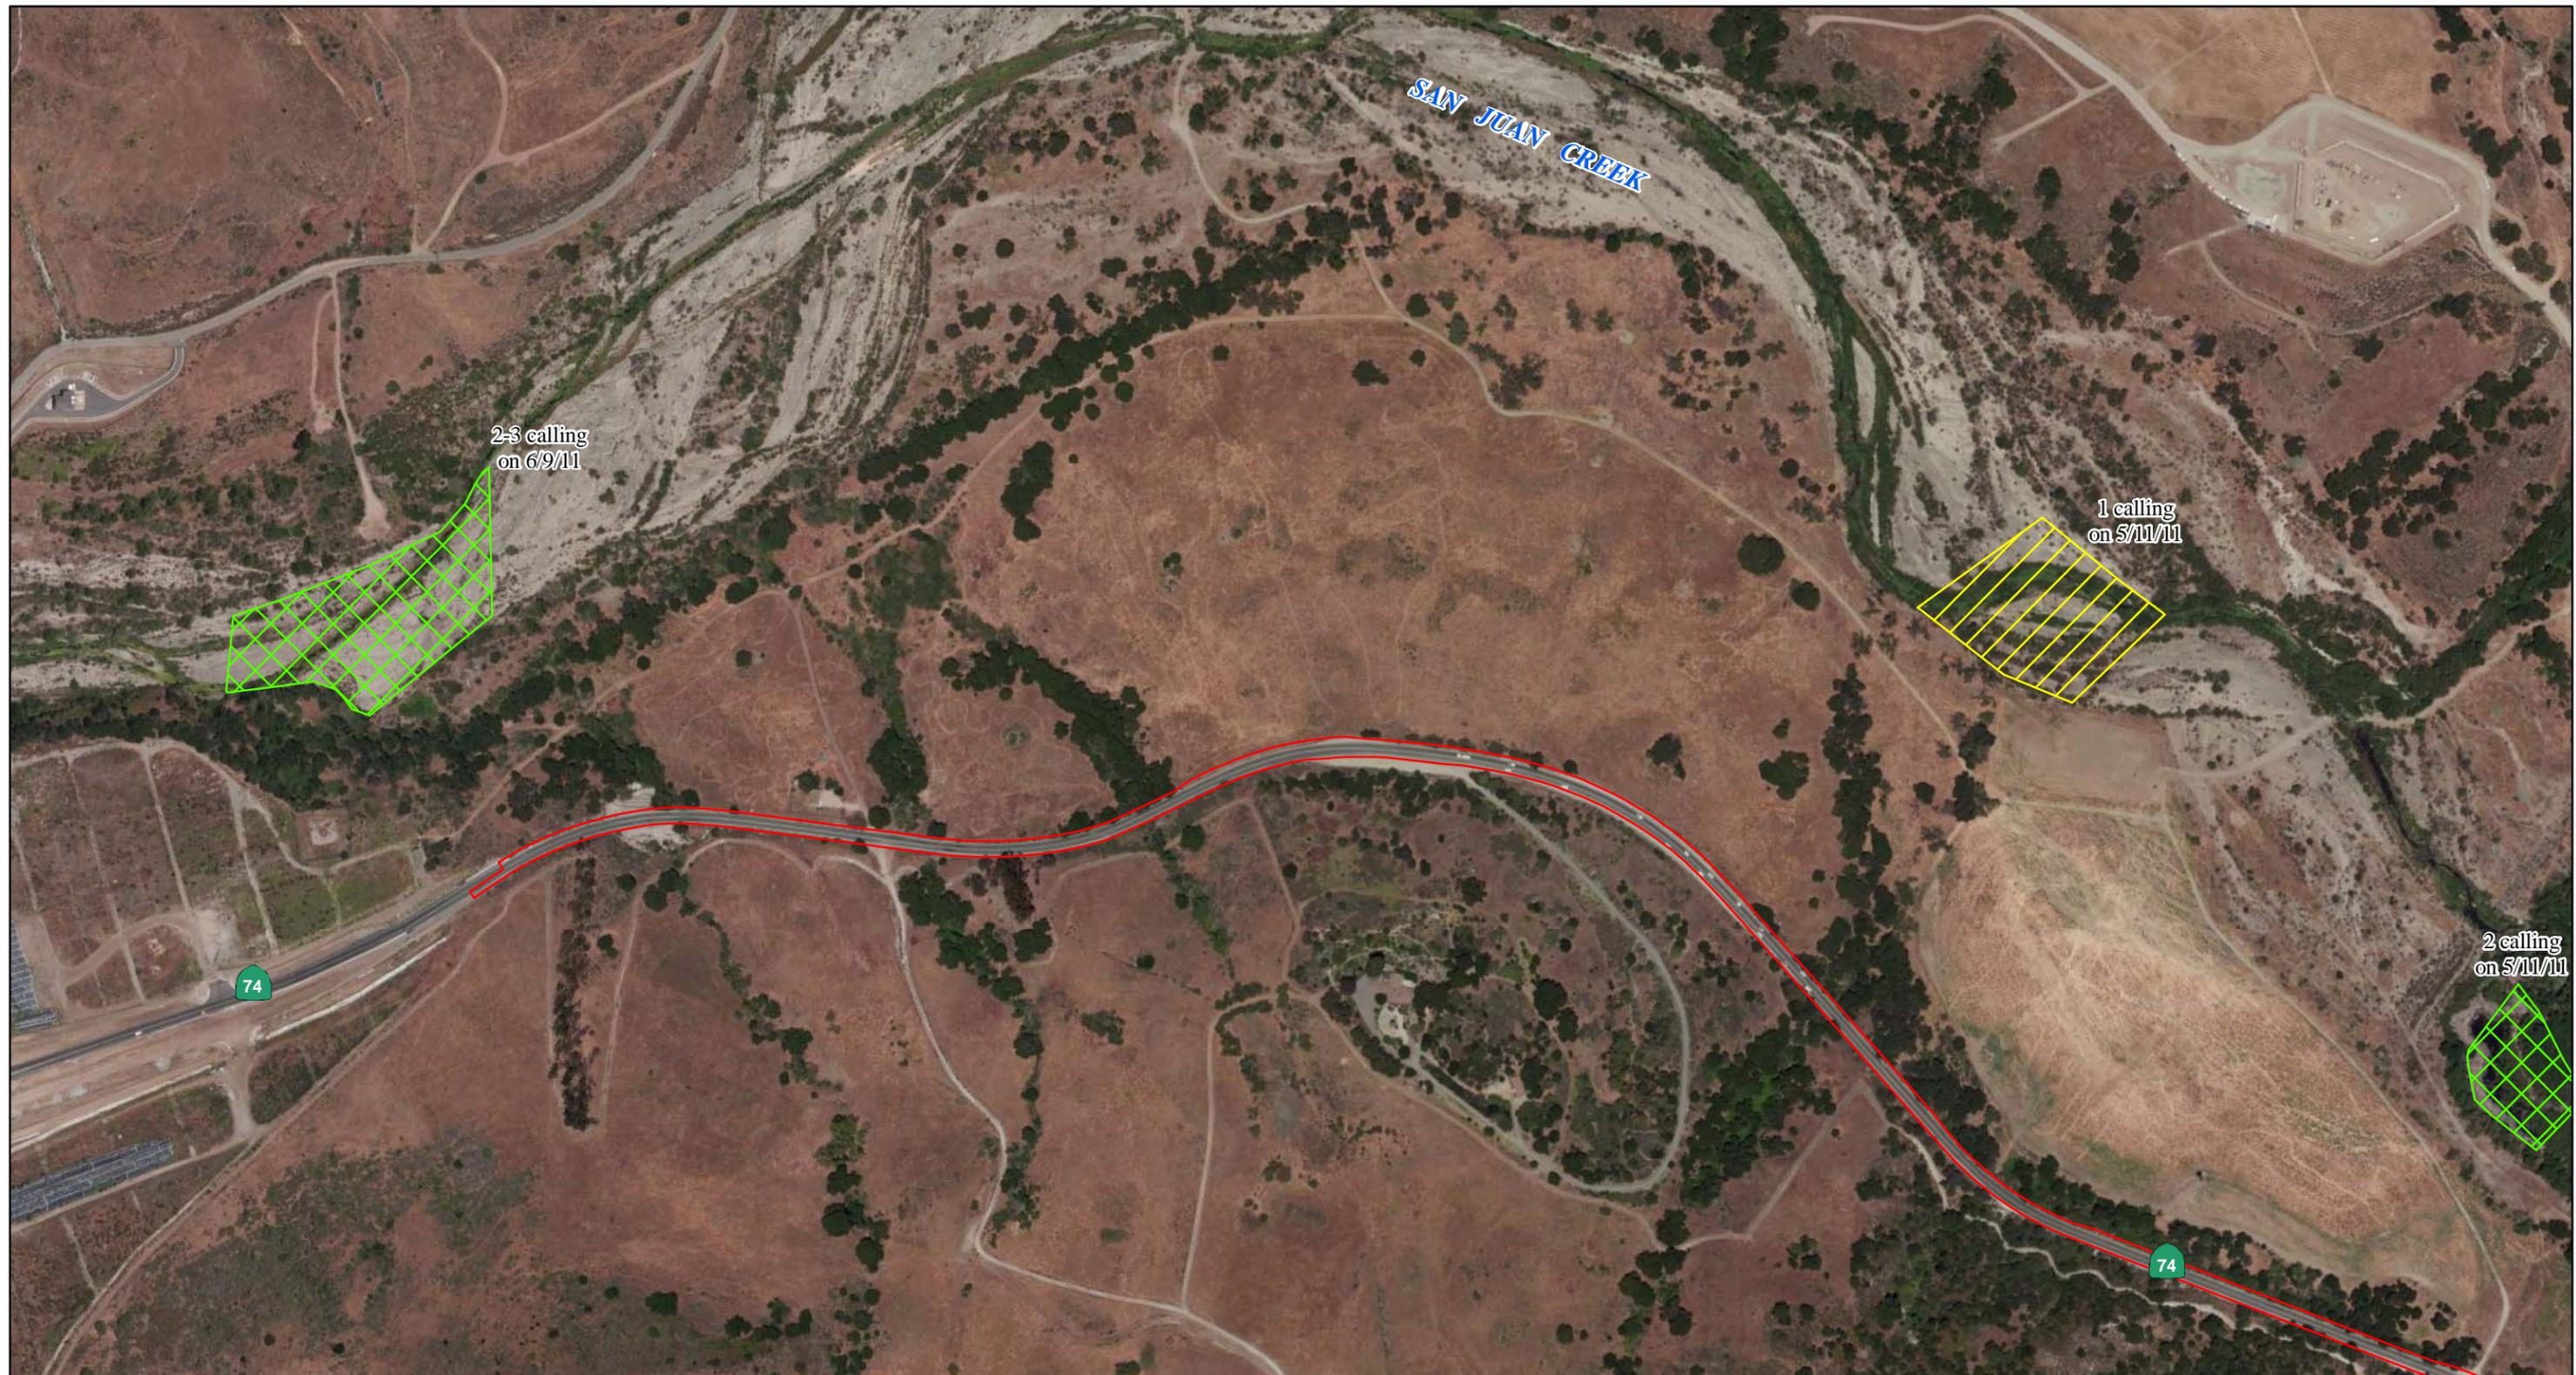
FIGURE 2  
 Sheet 1 of 2

SR-74 (Ortega Highway) Pavement Rehabilitation Project  
 2011 Arroyo Toad Survey Results  
 EA 0L7201  
 PM 2.93 to 5.06

arroyo toad given the contiguous upland habitat, suitable sandy substrate, and the gently flowing creek. Shallow, slowly flowing water was present in San Juan Creek during all six surveys (Figure 3).

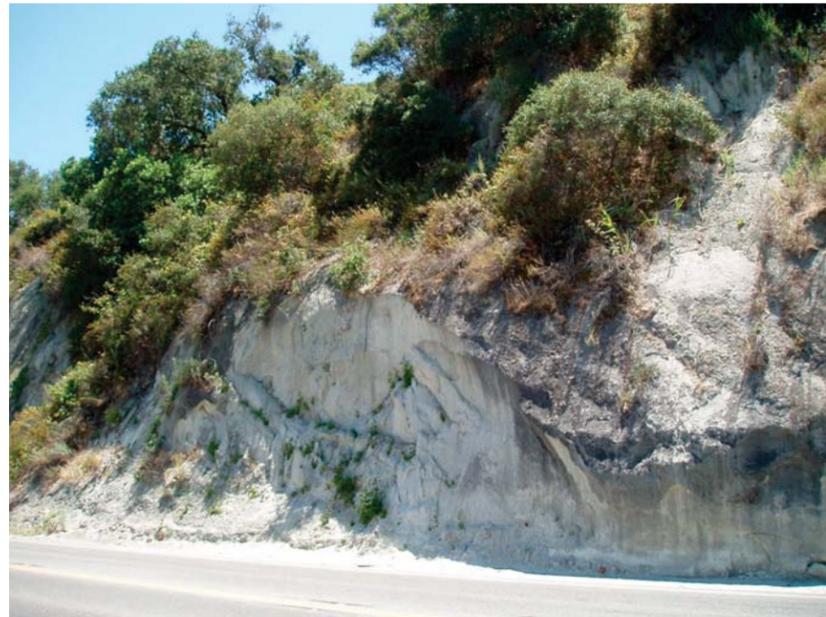
One of the small sandstone rock outcrops found at several locations in road cuts within the survey area.

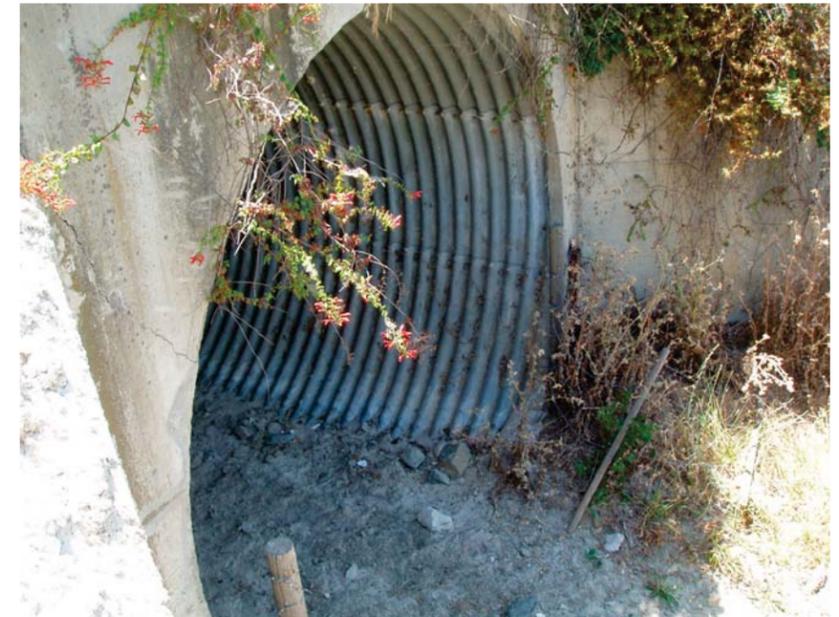
One of three large corrugated metal culverts within the survey area that contained bat guano.

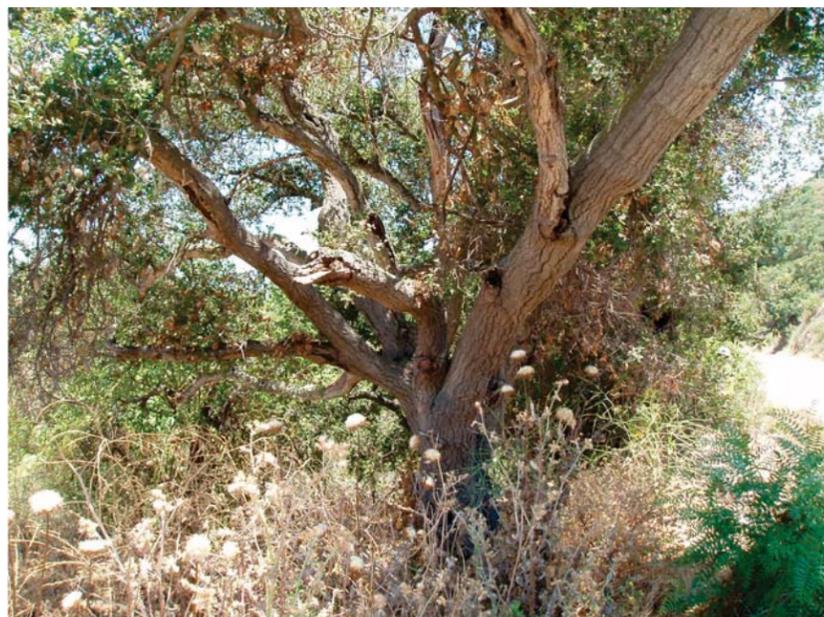
Large oak tree with obvious cavities that may be suitable for roosting bats. Many trees like this are present within the survey area.

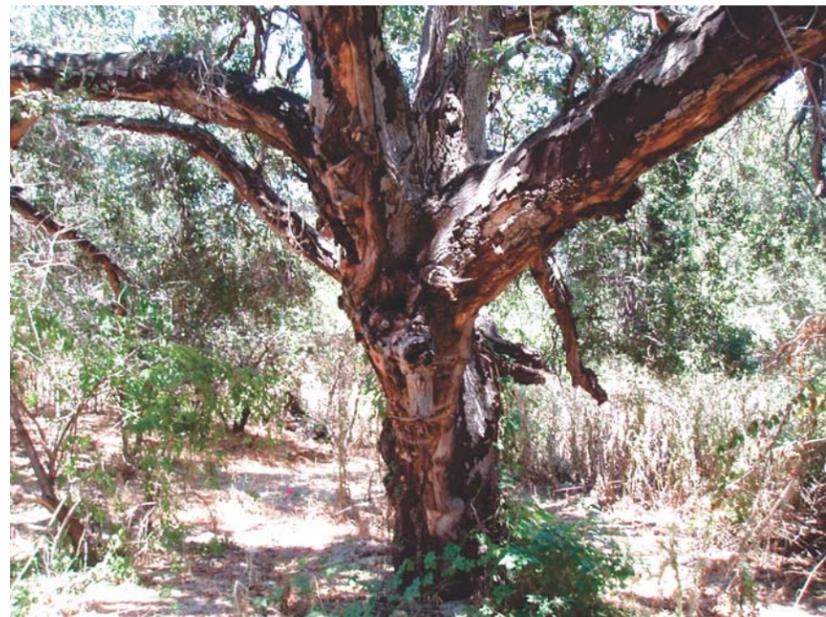
Large oak tree exhibiting extensive bark exfoliation; the crevices beneath the bark may provide bat roosting habitat.

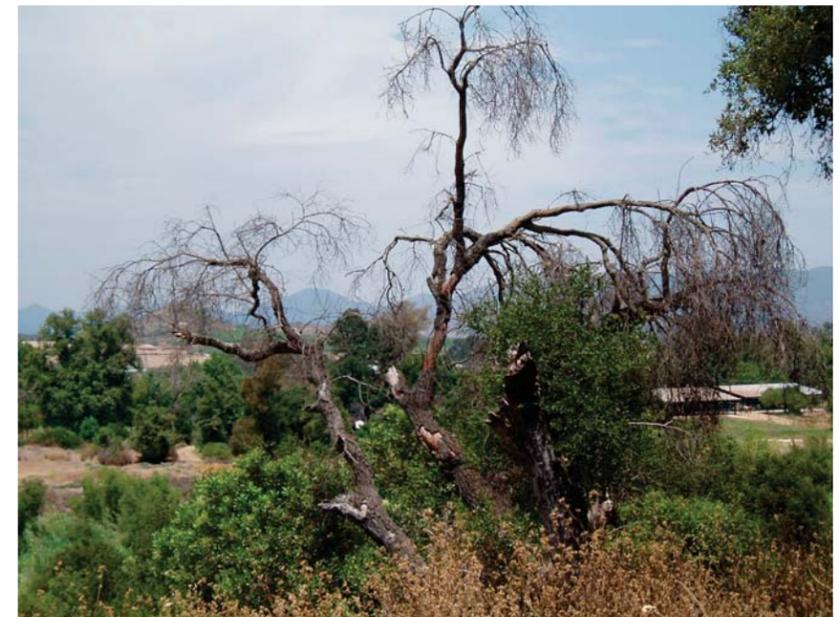
Large dead trees and snags that may be used by roosting bats.

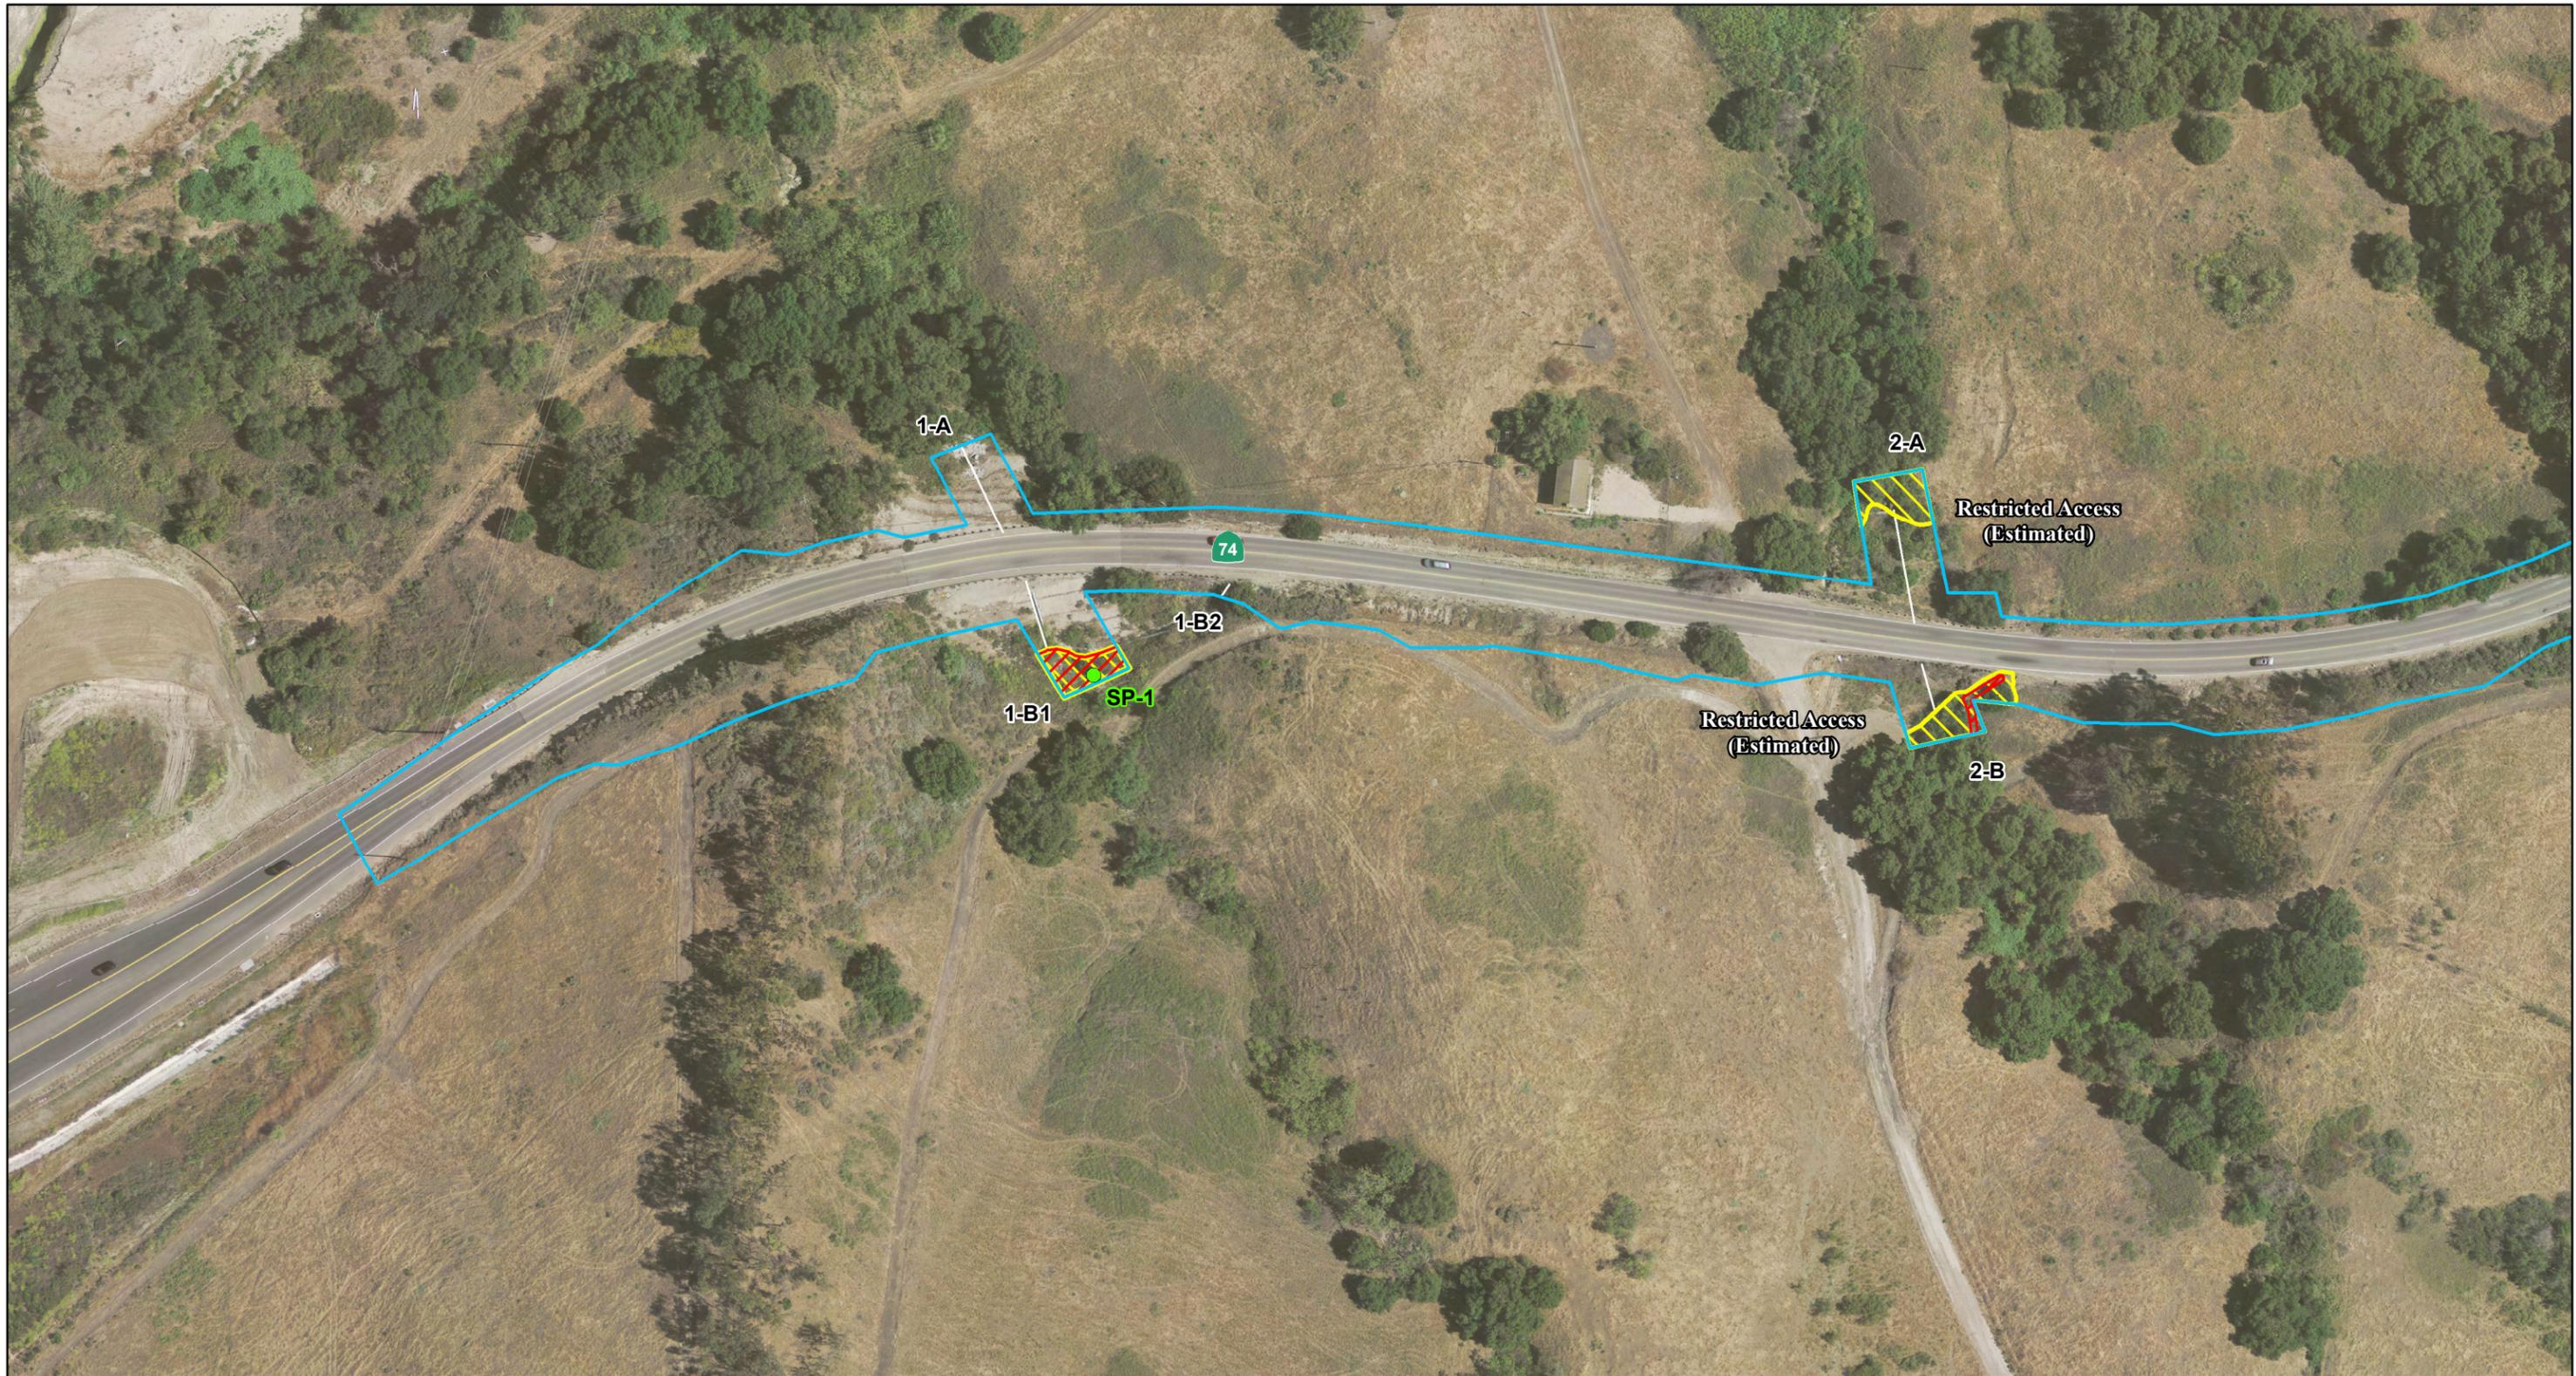
FIGURE 2  
Sheet 1 of 6

SR-74 Safety Project from  
Antonio Parkway/La Pata Road to Cristianitos Road  
Potential Corps and CDFG Jurisdictional Areas by Drainage  
12-ORA-74 PM 2.93/5.06  
EA 0L7200; Project No. 1200020180

Access permitting, areas of potential jurisdiction were evaluated according to Corps and CDFG criteria. The boundaries of the potential jurisdictional areas were observed in the field and mapped on a series of aerial photographs (scale at 1 inch = approximately 100 ft) included as Figure 2, which together show the entire study area. Measurements of federal and State jurisdictional areas mapped during the course of the field investigation were determined by a combination of direct measurements taken in the field and measurements taken from the aerial photographs. The on-site examination was conducted according to the Corps three-parameter (vegetation, soils, and hydrology) method of wetlands delineation (1987 Corps of Engineers Wetland Delineation Manual; 2008 Regional Supplement to the Corps of Engineers Wetland Delineation Manual: Arid West Region), as well as CDFG guidelines. An analysis of current aerial photographs and topographic maps was included in the site evaluation. General site characteristics were also noted. Representative site photos are included as Figure 3.

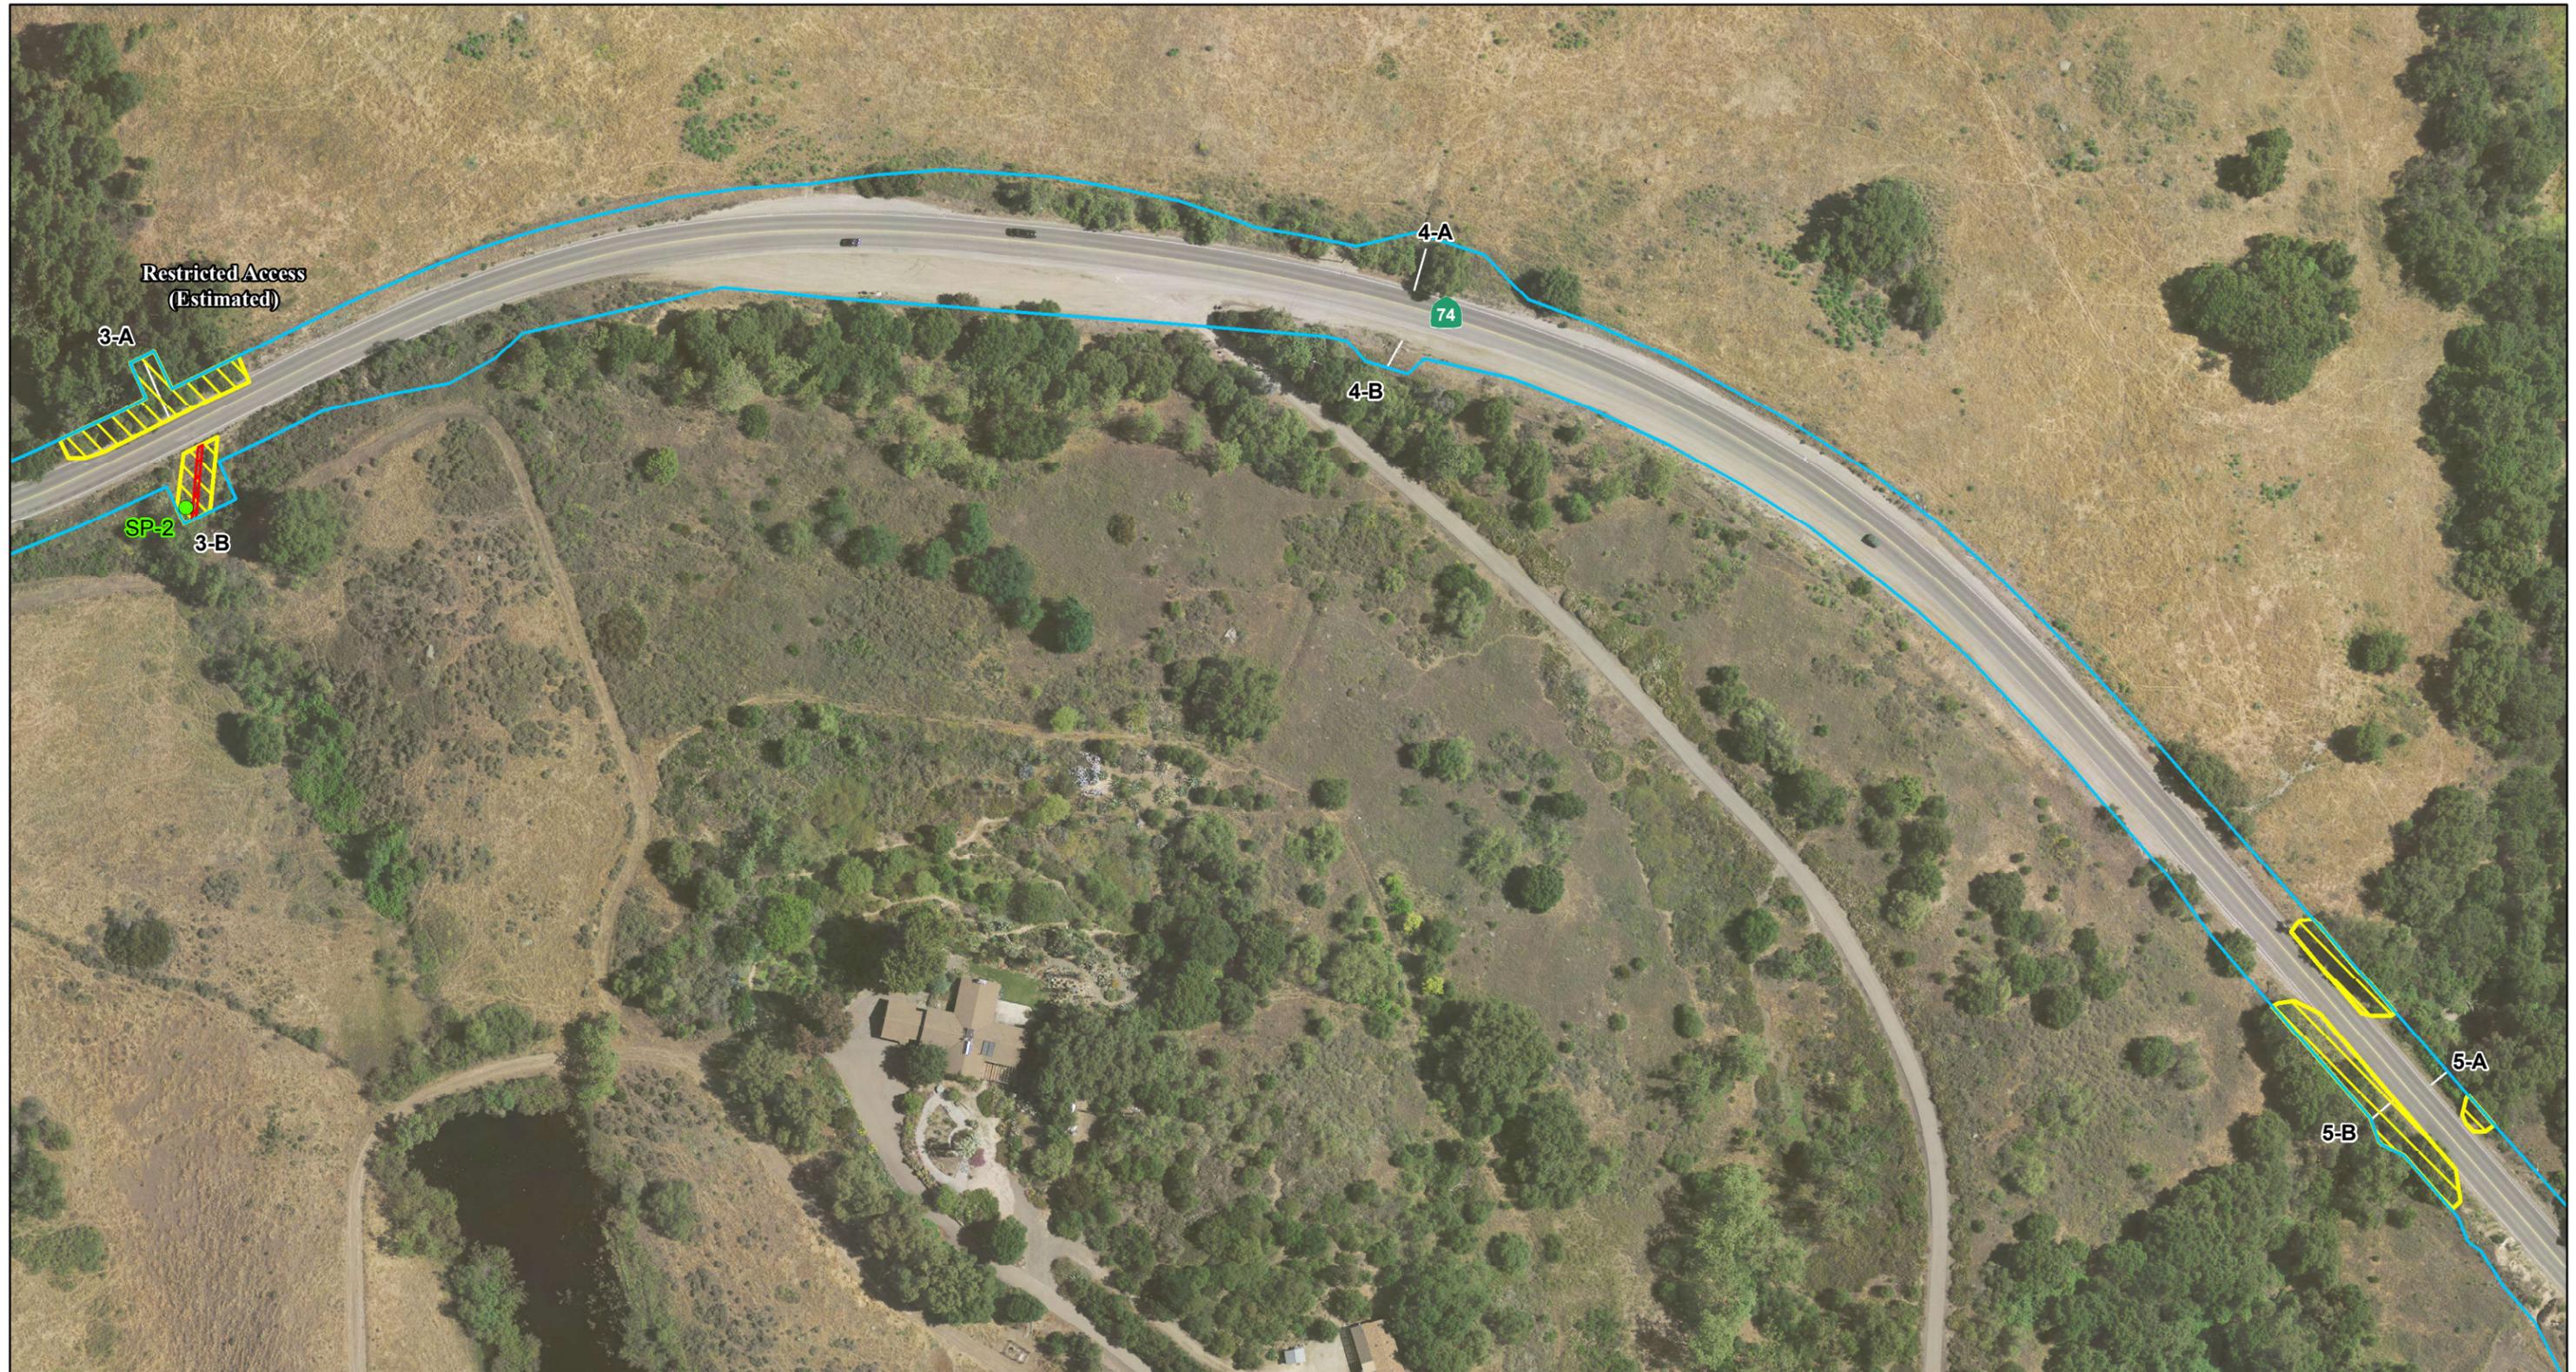
FIGURE 2  
Sheet 2 of 6

SR-74 Safety Project from  
Antonio Parkway/La Pata Road to Cristianitos Road  
Potential Corps and CDFG Jurisdictional Areas by Drainage  
12-ORA-74 PM 2.93/5.06  
EA 0L7200; Project No. 1200020180

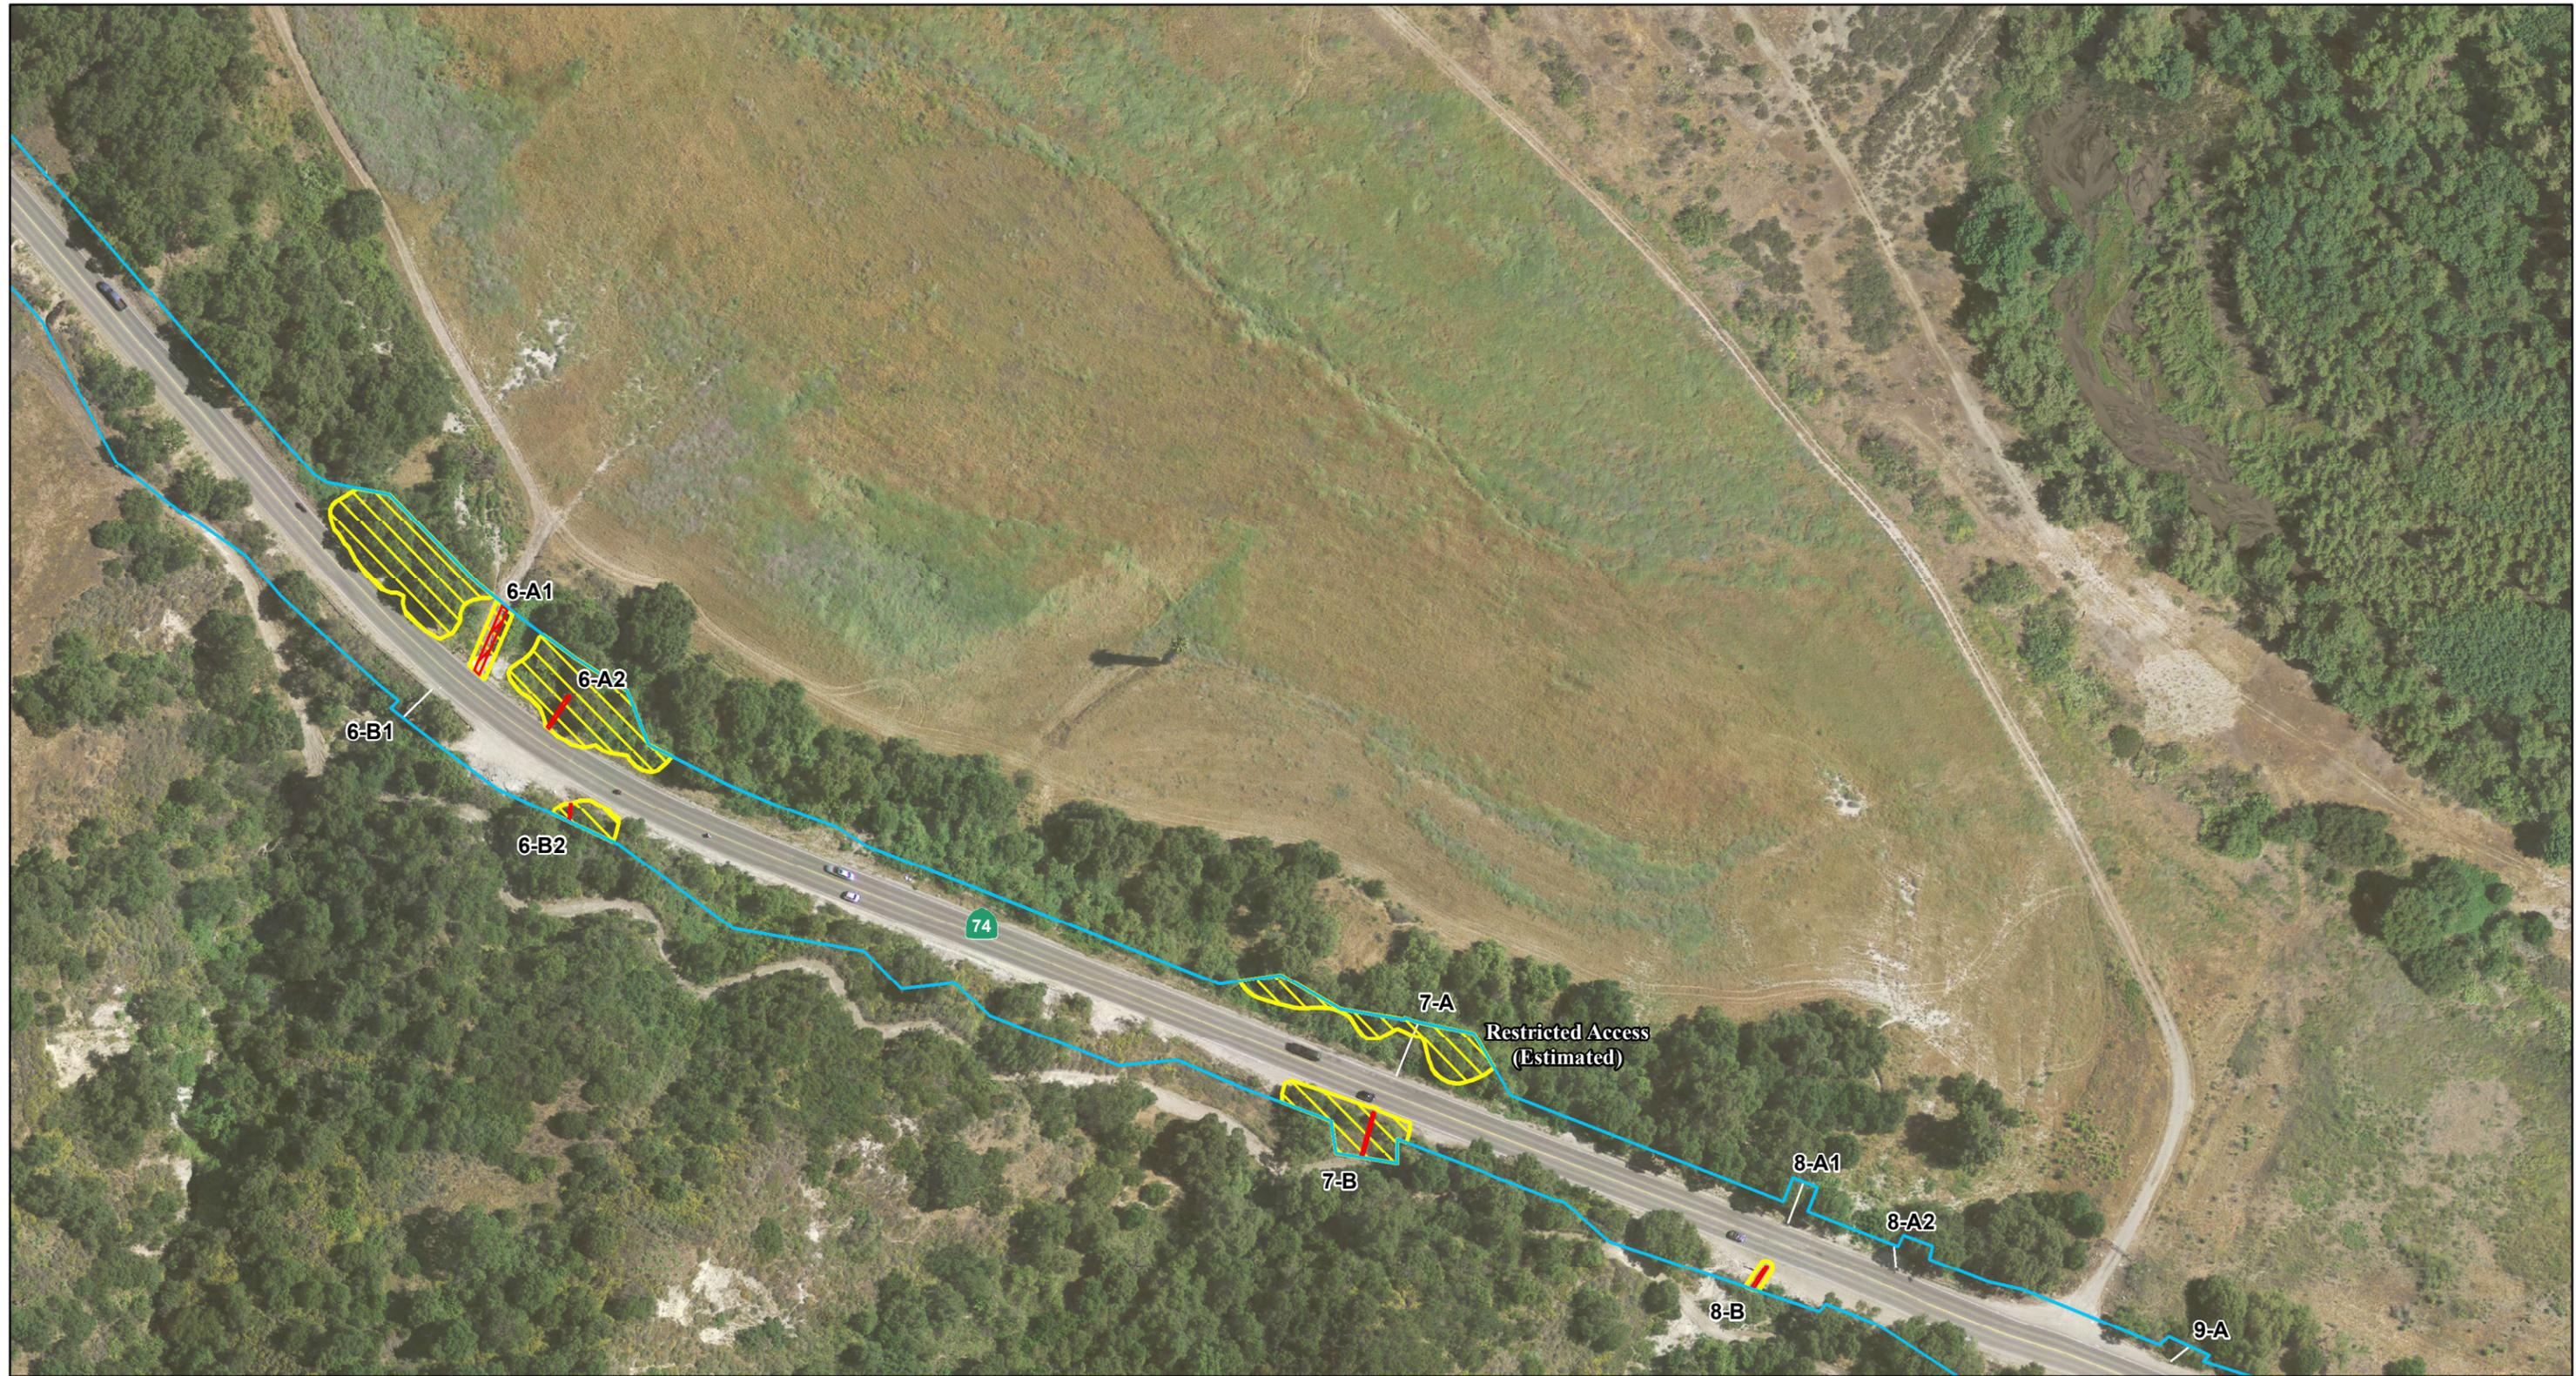
FIGURE 2  
Sheet 3 of 6

SR-74 Safety Project from  
Antonio Parkway/La Pata Road to Cristianitos Road  
Potential Corps and CDFG Jurisdictional Areas by Drainage  
12-ORA-74 PM 2.93/5.06  
EA 0L7200; Project No. 1200020180

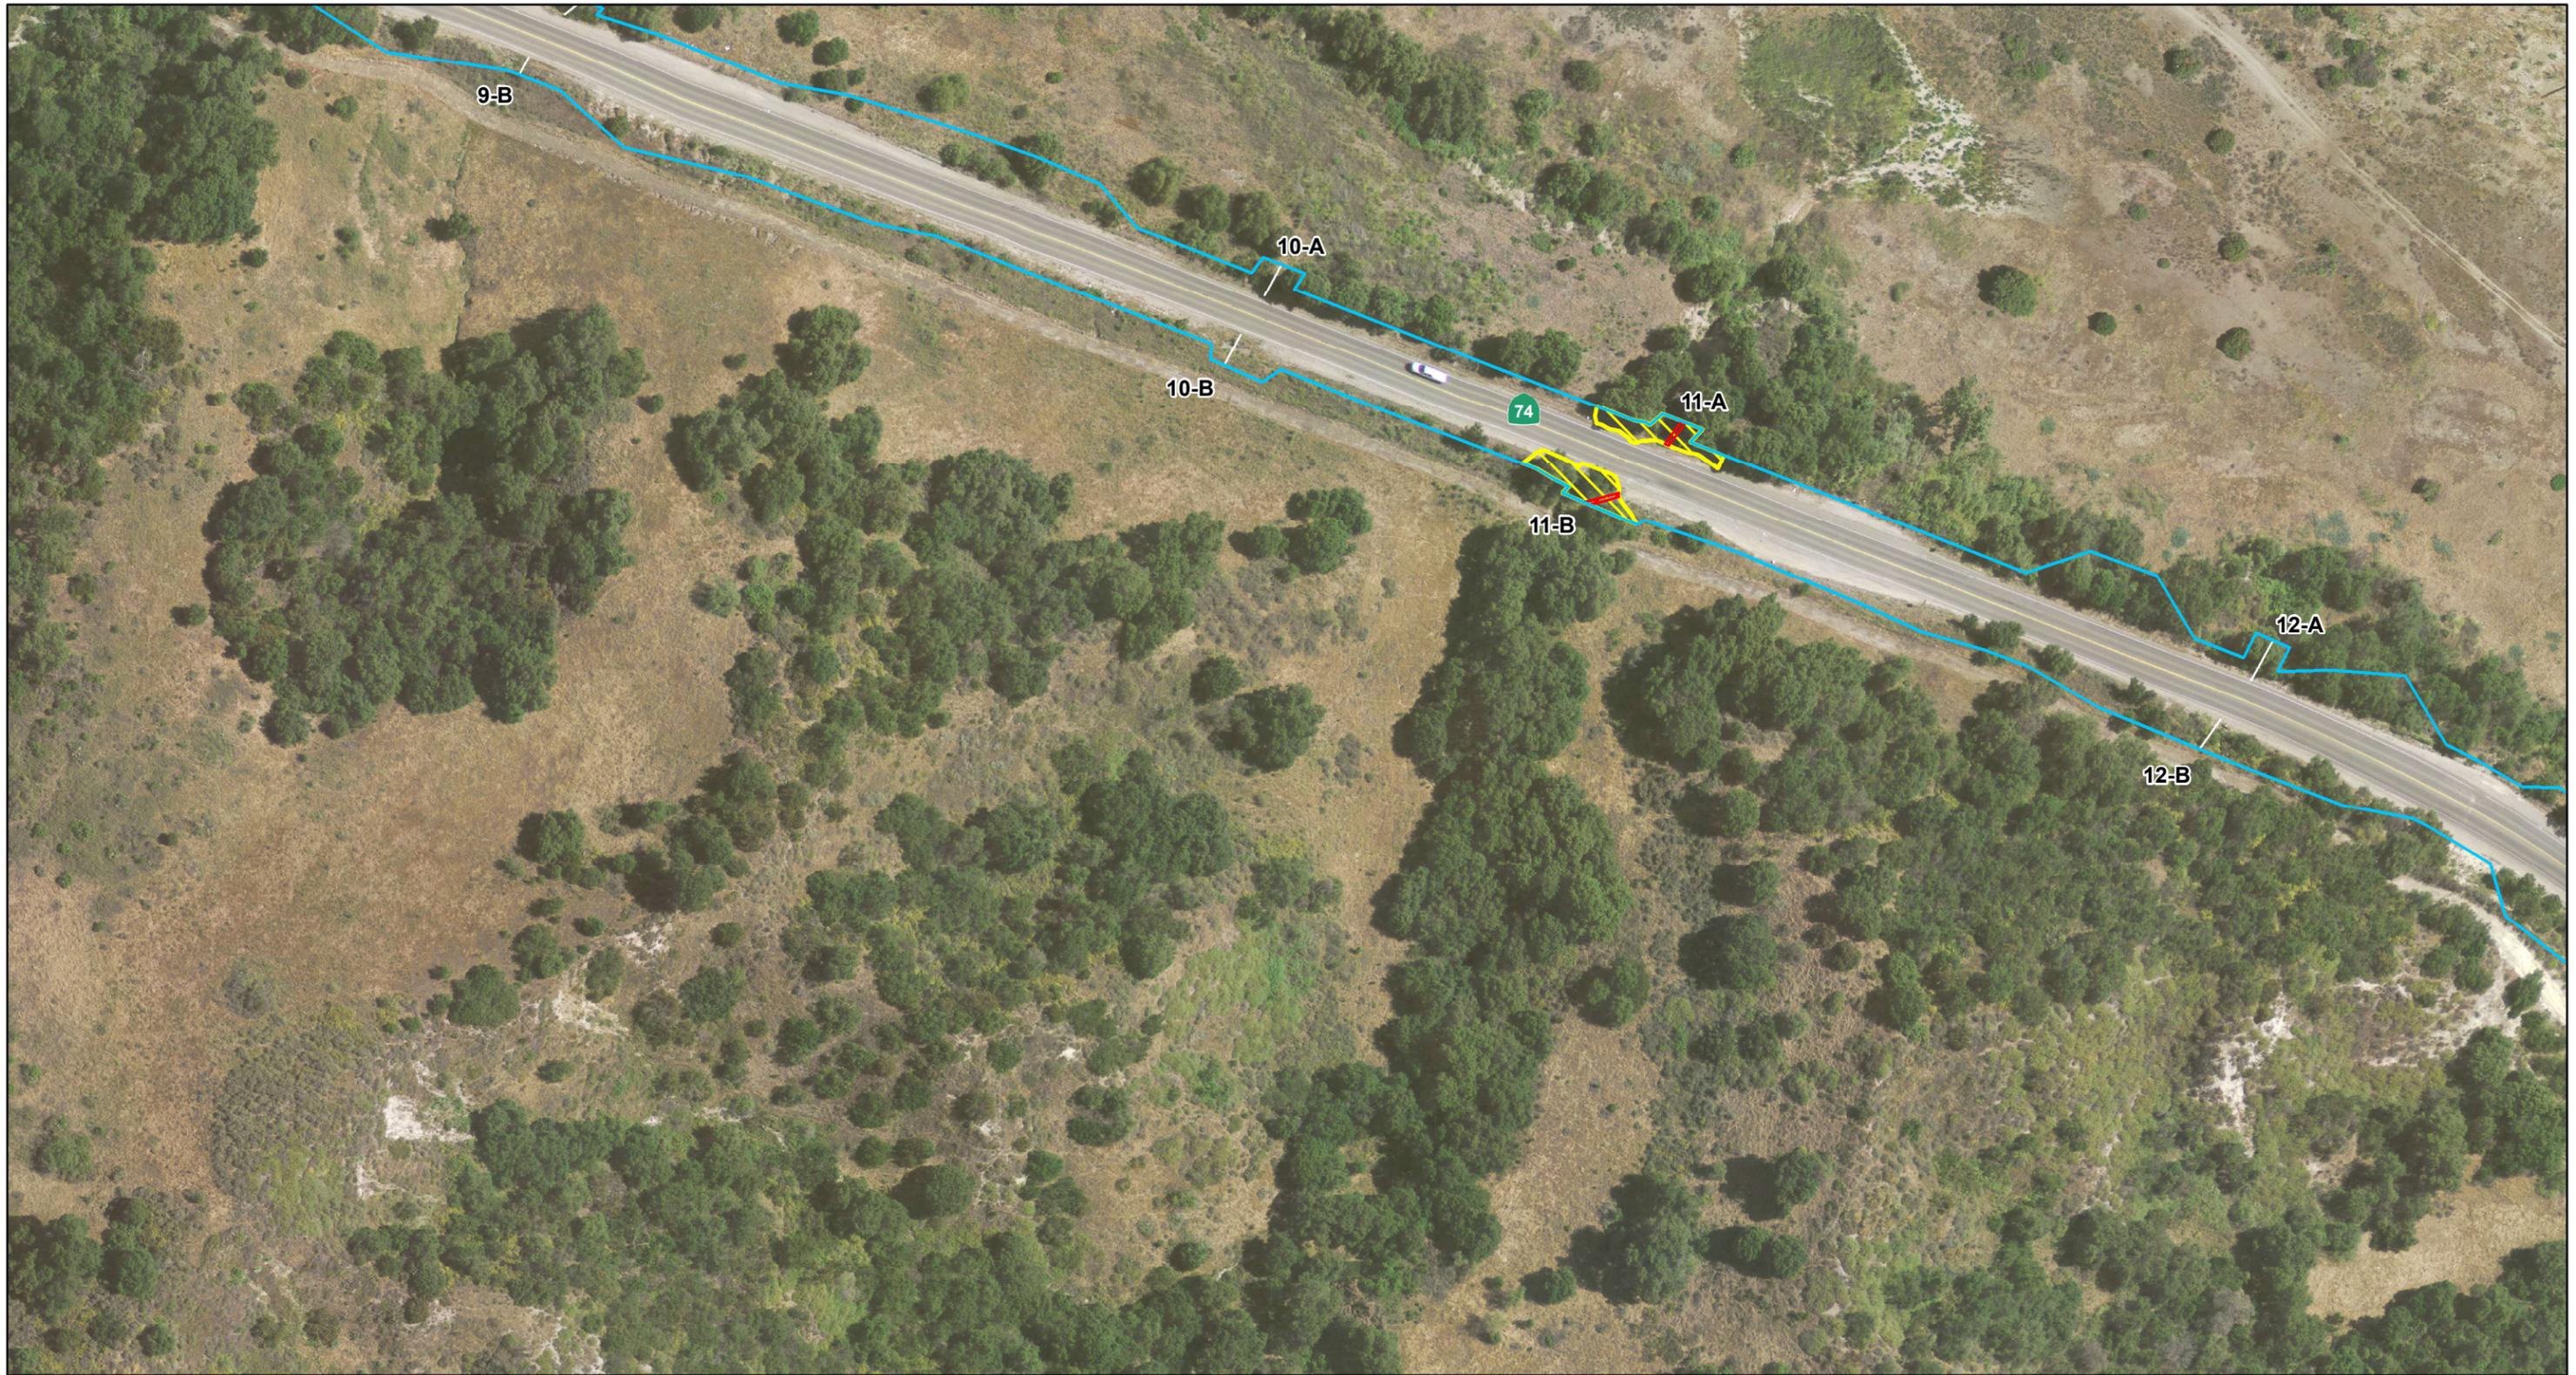
FIGURE 2  
Sheet 4 of 6

SR-74 Safety Project from  
Antonio Parkway/La Pata Road to Cristianitos Road  
Potential Corps and CDFG Jurisdictional Areas by Drainage  
12-ORA-74 PM 2.93/5.06  
EA 0L7200; Project No. 1200020180
