# **Natural Environment Study**

State Route 74 Safety Project

From Antonio Parkway/La Pata Road to Cristianitos Road

12-ORA-74 PM 2.93/5.06

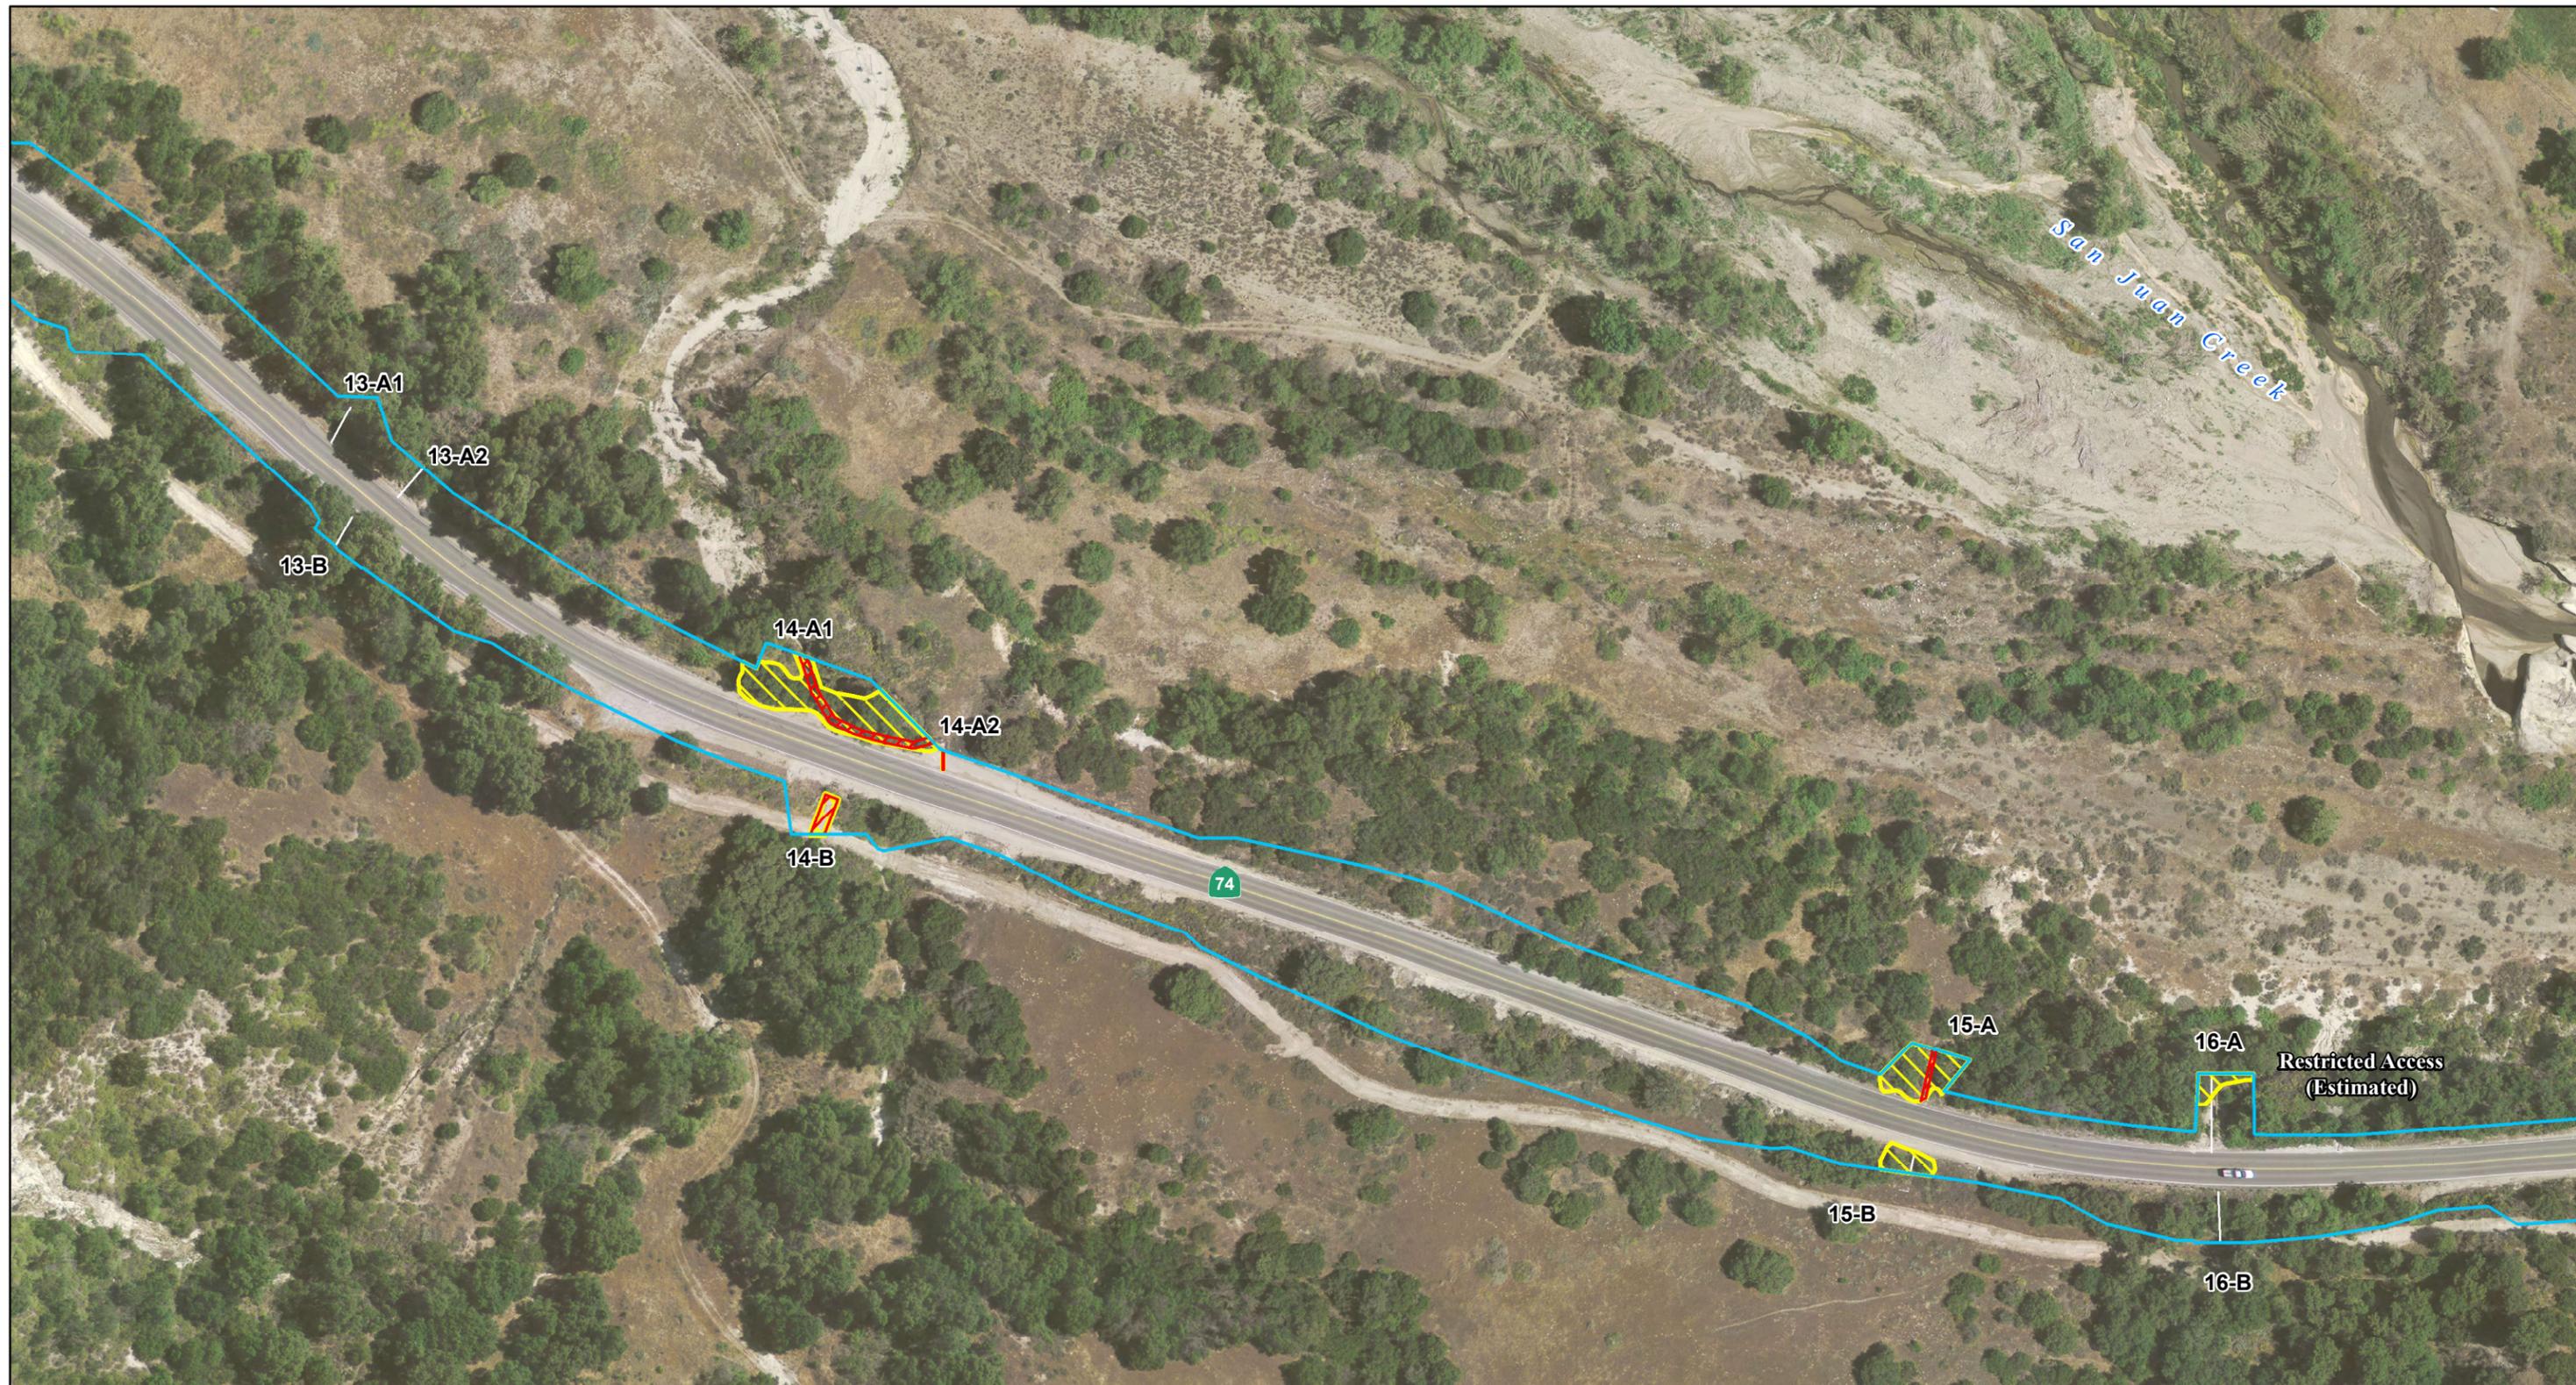
FIGURE 2  
Sheet 5 of 6

SR-74 Safety Project from  
Antonio Parkway/La Pata Road to Cristianitos Road  
Potential Corps and CDFG Jurisdictional Areas by Drainage  
12-ORA-74 PM 2.93/5.06  
EA 0L7200; Project No. 1200020180

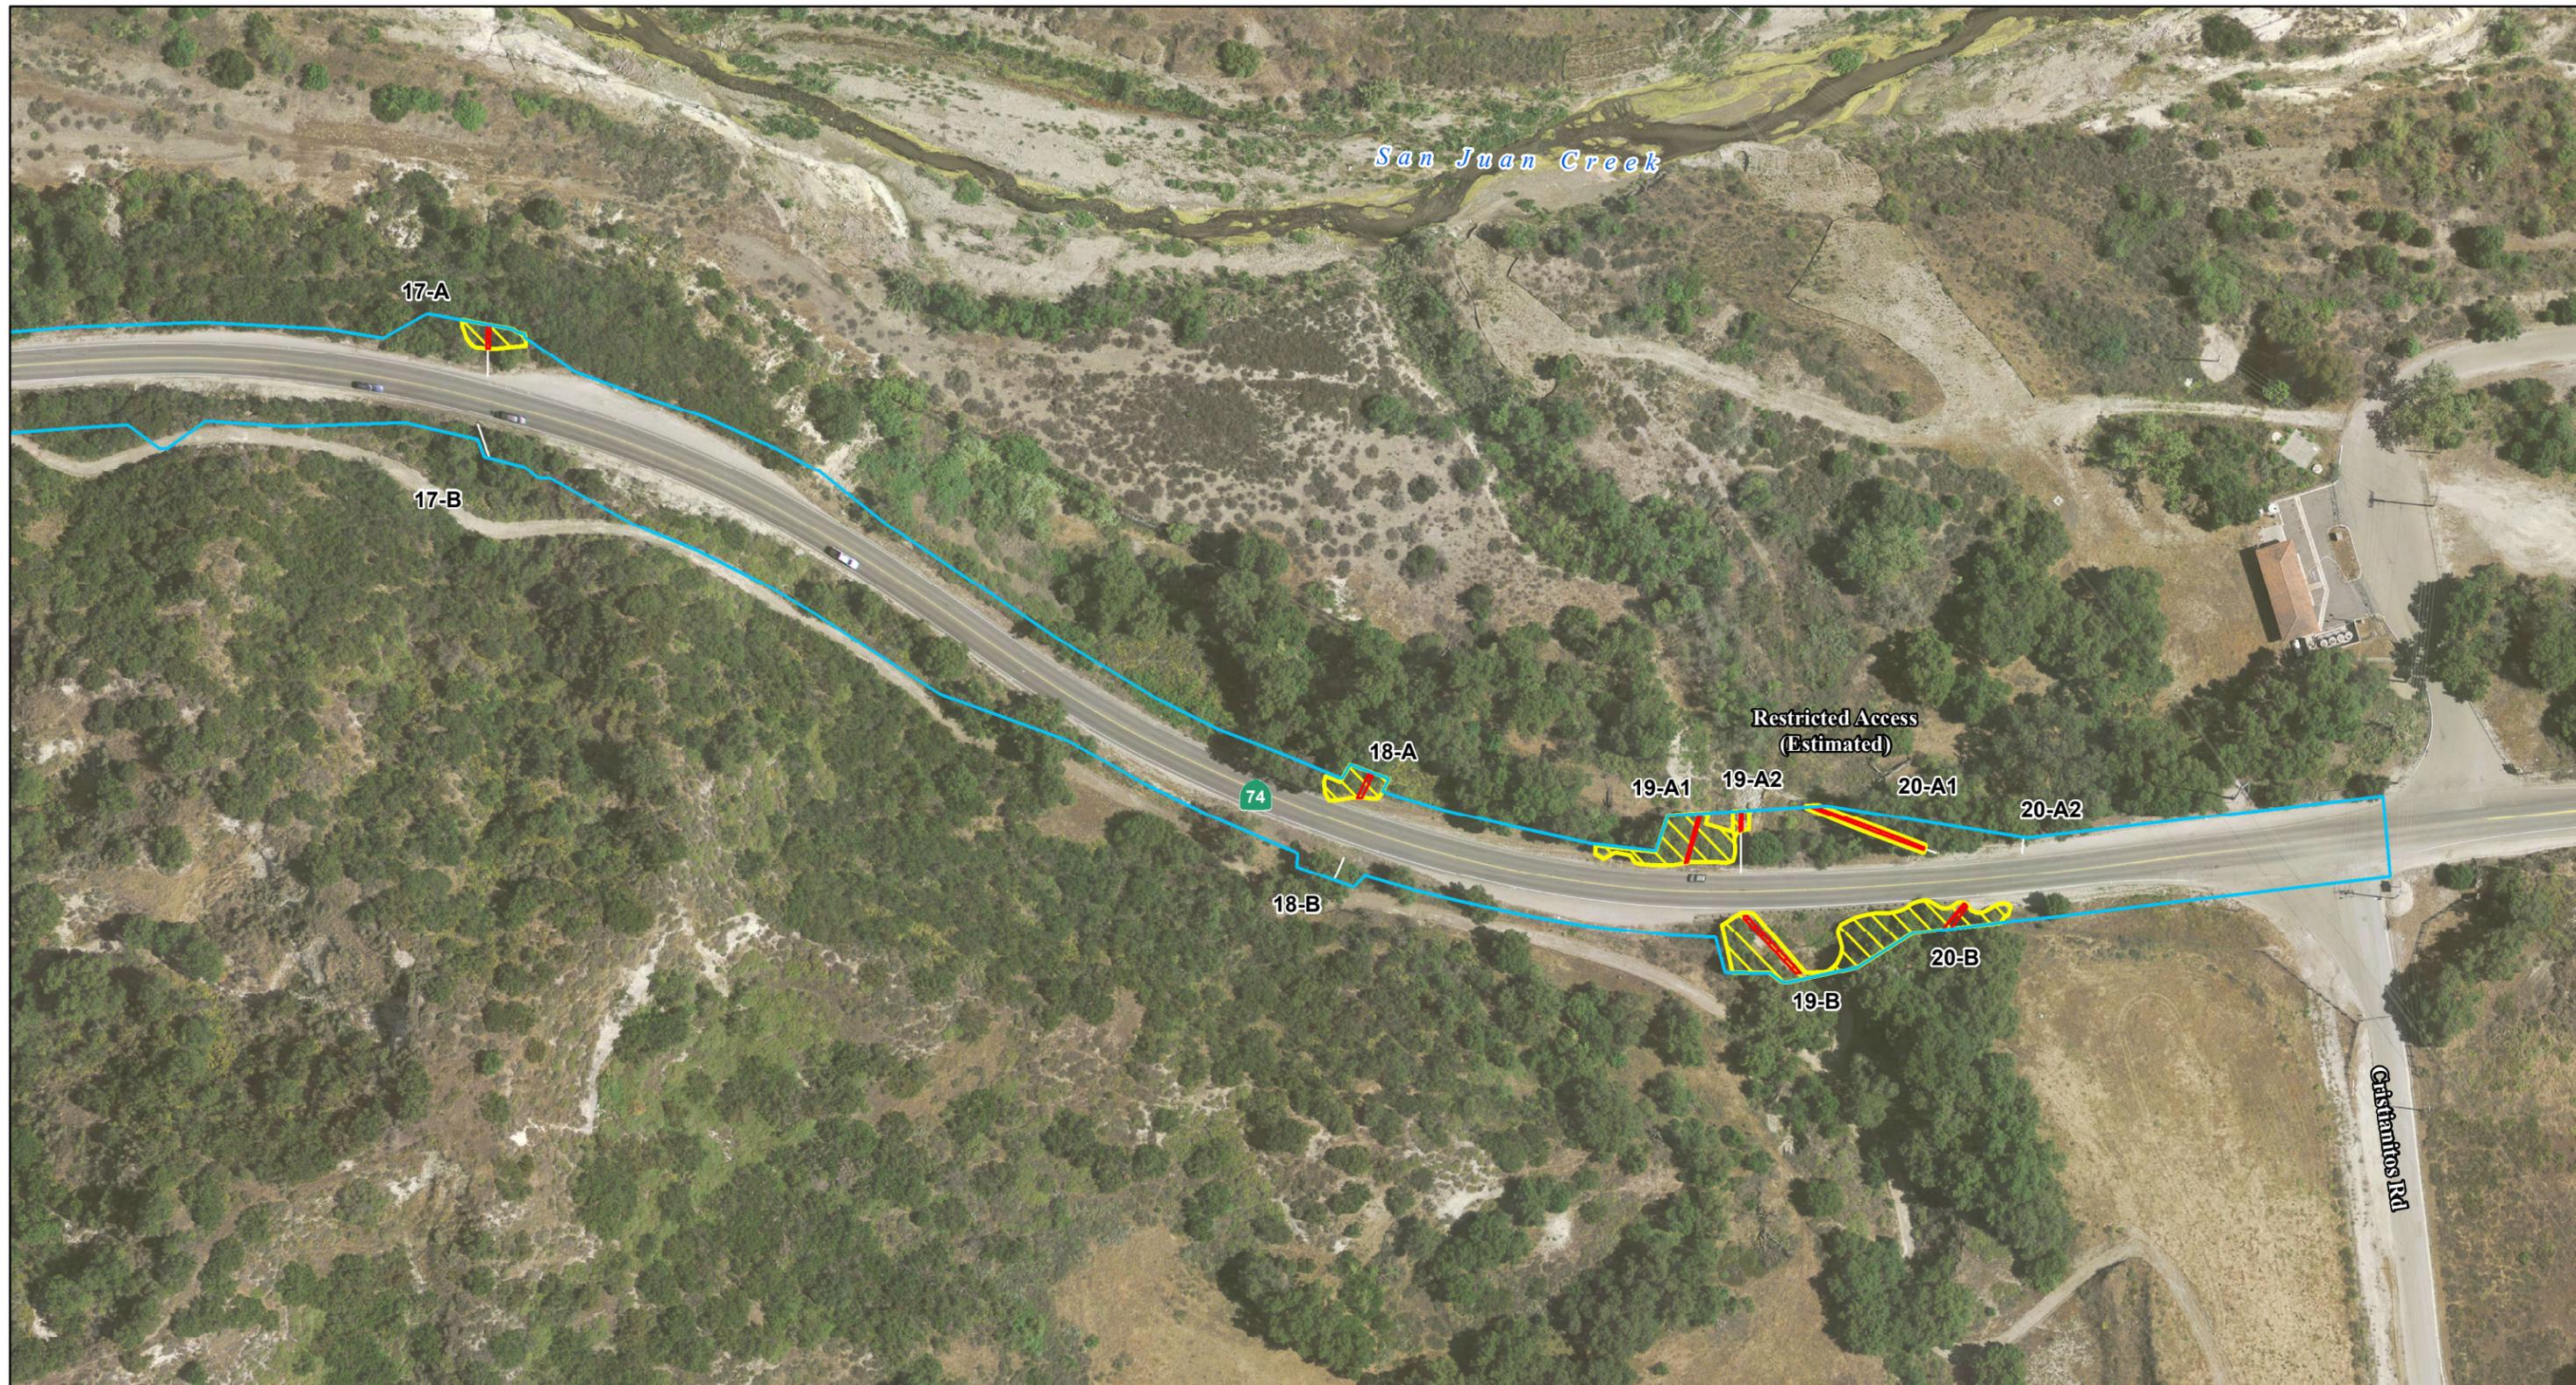
FIGURE 2  
Sheet 6 of 6

SR-74 Safety Project from  
Antonio Parkway/La Pata Road to Cristianitos Road  
Potential Corps and CDFG Jurisdictional Areas by Drainage  
12-ORA-74 PM 2.93/5.06  
EA 0L7200; Project No. 1200020180

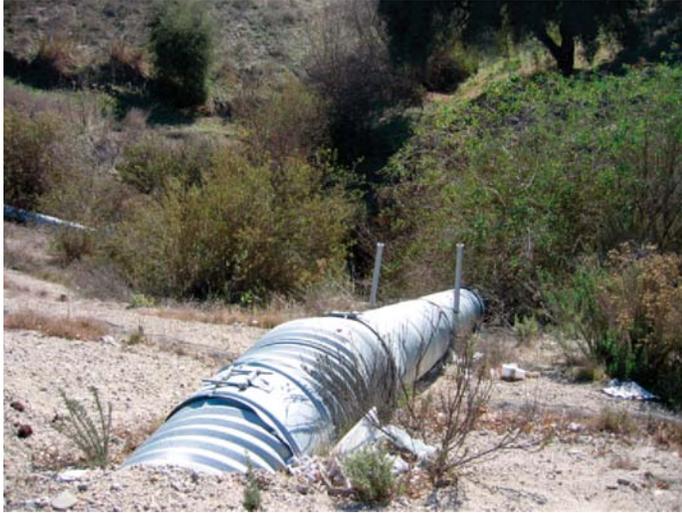
Drainage 1 is a natural drainage that conveys ephemeral flows towards San Juan Creek, passing under Ortega Highway through a culvert. The culvert also receives runoff from the highway via two corrugated pipes.

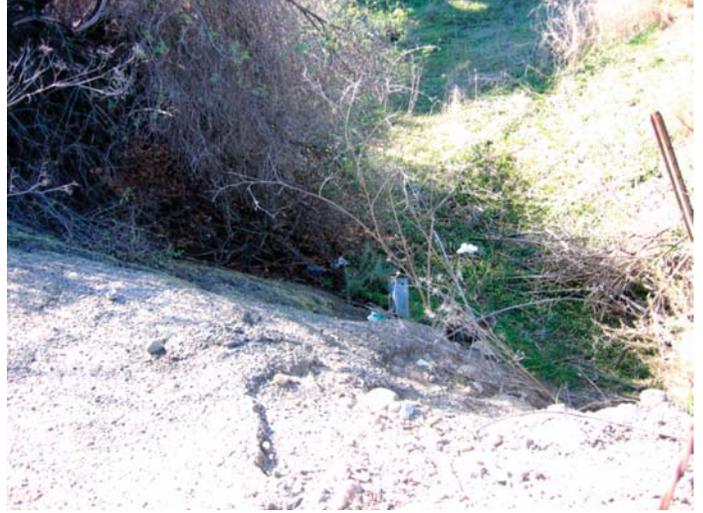
Drainage 2 is a natural drainage that conveys ephemeral flows northward towards San Juan Creek, passing under Ortega Highway through a culvert.

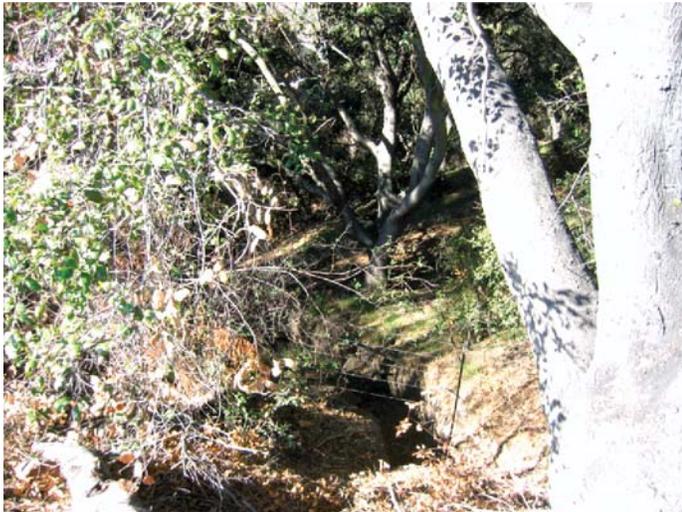
Drainage 3 is a natural, ephemeral drainage that flows northward toward San Juan Creek, passing under Ortega Highway through a 24-inch corrugated culvert.

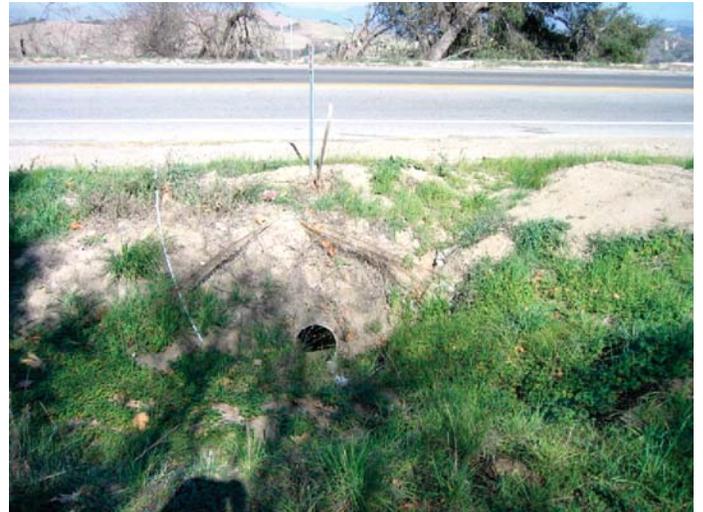
Drainage 4 is not a natural drainage. Runoff from the south side of Ortega Highway passes northward under the highway through a 12-inch fiberglass culvert. No OHWM or wetland indicators are present.

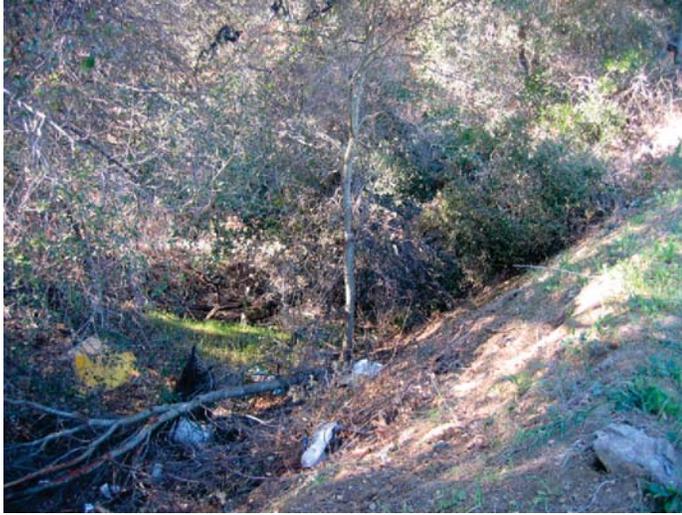
Drainage 5 is a natural riparian corridor with oak woodland. However, ephemeral flows enter a culvert outside of the southern project boundary to pass under the highway and do not daylight until outside of the northern project boundary.

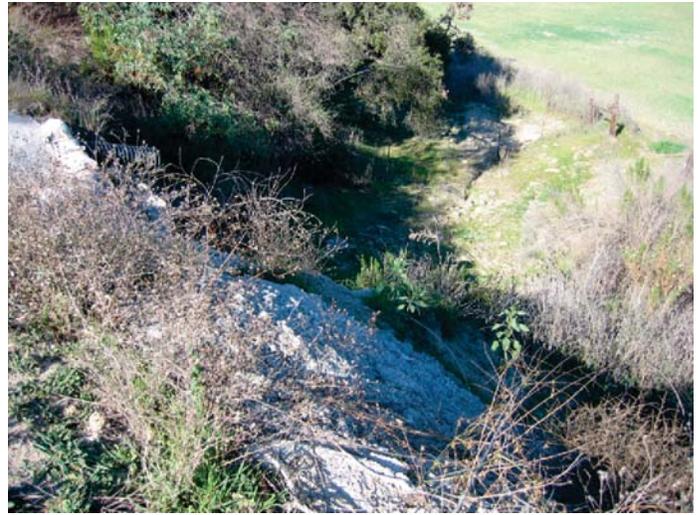
Drainage 6 is a natural riparian corridor with oak woodland. A large (10 ft) box culvert conveys ephemeral flows from south to north of Ortega Highway. The box culvert also acts as an undercrossing that is part of a trail for cattle/horses, vehicles, and wildlife.

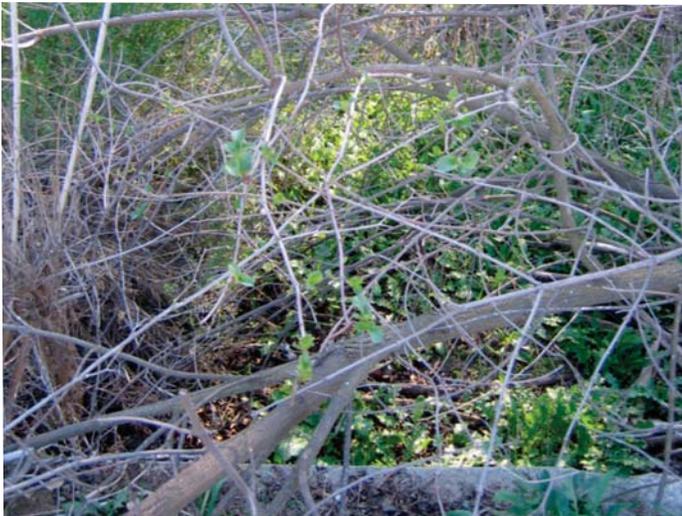
Drainage 7 is a natural riparian corridor with oak woodland. Ephemeral flows are channelled from south to north under the highway through a 24-inch concrete culvert.

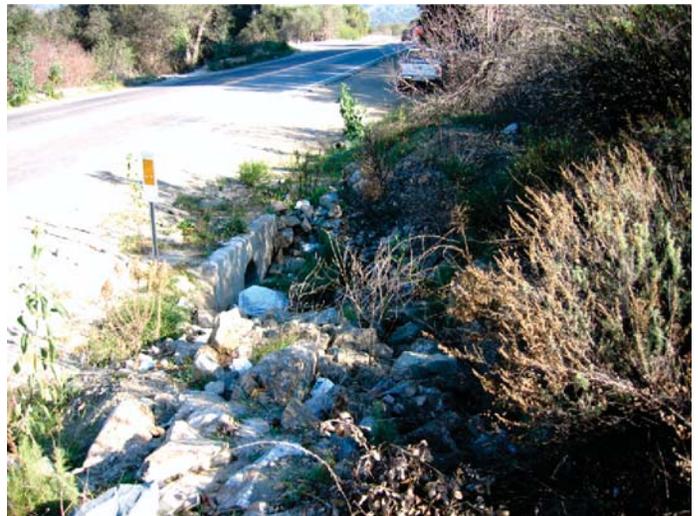
Drainage 8 is a natural riparian corridor with an ephemeral drainage. Flows enter a 24-inch corrugated culvert to pass northward under the highway.

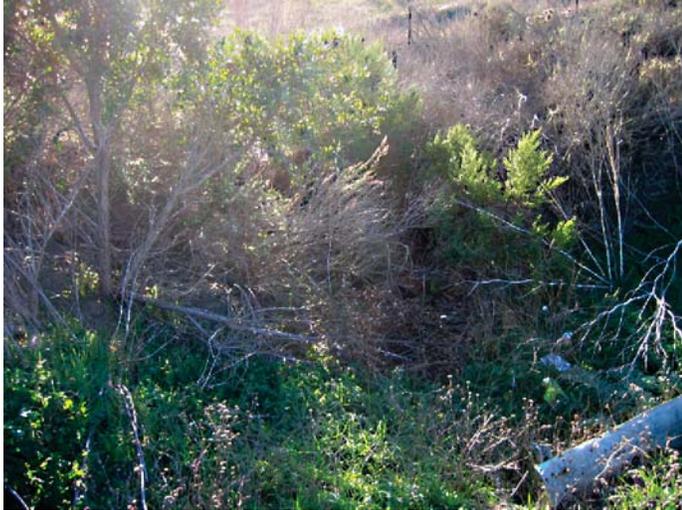
Drainage 9 is not a natural drainage. Runoff from the south side of Ortega Highway passes northward under the highway through a 24-inch corrugated culvert. No OHWM or wetland indicators present.

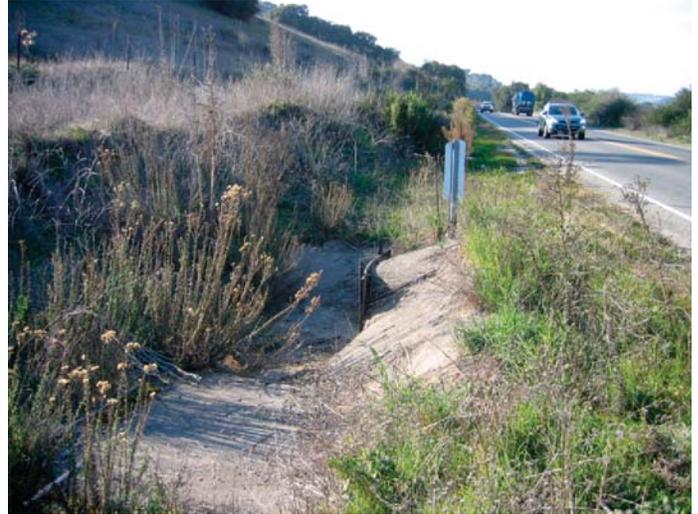
Drainage 10 is not a natural drainage. Runoff from the south side of Ortega Highway passes northward under the highway through an 18-inch corrugated culvert. No OHWM or wetland indicators present.

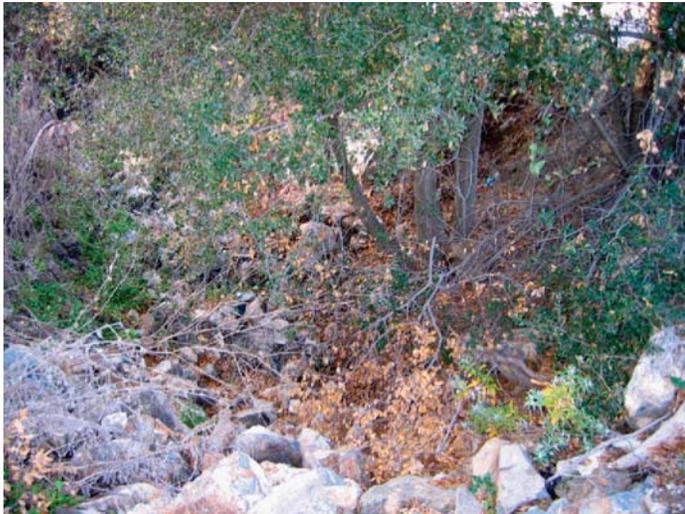
Drainage 11 is a natural riparian corridor with an ephemeral drainage and oak woodland. Flows pass over riprap and enter a 24-inch corrugated culvert to pass northward under the highway.

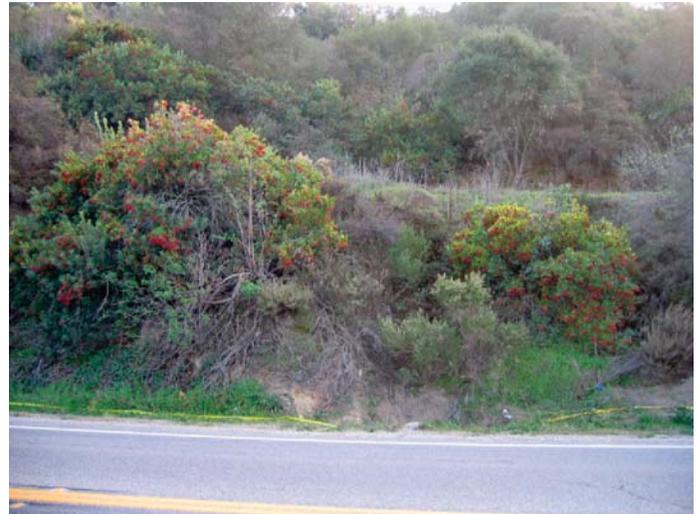
Drainage 12 is not a natural drainage. Runoff from the south side of Ortega Highway passes northward under the highway through a 24-inch fiberglass culvert. No OHWM or wetland indicators present.

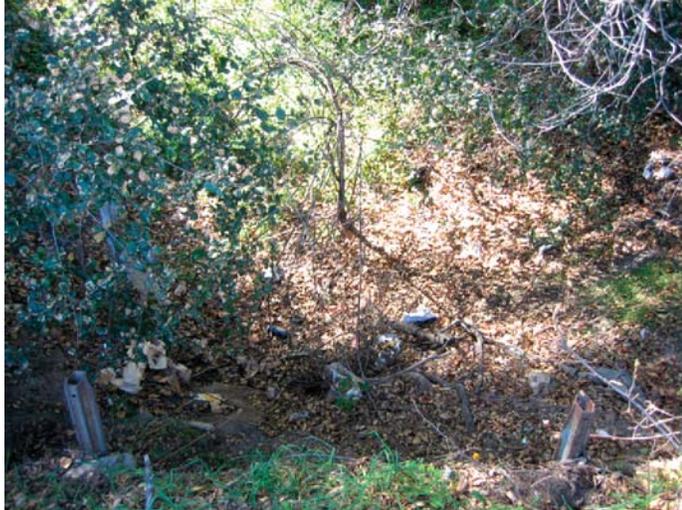
Drainage 13 is not currently a natural drainage, though it may have been historically. Runoff from the south side of Ortega Highway passes northward under the highway through a 24-inch culvert.

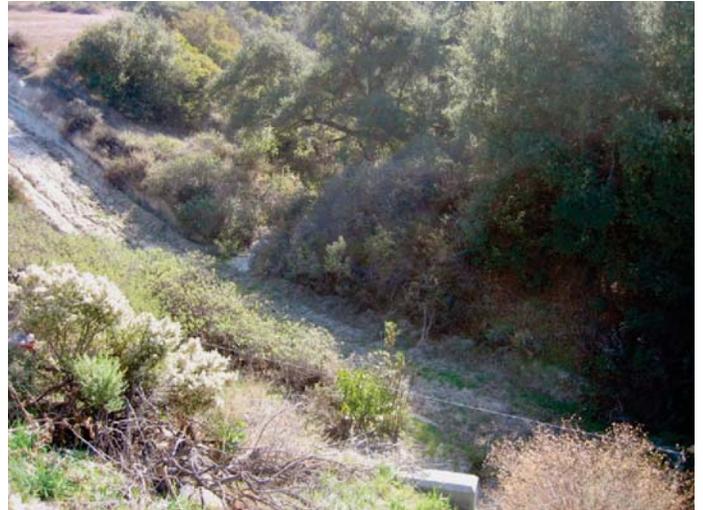
Drainage 14 is a natural riparian corridor with an ephemeral drainage and oak woodland. Flows pass northward under the highway through a 12 ft concrete box culvert.

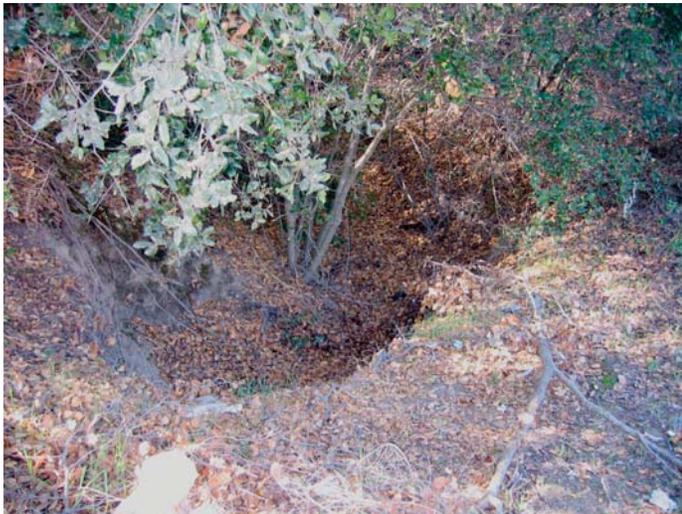
Drainage 15 collects ephemeral flows from a hillside south of Ortega Highway and channels it, along with runoff from the south side of the highway, into an 18-inch corrugated culvert to pass northward under the highway. There are no wetland indicators present.

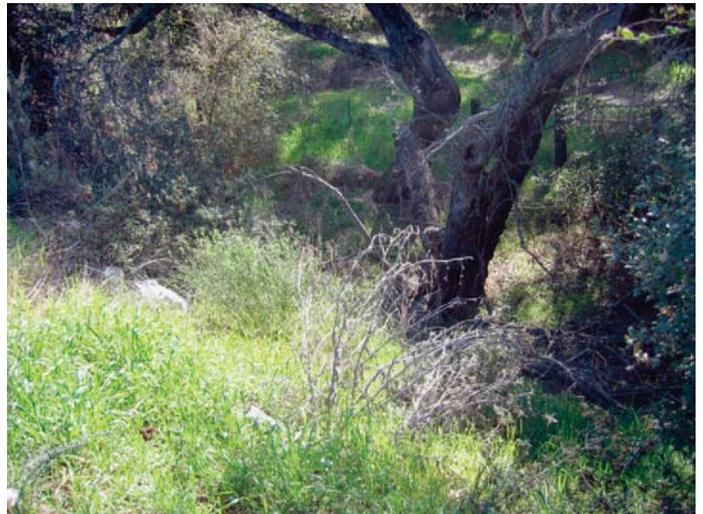
Drainage 16 is not currently a natural drainage, though it may have been historically. Runoff from the south side of Ortega Highway passes northward under the highway through a 24-inch corrugated culvert. There are no OHWM or wetland indicators present.

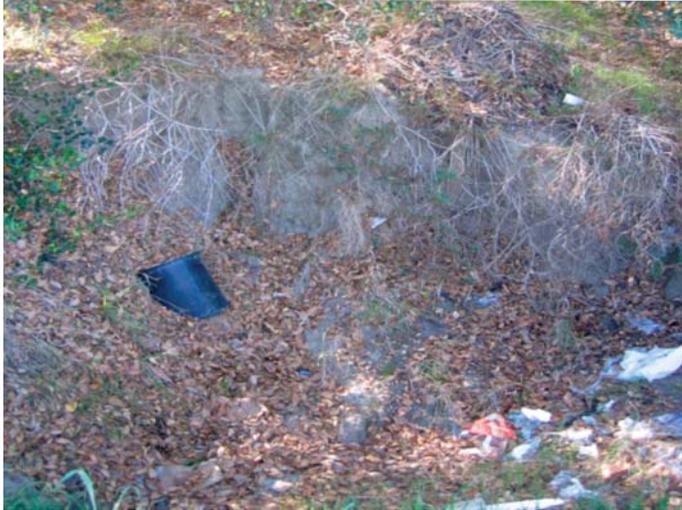
Drainage 17 is not currently a natural drainage, though it may have been historically. Runoff from the south side of Ortega Highway passes northward under the highway through an 18-inch corrugated culvert. No wetland indicators were observed.

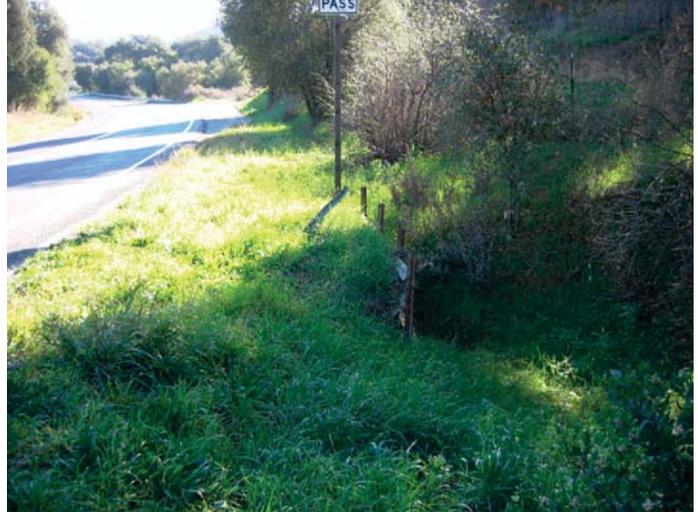
Drainage 18 is not a natural drainage. Runoff from the south side of Ortega Highway passes northward under the highway through a 24-inch corrugated culvert. No wetland indicators are present.

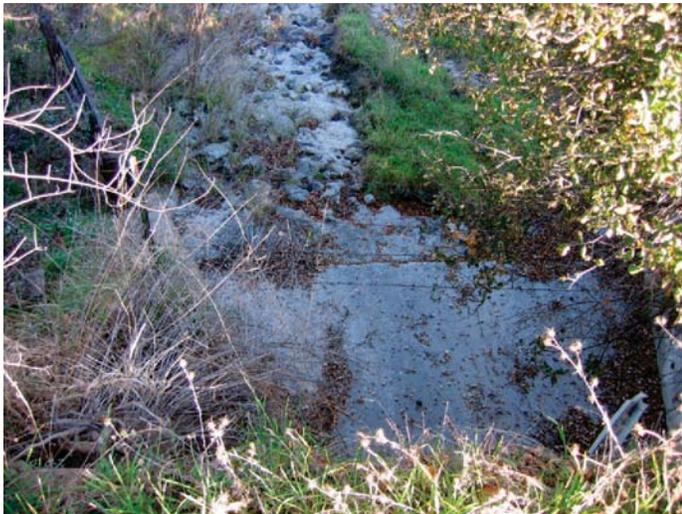
Drainage 19 is a natural riparian corridor with oak woodland. A large (12 ft) box culvert conveys ephemeral flows from south to north of Ortega Highway. Due to restricted access, jurisdictional areas were estimated. No wetland indicators were observed.

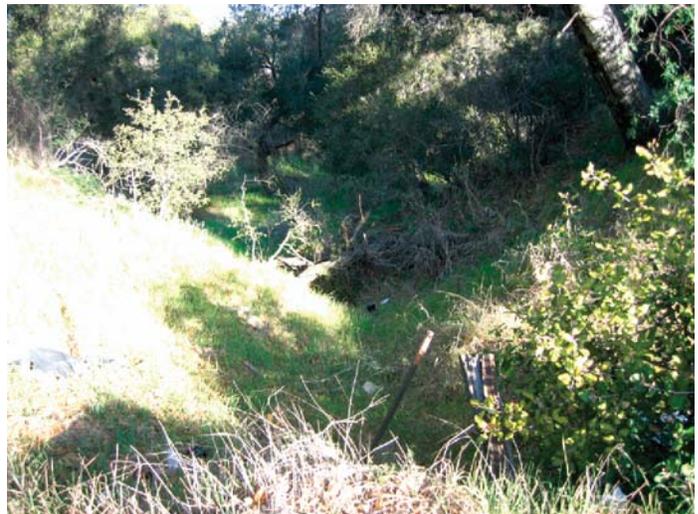
Drainage 20 is not currently a natural drainage, though it may have been historically. Runoff from Ortega Highway is directed towards the Drainage 19 concrete box culvert. Vegetation consists primarily of oak woodland and nonnative grasses. There are no wetland indicators present.

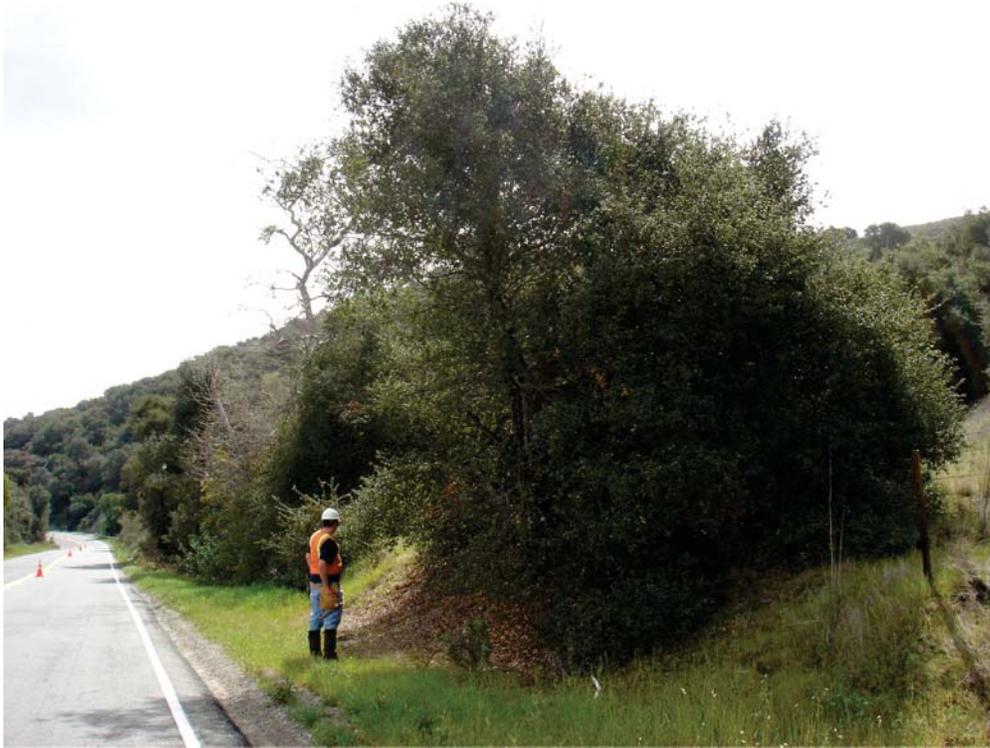
An example of a reduced-quality tree impacted by pruning.

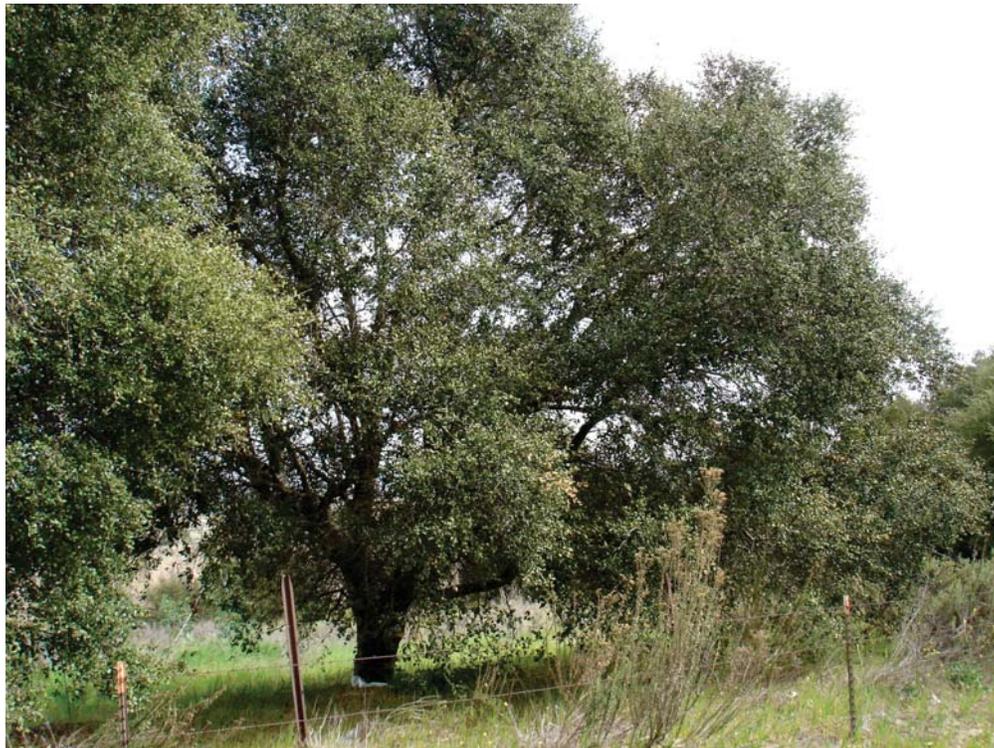
An example of a high-quality tree set back from the road.

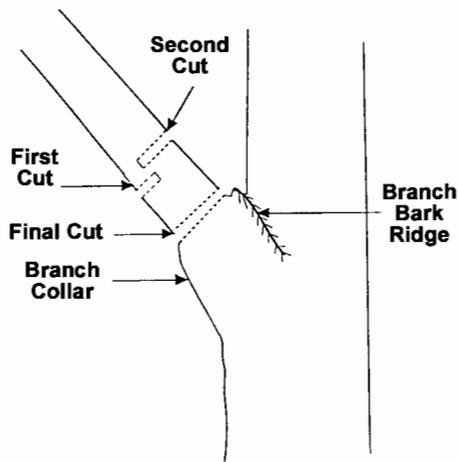
**Figure 5.3.2. – A pruning cut that removes a branch at its point of origin shall be made close to the trunk or parent limb, without cutting into the branch bark ridge or collar, or leaving a stub. Branches too large to support with one hand shall be precut to avoid splitting of the wood or tearing of the bark.**

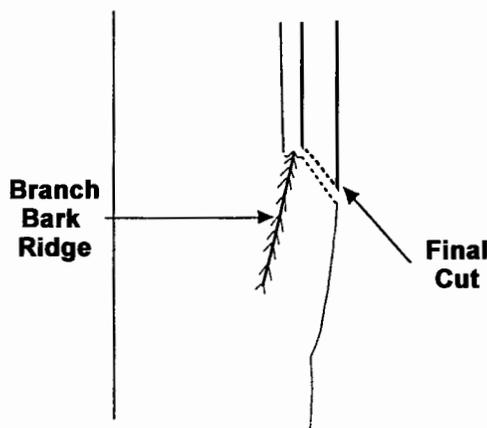
**Figure 5.3.7.** – A final cut that removes a branch with a narrow angle of attachment should be made from the outside of the branch to prevent damage to the parent limb.

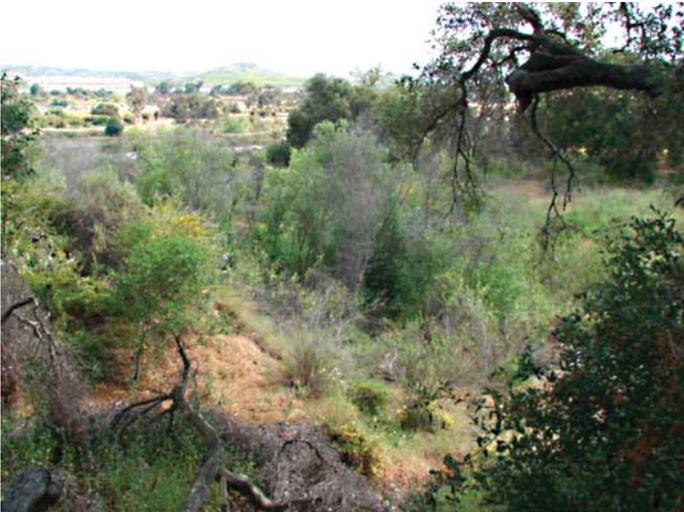
**C.** Northern view of the least Bell's vireo survey area adjacent to the ROW (05-19-2012).

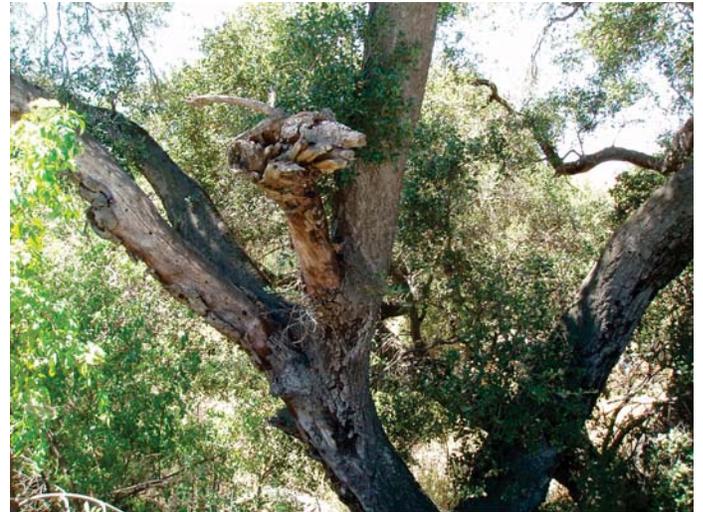
**D.** Potential bat roost area in an oak tree along Ortega Highway (07-01-2012).

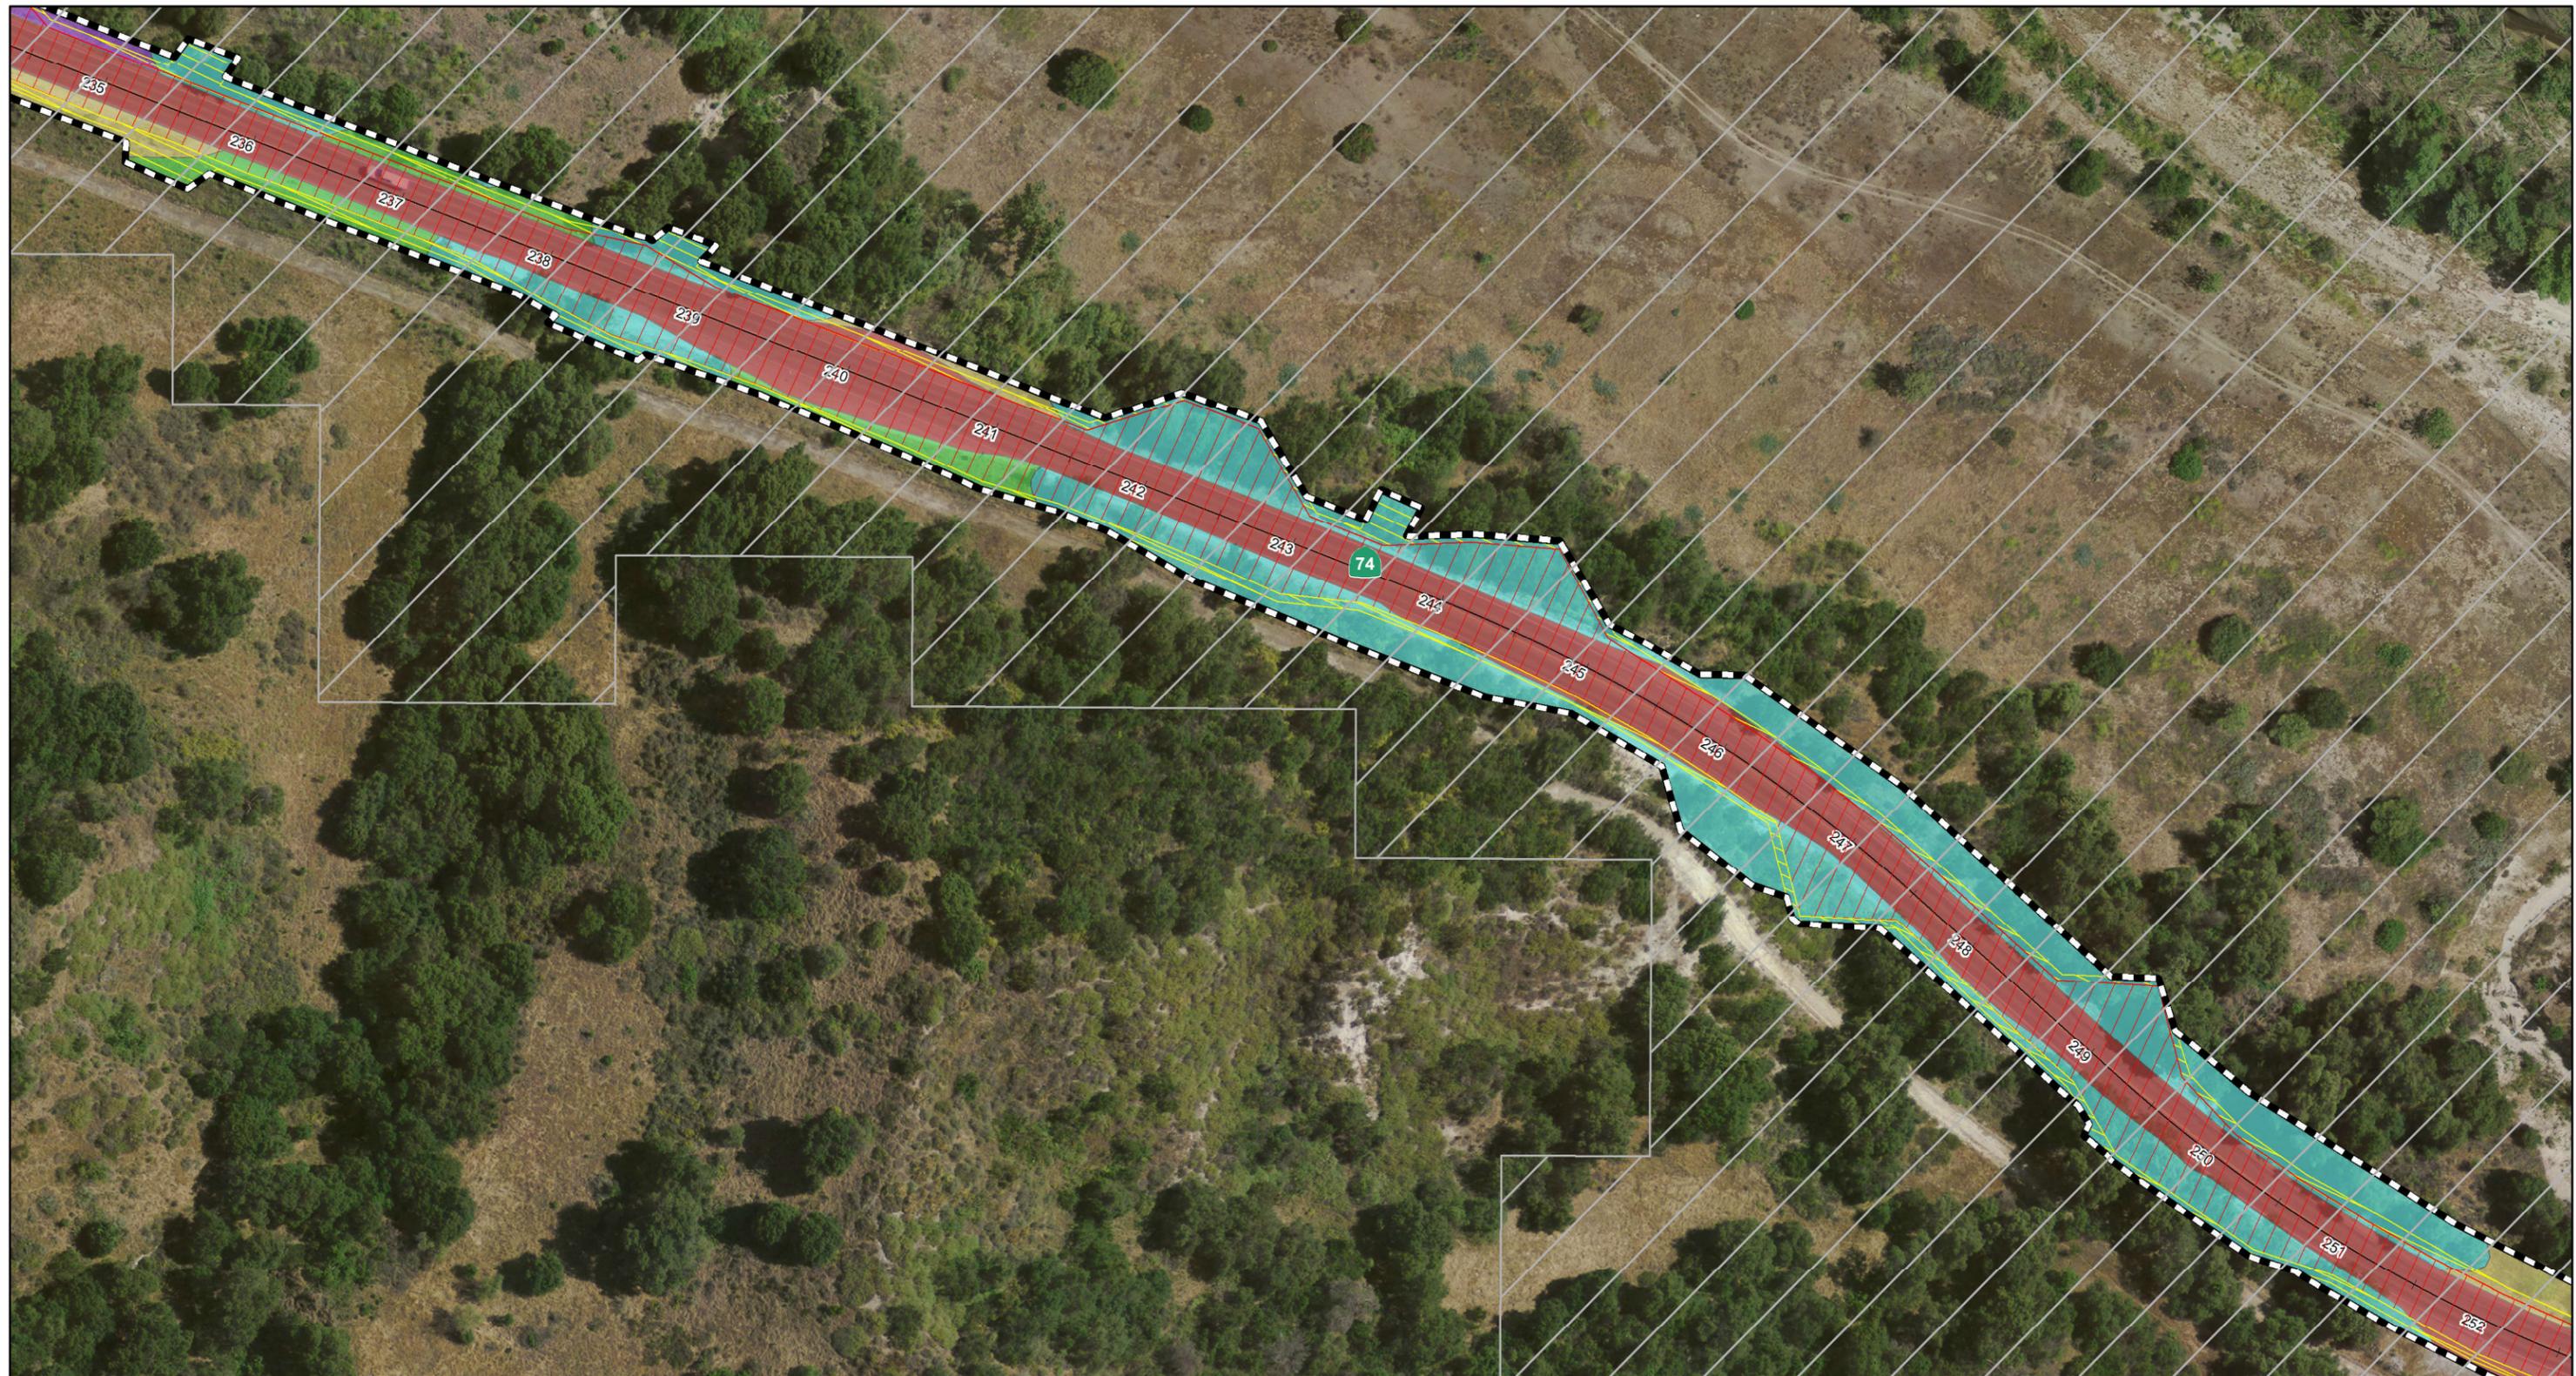
*SR-74 Safety Project from  
Antonio Parkway/La Pata Road to Cristianitos Road*  
Vegetation Community and Arroyo  
Toad Critical Habitat Impacts  
12-ORA-74 PM 2.93/5.06  
EA 0L7200; Project No. 1200020180
