Centennial Corridor Project

State Route 99 to Interstate 5

Focused Initial Site Assessment

**Focused Initial Site Assessment
Centennial Corridor Project
06-48460
KER-56 (PM T31.7/R55.6
KER-99 (PM 21.1/26.2)
October 7, 2013**

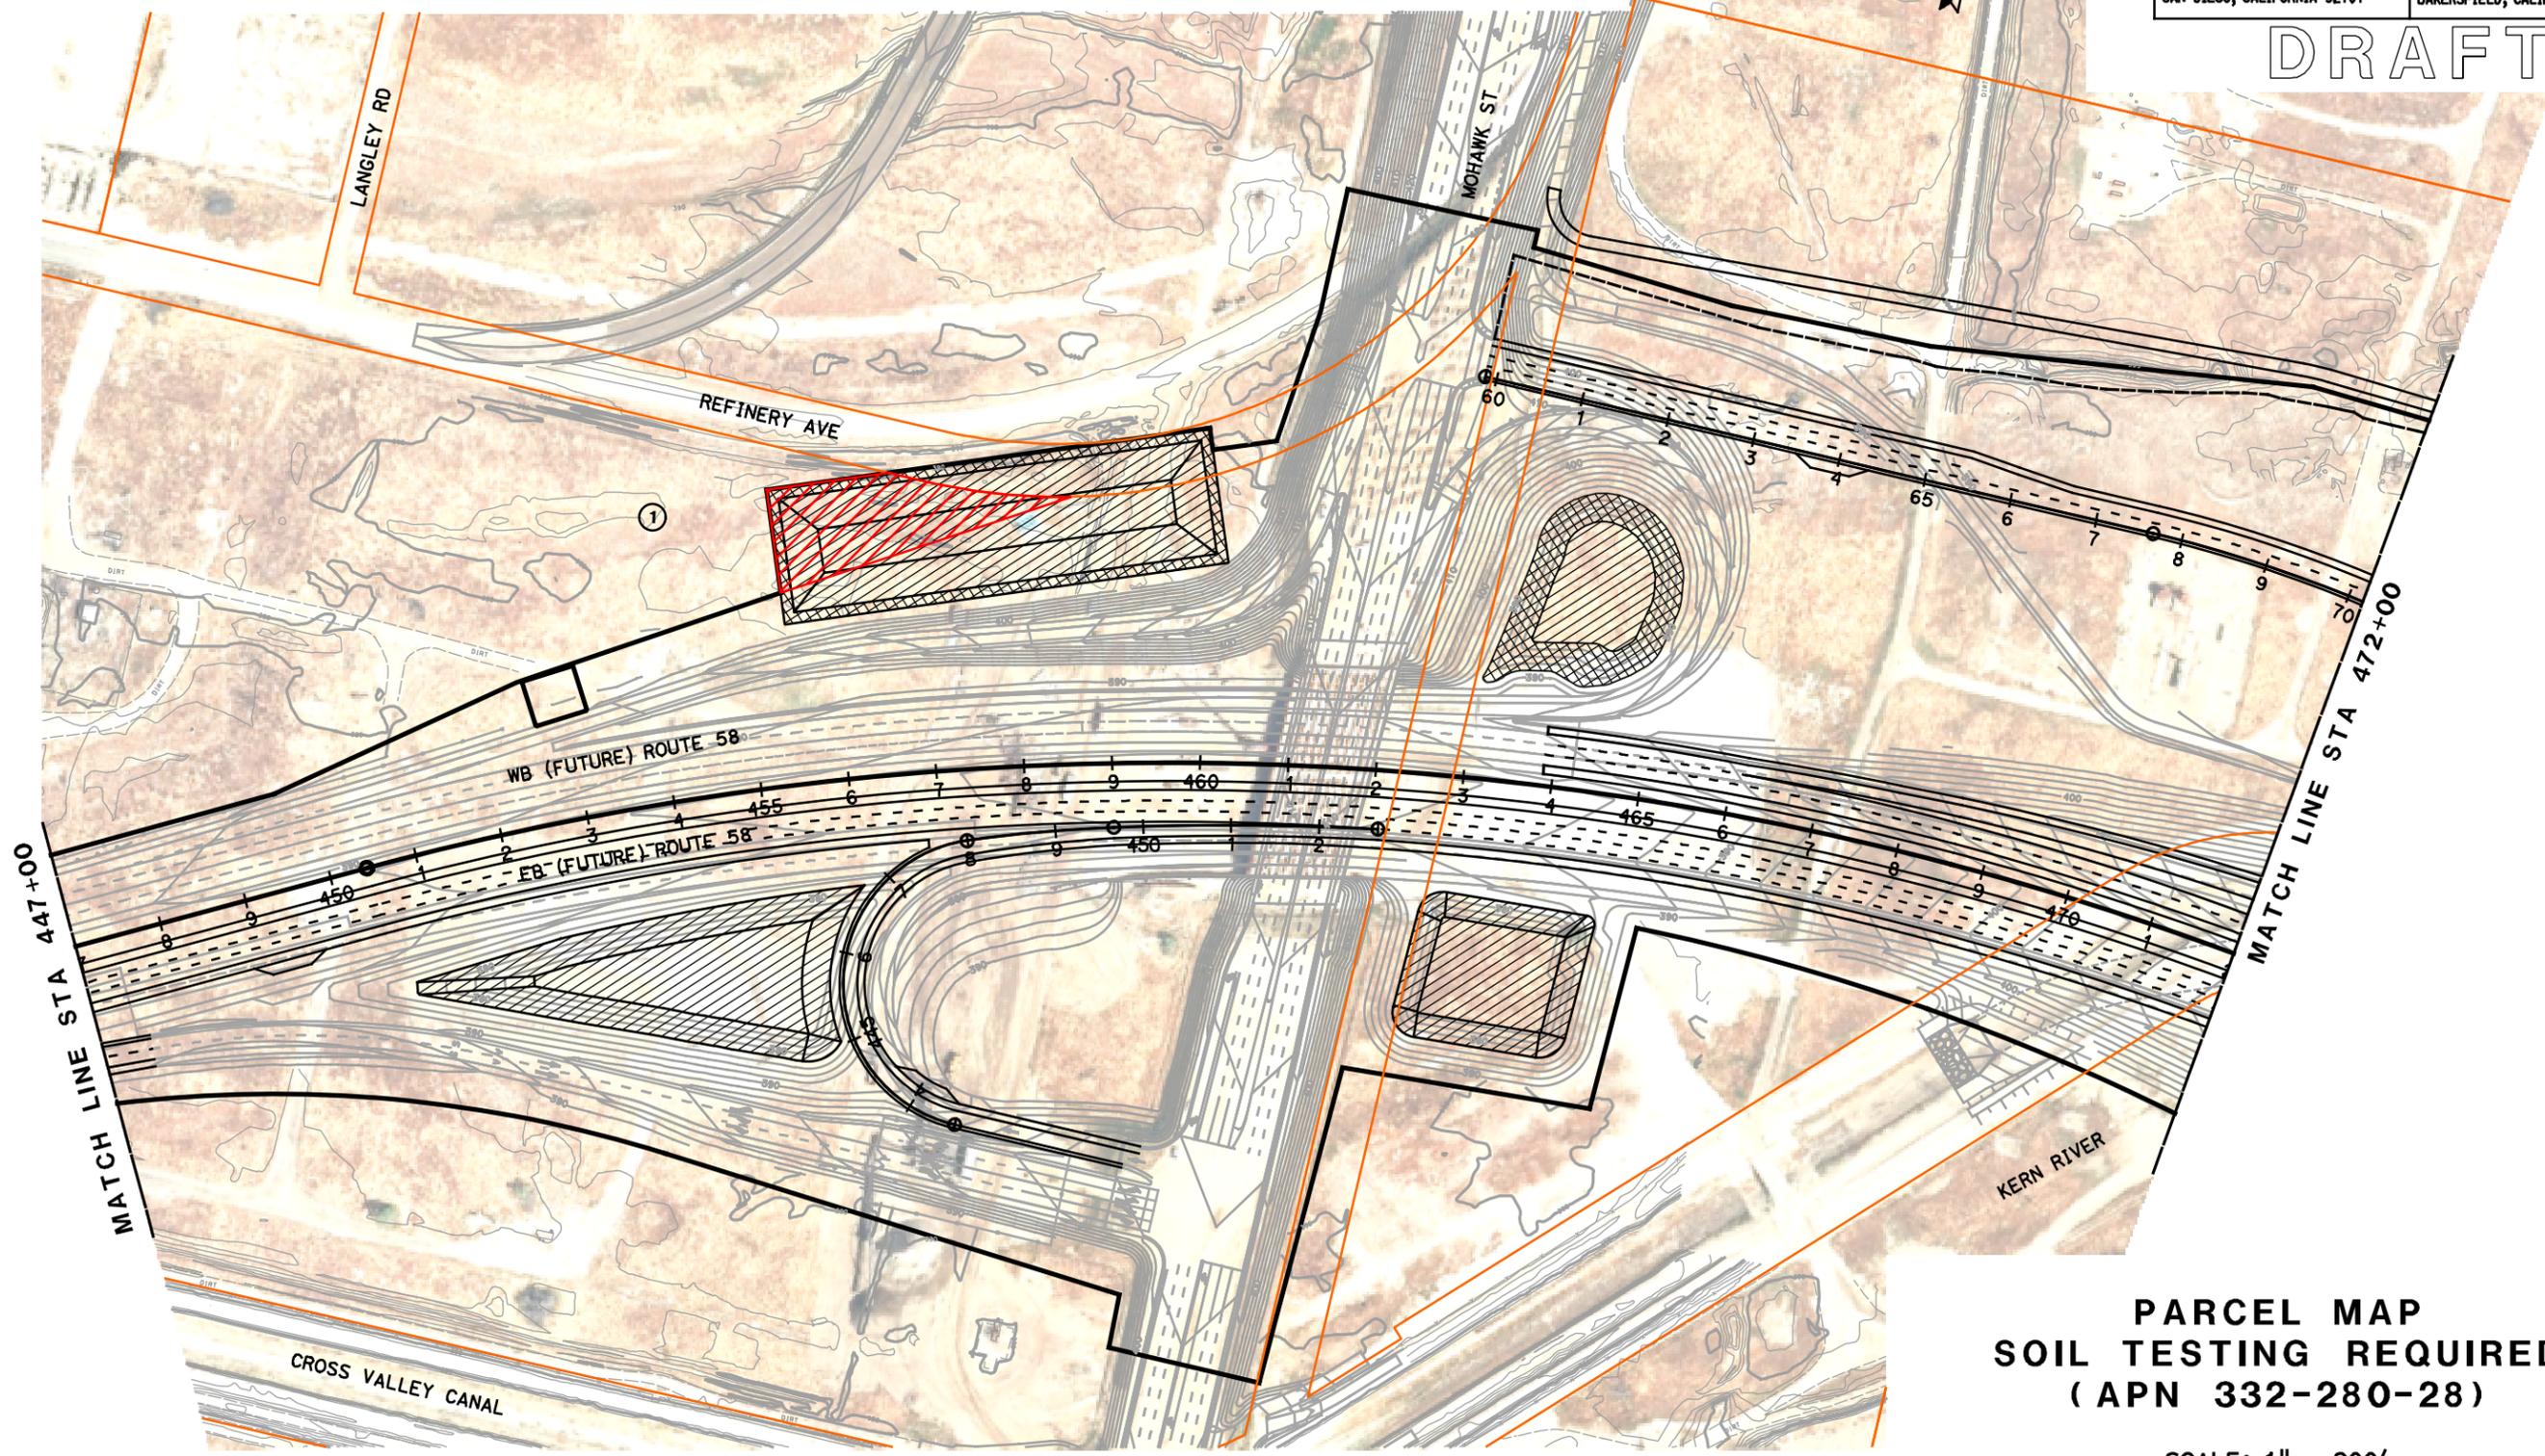
PARCEL MAP
SOIL TESTING REQUIRED
(APN 332-280-28)

332-280-28	Alon Bakersfield Property Inc	Partial (22,446 SF)	Vacant	No Street Number	Langley Road	Vacant parcel	Part of refinery	1	Oil cake sand was found at the eastern and southwestern portion of the parcel. California oil, gas, and geothermal resources maps indicated that there are five active oil wells, one active injector well, and one plugged well on site. Suspected contamination from oil pumping activities	7 wells	Presence of oil cake sand, Presence of wells associated with oil production	The additional ROW acquired is for the proposed drainage basin. The ROW on Mohawk Street was already acquired for WSP. Field visit indicated the presence of an oil well. While the area around the well has been disturbed by the construction of WSP, it looks like this well will have to be removed for the Centennial Project. Entry permit is not required since it is owned by the City.	YES
368-040-26 Previous APN was 502-010-47	Alon Bakersfield Property Inc	Partial (4 SF)	Vacant	No Address	No Address	Vacant parcel	Vacant	1	Oil cake sand was found on the site.	No wells or underground storage tanks reported	Presence of oil cake sand	No construction, ROW acquisition is required to meet Caltrans maintenance Access requirement. Field visit indicated no recognized environmental conditions found.	No

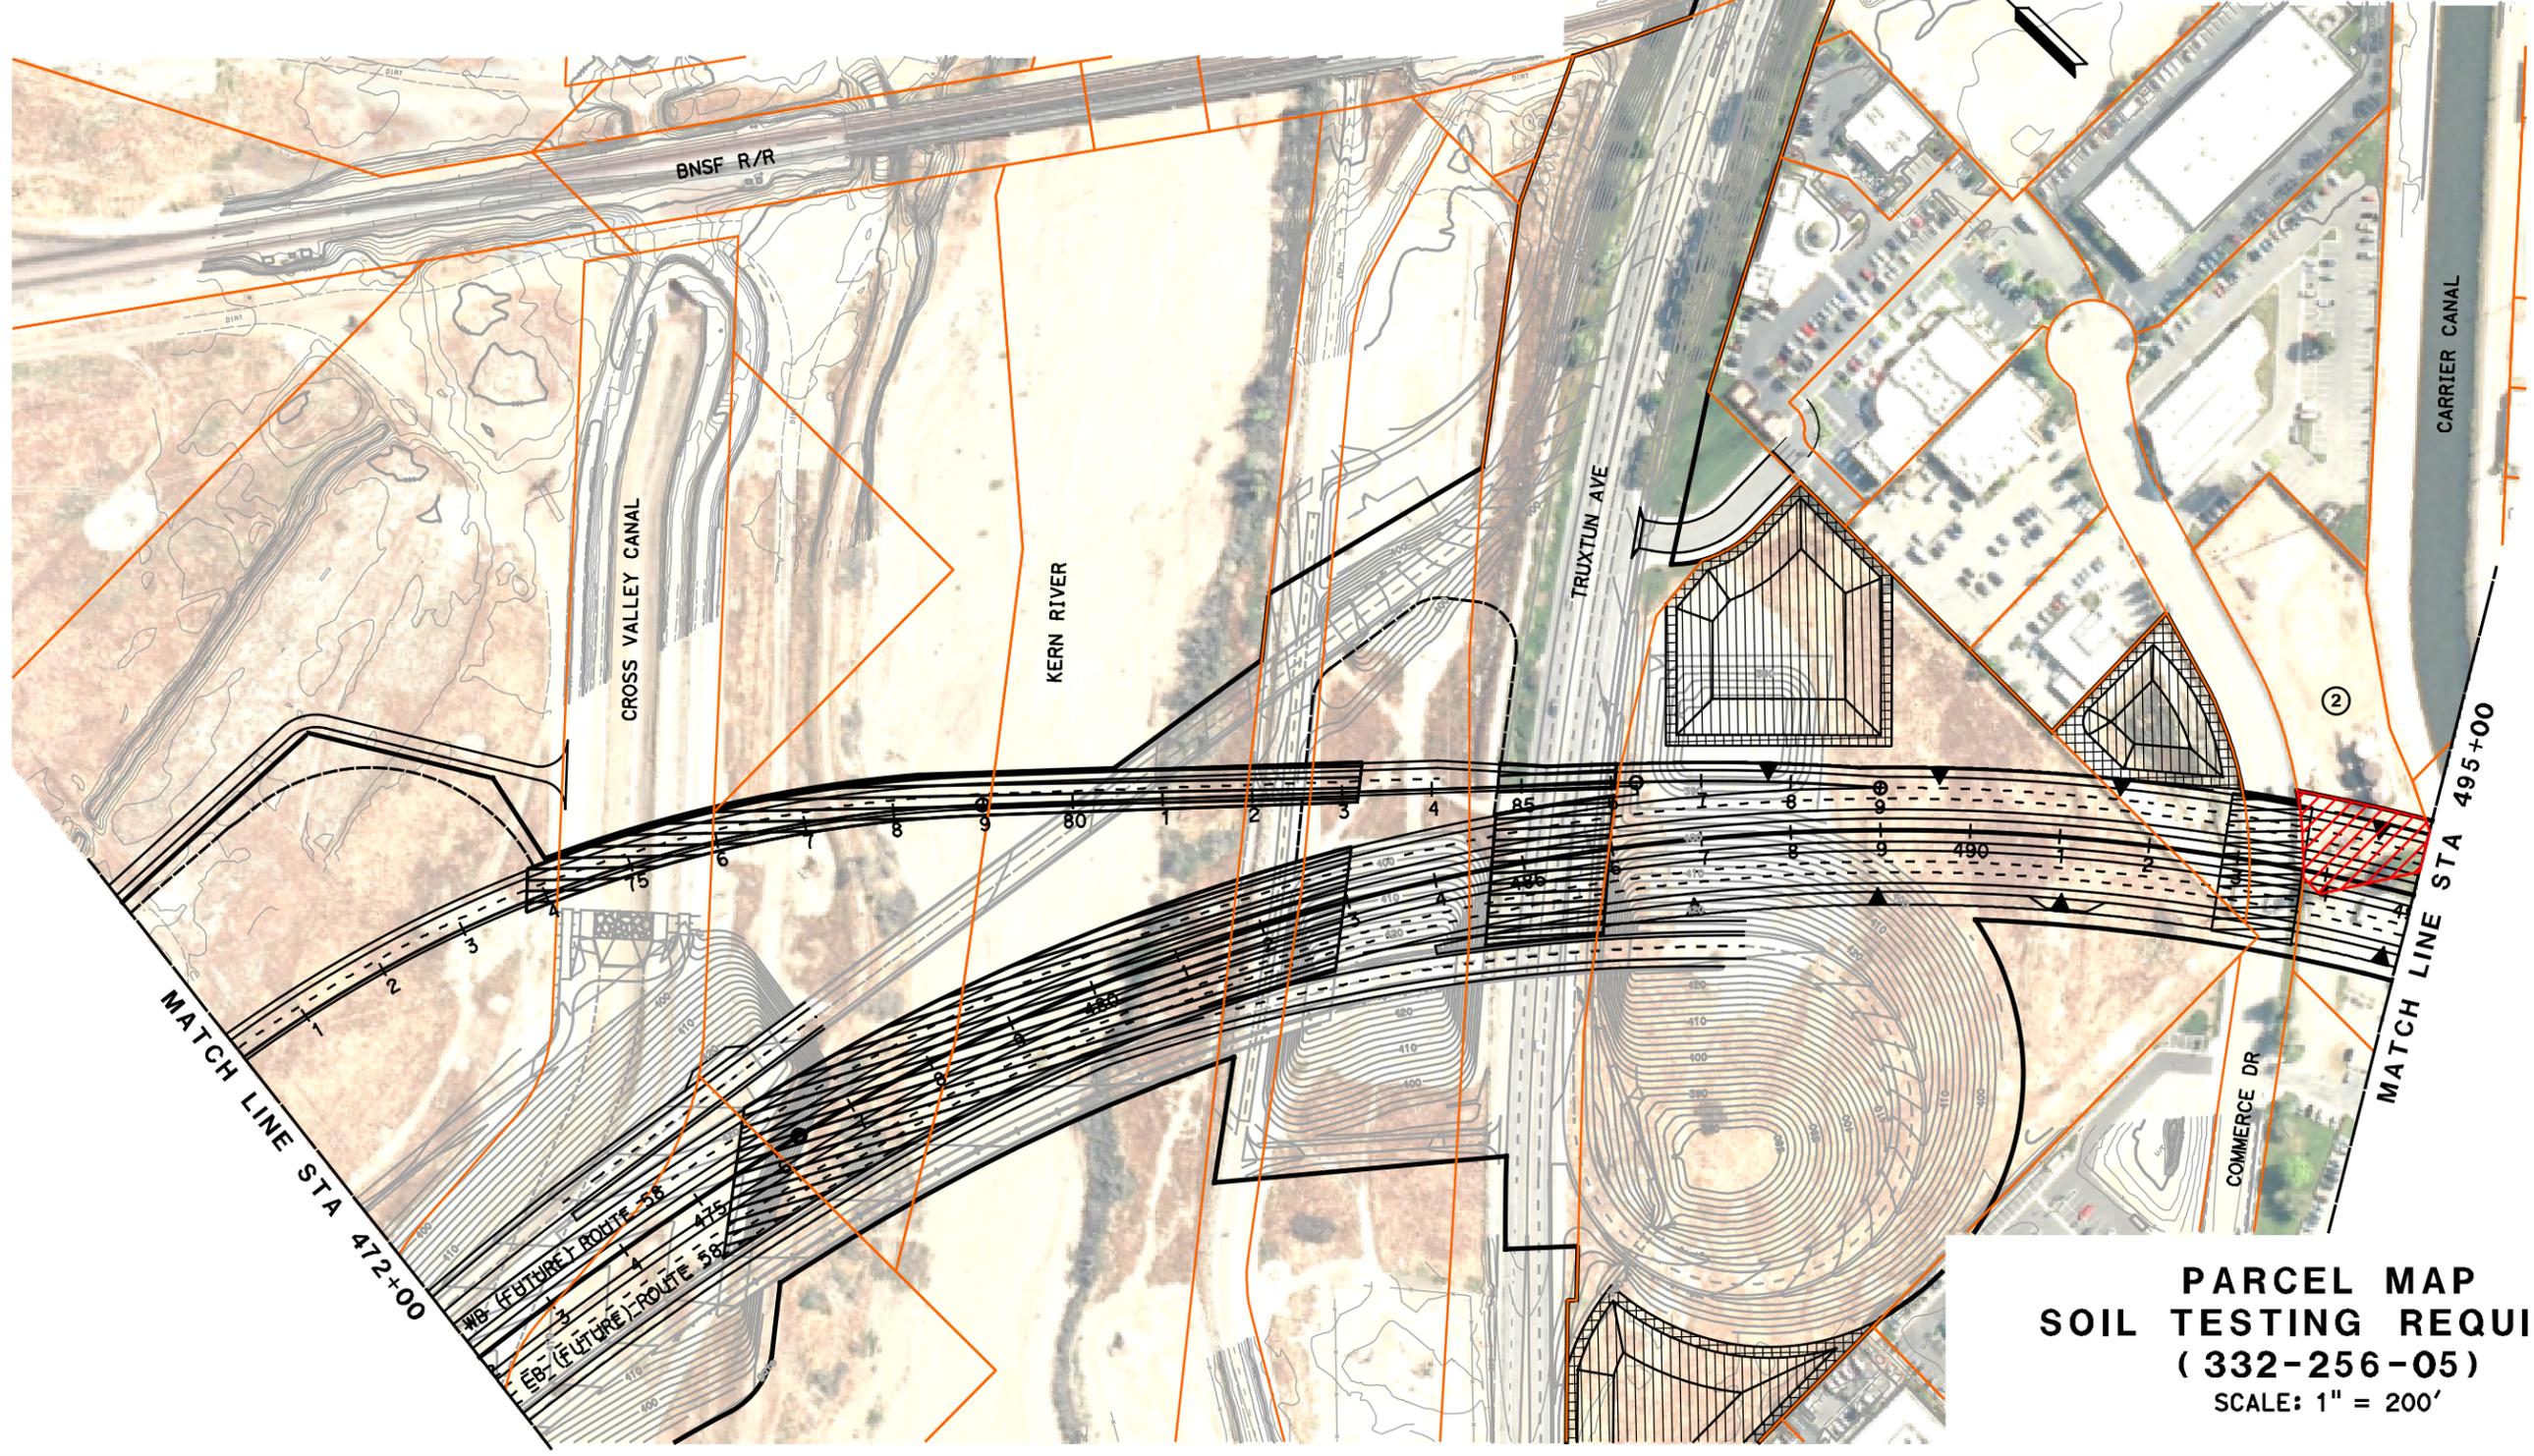
**PARCEL MAP
 SOIL TESTING REQUIRED
 (332-256-05)
 SCALE: 1" = 200'**

PARCEL SUBJECT TO RIGHT OF WAY ACQUISITION WITH SOIL TESTING REQUIRED

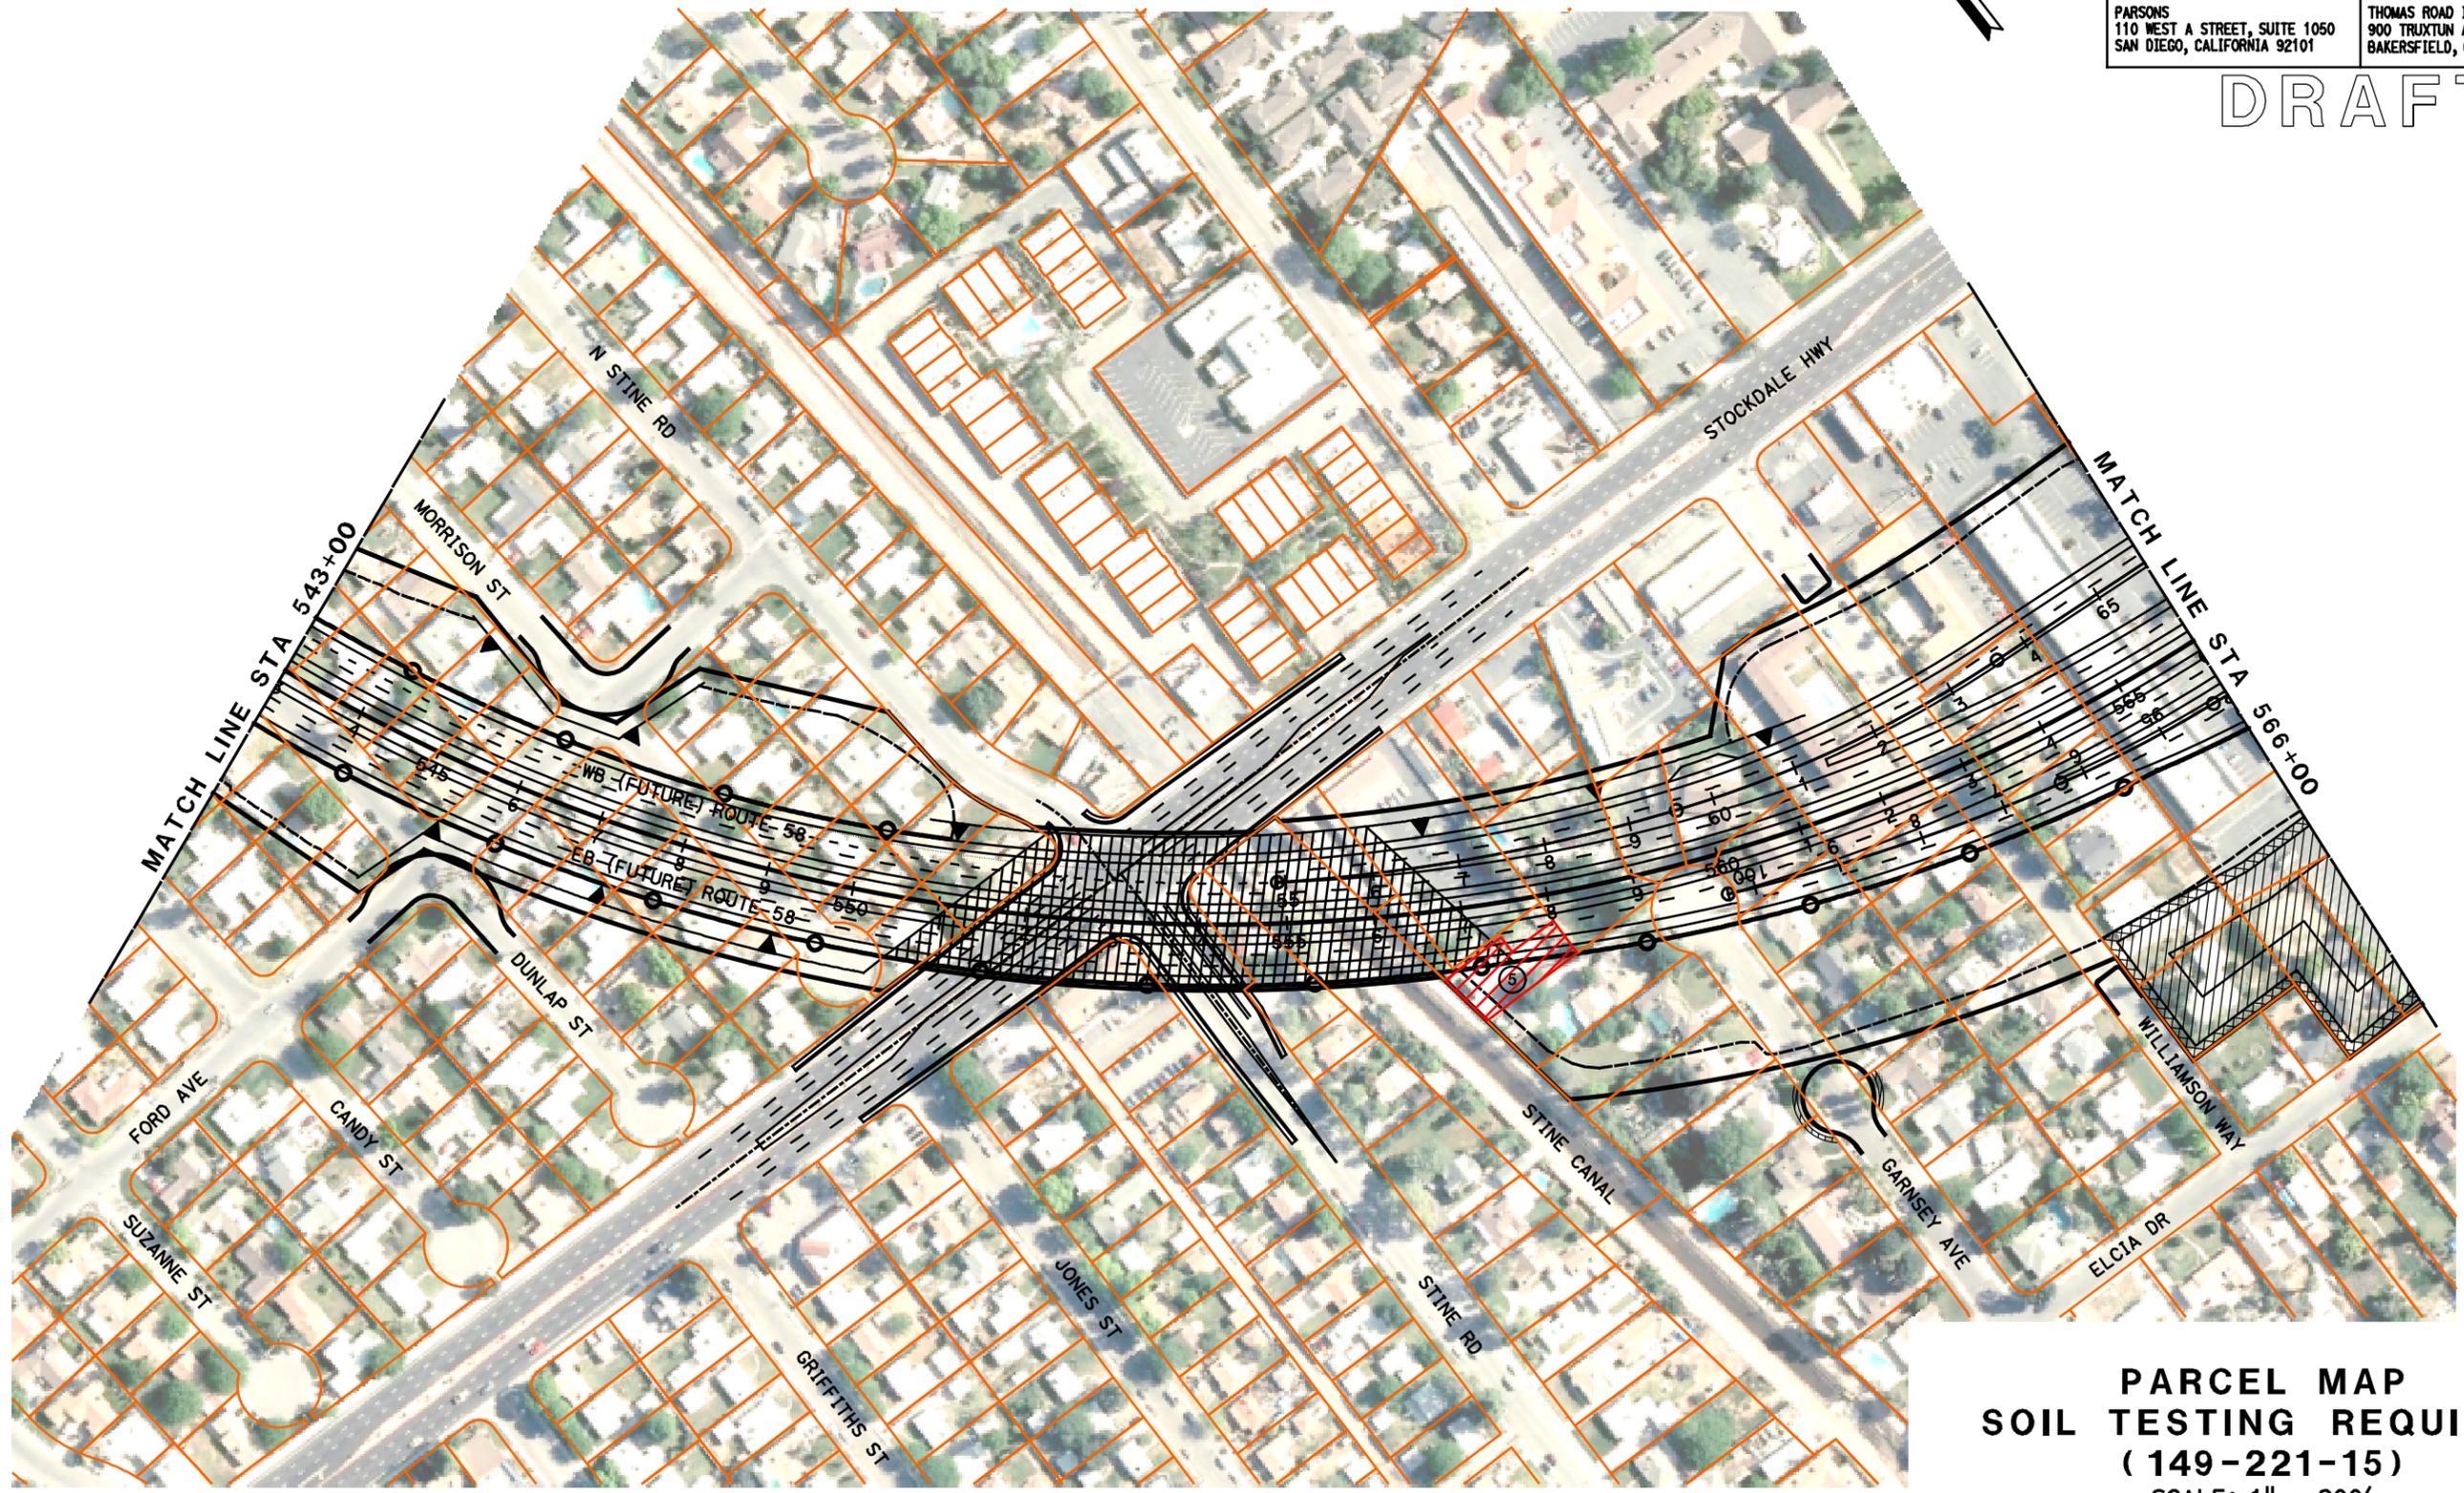
**PARCEL MAP
SOIL TESTING REQUIRED
(149-221-15)
SCALE: 1" = 200'**

⊕	APN	ACQUISITIONS		WALL EASEMENT (SQ FT)	TCE (SQ FT)	PROPOSED WORK	NOTES
		FULL	PARTIAL (SQ FT)				
5	149-221-15	X				Constructing Stockdale Highway OC, EB (Future) Route 58, and a sound wall, adding a fill slope.

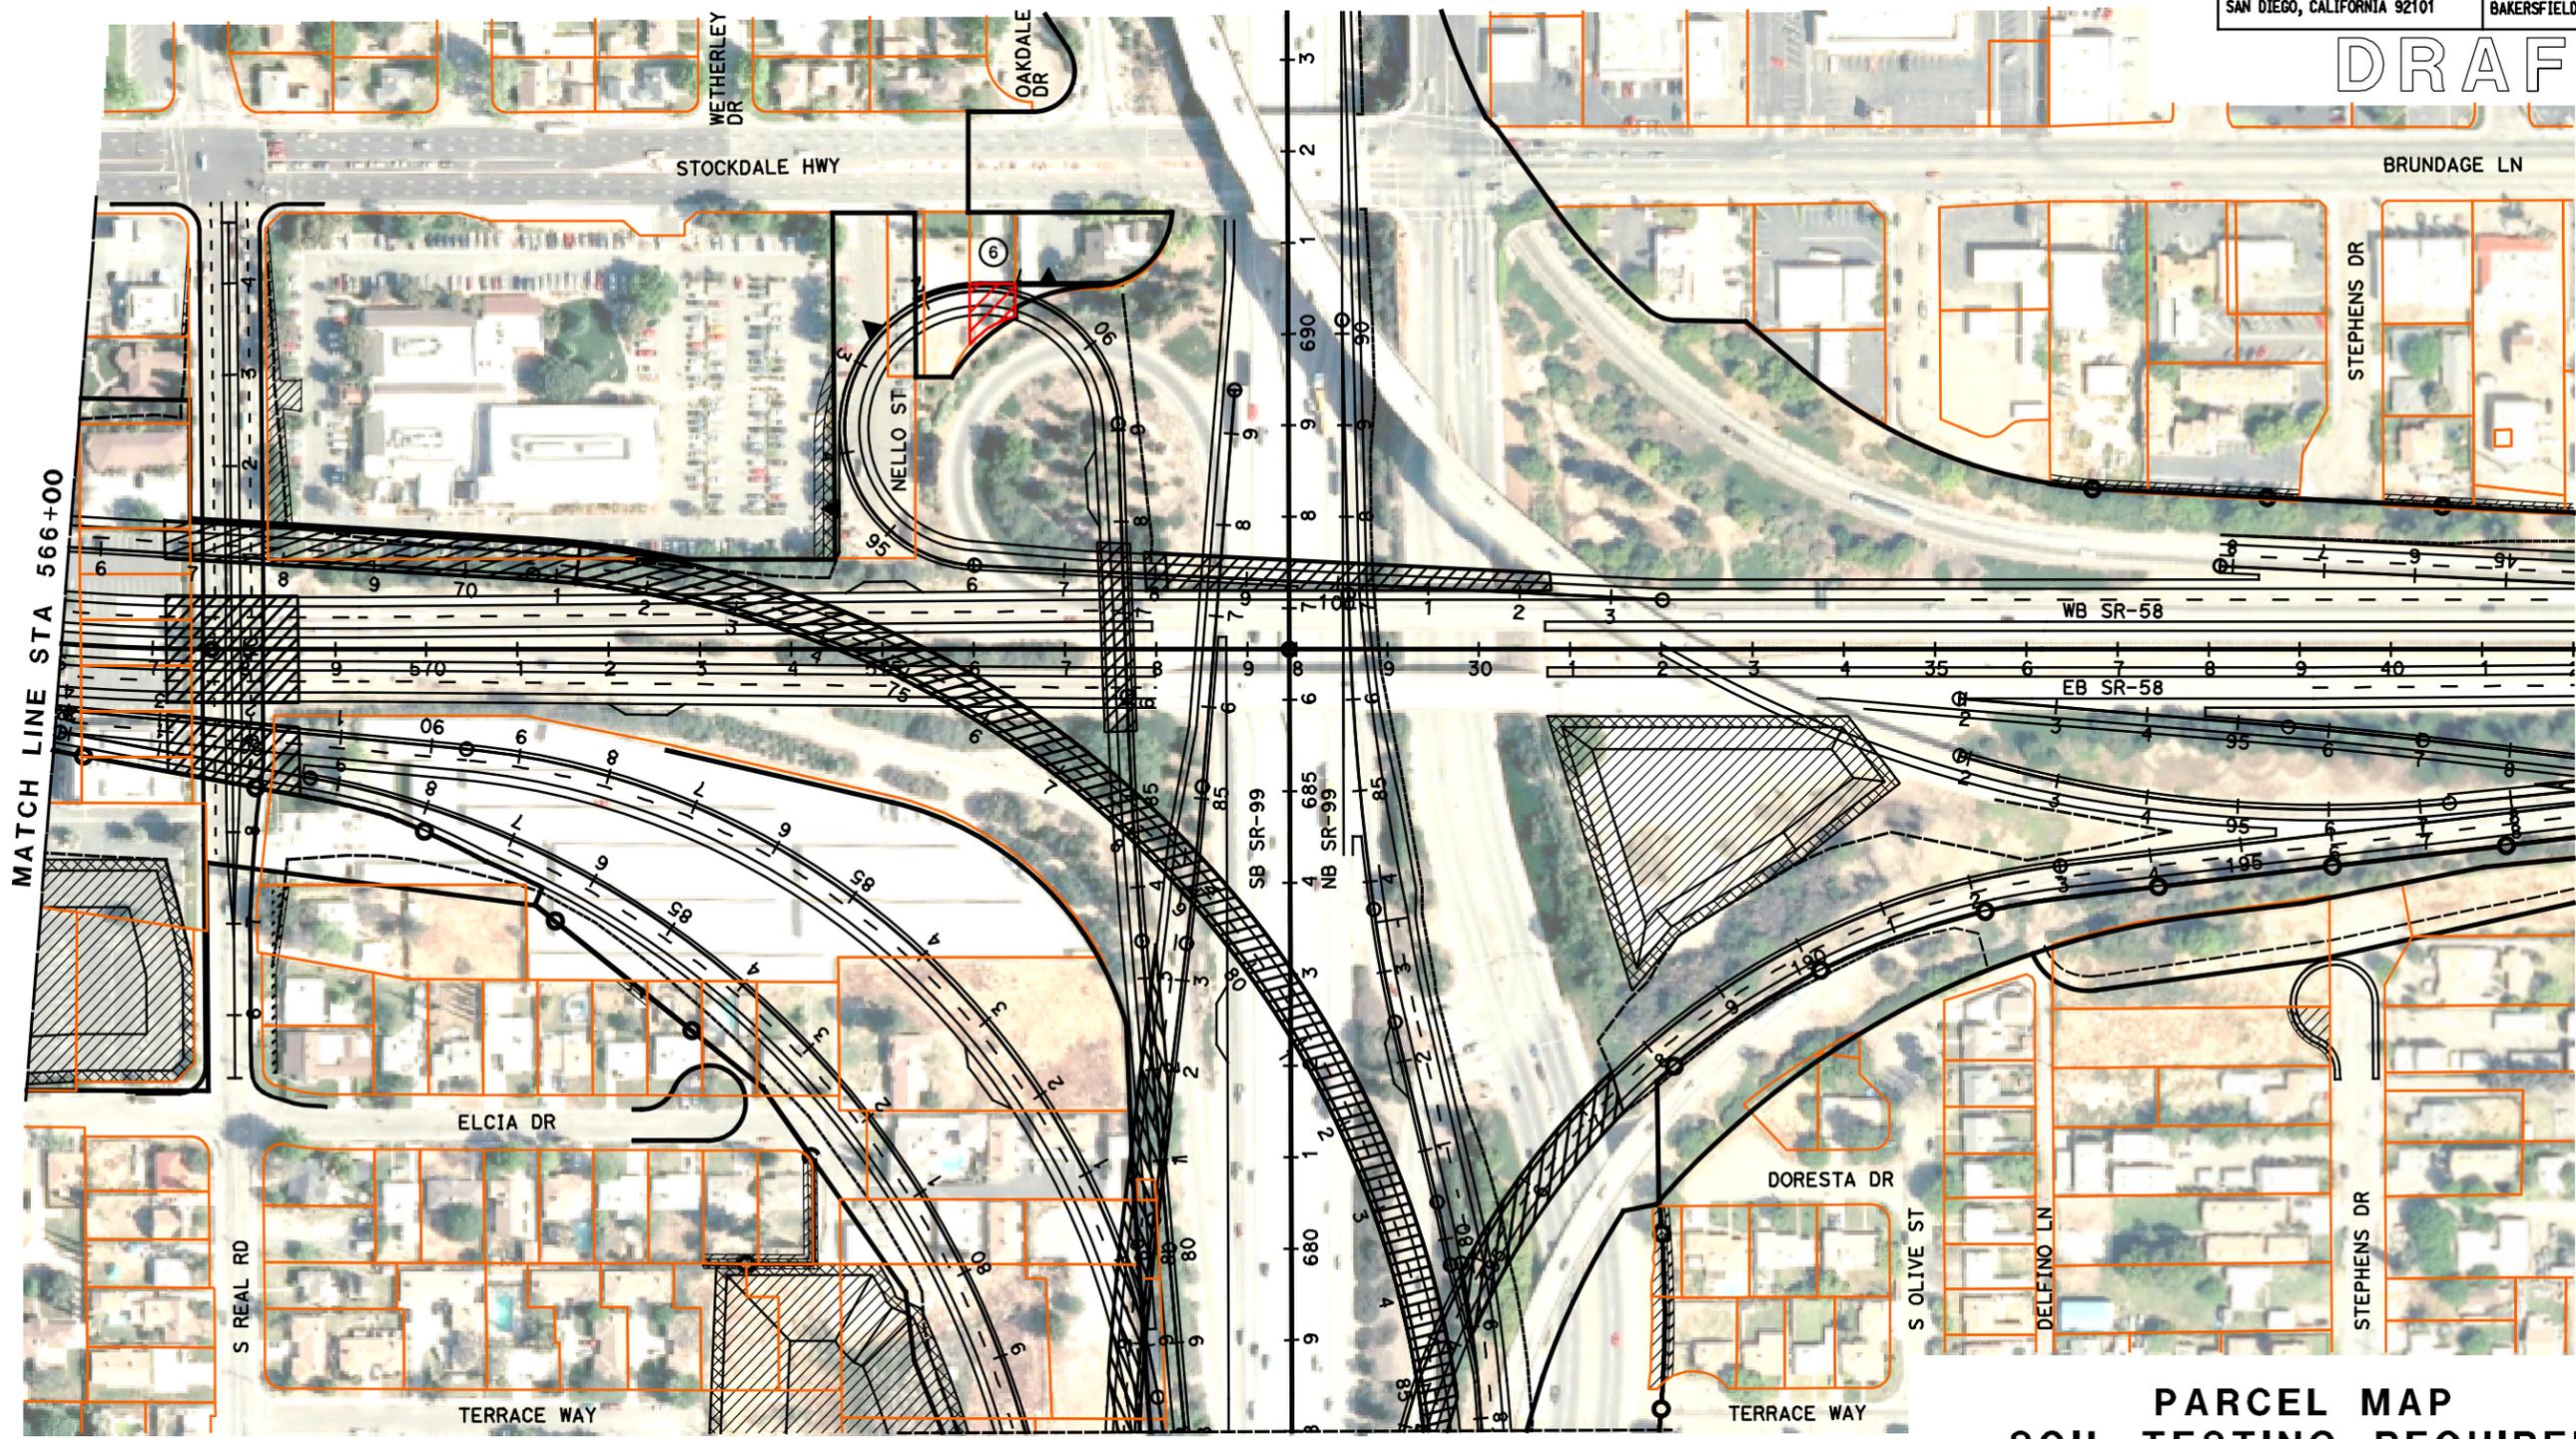
PARCEL MAP
 SOIL TESTING REQUIRED
 (149-180-03)
 SCALE: 1" = 200'

149-180-03	California Water Service Co	Full	Public Land	3333	Stockdale Highway	California Water Service	Vacant with water utility facility	3	The site is listed in the database report as "California Water Service Co" and had one 285-gallon diesel underground storage tank installed in 1967. No releases were reported for the site.	1 underground storage tank	Presence of underground storage tank	The work involves constructing WB (Future) Route 58, 40 ft retaining wall, and adding fill slope. Field visit indicated the site is completely fenced. An entry permit is required to conduct detailed inspection of the sampling location.	YES
164-040-30	David Blouin	Partial (1828 SF) Wall easement (6110 SF) TCE (3601 SF)	Commercial	1117	Wible Road	Commercial	Auto body/paint shop; Auto repair garage	3	Potential for contamination exists due to use as auto repair and paint shop.	No wells or underground storage tanks reported	Presence of hazardous materials/ wastes	The work involves constructing of soundwall and retaining wall. Wall easement and TCE are required. Field visit indicated the property is used for commercial auto repair/shop. The take area is located along the east wall of the property which is used for open parking lot. No unusual circumstance is noted in this area. No sampling is required. Final design will be done to minimize right-of-way impact. At the present time the City does not think full take is required.	No

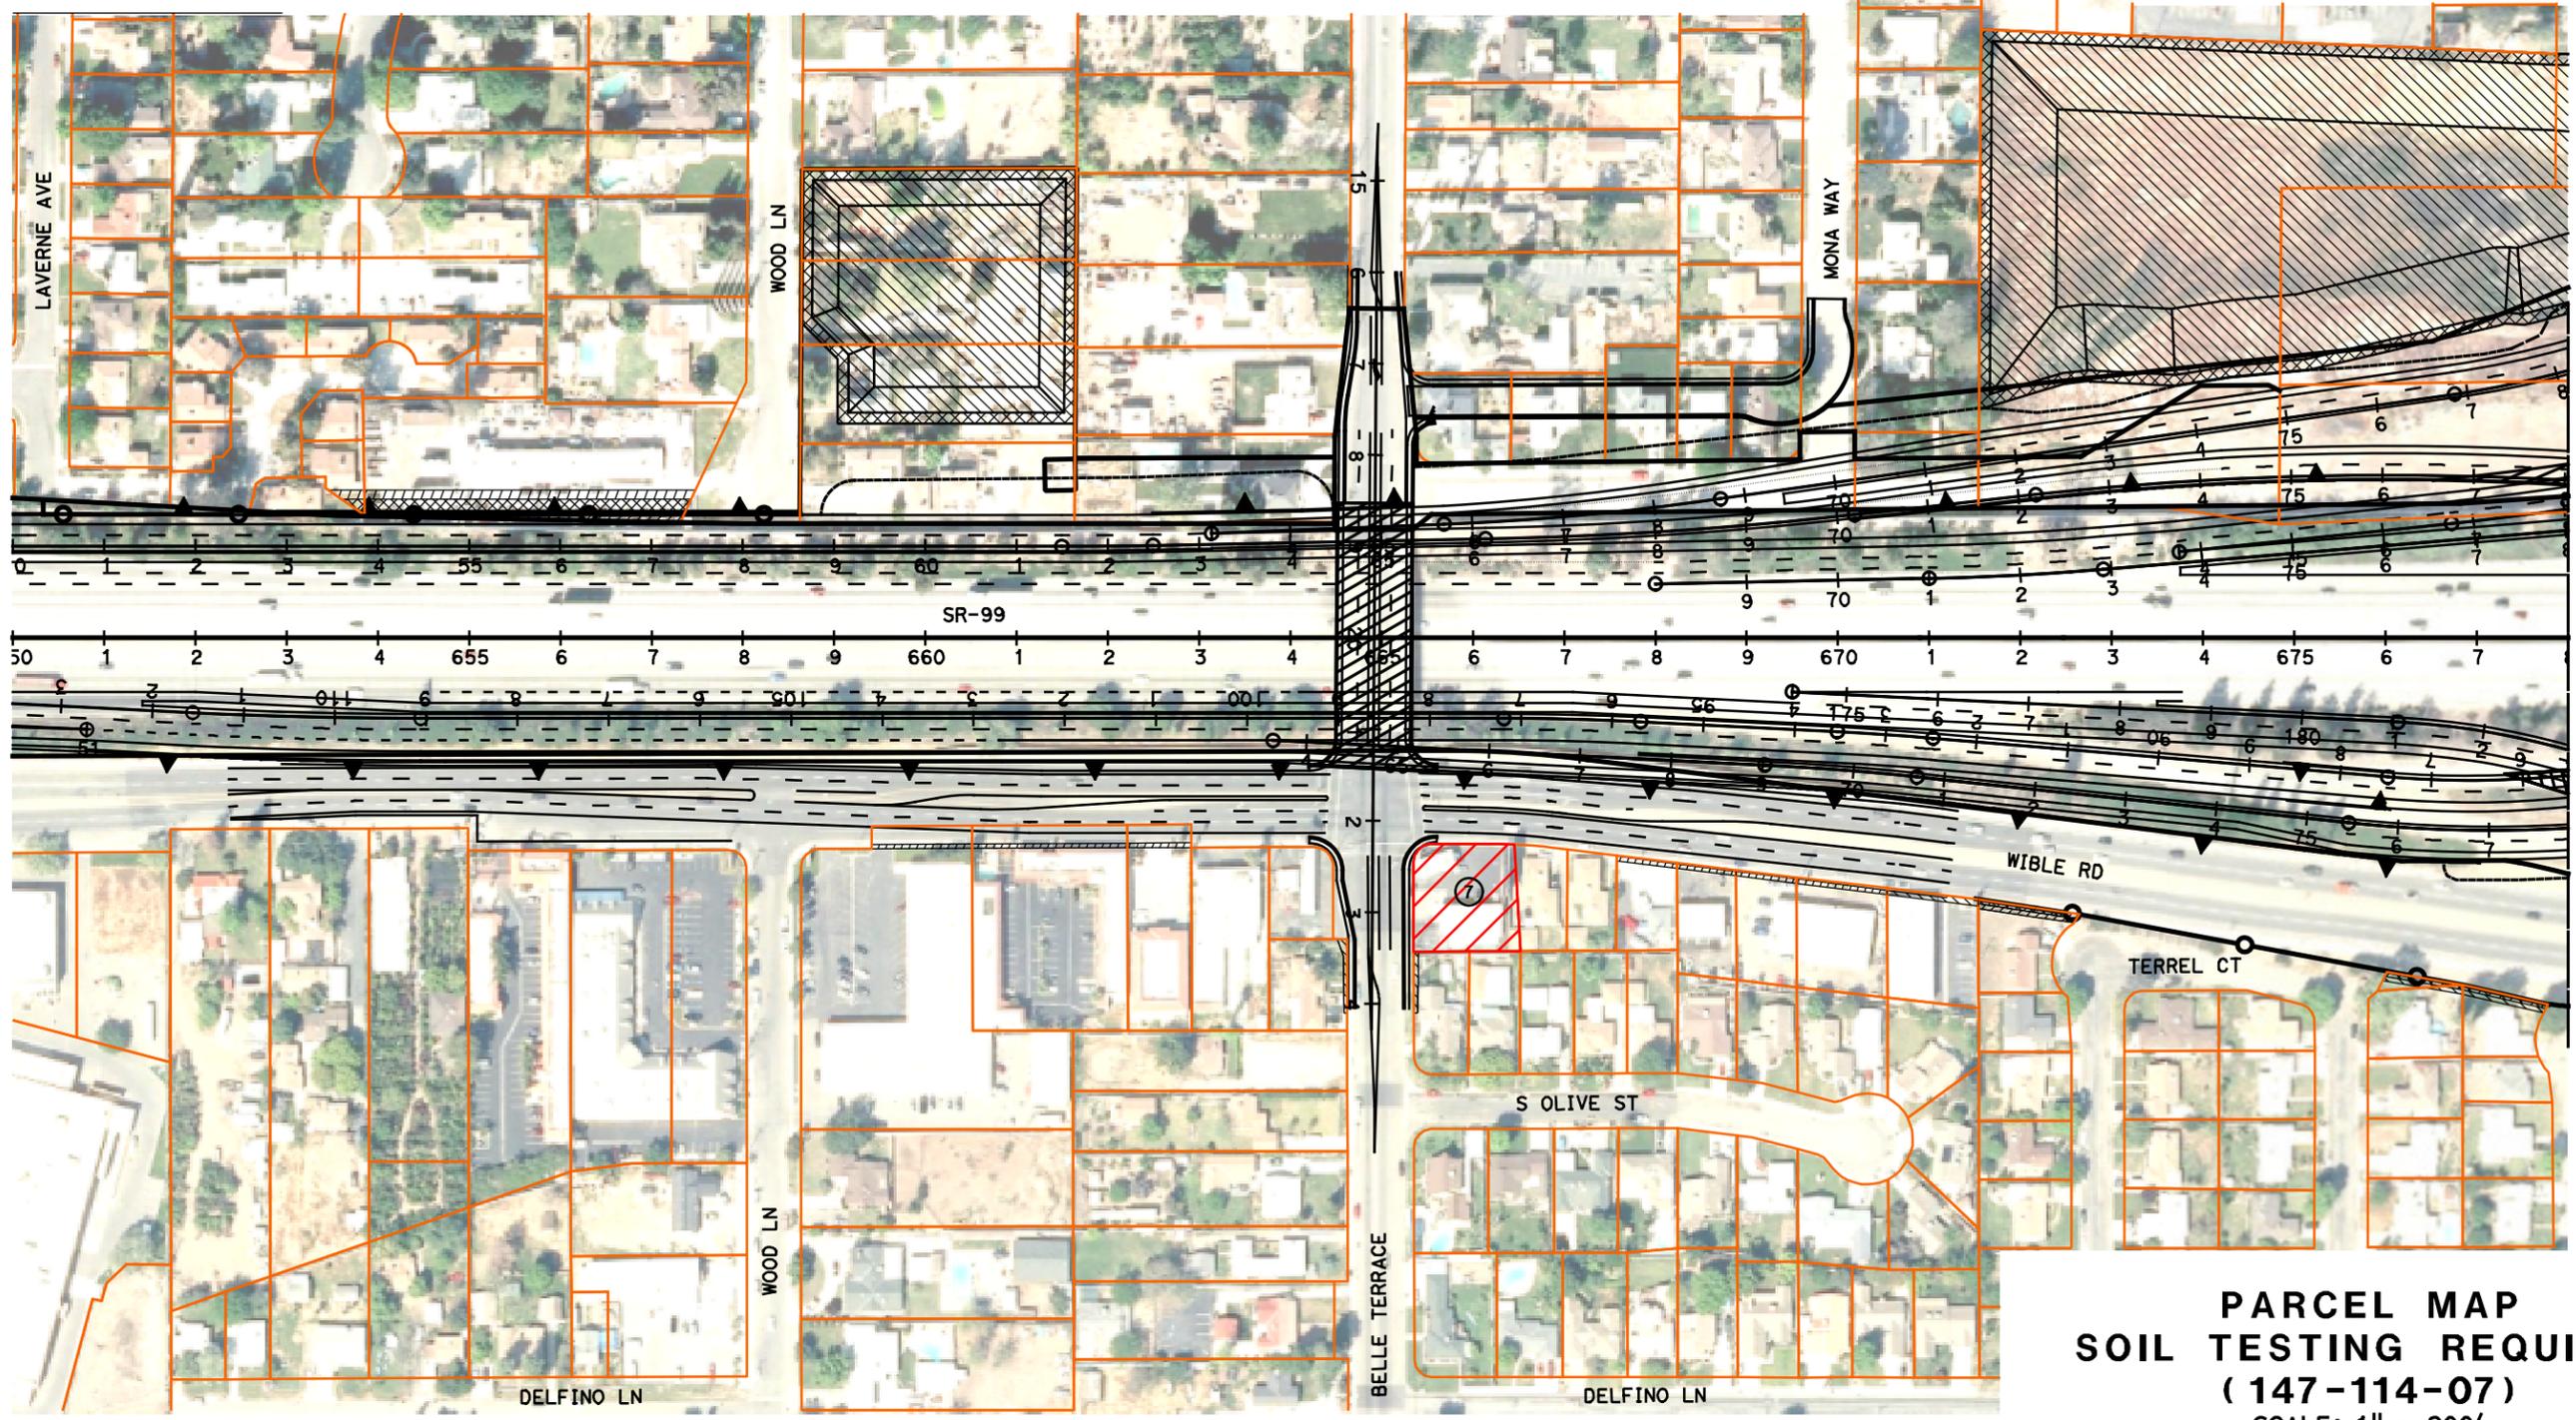
PARCEL MAP
 SOIL TESTING REQUIRED
 (147-114-07)
 SCALE: 1" = 200'

⊕	APN	ACQUISITIONS		WALL EASEMENT (SQ FT)	TCE (SQ FT)	PROPOSED WORK	NOTES
		FULL	PARTIAL (SQ FT)				
7	147-112-07	X				The Wible Road/Belle Terrace intersection is being elevated and this property will be demolished and regraded.
