Centennial Corridor Project

State Route 99 to Interstate 5

Focused Initial Site Assessment

**Focused Initial Site Assessment
Centennial Corridor Project
06-48460
KER-56 (PM T31.7/R55.6
KER-99 (PM 21.1/26.2)
October 7, 2013**

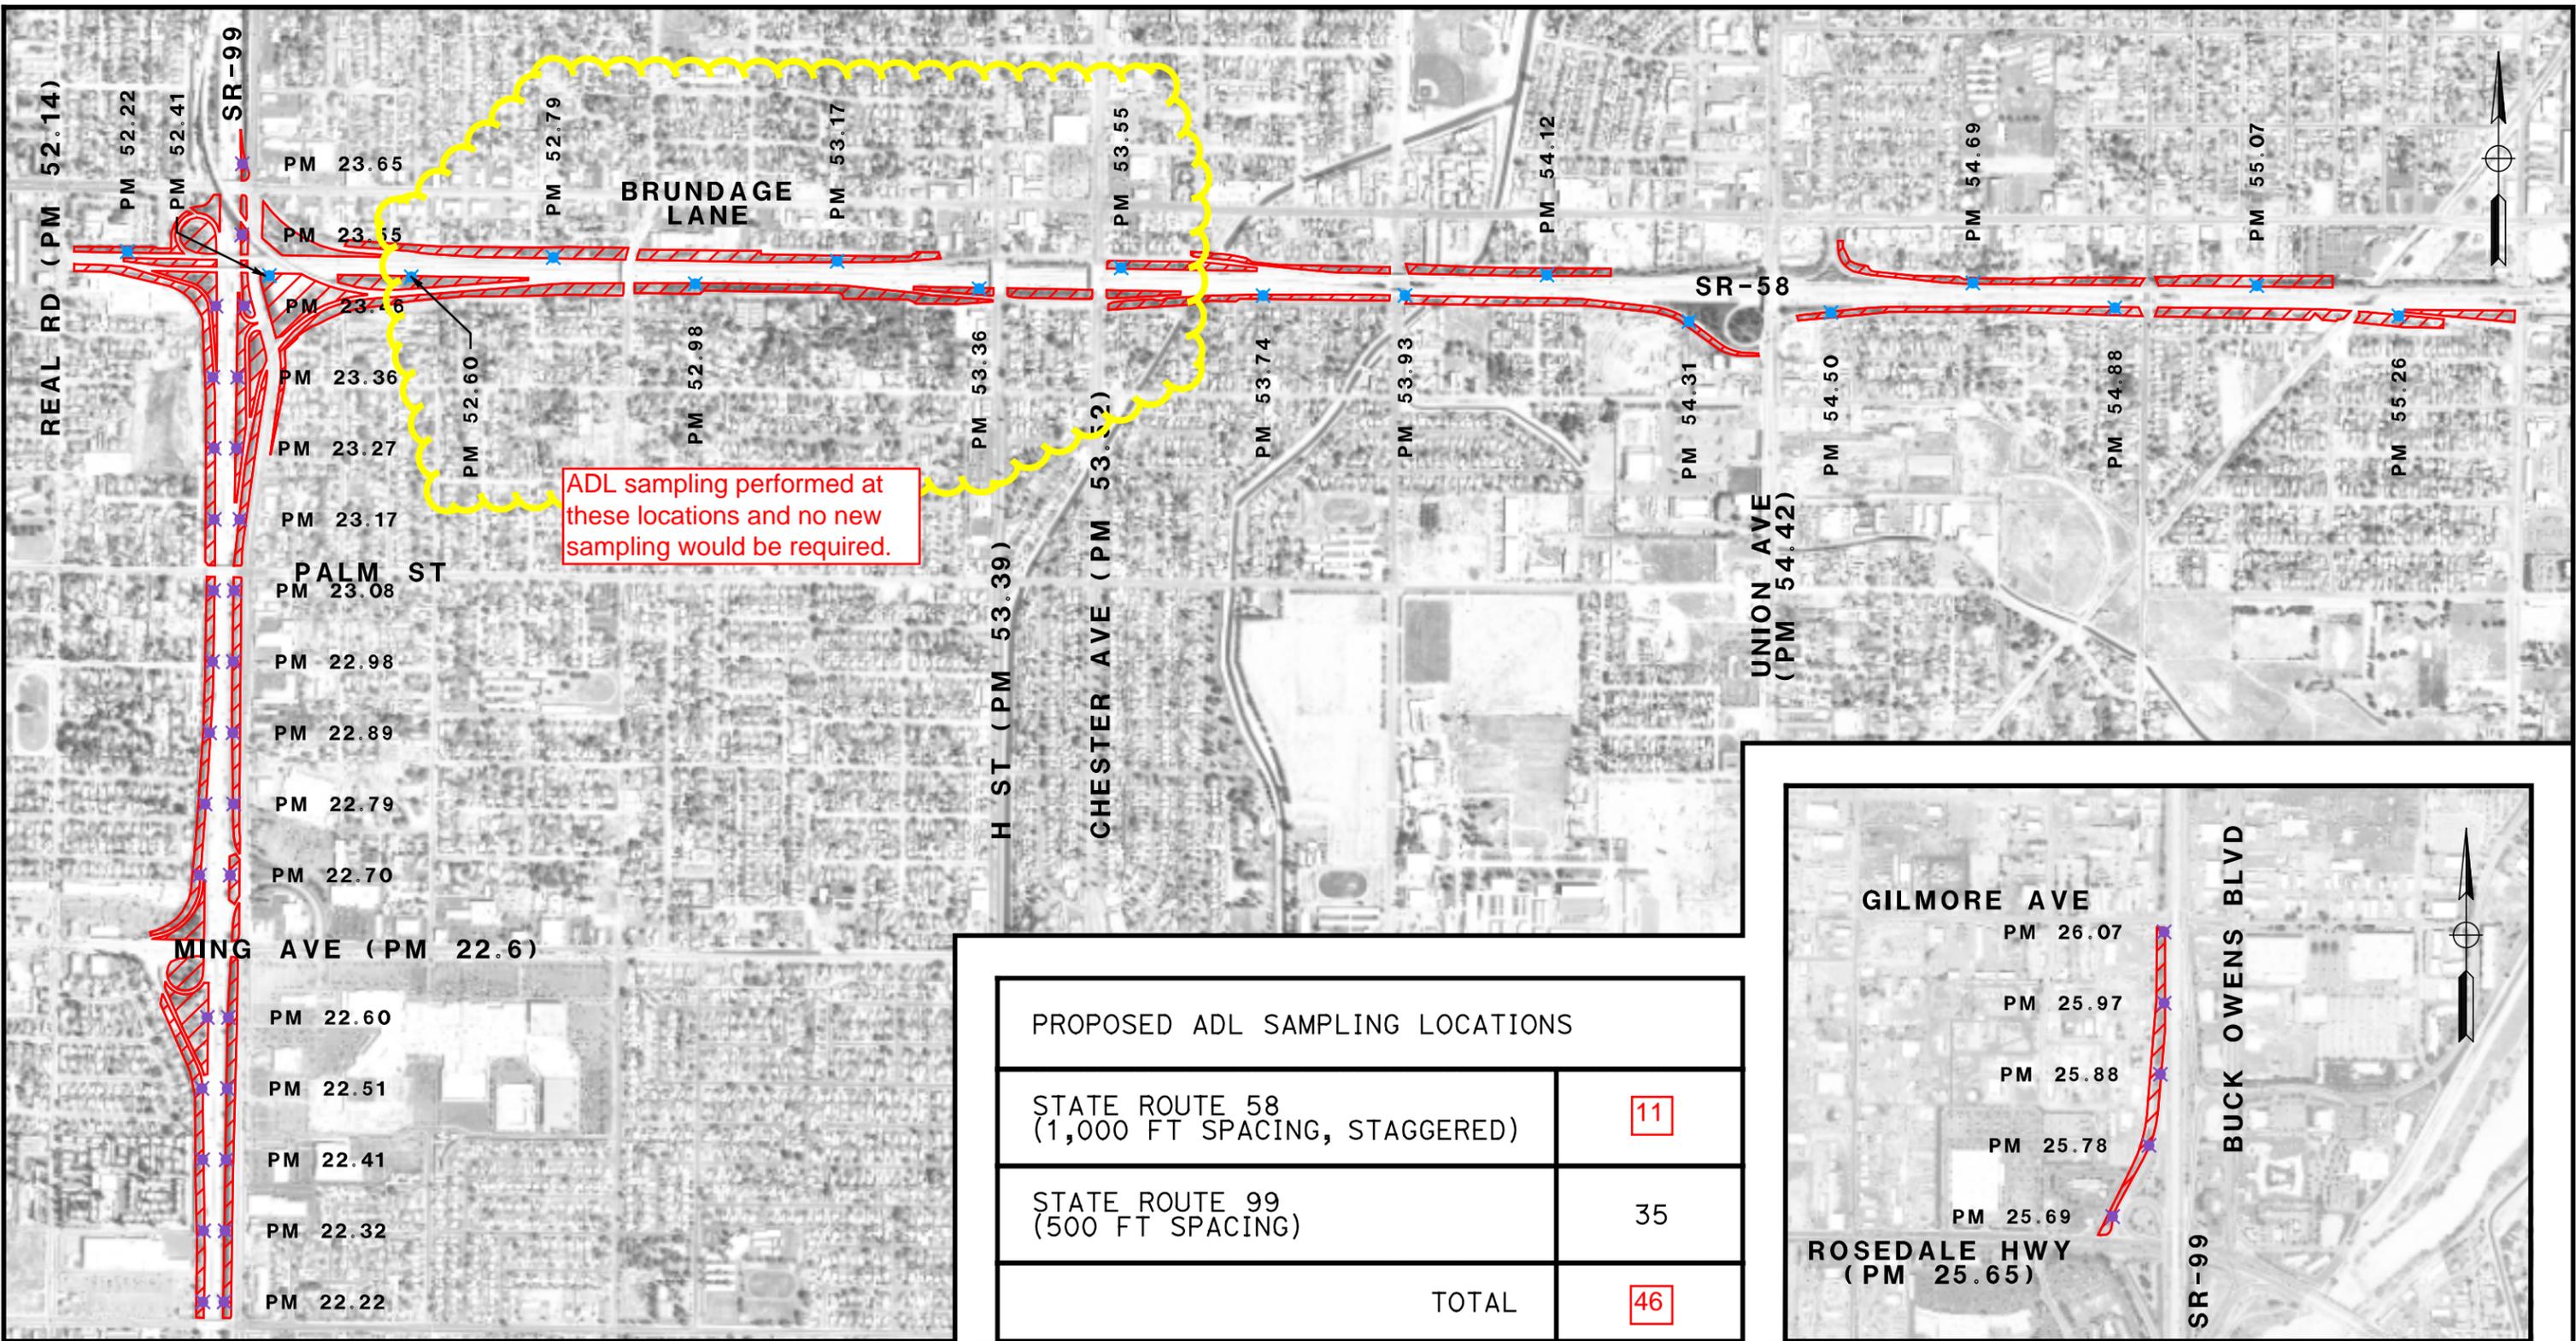
ATTACHMENT B
Recommended ADL Sampling Location Map

Aerially-Deposited Lead (ADL) sampling is recommended along major thoroughfares where soils may have been exposed to leaded gasoline emissions settling on the ground, especially around the Caltrans right-of-way and where Alternative B construction requires shallow soils disturbance along State Route (SR) 99 and SR-58. Based on the discussion and coordination with Caltrans staff, soil samples will be collected at three depths at a 500-ft interval on both sides of SR-99 within the project limits and at the 1,000-ft interval staggering on both sides of SR-58 within the project limits. Based on the information provided by Caltrans, sampling was previously performed along KER-58 PM 52.5/53.6 and KER-99 (PM 21.2/22.1) therefore no new sampling at these locations is proposed. A total of 46 sampling locations are estimated as shown in Attachment B. The appropriate special provision will be included in the contract specifications.

PROPOSED ADL SAMPLING LOCATIONS	
STATE ROUTE 58 (1,000 FT SPACING, STAGGERED)	11
STATE ROUTE 99 (500 FT SPACING)	35
TOTAL	46

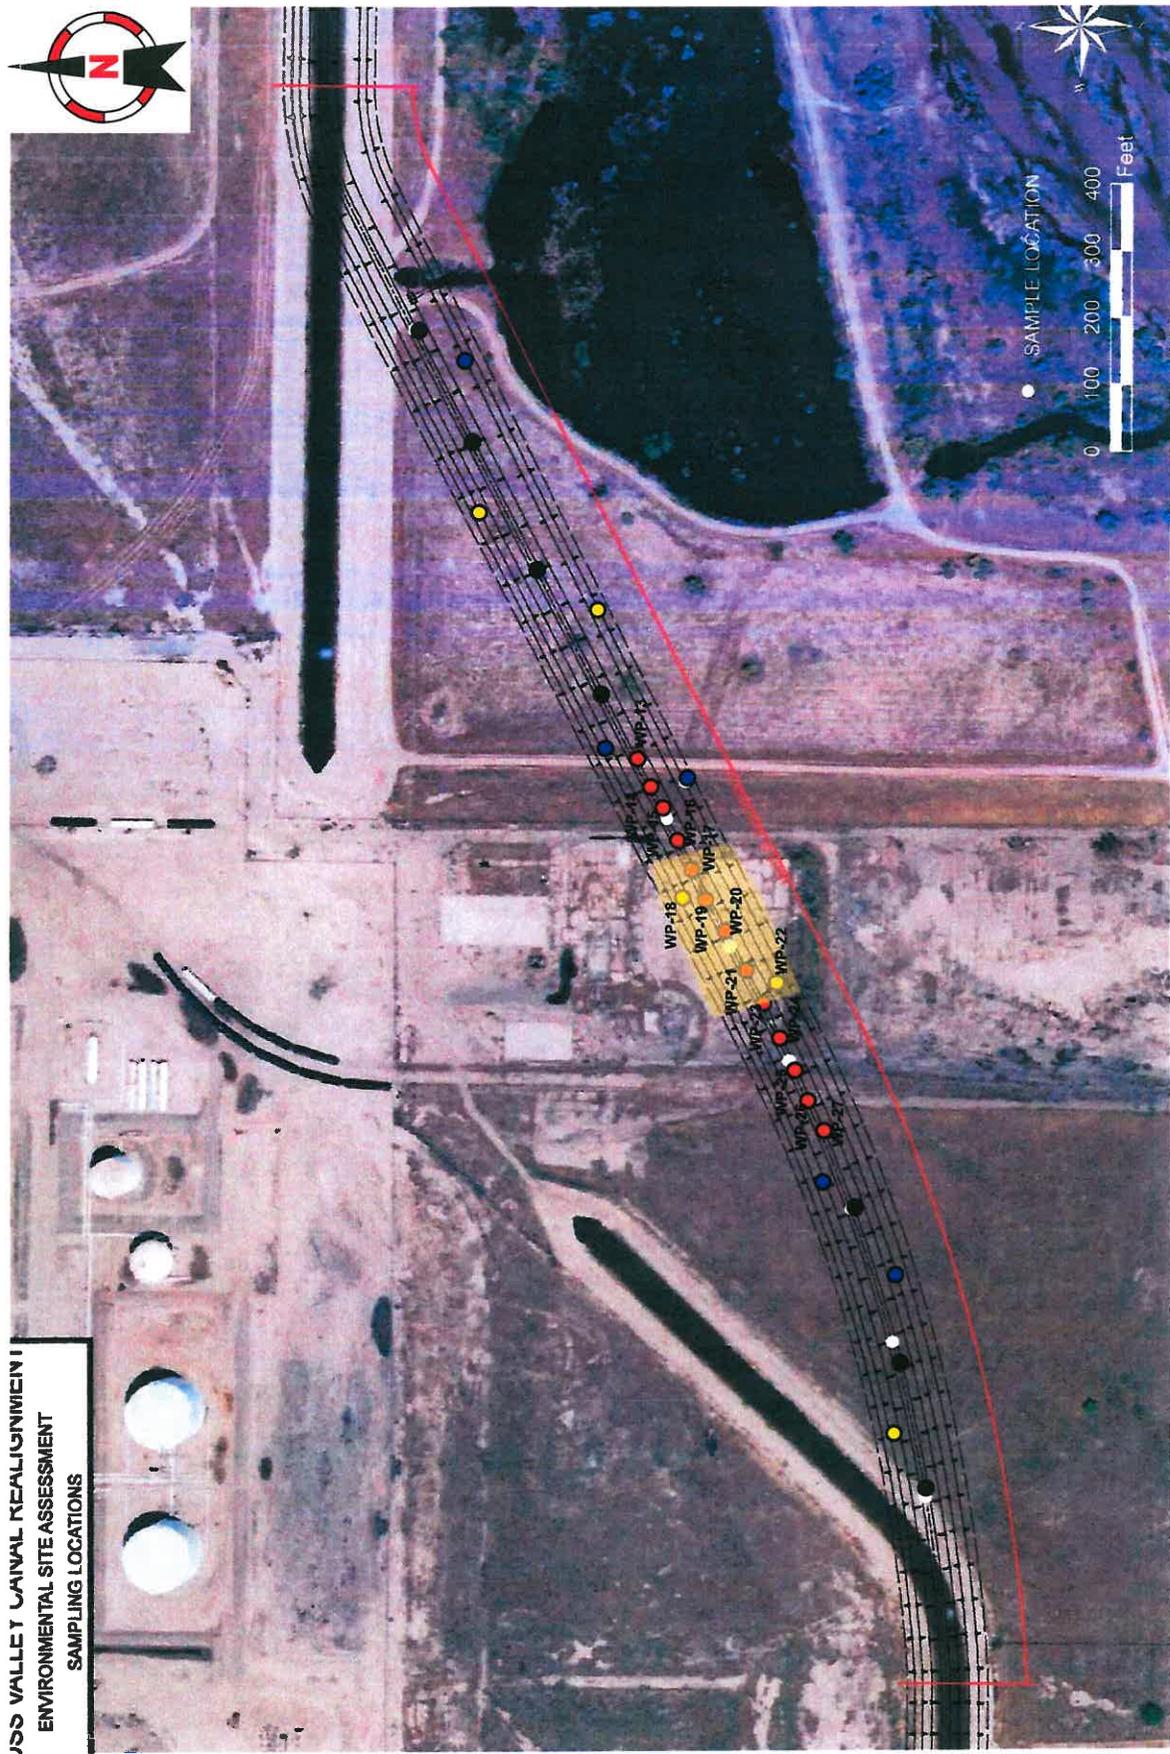
**SS VALLET CANAL REALIGNMENT
ENVIRONMENTAL SITE ASSESSMENT
SAMPLING LOCATIONS**

● 1, 3, 6, 9, 12, 15, 20 feet
● 2 feet
● 5 feet
● 12 feet
