**REPORT NO. FHWA-CA-TL-78-14**

# **SURFACE TEXTURES FOR PCC PAVEMENTS**

**FINAL REPORT  
APRIL 1978**

**Caltrans**  
CALIFORNIA DEPARTMENT OF TRANSPORTATION

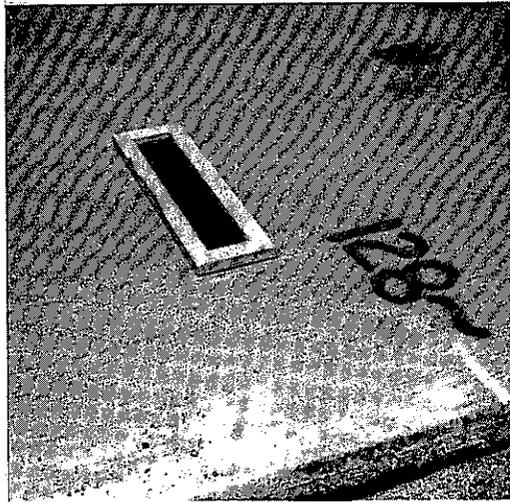
Figure 5 - Resin Casting.

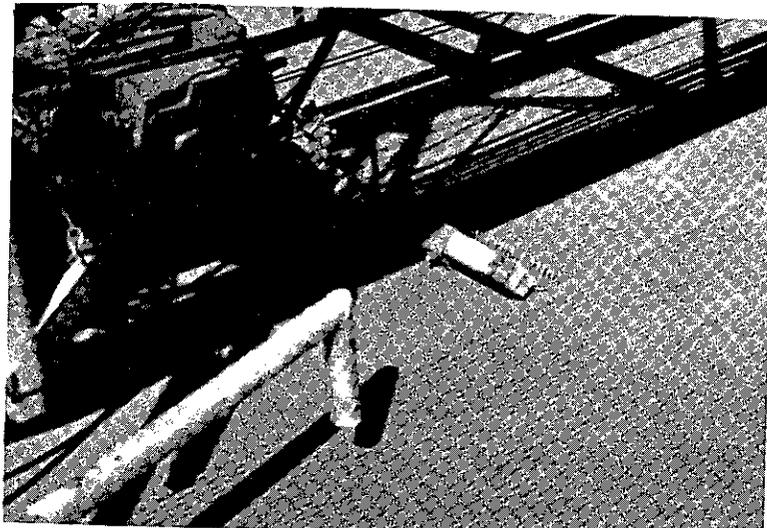
Figure 21 - Transverse Steel Tine Comb  
5 in. (127 mm) tines bent to  
make 4 in. (100 mm) tines at  
1/2 in. (13 mm) centers.

One more attempt was made with the 1/2 in (13 mm) spaced wire tine comb to try and get a deeper groove. The 5 in. (127 mm) tines were bent into an "L" shape (see Figure 21) giving an effective length of 4 in. (100 mm). As can be seen on the profiles a deeper groove was obtained, but due to the tine configuration a pulling of grout was observed.
